TAMAR CANAL, GUNNISLAKE, CORNWALL

Results of archaeological monitoring and recording

Scheduled Monument: Canal lock, island and salmon keeping pond known collectively as the Tamar Canal (National Heritage List no 1007302)

Document No: ACD1420/1/0

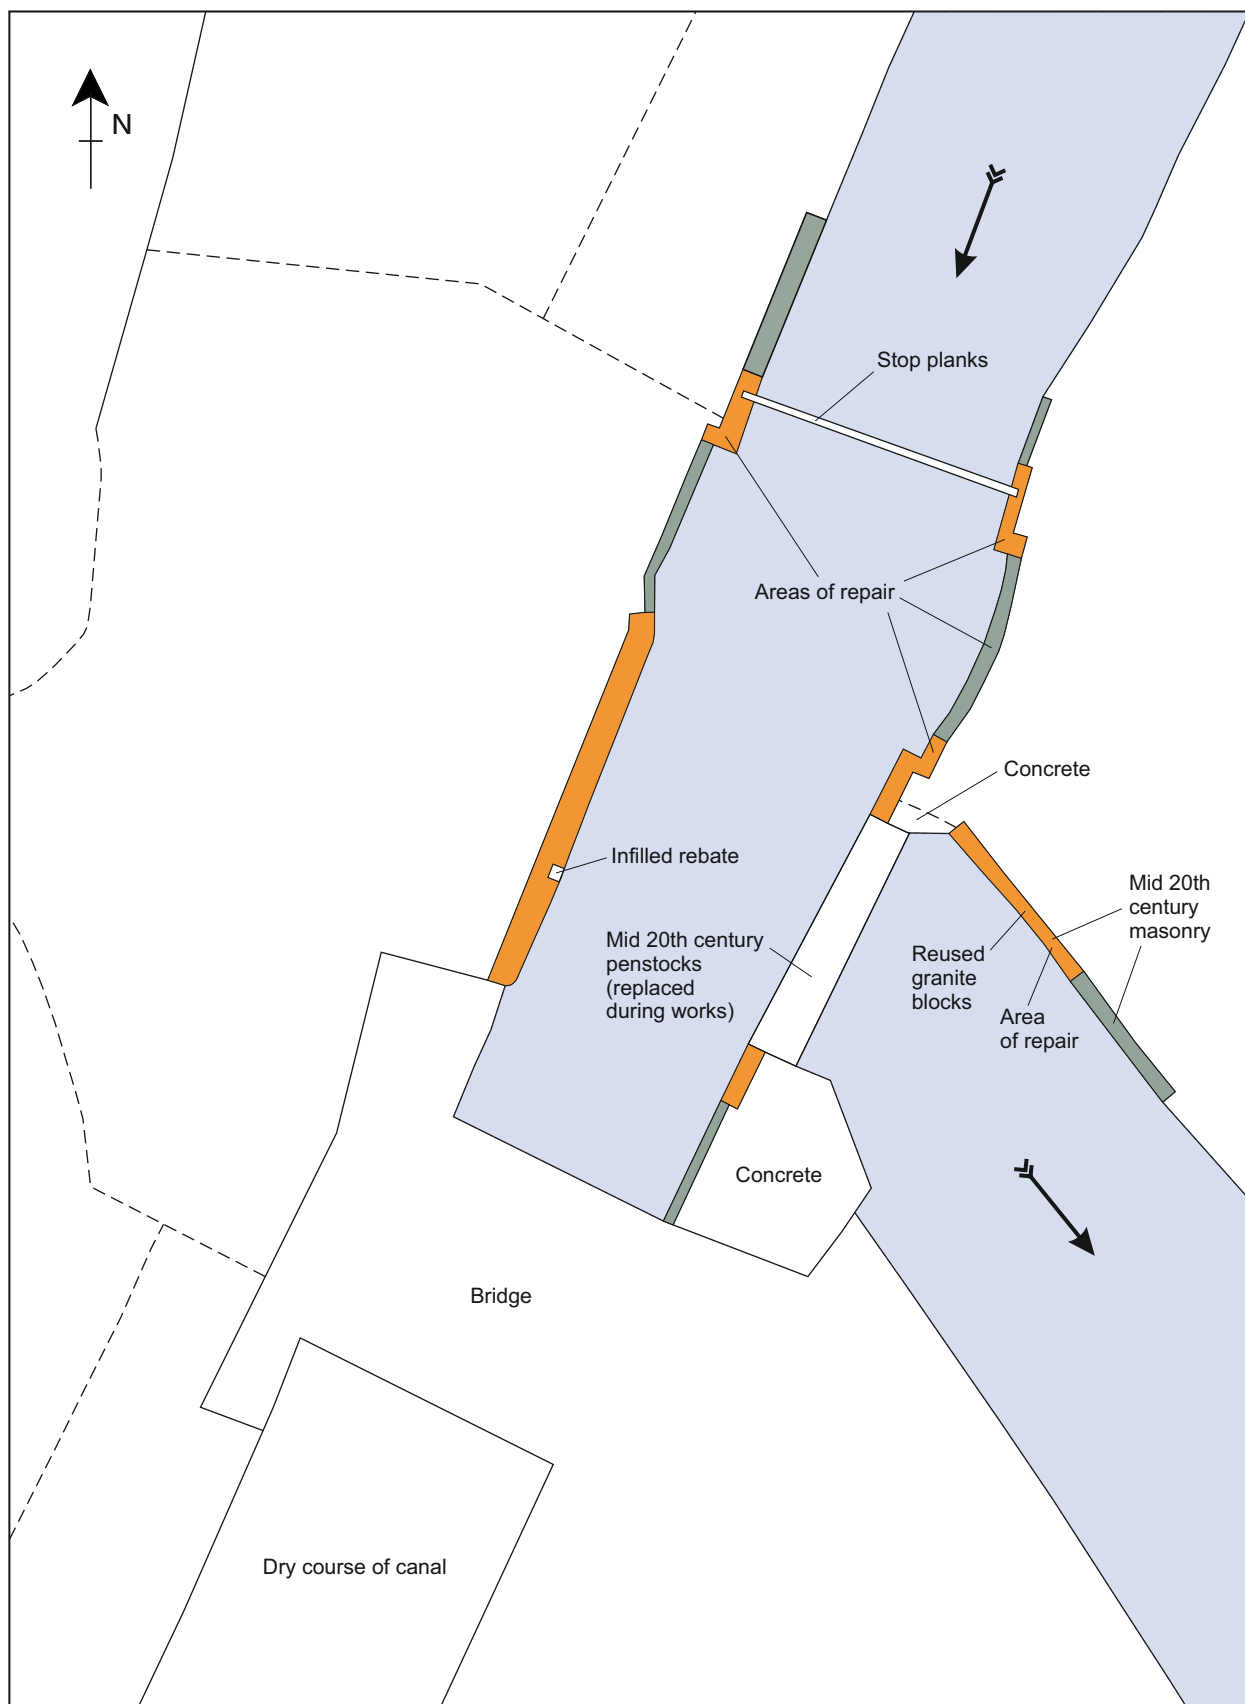
Fig. 2: Plan of lock showing location of repairs

- 1.5 The repairs took place in three nearby locations – the inside of the east face of the lock, the inside of the west face of the lock, and the wall at the head of the overflow channel. This comprised the drilling of injection ports to insert resin to plug water leaks, and involved drilling down through the historic stone walls from within the canal (but above water level), and in the mid 20th-century masonry of the overflow channel to the east. Works also took place to the nearby mid 20th-century penstocks, but did not impact on any historic masonry or architectural features.

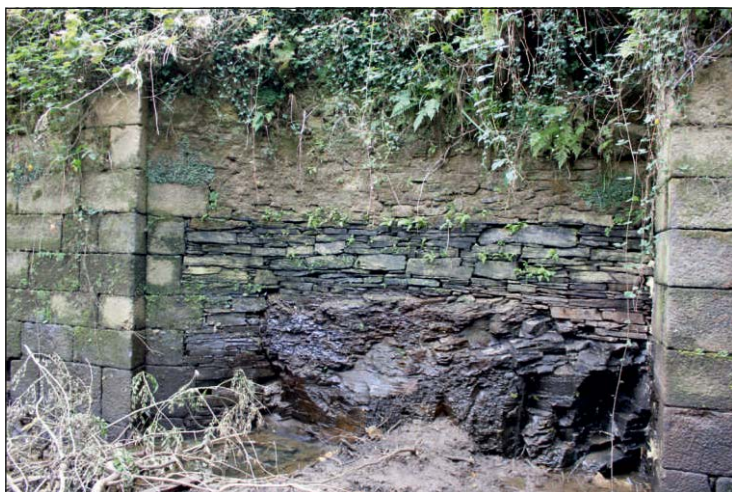
4.1 The lock is constructed into and onto bedrock which at the time of the survey was visible in the west face below the masonry (Plate 1). The main walls of the lock are constructed of tooled/dressed granite blocks measuring up to 0.7m long by up to 0.40m high and at least 0.35m deep extending back beyond the face, as well as smaller rectangular blocks of slate of varying size.

Plate 1: The recess in the west side of the lock showing the bedrock below, looking west

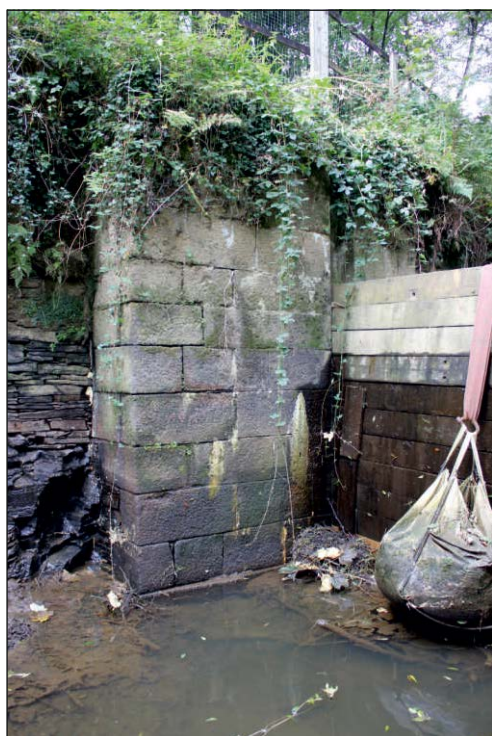
4.2 At the north end of the structure the granite masonry projects into the lock and incorporates rebates into which stop planks were inserted during the repairs (Plates 2 and 3); these are constructed onto slightly projecting footings on the west side visible that are only visible when the water within the lock is drained. To the south are recesses – one with a broad curve (Plate 4) and one with an angled straight side (Plate 1) using mainly coursed blocks of slate to within 0.20-0.35m of the present ground level. The north and south edges of this masonry incorporate granite quoins tying it into the adjacent granite walls. On the west side of the lock, to the south of the curved recess is a length of granite wall laid onto bedrock (Plate 5). Two-thirds of the way along this wall the masonry incorporates a vertical rebate, filled with concrete. This extends down to the bedrock, but it is capped with masonry, overgrown with vegetation that was not removed, that may represent a mid 20th-century repair. Beyond the end of the granite wall bedrock is visible in the side of canal overlain by soil covered with vegetation (Plate 6).

Plate 2: The granite masonry at the north end of the lock showing rebate, looking north

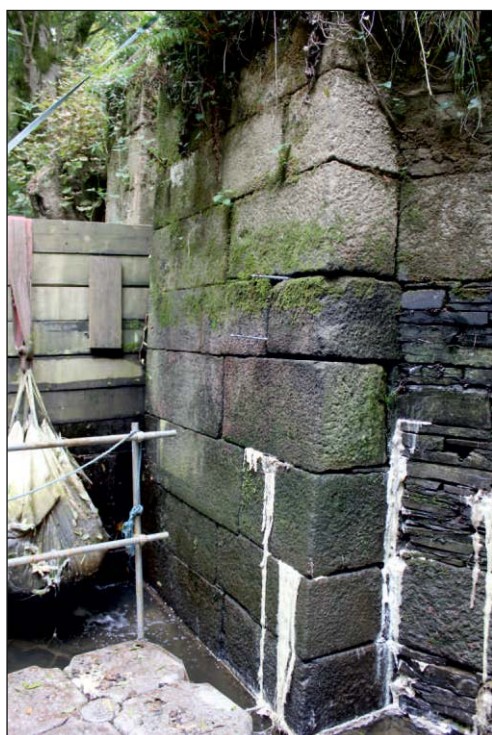
Plate 3: The granite masonry at the north end of the lock showing rebate, looking northeast

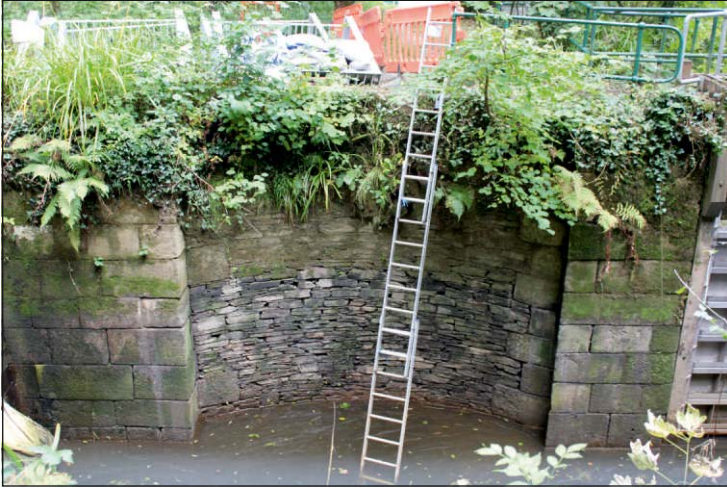
- 5.1** From a conservation point of view the methodology used to plug the leaks is a sensitive, effective technique. The stone masonry incurred almost no damage, and way the technique plugs the leaks within the masonry leaves no trace on completion (see Plate 4). Thus, the repairs remain hidden and the architectural value remains unchanged with no visible evidence that repairs have taken place.

Plate 4: The recess in the east side of the lock, looking southeast

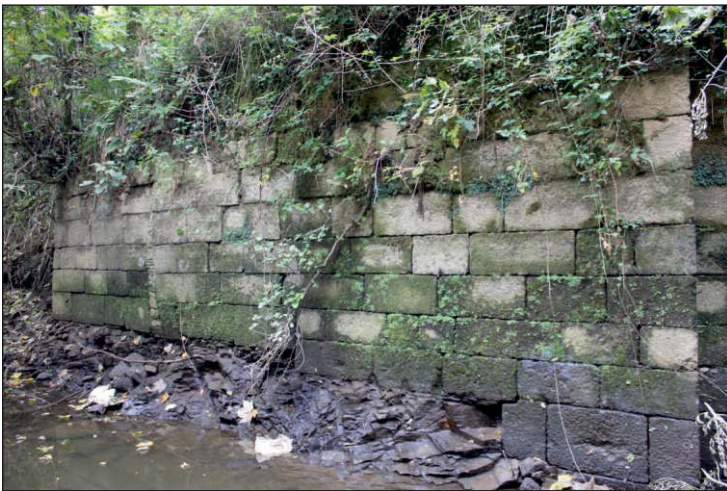
Plate 5: The granite masonry on the west side of the lock showing blocked rebate, looking southwest

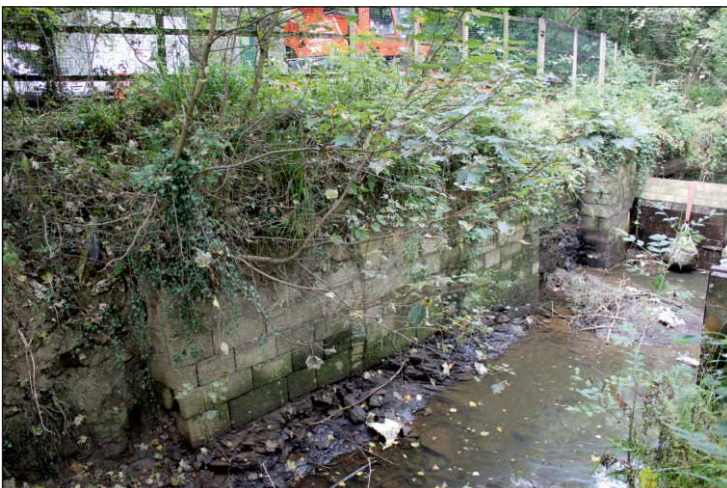
Plate 6: The west side of the lock, looking north

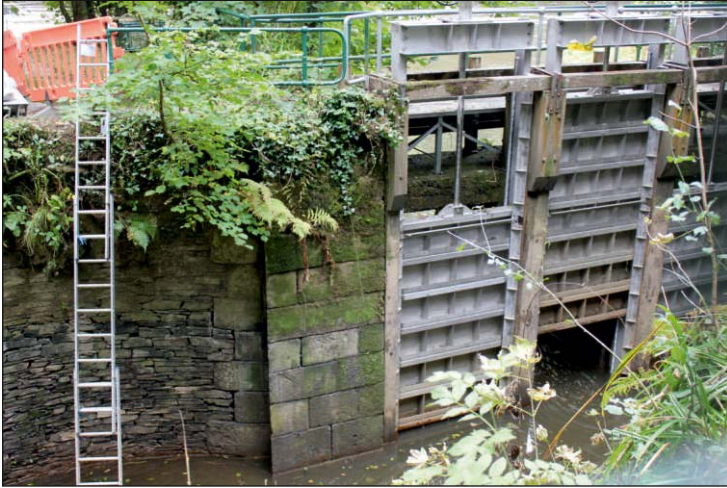
4.3 On the east side of the lock the opposing granite was only extends a short distance before it is truncated by the mid 20th-century insertion of steel penstocks (Plate 7). Beyond the penstocks the granite masonry continues giving way to a contemporary slate wall to the point where the canal has been infilled (Plate 8).

Plate 7: The masonry of and penstocks in the east side of the lock, looking southeast

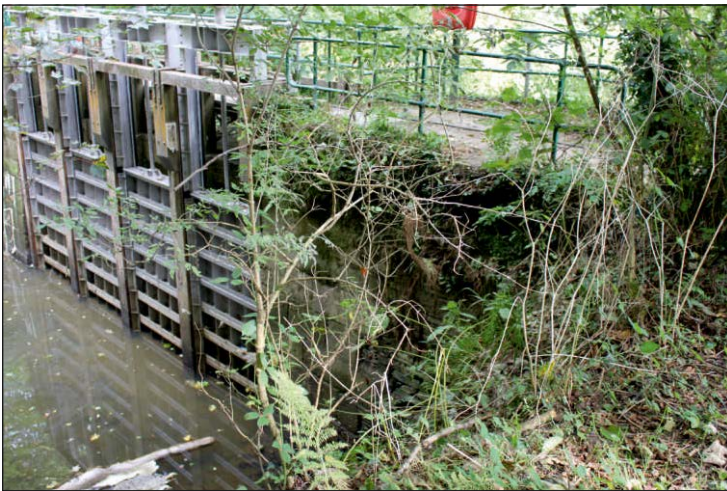
Plate 8: The masonry of and penstocks in the east side of the lock, looking northeast

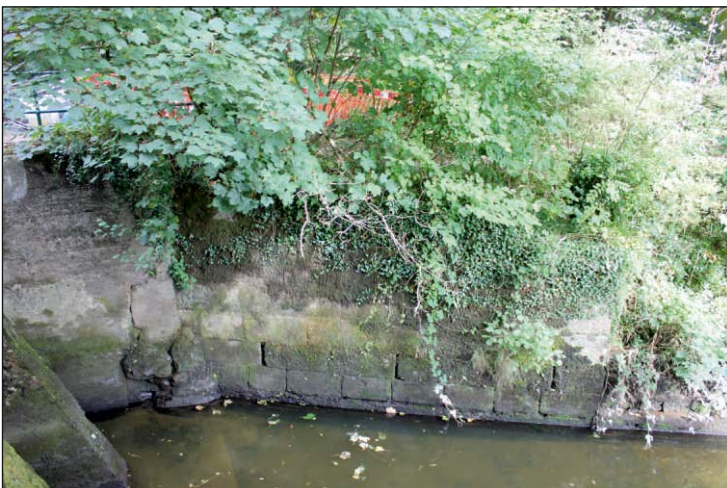
4.4 The penstocks are set into entirely concrete walls. On the northside of the outflow channel there is *circa* 5m length of granite wall, and beyond a lower slate wall, both set on a concrete foundation (Plate 9). This masonry is all of mid 20th-century date, and the granite is almost certainly reused from the earlier lock wall where the penstocks have been inserted. There is no historic masonry on the south side of the outflow channel.

Plate 9: The reused granite masonry in the outflow channel, looking northeast

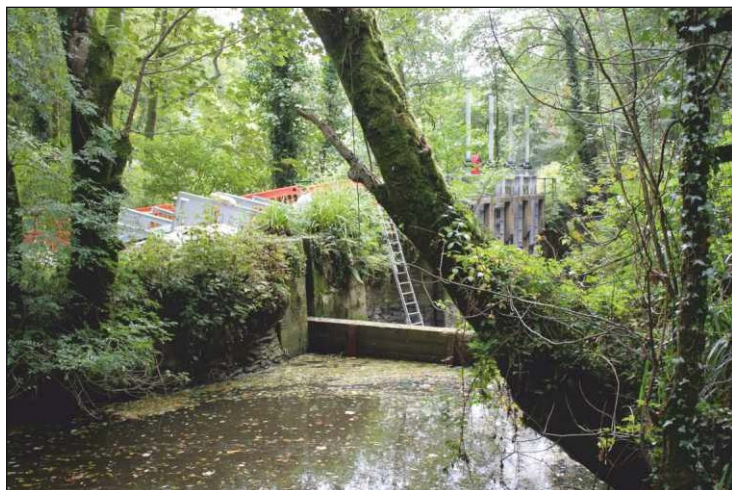
4.5 At the time of the survey, upstream of the lock water was ponded at its normal level and only the tops of the walls described below were visible. Beyond the north end of the lock are short lengths of walls constructed of rubble slate with some coursing (Plate 10). These are not tied into the adjacent granite masonry, and are of poorer quality than the slate walls within the lock. Above and beyond the walls the upper sides of the canal are formed by soil.

Plate 10: The canal above the lock, looking south

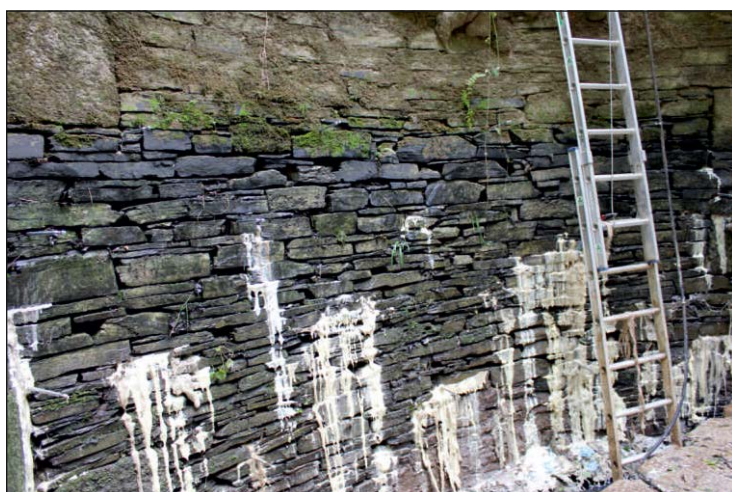
4.6 The majority of the injection ports were located within the joints of the walls negating the requirement to drill through and damage the masonry of the lock (Plates 11 and 12). Only a handful of the slate stones were damaged during the repairs, and all damage was confined to the edges of these stones where gaps in the joints was minimal.

Plate 11: The repairs to the east side of the lock, looking southeast

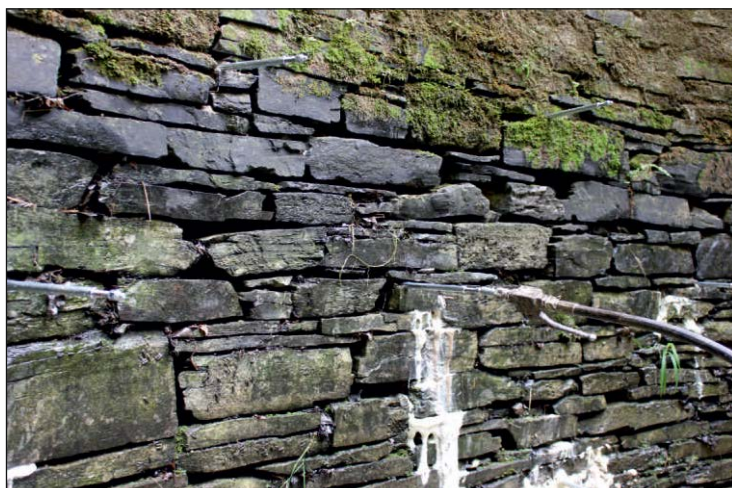
Plate 12: Close-up view of the repairs to the east side of the lock, looking southeast
