LAND AT FILLWOOD HOUSE, CHARLTON ROAD, ST GEORGE, BRISTOL

Results of Historic Building Recording and Archaeological
Monitoring and Recording

Bristol City Council Planning Ref. 17/00955/F (conditions
13 and 17)

Report No: ACD1701/2/0

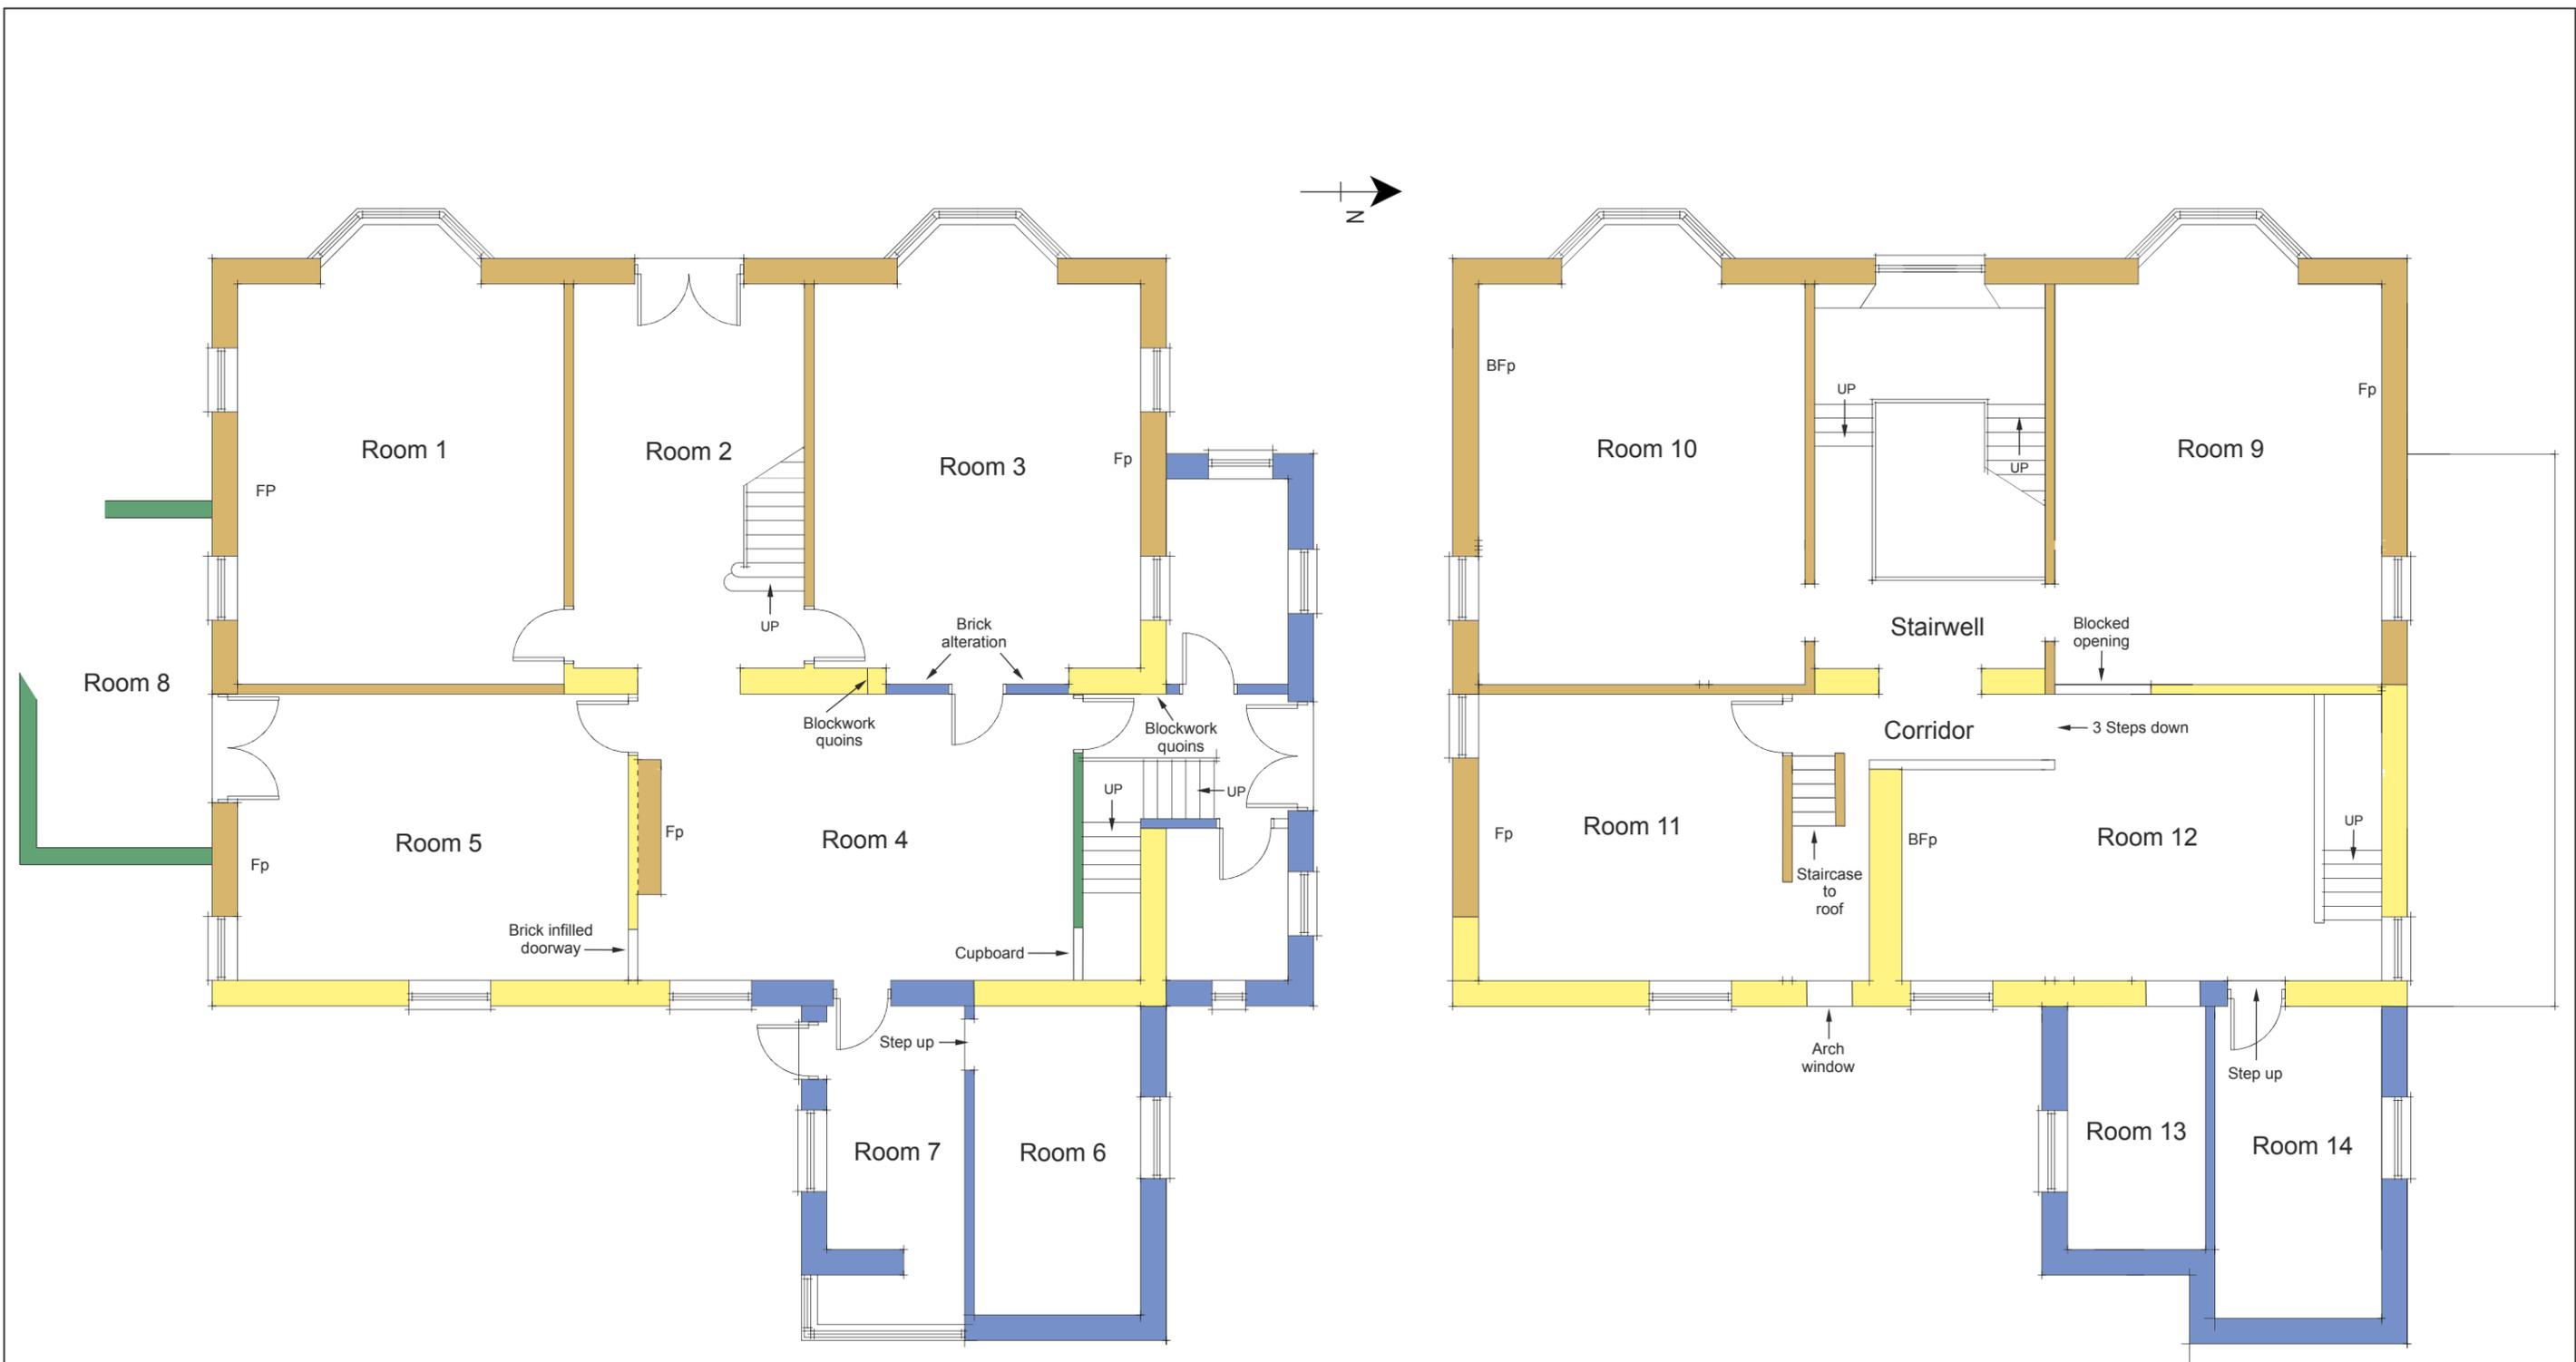
TITLE
 Fig. 4: Phased floor plans

The interior of the building had been almost entirely stripped of finishes, exposing the masonry of the walls, ceilings and the roof structure. The internal walls are almost entirely constructed of brick, with various 20th-century alterations observed, within them; some stonework was present. Some of the internal brick partitions contain thin timber lacing. The ceilings have closely spaced joists with scissor bracing. Originally these were finished with lath and plaster.

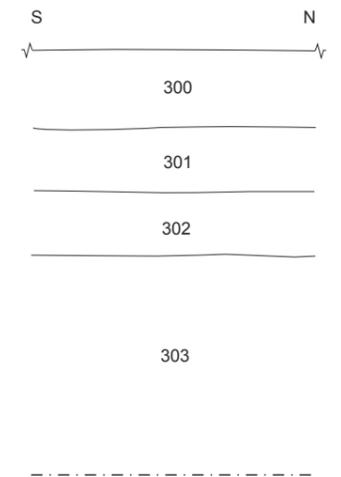
b) Area 3, representative section

The natural subsoil (context 303) was present at a depth of 1.5m below existing levels. It was overlain by 0.4m thick dark grey silty-clay buried soil that had frequent coal inclusions (303). Layer 303 was overlain by two layers of dark reddish-brown silty-loam garden soil (301 and 300) that measured a maximum total of 1.1m thick. No finds were recovered.

- 9.1 The results from the monitoring and recording were largely negative. No evidence for *in situ* coal working was exposed in the areas monitored. However, in Area 3, the coal-rich buried soil (302) may relate to workings in the vicinity; something that is consistent with records of an adjacent mine shaft (Coal Authority 2016).
- 9.2 In Area 1, only recent dumped soils were exposed as overlying the natural subsoil, suggesting that this part of the site had been previously stripped of soils and terraced during the late 20th century.
- 9.3 Area 2 exposed a mixed leveling deposit through which Fillwood House had been built. This was likely to represent associated landscaping of the site in relation to the construction of the house.

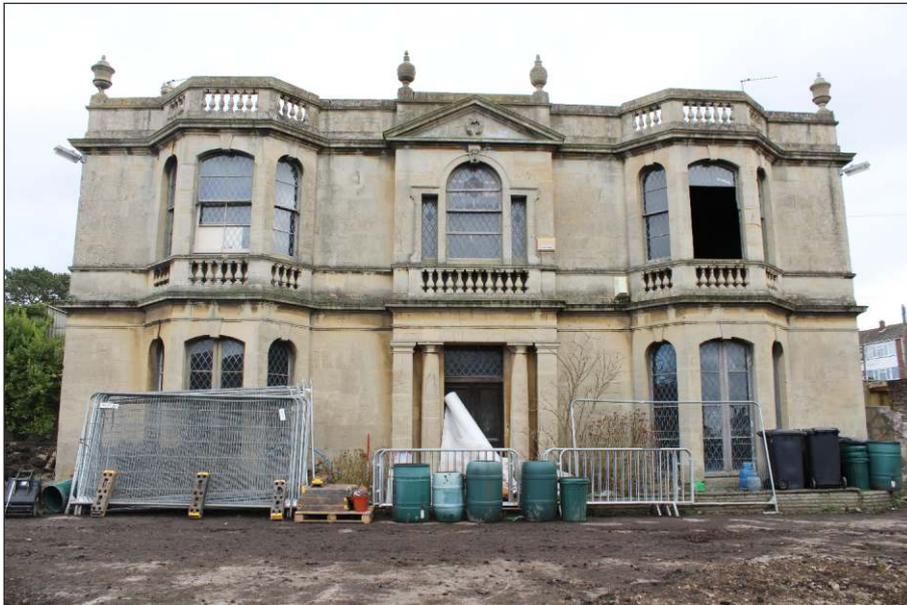
The building is set well back within its plot but fronts Charlton Road, and its main façade faces west onto this road (Plate 2). The elevation is constructed of ashlar Bath stone with detailing executed in a classical style with the central front door set behind a bold but plain porch with square and tapering columns. This rises to a pediment at roof level over a large first-floor window, with margin lights, serving the landing and stairwell. To either side, are two-storey bay windows. Across the elevation the windows are leaded (dating to the second half of the 20th century), with glazing set within either fixed or opening casements, as well as horned sashes. The first-floor landing window incorporates a coat of arms. Other detailing on the elevation includes rows of balustrades under the first-floor windows and within the parapet above the bay windows. The parapet is also finished with (two types of) finials.

Plate 2: Fillwood House front elevation. View to east (scale 1m)

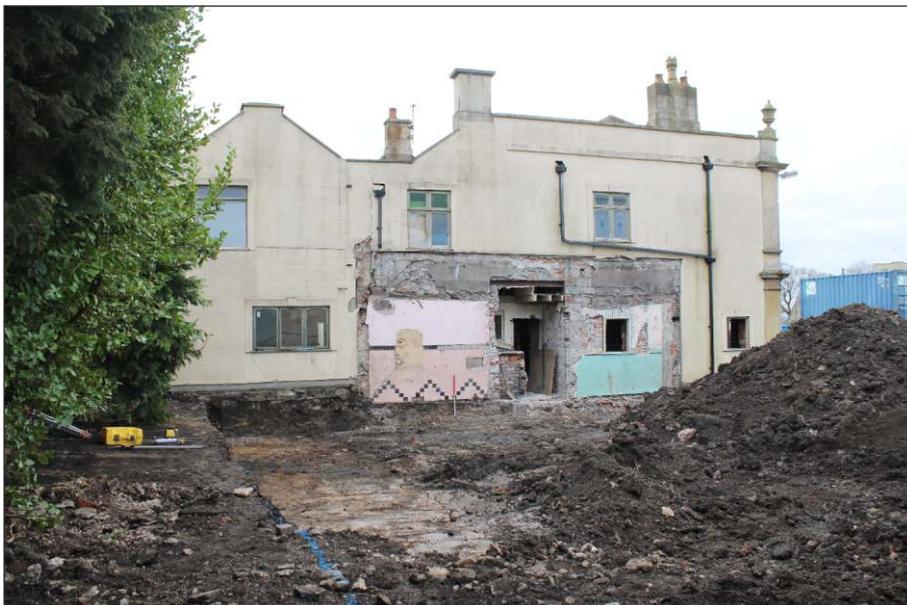
The north, side elevation has a render finish, scored to imitate ashlar stonework (Plate 3). This has been applied over stone and brick masonry. Primary windows and doors are set within slightly projecting plain reveals with keystones, and where surviving glazing is leaded (with stained glass elements), set within casements. The south, side elevation has the same finish as the north elevation, and again the

Plate 3: Fillwood House north elevation. View to south (scale 1m)

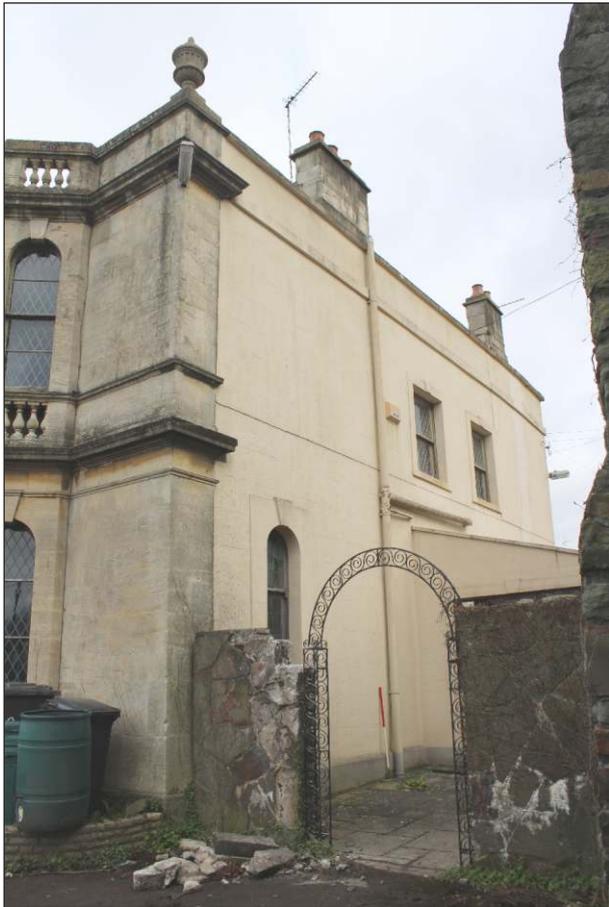
glazing to the windows is leaded with stained glass in the front reception room window (Plate 4).

Plate 4: Fillwood House
south elevation. View to
northeast (scale 1m)

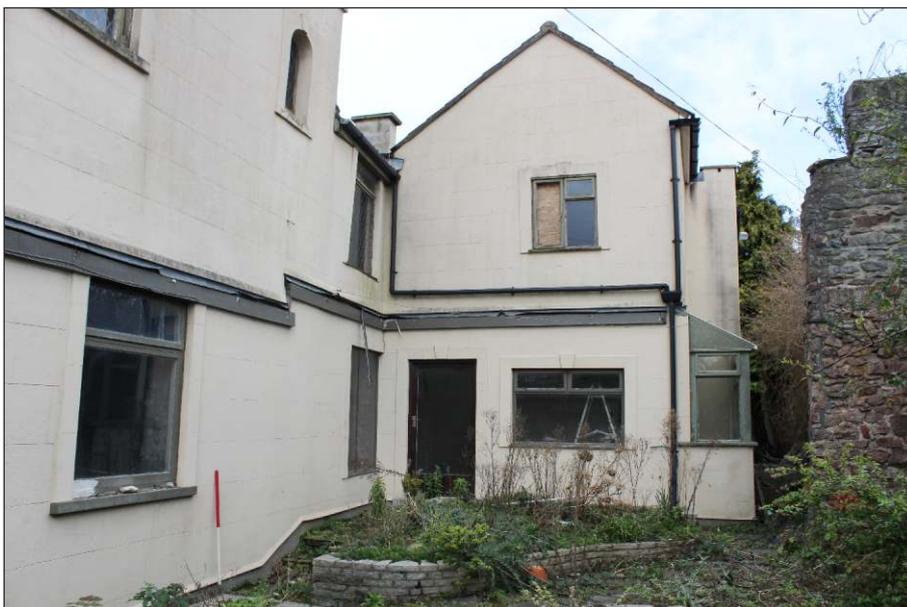
The rear elevation of the main house and along with the service range also have the same finish, and window styles with, where surviving, a mixture of casements and sashes (Plate 5).

Plate 5: Fillwood House
rear elevation. View to
northwest (scale 1m)

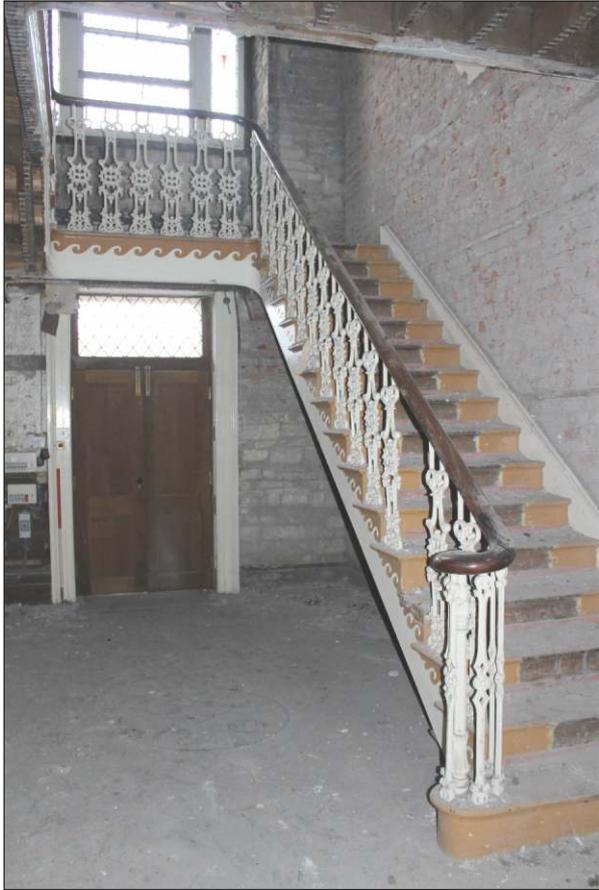
The main doorway leads to a central hall (Room 2) containing the main staircase to the first floor (Plate 6). It also gives access to reception rooms (1 and 3) and a third room to the rear (4). There is no direct access to room 5 which is entered only from room 4. The staircase is of the dogleg type with half landing, and open string with a continuous bracket decorated with a wavy finish. The handrail is supported on iron balusters with a highly ornate design.

Plate 6: Room 2, main staircase and central hall. View to northwest (scale 1m)

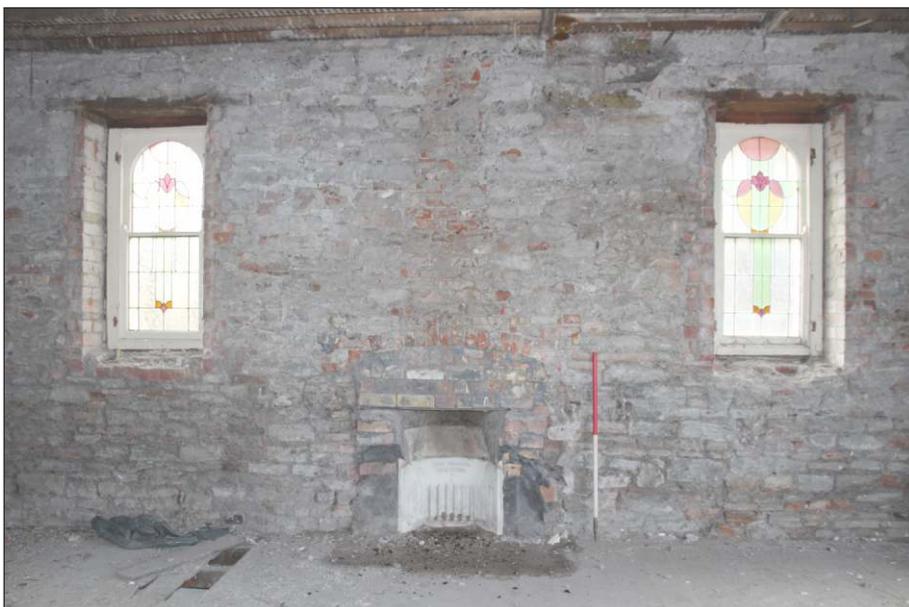
Plate 7: Room 1, fireplace narrowed in the 20th century, and flanking leded windows with stained glass. View to south (scale 1m)

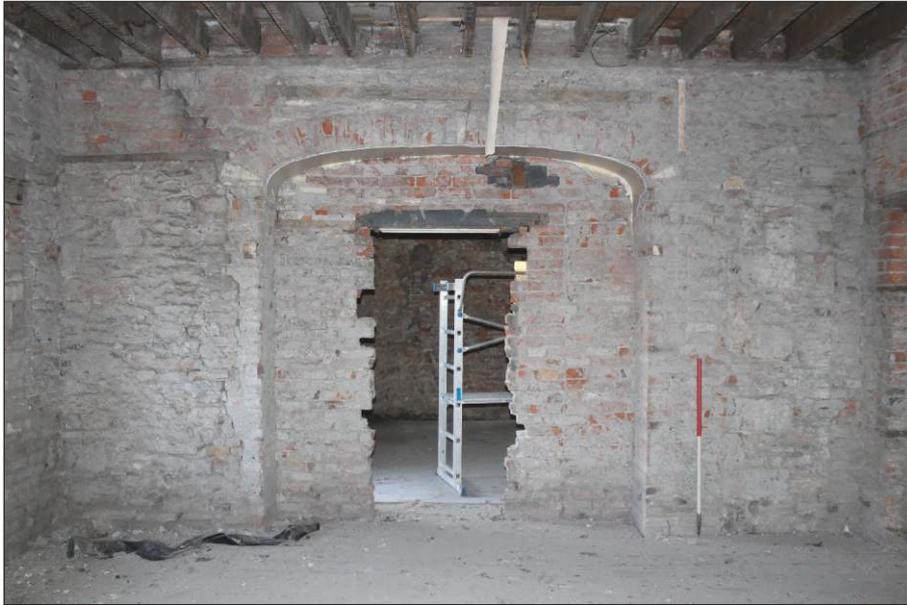
Plate 8: Room 3, arched recess in the east wall with a central, probably inserted or more likely narrowed, opening. View to east (scale 1m)

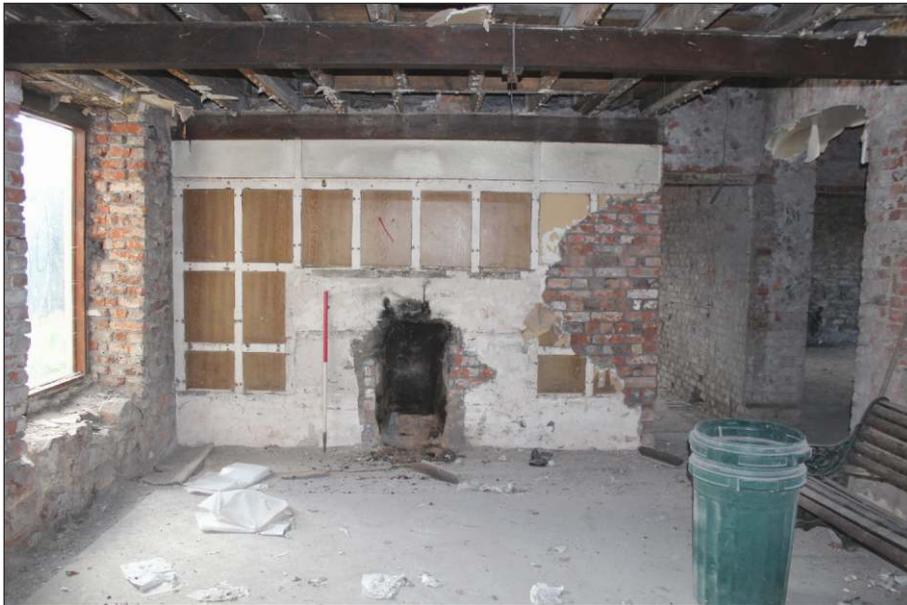
Plate 9: Room 4, fireplace in the south wall. View to south (scale 1m)

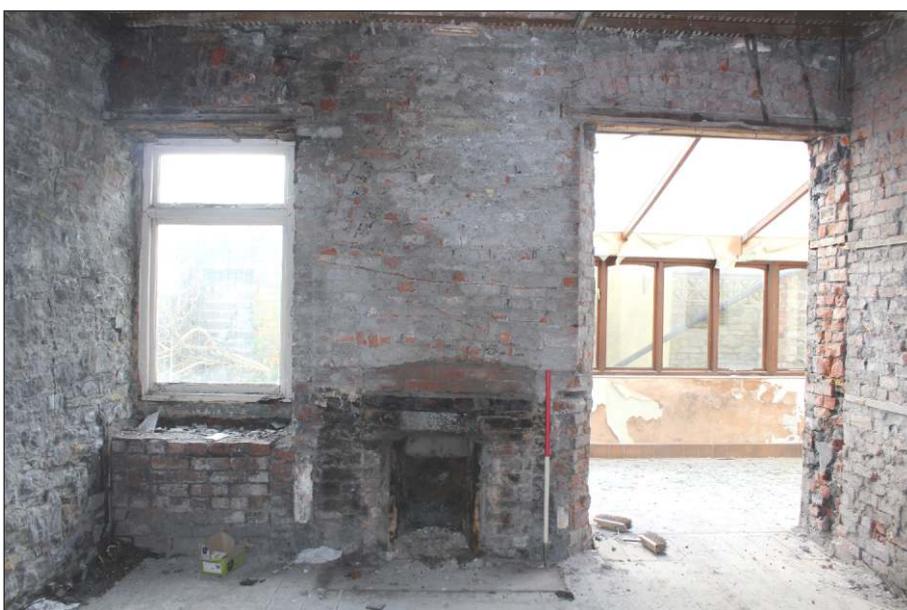
Plate 10: Room 5, fireplace in the south wall, with window opening to the east, whose lower, walk-in, section has been infilled and doorway inserted to a former window opening to the west into the modern conservatory. View to south (scale 1m)

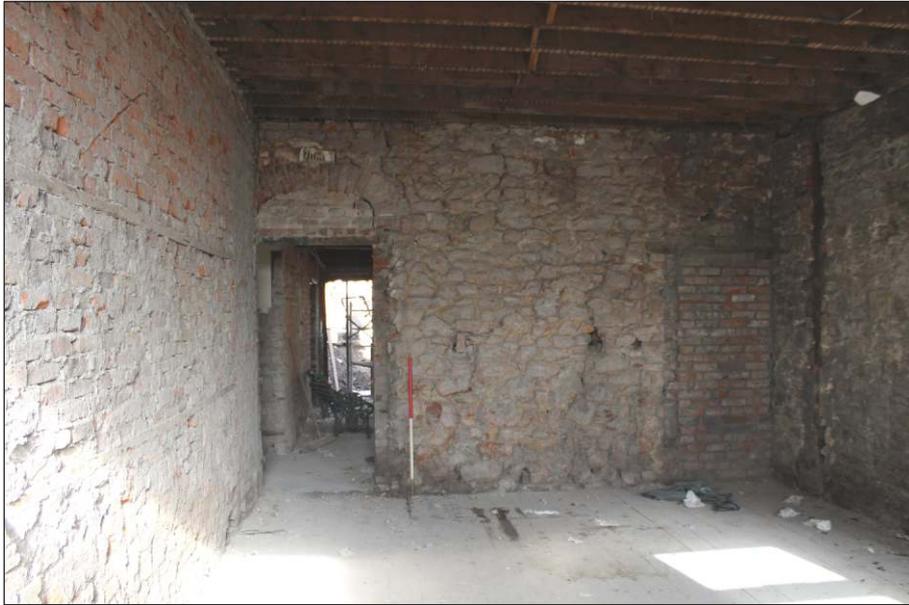
Room 5 has a fireplace (fittings removed) in the centre of the south wall. There is a window opening to the east, whose lower, walk-in, section has been infilled. A doorway into the modern conservatory has been inserted to a former window opening to the west of the fireplace (Plate 10). The east and north walls are made predominantly constructed of stone with the north wall having an inserted doorway which has been blocked in brick to the east and to the west an abutted brick component featuring a brick-arched doorway, which has been reduced in height (Plate 11).

Plate 11: Room 5, the north wall predominantly constructed of stone with an inserted doorway which has been blocked in brick to the east and to the west an abutted brick component featuring a brick-arched doorway. View to north (scale 1m)

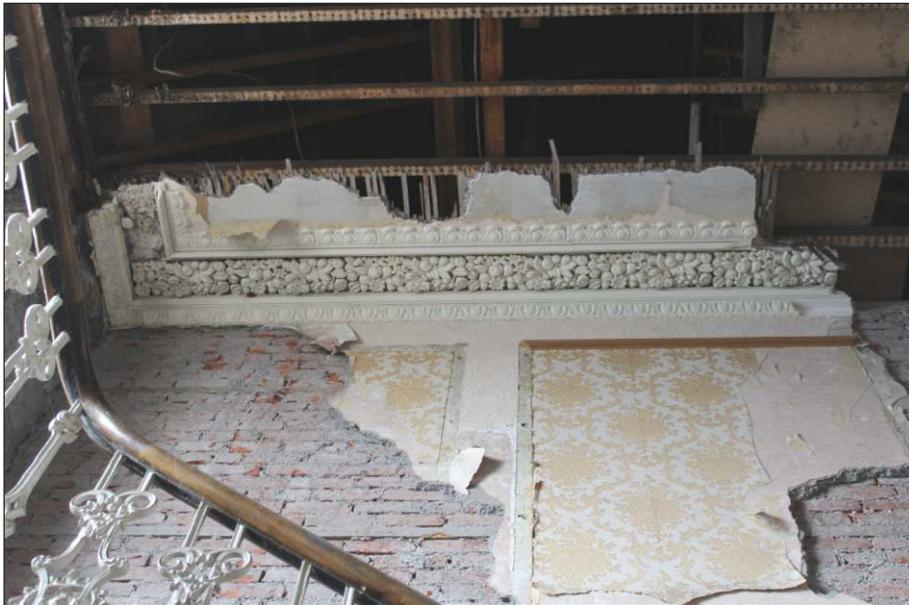
Plate 12: The remains of ornate plasterwork on the stairwell wall and ceiling

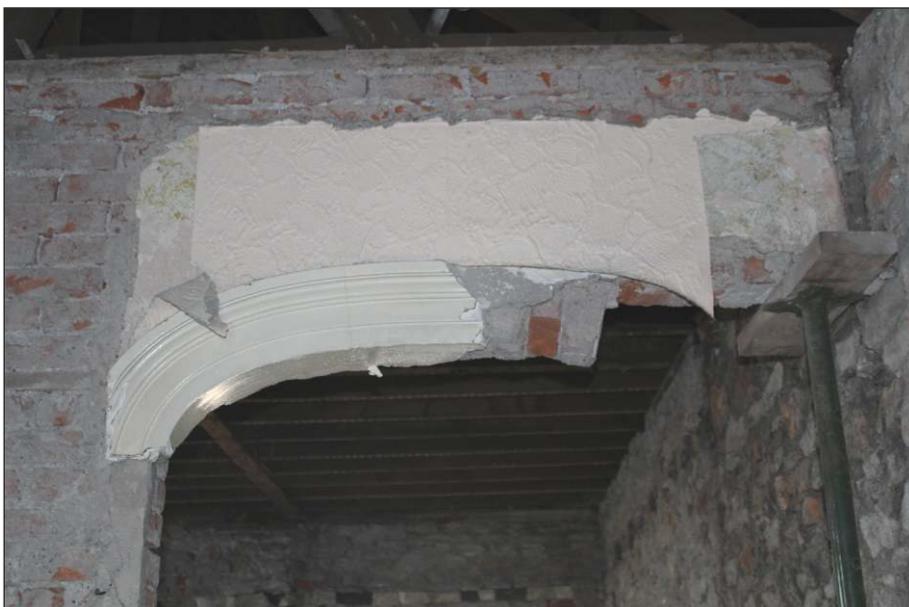
The landing gives access to two bedrooms (rooms 9 and 10) and a rear corridor providing access to rear rooms (11 and 12). Part of the coving of the ceiling survives, incorporating inner and outer bands of (different) egg and dart designs separating a wide band of fruit designs (Plate 12). Typically for the period it extends onto the ceiling. The doorway into the lobby of room 9 also retains some of its wide plaster moulding (Plate 13).

Plate 13: The remains of wide plaster moulding on the entrance to the former lobby for room 9 from the stairwell looking north

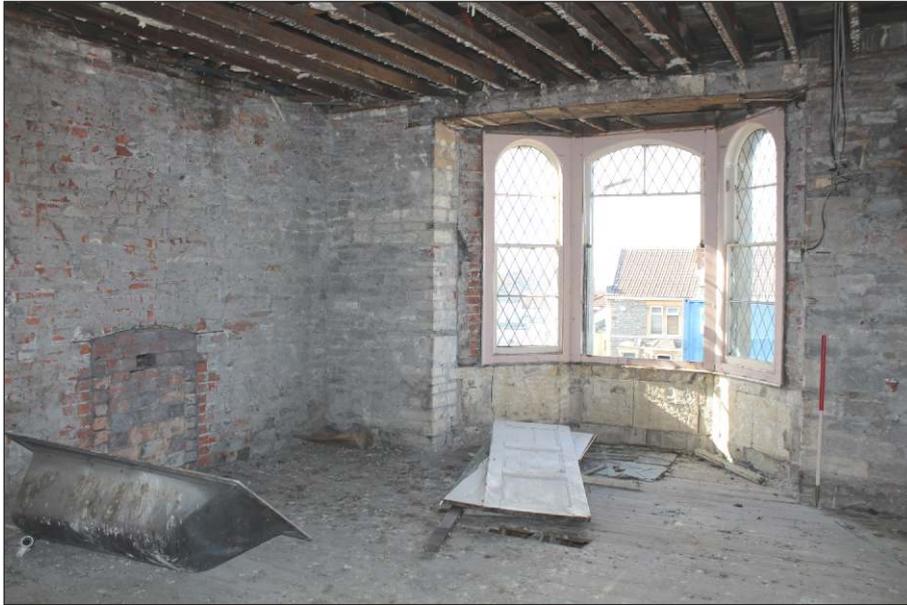
Plate 14: Room 10, the blocked fireplace in the south wall and the west-facing bay window. View to southwest (scale 1m)

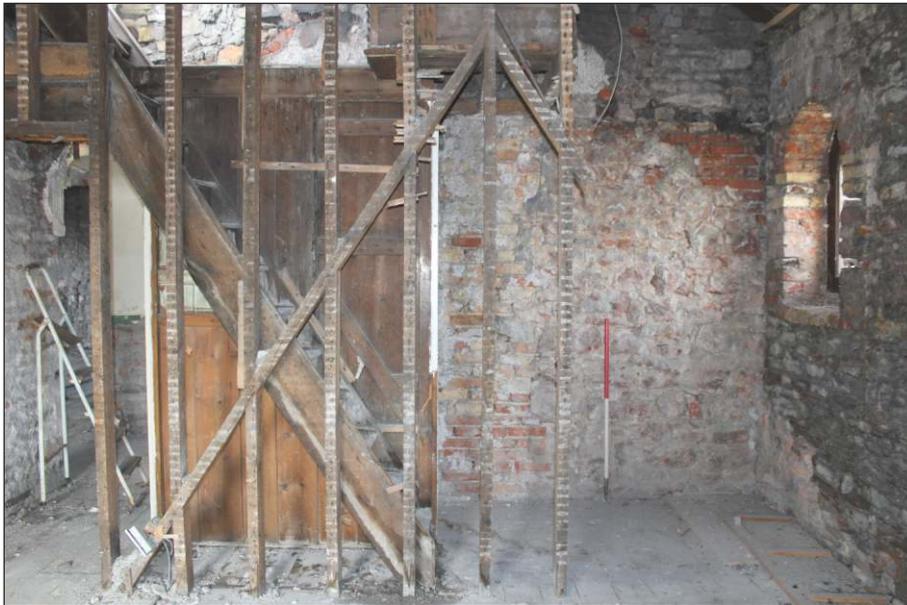
Plate 15: Room 11, the formerly enclosed staircase to the roof. View to north (scale 1m)

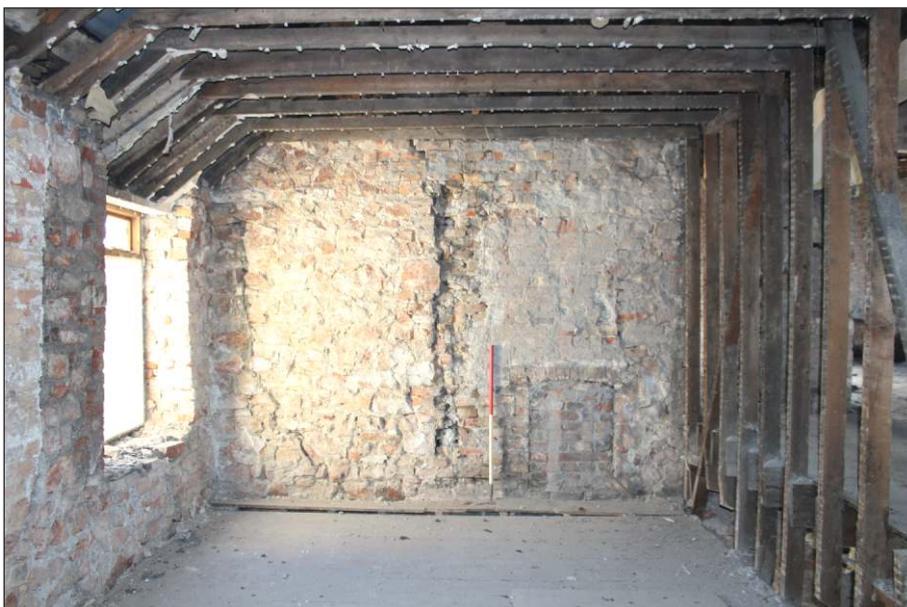
Plate 16: Room 12, the blocked fireplace in the south wall. View to south (scale 1m)

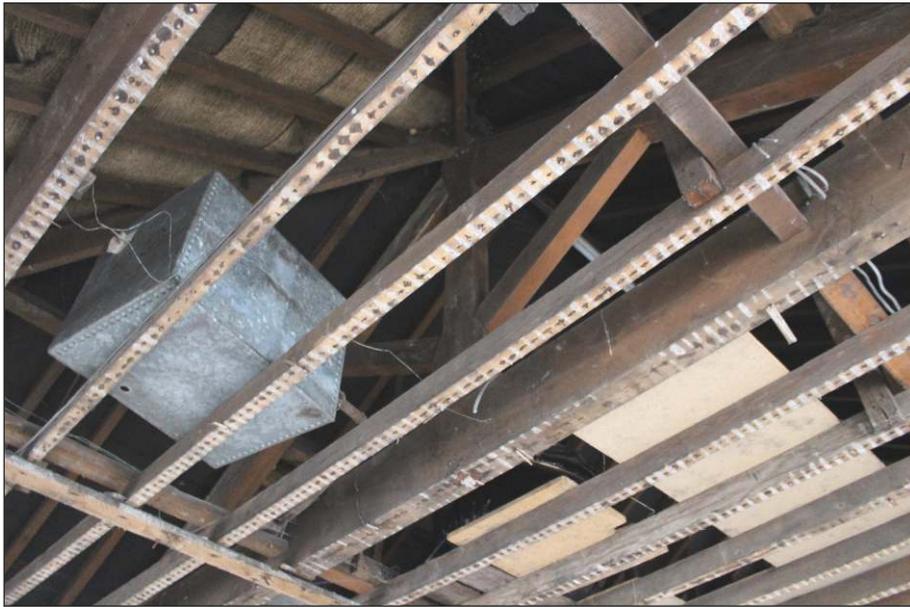
Plate 17: The king-post truss with diagonal struts, supporting purlins and rafters above room 9

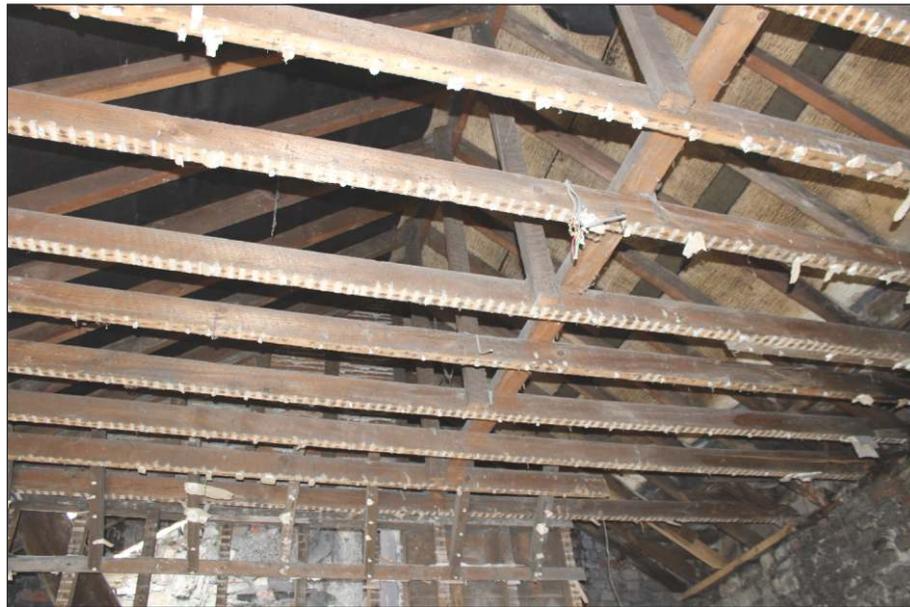
Plate 18: The roof above room 11 constructed of a series of closely-set rafters to which tie beams are attached with additional support provided by vertical studs attached to both timbers

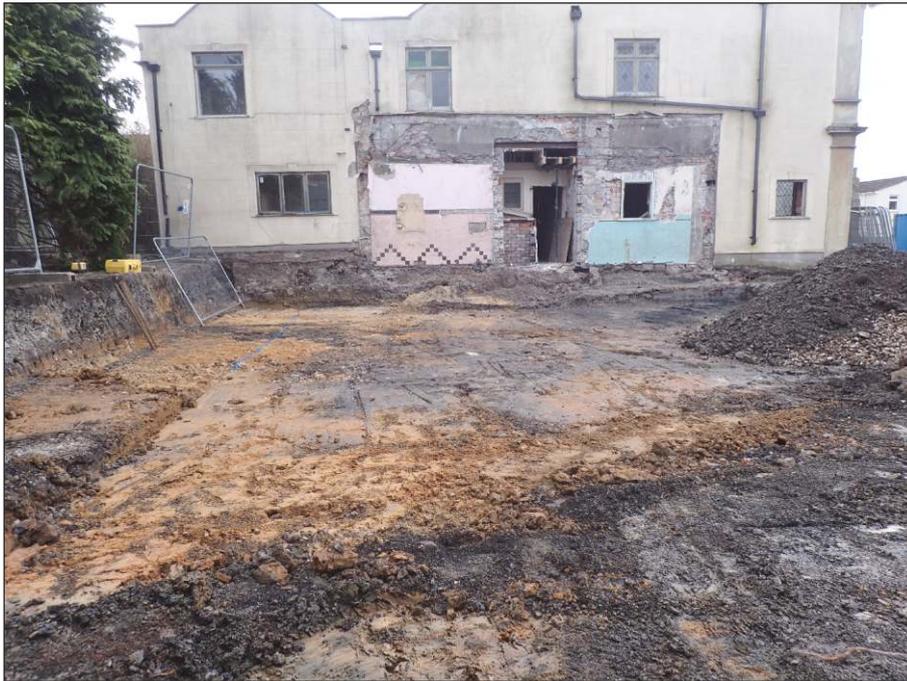
Plate 19: Area 1, view to south

Area 1 was located to the northwest of Fillwood House. It was excavated in four stepped piling platforms for each of the terraced house plots. Natural subsoil, which consisted of a light red to yellow clay with weathered mudstone bedrock, was only exposed in the platform for House 1 at a depth of approximately 1.3m below existing levels. It was overlain by mixed made ground comprised of dark grey silty-loam with inclusions of clinker, brick fragments, ash and 20th century plastics.

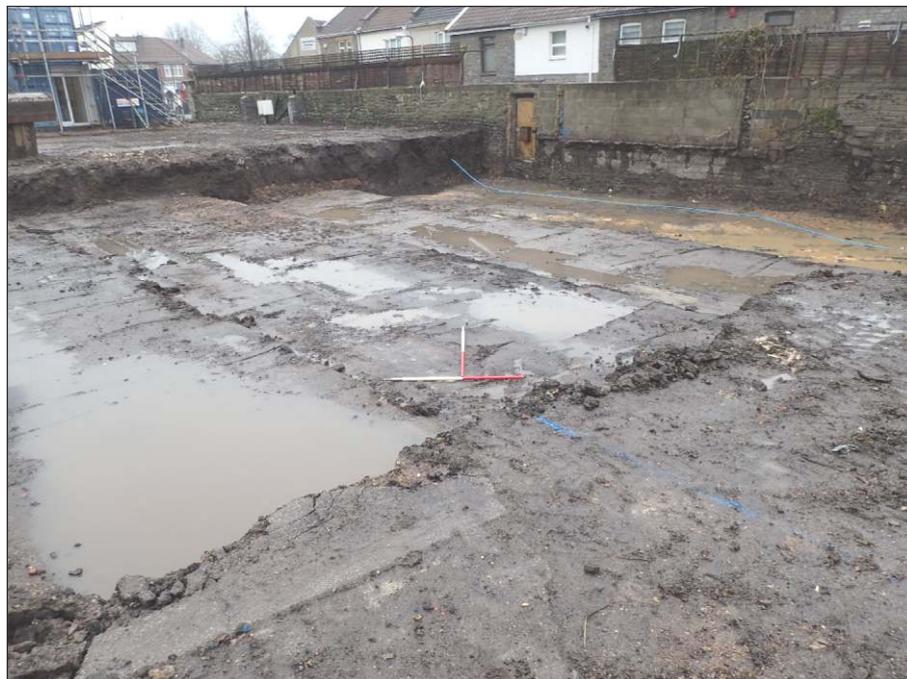
Area 2 was located to the north of Fillwood House and partially on the site of a recently demolished conservatory. The natural subsoil was exposed at a depth of 1m

below existing levels. It was overlain by a mixed levelling layer of dark greyish-brown clayey loam, which was in turn sealed by a 0.2m thick hardcore and tarmac surface. The area contained a number of modern drains. No archaeological features or deposits were exposed.

Plate 20: Area 2, view to southwest (scales 2 x 1m)
