YORK HOUSE, ST CLARE, PENZANCE, CORNWALL

Results of historic building recording

Cornwall Council planning reference PA16/12038,
condition 3

Document No: ACD1635/5/0

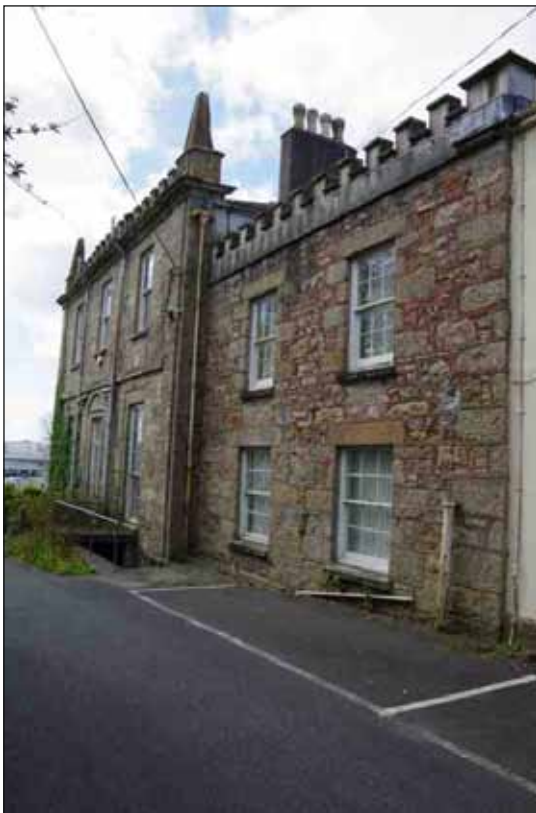
- 5.6** The northeast and southwest elevations of the front part of the house incorporate three 12-pane sash windows on each floor, with those on the ground floor having pointed gothic tracery detail at the top of the upper sashes (Plates 2 and 3). The first-floor windows are 20th-century replacements. On the northeast elevation the central window on the ground floor is a replacement casement window, within a former doorway, but displays the same pointed tracery as the other windows. It is within a moulded surround with a stone arch above. All the other windows on the ground floor are set slightly back from the façades.

- 5.7** The northeast and southwest elevations of the rear range of the house contain two 12-pane sash windows on each floor, these are 20th century replacements with concrete sills (Plates 2 and 3).

Plate 2: Northeast elevation of York House, looking south

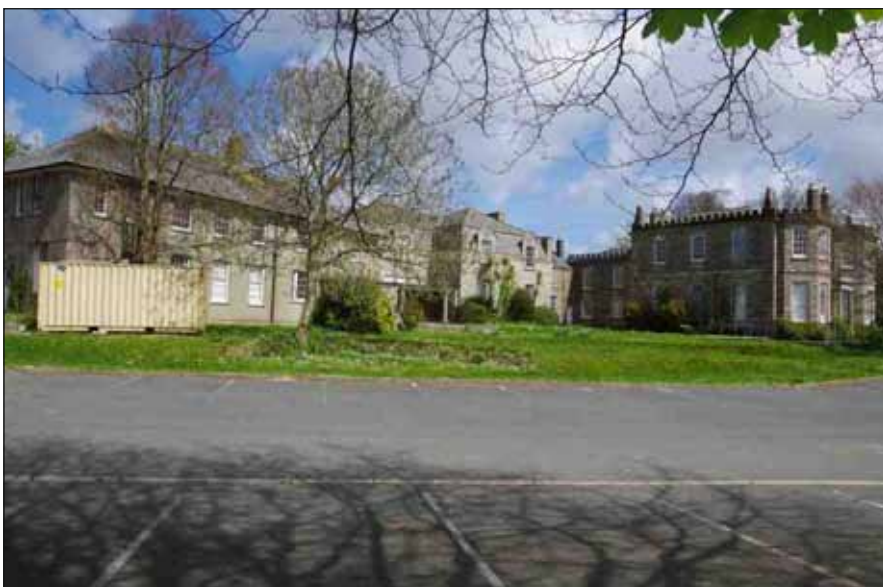
Plate 3: General view of southeast elevation of York House and the dining hall and dormitory building, looking northeast

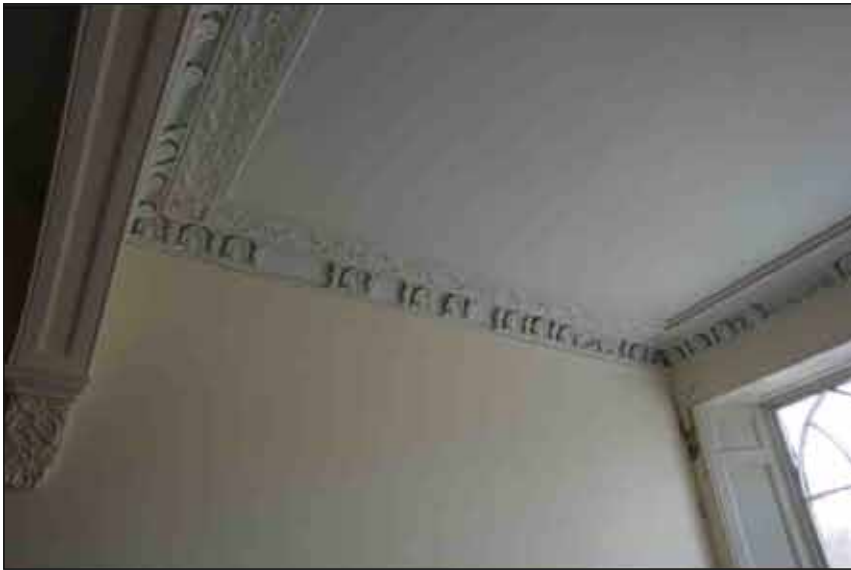
- 5.11** On the first floor over the stairwell the coving has a 'fountain' and shell pattern with a grapevine border to the ceiling, which again has a round moulded border with cornices containing a 4-leaf pattern; however, it is damaged in places. At the top of the stairs is an arched opening over the landing identical to those in the reception areas below; this is supported on two decorative brackets with scroll detail and a flower band motif around the top (Plate 17).

Plate 17: The ceiling of the stairwell on the first floor, looking northwest

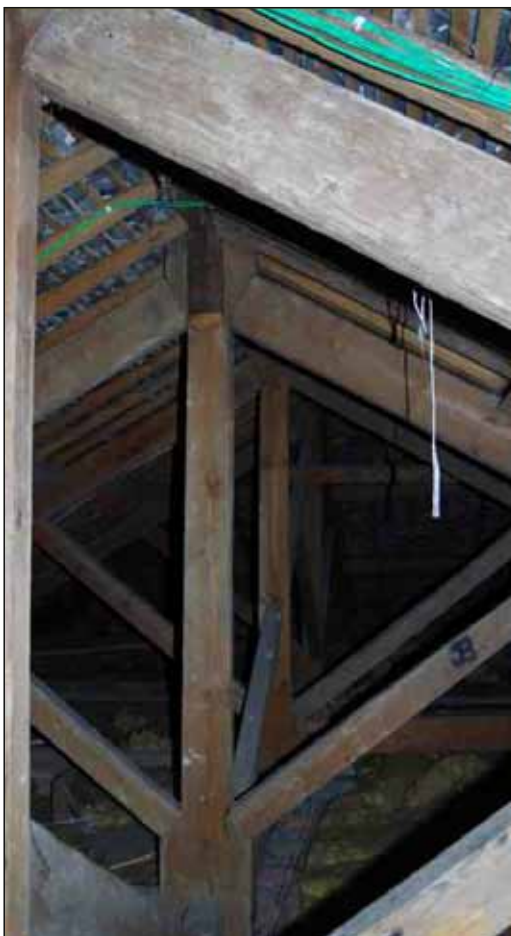
- 5.14** Wooden stairs lead to the roof space, and the stairwell contains a cupboard halfway up; the doors are fixed using, possibly reused, H-shaped brackets. The roof is supported on king post trusses with diagonal braces (Plate 26). Some of the purlins have trench joints, whilst others just rest on the back of the trusses. Rafters are laid on the back of the purlins and support laths to which the slates are pegged. The majority of the roof structure is original, although parts of the slate finish have been replaced.

Plate 26: King post roof trusses, looking southwest

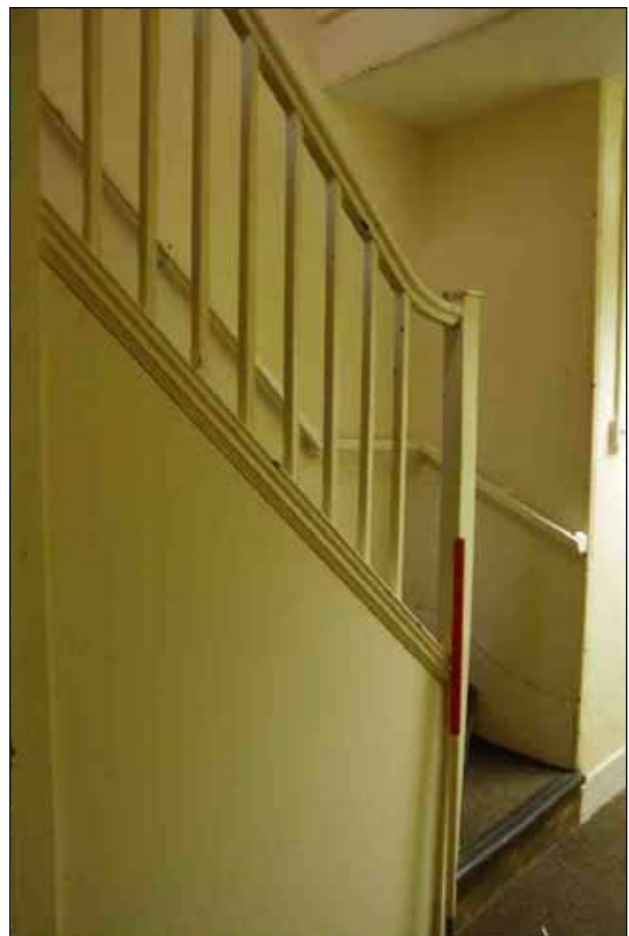
- 5.15** The rear range of the house has two floors with its own servant's staircase with a simple square balustrade and a rounded handrail serving the first-floor rooms (Plate 27). All internal doors from the corridor are replacement fire doors. On the ground floor, adjacent to the rear of the front range, there were originally two rooms, but the west room has been sub-divided by the insertion of a concrete block partition. In the current southwest room there is a fireplace in the southeast wall which has been blocked but retains its simple wooden surround. Removal of the surround following the fire revealed that the current opening was smaller than the original fireplace. The alcoves to either side are fitted with shelving (Plate 28). The original skirting boards are still *in situ*. In the room to the east there is a modern door, suspended ceiling and skirting boards. There are moulded surrounds to the windows and a fireplace opening in the northwest wall, however this has been boarded out to form an alcove. To the left of this is a blocked doorway which within the room takes the form of a boarded alcove but in the corridor to the north the original 4 panel door with plain surround has been retained *in situ* (Plate 29). This doorway would originally have led into an open passage (see Section 5.23 below). Analysis of the plan form would suggest that the east room was the kitchen with sculleries beyond extending out into the yard.

Plate 27: Staircase in rear range of the house, looking southeast (1m scale)

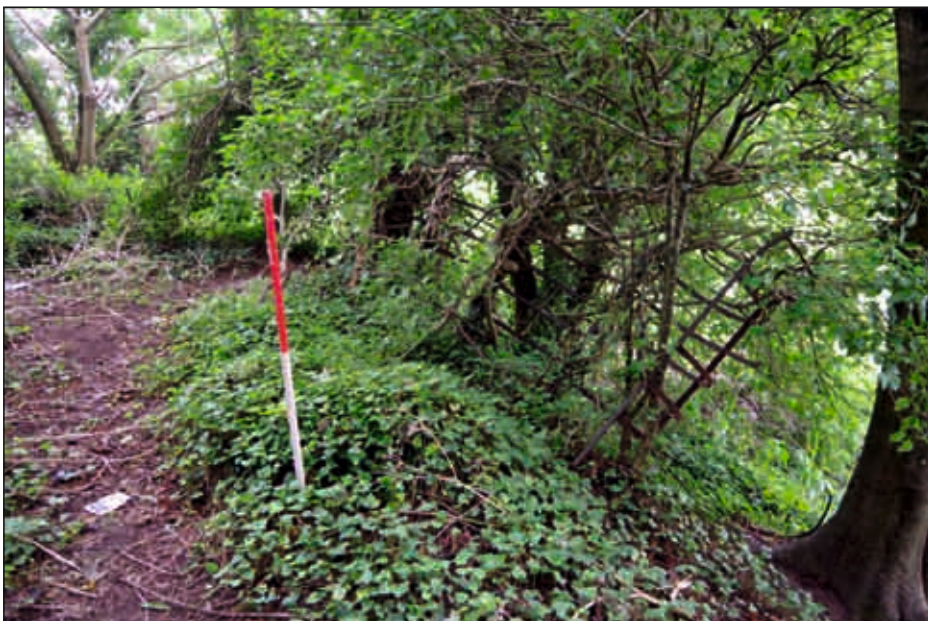
- 5.19** Within the woodland to the southwest of York House there is an iron fence which is in very poor condition with only short segments remaining. Dense vegetation rendered a visual assessment of the whole length of the fence impossible and only approximately 30m of it was visible. The fence is formed of semi-circular segments each with approximately seven horizontal bars with vertical bars to the sides and in the centre (Plate 36). The ground level beyond the fence drops off.

Plate 36: Metal fence in the woodland, looking east (1m scale)

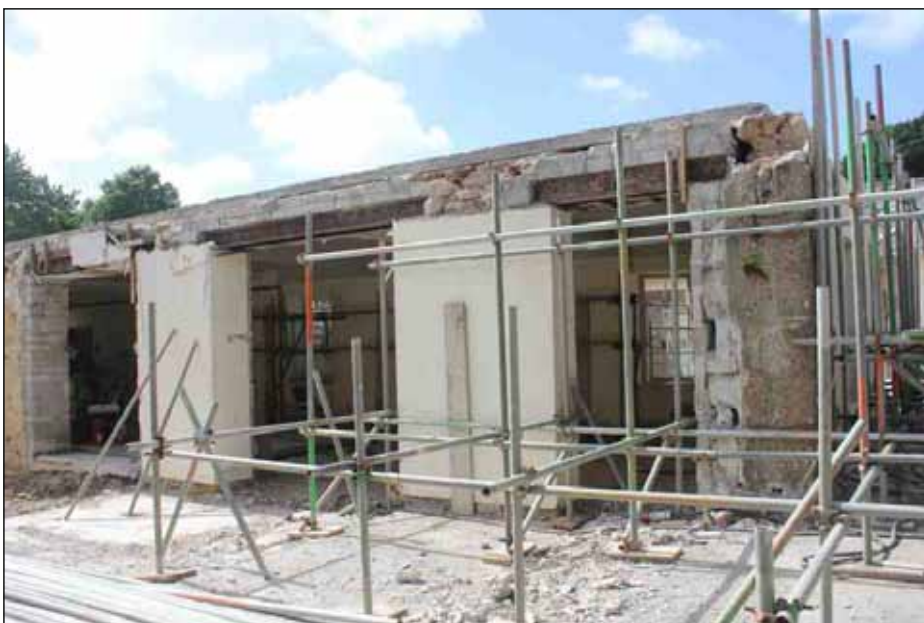
Plate 39: The south elevation of the original stable block following removed of the attached infill building showing modern openings, looking northwest

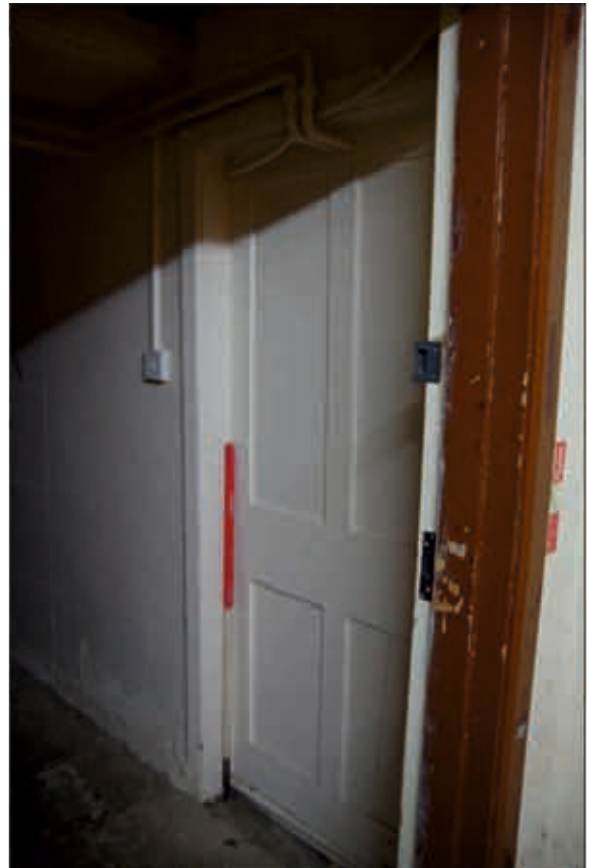
Plate 41: Blocked doorway containing 4-panel door in the corridor on the ground floor of the infill building, looking southeast (1m scale)

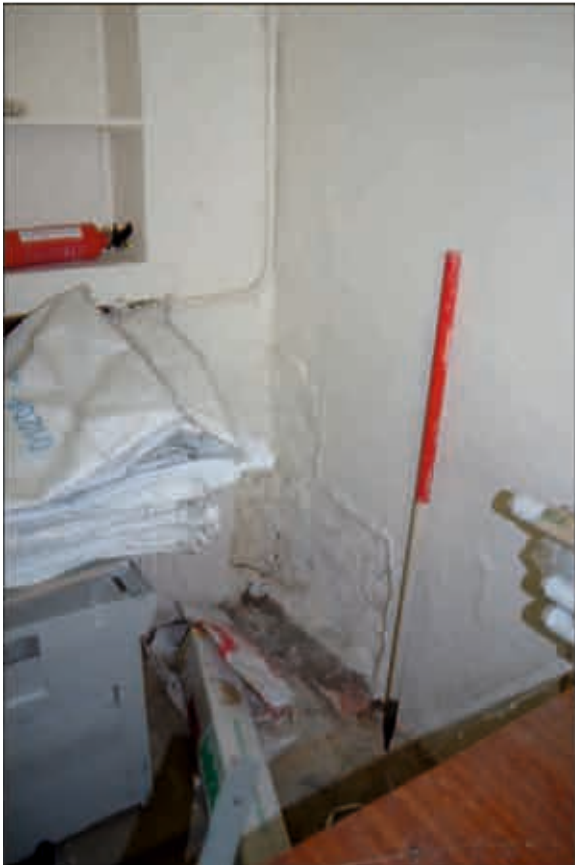
Plate 42: Scar of removed copper in the southeast room on the ground floor of the infill building, looking northwest (1m scale)

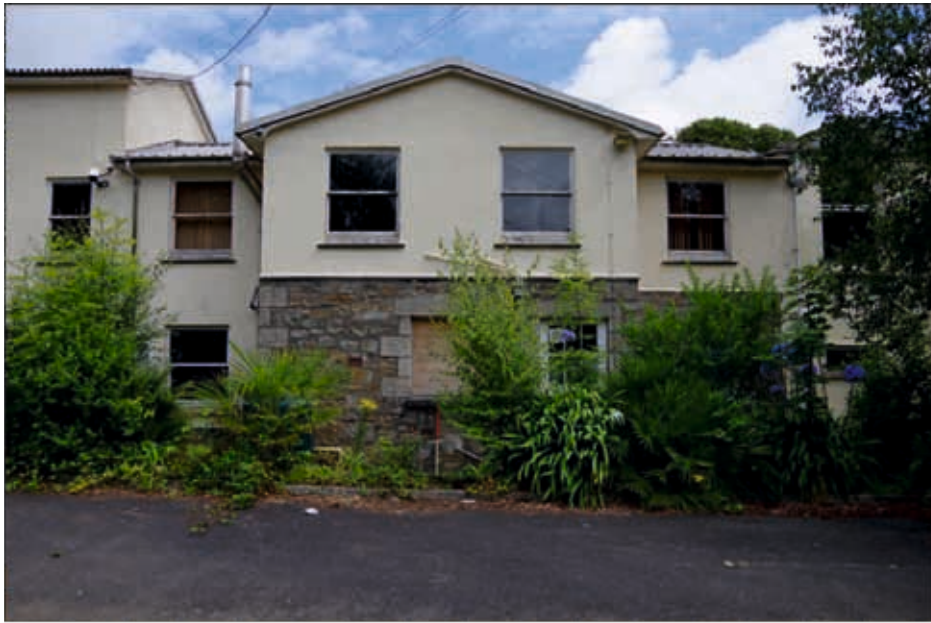
- 5.29** The southwest elevation has a staggered plan representing the main bulk of the range, with a narrower area to the south and part of the mid-20th-century connecting range to the north that creates a symmetrical plan (Plate 47). The original ground floor is exposed granite masonry, with the remainder rendered. On the ground floor there are three 20th-century sash windows and a doorway with a replacement door; a small lean-to extension has been added adjacent to the doorway. There are four 20th-century sash windows on the first floor. The roof of this range is a late 20th-century replacement in corrugated metal sheets.

Plate 47: Southwest elevation of later stable block, looking northeast (1m scale)

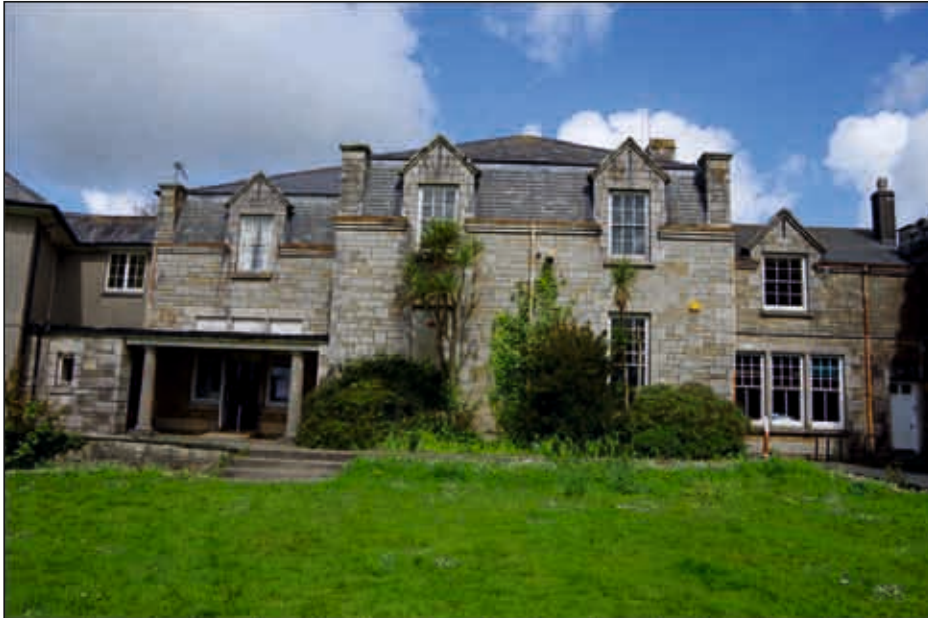
- 5.31** This range is constructed of coursed granite blocks under pitched slate roofs. The central part of the southeast elevation projects forward and contains two sash windows on each floor (Plate 50). The west window on the ground floor has been blocked and those on the first floor are half dormers. The eastern part of the elevation contains three sash windows and a door on the ground floor and a single sash half dormer window on the first floor, all with granite sills; these are all 20th century replacements. The floor level is defined by a plat band. The western part of the elevation is partially obscured by a projecting canopy to the front, which is supported on two pillars. On the ground floor there is a group of two casement windows and a door, with a further smaller casement window in the masonry to the west of the canopy; this incorporates a projecting keystone. On the first floor there is a single casement half dormer window. All the dormers also incorporate a narrow ventilation slit (now mostly glazed) within their gables.

Plate 50: Southeast elevation of the dining hall building, looking northwest

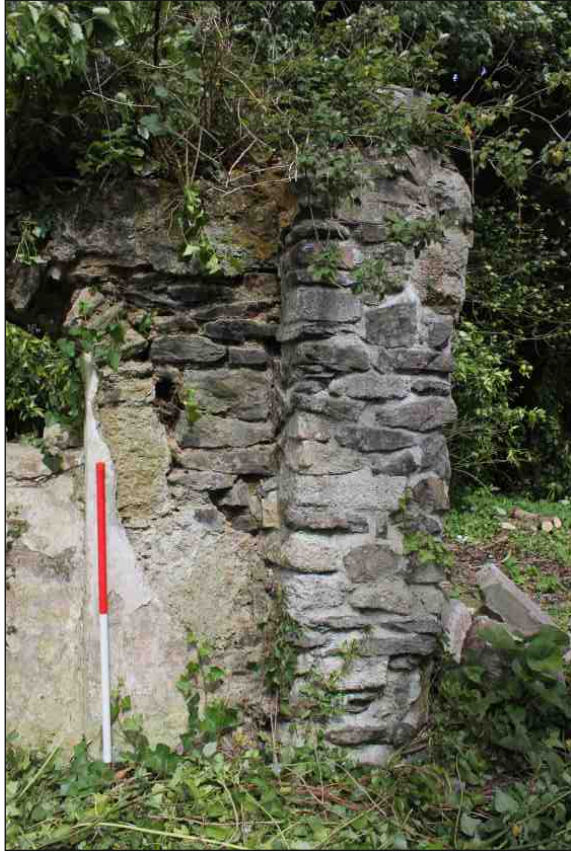
Plate 1: The west elevation of the boundary wall showing the rebuilt pier, looking east. 1m scale

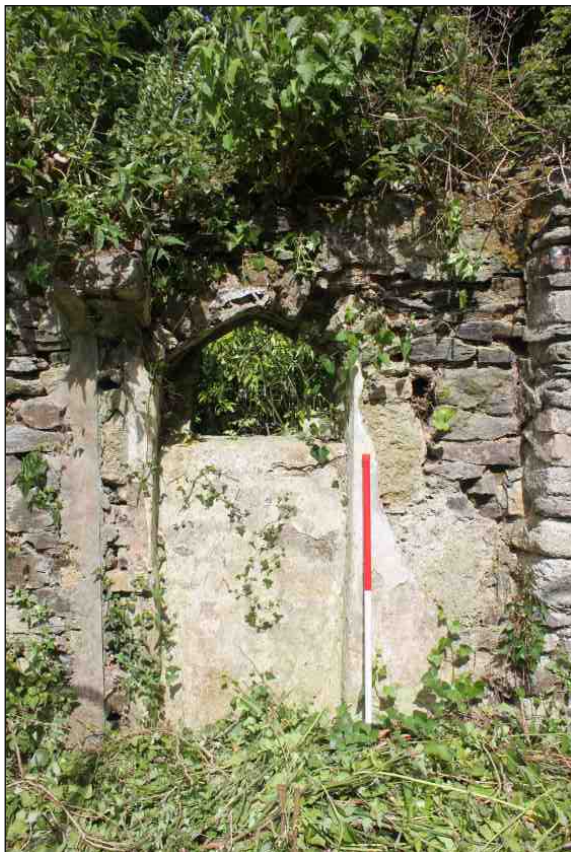
Plate 2: The west elevation of the boundary wall showing the blocked doorway, looking east. 1m scale

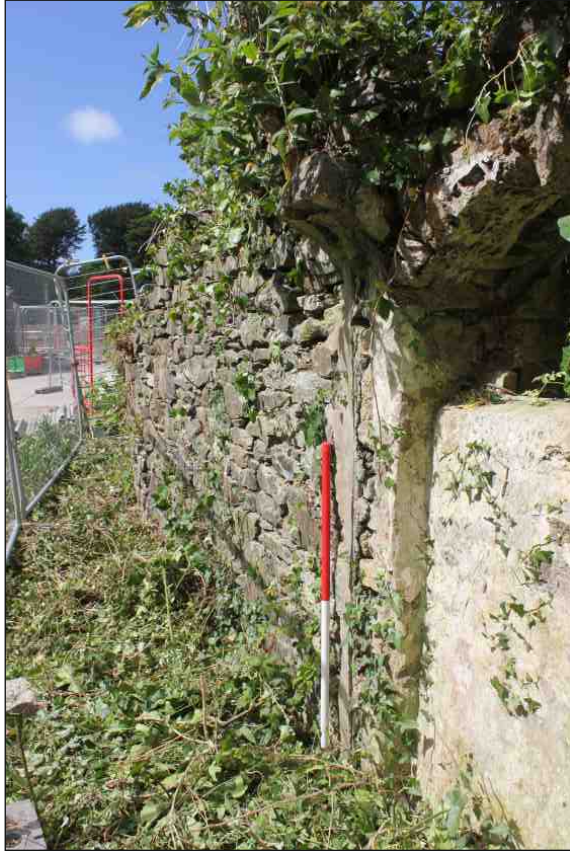
Plate 3: The west elevation of the boundary wall showing the remains of the arch, looking north. 1m scale
