18 CATHEDRAL YARD, EXETER

Results of historic building recording

Document No: ACD1741/2/1

Date: February 2018

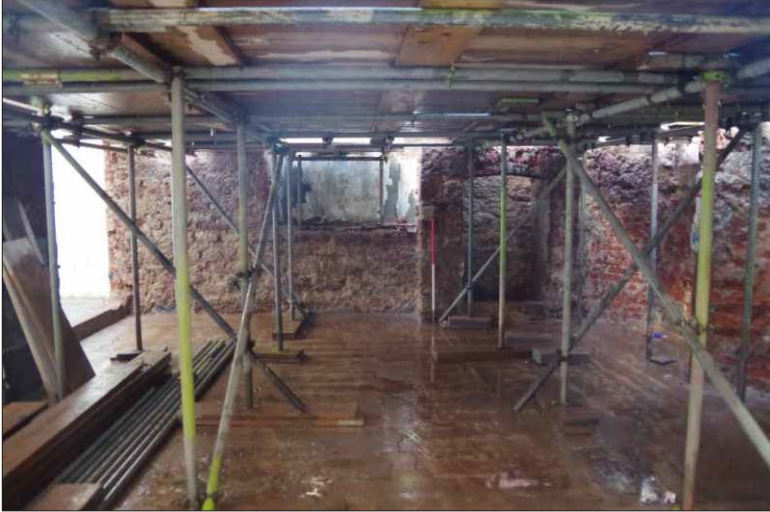
Plate 1: The rear basement, northwest wall showing former cellar light and fireplace, looking northwest. (1m scale)

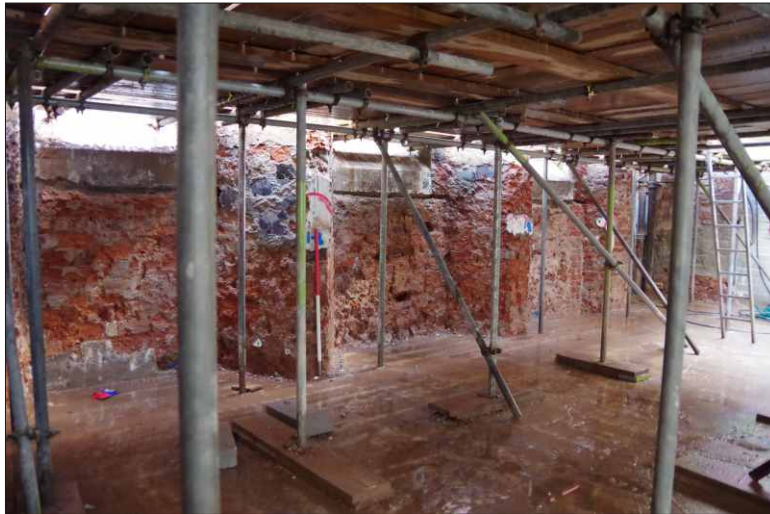
Plate 2: The rear basement, northeast wall showing former cellar lights, looking east. (1m scale)

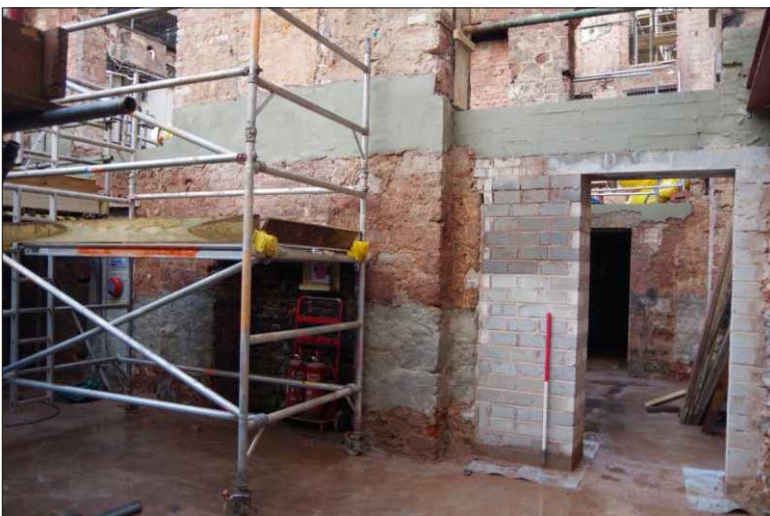
Plate 3: The rear basement, southeast wall showing fireplace, looking east. (1m scale)

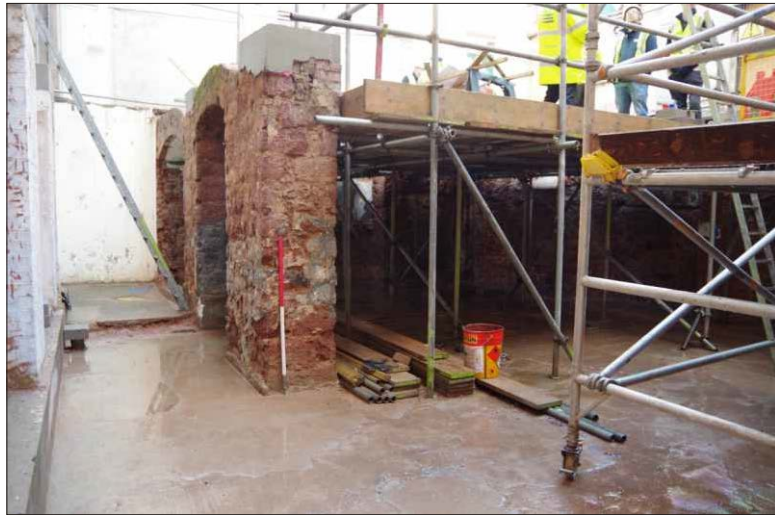
Plate 4: The rear basement showing the arched-headed piers, looking north. (1m scale)

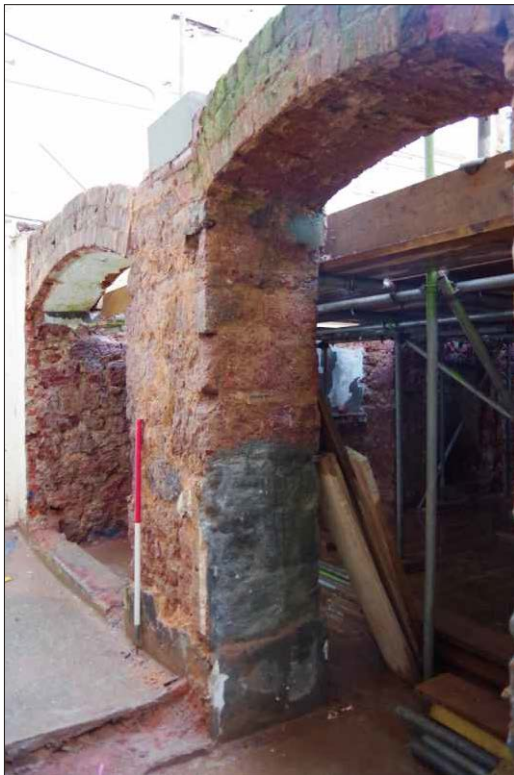
Plate 5: The rear basement, close-up view of the arched-headed piers, looking north. (1m scale)

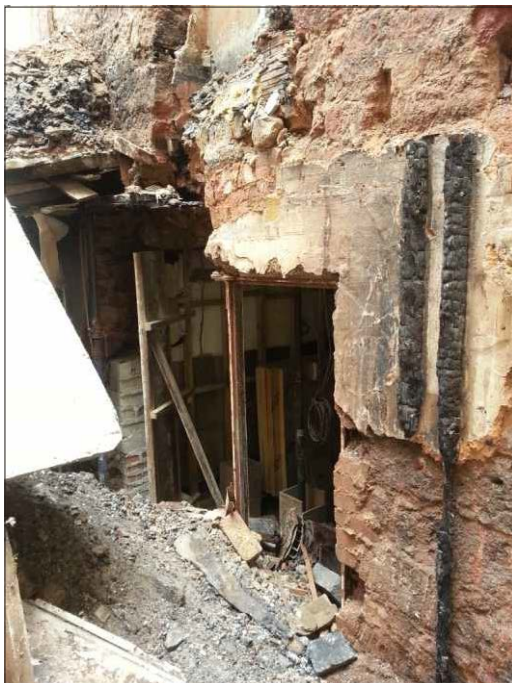
Plate 9: The middle basement, southeast wall showing the remains of an iron-frame to the central doorway

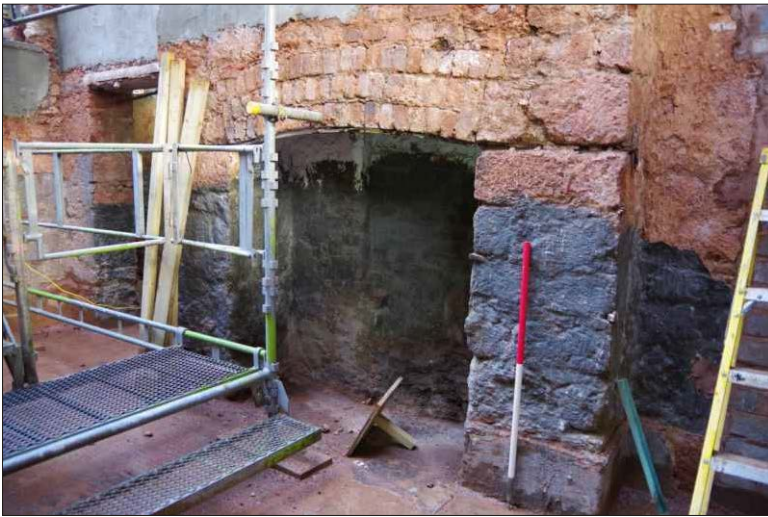
Plate 14: The front basement, fireplace in the northeast wall, looking north. (1m scale)

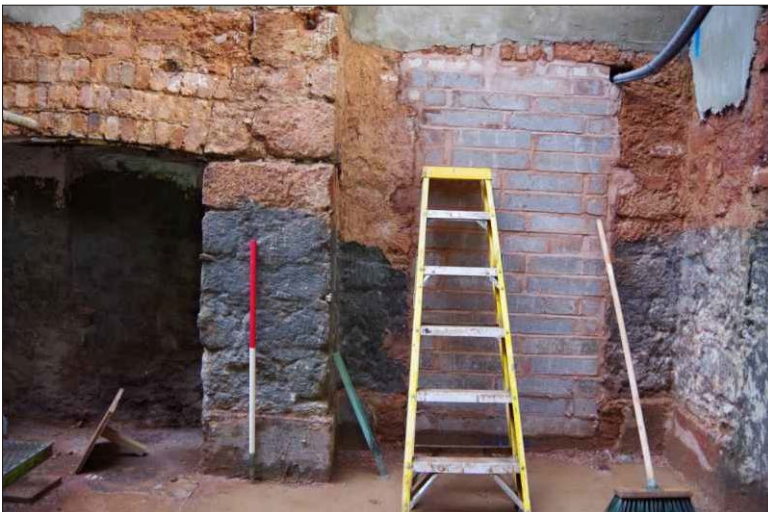
Plate 15: The front basement, blocked doorway in the northeast wall, looking northeast. (1m scale)

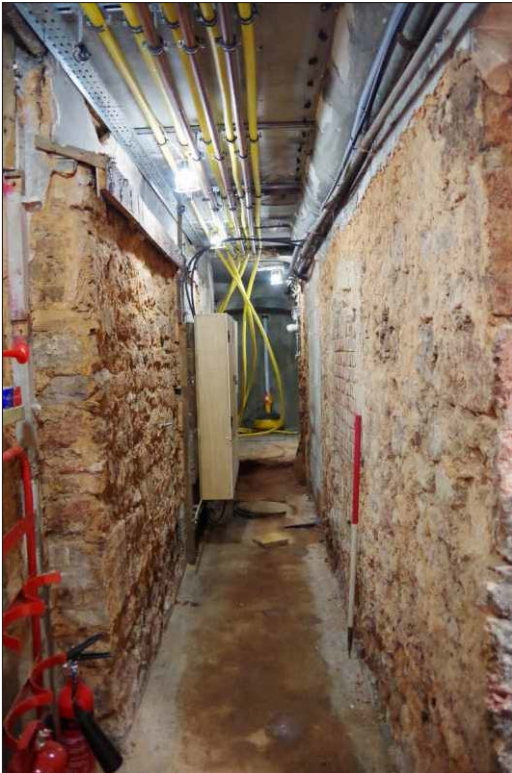
Plate 17: Basement passage under Lamb Alley showing break in northeast wall, looking southeast. (1m scale)

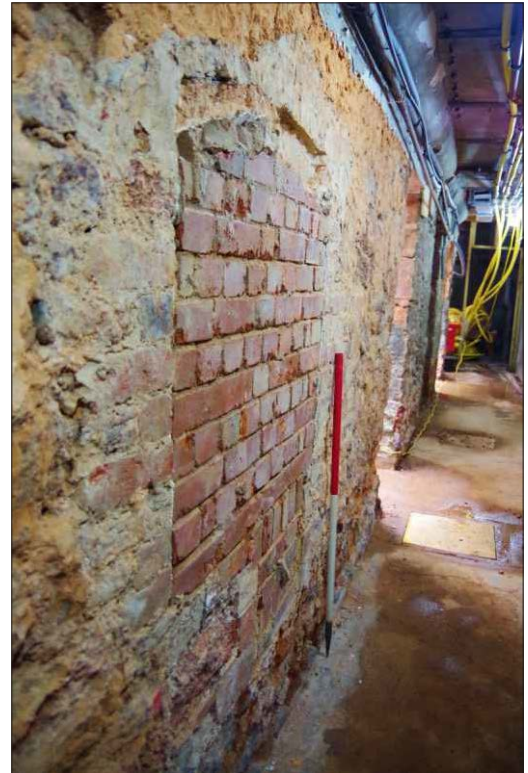
Plate 18: Basement passage under Lamb Alley showing infill behind the fireplace, looking west. (1m scale)

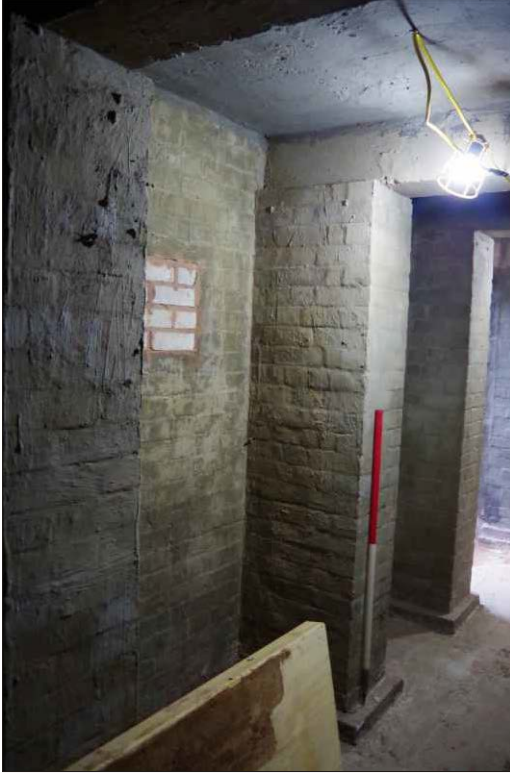
Plate 19: The eastern former cellar light under the front yard, looking north. (1m scale)

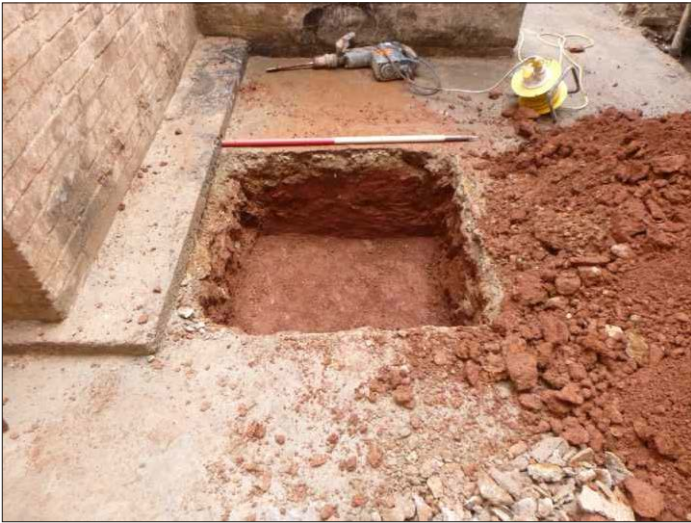
- 4.3** A test pit was excavated within the central basement area adjacent to the base of the 20th-century lift shaft; it measured 1m by 0.90m (Plate 21). The current basement floor was 0.10m thick and had been laid directly (at 38.36 aOD) onto the natural that consisted of medium reddish-brown sandy clay with abundant gravel. No groundworks took place during the rebuilding of the property.

Plate 21: The test pit in the basement, looking northeast. (1m scale)

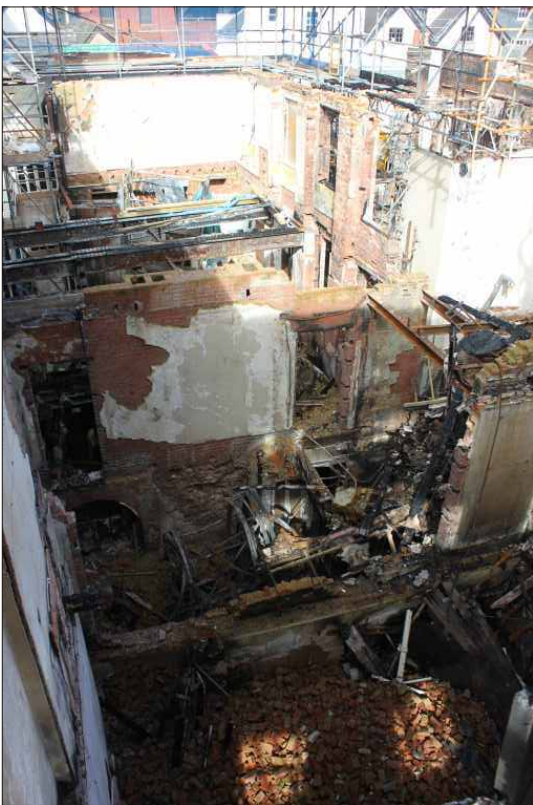
Plate 22: Pre-clearance view through the building looking down from the second floor to the ground-floor front range, looking north-northeast

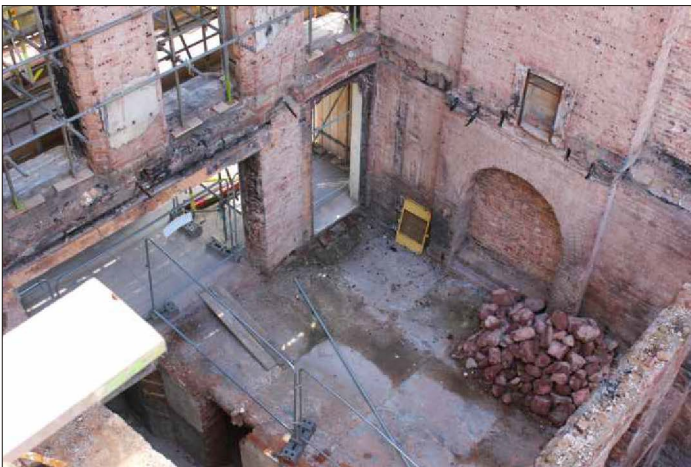
- 4.7 Most of the finishes to the front shop have been lost, and the surviving plasterwork removed to expose the brick walls. Within the front range the ground-floor walls are constructed of a variety of materials (Plates 22-28). The northwest wall for example is breccia, probably representing an 18th-century or earlier wall, whilst the southwest wall is brickwork (Plate 4), and appears to predate the late 19th-century rebuilding; there is no evidence of extruded bricks used elsewhere at this period. The front, southeast elevation is constructed of breccia with some volcanic trap fragments, and brickwork used around the southwest doorway and for arches to this and other openings; the latter openings were combined when the wider shop front was installed (Plates 4 and 5). These observations either indicate that there is an additional phase of mid-late 19th century alterations predating the main rebuilding, or that the extruded brick was not used at all on this floor.

Plate 23: The ground-floor front range following clearance showing the brick southwest elevation, and the stone southeast elevation, looking south

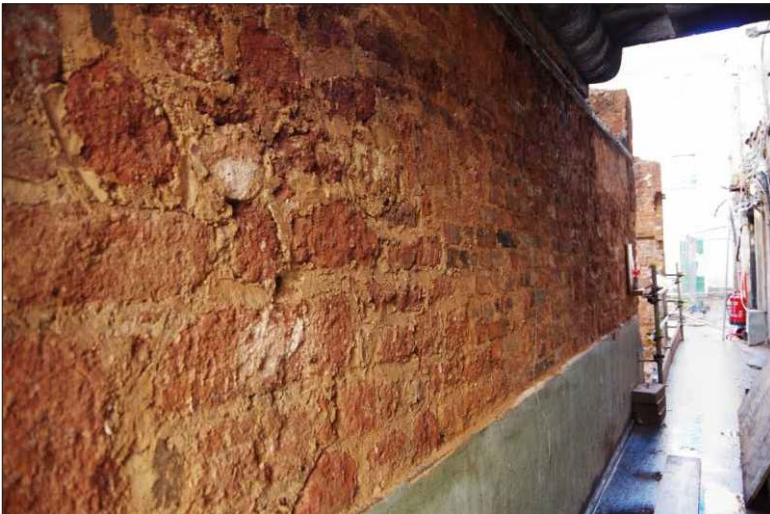
Plate 28: The ground-floor Lamb Alley passage showing brickwork in the rear of the front range fireplace, looking west

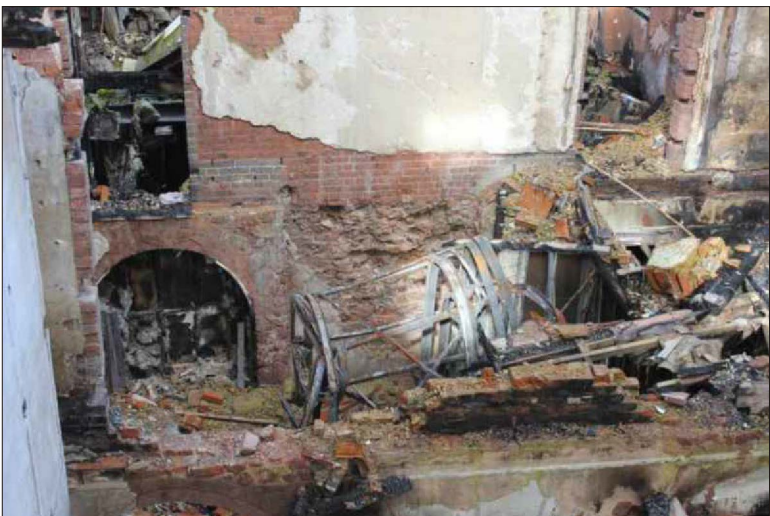
- 4.8 In the central part of the building the late 19th-century staircase has been entirely lost – there were also no remains of this in the debris within the cellar below – and the adjacent lift structure had buckled and collapsed over the site of the stairs (Plate 29), and was removed. In the east elevation 19th-century brickwork with timber lacing incorporating a former doorway and window was removed. This removal revealed stubs of 18th century or earlier breccia walls at the south end and north end (where it was only half height), which clearly represent remains of a continuation of the wall surviving in the front range. The southern doorway in the northwest wall is an insertion, and is contemporary with an entire re-facing of the east elevation of this wall. The general condition of the area post clearance is shown in Plates 29-31 and Plate 35.

Plate 29: The central area of the ground floor, looking northeast

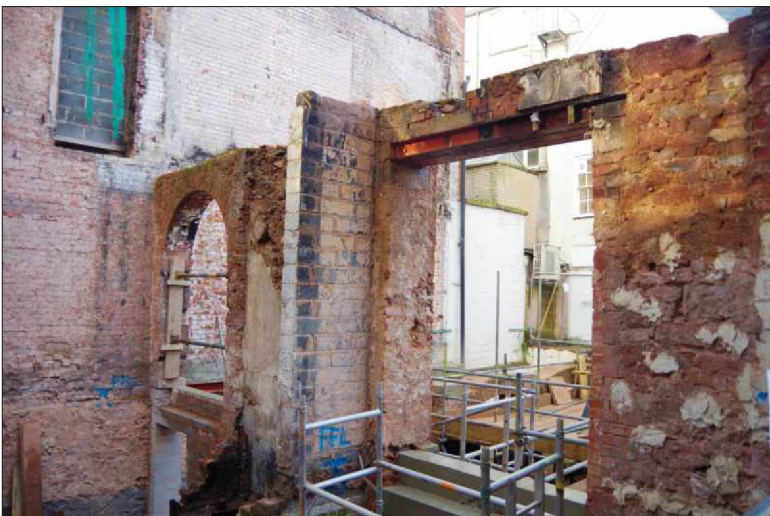
- 4.9 The rear block (Plates 32-37) contains walls with mixed brick and breccia and timber lacing, with the east elevation incorporating a series of (altered) full-height window openings with partially splayed internal reveals. Inspection of these exposed reveals indicates that the breccia is dressed to form these openings, rather than the stonework having been chopped through to create the windows. These openings do not correlate with those recorded on Tothill's 1770 plan (Parker 2010, fig. 3), and it is therefore put forward that these walls post-date 1770, and are perhaps of late 18th-

Plate 32: The ground-floor middle range, northwest wall, looking west

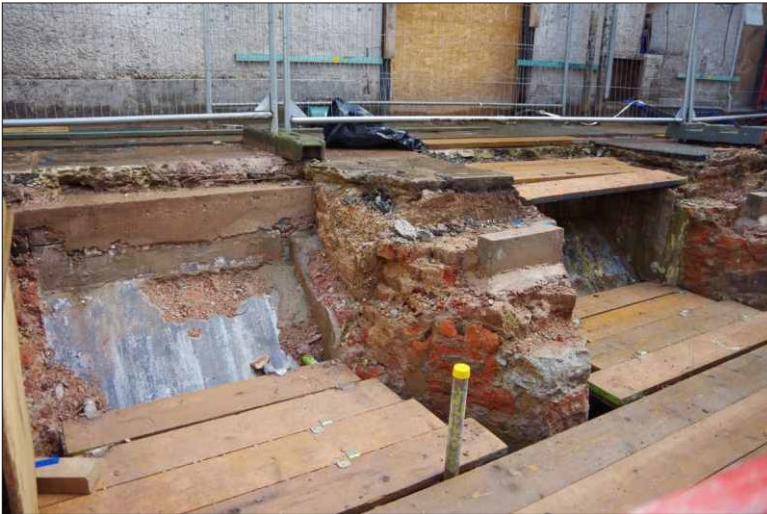
Plate 37: The ground floor, north range, base of northeast wall, looking east
