OAKHAY BARTON, STOKE CANON, DEVON

Results of historic building recording

East Devon District Council planning reference
15/0799/FUL, condition 12

Document No: ACD1645/2/0

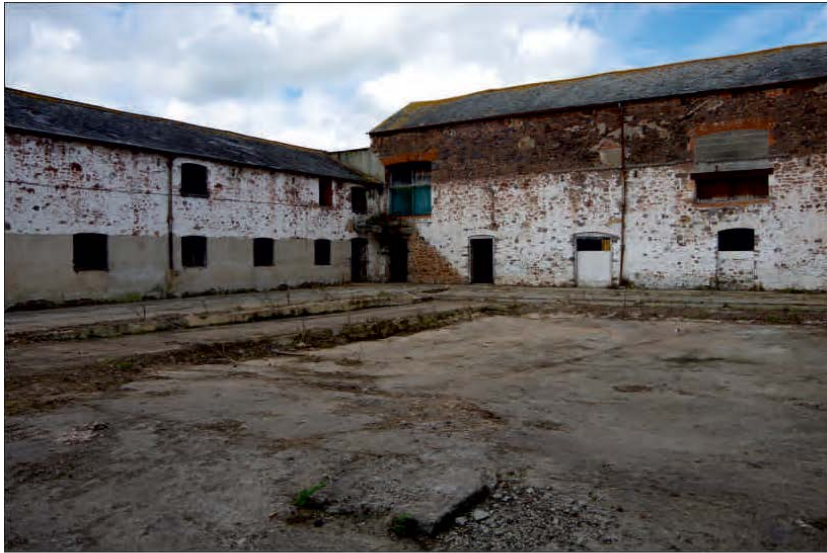
5.2 The central courtyard in the quadrangle is accessed through double doors in a covered passage between the east and south barns and through a gap between the west and south barns. The courtyard has a concrete surface along with an area of brick forming a walkway. There were previously structures within the quadrangle, and scars of walls, a first floor, and roofs of these demolished structures are visible on the courtyard surface and elevations of the north and west barns. The ground level in the courtyard is stepped, being higher to the north and west in the area of the former structures, and lower to the southeast. This lower area was probably used as a covered yard (Plate 1). To the north and west of the barns, on the exterior of the ranges, are a series of lean-to structures (Plate 2).

Plate 1: General view of central courtyard, looking northwest towards the north and west barns

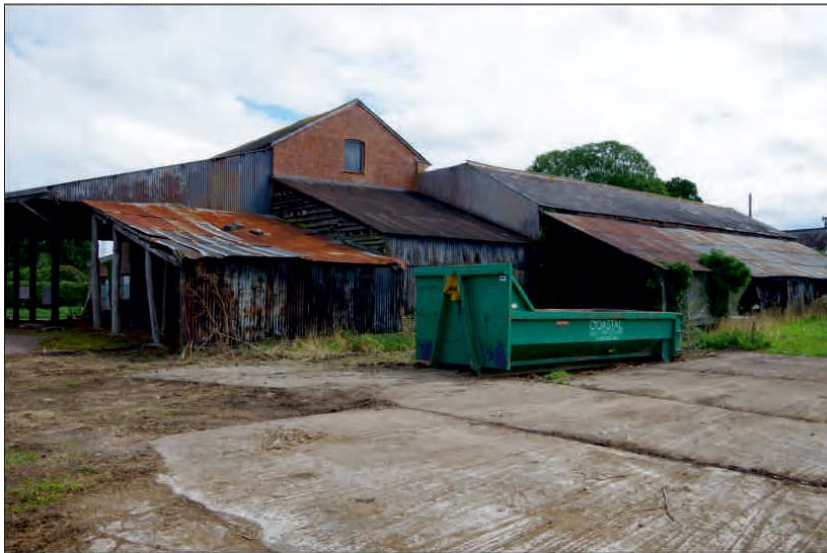
Plate 2: General view of lean-to structures, looking southeast

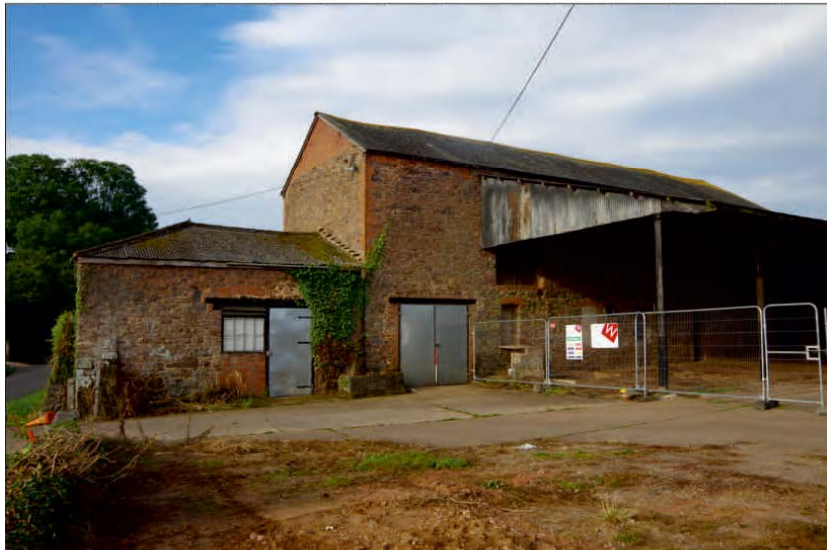
- 5.8** In the western two-storey section of the north elevation there are six openings on the ground floor (Plates 5 and 6). The central four openings were originally windows with brick-arched heads. Two of these openings have been filled with concrete blocks, with the western window converted into a door; this has brick jambs to the enlarged opening. The other window retains its original peg-jointed timber frame which displays sockets for now-removed security bars. The other two doorways are inserted and have brick jambs. The west opening has a wooden lintel and is fitted with wooden double doors, whilst the east opening is later and has a metal lintel and is fitted with metal double doors.

Plate 5: East end of north elevation of north barn, looking southwest (1m scale)

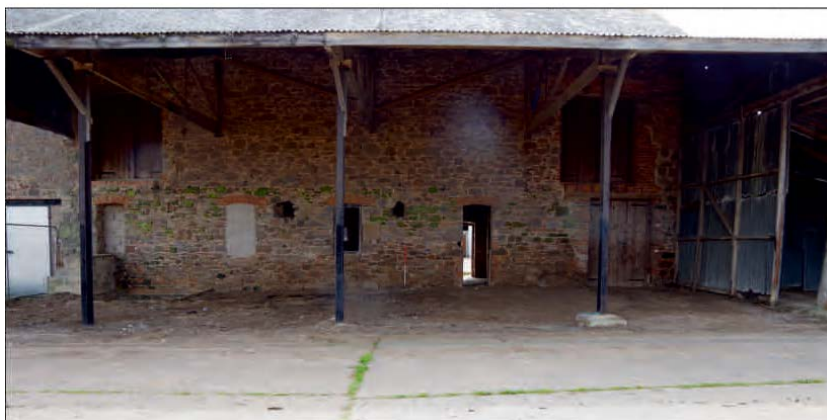
Plate 6: West end of north elevation of north barn, looking south (1m scale)

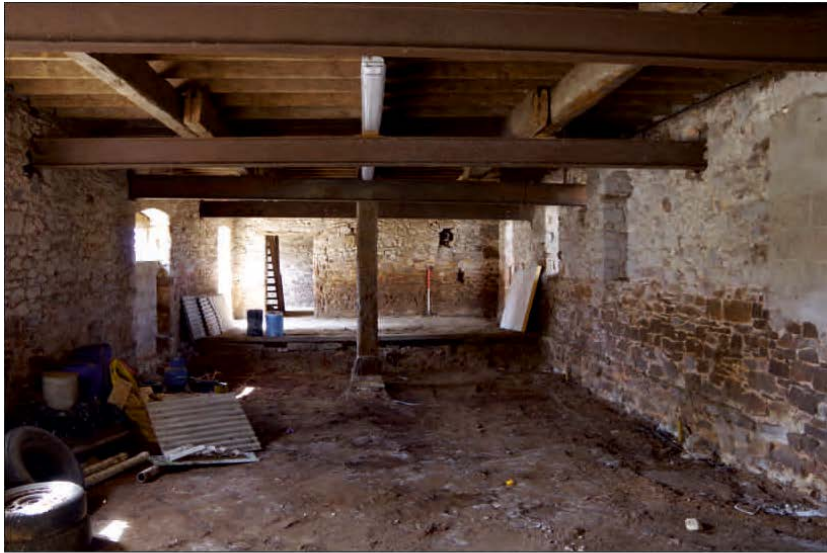
- 5.12** The central room is currently on two levels with the higher level being to the west and the original floor level having been reduced slightly to the east (Plate 7). There are two central posts supporting the first floor. The base of one has been exposed, and is a tapering block of volcanic trap supported with recently added concrete. The first-floor joists are supported on slender beams aligned east to west. These must have originally been supported on additional north-south aligned beams that have been replaced with four rolled steel joists. The central posts support the present lower wooden beams. The surviving floor at the west end of the room is a brick surface, which appears latterly to have lined a passage.

Plate 7: General view of central room on the ground floor of the north barn, looking west (1m scale)

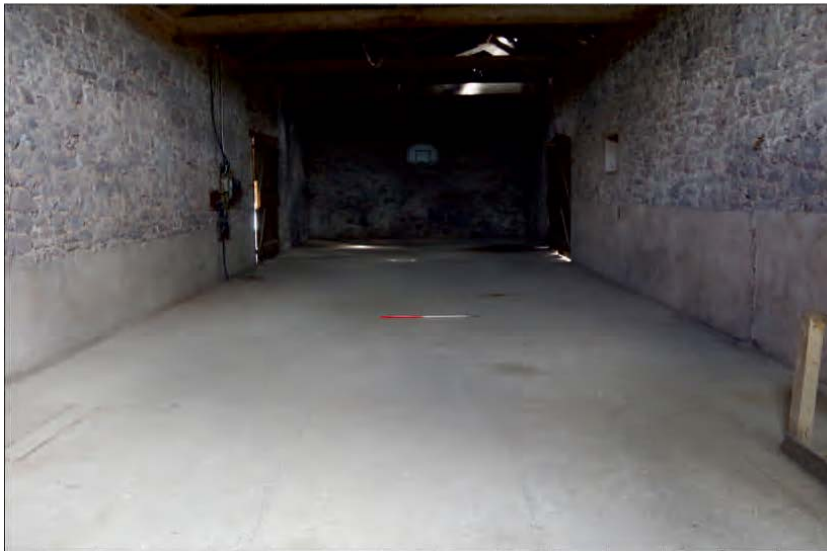
- 5.14** The first floor is a single open room with a chipboard floor replacing the original boards (Plate 8). The lower parts of the walls have been finished with concrete render. The roof comprises five king post trusses with back purlins resting on cleats that support the rafters, battens and slates.

Plate 8: General view of first floor of the north barn, looking east (1m scale)

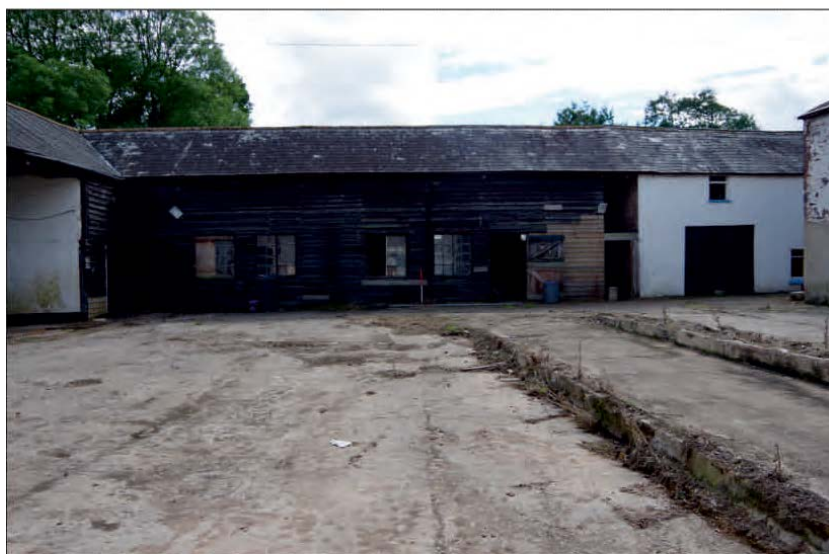
- 5.17** The west section of the north elevation is covered with white painted concrete render, with the remainder finished in timber cladding that continues around the east end of the barn (Plate 11). On the ground floor of the west section are a set of double wooden doors with round-ended strap hinges (one of which has been replaced with a plain strap) and a modern fixed window. On the first floor are two windows; the west window is a modern fixed casement, and the other is of three lights, each of three panes. The central light is hinged with small L-shaped strap hinges which is possibly a 19th- or early 20th-century replacement (Plate 12). In the east section, on the ground floor there are two wooden doors – one of which is a stable door – along with four horizontal sliding 16-pane windows. However, two are missing half of their windows. On the first floor there is a doorway above the corridor. The barn returns slightly to the north at its east end. Here there is a ground-floor wooden door.

Plate 11: North elevation of south barn, looking north (1m scale)

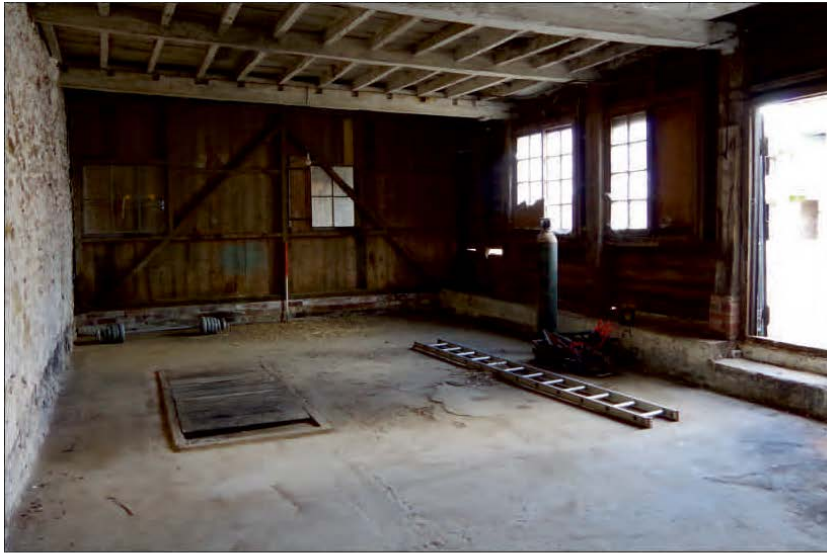
- 5.19** The east room has a concrete floor. At its east end is an inserted ceiling associated with a complete replacement first-floor structure. This is at a higher level than the original first floor. The original bridging beams survive and display unused sockets for the primary joists. There is a timber plank partition between this room and the stables to the west which is constructed onto a low brick plinth and contains two six-pane metal-framed windows. The original function of this room is unclear but was probably used to house animals, and may have been an open-fronted linhay. It last functioned as a garage and has an inspection pit in the floor (Plate 13).

Plate 13: General view of east room on the ground floor of the south barn, looking northwest (1m scale)

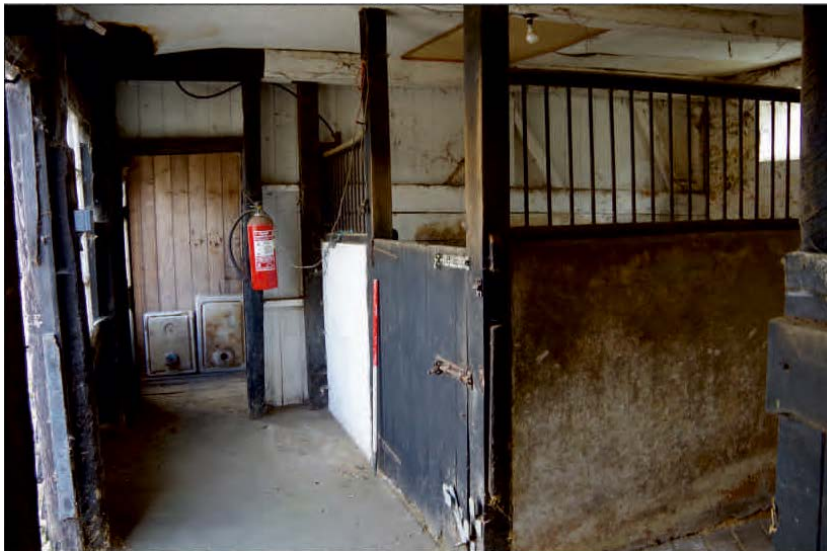
- 5.20** The central stable contains two stalls with a central concrete partition between, and with concrete floors to all elements (Plate 14). To the west is a tack room with a wooden floor. The partition wall between the tack room and stable is of timber planks and rendered blockwork, and the partition between the stable and the corridor to the west is also of timber planks and brickwork. There are concrete feeding troughs in each stable, with one having had a Belfast sink added on top. The room has a lower, inserted ceiling.

Plate 14: General view of stables on the ground floor of the south barn, looking east (1m scale)

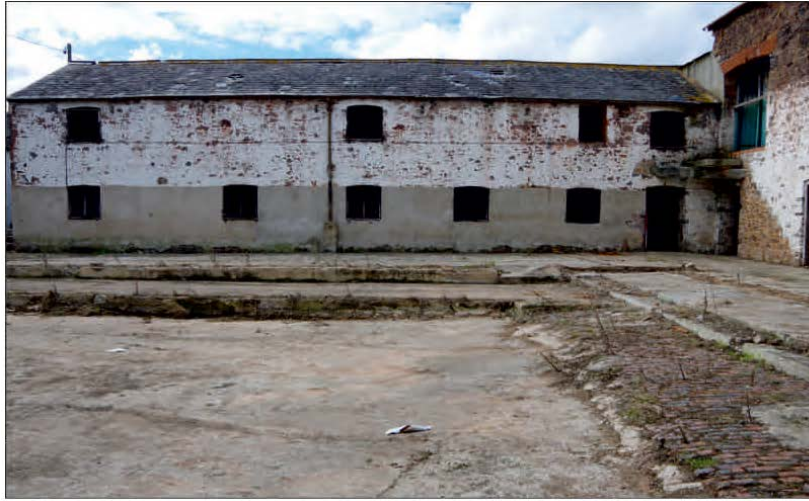
- 5.26** In the east elevation there are five windows and a door on the ground floor and four windows on the first floor (Plate 16). All but one of the openings on the first floor have brick arches above them. The window without an arch has been inserted and has brickwork around its opening. All of the original openings have peg-jointed timber frames. on the ground floor all of the windows retain their interior wooden shutters and iron security bars with two of the three windows on the first floor also retaining their shutters (Plate 17). The lower half of the elevation is covered with cement render with the remainder painted white. This reflects the two floors of the adjacent removed structures in the courtyard. Just below the eaves level is a row of inserted (and sawn-off) rolled steel joists associated with the roof of this demolished structure.

Plate 16: East elevation of west barn, looking west (1m scale)

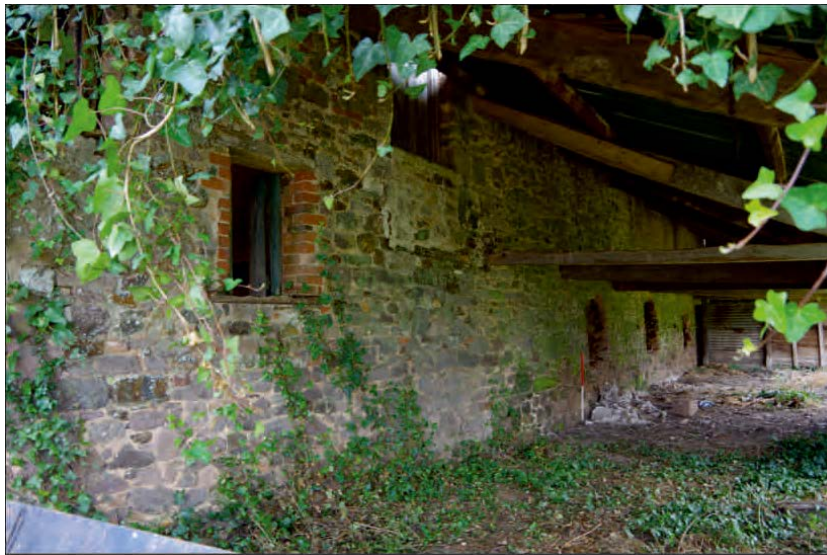
- 5.28** In the west elevation on the ground floor there is an inserted window at the north end, and to the south three holes have recently been knocked through the wall (Plate 19). The window has a wooden lintel and brick jambs, along with internal wooden shutters. On the first floor, at the north end of the elevation there is a door and loading hatch, both of which have peg-jointed timber frames and wooden plank doors. Brickwork has been inserted beneath the door opening and between the door and loading hatch.

Plate 19: West elevation of west barn, looking southeast (1m scale)

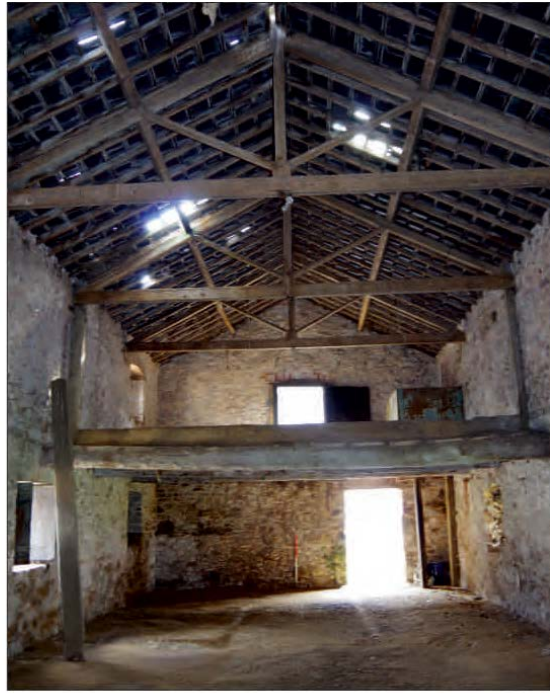
- 5.31** The north room has a part first floor with a central gap on the west side, which appears to have been utilised for the transfer of power to a threshing machine. The south room only retains its first floor at the south end. The rest has been removed with the sockets for the beams visible in the walls. The roof is supported on five king post trusses, with back purlins in turn supporting the rafters and batons (Plate 22).

Plate 22: General view of south room of the west barn, looking south (1m scale)

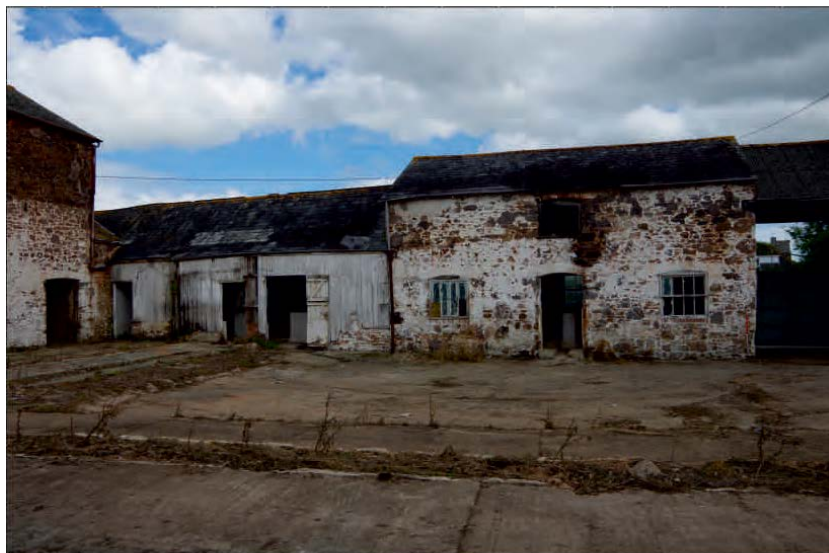
- 5.34** In the south part of the west elevation there are two windows and a door on the ground floor (Plate 24). The windows retain their peg-jointed timber frames, but the glazing is modern. The door has some brickwork repair to the side of its peg-jointed timber frame. All of the openings have brick arched heads. There are the cross ends of structural tie rods above these openings. There are some patches of brick repair to the corners of this part of the elevation. The north part of the elevation has timber cladding above a low brick wall incorporating three doors.

Plate 24: West elevation of east barn, looking east (1m scale)

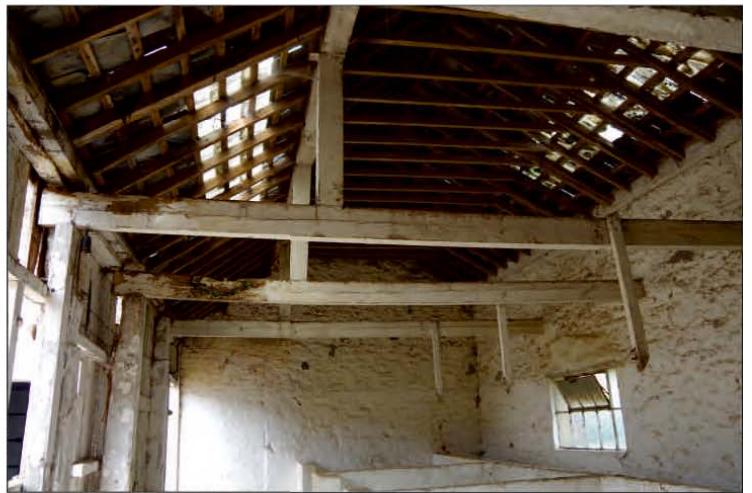
tie beams are offset king posts that support a north-south aligned horizontal beam. These timbers appear to represent part of an early queen post roof structure, that has been partially replaced (Plate 26). The current roof above these timbers is modern and is formed of rafters with trench jointed collars and back purlins. The slate roof incorporates long skylights in each pitch, both of which have been covered over with slates.

Plate 26: Roof structure in north end of ground floor of east barn, looking north (1m scale)
