FARLEIGH BARNS, NR CADELEIGH, CHERITON FITZPAINE, DEVON

Results of historic building recording

Mid Devon District Council planning reference 16/01499/FULL, condition 3

Document No: ACD1772/2/0

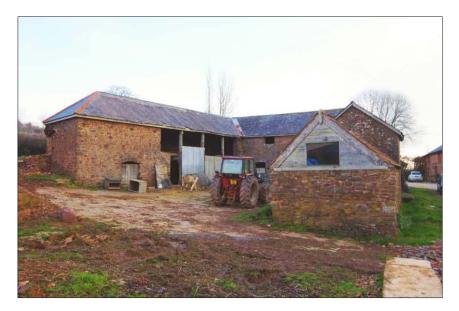
5.1 The recorded barns form three ranges surrounding a yard on three sides (Plate 1) with a former threshing barn and attached pens having previously formed the fourth side; these have been largely demolished. A further, detached garage/store to the south of the yard was also recorded. All of the barns are terraced into the hillside with the land being higher to the north and west, at the first-floor level of the north range. The yard has a concrete surface and is accessed from the southeast and southwest side of the south range, with the former entrance finished with a cobbled surface. There is a third entrance at the west end of the north range. The yard slopes down to the southeast and there is a drain running east-west along its south side. The barns are all constructed in local mudstone laid in rough courses with a pinkish lime mortar containing frequent inclusions.

Plate 1: General view of barns, looking northeast

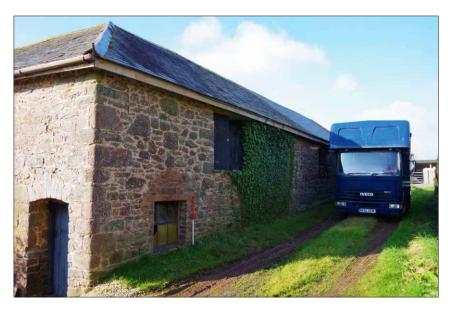
- **5.2** The range comprises two historic elements, and is two storeyed under a hipped slate roof; the west end of the roof has been recently replaced in slate with ceramic ridge tiles. The north elevation incorporates a low ground-floor, six-pane, metal-framed window at its east end. This is a later insertion and has a concrete lintel; the stonework around the opening has been repointed with cement. There are two first-floor loading hatches with wooden doors (Plate 2). The eastern opening retains one historic door with round and spear headed strap hinges, whilst the western opening retains both historic doors with spear headed strap hinges at the base. The upper brackets have been replaced. Both openings have empty sockets in the centre of their lintels indicating that these timbers have been reused. The ends of several timbers which internally support the first floor are visible in the stonework.

Plate 2: General view of east end of north elevation of the north range, looking southwest (1m scale)

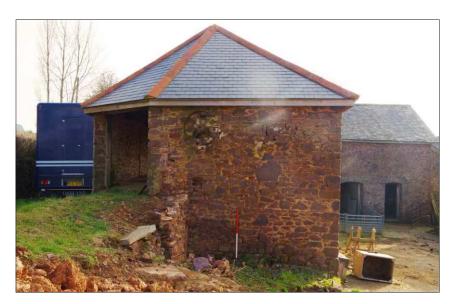
- **5.3** The northwest corner of the west elevation is angled, with a wide doorway at first-floor level. This has a pegged wooden frame but no doors. Immediately to the south is the remains of a stone wall flanking the entrance into the yard. Further south, at first-floor level, is the end of an overhead driveshaft (Plate 3). Attached to this driveshaft is a pair of belt drive pulley wheels. This feature incorporates a mechanism for engaging/disengaging belts to/from the wheels.

Plate 3: General view of west elevation of the north range, looking east (1m scale)

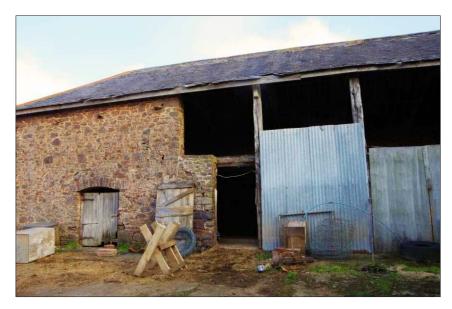
- 5.4 The western section of the south elevation is constructed of stone masonry, and incorporates a central ground-floor door to the western room. The opening has an arched opening with a central keystone, and is fitted with a wooden plank door. Above the opening the end of a first-floor joist is exposed. Just below the eaves the ends of four sawn-off timbers project out from the wall line. These are associated with a former lean-to within the yard. The eastern two-thirds of the elevation was originally fully open fronted (on both floors), and divided by three vertical posts into four bays. Two of the bays have been partially enclosed with corrugated metal sheeting and timber boarding (Plate 4). The east elevation features two doors on the ground floor with arched openings, keystones, and are fitted with wooden doors.

Plate 4: General view of south elevation of the north range, looking north

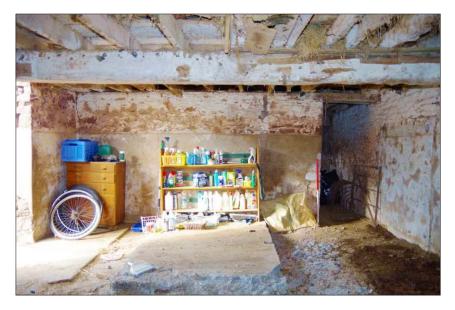
5.5 The ground floor is currently divided into three areas. At the west end is a small original store room, whilst a second store and adjacent corridor has been inserted into the east end of the range; concrete blocks have been used to create the latter. The central area and the east end would formerly have been used to house livestock. The lower half of the walls are rendered and the floor is a concrete replacement. Contemporary, later 20th-century, fittings have been removed, but there would have

been a feeding passage adjacent to the north wall, divided from the stalls by troughs. In the floor of the stalls is an east-west aligned drain (Plate 5). The south end of one of the bridging beams supporting the first floor has failed and is now supported on a pier of concrete blocks. There are no historic fixtures and fittings in any of the groundfloor rooms.

Plate 5: General view of the central livestock area in the north range, looking west (1m scale)

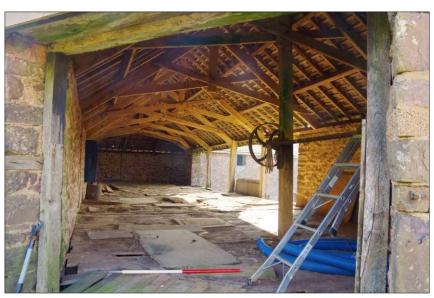
5.6 The first floor comprises an open-plan hayloft which continues around into the east range (Plate 6). It was not entered due to the unsafe nature of the wooden boards. At the west end, within the first two bays, is a drive shaft with three attached belt drive pulley wheels. It is supported at its east end by a vertical timber extending down from the roof. This belt drive relates to the provision of threshing or crushing machinery formerly located within this end of the building. The roof is supported on replacement 20th-century cross-braced trusses with central vertical posts. The purlins rest on the back of the trusses supported with cleats, and in turn support the rafters and battens.

Plate 6: General view of the first floor of the north range, showing the drive shaft and end pulley wheel on the right, looking east (1m scale)

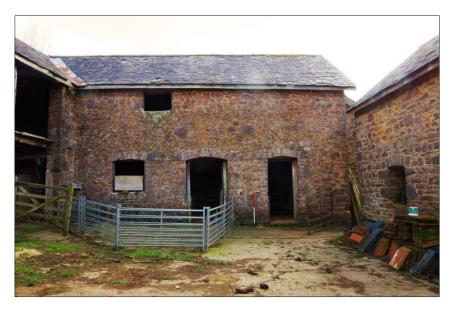
- **5.7** The main section of this range is two storeyed under a slate roof that is gabled to the south, and continues over the east end of the north range to a hipped corner. At its south end there is an attached garage that opens onto the track east of the yard. The west elevation has three openings on the ground floor; two doorways and a window, all of which have arched openings and wooden frames. The southern doorway has been created from an original window. On the first floor is a small window under the eaves (Plate 7). On the first floor of the east elevation is a loading hatch fitted with a pair of wooden doors. Some of the first-floor stonework has been repointed in cement mortar (Plate 8). Only the upper gable of the south elevation is visible above the roof of the attached garage. Here there is a loading hatch with a wooden lintel, above which are three pigeon holes with landing slates.

Plate 7: General view of west elevation of the east range, looking east (1m scale)

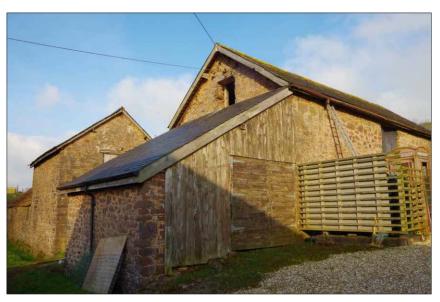
- **5.8** The attached garage has stone south and west walls, under a single pitched replacement slate roof. The only opening is in the east elevation where there is a pair of modern double wooden doors set within a timber clad façade (Plate 9).

Plate 9: General view of garage and south elevation of the east range, looking northwest

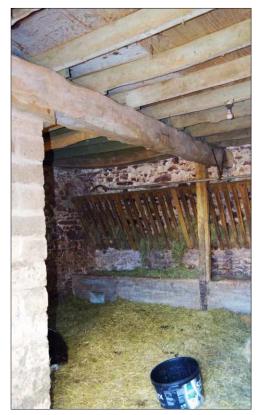
5.9 The ground floor of the main part of the range was originally a single space, but has been divided into two rooms by a 20th-century concrete block wall. It has a cobbled floor and feeding trough, and manger along the east wall. The west end of one of the bridging beams supporting the first floor has failed and is now supported of a pier of concrete blocks (Plate 10).

Plate 10: General view of ground floor of the east range, looking northeast

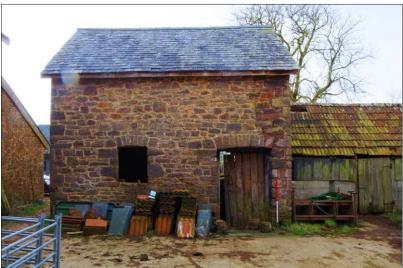
5.11 The north elevation of the barn contains a ground-floor doorway and a window, both with arched openings (Plate 11). The doorway is fitted with a basic wooden plank door. The east elevation has a first-floor loading hatch under a wooden lintel, fitted with a pair of wooden doors. The south elevation features a ground-floor window, fitted with a modern grill, on the ground under a wooden lintel (Plate 12).

Plate 11: General view of north elevation of the south range barn, looking south (1m scale)

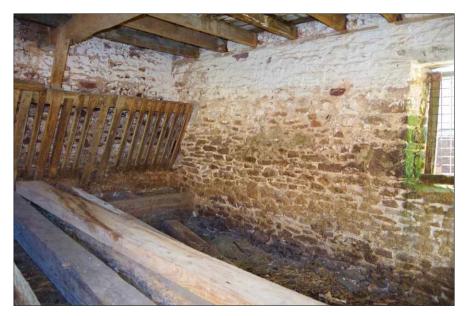
5.12 The ground floor contains a single room with a cobbled floor, and features a feeding trough and manger along the east wall (Plate 13). In the west wall is a doorway under a wooden lintel giving access to the piggery. The first floor was not accessible. The roof is supported on a single king-post truss.

Plate 13: General view of ground floor of the south range barn, looking southeast

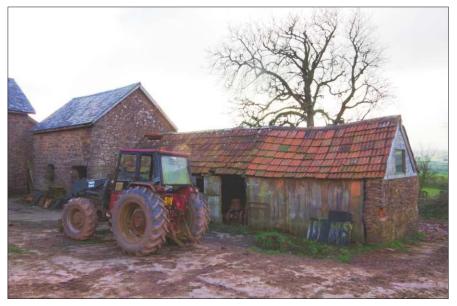
- **5.13** The south elevation is continuous with the adjacent barn and incorporates a highlevel window opening (without fittings) at the east end. The upper part of the stone masonry in the east elevation has been rebuilt using local reclaimed stone. The gable above is timber clad with applied barge board, and incorporating a central plate glass window. The north elevation was originally open fronted with six bays divided by five vertical posts, of which all but one support roof trusses. The openings have been infilled with low concrete block walls topped with timber cladding. There are currently three doorways, two of which contain wooden doors (Plate 14).

Plate 14: General view of north and west elevations of the piggery, looking southeast

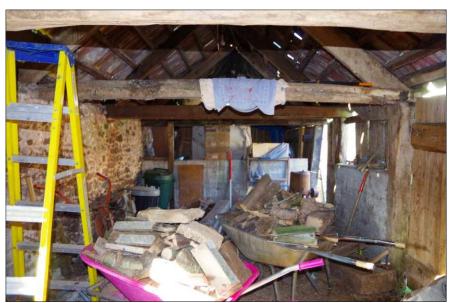
- **5.14** The structure is divided into two spaces by a 20th-century concrete block wall creating a store at the west end (Plate 15). There are no historic fixtures or fittings. The roof is supported on simple trusses with principal rafters rising from tie beams supported on the front posts, on the back of which rest the purlins. Two of the trusses also feature secondary applied collars.

Plate 15: General view of the piggery, looking west (1m scale)

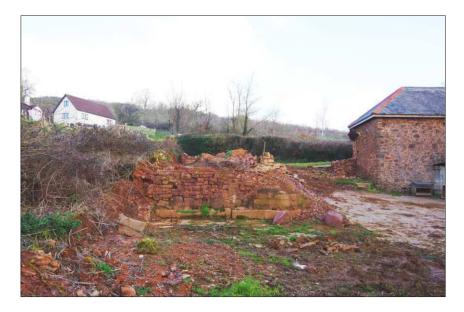
5.15 A threshing barn originally formed the part of the western side of the yard, and predated the other recorded barns. It no longer exists apart from a low section of the south wall that displays remnants of the construction materials used – local mudstone laid in rough courses and bonded with a pinkish lime mortar containing frequent inclusions, which was topped with cob. The barn stood on a higher-level terrace than the other barns and yard (Plate 16). To the south of the barn there was formerly a pen structure, which was situated at the same level as the yard. All that remains of this is the concrete south wall, along with a low concrete feeding trough abutting the south wall of the threshing barn.

Plate 16: General view of former threshing barn, showing remaining south wall, looking north

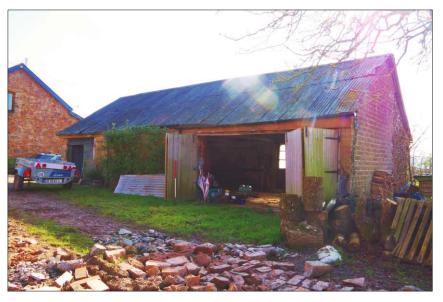
- **5.16** This structure is single storeyed under a gabled corrugated sheet roof. It is constructed in local mudstone laid in rough courses with a pinkish lime mortar containing frequent inclusions. The upper part of the east elevation, the north part of the west elevation and the majority of the south elevation have been rebuilt in the 20th century using concrete blocks. In the centre of the rebuilt south elevation is a 20th-century glass-panelled door. The building was formerly open fronted to the north, but this has been infilled with piers of 20th-century concrete blocks separating full height double wooden doors to the west and timber cladding and a single wooden door to the east (Plate 17).

Plate 17: General view of the north and west elevations of the garage/store, looking southeast (1m scale)

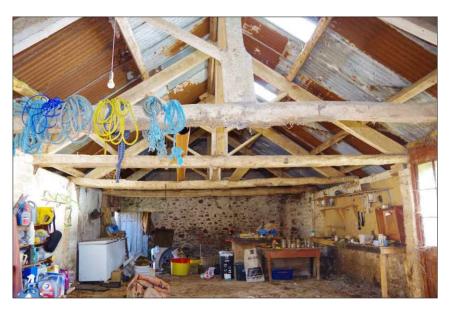
- **5.17** The building contains a single room with a concrete floor; there are no historic fixtures or fittings. The roof is supported on king post trusses with diagonal struts, and with modern battens set on the rear of these truss rafters (Plate 18).

Plate 18: General view of the garage/store, looking east (1m scale)
