BUDDLE BRIDGE, LYME REGIS, DORSET

Results of historic building recording

West Dorset District Council planning reference
WD/D/17/000504

Document No: ACD1039/2/0

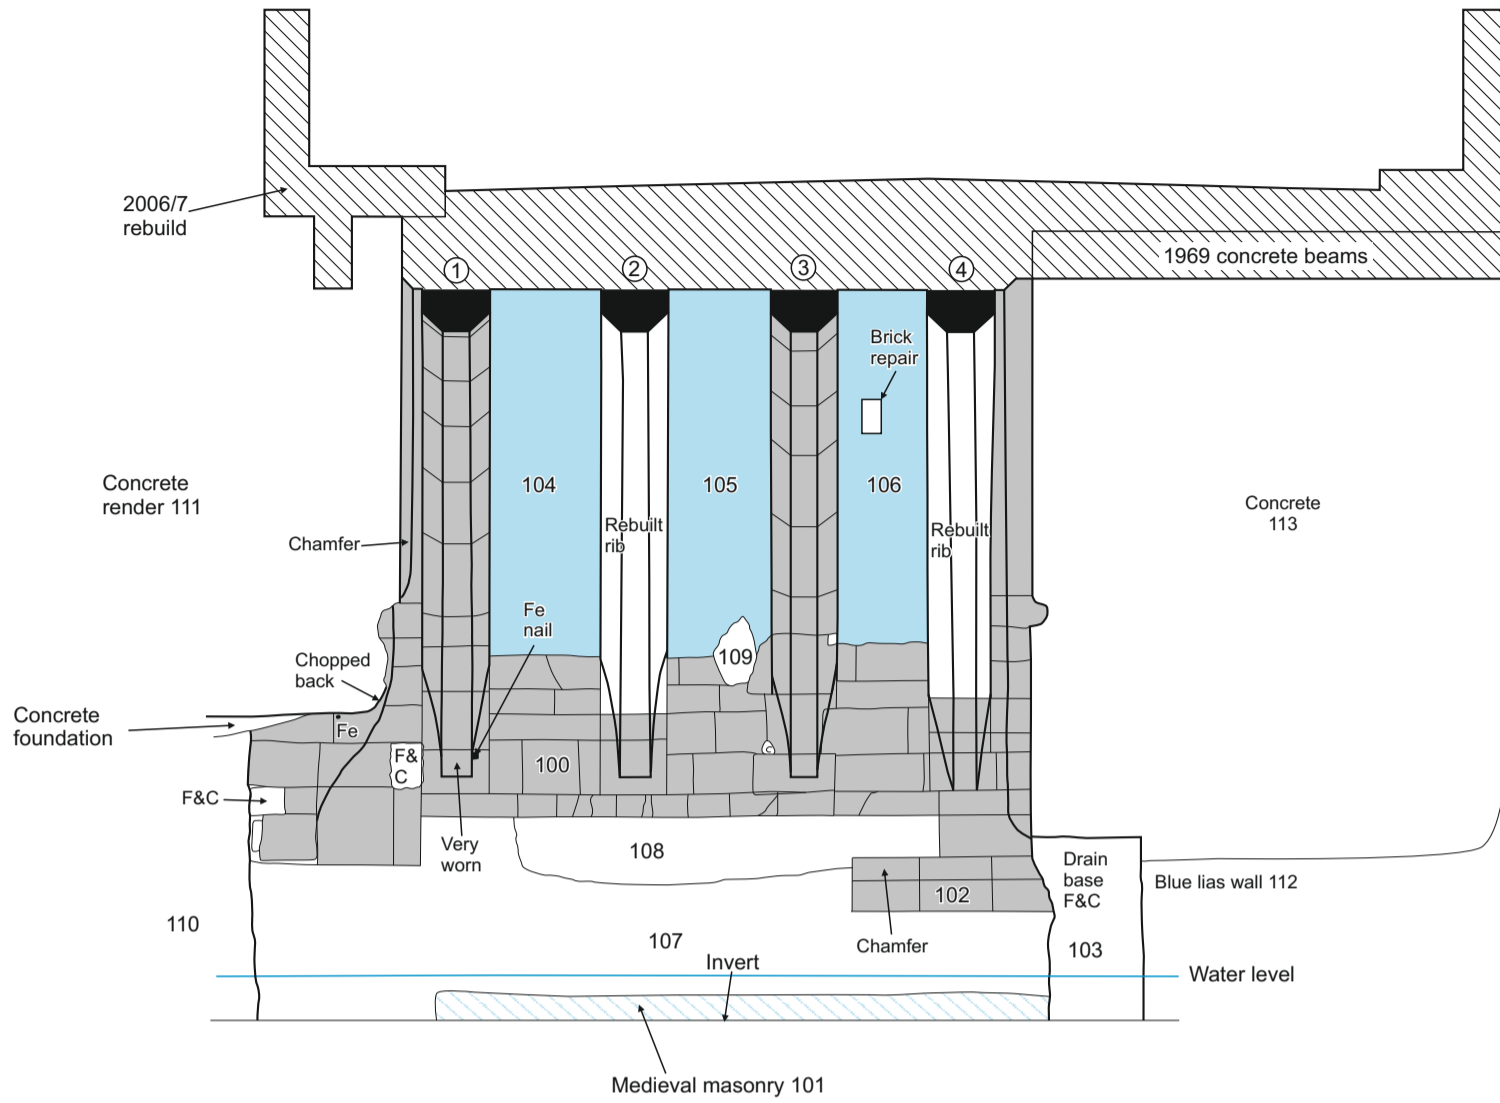
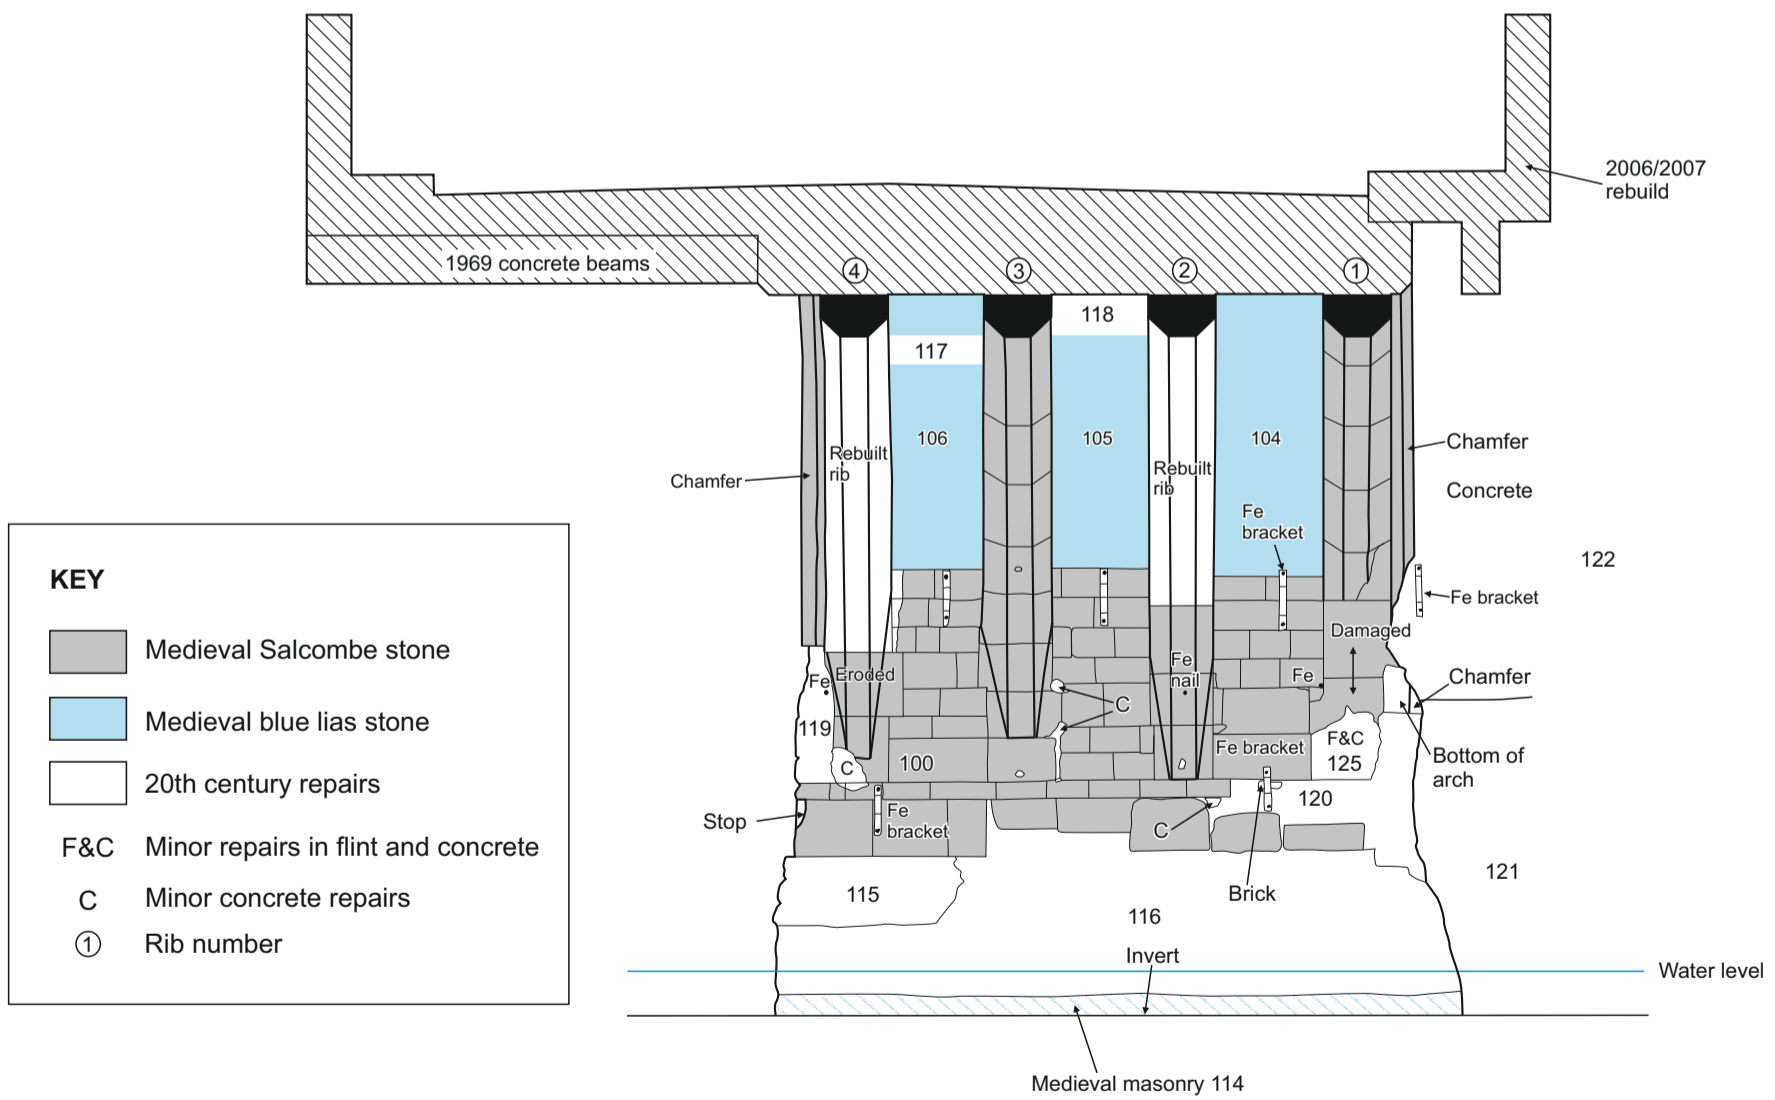
a) East elevation of the arch

b) West elevation of the arch

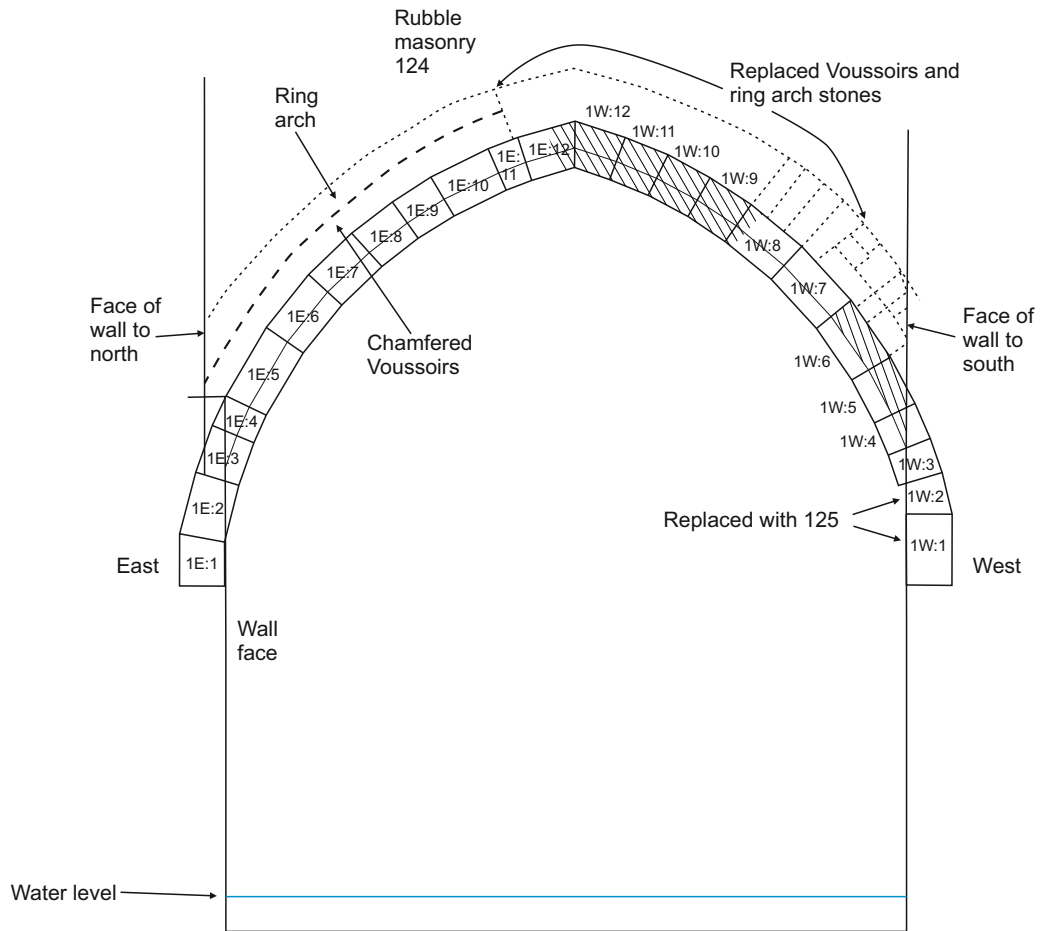
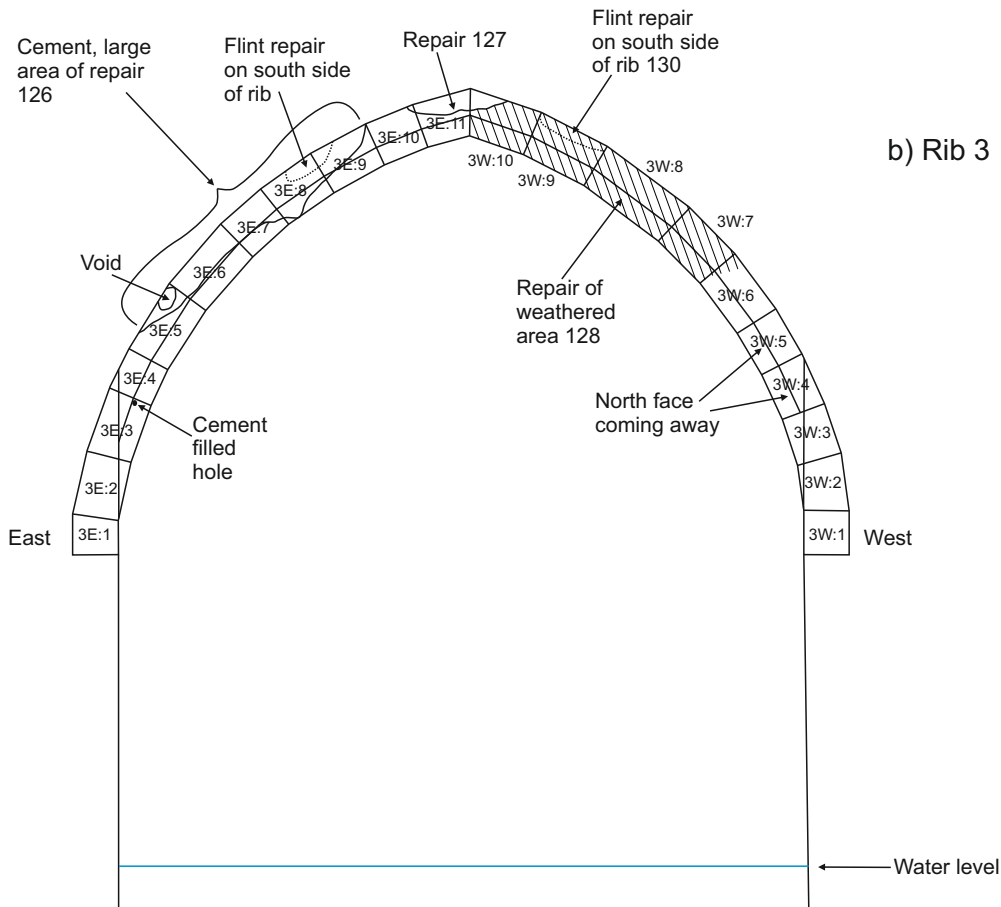
Fig. 9: The north elevations of ribs 1 and 3

a) Rib 1

b) Rib 3

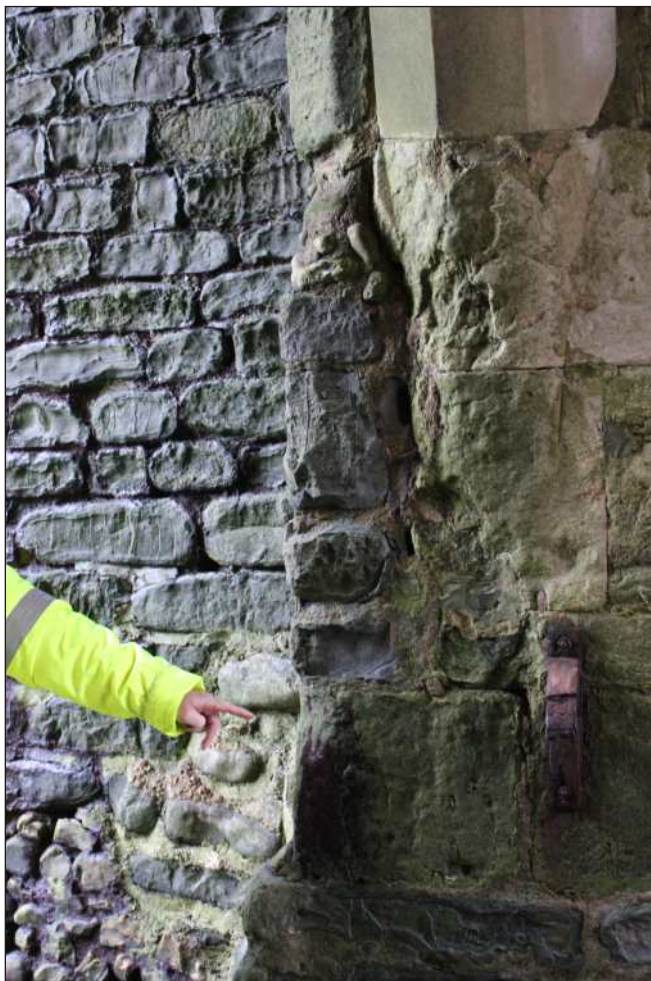
Plate 10: Eroded chamfer stop on the south end of the bridge on the east side

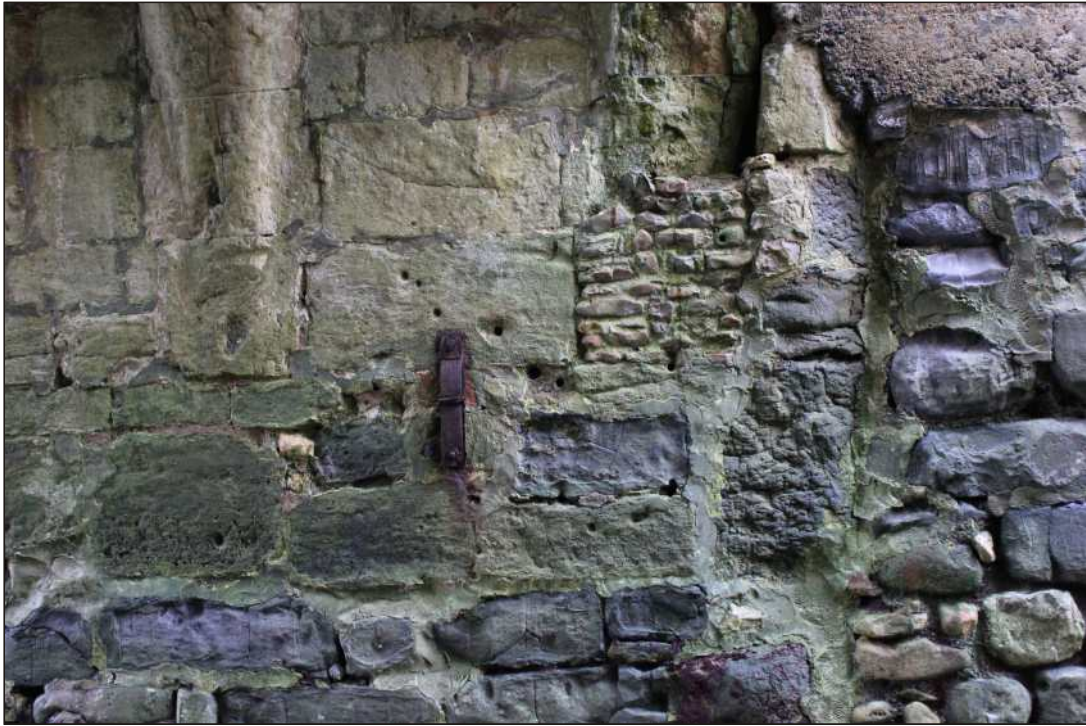
Plate 11: Repairs at the base of Rib 1 on the west side of the bridge

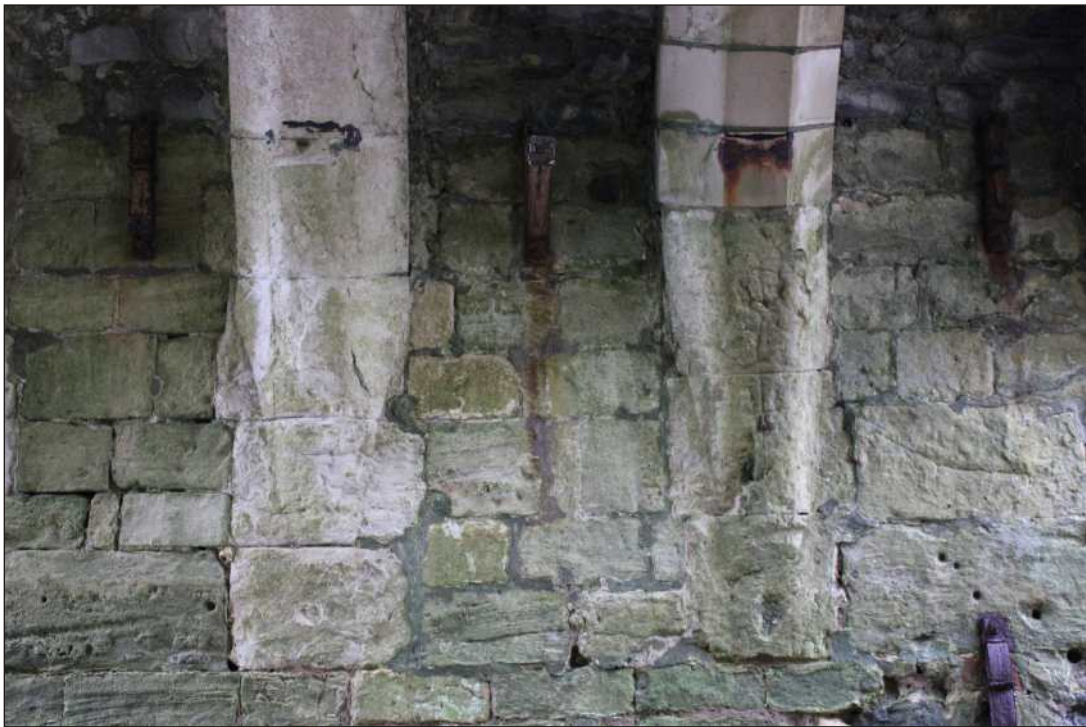
- 5.7 The arch between the ribs is formed from either six or seven lower courses of dressed Salcombe Stone (100) that extends much higher up the arch than on the east side (Plate 12). Above this, the stonework is coursed rows of roughly dressed local blue lias stone (104-106). Within this masonry, high up between ribs 3 and 4, there is a repair in brickwork comprising two courses of red brick (Plate 13). The apex of the span between ribs 2 and 3 has been repaired using flint pebbles.

Plate 12: Dressed masonry between ribs 2 and 3 on the west side of the bridge

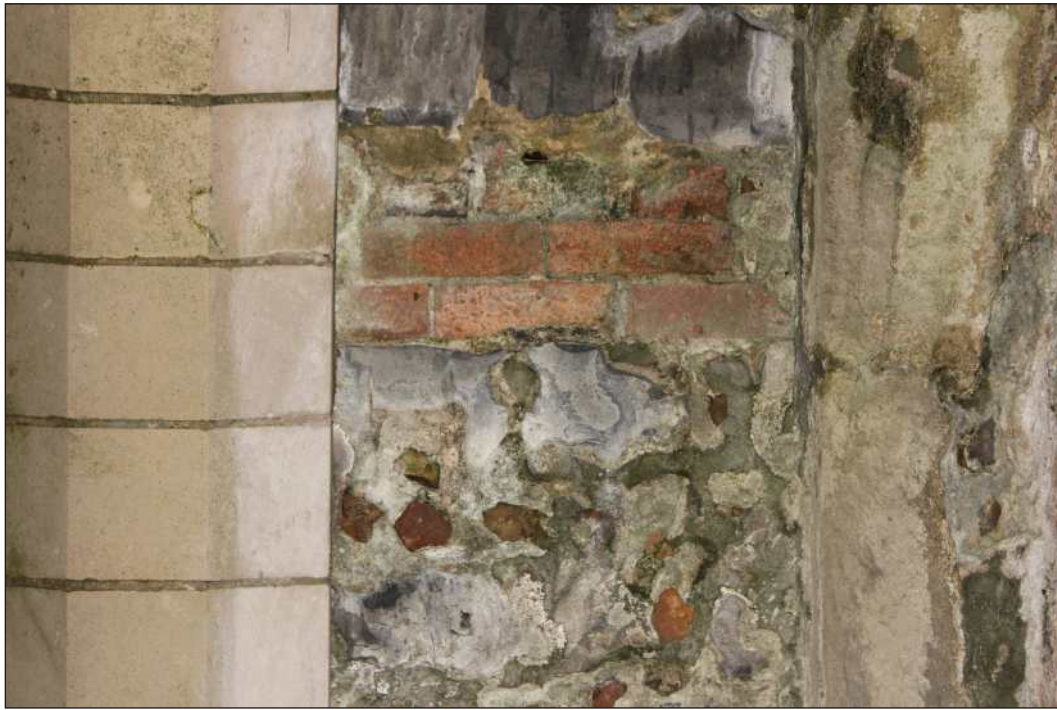
Plate 13: Repairs between ribs 3 and 4 on the west side of the bridge

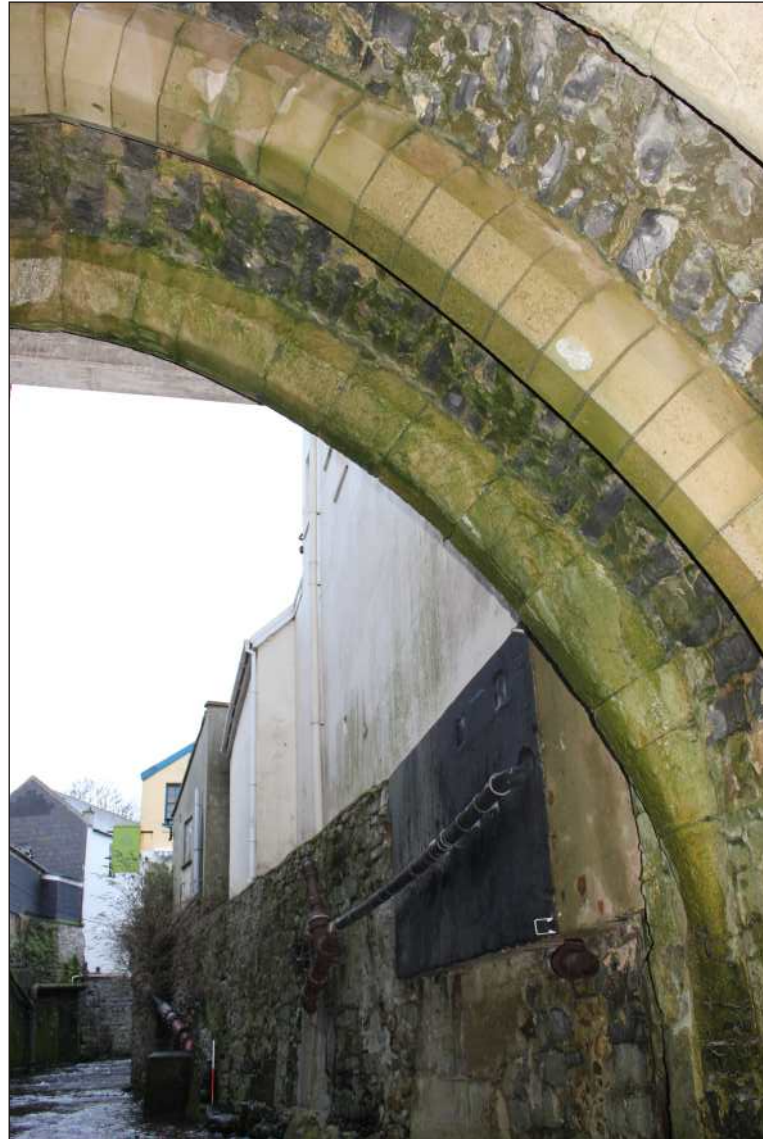
- 5.12** This is one of the two surviving medieval ribs, and originally comprised 24 stones of which 22 survive (Plates 17 and 18). The following features, damage and repairs have been identified:

- 1E:1 The base of the rib is very worn and barely extends out from the face of the wall. An iron nail has been inserted into the stone.
- 1E:11 There is a small area of lamination on the north side of the chamfer.

- 1E:12 On the north side of the rib, the eastern side of the stone has badly weathered.
- 1W:1 This stone has been replaced with a flint and concrete repair (125).

- 1W:2 This stone has been replaced with a flint and concrete repair (125).
- 1W:3 The front of this stone has collapsed and has been lost. The *in situ* section is cracked.

- 1W:4 The lower front section, extending around to its north side has collapsed and has been lost. The *in situ* section has a crack on its north face.

- 1W:5 The north face has weathered badly and cracked.
- 1W:6 The north face has weathered badly and cracked.
- 1W:7 The north face has cracked, and the front face has partially laminated and fallen away.

- 1W:8 The north face has cracked and is weathering at its top (extending into 1W:9)
- 1W:9 The north face has weathered and a crack extends from this face up onto the front face. This has been patched with concrete.

- 1W:10 The north face has weathered and a crack extends from this face up onto the front face. This has been patched with concrete.
- 1W:11 The north face has weathered and a crack extends from this face up onto the front face. This has been patched with concrete.

- 1W:12 The north face has weathered and a crack extends from this face up onto the front face. This has been patched with concrete.

Plate 17: The southern face of the west side of Rib 1

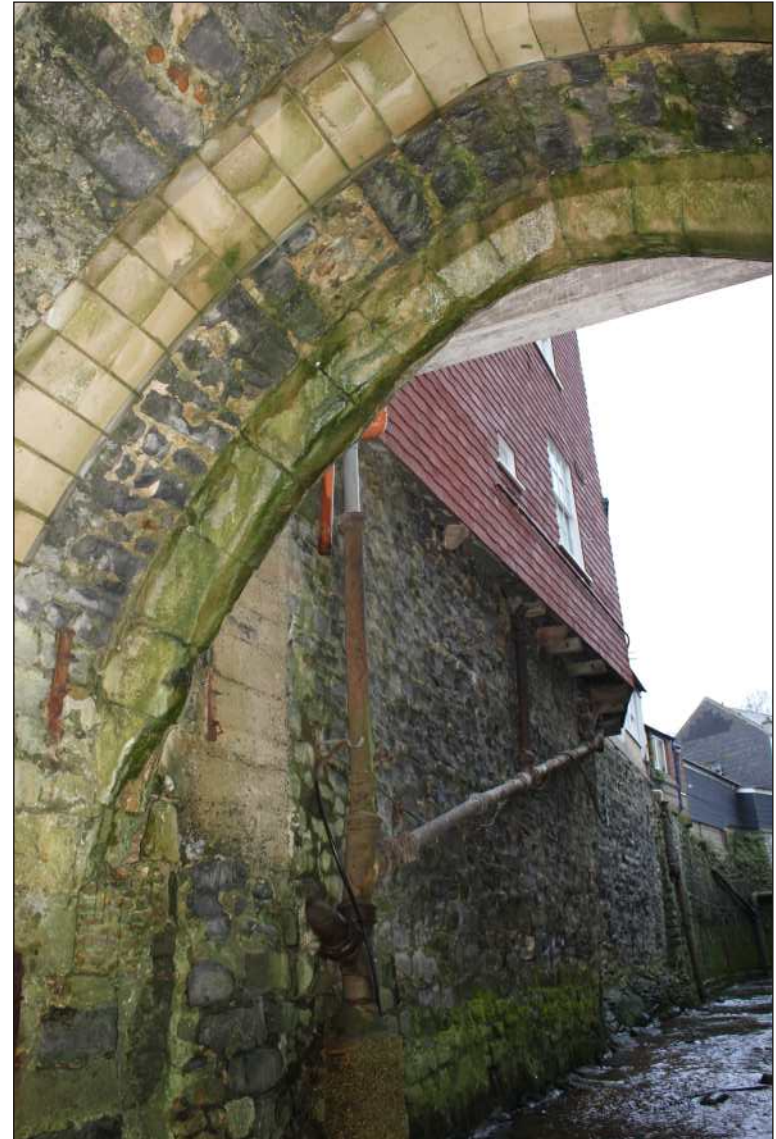
Plate 18: The southern face of the east side of Rib 1

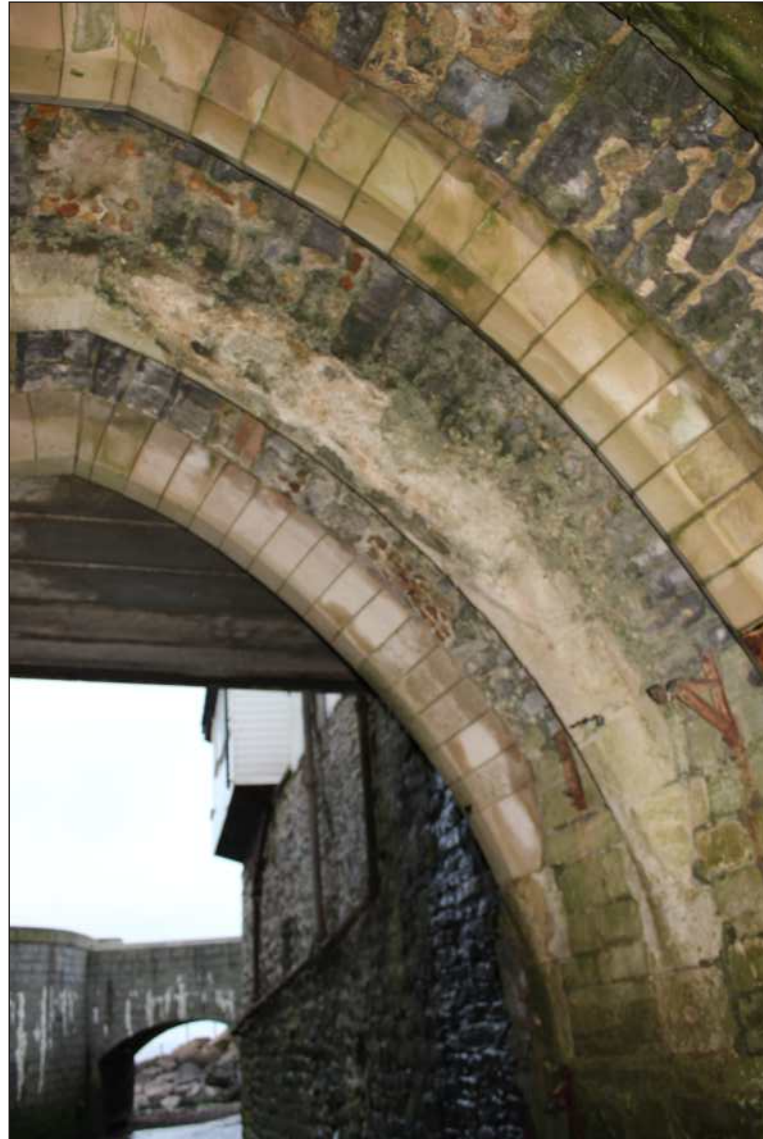
- 5.14** This is one of the two surviving medieval ribs, and comprises 21 stones of which all survive (Plates 19 and 20). The following features, damage and repairs have been identified:

3W:1 The base of the rib is very worn and barely extends out from the face of the wall. A hole in the west face has been infilled.

3W:5 There is lamination on the north face turning into a crack. Two iron nails have been inserted into the south face.

3W:6 There is a crack and some weathering on the north face

3W:7 The north face has weathered and a crack extends from this face onto the east face.

3W:8 The north and east faces have weathered and have been repaired using white lime mortar with charcoal inclusions (129). A pink mortar is also visible.

3W:9 As 3W:8. On the south face there is a crack, a hole filled with cement, and a flint repair adjacent to the span (130).

3W:10 As 3W:8. There is a different repair (127) adjacent to 3E:11. There is a crack on the south face extending up from 3W:9.

Plate 19: The northern face of the west side of Rib 3

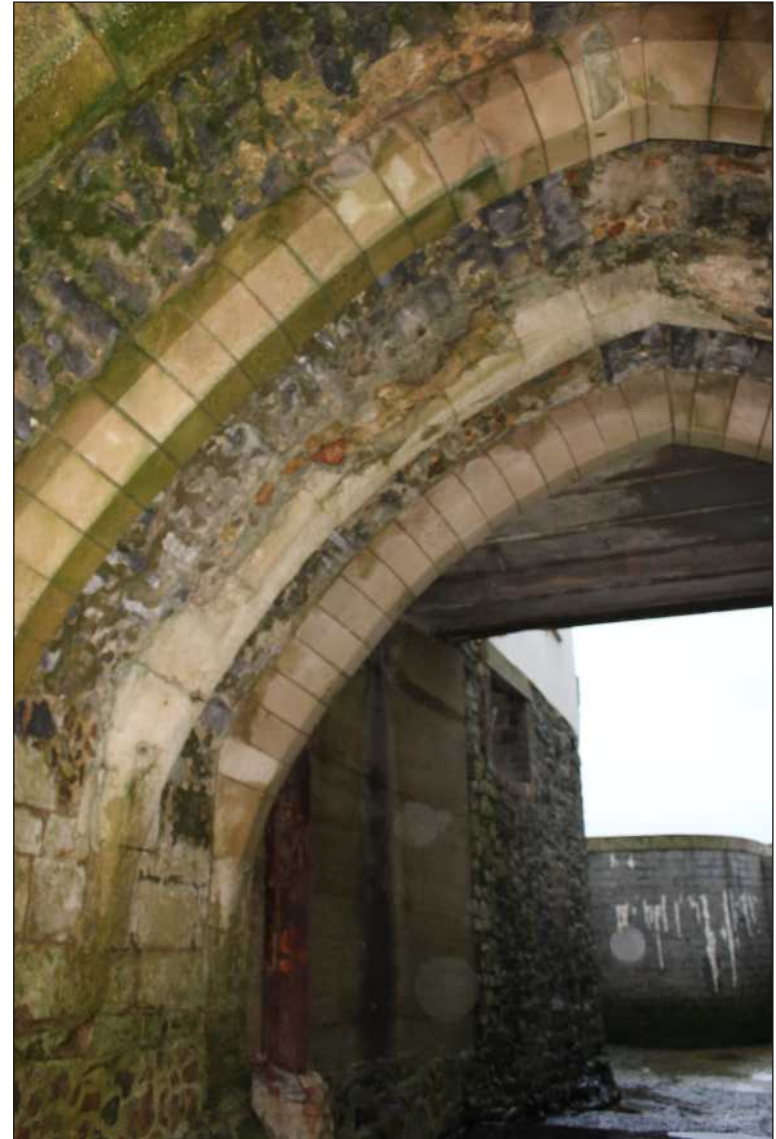
3E:4 Cement repairs to weathered joints on south face.

3E:5 Lamination and weathering to the north face adjacent to the wall (continues into 3E:6), including a void. Repairs in flint and red sandstone bonded in cement (126)

3E:6 Lamination and weathering to the north face adjacent to the wall. Repairs as 3E:5.

3E:7 Lamination and weathering to the north face adjacent to the wall. Repairs as 3E:5, with additional later cement repairs.

3E:8 As 3E:7 with a crack continuing onto the west face. Repairs as 3E:5. Repair in flint on south face extending into 3E:9.

3E:9 As 3E:8. Repairs as 3E:5. Repair in flint on south face.

3E:10 Small repair on north face (continues into 3E:11)

3E:11 Small repair on north face (127; continues into 3W:10)

Plate 20: The northern face of the east side of Rib 3

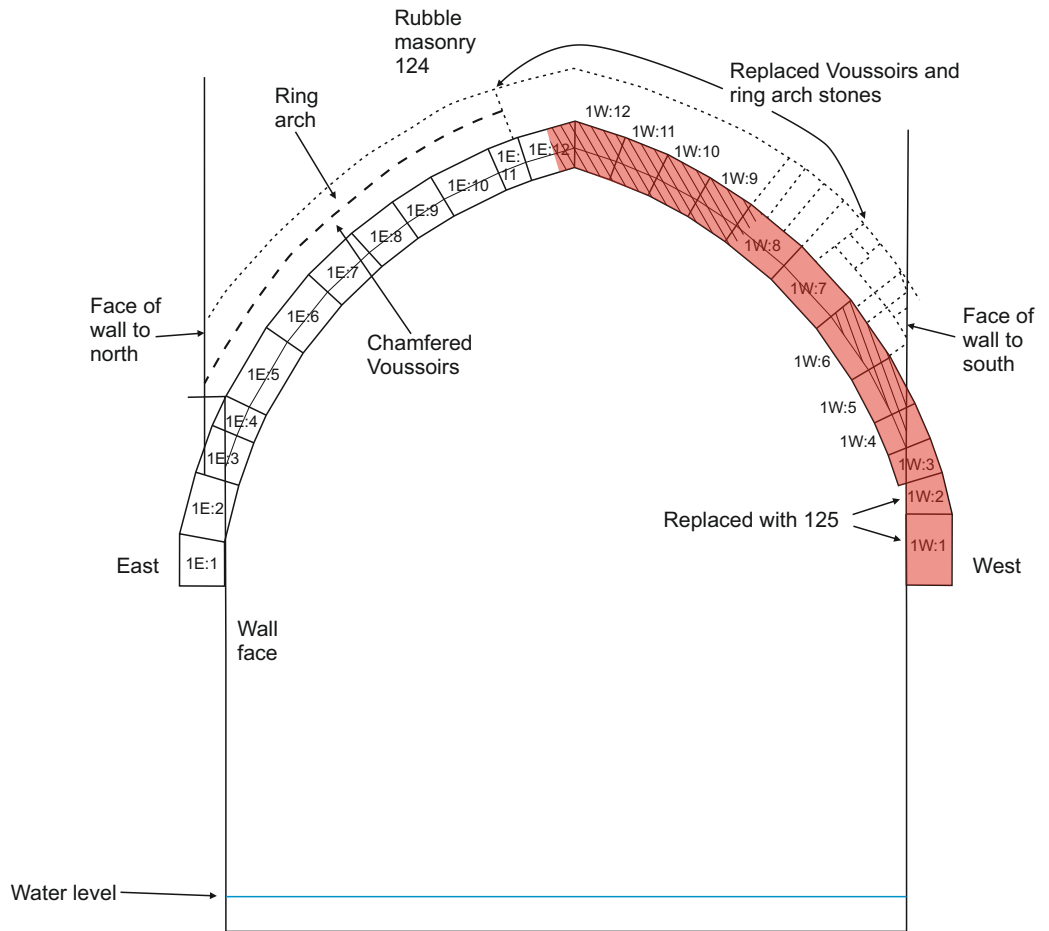
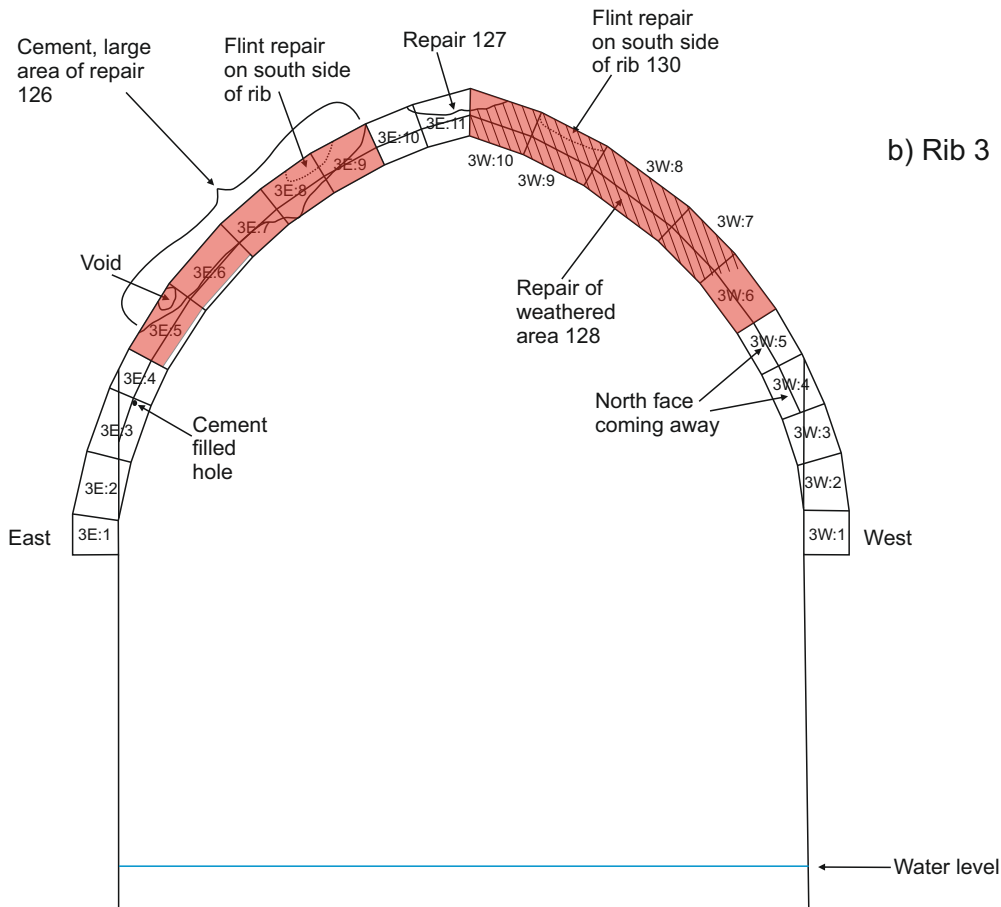
Appendix Fig. 2: The north elevations of ribs 1 and 3 showing locations of replaced stones

Stones (or parts of) replaced

- 1.4** The works to the bridge involved repairs to the two surviving historic ribs (ribs 1 and 3) under the bridge. Approximately one-third of the stones forming these ribs were repaired or replaced. An additional shelter coat was also applied to the ribs. A fuller description is set out in Appendix 2.

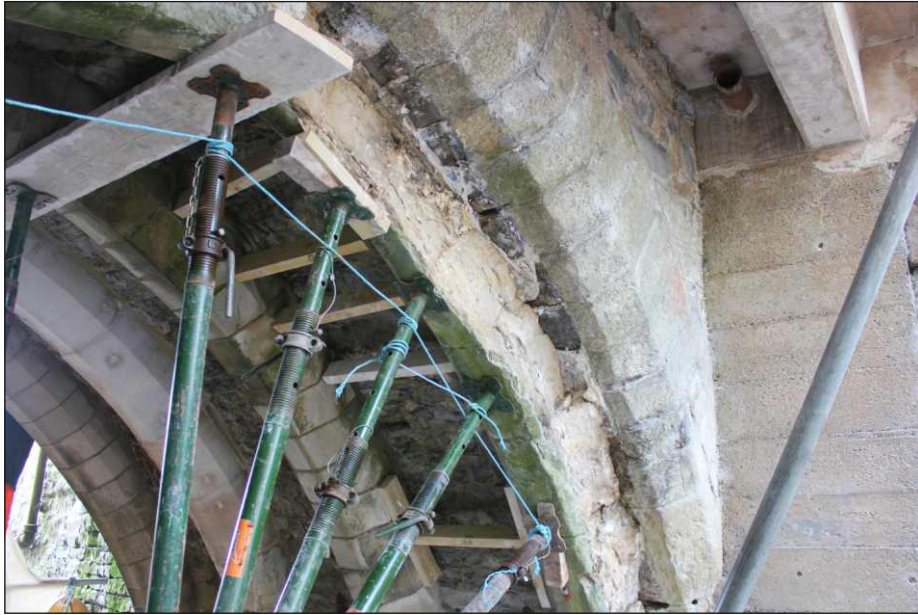
Appendix Plate 1: Rib 1 following removal of damaged elements of voussoirs, viewed from the north

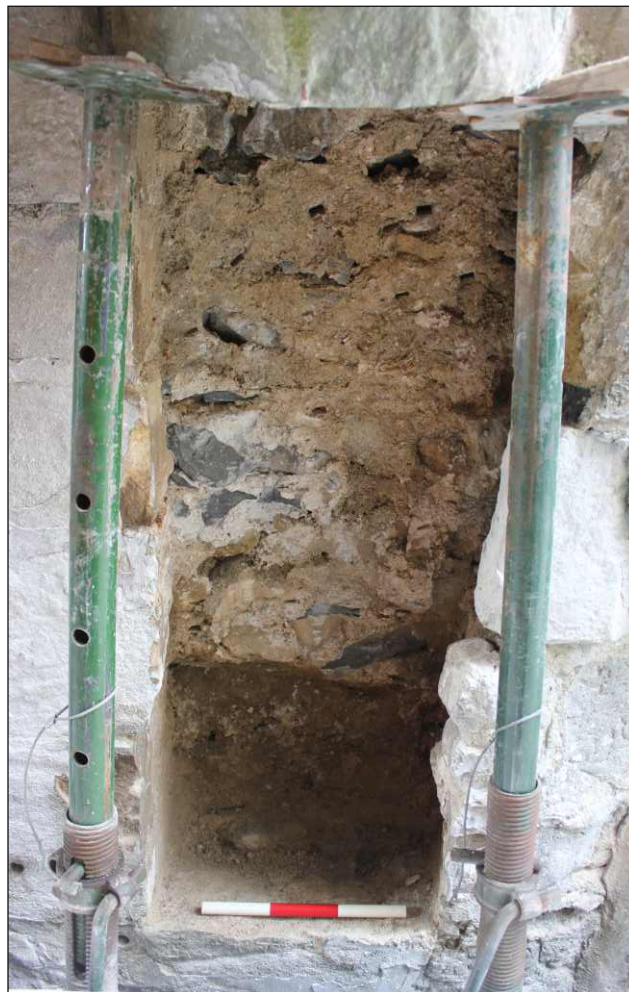
Appendix Plate 2: Rib 1 following removal of damaged lower voussoirs, viewed from the northeast. (0.30m scale)

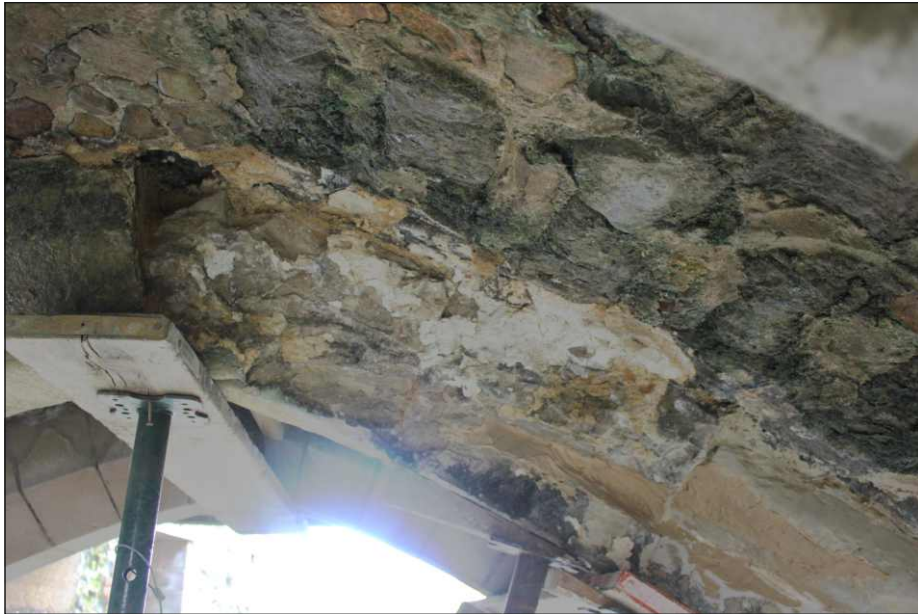
Appendix Plate 3: Rib 3 following removal of some of the damaged voussoirs, viewed from the northwest

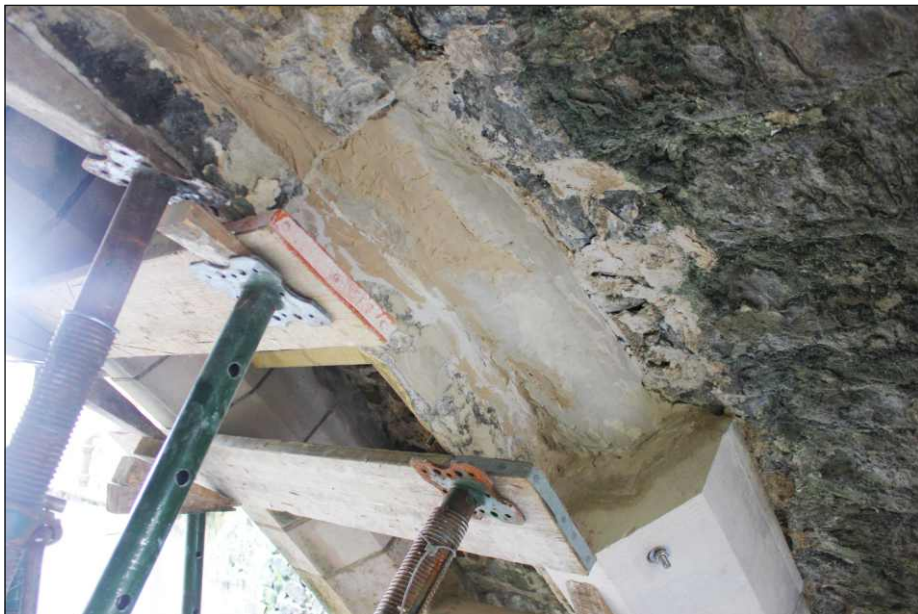
Appendix Plate 4: Rib 3 showing voids in masonry filled with mortar, viewed from the north

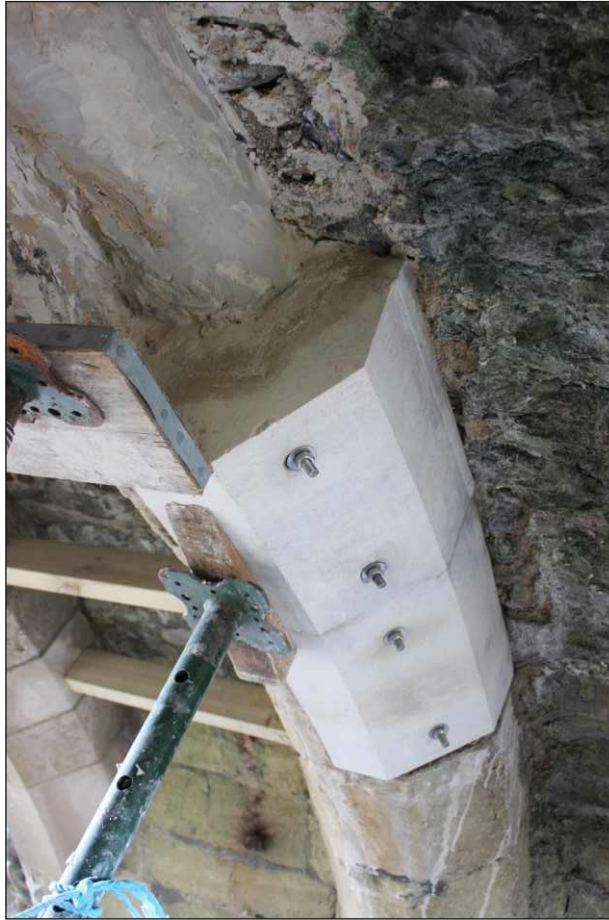
Appendix Plate 5: Rib 3 showing replacement voussoirs with pins, viewed from the north

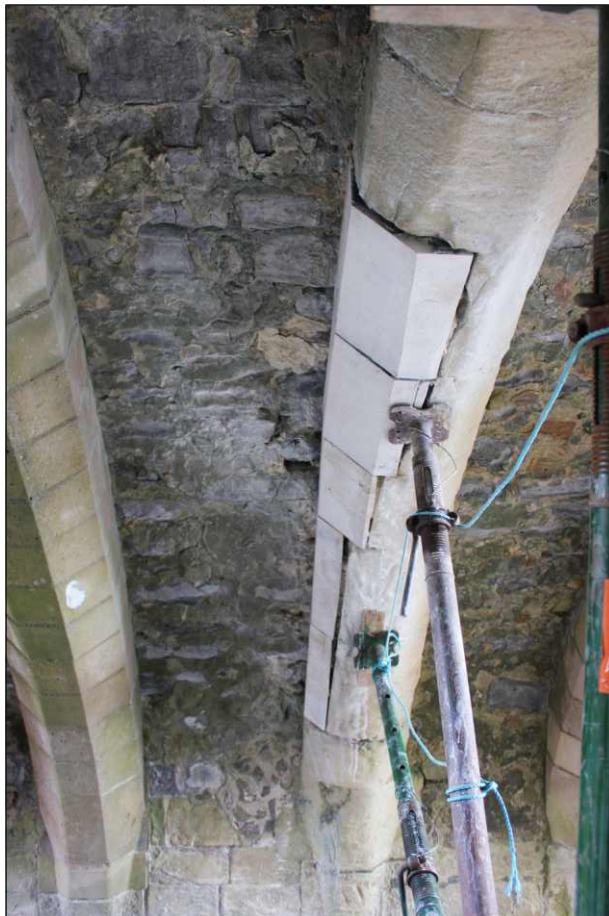
Appendix Plate 6: Rib 3 showing replacement voussoirs following the cutting flush of the pins, viewed from the southwest

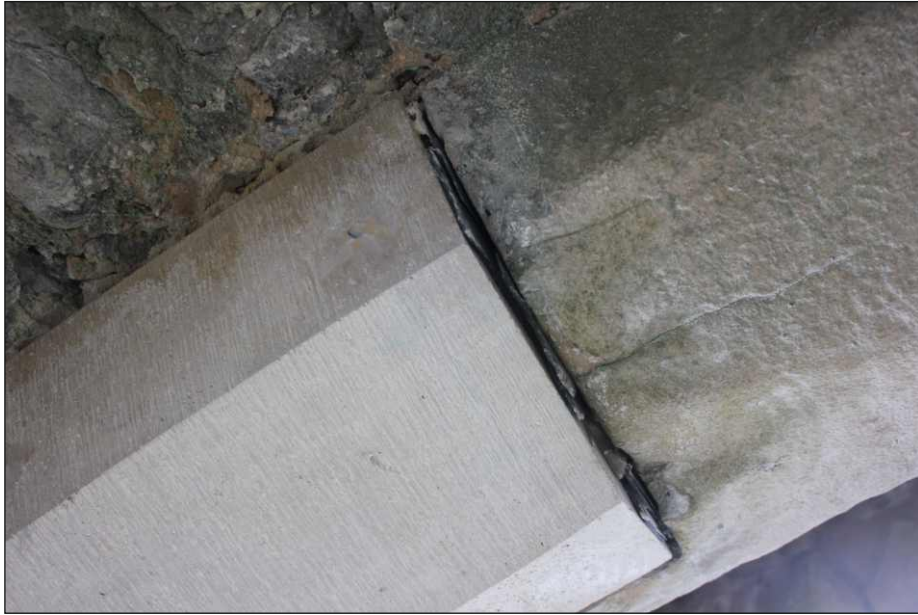
Appendix Plate 7: Rib 3 showing packing between stones, viewed from the northwest

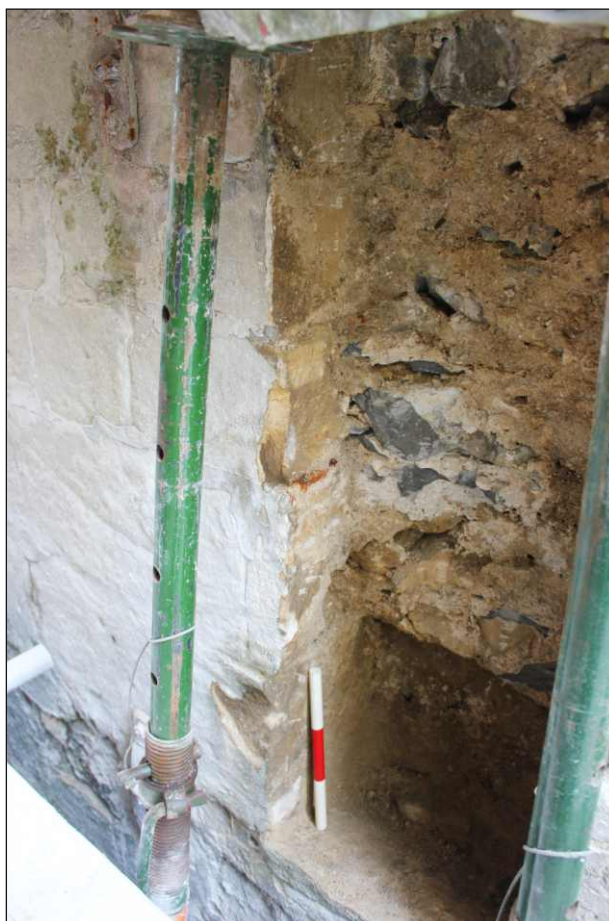
Appendix Plate 17: Rib 1 following removal of stones 1W:3 and 1W:4 and repair 125 showing masonry 100, viewed from the north. (0.30m scale)

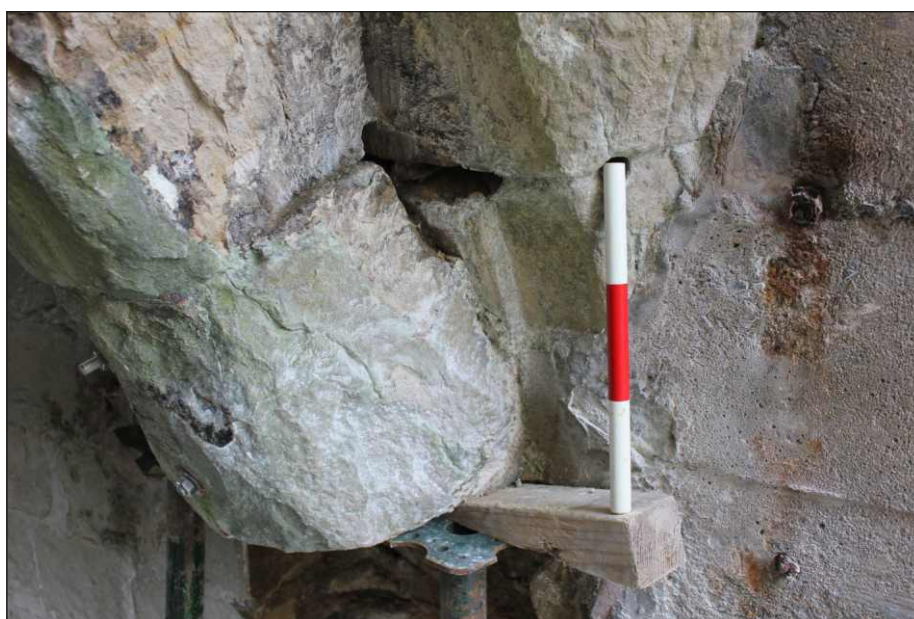
Appendix Plate 18: Rib 1 showing stones 1W:5 and 1W:6 with the projecting ring arch to the right (behind the 0.30m scale), viewed from the north

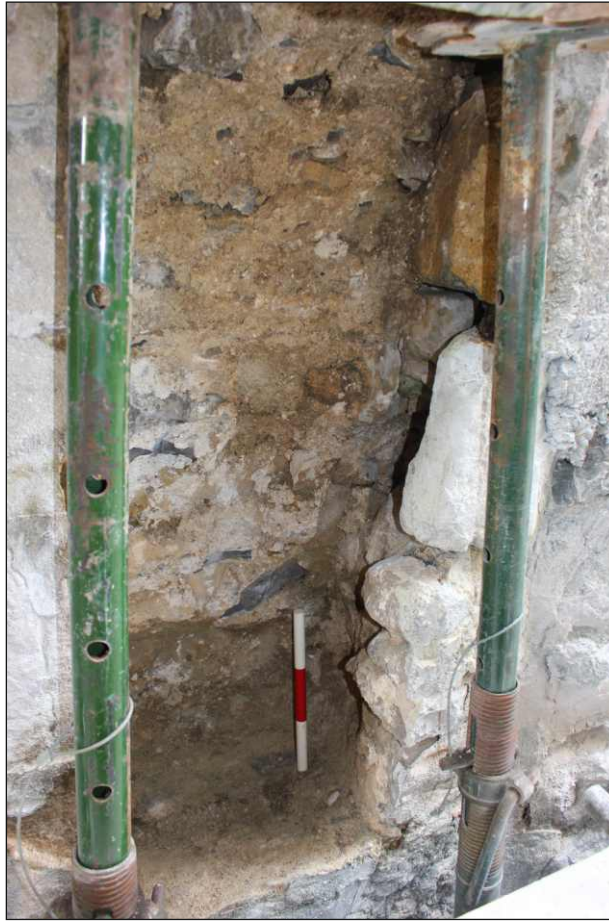
Appendix Plate 19: Rib 1 following removal of stones 1W:3 and 1W:4 and repair 125 showing the inside of the ring arch and abutting lias masonry 104, viewed from the east. (0.3m scale)
