ST MARY THE VIRGIN CHURCH, WILLAND, DEVON

Results of Archaeological Monitoring and Recording

Report No: ACD1929/2/0

Date: February 2019

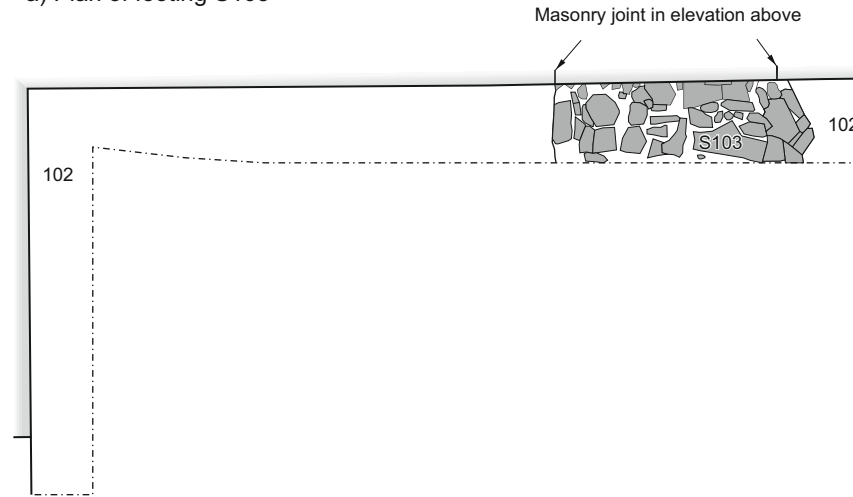
a) Plan of footing S103

- 5.4** Extending from the south elevation a north to south aligned stone footing was exposed (S103). The footing, which were comprised of sandstone rubble in a lime mortar bond, measured 1.55m wide and extended below the excavated level of the trench. The position of the footings corresponded with a clear vertical masonry joint present on the elevation above (Plate 6).

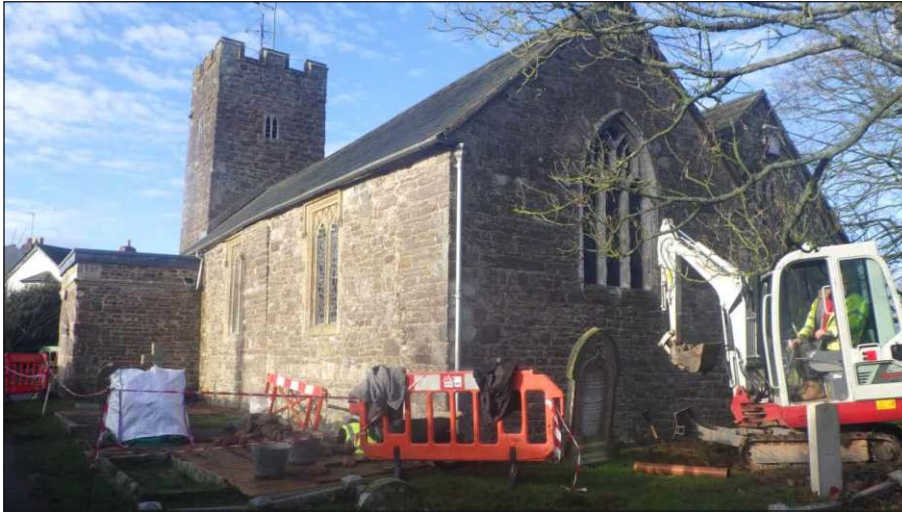
Plate 1: General view looking west towards St Mary the Virgin Church

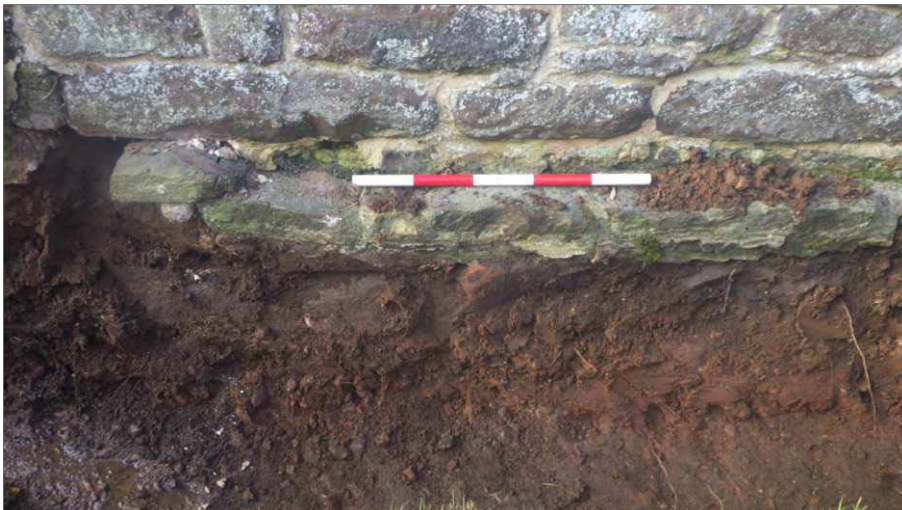
- 5.3** The footings for the church (107) generally measured between 0.2m and 0.3m deep below current ground levels and was comprised of mixed sandstone and chert rubble. At the east end of the south elevation, and in the portion of the church in which underpinning pits were excavated, the footing construction was approximately 0.65m deep and comprised a 0.26m thick light yellow sand bed, overlain by rubble footing.

Plate 2: Representation of excavated drain trench with exposed footing S107. Chancel elevation, view to west (scale 0.5m)

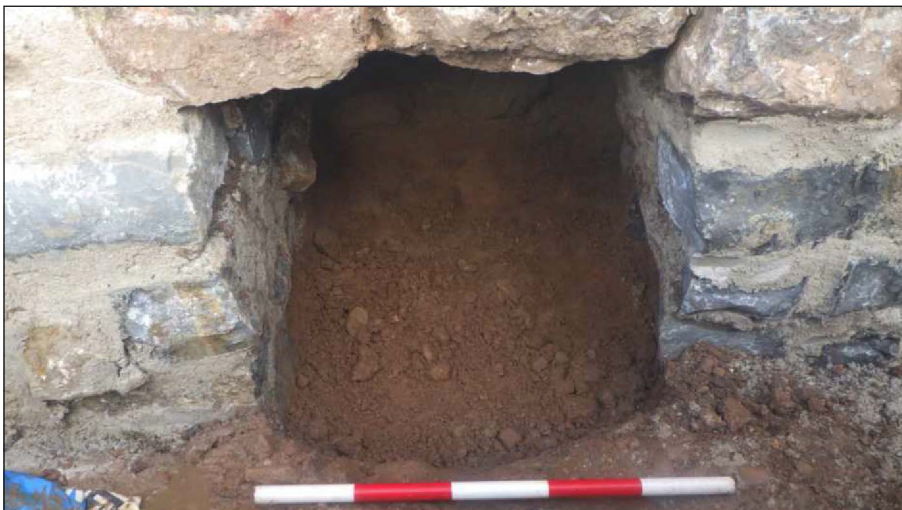
Plate 3: Showing underpinning pit excavated into chancel wall footing. View to north (scale 0.5m)

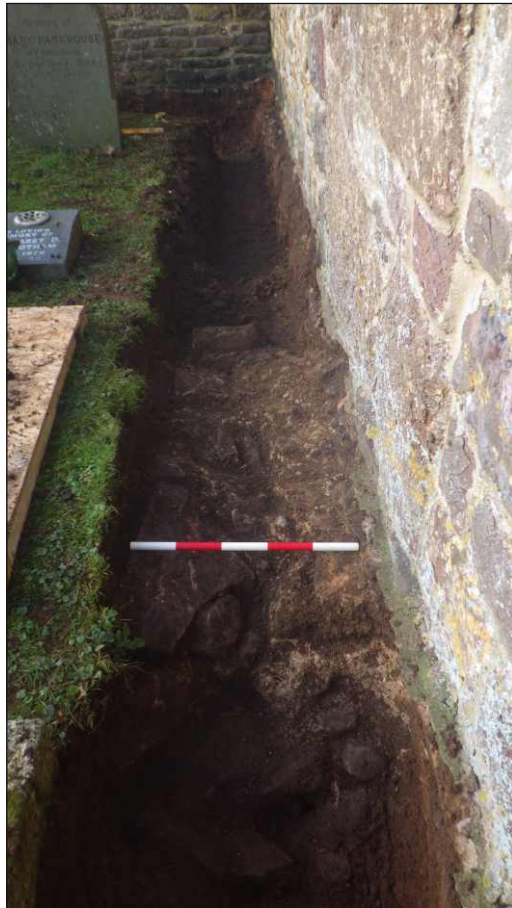
Plate 4: Showing excavated drain trench with footing S103. View to west (scale 0.5m)

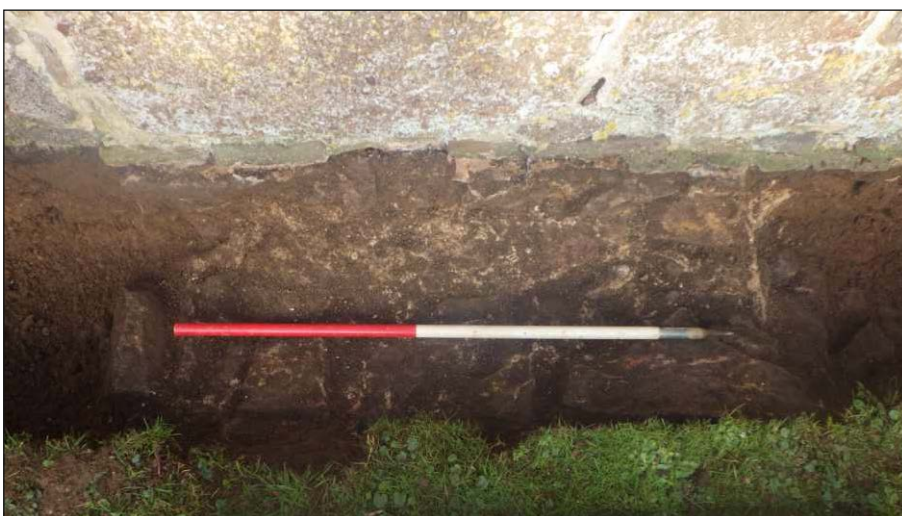
Plate 5: Plate 5. Footing S103, view to north (scale 1m)

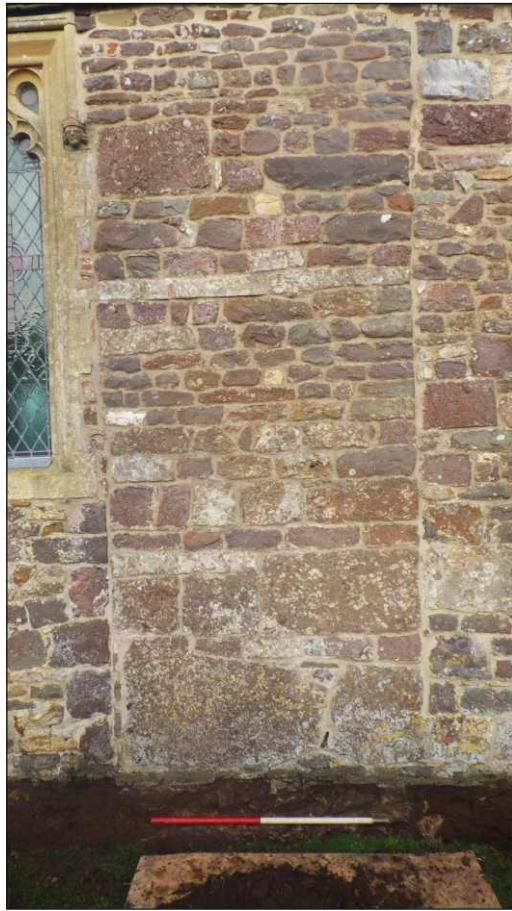
- 6.2 Buried mortar bonded footing S103 was likely to represent part of a former phase to the current church. Its corresponding position to a section of infilled masonry of similar width visible in the fabric above, suggests that these features are associated (Plate 6). This feature in the south elevation is included in the Historic England listing description as representing the traces of a dismantled and infilled former rood screen stair turret. Based on exposed footing S103, the former stair turret would have projected externally from the south elevation to access the top of a former rood screen dividing the nave from the chancel. No datable evidence was recovered to date the footing, but it is likely that the former rood screen and associated stair turret, would have been part of the original 15th or subsequent 16th century phase of the church.

Plate 6: Plate 6. Showing footing S103 in relation to masonry scar of former rood screen stair turret. View to north (scale 1m)
