Results of an archaeological watching brief at Bratton Camp Hillfort, Wiltshire:

Scheduled Monument 1013393

Document No: ACW1209/1/0

Date: June 2019

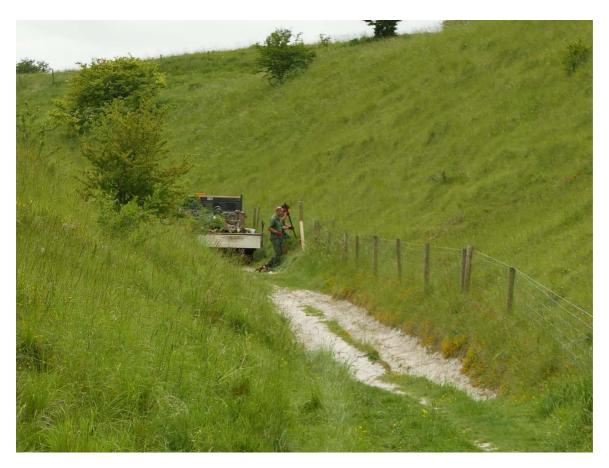
Plate 1. General view of work

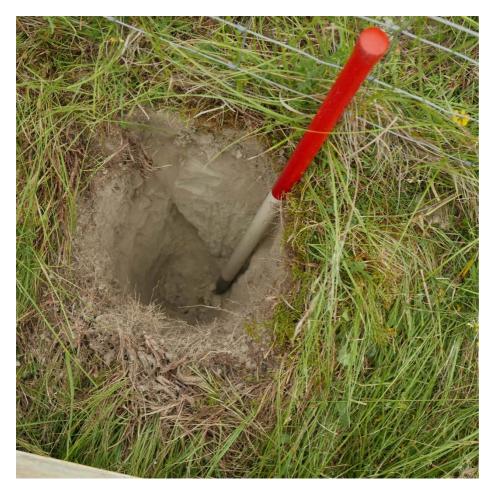
This involved digging a new post-pit next to an existing fence post on the north-western side of the trackway. Once the turf was removed solid chalk bedrock was excavated to a depth of 0.65m. Nothing of archaeological significance was recorded.

Plate 2. Excavated post-pit (Post 4)
