UPTON FARM, CLYST ST LAWRENCE, DEVON

Results of historic building recording

Planning references: East Devon District Council
08/2553/LBC and 08/2552/FUL

Document No: ACD54/2/0

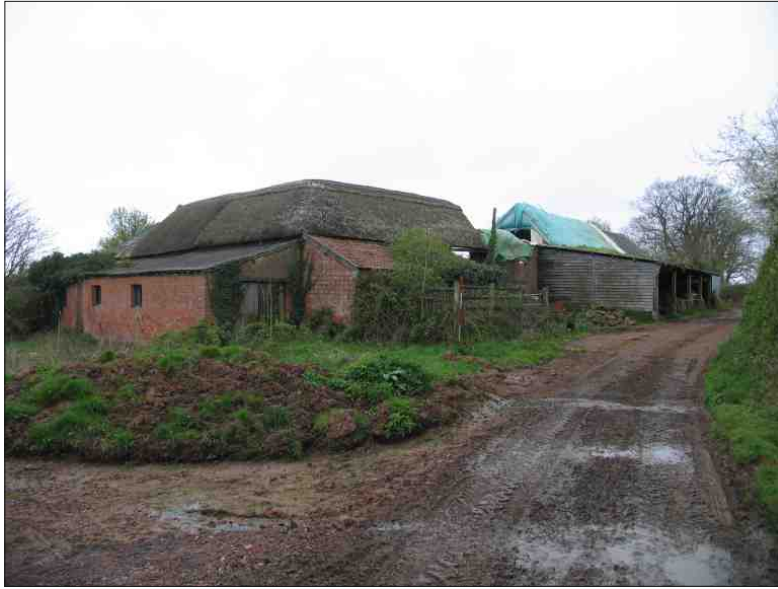
- 1.4 The farm buildings (a threshing barn and dairy) are arranged around a yard immediately to the north of the farmhouse (Plate 1) with a wagon shed to the northeast. The threshing barn and dairy are also designated as Grade II Listed Buildings under

- 5.6** There is a further mid-late 19th-century structure attached to the north of the dairy (Plate 1). This is constructed of brick, with a sloping tiled roof and has a double width opening in the west elevation with timber cladding above. The roof is supported by closely-set principal rafters, which were in a poor condition causing a partial collapse of the roof.

Plate 1: The dairy with attached root store (centre and left) and threshing barn with attached lean-to beyond to the right, looking southwest (2m scale)

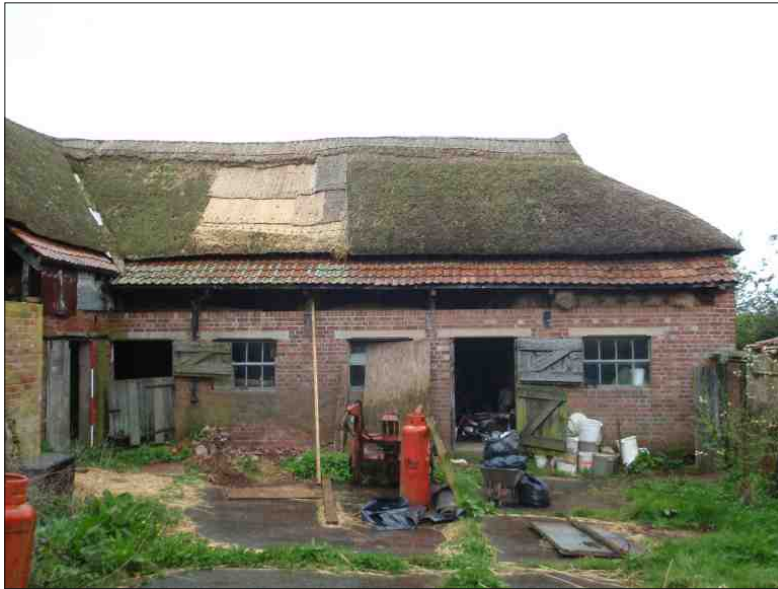
was enclosed in 1948 with bricks laid in English bond. In this frontage is a pair of stable doors and three eight-pane top-opening windows (Plates 1-3). The windows have bullnose brick cills, and all the openings have chamfered concrete lintels. The only other openings are in the east elevation where there is an inserted doorway into the mid-late 19th-century root house along with a series of inserted vents. The building has a hipped thatched roof, which on the west, yard elevation has been extended down and lowered at eaves level with Roman ceramic tiles, partially infilling an originally open first floor.

Plate 2: The dairy, looking east (2m scale)

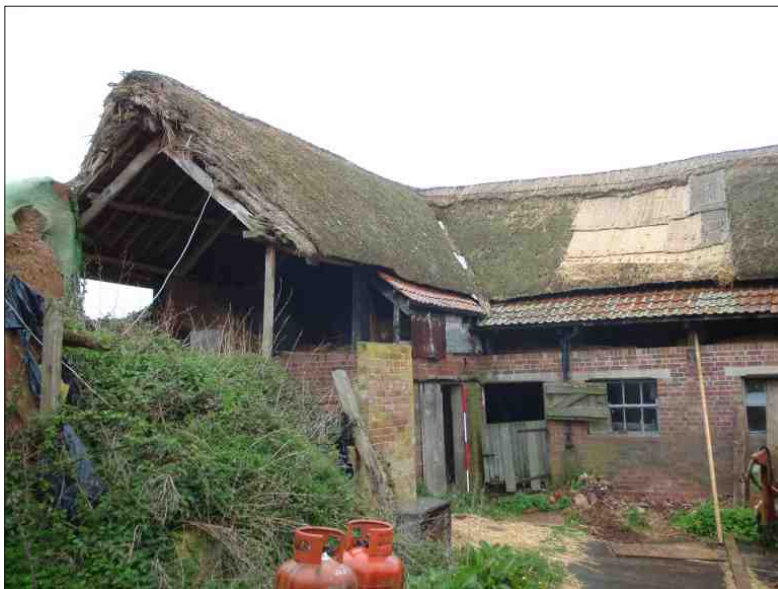
- 5.3** The 1948 refronting continues to the west forming the south and west wall of a rebuilt structure at the end of the north range (Plate 3). Here there are sliding doors in both the south and north elevations; the former again has a chamfered concrete lintel, whereas the latter has a plain thinner concrete lintel set into the earlier cob, along with additional brickwork. The thatched roof, with Roman tiles below, continues above this structure, and extends west over the covered passageway. Internally, there are suspended glass tanks and fittings formerly linked up to pipes connecting with the dairy to the east (Plate 6).

Plate 3: The dairy, looking northeast (2m scale)

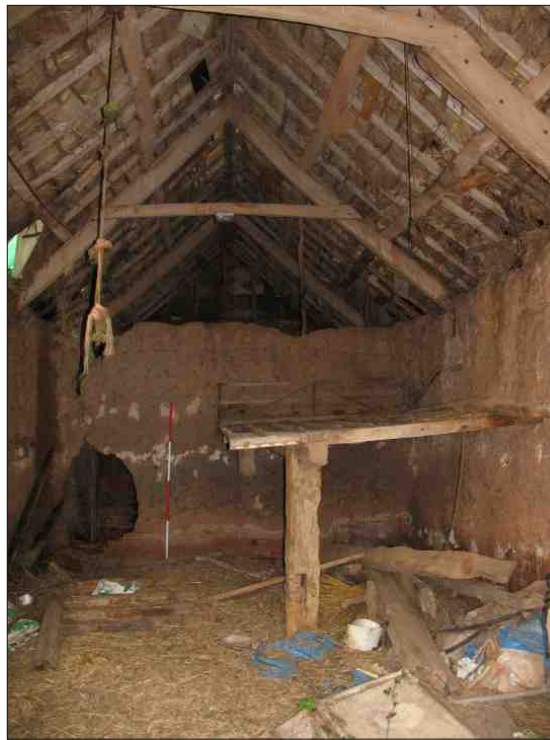
5.8 The floor in the east part of the barn is at a lower level than the central threshing floor but was covered with fallen thatch at the time of the site visit. In the main part of the threshing barn a small area of loft floor survives in the northwest corner (Plate 13). This has been inserted, and is supported on a reset post, possibly reused from the linhay in the 1940s. The roof is supported on nailed A-frame trusses, of which four survive, with applied collars. All the joints, including the lapped apexes, are nailed. They support pairs of back purlins on each side, with ridge pieces set angled between the overlapping ends of the rafters.

Plate 13: Partition wall to the stable and surviving loft floor in the threshing barn, looking west (2m scale)

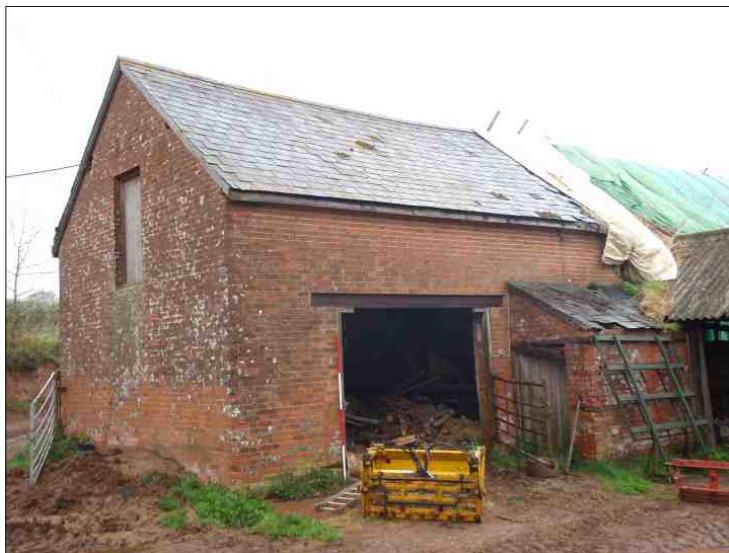
5.9 The barn has been extended on all three sides. The earliest addition is a two-storey stable with attached harness room to the west that dates the mid-late 19th century (Plate 14). It is constructed of brick laid in Flemish bond under a slate-covered roof. This has a wide doorway and a window in the south elevation and a pair of windows in the north elevation. The former has been widened to the west and is now open with the wall above supported on a rolled steel joist. In the west wall is a first-floor loading door with a head of bricks laid in a V-shape. The windows in the north elevation have the same design of head, and are fitted with wooden frames with top-opening casements. Internally the stable has a brick floor. Fittings comprise an iron gate partition along the east wall, and a metal trough against the west wall (Plate 15). There is also a ladder adjacent to the south door providing access to the first-floor loft. The first floor is supported on slender sawn closely-set joists with scissor bracing between. To the north of the threshing barn is a deep open-fronted mid-late 20th-century lean-to structure, with a corrugated sheet west side and weather boarded east side. The open front to the north has wooden posts laid onto concrete bases that support an asbestos sheet roof. To the south of the barn is a pair of mid-late 20th-century brick single storey calf houses. These have partially collapsed and/or been taken down following the collapse of the adjacent threshing barn. They had pitched roofs finished with a corrugated sheet covering.

Plate 14: The mid-late 19th-century stable, looking east (2m scale)

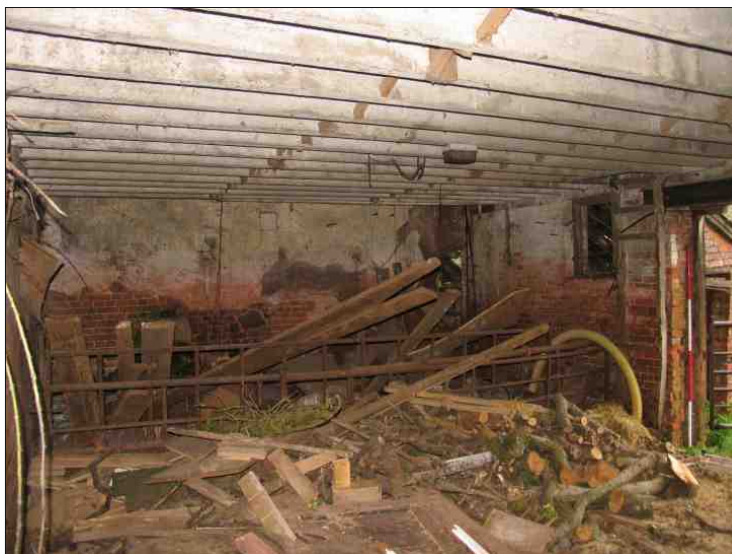
Plate 15: The mid-late 19th-century stable, looking northeast (2m scale)

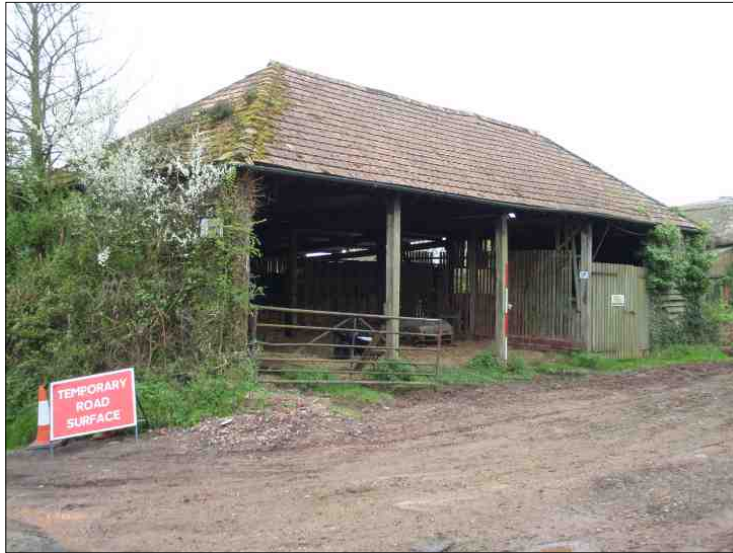
5.10 The shed is a five-bay structure, with the eastern three bays being open on the north side (Plate 16). The two parts of the building are divided by a replacement wooden partition constructed onto a low brick wall with bullnose brick capping. The roof is supported on timber posts. The other elevations are weather boarded laid onto a timber frame constructed on a low brick wall. There are double wooden doors in the enclosed section of the north elevation, and a further double door width, but now doorless, opening in the south elevation of this part of the building. It has a hipped tiled roof supported on king-post trusses with diagonal struts, and with the back purlins supported by cleats. There are additional metal straps holding the ends of the rafters and tie beams together and the king posts to the tie beams.

Plate 16: The wagon shed, looking southwest

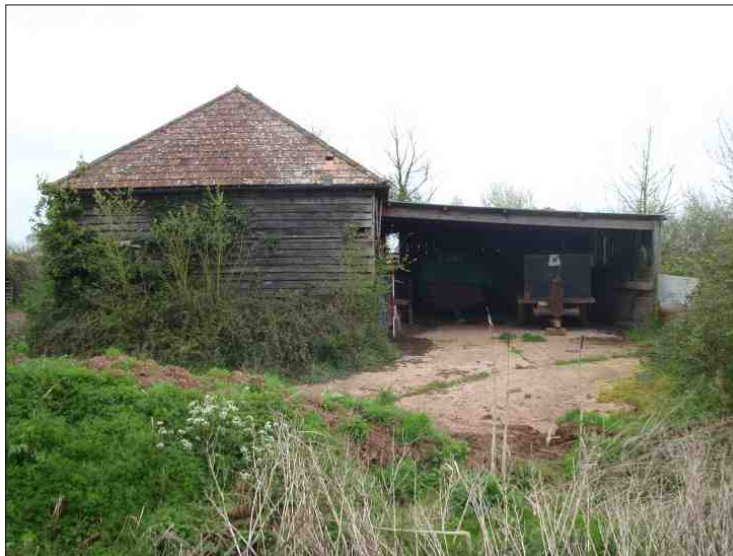
- 5.11** Attached to the south side is a late 20th-century lean-to structure that is open-fronted to the west (Plate 17). The other walls are constructed of concrete blocks with timber cladding above. It has a corrugated sheet roof.

Plate 17: The wagon shed and attached lean-to, looking northeast
