SHOBROOKE FARM, MORCHARD ROAD, MORCHARD BISHOP, DEVON

Results of historic building recording

Mid Devon Council planning reference 16/01885/FULL,
condition 4

Document No: ACD2187/2/0

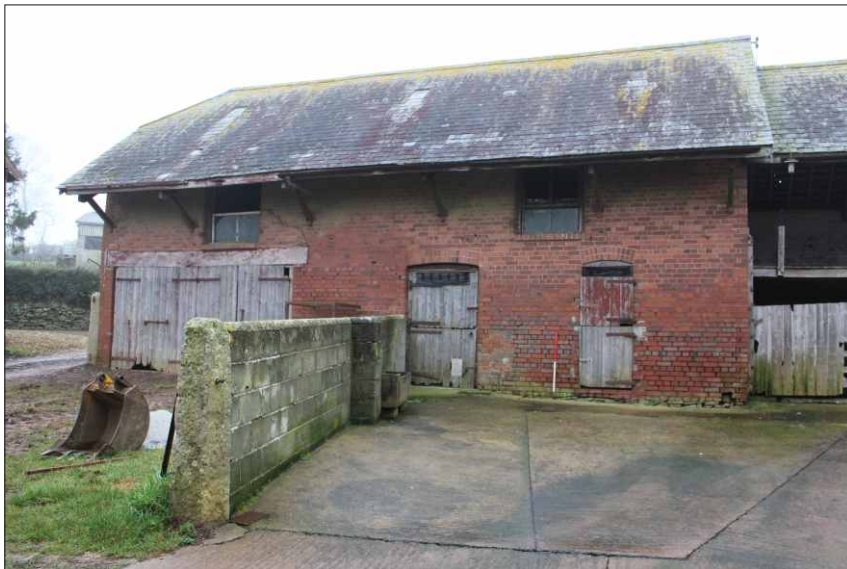
5.2 This building forms the south part of the west range, and is constructed of red brick laid in English garden wall bond with a straight gable to the north and half hipped gable to the south. The roof overhangs the east elevation (Plate 2). In the east elevation there are three doors on the ground floor. The southern opening is very wide and contains two pairs of doors under a large wooden lintel, whilst the pair of northern openings are of different widths, with bricked arched heads, and are fitted with single stable doors. At first-floor level there are two window openings, both with brick sills, fitted with wooden hornless sashes; these are in a poor condition missing

some glass and the whole upper frame in the southern window. The south elevation incorporates a central window opening with a brick arch and a brick sill; this has been blocked with brick laid in stretcher bond. In the west elevation there are no openings at ground floor level, but there are four brick piers that extend up to eaves level. The north end at this level is obscured by a later 20th-century extension (see Section 5.4 below). On the first floor there are four high-level square openings, one of which is larger than the other three and fitted with a shutter. There is also an inserted doorway fitted with a wooden door accessed via a flight of later 20th-century concrete block steps (Plate 3).

Plate 2: East elevation of the stables, looking west (1m scale)

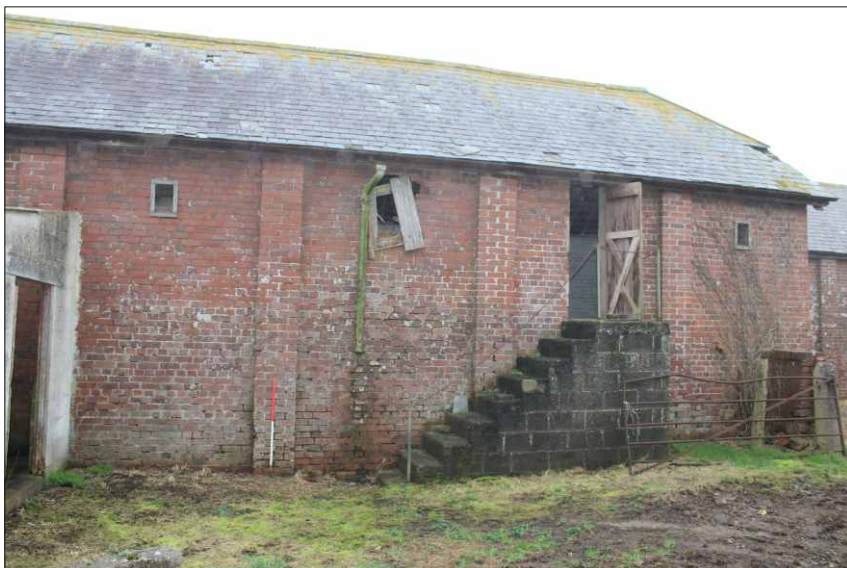
Plate 3: West elevation of the stables, looking east (1m scale)

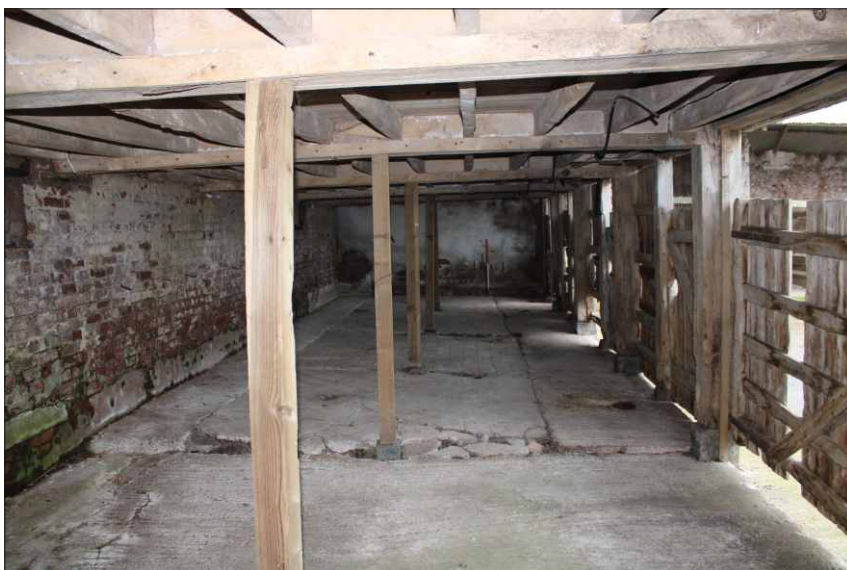
- 5.6** On the ground floor there are no surviving internal fixtures or fittings; wooden partitions between bays have been removed. The floor is concrete and has been

laid in several sections (Plate 9). Use of the ground floor had been divided into housing for yearlings (southern two bays) and bullocks (northern four bays); the first-floor structure above the latter incorporates original trap doors adjacent to the yard elevation above the positions of removed hayracks and feeding troughs. In the mid 1920s these fittings were replaced with brick feeding troughs constructed against the west elevation. These had fallen out of use and been removed in the later 20th century when the building was used for rearing ducks and chickens. The first floor is accessed via a vertical wooden ladder attached to the north gable of the stables, and outside the line of the front elevation. The floor structure comprises beams, supporting joists, set into the west wall and into rebates on the inside of the posts. There is an additional row of thinner posts, also resting on stone pads, within the barn. The roof is supported on five king-post trusses with bolted mortice and tenon joints with purlins resting on the back of the trusses. These in turn support the rafters and batons (Plate 10). As in the stables, the roof oversails the east elevation.

Plate 9: Internal view of top cattle building, looking north (1m scale)

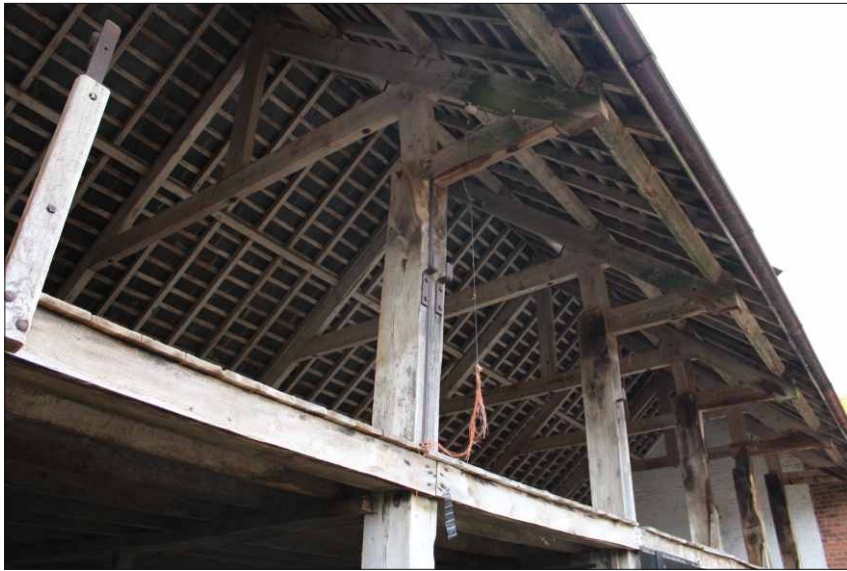
Plate 10: Roof structure of top cattle building, looking northwest

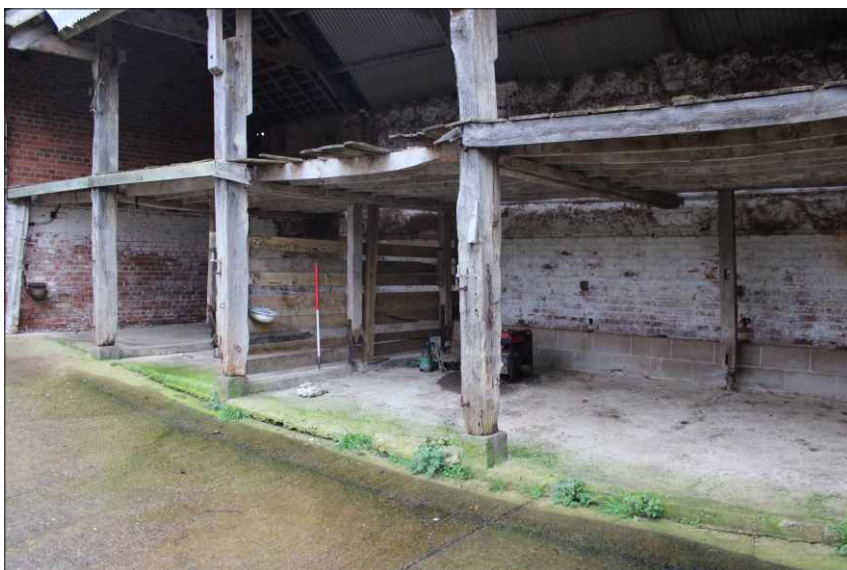
- 5.10** The ground floor has a concrete floor and is divided in two spaces by a timber partition (Plate 15). There is a concrete block trough running along the length of the north wall. Originally there would have been additional partitions but these have been removed. One beam has an empty socket which may relate to a former partition, but it seems more likely that it has been reused as partitions would probably have been nailed to the structure. The first floor was accessed via vertical ladder attached to the east gable of the root house outside the line of the front elevation. The floor is supported on beams set into the north wall and into rebates in the insides of the posts of the south elevation where they are fixed with bolts. The roof is supported on four trusses. The western truss is of a king-post design with bolted mortice and tenon joints. The two central trusses are A-frames with applied collars attached with bolts; the eastern truss is of a similar design but with an additional higher collar. In the western bay the purlins rest on the back of the trusses and in turn support the rafters, battens and a slate finish. The remainder of the roof covering is a 1960s replacement (of the original thatch) using corrugated sheets supported on new purlins attached to the backs of the trusses.

Plate 15: Internal view of far side cattle building, looking northwest (1m scale)

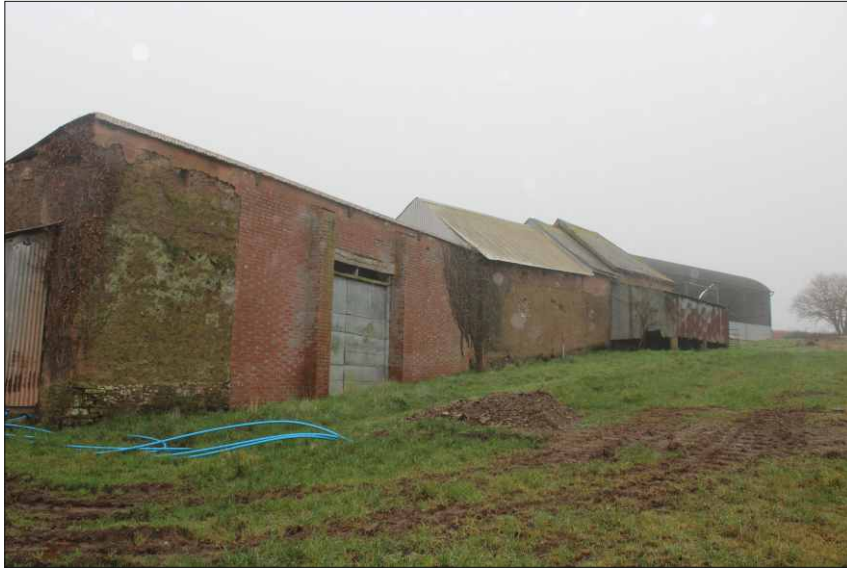
- 5.11** This building forms the eastern half of the north range and pre-dates the 1909 rebuilding of the farm. It is constructed of cob with brick used in subsequent repairs. The north elevation is largely a brick rebuild in Flemish bond incorporating a central opening with a large wooden lintel and flanked by tall brick buttresses; it is fitted with pair of double wooden plank doors but has been blocked externally (Plate 16). The original cob wall survives at the northeast corner, as well as within the east elevation where it is constructed on a low rubble slate stone wall. This (east) elevation incorporates an inserted opening fitted with a wooden plank door (see also Section 5.12 below) along with two original high-level ventilation openings. The south elevation of the threshing barn is formed entirely from corrugated plastic and metal sheeting (Plate 17) added in the 1990s when the cob wall collapsed; there is some rubble stone, with concrete block and brick repair, surviving at the west end. There is a wide central opening fitted with a modern gate and plastic corrugated sheets, along with a single wooden plank door to the west of this opening. In front of the western half of the building is a late 20th-century ramp constructed of concrete blocks and concrete.

Plate 16: North elevations of the threshing barn, far side cattle building and the root house, looking southwest (1m scale)

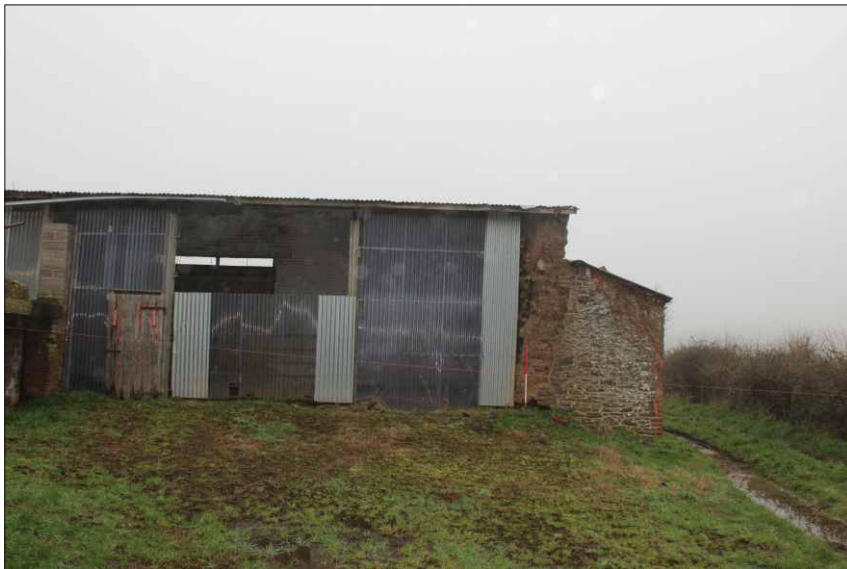
- 5.12** A modern open-fronted lean-to structure has been attached to the elevation, and is now partly ruined. This has a raised concrete floor at the level of the interior of the threshing barn. The threshold of the doorway is also concrete and has the date '1979' inscribed into the surface. The south wall of the lean-to is formed of rubble slate stone laid in rough courses with brick jambs at the southeast corner, and represents part of an earlier, now demolished, structure, possibly a wall across the a trackway. The other sides are/were of corrugated sheeting with a sloping corrugated sheet roof. There are has no internal fixtures or fittings.

Plate 17: South elevation of the threshing barn, looking north (1m scale)

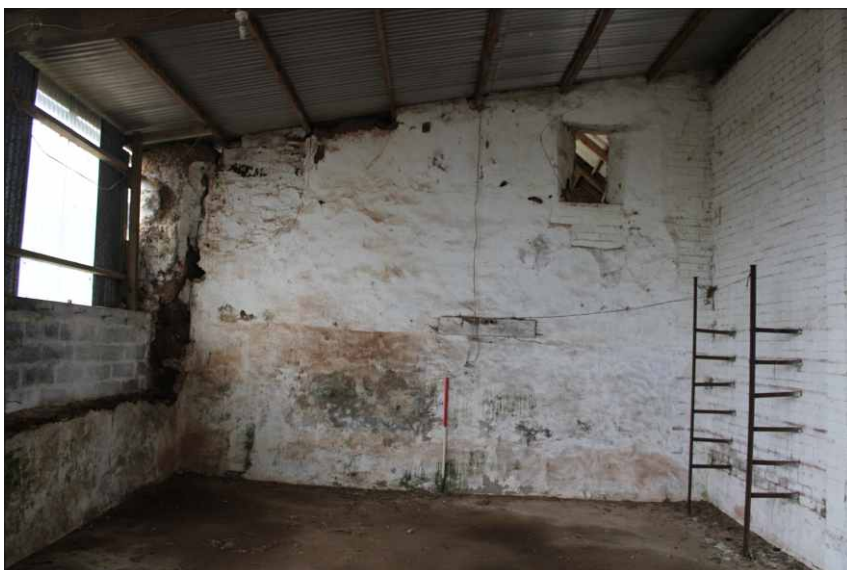
- 5.13 The floor is concrete, and there is no evidence for a threshing floor associated with the historic use of the barn. The only fitting is a series of metal brackets for supporting shelves; the shelves themselves have been removed (Plate 18). The original roof structure has been removed, and the walls of the barn at least partially lowered. The current roof finish is a single pitch of corrugated metal sheets sloping down to the yard, supported on a frame of late 20th-century battens.

Plate 18: Internal view of threshing barn, looking west (1m scale)

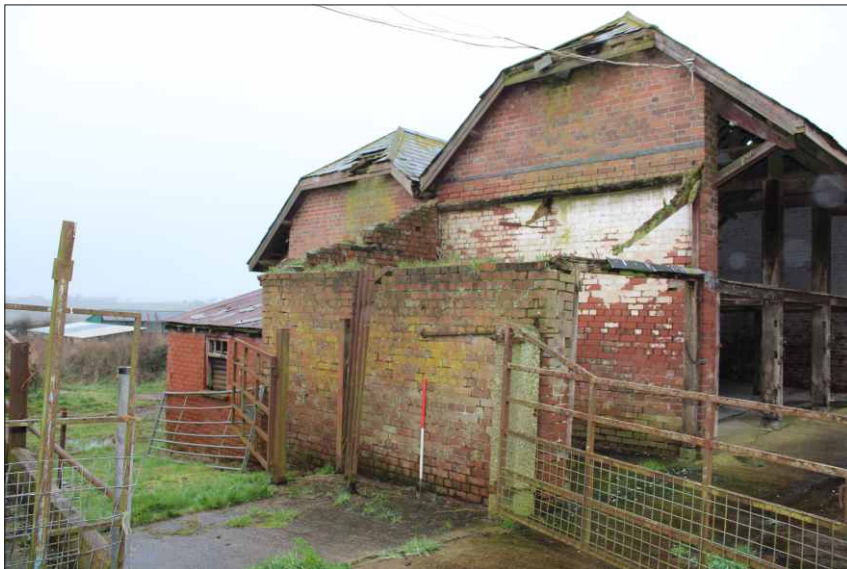
- 5.18 This is contemporary with the bottom cattle building, and is attached to its north elevation. It is constructed of brick and had a single pitch roof, which has collapsed and been removed. The north and east elevations are featureless, whilst the east elevation is fully open but with posts and fittings for a removed door (Plate 20). Internally, there is a concrete block trough along the east wall.

Plate 20: North elevations of the bottom cattle building, the cart linhay, brick shed and store, looking southeast (1m scale)
