COUNTY GATE, BRENDON AND COUNTISBURY, DEVON

Results of historic building recording

Exmoor National Park Authority planning
reference 62/11/21/016LB, condition 3

Document No: ACD2664/2/0

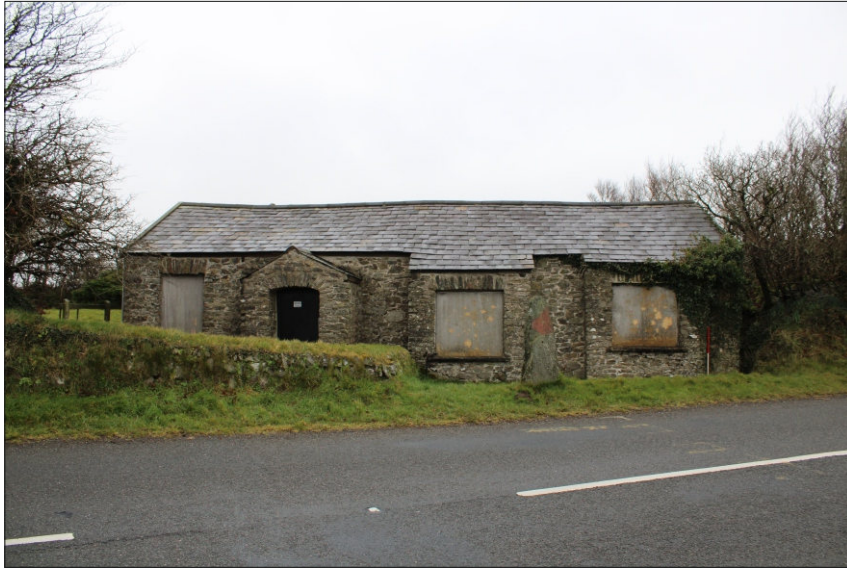
5.1 The building is aligned northeast-southwest, at a slight angle to the adjacent highway, but for the purposes of this report will be referred to as being orientated north-south (Plate 1). It is single storeyed, and constructed of local rubble stone laid in rough courses and bonded with a light grey mortar with frequent inclusions. There has been

Plate 1: Main façade, looking northwest (1m scale)

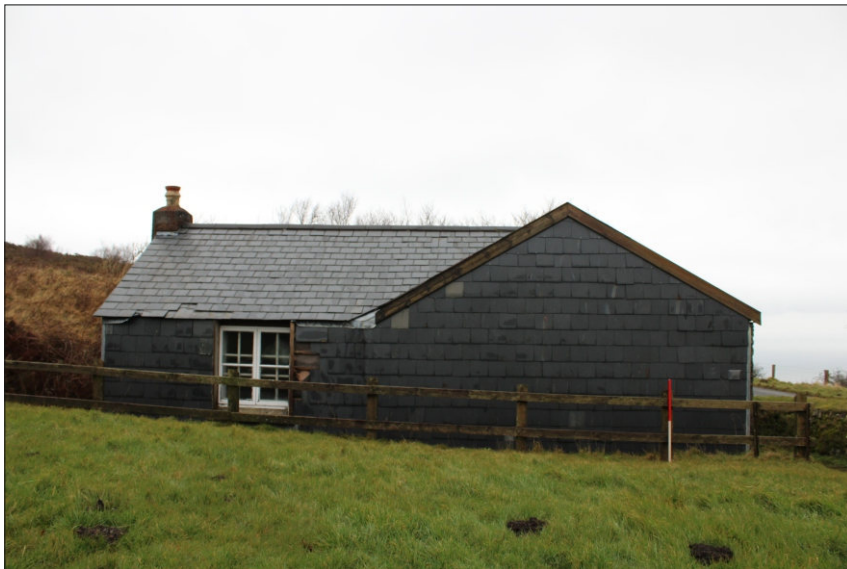
- 5.3** The north and south elevations have no openings, and the latter is hung with slates (Plate 2).
- 5.4** The south elevation of the south extension is also hung with slates and incorporates a single window opening with a concrete sill. This is fitted with a late 20th-century wooden two-light casement, each of two panes. On this side of the building there is a stone retaining wall supporting the higher ground to the south above the construction terrace for the building. The west elevation is finished with roughcast render (replacing hung slates) and features a central projecting chimney stack that has had a doorway inserted through it (Plate 3). This opening is fitted with a late 20th-century wooden door. The chimney stack is topped with an early 20th-century ceramic pot.

Plate 2: South elevation, looking northeast (1m scale)

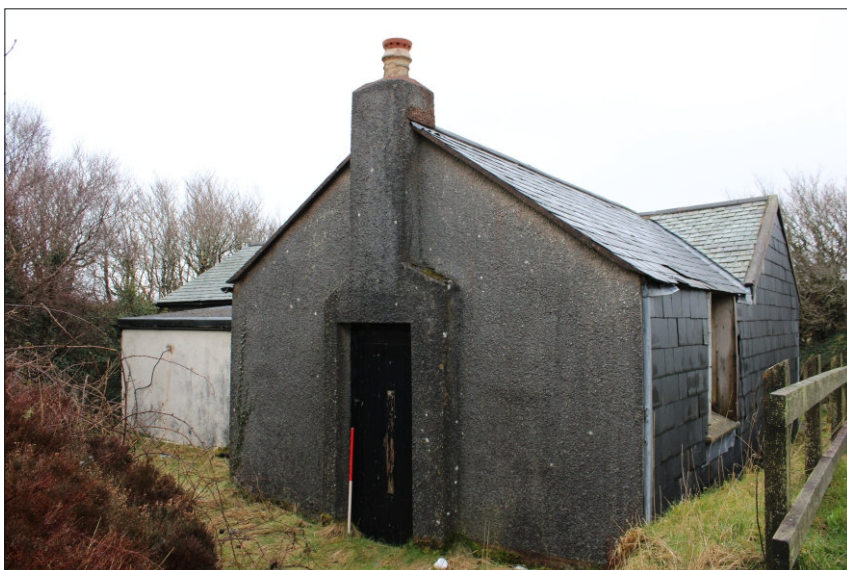
Plate 3: West elevation of south extension, looking east (1m scale)

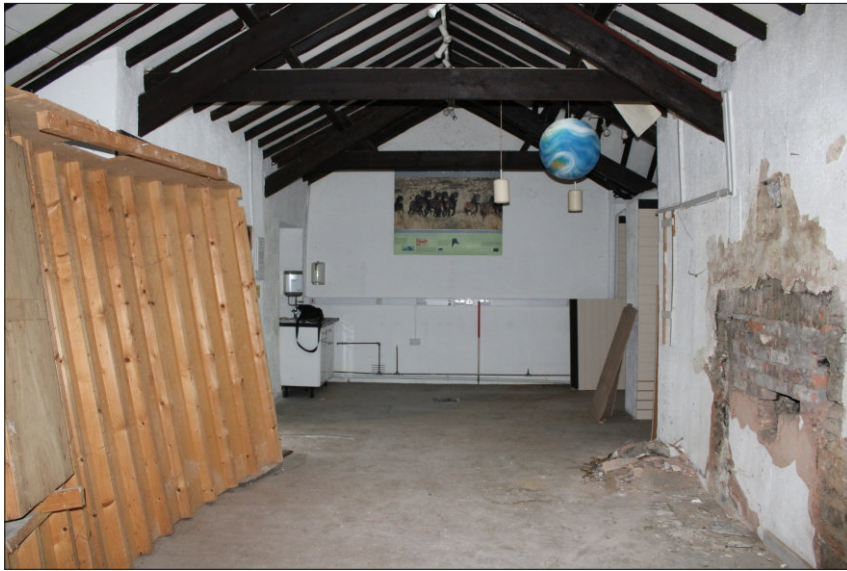
- 5.6** Prior to works commencing the interior of the building had a modern finish throughout, including plastered walls and contemporary skirting boards, with fittings related to its former use as a visitor centre (Plates 4 and 8). The main roof structure was exposed, and comprised three A-frame trusses with bolted applied collars (Plate 5). There are single rows of side purlins that rest on the back of the trusses and are not jointed together; rather they overlap, with their ends resting on the top of the previous purlin. These in turn support the slender secondary rafters. In the west wall the blocked-up fireplace, as previously recorded by Shirley Blaylock, was exposed, in the same condition as in 2019 (Plate 6). This has a very slightly arched brick head, and has been infilled with concrete blocks up to a height of approximately 0.8m from the floor and topped with brick laid in a stretcher bond and bonded with a grey cement mortar. Behind this the opening is infilled with rubble. Part of a slate hearth is visible in front of the fireplace, and above its arched head is a modern slate slab of unknown function. In the north part of the building, along the north and west walls, is a projecting plinth approximately 0.15m above the existing floor level; its south end terminates at the line of a known former partition as recorded by Blaylock. Internally, the sides of the northern two bay windows are splayed, and at the level of the plinth the north bay has stone

Plate 4: Internal view, looking southwest (1m scale)

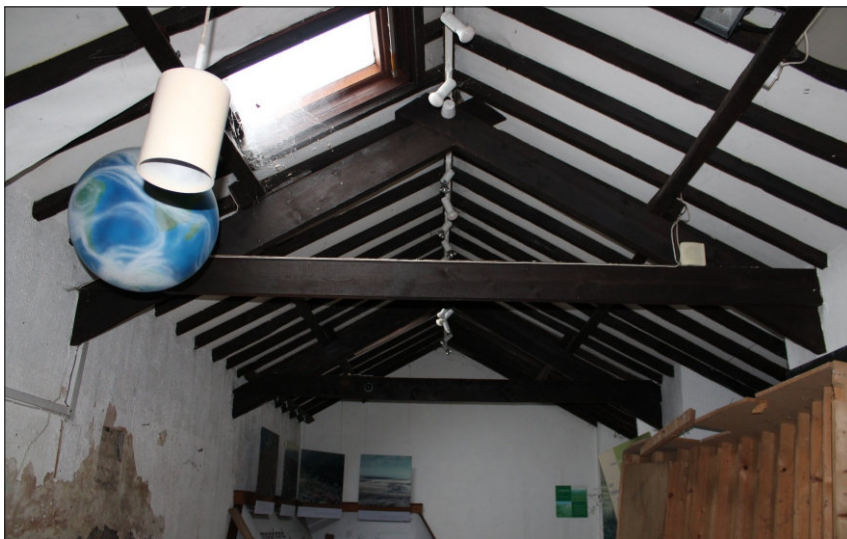
Plate 5: Roof structure, looking northeast

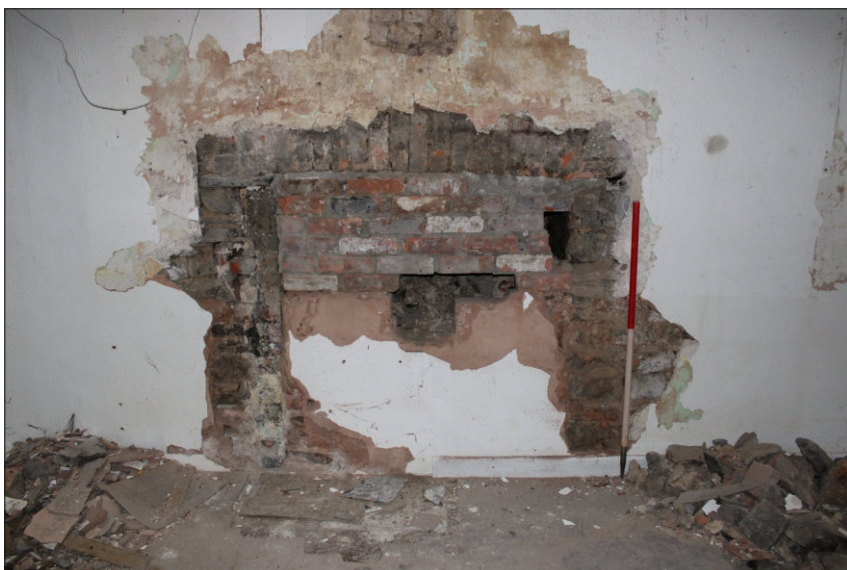
Plate 6: Blocked fireplace in the west wall, looking northwest (1m scale)

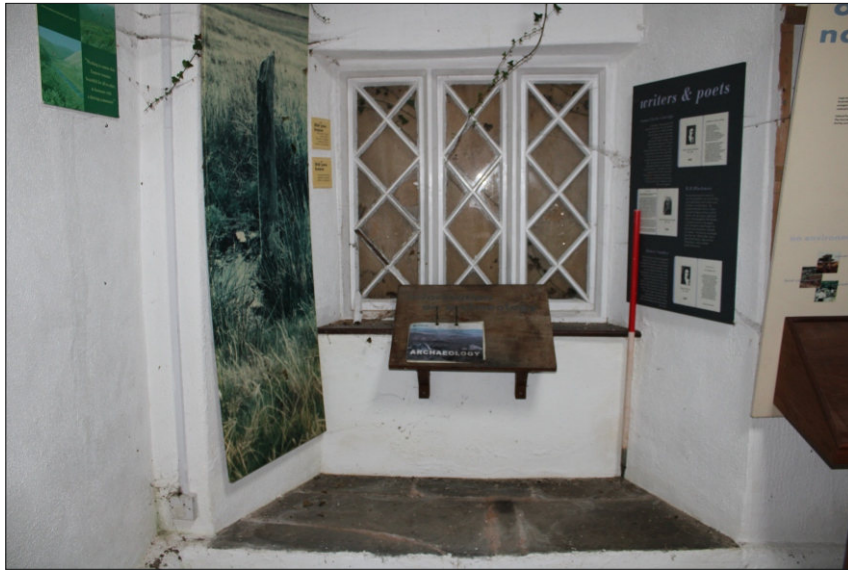
slabs (Plate 7). Both windows have deep slate cills. The south extension has a late 20th-century replacement roof structure formed of eight closely-spaced A-frame trusses with applied collars (Plate 9), and a further five smaller trusses carrying the roof over the line of the western pitch of the earlier roof of the main front range. The space was ceiled over directly above the trusses. The north extension contains a toilet and a small kitchen area, with the two spaces divided by a lightweight partition finished with tongue-and-grooved boarding.

Plate 7: Internal view of north window in east elevation, looking southeast (1m scale)

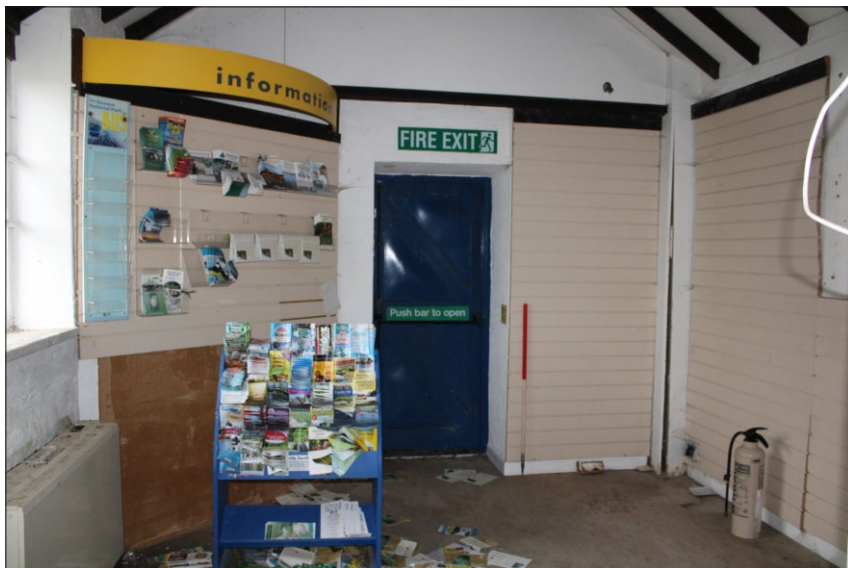
Plate 8: Internal view of south extension, showing inserted doorway, looking northwest (1m scale)

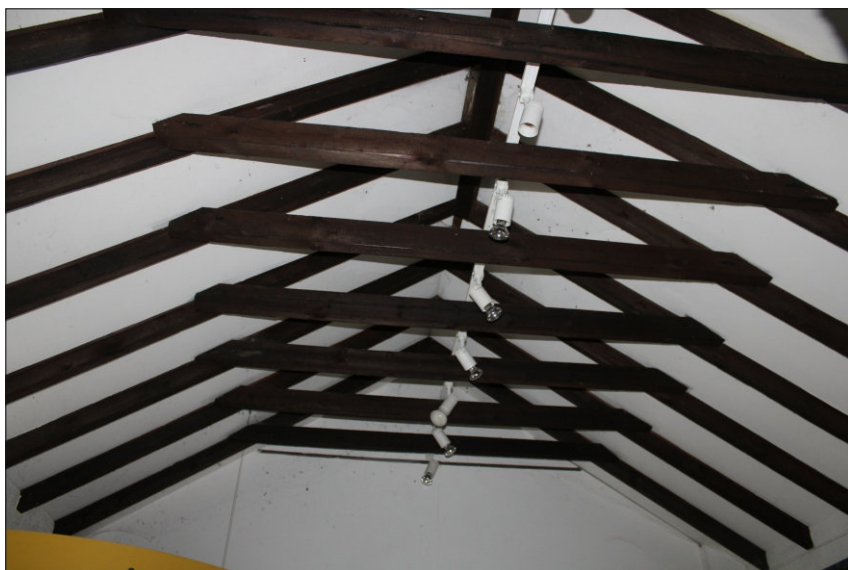
Plate 9: Roof structure of south extension, looking northwest

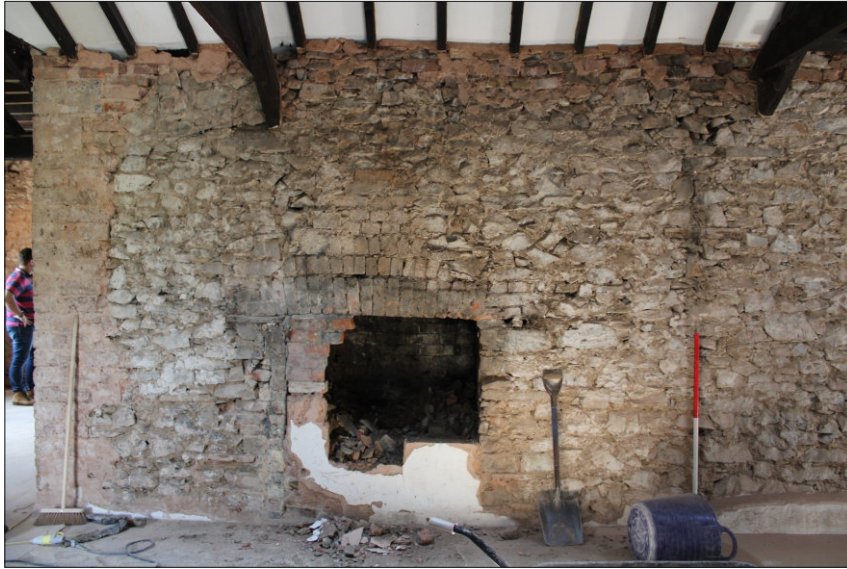
- 5.9** In the west wall within the rubble stonework the scar of a former partition (as previously noted by Shirley Blaylock) was exposed; this had a horizontal small timber set into the stonework about half way up the wall (Plate 10). The association of the plinth to the north (described above) indicates that the northern room beyond this partition was at a slightly higher level than the rest of the building, Above the now-infilled cellar. The infill within the fireplace in the west wall was largely, but not fully, removed. Within the opening it was observed that it had been narrowed on the south side. There was no evidence for any fittings such as a cast-iron grate or a bread oven. Above the brick head was further brickwork (representing part of the chimney stack), which includes a curved partial row of bricks that may have represented a crude relieving arch. The south end of the wall has been rebuilt using concrete blocks, associated with the creation of a modern opening into the south extension.

Plate 10: West wall showing wall scar to right, unblocked fireplace, centre and rebuilt wall to left, looking northwest (1m scale)

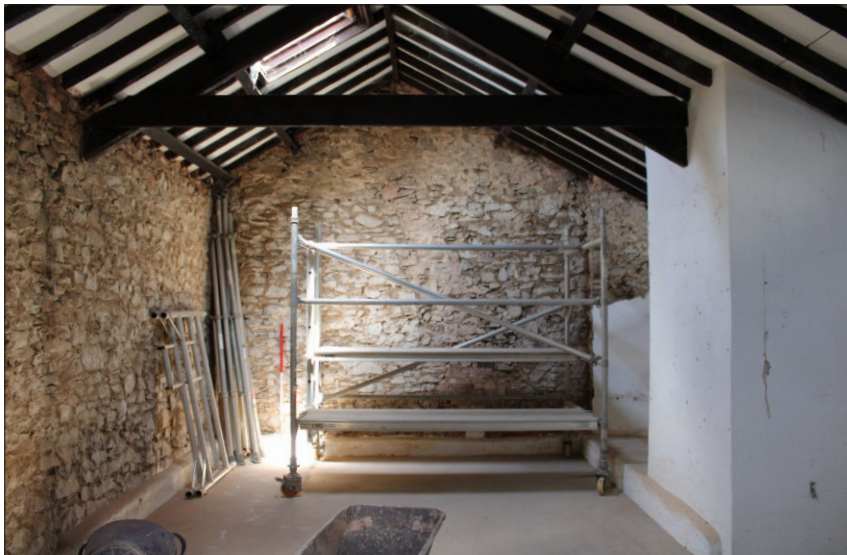
- 5.10** In the north wall a blocked fireplace was exposed offset towards its the east side (Plates 11 and 12). This was infilled with rubble stone and brick and had a ceramic ventilation brick indicating that the infilling is an outer skin and the hearth behind is open. The fireplace has a narrow brick arch supported on an iron bar, and the chimney stack was identifiable within the rubble stonework above.

Plate 11: North and west walls showing projecting plinth, wall scar to left, and blocked fireplace with chimney stack, looking northeast (1m scale)

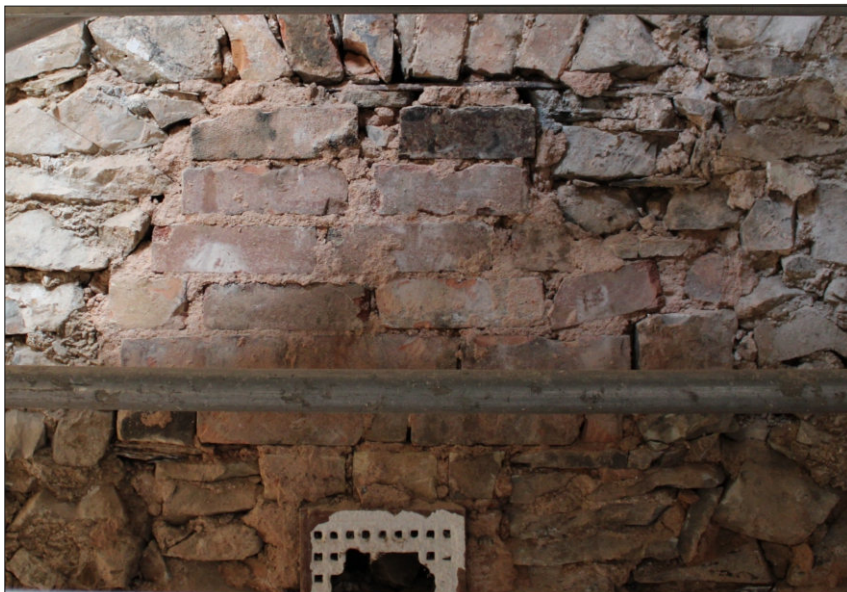
Plate 12: Close-up view of blocked fireplace in the north wall, looking northeast

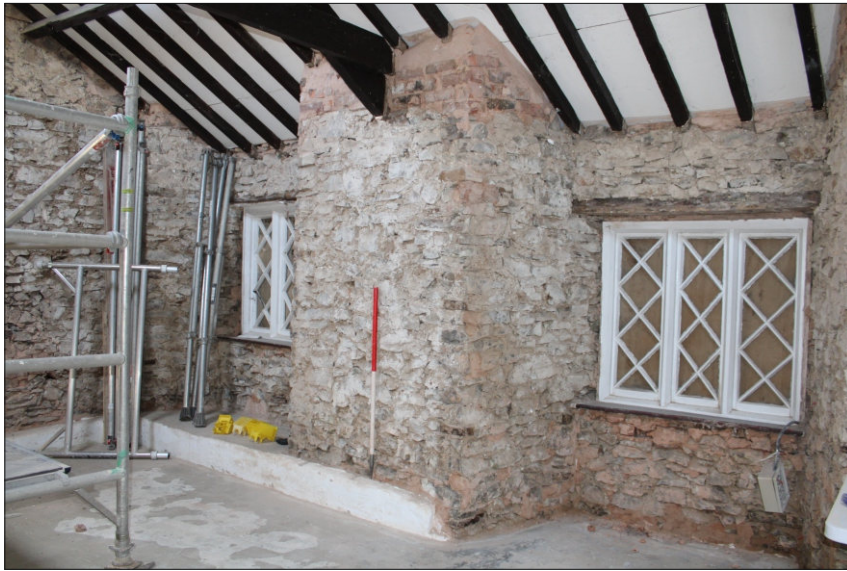
- 5.8** In the main front range of the building the walls are constructed of rubble stonework bonded in a light grey lime mortar. They have been heightened (west wall) and rebuilt (east wall) with brick bonded with an off-pink cement mortar (see Plates 13 and 14). This change in masonry lined up with a break between historically painted masonry below and unpainted masonry above; this was most clearly visible on the gable elevations (see Plate 15). It is likely that this represents the line of a former ceiling across this range.

- 5.11** In the east wall all the openings have timber lintels and there is some historic repointing in a light red lime mortar particularly below the central window (Plates 13 and 14). The south wall also featured a blocked fireplace, again offset towards its east side. This was infilled with brick bonded with a pink cement mortar – the same material as that used in the brick heightening of the walls. Again, the blocking contained a ceramic vent indicating that the hearth behind remains open. The fireplace has a brick arch, and the line of the chimney stack can be determined within the rubble stonework above (Plate 15).

Plate 13: East wall with repointing visible particularly below the central window (on the right), looking east (1m scale)

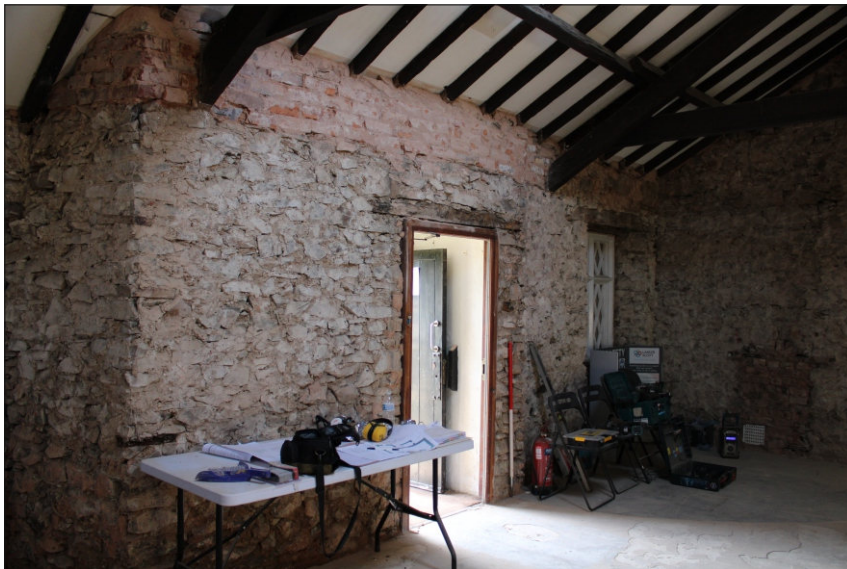
Plate 14: East wall, looking east (1m scale)

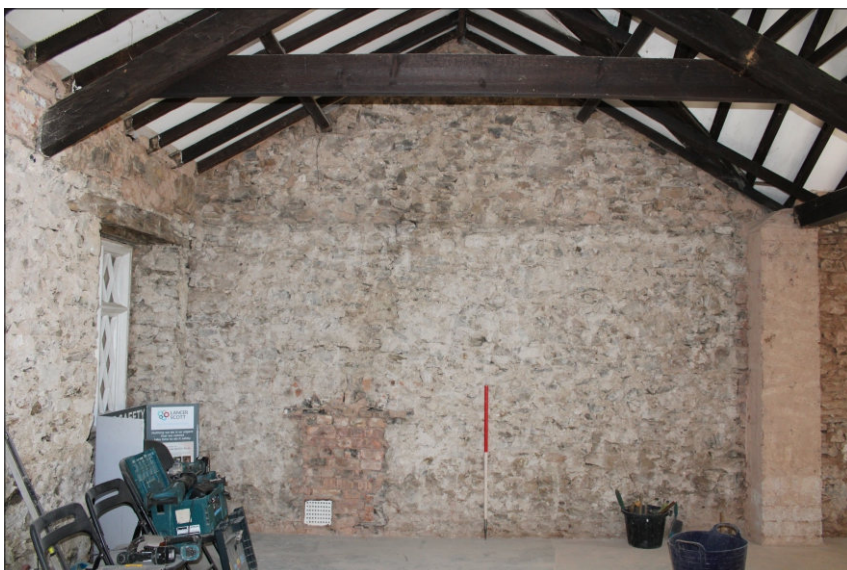
Plate 15: South wall with blocked fireplace, looking southwest (1m scale)

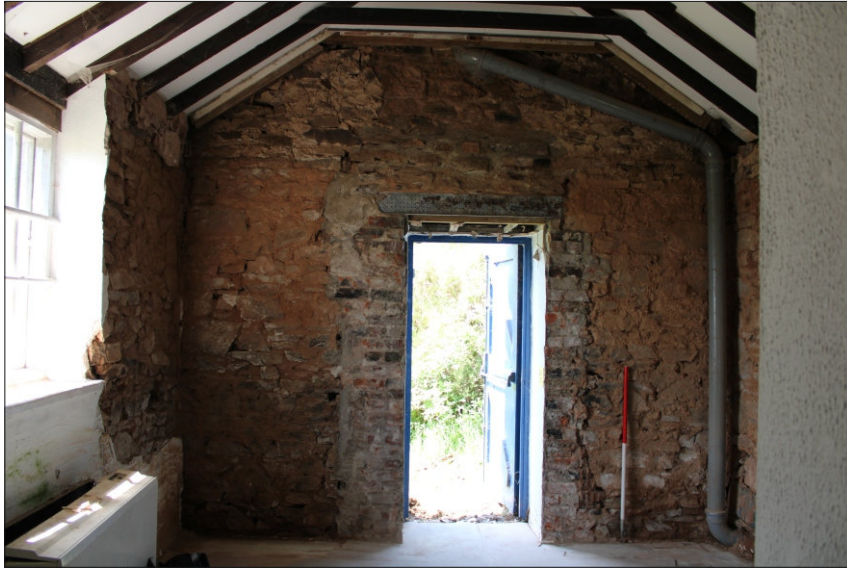
- 5.12** In the south extension the walls are constructed of rubble stone bonded with a light brown lime mortar. They have again been heightened with brick bonded with an off-pink cement mortar. Set within the brickwork were sawn-off timbers, either tie beams for a former roof structure or joists below supporting a lower ceiling; one survived *in situ* painted black as with the later roof timbers. In the west wall the central doorway cuts through a former fireplace. The doorway has a rolled steel joist lintel and brickwork

around the opening. The brickwork is wide, perhaps indicating that the fireplace was also wide, and of a form found in a kitchen rather than used for heating living spaces. The line of the chimney stack is visible above the doorway. There are some areas of heavy repointing on the wall (Plate 16). The north wall has had a doorway inserted on its east side to give access to the north extension; the wall above and to the right of the opening are constructed of concrete block (Plate 17). The south wall also has some heavy repointing as present the west wall, particularly on the west side (Plate 18).

Plate 16: West wall of south extension, showing doorway cutting through former fireplace, looking northwest (1m scale)

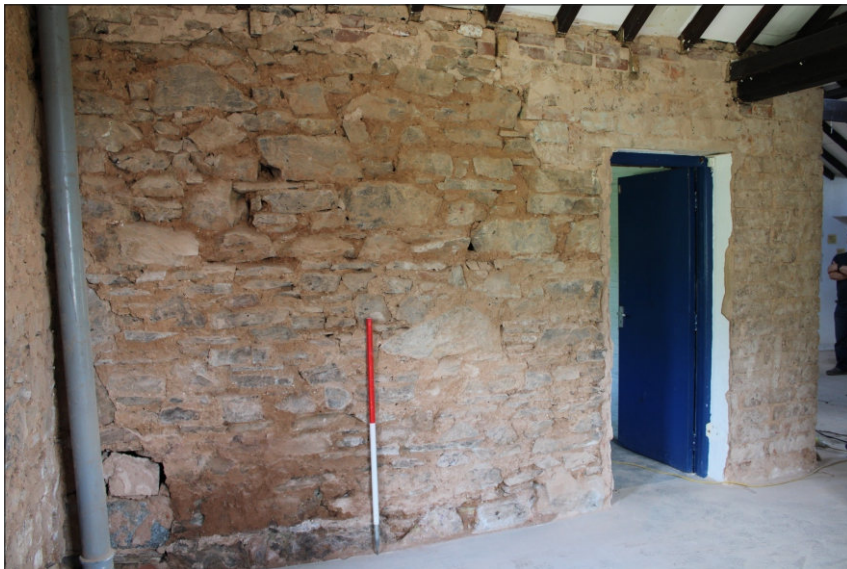
Plate 17: North wall of south extension, showing inserted doorway to right, looking northeast (1m scale)

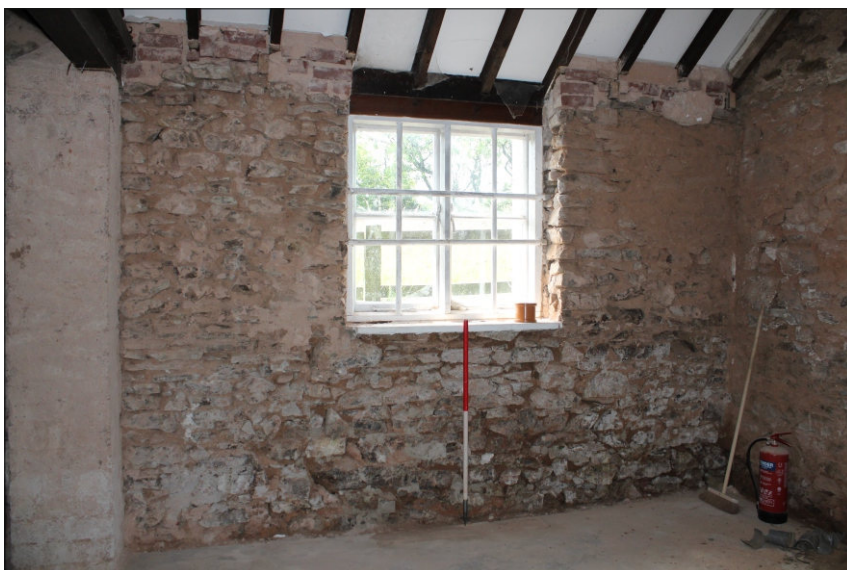
Plate 18: South wall of south extension, looking southwest (1m scale)
