# Wessex Water Domestic Supply Pipe Repair, Land off Thorney Lane, Marston Magna, Somerset:

Results of archaeological monitoring

Document No. ACW1580/1/0

Date: September 2023

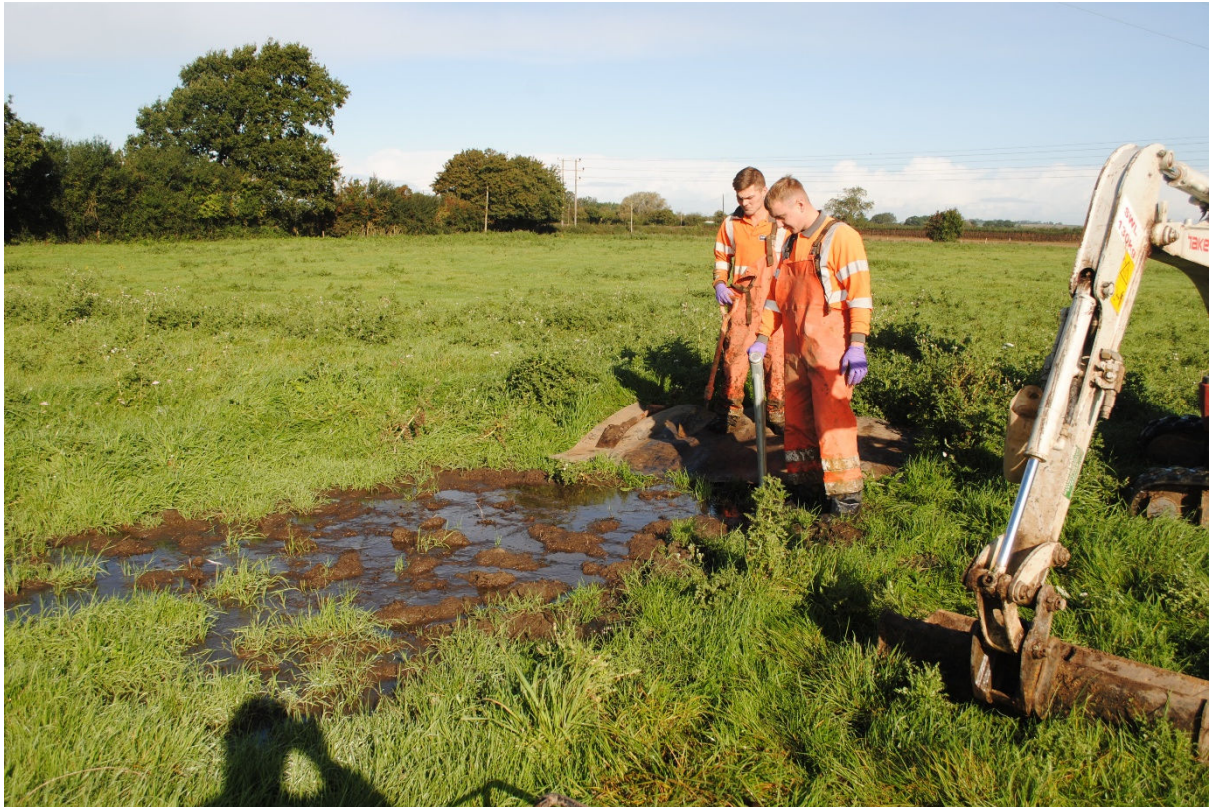
**2.1** On arrival, running water was seen breaking ground and displacing small amounts of liquified soil onto the surrounding ground surface (Plate 1). Remedial works (Plates 2 & 3) comprised hand-excavation by Wessex Water groundworks staff of a sub-oval access hole measuring approximately 0.50m by 0.70m, and up to c 0.60m deep, with arisings stored on an adjacent rubber ground-mat. The majority of digging was within the modern backfill of the pipe trench, with only minor, peripheral impacts on in-situ soils to either side.

**Plate 1: Condition of leak site on arrival. View from SSE**

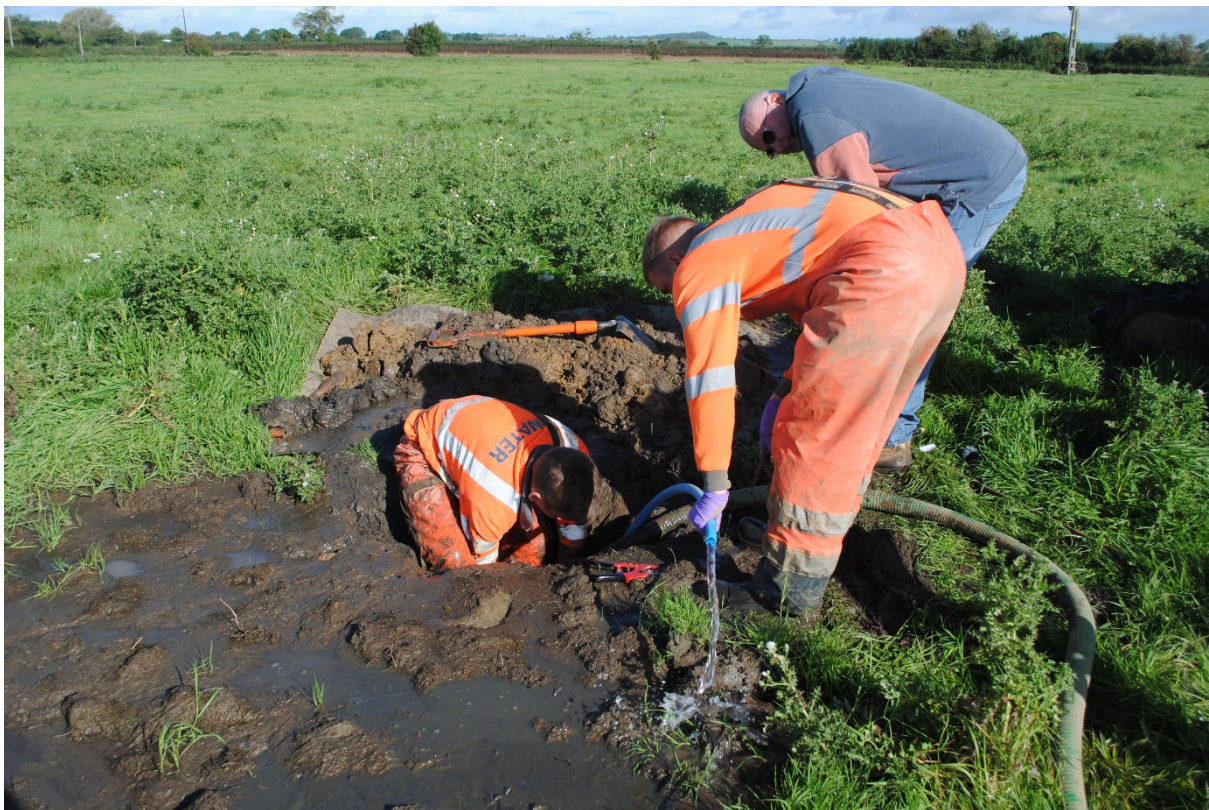
**Plate 2: Excavation of pipe access pit. View from south**

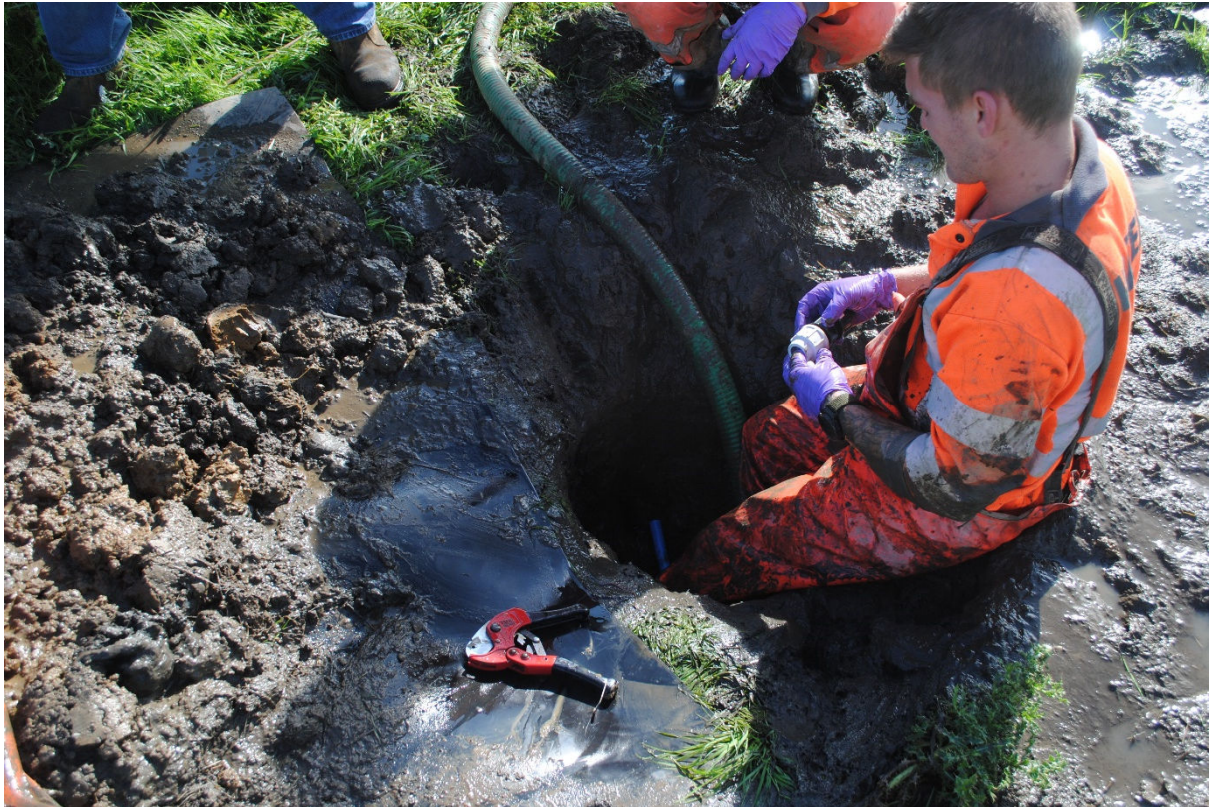
**Plate 3: Detail of pipe repair works in progress. View from west**

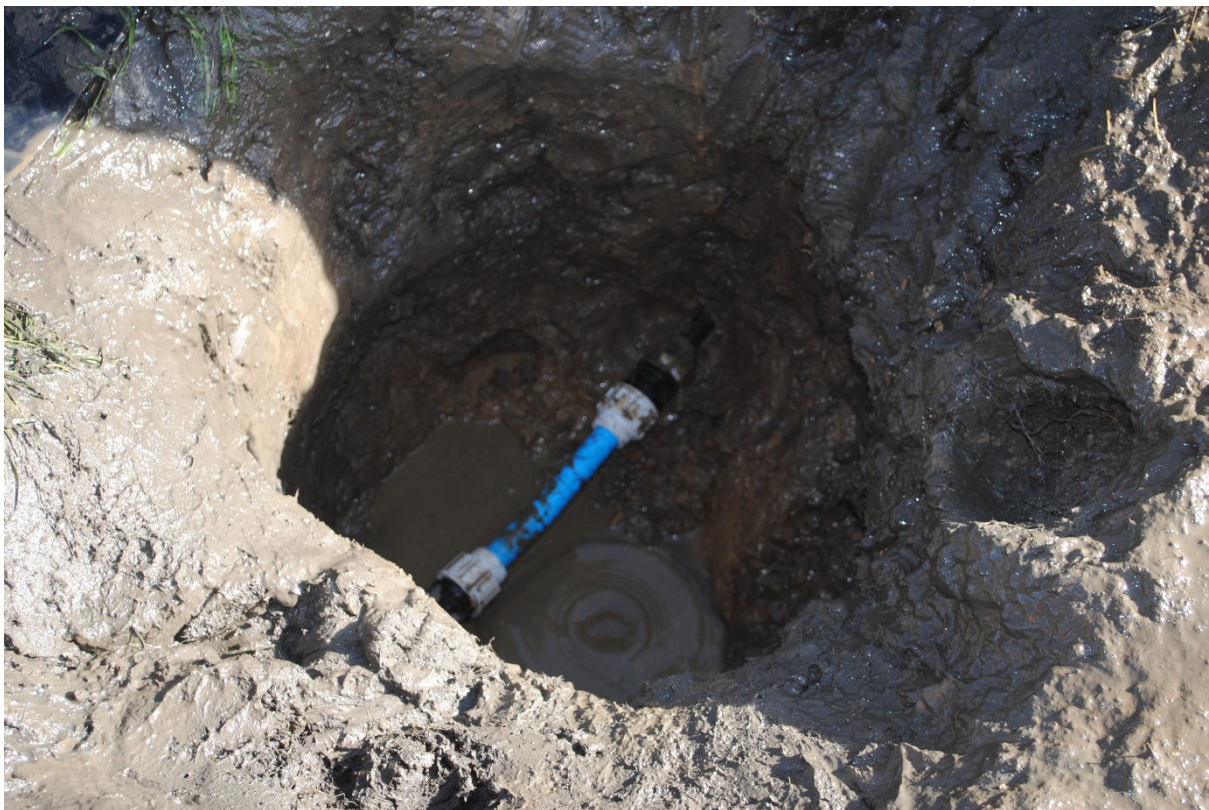
**Plate 4: detail of completed pipe repair and full extents of access pit immediately prior to backfilling. View from south west**

**2.4** Following replacement of the broken pipe segment (Plate 4), the access hole was backfilled with excavated arisings and water-displaced soils, and the site vacated.
