Archaeological Recording of former Coach House to the rear of No. 16 Vyvyan Terrace, Clifton, Bristol.

Archaeological Standing Building Survey Report

HER/Planning Reference no. BHER 24768

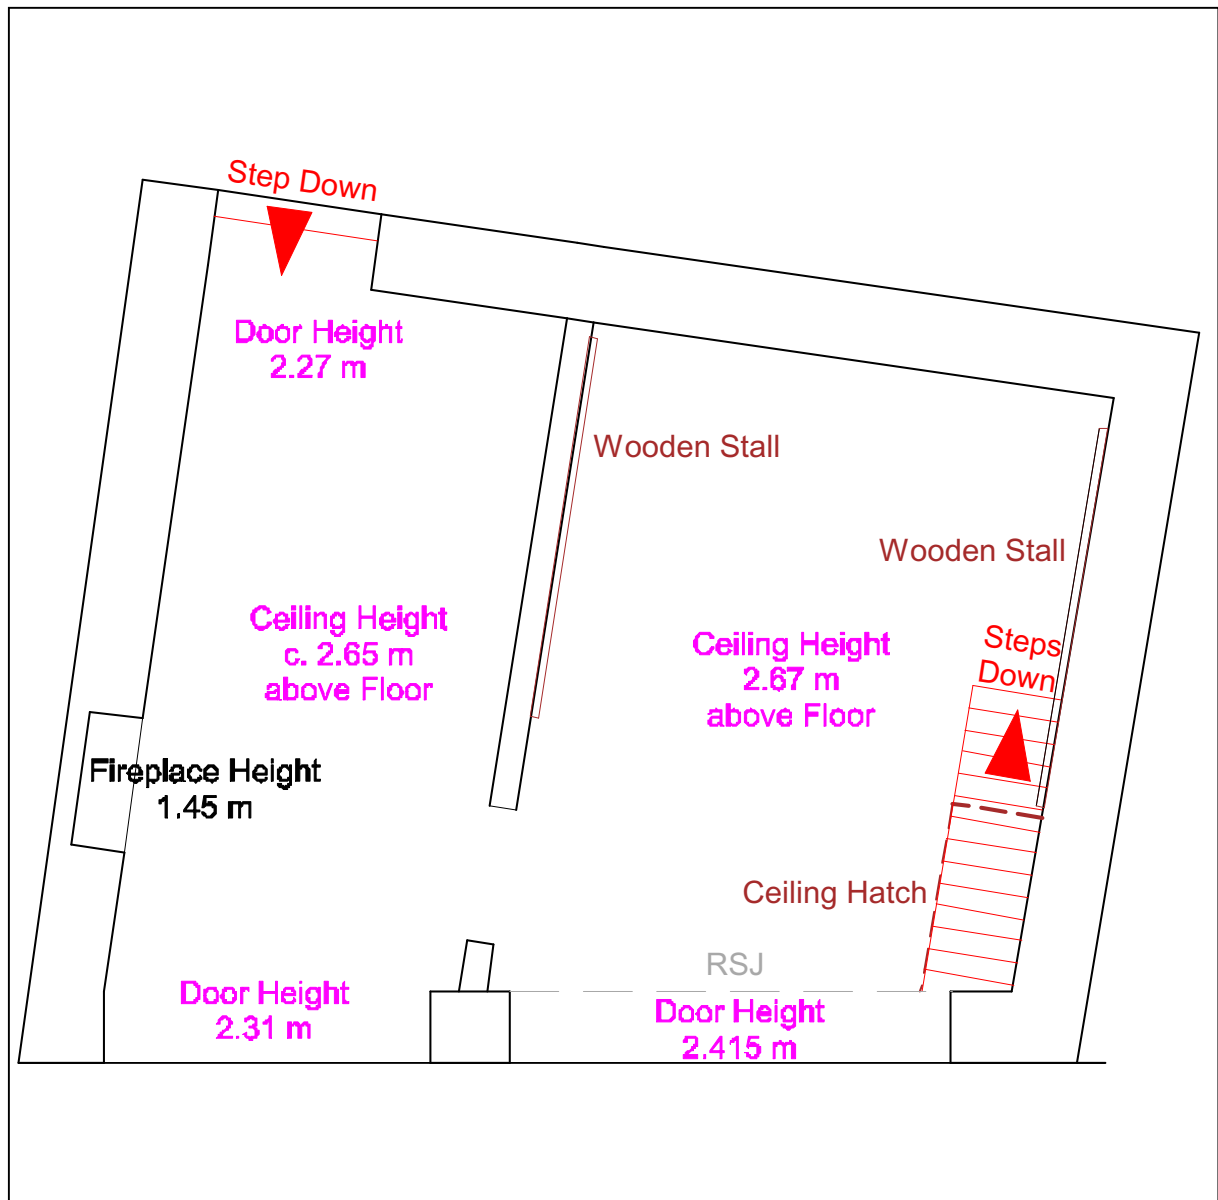
Figure 3

Although the former coach house appears rectangular, on closer inspection it is in fact an irregular four-sided polygon (see **Figure 3**). As recorded this structure measured c. 7.10 m long east to west, c. 5.85 m wide at the western end and c. 4.90 m wide at the eastern end. While the eastern and western walls are roughly parallel, the northern and southern walls are not.

Ground Floor survey of the Coach House (scale 1:50)

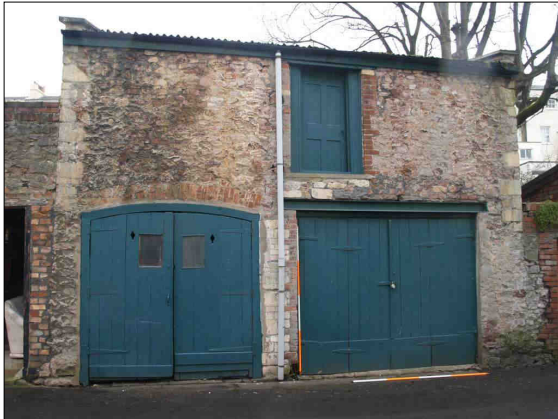
As exposed the majority of the external walling appears to be of rough-coursed rough-hewn or unhewn stone, bonded with lime mortar. The south face was the easiest to record as this is completely accessible from Vyvyan Road (see **Plate a**). Here the majority of the stone appears to be the locally occurring dolomite conglomerate, with occasional slabs of pennant sandstone and more frequently occurring use of (presumably reused) Bath stone ashlars. From approximately head height up the corners are in stressed Bath stone quoins. The height of this face measured 4.72 m from street level to guttering.

In the south face there are two entrances. The eastern is a segmental arched wooden double doorway opening outwards on wrought iron hinges. The arch is executed in

brick. This appears to be an original feature of the structure. The western entrance is a folding double door beneath a reinforced steel joist (RSJ) that indicates this doorway was a later insertion. Between the two entrances stands a pier of material, the western side of which is composed of Bath stone ashlars, while the eastern side of which is in hand-made house bricks laid to a pattern that suggests it was formerly one side to an earlier entrance. It is surmised the earlier entrance (for a horse) was replaced with a wider entrance for a car.

There is a low first floor single wooden doorway located centrally in the south face. Mortared hand-made bricks define both sides of the door. A moulded concrete threshold appears to be a later replacement. The lintel is in wood. Although no pulley apparatus or fixings were visible it is suggested this doorway was for loading hay and other goods from the street directly onto the first floor.

a. The southern face of the Coach House fronting Vyvyan Road, looking north. Scales 2 m by 2 m.

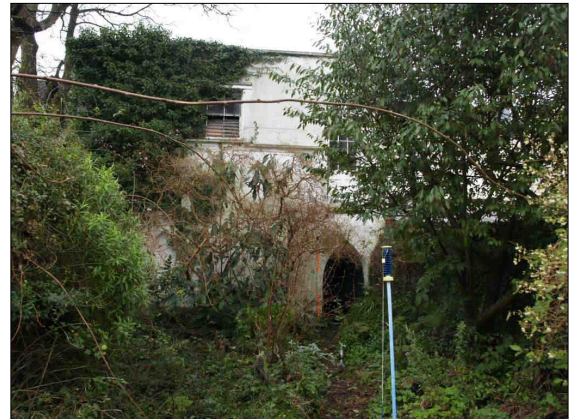
The north wall was harder to record as it is partially obscured by ivy and other garden shrubs and bushes. This face is also rendered and painted white (see **Plate b**). There is a single ground floor entrance at the western side, a pointed gothic arch at variance with the architecture of both the house and the south face of the coach house. There is a single 330 mm step down from the garden into the doorway. On the eastern side of this wall are four blind pointed arches, two at ground floor level and two at first floor level. There is no internal indication these were ever windows. There is a pilaster strip above first floor level and the wall ends in a low parapet. It was not possible to measure the height of the north face.

There is a first floor single wooden doorway above the ground floor entrance with wooden lintel and threshold. A vacant slot beneath the threshold indicates where a porch was once located (Catherine Coates, personal communication). In the eastern side of the wall is a first floor wooden sash window with six lights.

b. The northern face of the Coach House, looking south from the garden of No. 16. Scale 2 m.

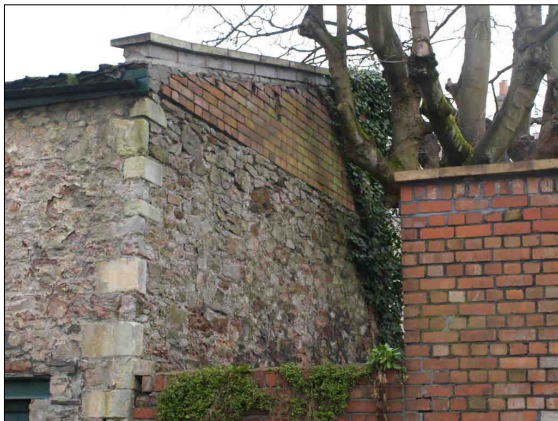
As exposed the eastern wall is of similar construction to the southern wall, up to the height of the southern wall (see **Plate c**). From that level an extension in machine made brick rising upwards towards the north is evident. The same is also true on the west side of the building.

c. Detail of the east face of the Coach House, looking northwest. No scale.

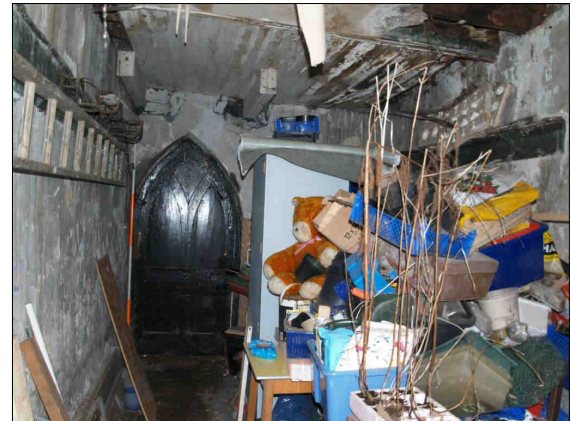
Internally the ground floor is divided into two rooms, the longer but narrower western room measuring 4.85 m north to south by c. 2.40 m wide (see **Figure 3** and **Plate d**), and the larger eastern room, measuring up to c. 4.45 m north to south by up to 3.70 m wide (see **Plate e**). As exposed the western room is floored with flagstones, while the eastern room is floored with a mixture of flagstones and cobbling. In the eastern room a single drain is evident near the foot of the steps to the first floor. A lime-plastered brick built wall 180 mm thick forms the partition between the two rooms, with a single standard doorway between the two at the southern end. There is no artificial lighting in either room.

There is only one surviving part of the ceiling that is not of plasterboard or similar material. This is a rectangular area inside the garden door of the property, composed of painted or stained wooden strips or lathes (again, probably pine), fastened to the joists with nails and moulded wooden rails. Above, and projecting back from either side of the doorway were two rectangular wooden boxes, apparently to accommodate the supports for a first floor balcony no longer extant (Catherine Coates, personal communication). The balcony and first floor doorway probably date from a time when the building was occupied as a home. Apparently a family were still living there after World War 2 (Catherine Coates, personal communication).

d. Ground floor interior view showing ceiling and former balcony supports over garden door, looking north. Scale 2 m.

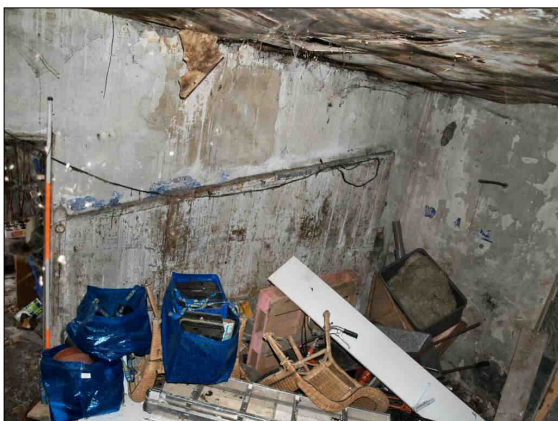
On either side of the eastern room are the remains of wooden stalling for a horse or horses. The western side appears to be complete, while on the eastern side several planks have been missing since before the present owner took up occupancy (Catherine Coates, personal communication). There was no observable trace of a central stall, though the appropriate place where traces of one might be found against the north wall was obscured. It is possible this area was intended as stalling for one horse only, with more room for the horse (Amy Willis, Avon Archaeological Unit Limited, personal communication).

e. View of the former stables area, showing stalls and water damaged ceiling boards, looking northwest. Scale 2 m.

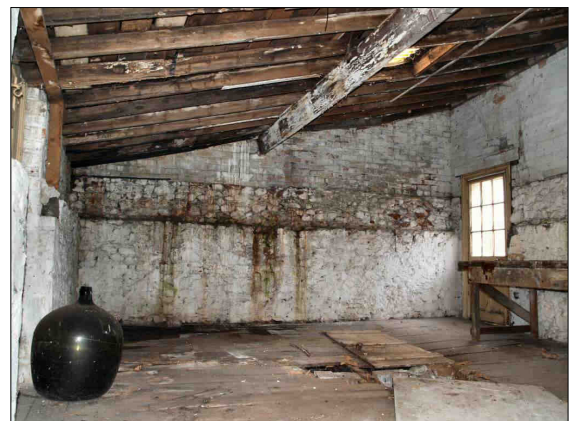
The first floor (see **Plate f**), as examined from the hatchway and from the underside is clearly in a parlous state and in the opinion of the author is unfit to bear any significant weight. In places, particularly towards the western side, the floor is broken. Where portions of the ceiling material (late 20th century boarding) have been removed/dislodged, the rotten condition of the joists can clearly be seen from below. Therefore only photographic recording from the upper steps of the ladder was possible at first floor level.

Where not repaired or replaced, the majority of the flooring is of short lengths of solid wood (probably pine, but not determined on site) planks or 'deals', of varying widths, laid from south to north across the width of the building. The homogenous appearance of the timber suggests the majority of it had been laid at the same time, with very little later replacement. The varying widths and lengths give the impression that economy had been a major factor in the choice of flooring material, with offcuts used wherever practicable in preference to long lengths of timber.

f. Interior view of the first floor of the Coach House, looking west. No scale.
