The Glasshouses, Bicton College, East Budleigh, Colaton Raleigh, East Devon.

A programme of Historic Building Recording

COAS reference: C1/SBR/14/GBD

December 2014

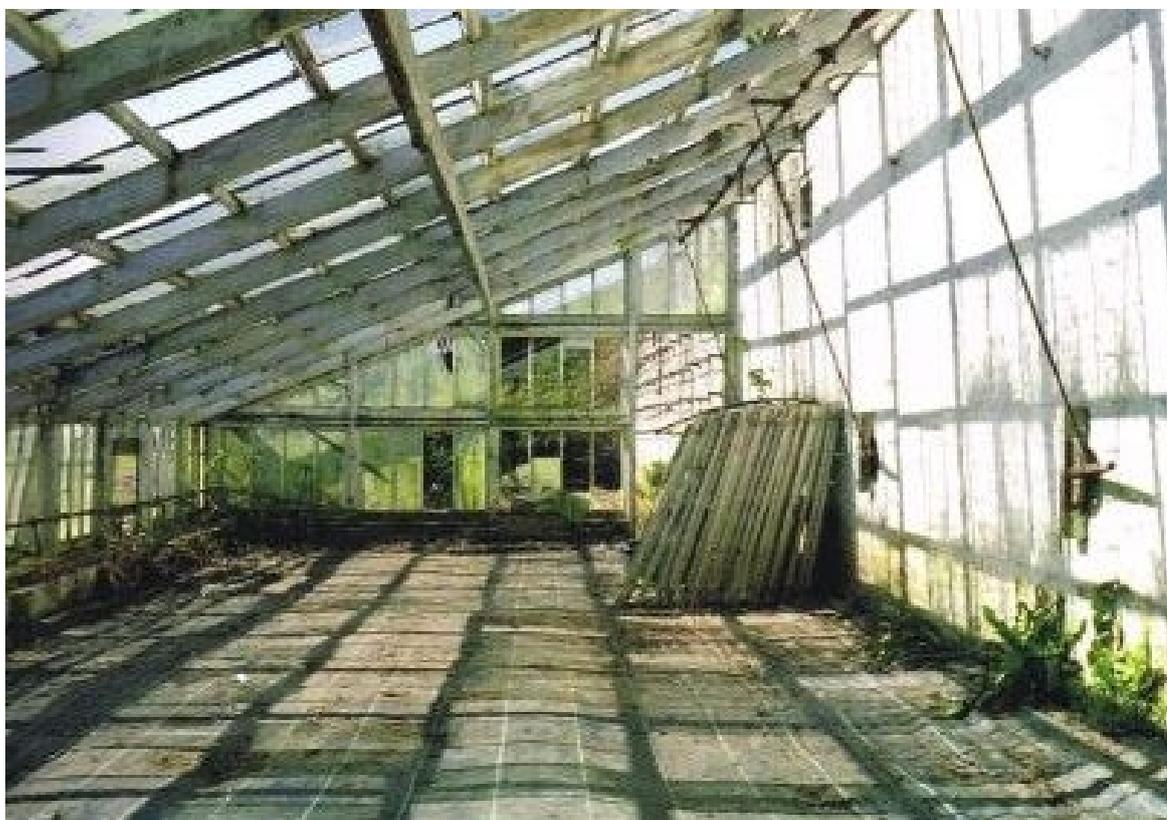
along the back wall near ground level (**Plates 3 & 5**). The front window opening mechanisms were very similar, comprising a long rotating pole with short hinged arms attached to the front windows (**Plate 3**).

Plate 3. Glasshouse B (looking W) (from Thompson 2009)

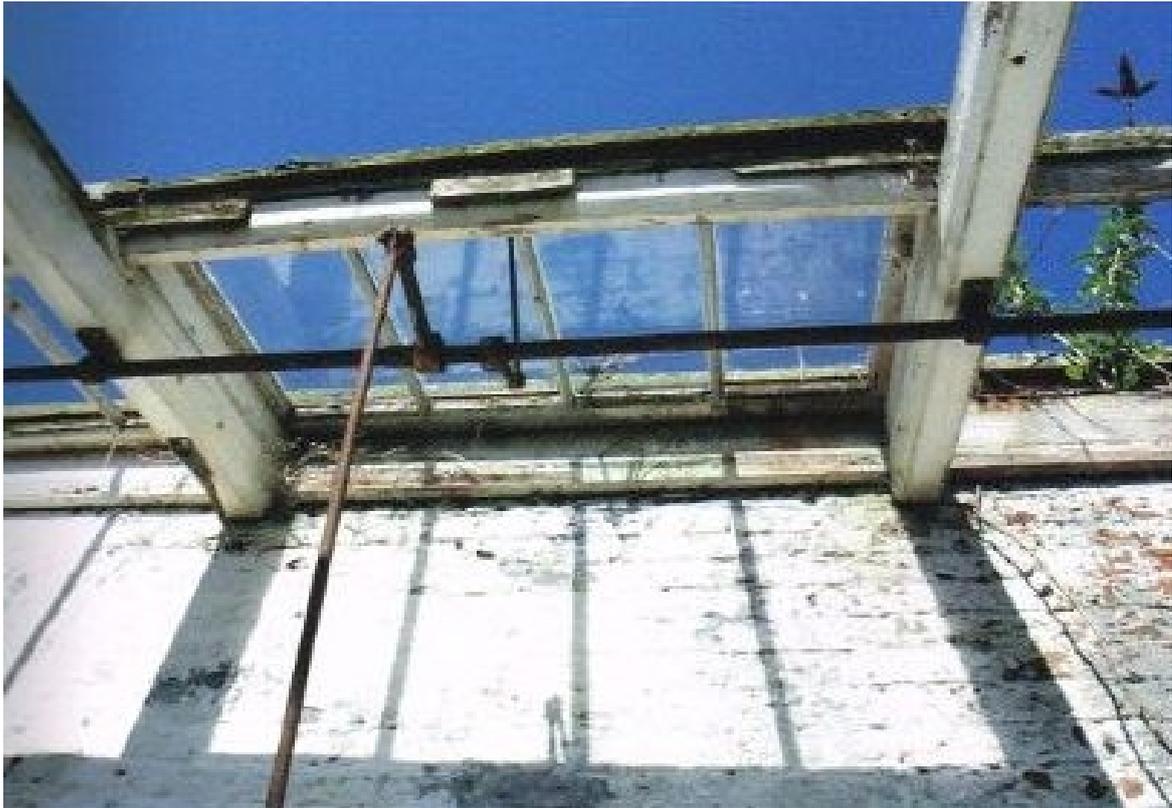
Plate 4. Window opening mechanism in roof of glasshouse B (looking N) (from Thompson 2009)

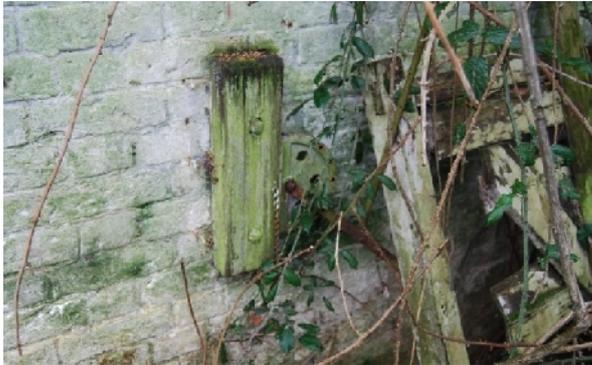
Plate 5. Gear with handle for opening roof lights in glasshouse B (from SW)

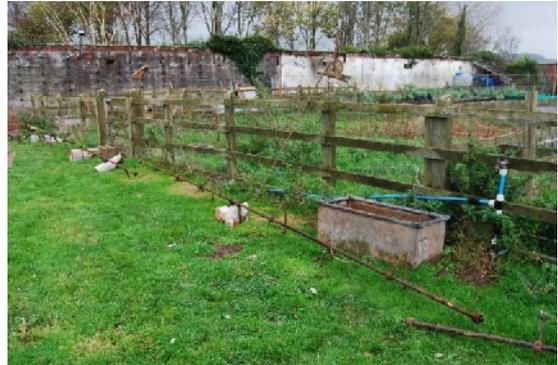
- 5.2 Following removal from glasshouse B, it was possible to view details of the roof opening mechanism in more detail. It was evident that the long pole (**Plate 6**) comprised individual sections each of which rotated freely within each bracket, allowing the roof lights to be opened individually or in sections. The gear mechanisms were stamped 'Harding' and 'Torquay' on either side of the handle (**Plates 7 & 8**). Inspection of the front window opening mechanisms did not identify any manufacturer's stamps, however the long rotating pole was again found to comprise individual sections each of which rotated freely within a bracket. At the time of the survey, the eastern end of glasshouse B was still upstanding and the brackets were attached to the supports between each window frame with each hinged arm attached to the central division of each window (**Plate 9**).

Plate 6. Roof opening mechanism of glasshouse B

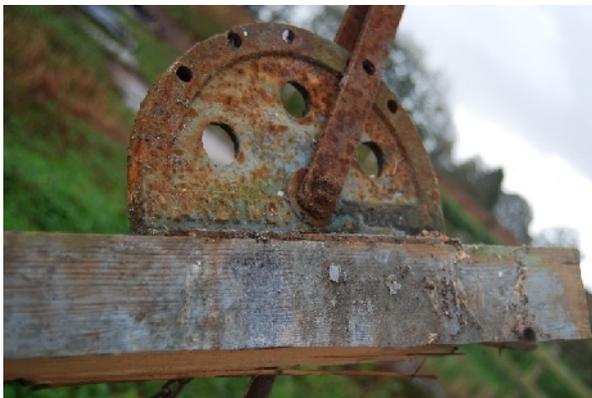
Plate 7. Close-up of gear for roof opening mechanism with stamp 'Harding' 'Torquay'

- 6.3 The mechanisms and doors were inspected for manufacturing stamps to look for evidence of where and when the glasshouses were made. The gear mechanisms for the roof opening system in glasshouse B are stamped with 'Harding Torquay'. A search of on-line resources suggests that this was T. L. Harding, which in 1878 was an ironmongers shop and iron foundry in Torquay, later becoming T. L. Harding & Sons, Torquay, which continued to operate in to the 20th century. The Historic Building Evaluation concluded that the purlin, principal rafters, common rafters and frames (for the gable ends and front windows) of glasshouse B appeared to be original (*ibid.*, 22). However, the glazed roof with lead tingles represents a replacement, although the tingles may have been re-used from the original roof (*ibid.*). Crucially, the alcan glazing bars were misaligned from the rest of the glasshouse frame creating an atypical uniform appearance (*ibid.*). Consequently, it is likely that the roof opening system manufactured by Harding, at least in part, formed part of this later addition. The front window opening system, which is very similar in form

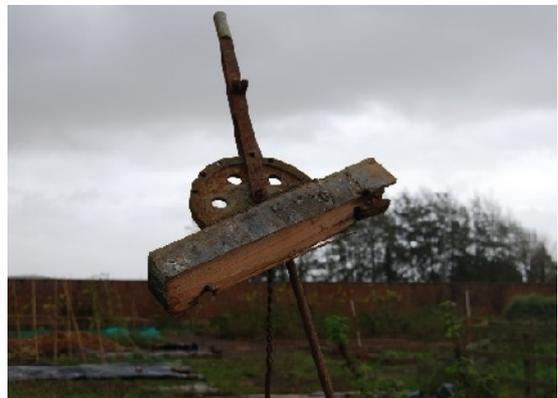
Plate 8. Gear of roof opening mechanism fixed to wooden bracket, with long pole to connect to roof & pin with chain to lock the gear

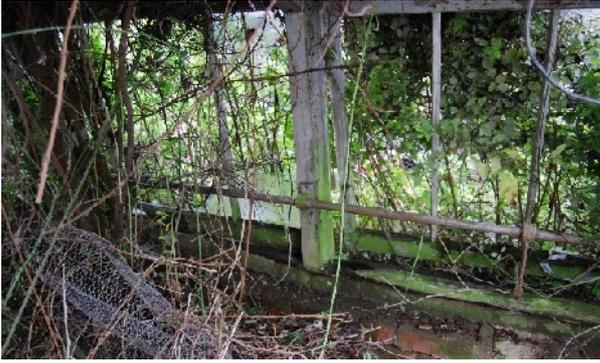
Plate 9. Front window opening mechanism in glasshouse B during demolition (from NW)

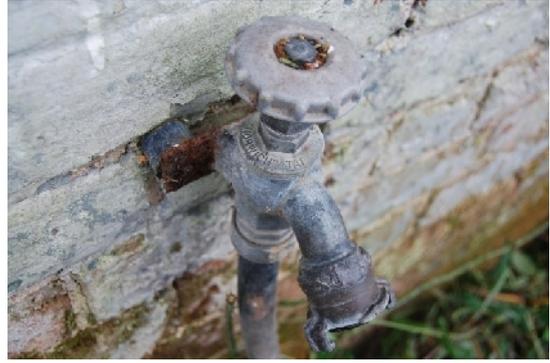
- 5.3 A single tap stamped 'Norwich Tap' 'Halcast' remained *in situ* on the back wall of glasshouse B (**Plate 10**). Pairs of square headed bolts for attaching the wooden brackets for the roof light gears were also present at regular intervals along the same wall.

Plate 10. Tap on back wall of glasshouse B, with stamp 'Norwich Tap' 'Halcast' (from SW)

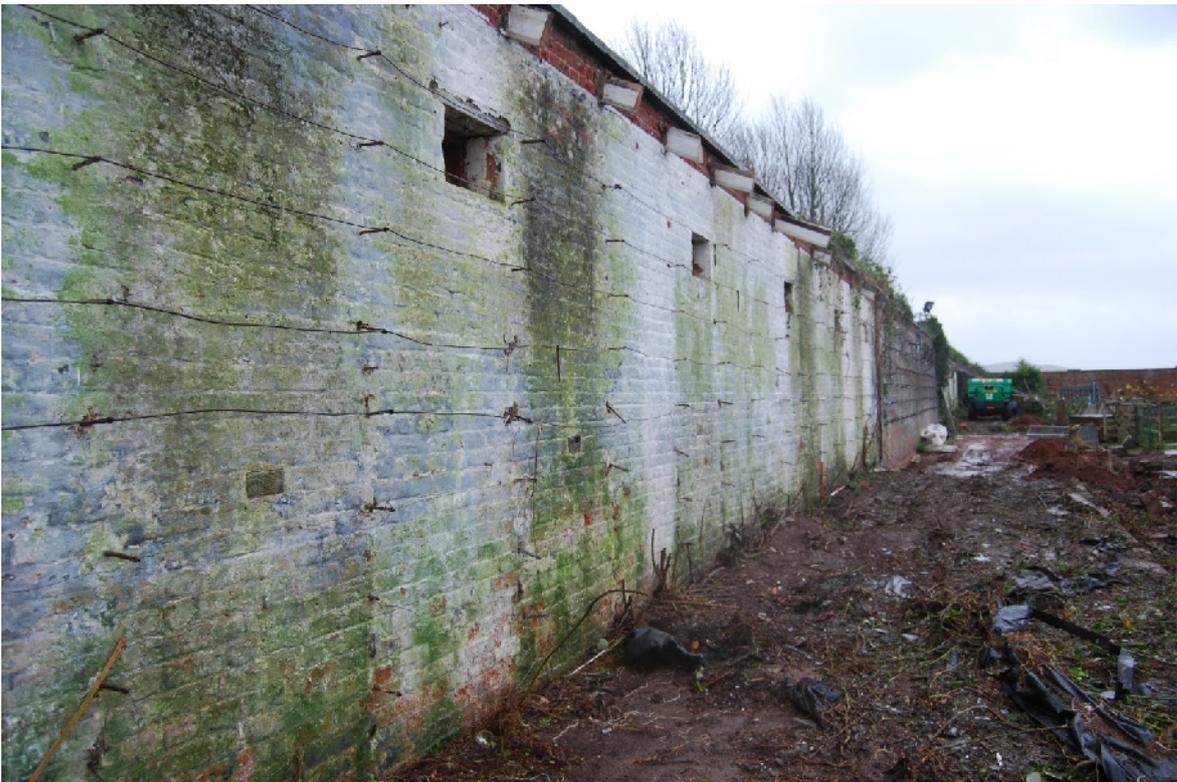
- 5.4 Vine ladders survive along the back walls of glasshouse A and the central glasshouses while less substantial fixings survive along the back wall of glasshouse B (**Figure 2**). In glasshouse A there are 16 ladders measuring c. 1.15m wide and set 0.70m in from the gable ends (**Plate 11**). Each ladder consists of 8 rows of wires positioned c. 0.33m apart with the wires running through holed pegs driven into the mortar joints between the bricks and held in place with cement (**Plate 12; Figure 3**). The wires measured c. 0.07m in diameter and the pegs protruded from the wall by 0.125m (**Figure 3**). The wires are missing from the lowest three rows and some of the pegs are either missing or insecure.

Plate 11. Vine ladders along back wall of Glasshouse A (2 x 2m scales; looking ENE)

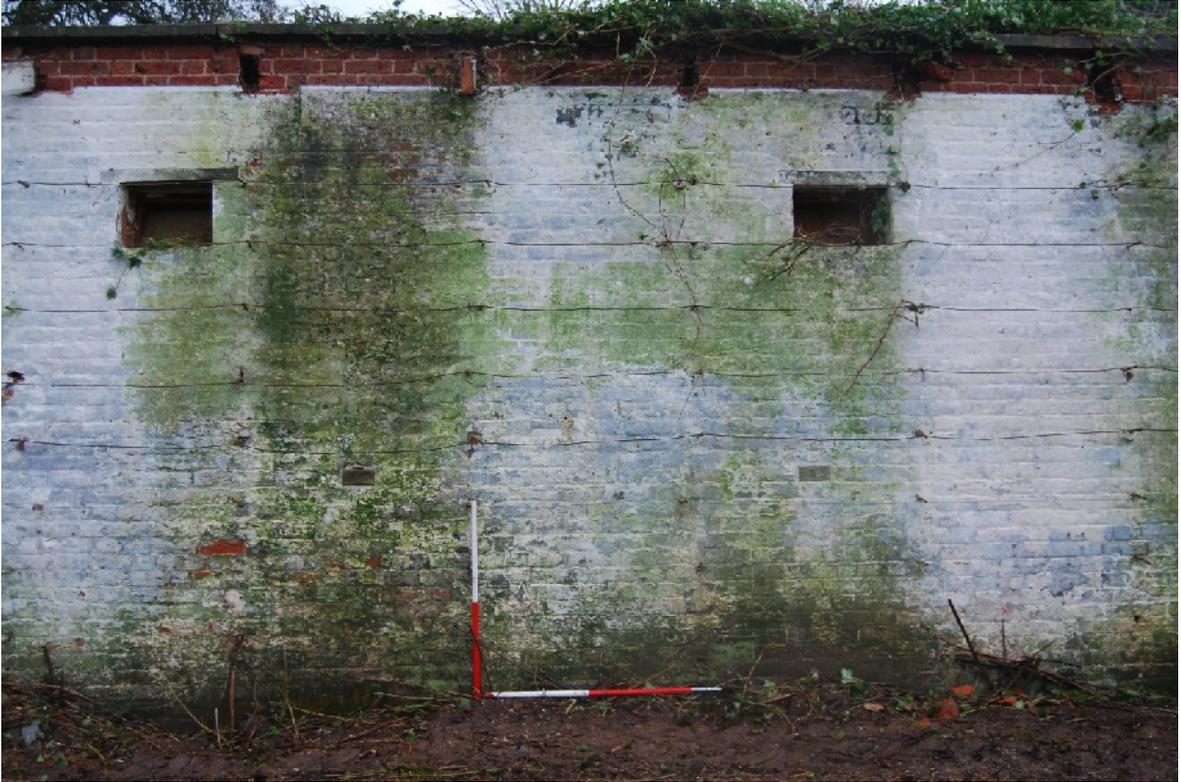
Plate 12. Section of vine ladders along back wall of Glasshouse A (2 x 2m scales; looking N)

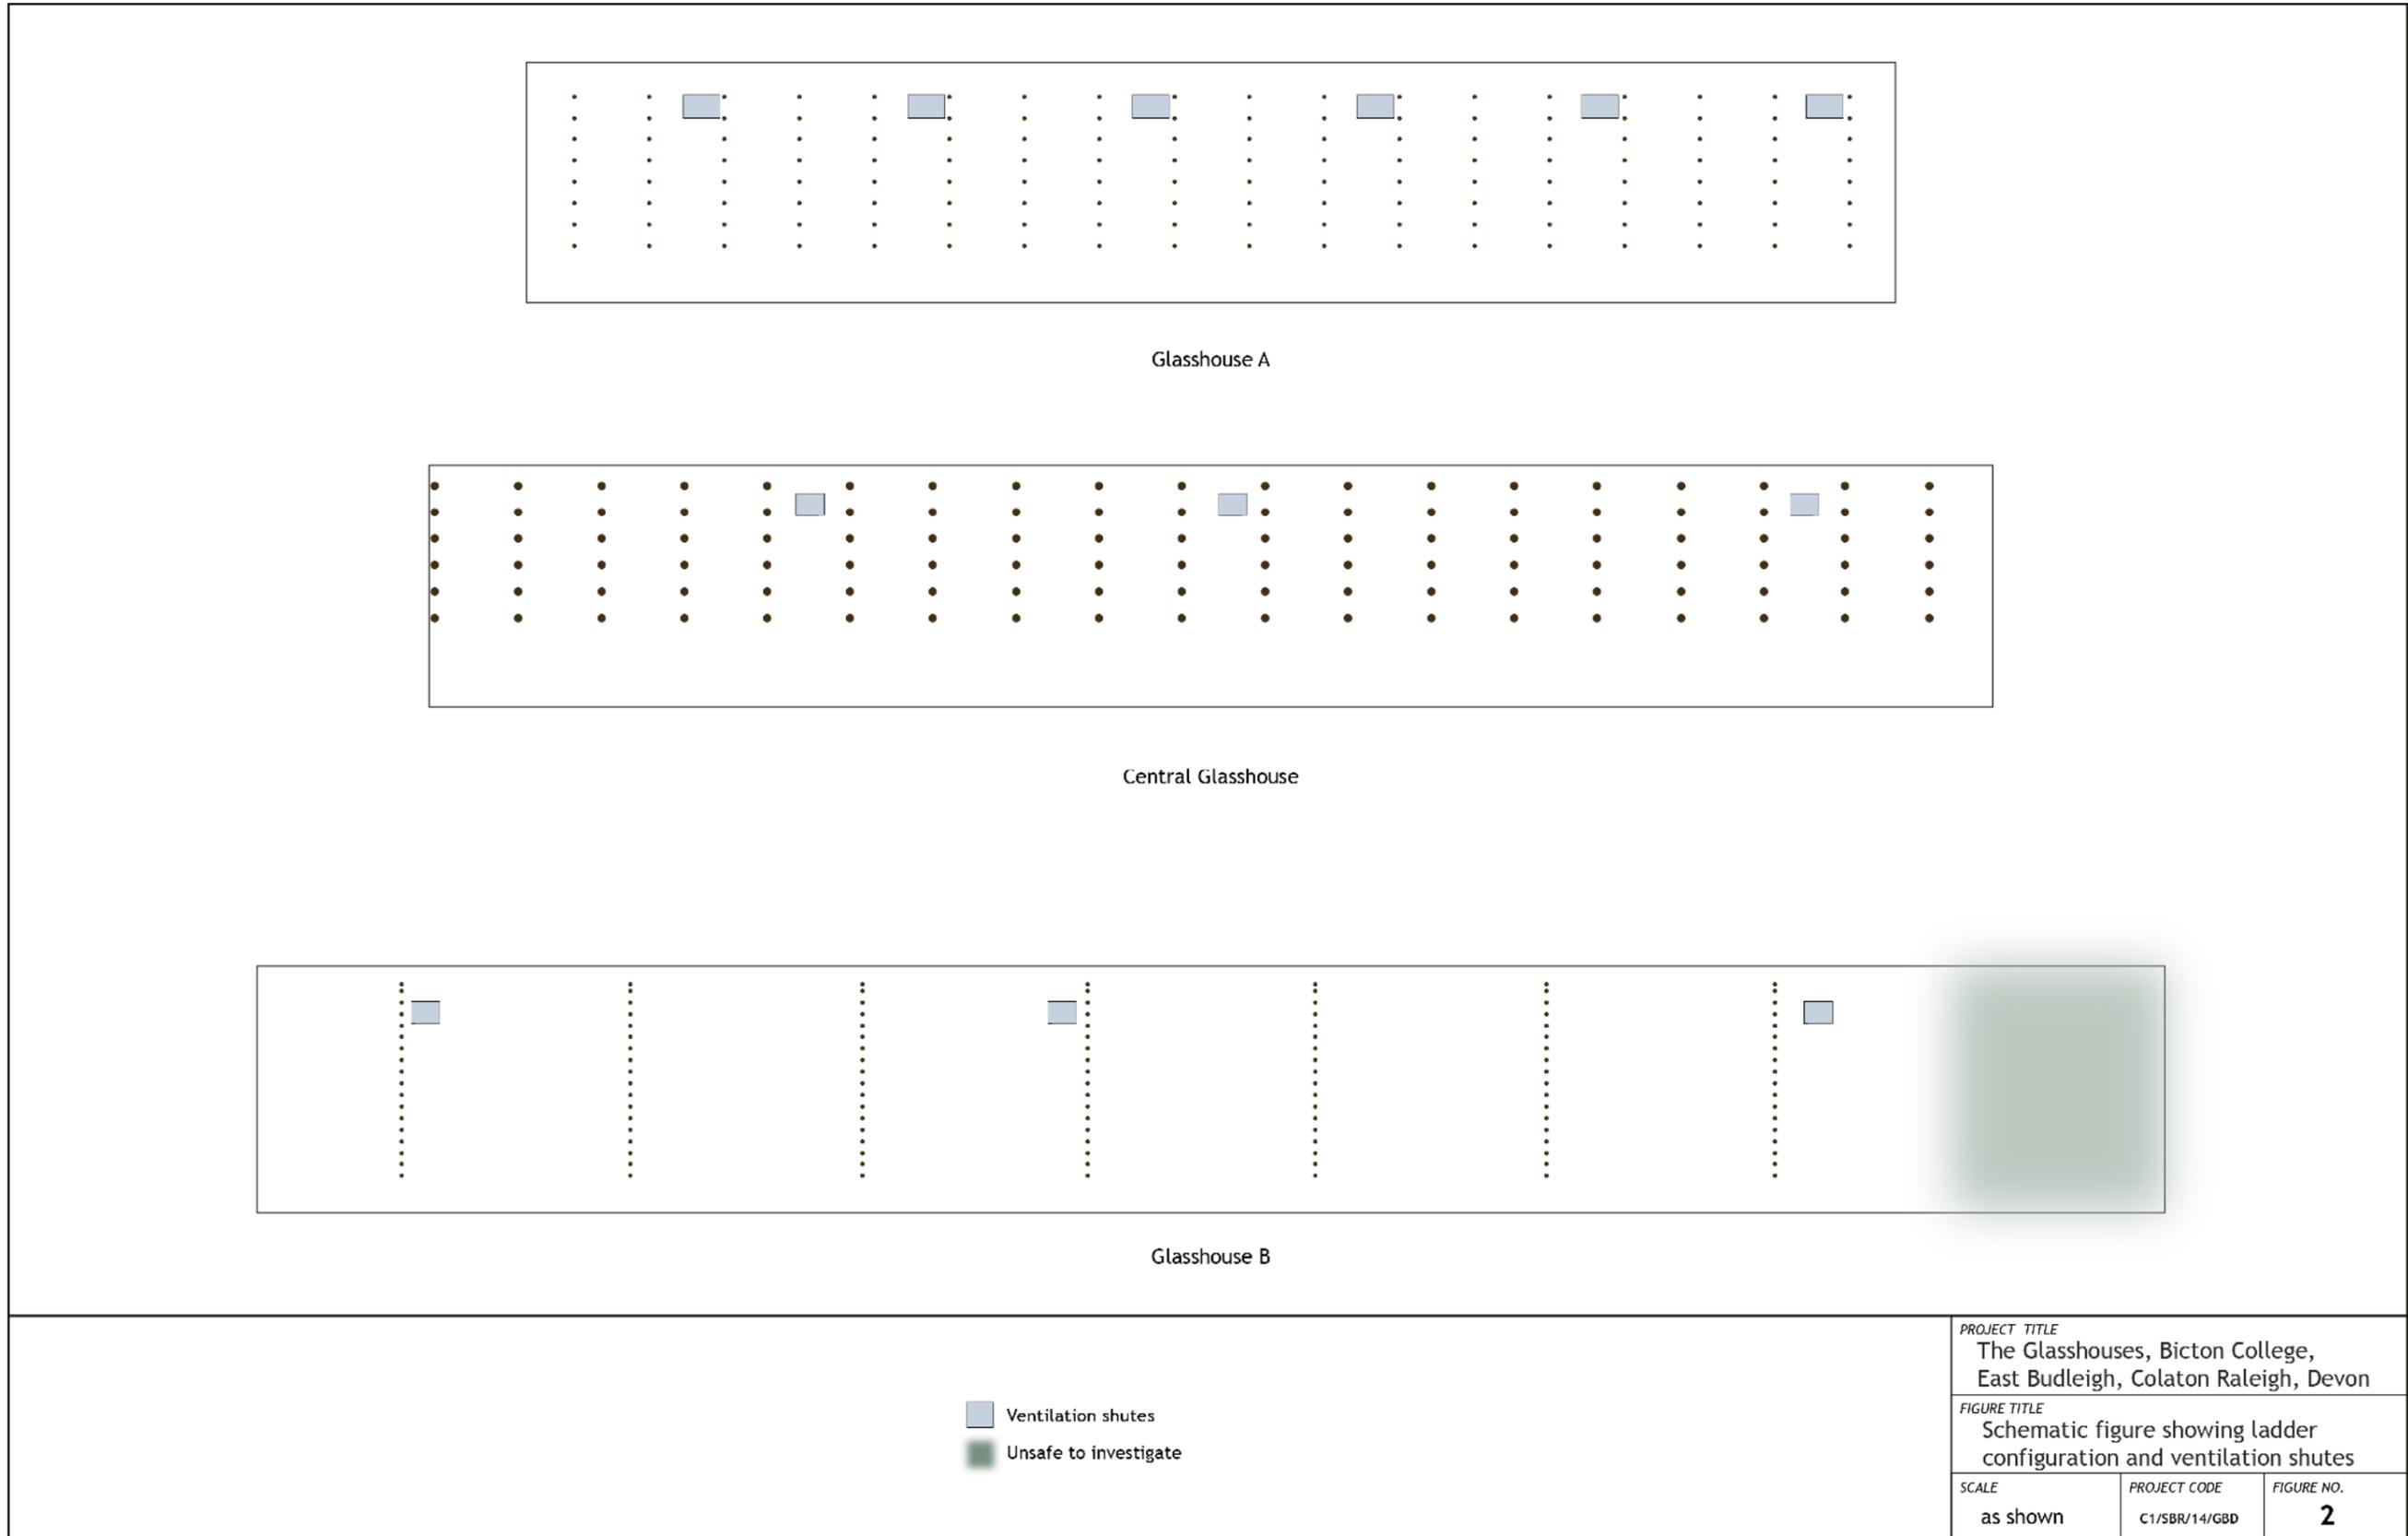
Figure 2. Schematic figure showing ladder configuration & ventilation shutes

- 5.8 Rectangular ventilation shutes were present near the top of the back wall behind all three glasshouses although the configurations are variable. In glasshouse A there are six shutes at regular intervals, each on the immediate west side of a vertical vine ladder row (**Figure 2**). In the missing central glasshouse (**Plate 13; Figure 2**) and in glasshouse B (**Plate 14; Figure 2**) there are only three shutes approximately spaced.

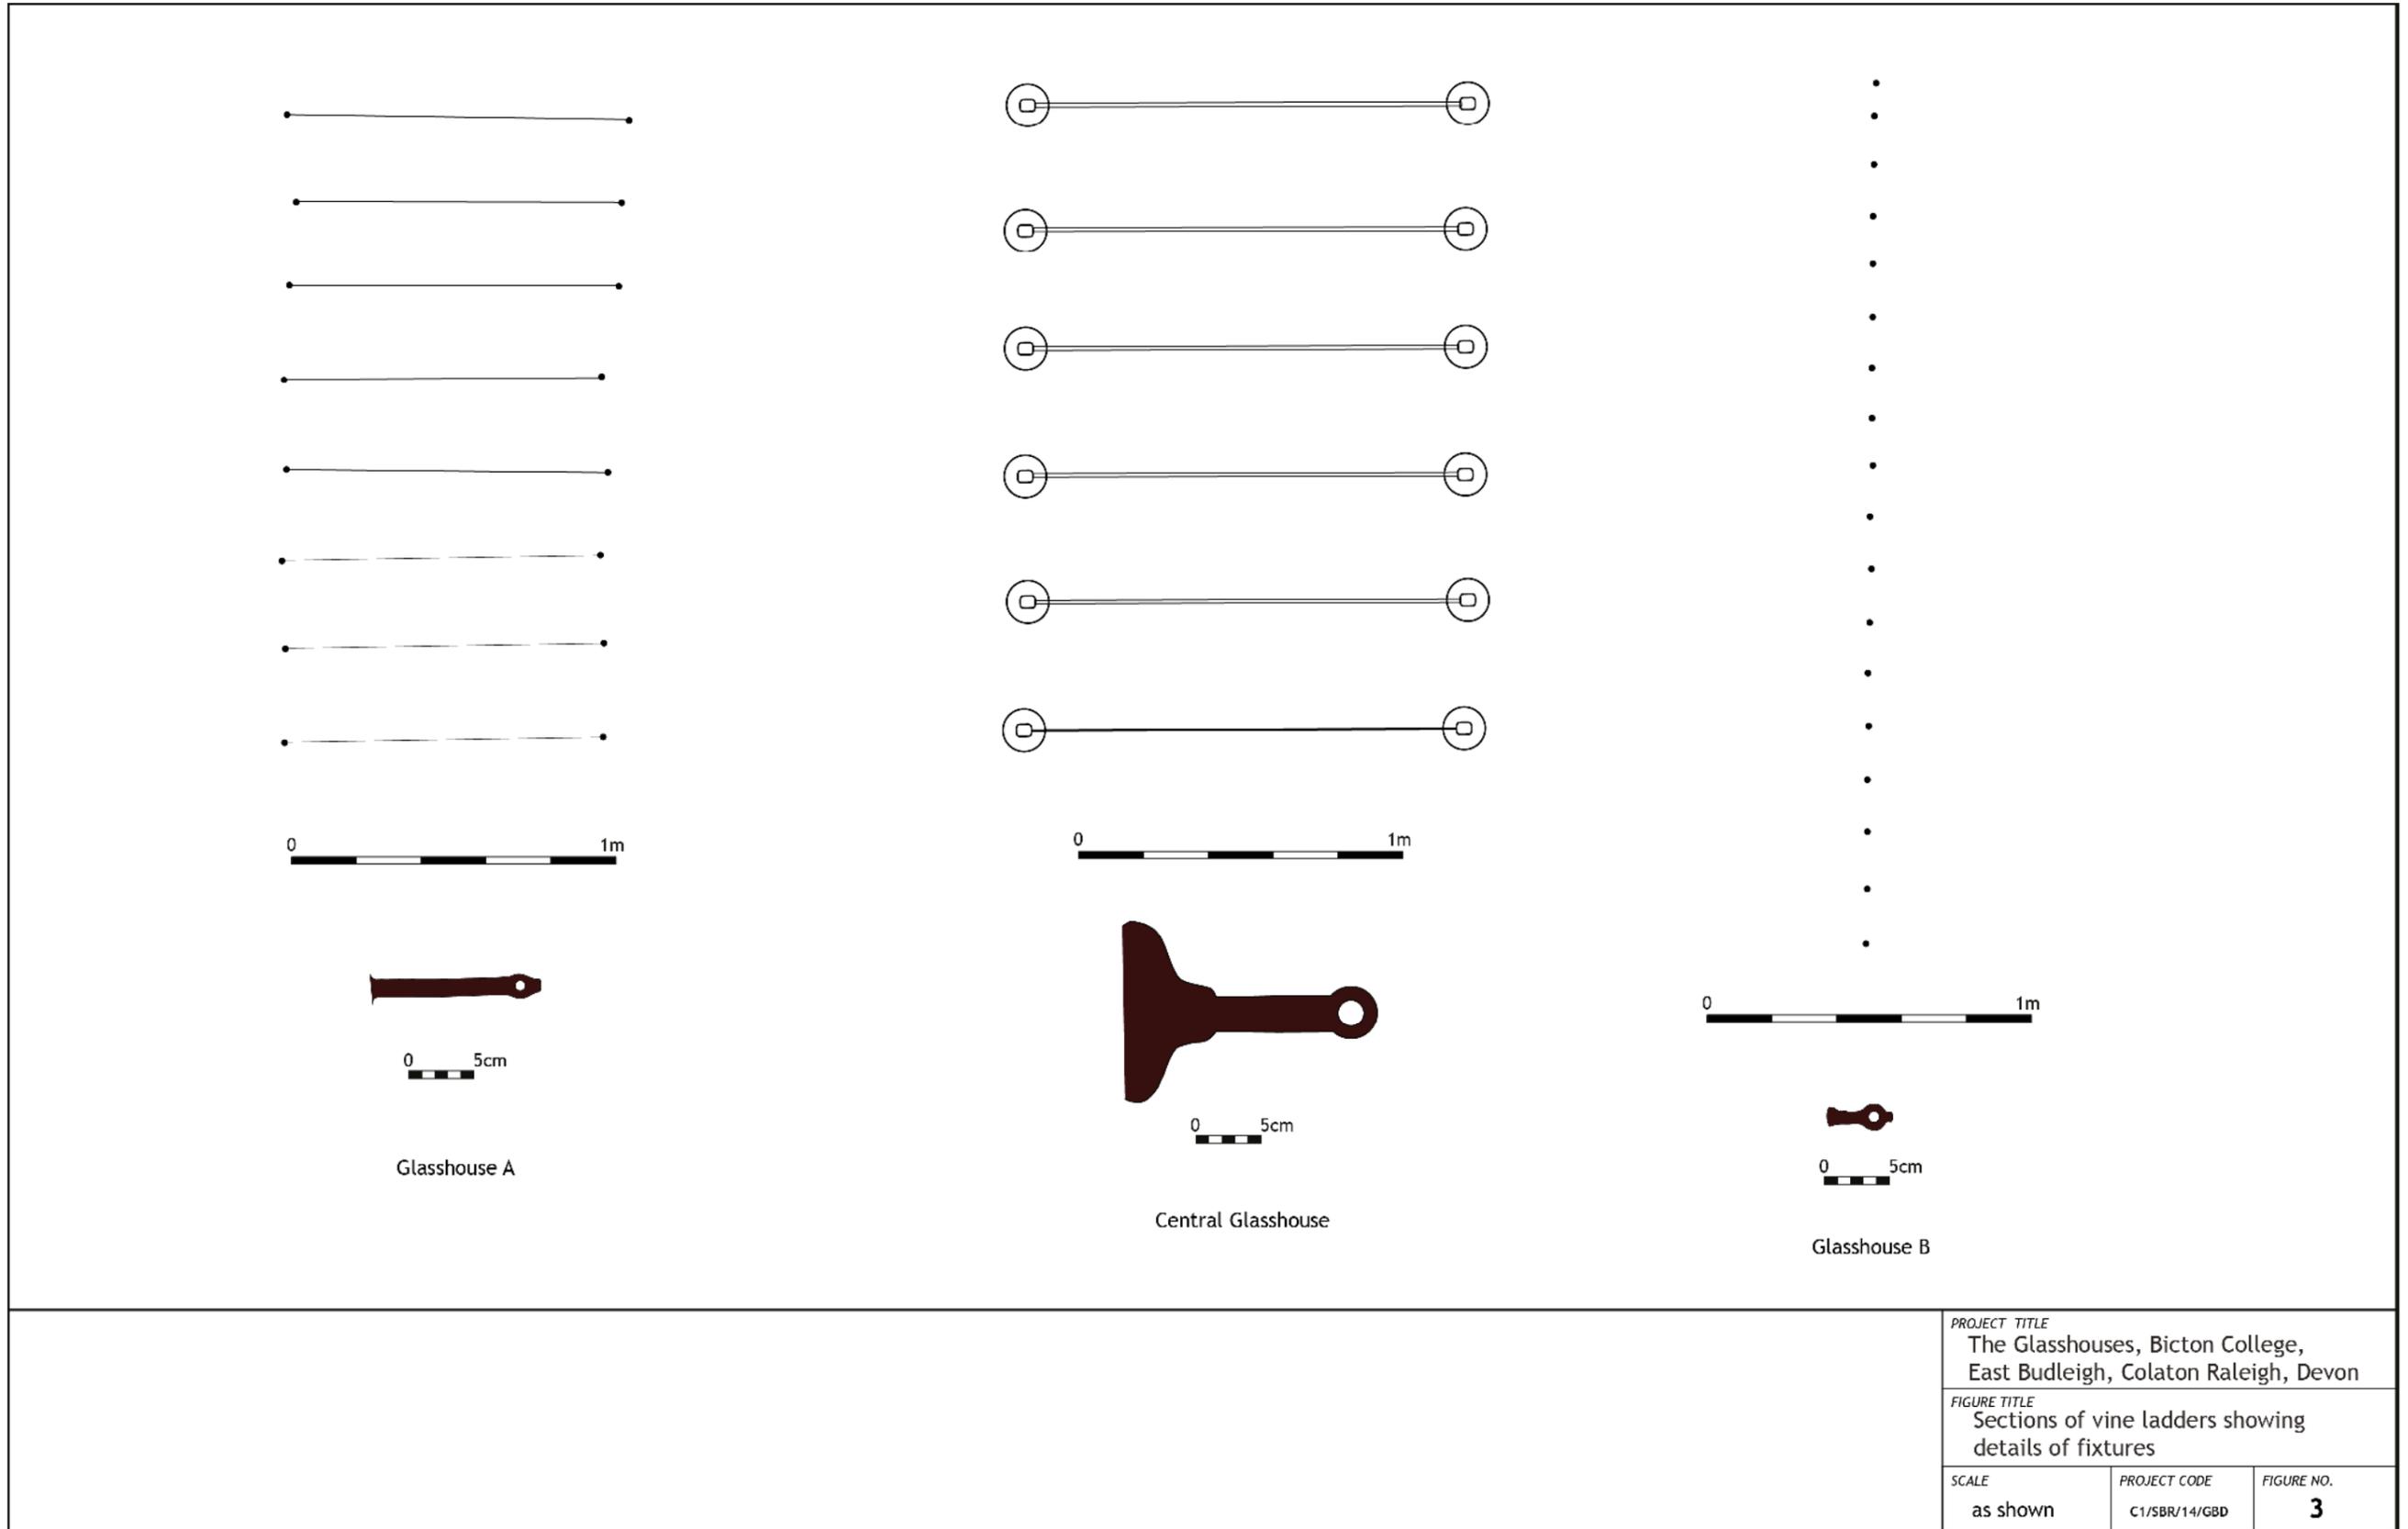
Figure 3. Sections of vine ladders showing details of fixtures

- 5.7 In glasshouse B the fixtures along the back wall comprise 7 vertical lines of small pegs spaced at c. 3.5m intervals (**Plate 19**). There are 8 rows at 0.16m intervals within each vertical line and the pegs have small round holes in the head with a small rectangular projection, and are driven into the mortar joints between the bricks (**Plate 20; Figure 2**). The pegs protrude from the wall by 0.5m (**Figure 3**). No wires are present between the pegs.

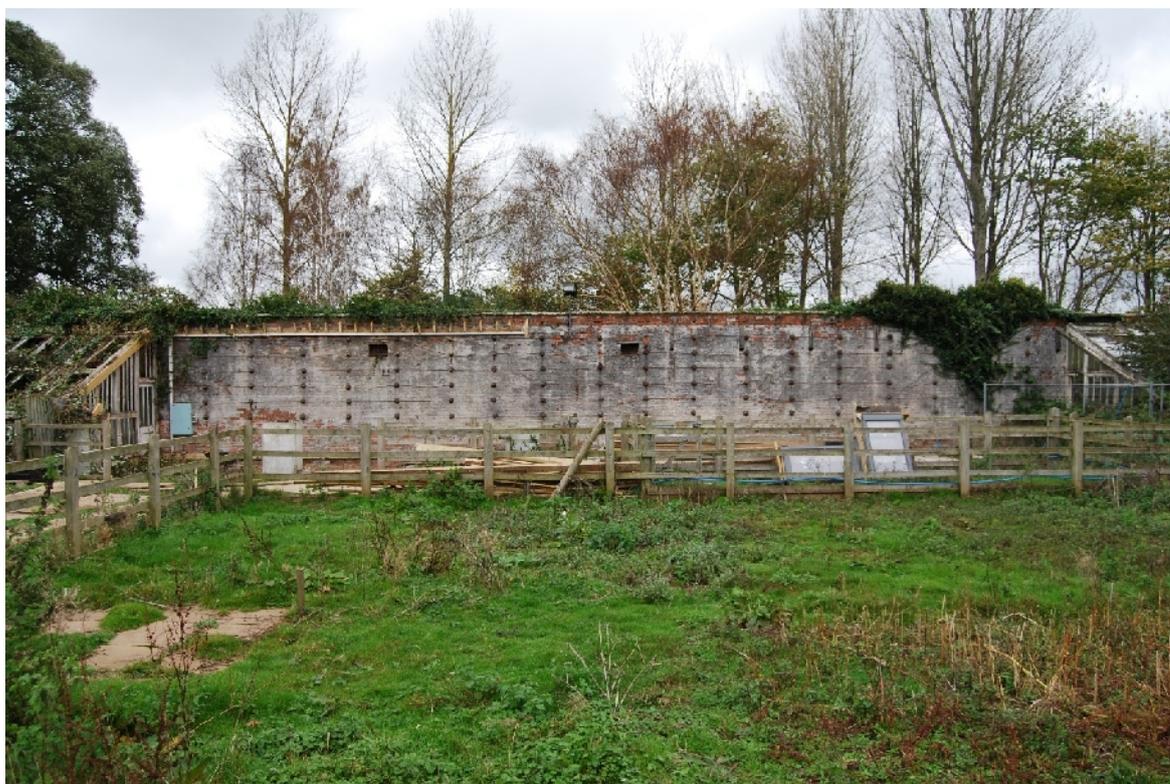
- 5.5 Behind the central missing glasshouse, the vine ladders are the most substantial in terms of the size of the fixings and the dimensions of the wires. There are 18 ladders across a 24.04m length (**Plates 13 & 14; Figure 2**); the ladders vary slightly in width however the section subject to detailed recording measures 1.23m wide (**Plate 15**). The ladders extend to the former position of the west gable wall however they stop just short of the former position of the east gable wall. Each ladder consists of 6 rows of wires positioned c. 0.40m apart, the wires running through cylindrical-headed brackets attached to long 'stakes' driven into the wall and held in place with a bell-shaped disc pressed against the wall (**Plate 16; Figure 3**). Where the plates have come adrift the discs can be seen to have left distinct impressions within the brickwork and the underlying render is clean of render, indicating the fixtures were an original feature. The wires measured c. 0.12m in diameter and the brackets protruded from the wall by 0.17m (**Figure 3**). The lowest wire has been replaced with a much thinner wire in recent times, in some places the original wires have come adrift from their brackets and some of the discs are hanging off or have partly come away from the wall.

Plate 13. Vine ladders along back wall of central glasshouse (looking N)

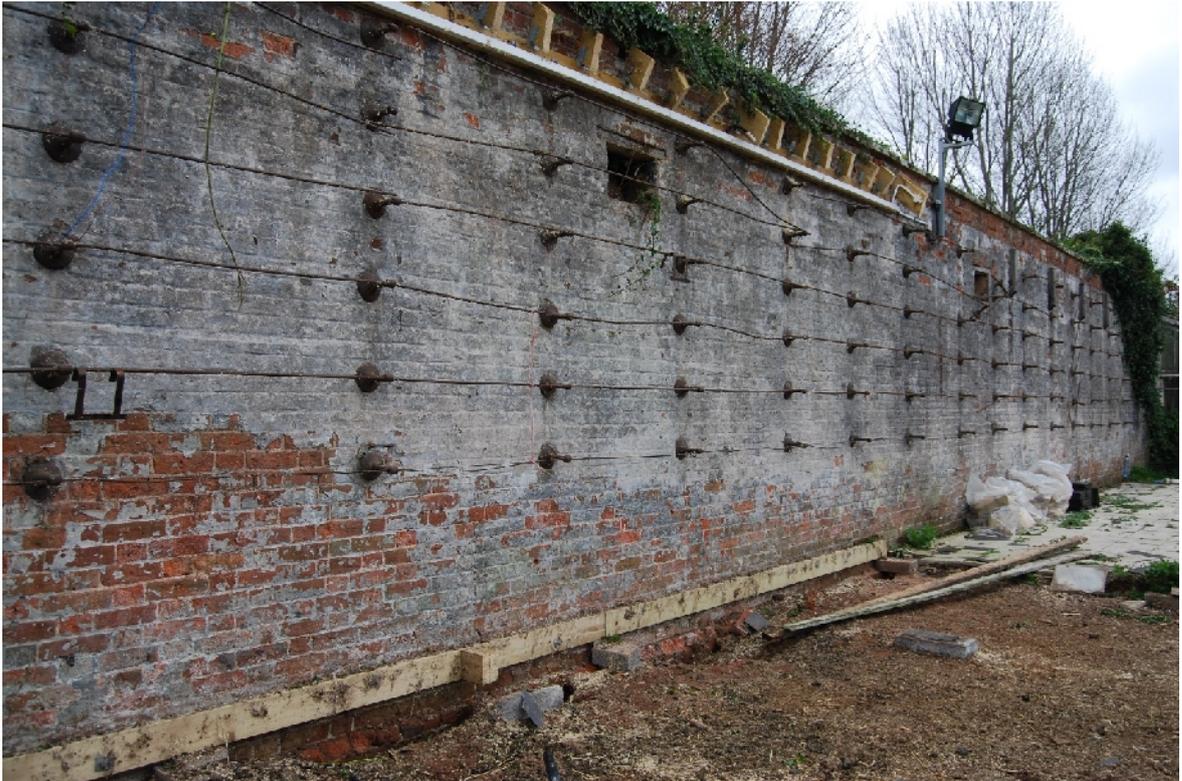
Plate 14. Vine ladders along back wall of central glasshouse (looking NE)

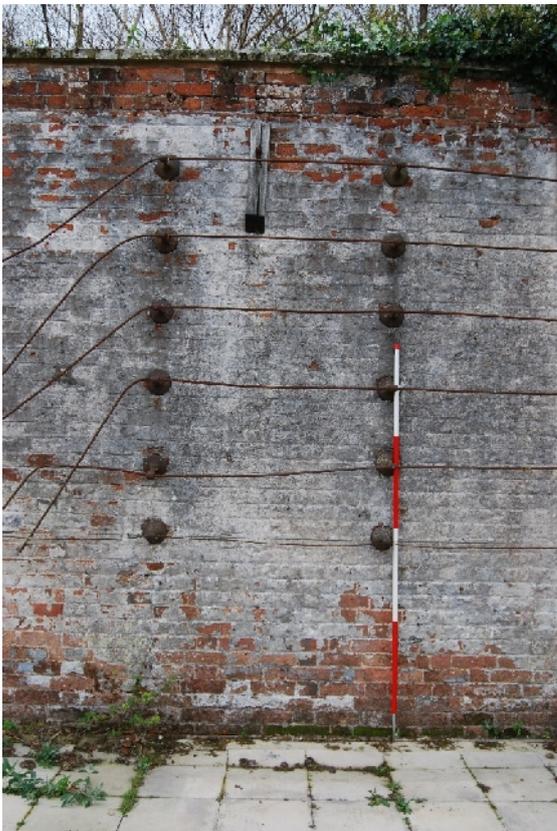
Plate 15. Section of vine ladders along back wall of central glasshouse (2m scales; looking N)

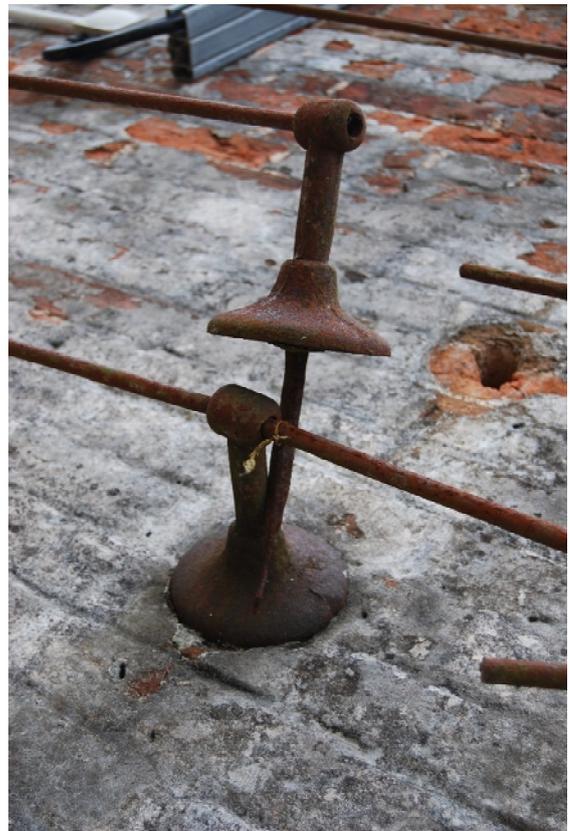
Plate 16. Fixings for vine ladders along back wall of central glasshouse

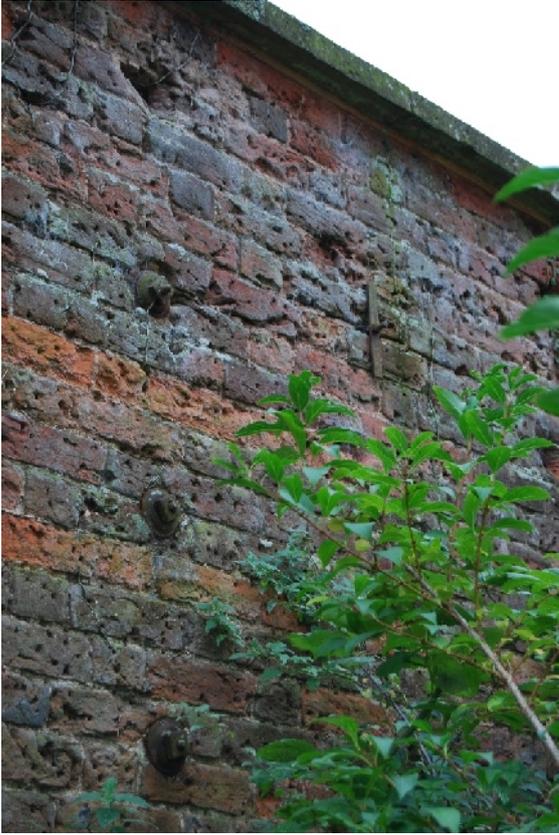
- 5.6 The rear wall of the garden was largely overgrown at the time of the survey however in the position of the central glasshouse vertical rows of circular plates were observed (**Plates 17 & 18**). These correspond with the positions of the vine ladder fixings and demonstrate that the fixings were driven right through the wall, terminating in the round plates along the rear wall of the garden.

Plate 17. Vine ladder fixings in rear wall behind central glasshouse (looking SW)

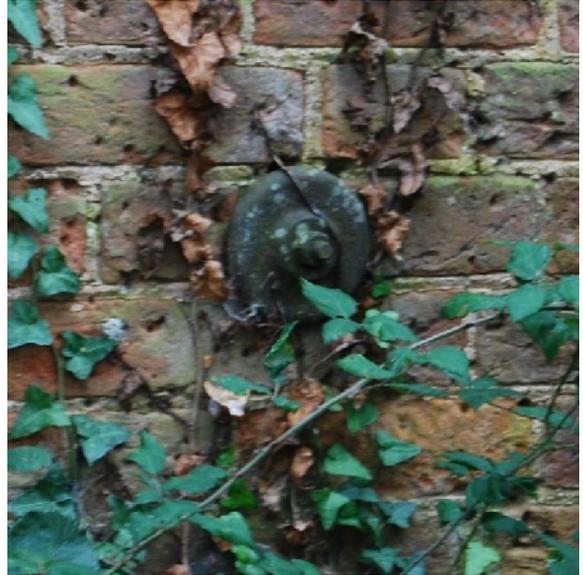
Plate 18. Close-up of vine ladder fixing in rear wall behind central glasshouse (looking SSW)

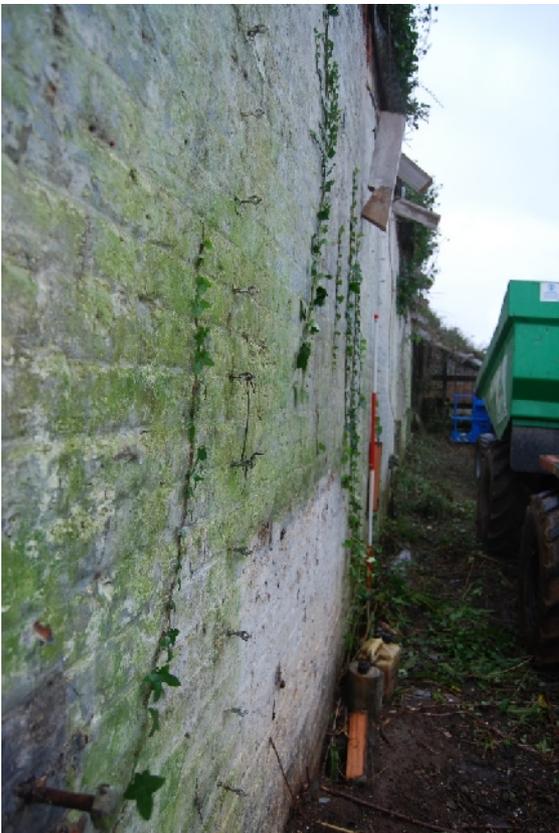
Plate 19. Vertical lines of small pegs along back wall of glasshouse B (2m scales; looking ENE)

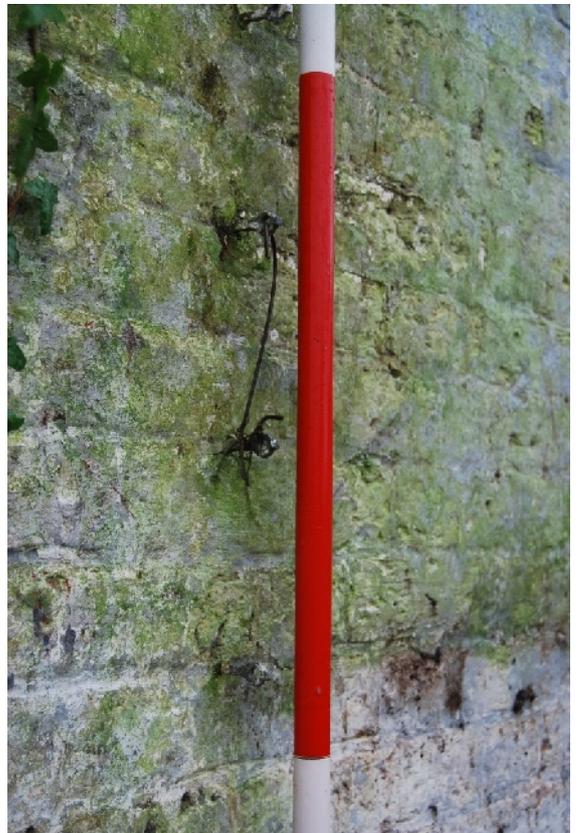
Plate 20. Close-up of vertical line of small pegs along back wall of glasshouse B (0.5m scales; looking NE)

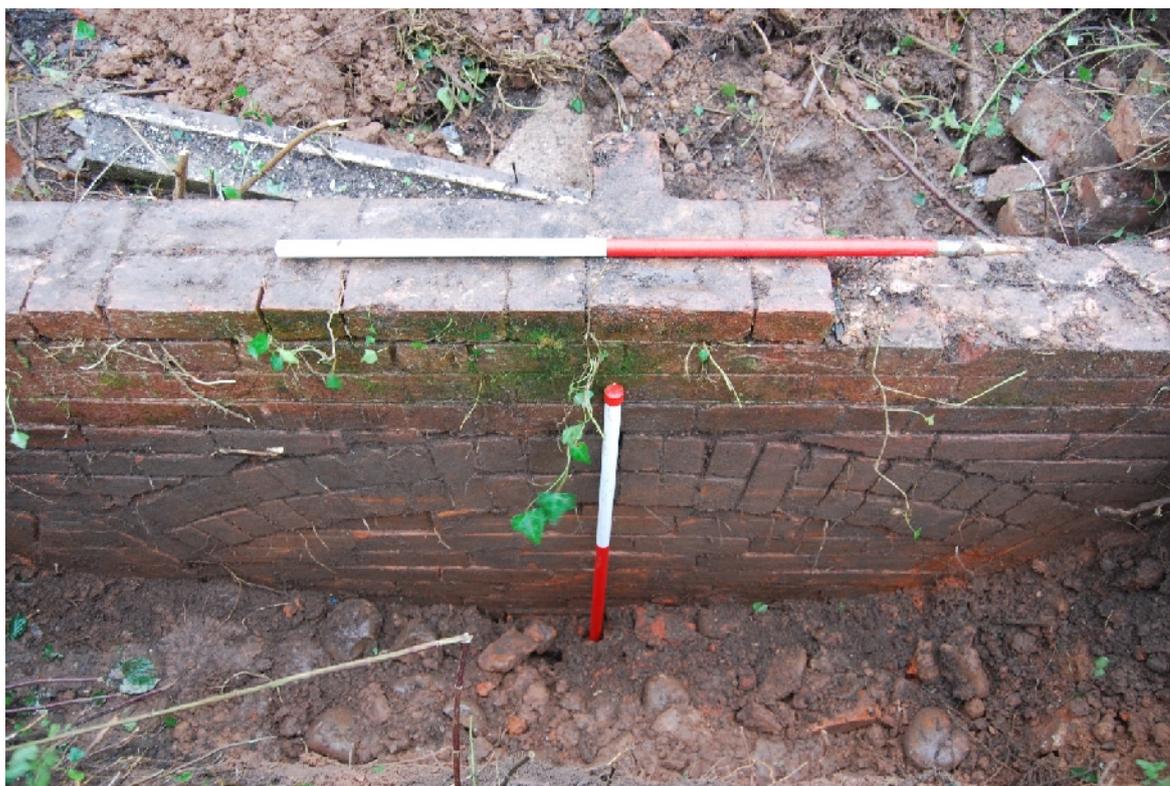
Plate 21. Vine arch in glasshouse A (2 x 1m scales; looking N)

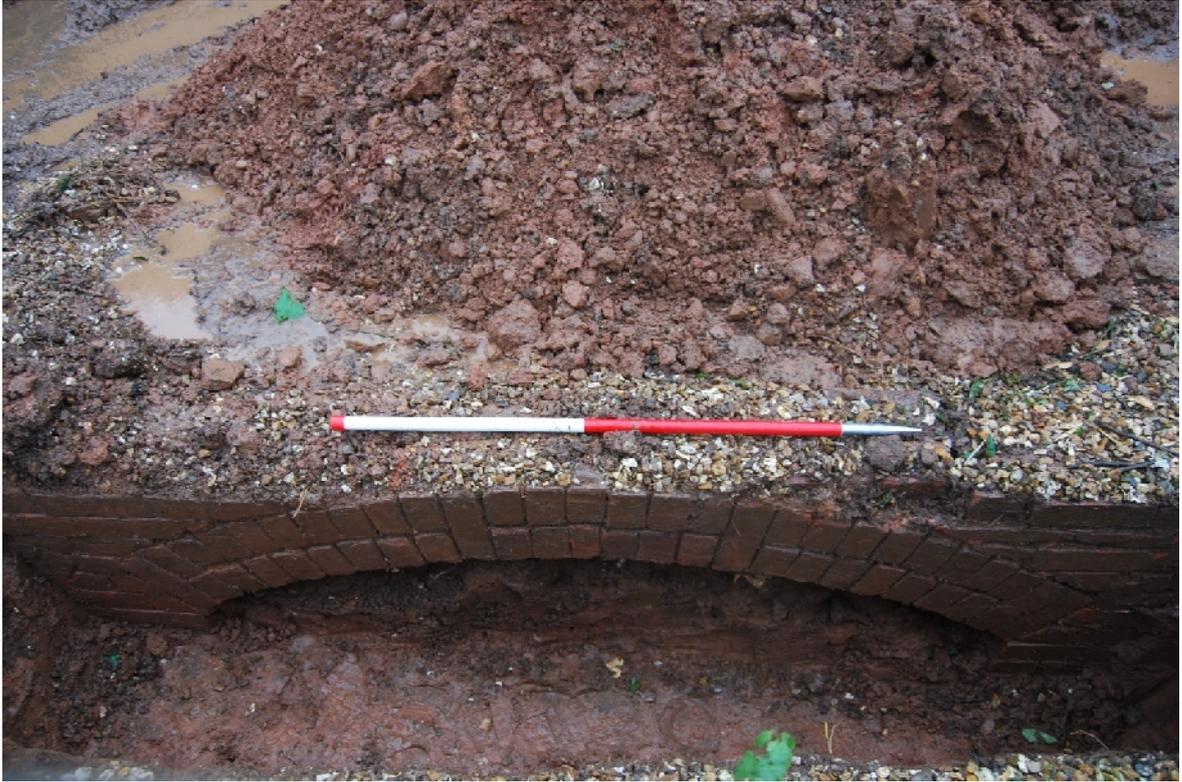
Plate 22. Vine arch in central glasshouse (1 x 1m scales; looking N)

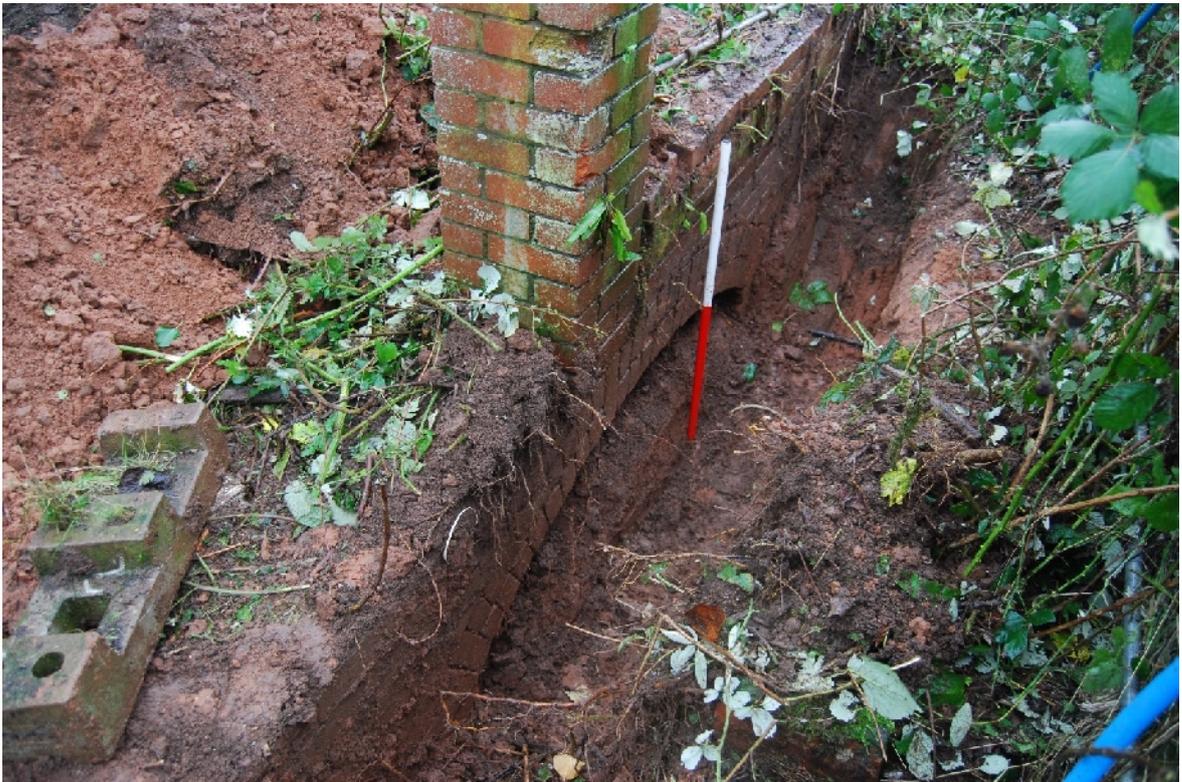
Plate 23. Vine arch in glasshouse B (1 x 1m scales; looking ENE)

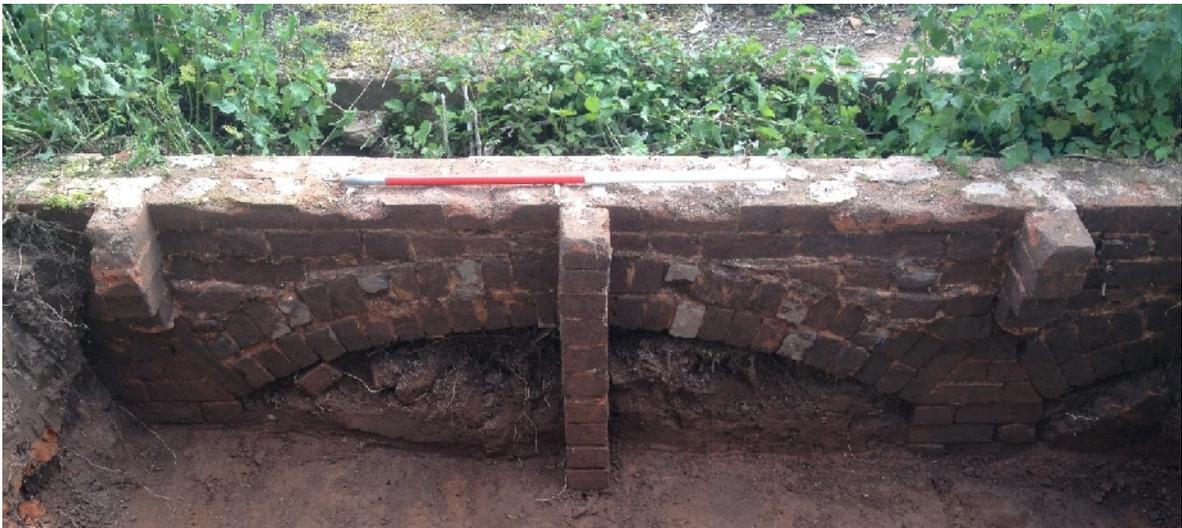
brickwork between the arches (**Figure 4; Plate 24**). These features were one brick wide and rose to the top of the wall. The central piers were constructed of equally sized bricks whereas the corbels comprised four courses with two smaller bricks below and two larger bricks above. The purpose is unclear however they may have provided a support for elements of the glasshouse superstructure. Interestingly, in glasshouse A and the central glasshouse the piers and corbels had all had been broken-off to varying degrees, reflecting the significant alterations to the former (**Plate 25**) and possibly relating to the demolition of the latter (**Plate 26**). The absence of soldier bricks in the exemplar arch of glasshouse B was also noted on the inner side (**Plate 24**). The mortar for the brickwork throughout the vine arches was identical, comprising natural silty sand with some shell inclusions.

Plate 24. Vine arch in glasshouse B (inner side) showing central pier & corbels (1 x 1m scales; looking S)
