The Glasshouses, Bicton College, East Budleigh, Colaton Raleigh, East Devon.

A programme of Historic Building Recording

COAS reference: C1/SBR/14/GBD

December 2014

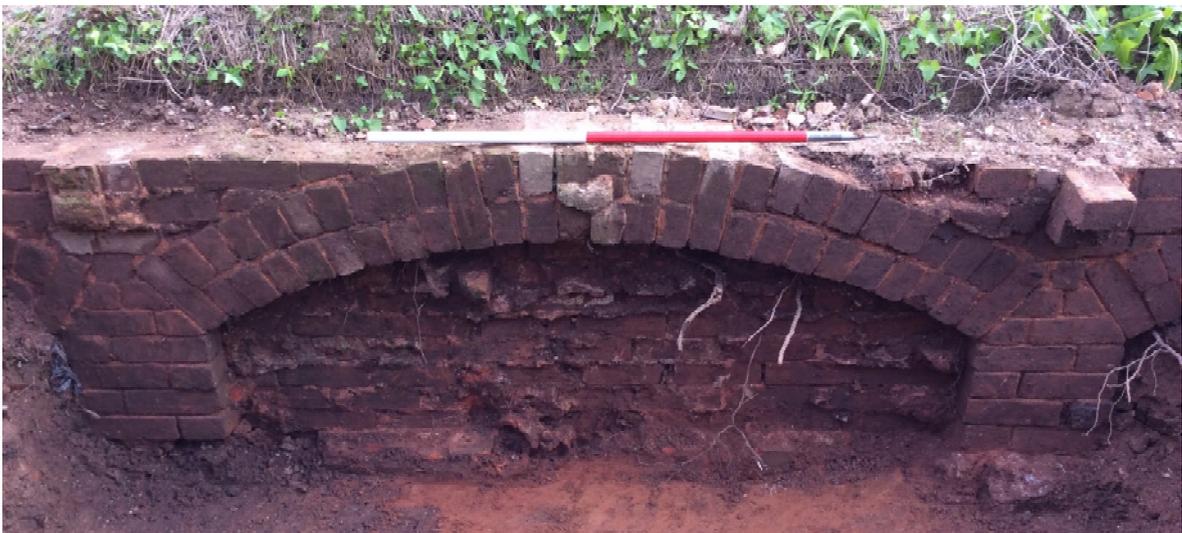
- 5.11 It was confirmed that the vine arches ran continuously along the front of the glasshouses, with the exception of one area of solid walling measuring 2.2m in width towards the eastern end of the central glasshouse (**Plate 27**). This is the same width as the widest measurements of the arches and therefore is simply a section where no arch was built. It was also confirmed that all the arches in glasshouse A had been roughly blocked (**Plate 25**) and that the courses of brick above the vine arches in the central glasshouse had previously been removed (**Plate 26**), no doubt during demolition of the superstructure in the early 20th century. A ceramic pipe ran through the blocking of the exemplar arch in glasshouse A (**Plate 25**).

Plate 25. Vine arch in glasshouse A (inner side) showing broken central pier & corbels (1 x 1m scales; looking S)

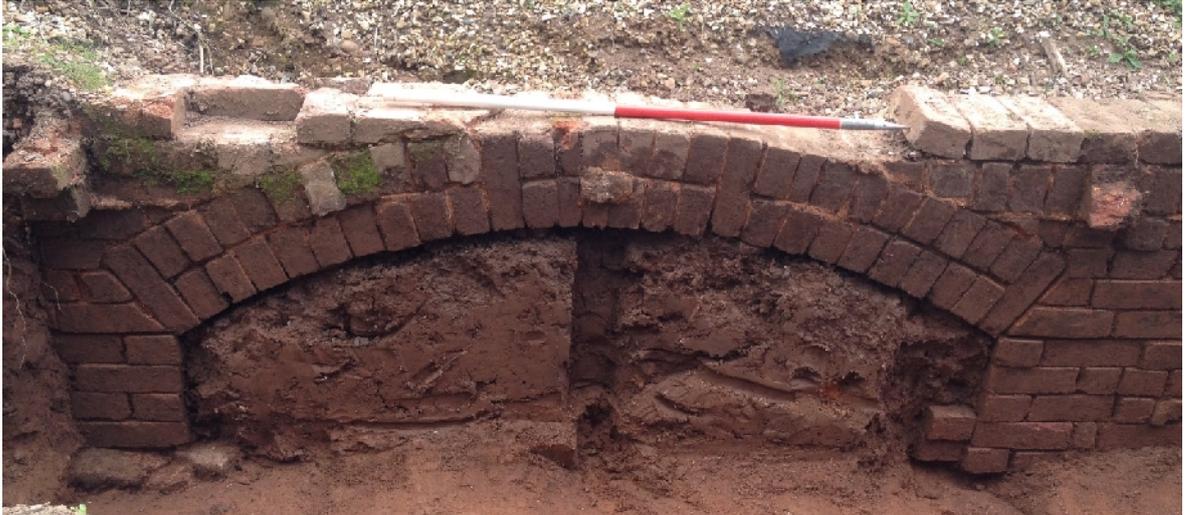
Plate 26. Vine arch in central glasshouse (inner side) showing broken central pier & corbels (1 x 1m scales; looking S)

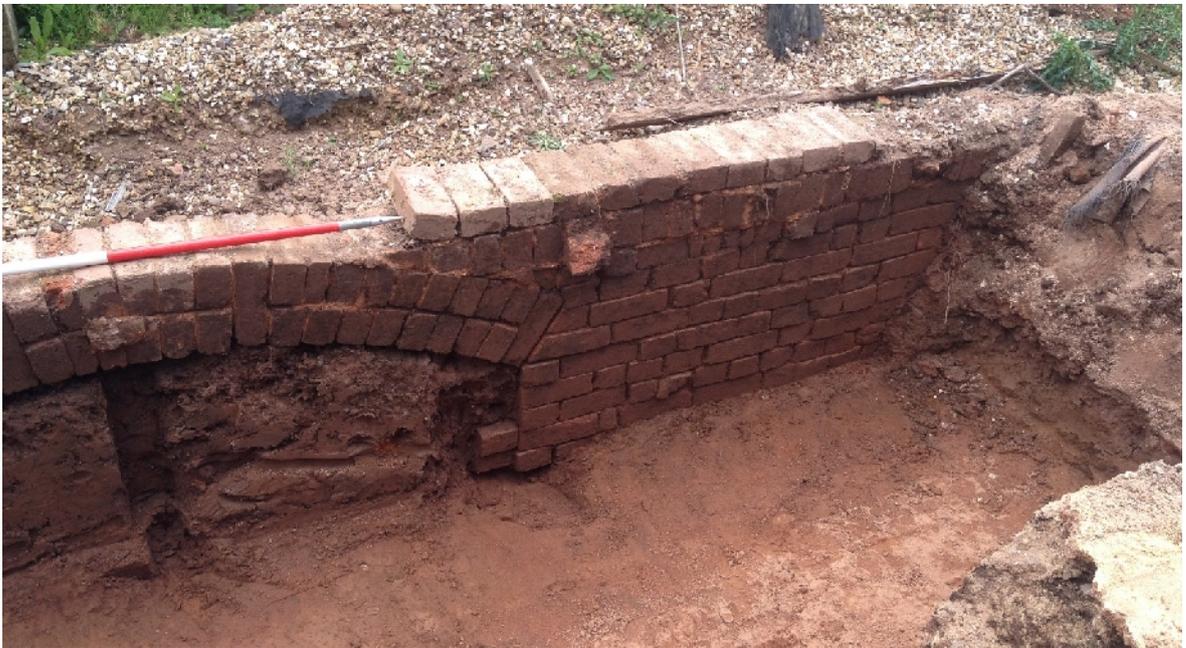
Plate 27. Solid walling between arches in central glasshouse (1 x 1m scales; looking SSW)

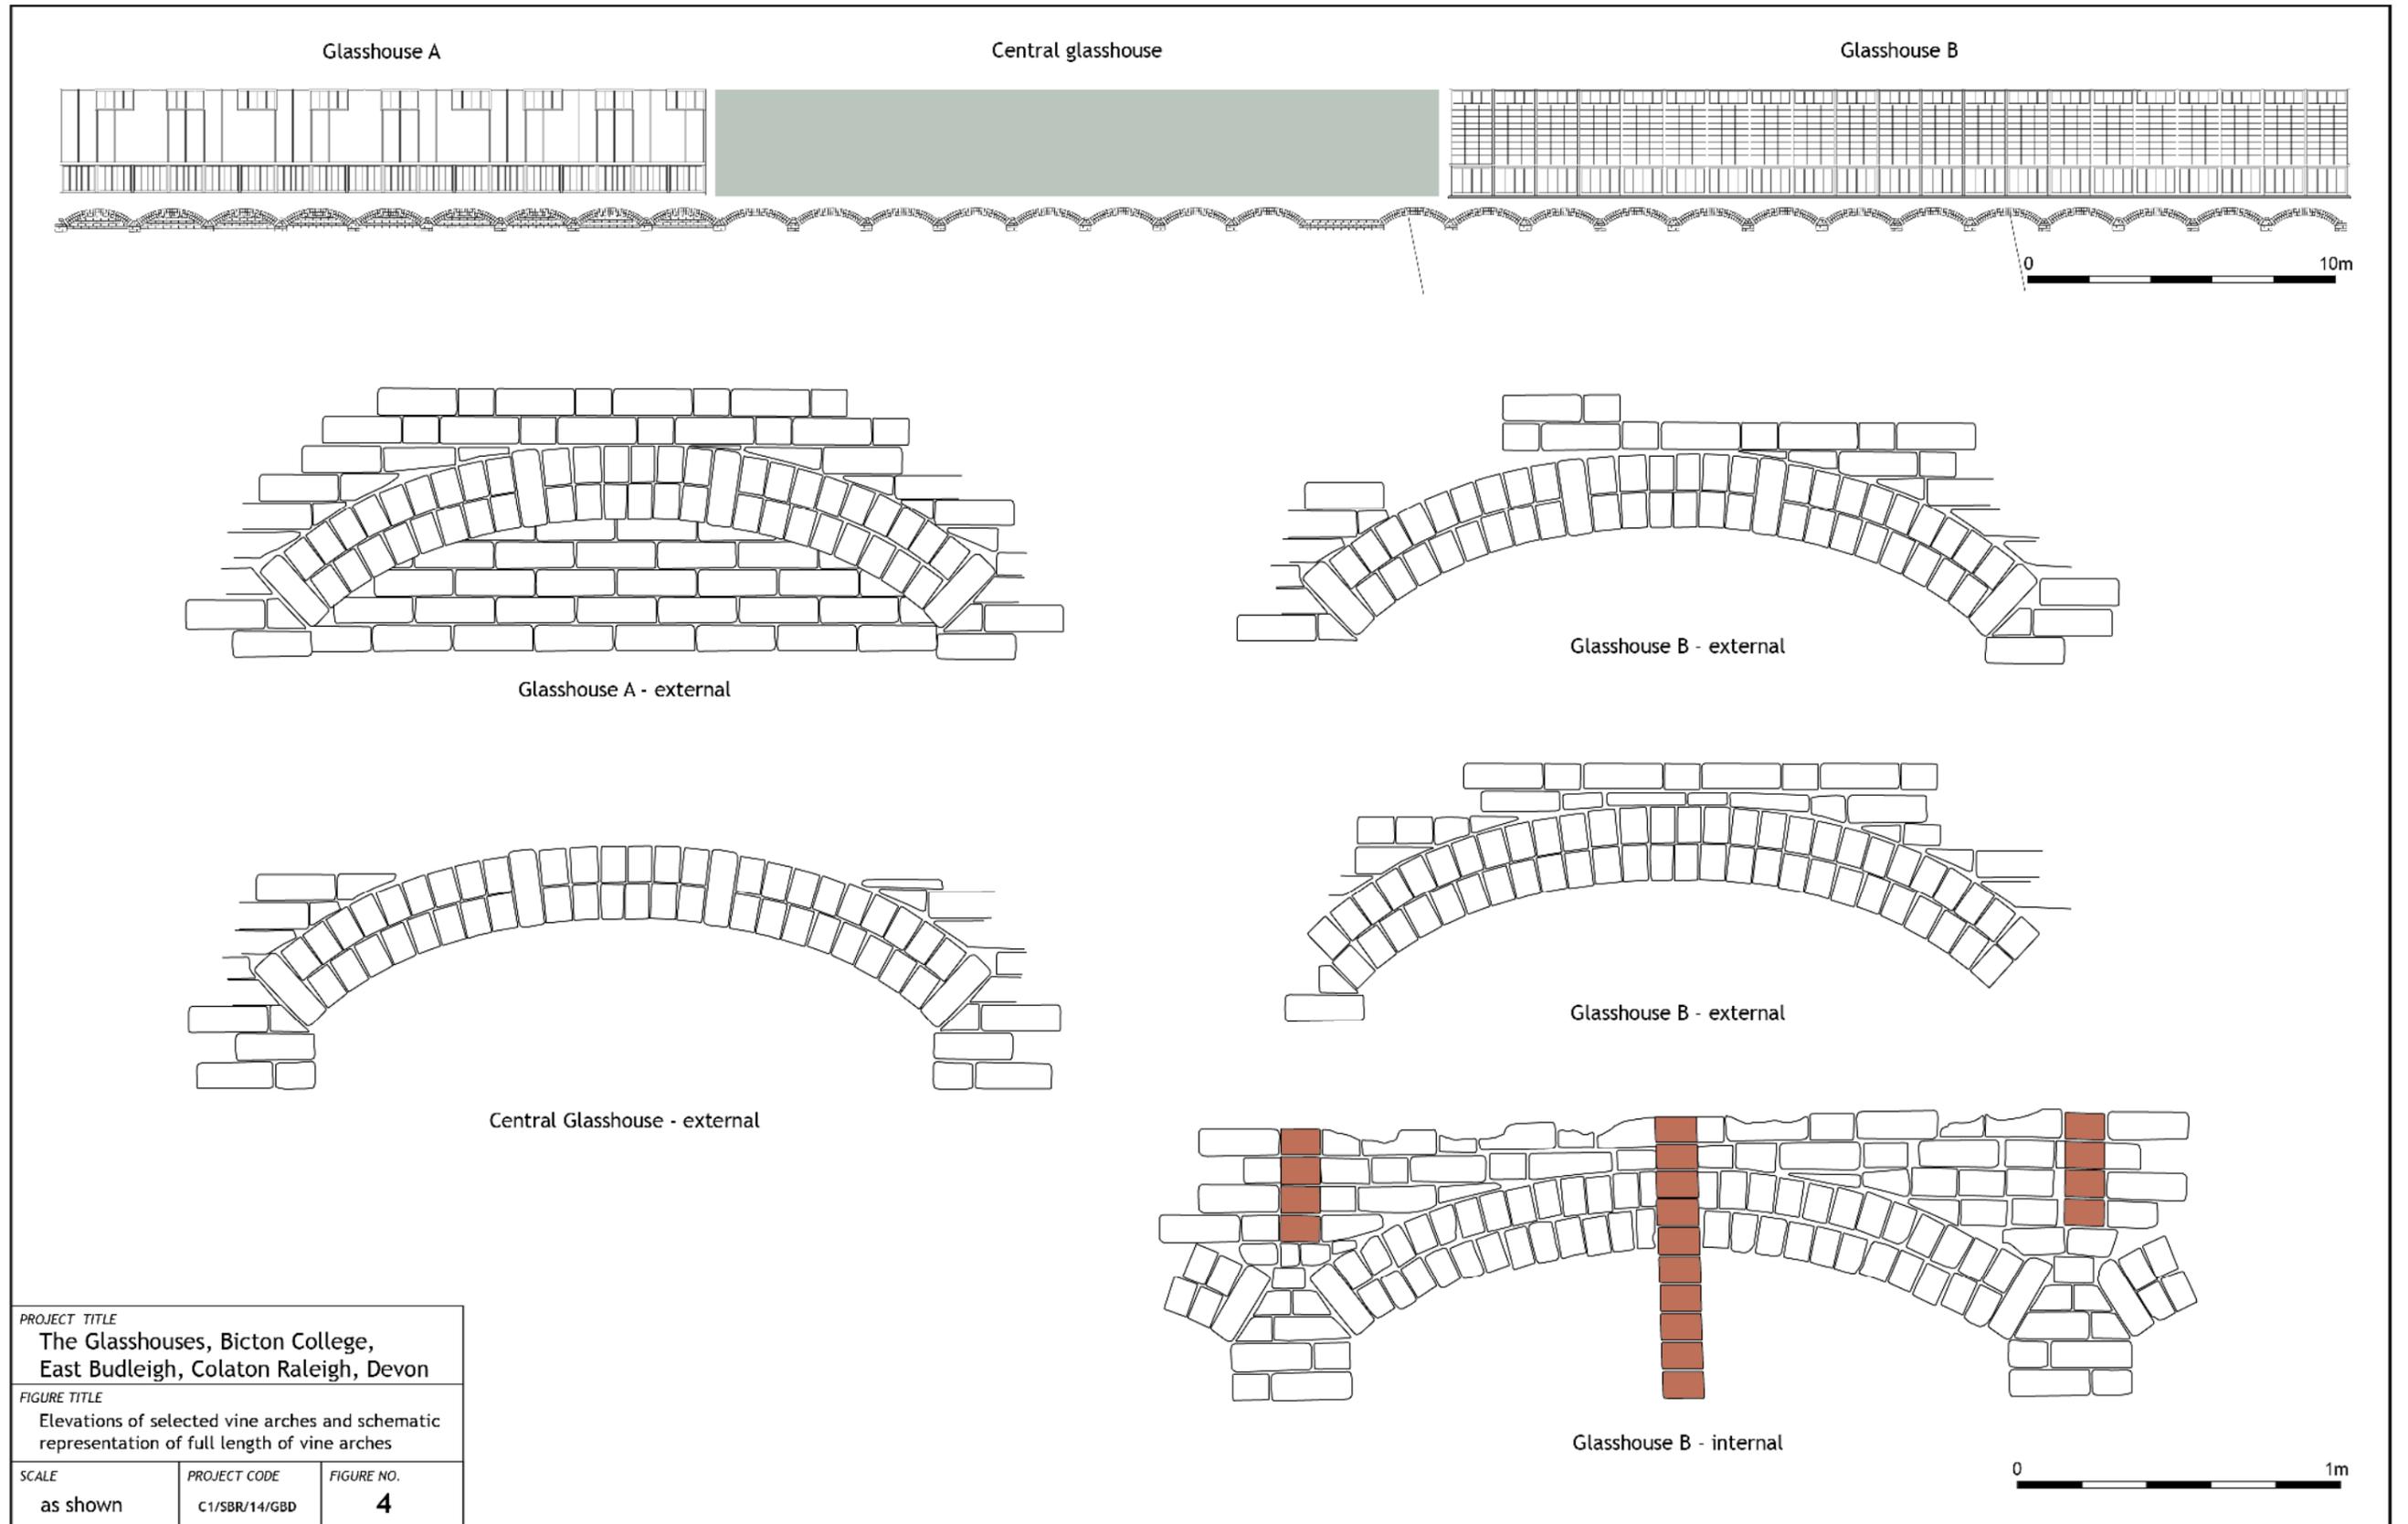
Figure 4. Elevations of selected vine arches and schematic representation of full length of vine arches

- 5.10 Test-pits positioned on the inside of the dwarf front wall revealed the full depth of the vine arches to be 0.7m, inclusive of the depth of the brickwork between each arch (**Figure 4**). Previous visits had recorded the external side of the wall and the inner side was found to differ slightly. In glasshouse B there was a pier in the centre of the arch with a corbel springing from above the

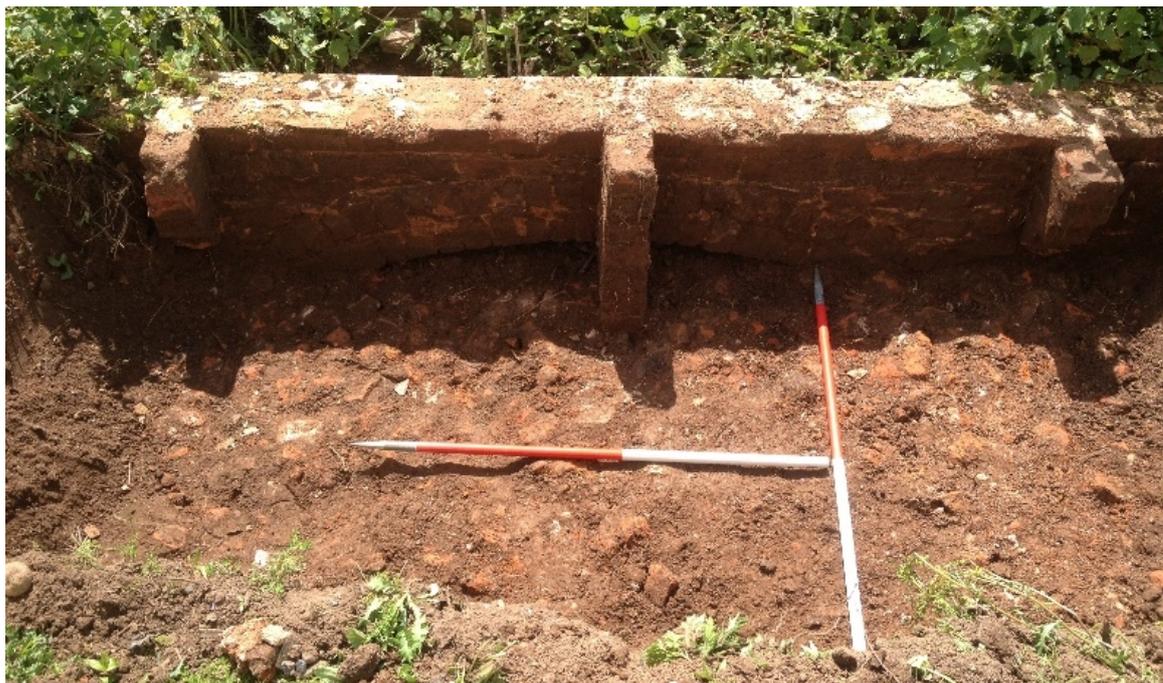
Plate 28. Layer of rubble encountered during excavation of glasshouse B test-pit (2 x 1m scales; looking S)
