The Cobb, Lyme Regis, Dorset.

A Programme of Archaeological Monitoring and Recording

West Dorset District Council

Version 2 - March 2015

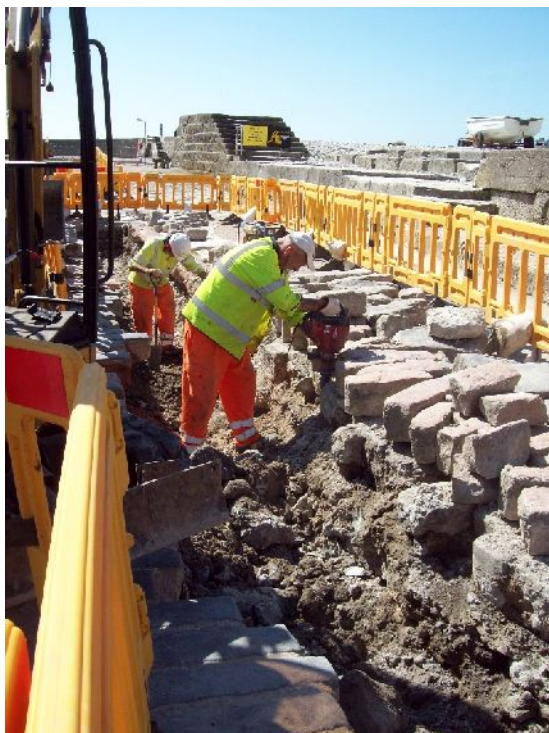
Plate 1. Open cut trenching in central area of main duct trench (from NNE)

- 3.3 The main open-cut trench for the duct works measured 70.20m long (including ramps), 0.80m wide (extending to 1.00m to make allowance for larger cobbles) and up to 0.80m deep (**Appendix 1, Sheet 1; Plate 1**). Excavations began in the central area before moving south towards the damaged cables and north to the RNLI shop. At the southern end a 4.00m length ramp was excavated to allow the connection of undamaged cables and new cables. A further ramp measuring 2.5m long was excavated at the northern end adjacent to the RNLI shop. In Area 4, the duct works measured c. 23.00m long (**Appendix 1, Sheet 4; Plate 2**).

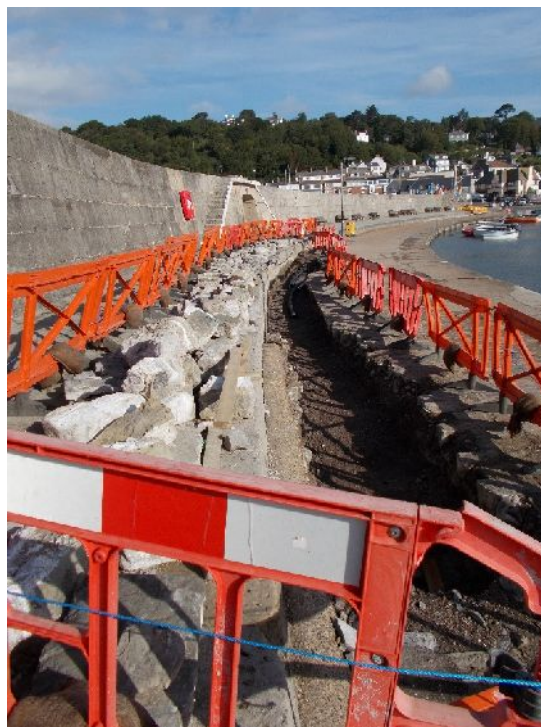
Plate 2. Duct trench in Area 4 (from SSW)

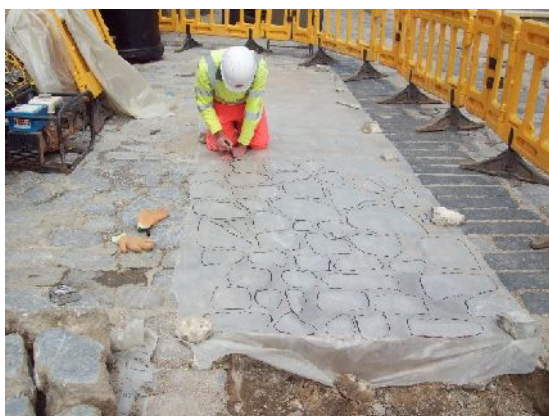
Plate 3. Tracing & numbering of cobbles (from S)

- 3.4 Prior to excavation, the lias blocks were traced onto clear plastic and marked with reference numbers and letters (**Plate 3**). They were subsequently lifted by hand and placed alongside the trench on the corresponding area of the plastic sheet (**Plate 4**). Approximately 20% of the Blue Lias cobbles disintegrated and could not be re-used. The concrete lump supposed to be a World War Two anti-tank defence barrier was recorded and removed. Following installation of a series of service ducts beneath the concrete lump it was re-instated.

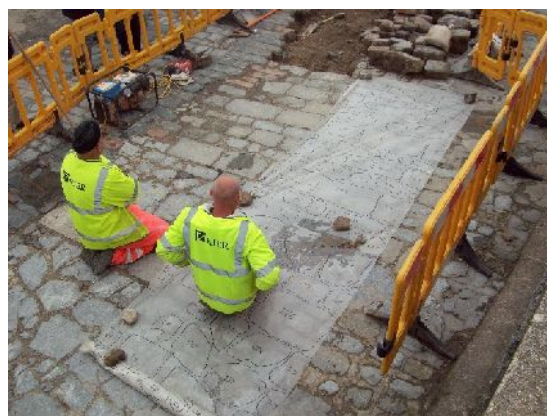
Plate 4. Removal of cobbles to tracing on side of trench (from N)

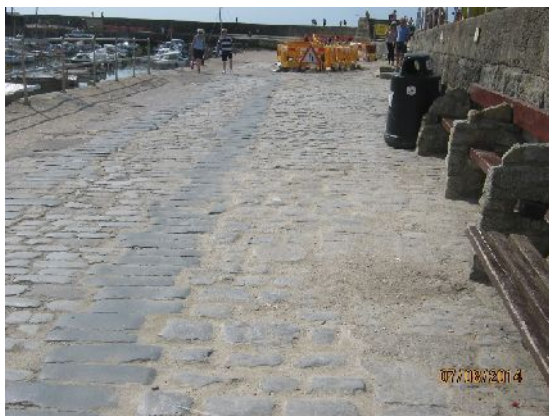
Plate 5. Re-instatement after duct trench works (from the N; photo by David Wilson)

- 3.5 The trench was excavated by a machine equipped with a 0.20m wide toothless grading bucket and the excavated material transferred to the compound area. Following construction of the 4-way duct block and concrete surround, the trench was backfilled to the level of the underside of the cobbles using the previously excavated material. The cobbles were re-instated from the plastic sheets in their original locations and disintegrated Blue Lias cobbles were replaced with newly sourced Blue Lias and suitable stones retrieved from the trench (**Plate 5**). In the areas of concrete a neat edge was cut and the removed concrete discarded. Re-instated concrete in these areas was given an exposed aggregate finish by application of a retarder to the surface of the newly placed concrete and then the surface laitance removed by water jet the following day, exposing the coarse aggregate (**Plate 6**).

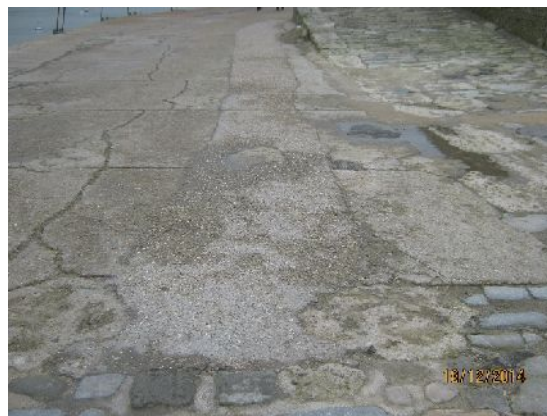
Plate 6. Duct trench concrete reinstatement (from the N; photo by David Wilson)

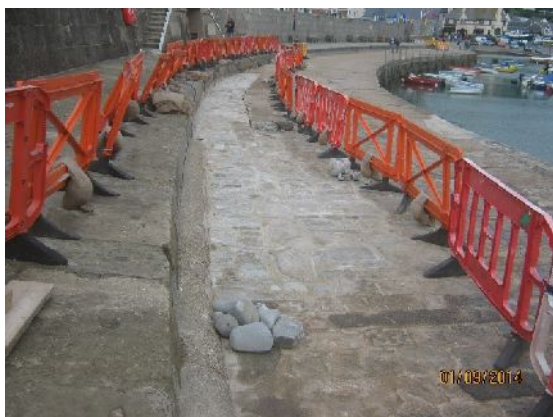
Plate 7. Re-instatement in Area 4 after duct trench works (from the SSE; photo by David Wilson)

- 3.6 In Area 4, the concrete cable covering had been displaced as a result of storm damage and therefore required re-enforcement and replacement (**Plate 7**). This was broken out and the blocks (mostly Lias) were lifted in the same way as for the main duct trench. Following excavation of the trench a 4-way duct block was inserted with concrete surround and the Lias blocks re-laid, with additional stone sourced from Monmouth beach (**Plate 8**).

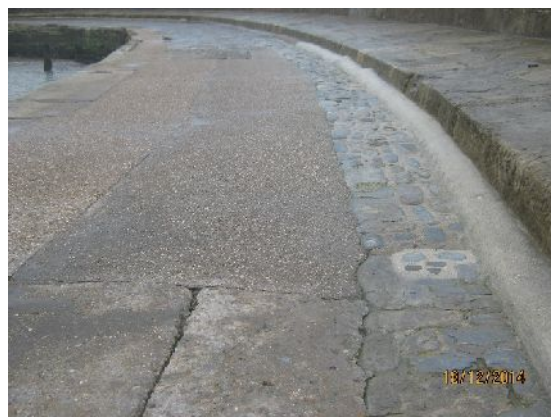
Plate 8. Re-instatement in Area 4 after duct trench works (from the NNW; photo by David Wilson)

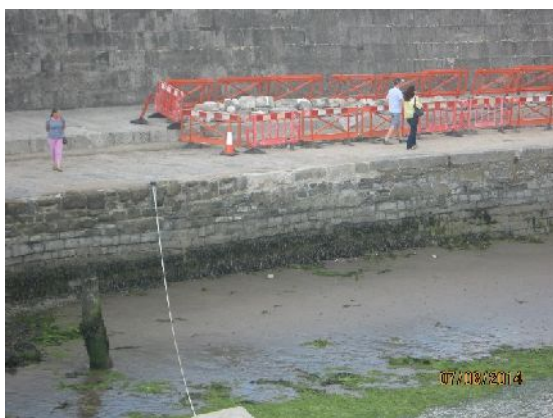
Plate 9. Coping stones replaced in Area 5 (from the SSE; photo by David Wilson)

- 3.7 As a result of storm damage, many parts of the inner sea wall and cobbled surfaces were damaged requiring reconstruction and repair. Cracked and broken concrete and tarmac patching was broken out using a mini digger and re-instated with original material, stone from Monmouth beach and concrete (see above for treatment of concrete). Missing coping stones opposite the lifeboat station were replaced with Lias recovered from Monmouth beach (**Appendix 1, Sheet 1**). In Area 5, a 4m section of the inner harbour wall coping stones were replaced using the original stones (which had fallen into the harbour) and one replacement stone (**Appendix 1, Sheet 4; Plate 9**). Surface repairs were undertaken along much of the Cobb. Along the Causeway this comprised surface re-pointing to the east of the main duct trench (**Appendix 1, Sheet 2**); insertion of concrete slabs in Areas 2 (**Appendix 1, Sheet 3; Plate 10**) and 5 (**Appendix 1, Sheet 4**); re-pointing to random paving and replacement of broken concrete with lias blocks (to match adjacent surface) in Area 5 (**Appendix 1, Sheet 4**). In Areas 8 and 9 a stretch of rounded cobbles were lifted and re-bedded as a test (**Plate 11**) while the adjacent stretch and Area 10 underwent surface re-pointing where the old mortar had been washed out (**Plate 12**), with some replacement stones where necessary in the latter including a trial area using 'prompt' mortar (**Appendix 1, Sheet 5**). Finally, two slabs were replaced in the surface of the southern arm (Area 11) using Portland Roach (**Appendix 1, Sheet 6; Plate 13**).

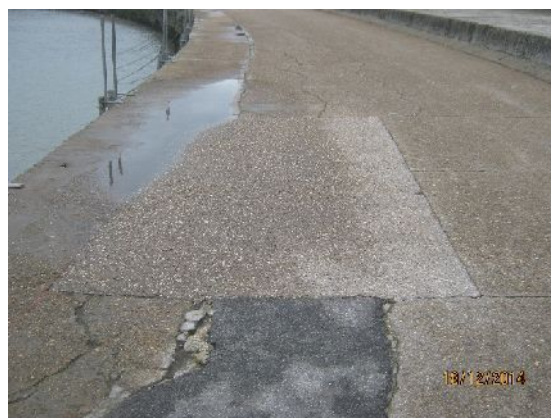
Plate 10. Concrete repair in Area 2 (from the NNW; photo by David Wilson)

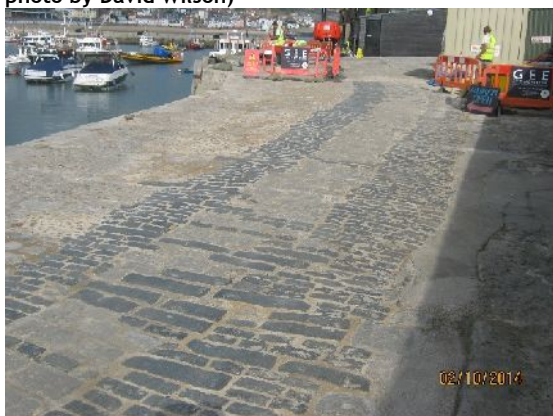
Plate 11. Repointing of Areas 8 & 9 (from the SW; photo by David Wilson)

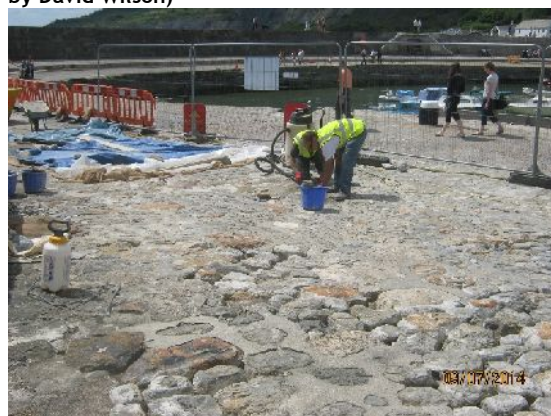
Plate 12. Re-pointing in Area 10 (from the ESE; photo by David Wilson)

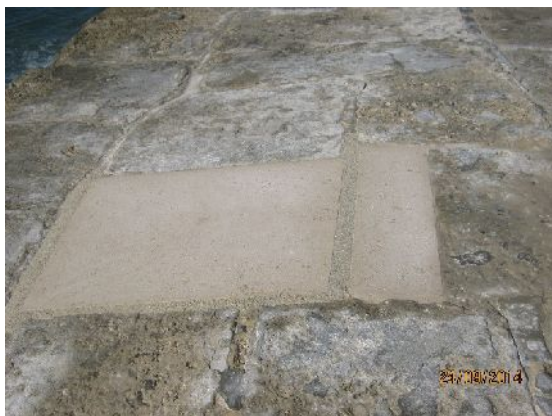
Plate 13. Replacement Portland Roach stone in Area 11 (from the N; photo by David Wilson)

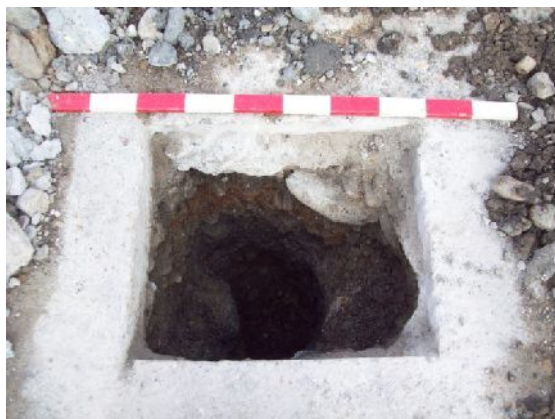
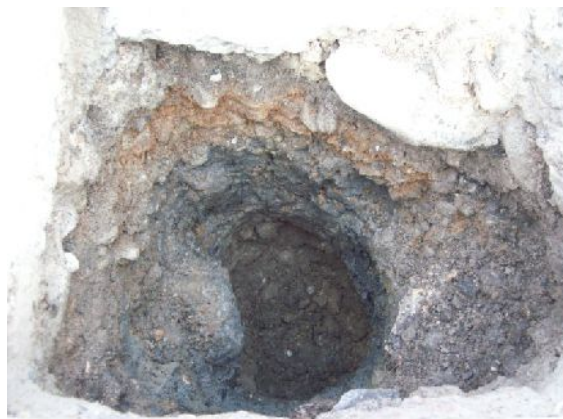
- 4.1 Trial Hole 1 was excavated to a maximum depth of 0.90m. The concrete surface, (101) up to 0.22m thick, was removed exposing a 0.18m thick deposit of mid-dark yellowish brown coarse sand and silt (102) with frequent gravel and rare, large (<0.30m in diameter) flint boulders and rounded large (<0.10m in diameter) beach cobbles. This overlay a deposit of very dark brown, coarse sand silt clay (103) 0.30m in depth with frequent pebbles and sparse rounded beach cobbles (<0.10m in diameter). This rested on a 0.20m+ layer of very dark grey brown silty clay with frequent beach pebbles (104). Excavation ceased at this point. The section against one of the former concrete anti-tank defence posts showed this to be <0.25m deep (Figure 2).

Plate 14. Trial Hole 1 excavated (1m scale)

Plate 15. Trial Hole 1 excavated, plan view (no scale)

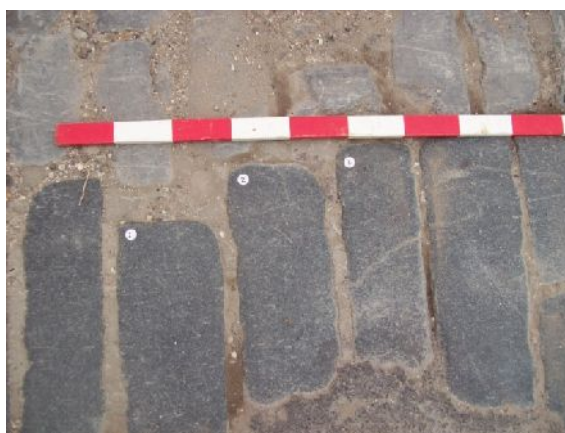
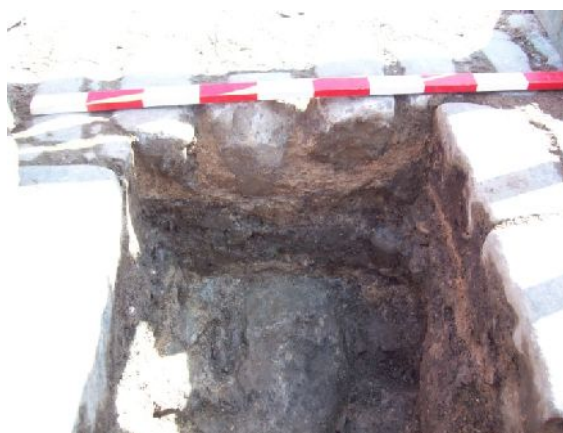
- 4.2 Trial Hole 2 was excavated to a maximum depth of 0.45m. The granite cobbles (201), up to a depth of 0.22m were set in a matrix of mid-yellowish brown mortar with coarse sand. This overlay a very dark greyish brown, sandy silt clay with moderate gravel, 0.18m thick (202), over a 0.05m lens of yellowish brown, sandy silts, possibly incorporating some lime mortar (203). The removal of this deposit exposed large Lias boulders (204) (>0.40m in diameter) which showed no sign of wear. Excavation ceased at this point.

Plate 16. Trial Hole 2 - numbering of cobbles (1m scale)

Plate 17. Trial Hole 2 excavated (1m scale)

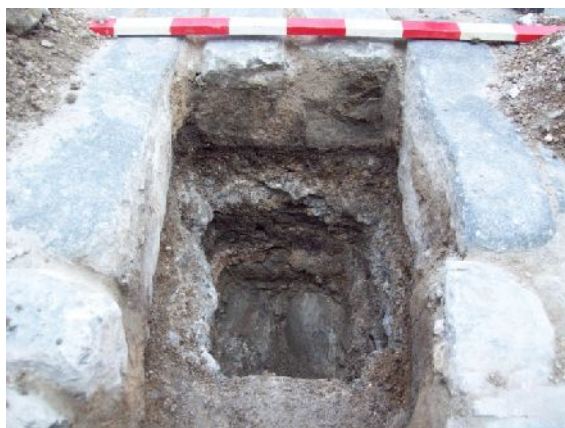
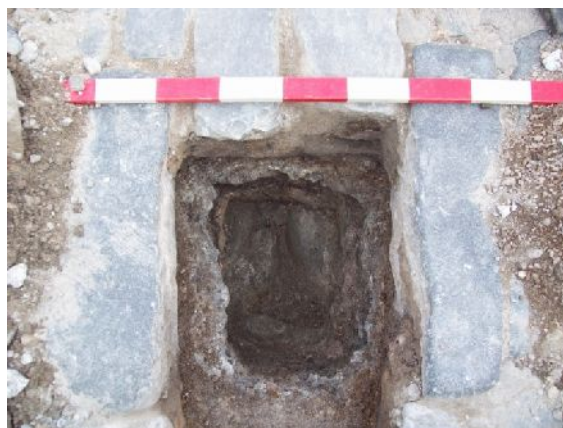
- 4.3 Trial Hole 3 was excavated to a maximum depth of 0.60m. The granite cobbles (301), extending to a depth of 0.20m and set in mortar and sand matrix similar to Trial Hole 2, were removed to expose a layer of very dark yellowish brown coarse sand and beach pebbles (<0.05m in diameter) (302), 0.06m thick. This overlay a deposit of concrete (303), 0.10m thick, above a deposit of very dark greyish brown silty coarse sand (304), 0.12m deep, with beach gravel and grit (<0.05m in diameter). This rested on a 0.04m thick deposit of light yellowish brown sand and grits (305) over a 0.08m lens of greyish brown silty sand (306). The removal of this deposit exposed irregularly laid Lias blocks (307) bonded with a yellowish brown sandy mortar. Excavation ceased at this point.

Plate 18. Trial Hole 3 excavated (1m scale)

Plate 19. Trial Hole 3 excavated, plan view (1m scale)

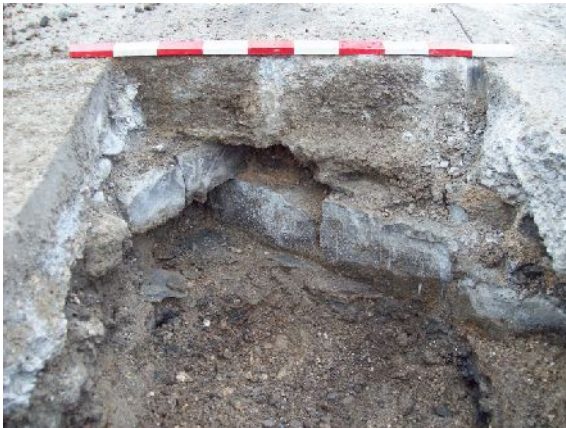
- 4.4 The following description starts from the southern end of the c. 70.20m open cut main duct trench. The deposit sequence in the first 17m comprised a surface material of pebble and reddish brown concrete (possibly early 20th century) measuring c. 0.15m deep. Cobbles constituted most of the surface materials along the remainder of the duct trench route, with the exception of a strip of concrete and patches of tarmac repairs. The cobbles comprised rectangular granite blocks, Blue Lias and Cow Stone blocks of varying sizes with rare brown and red granite, bonded with mortar.
- 4.5 At 7.50m a culvert measuring 0.30m deep and 0.30m wide crossed the trench from east-north-east to west-south-west comprising mortared rectangular Lias blocks for the sides and top with a slate base (Plate 20; Figure 2). A beach drain joined the west side of the culvert, exiting through the

Plate 20. Culvert (from W; 1m scale)

inner harbour wall. A new pipe was inserted and cemented in place to re-connect the culvert with the drain. One of the WWII concrete bases previously recorded in Trial Hole 1 was removed, which was set into the concrete at a depth of 0.20m (**Plate 21; Figure 2**).

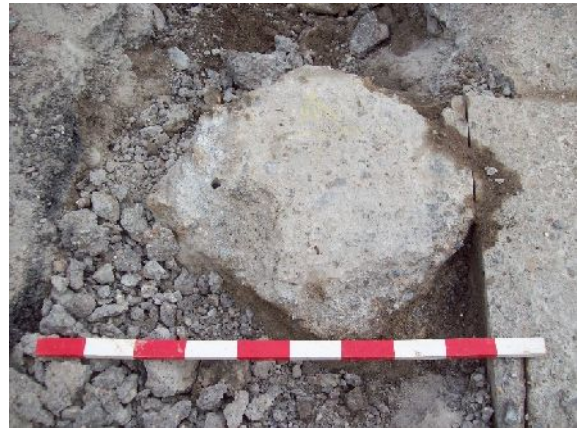
Plate 21. WWII concrete base (1m scale)

- 6.3 The excavation of Trial Hole 1 demonstrated that the supposed anti-tank barrier post was fairly shallow at 0.25m from the surface and was successfully removed during the duct trench works. It was not possible to determine whether the posts were part of the original defence structure or a subsequent re-instatement. However, installation was in reality a small arms protection barrier as opposed to an anti-tank barrier. Late/post-war aerial photographs show 0.55m square re-enforced concrete stantions standing at least 1.8m high. These were set in 3 rows across the Cobb at 1.5m intervals, comprising 5 stantions with a centre row of 4 in a diamond formation. This would appear as a solid wall when viewed from either the sea or shore side and once behind the second row personnel would be protected from oncoming fire.

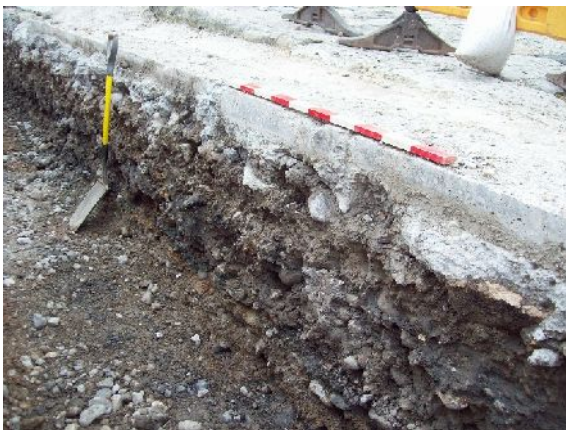
- 4.6 From 0m to 7.50m the underlying deposits consisted of gravel and coarse sand measuring c. 0.38m deep, overlying dark greyish brown sandy silt measuring <0.50m deep, above harbour silts, overlying gravel and coarse sand to the trench base (**Plate 22**). From 7.50m to 23m the cobbles were bedded on a mortar levelling base up to 0.10m deep, over gravel and coarse sand to the trench base depth of 0.80m. At 23m, large randomly laid Lias boulders were recorded at a depth of 0.60m, the edges of which were aligned north-east to south-west, varying in shape and size (**Plates 23 & 24; Figure 2**). These continued to 26.50m at which point the boulders rose up to 0.45m from the surface. From 26.50m and at the same horizon were large, dressed and mortared Lias blocks with weathered surfaces (**Plate 25; Figure 2**). This probably represents the earlier Cobb working surface, a spirit level showing only a slight decline towards the road. At 44m these were 0.40m below the present cobbled surface and were overlain by gravel and coarse sand measuring 0.20m deep, with a lens of greyish silt overlying the Lias.

Plate 22. Southern end of duct trench (from SW; 1m scale)

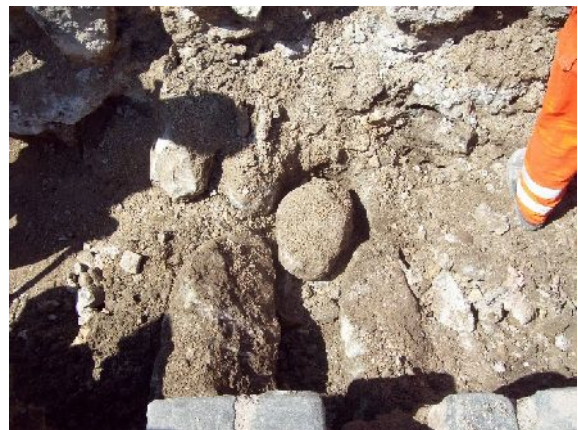
Plate 23. Earlier surface of large random boulders in duct trench, between 23m & 26.50m (from SW)

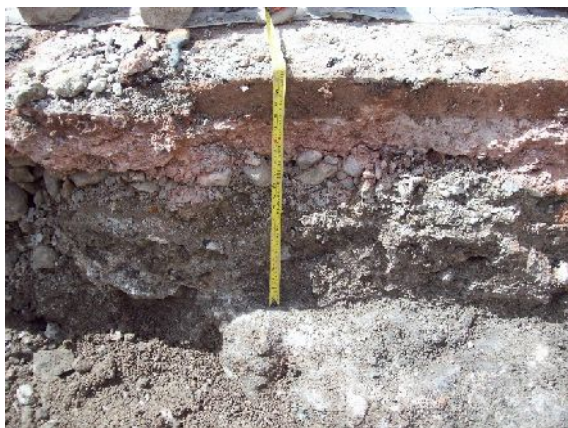
Plate 24. Deposit sequence in duct trench, between 23m & 26.50m (from E; 0.54m extended tape)

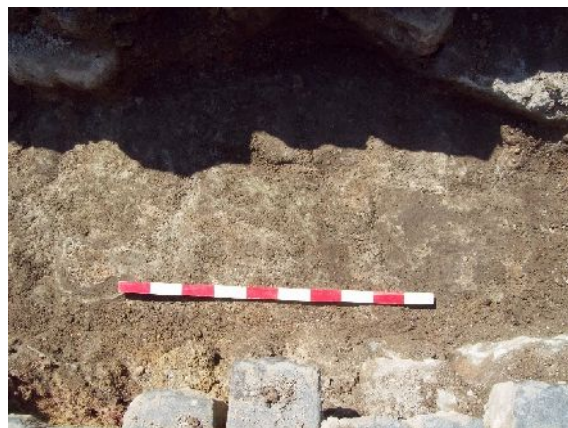
Plate 25. Earlier surface of large Lias blocks in duct trench, from 26.50m northwards (from E; 1m scale)

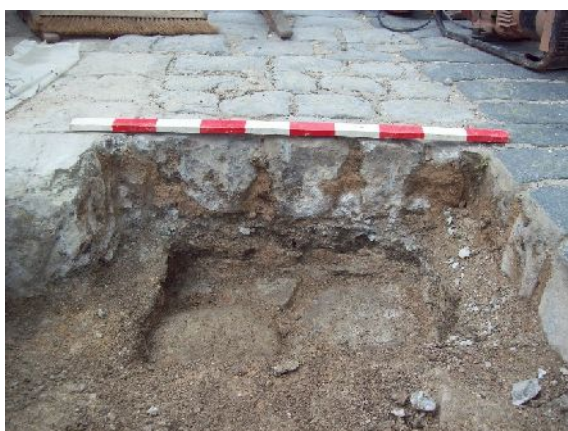
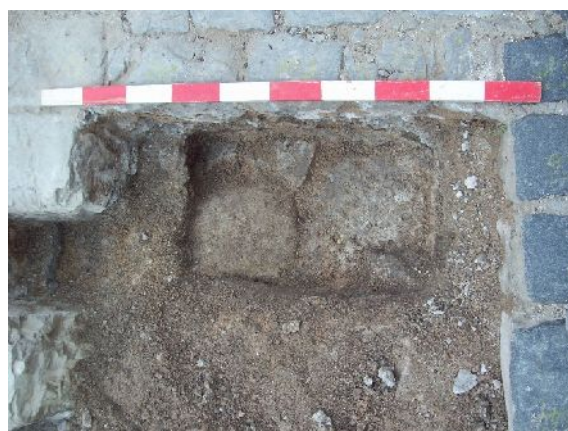
- 4.7 As the trench continued northwards the depth between the surface and the earlier Lias blocks diminished. By 50m they were only separated by a mortar bedding/ make-up layer, continuing for approximately 2 metres (**Plates 26 & 27**). Thereafter the depths between the earlier and later surfaces increased again before the Lias blocks gave way to rounded blocks set on edge with a covering of sandy gravel matrix which gradually increases in thickness. At the northern end of the trench, outside the entrance to the RNLI boat entrance, where the trench rises the make-up is 0.20m cobble, 0.10m mortar bedding, 0.15m sand and gravel mix, 0.10m of mortar, 0.80m of 'dirty' sand and gravel.

Plate 26. Profile of earlier surface of Lias blocks below present cobbled surface, N end of duct trench (from E; 1m scale)

Plate 27. Plan of earlier surface of Lias blocks below present cobbled surface, N end of duct trench (1m scale)

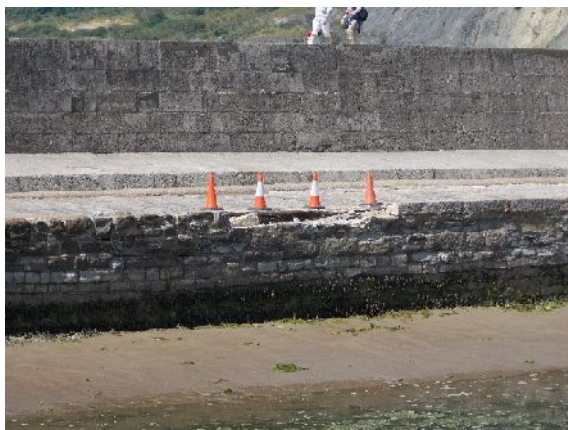
- 4.8 In Area 2 the depth of concrete was 0.20m covering mixed deposits of mortar, dark brown 'dirty' sandy gravel and harbour silt clay with occasional Lias. In Area 5 the depth of concrete was between 0.15m - 0.20m, covering a similar mix of materials as noted in Area 2. Damage to the inner harbour wall (**Plate 28**) was repaired. A cast iron surround of a drain cover was noted within the make-up (**Plate 29**). Further south, the depth of concrete was 0.20m covering a modern aggregate.

Plate 28. Damage to inner harbour wall in Area 5 (from E)

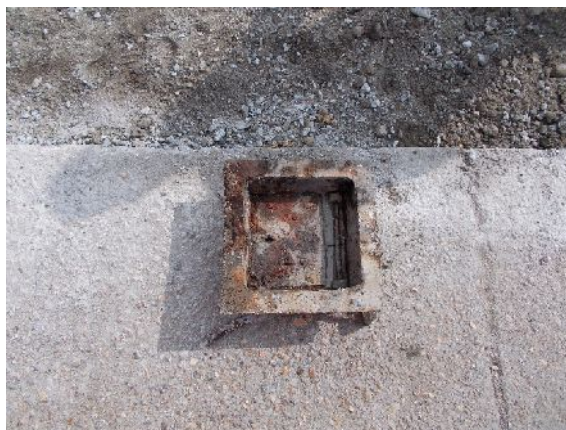
Plate 29. Cast iron surround recovered from make-up in Area 2 (1m scale)

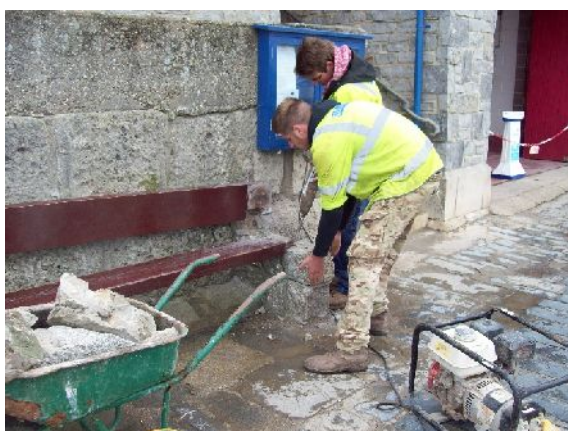
- 4.9 In addition to the works detailed in the methodology, the benches outside the Harbour Masters office were removed as the footings overlay the cobbles (**Plate 30**). Some of the re-pointing works were also observed (**Plate 31**). During the archaeological observations, mortar samples were passed to English Heritage to assist with the selection of appropriate new bonding materials. This generally comprised NHL5 (mortar 2 sand 1) (**Plate 32**) however one trial area at the west end of the south arm used 'prompt' (mortar 2 sand 1 and part prompt) (**Plate 33**). Also, in one area the cobbles were lifted and re-bedded on 75mm of NHL5 to see how this would compare to the surface re-pointing used elsewhere on the structure.

Plate 30. Removal of benches south of RNLI shop (from SE)

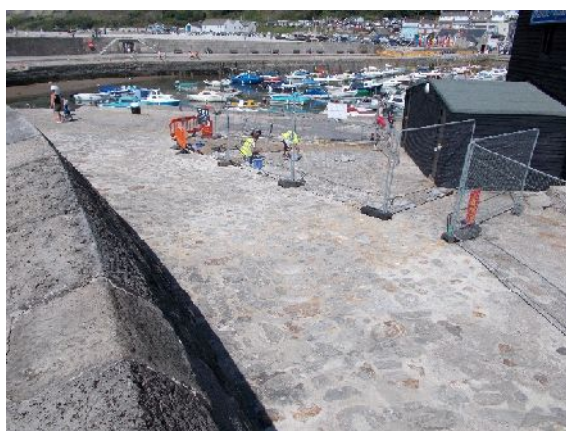
Plate 31. Repairs adjacent to aquarium (from SW)

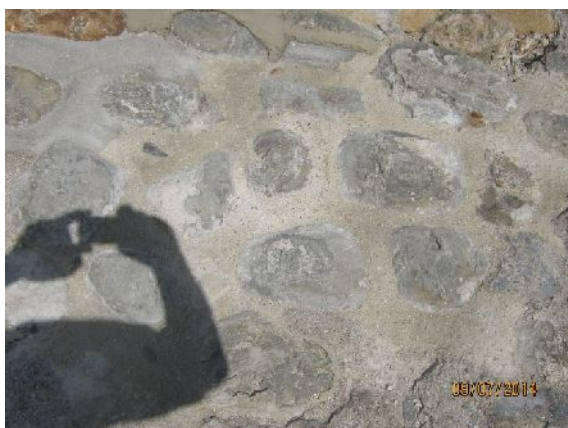
Plate 32. Re-pointing in NHL5 in Area 10 (photo from David Wilson)

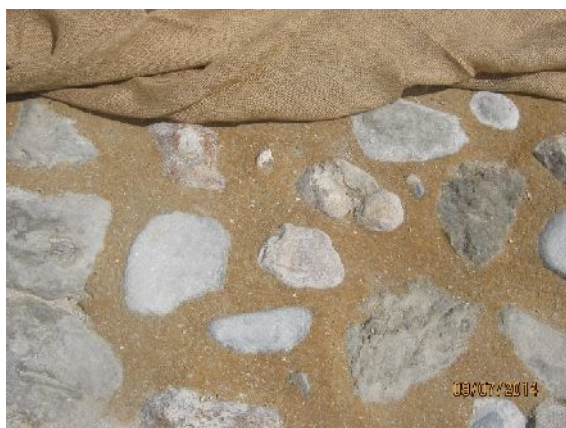
Plate 33. Re-pointing using 'prompt' in Area 10 (photo from David Wilson)
