# Church of St James, Jacobstowe, West Devon.

## Historic Building Recording

**COAS reference:** C1/SBR/14/SJJ

September 2014

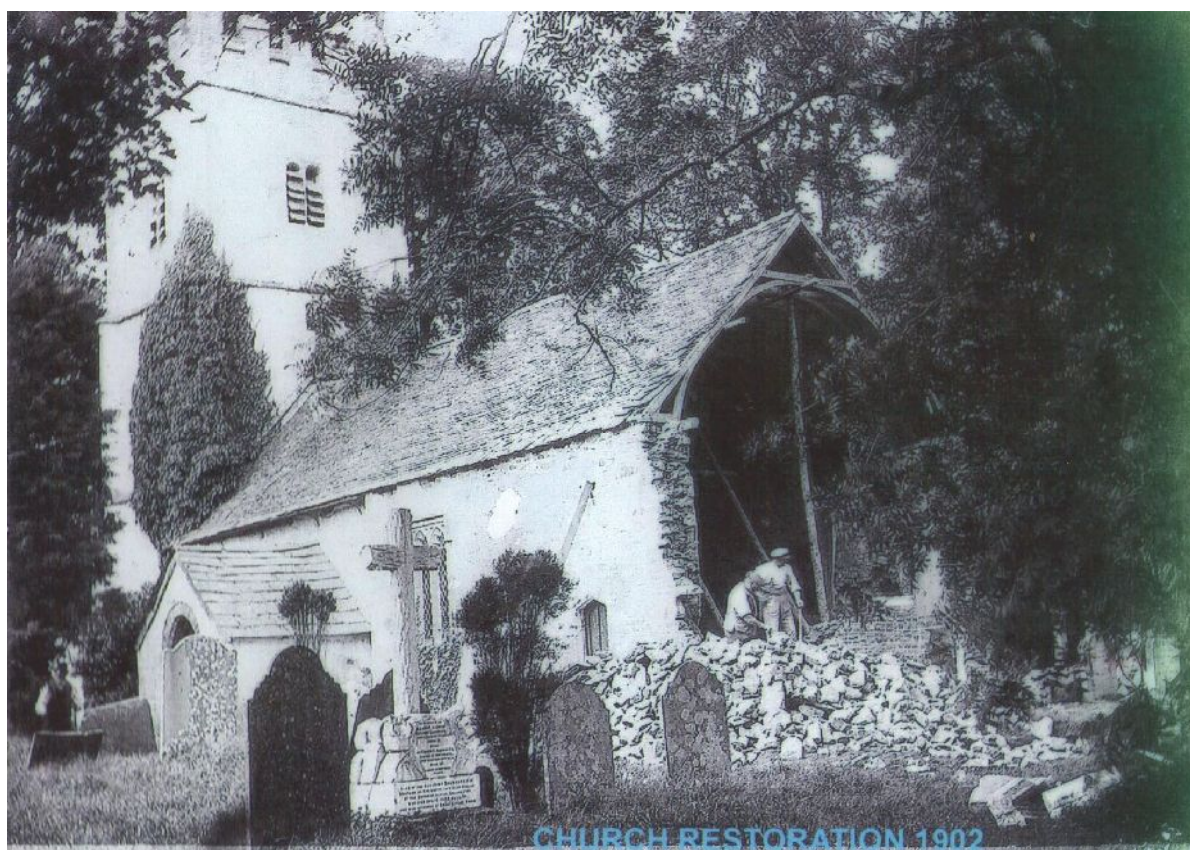
Plate 3. Photograph of 1902 restoration showing dismantled east end (DHC 4084A/PY/5/1)

- 5.9 The 1902 works saw the extension of the east end by 1.5m (**Plate 3 & 44**); restoration of all the 15<sup>th</sup> and 17<sup>th</sup> century windows described above; and extensive renewing of the wagon roof with new ribs (**Plates 37, 38 & 39**). Marks left by the fixings for the lathe and plaster remain visible on the underside of the original ribs above the nave (**Plate 39**). Above the chancel the timber of the wagon roof is all new, incorporating a decorative wooden chancel arch and wooden bosses (**Plate 40**). The facing of the central part of the north elevation is very similar to the 1902 work, suggesting this section was re-faced as part of the restoration work (**Plate 44**), perhaps in response to a vertical bulge in the wall which is still evident today. In 1935 the vestry was added to the south side of the chancel, with access to the chancel provided by the 15<sup>th</sup> century priest's doorway (**Plate 41**).

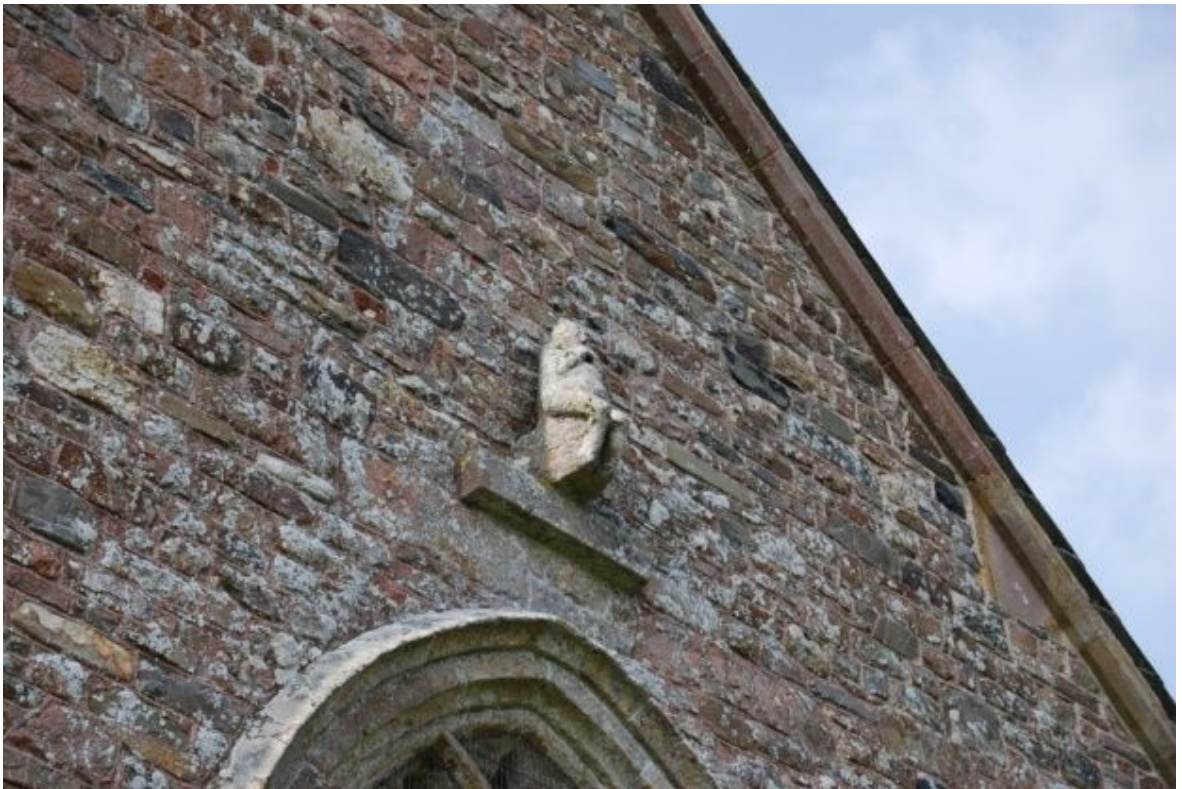
- 5.4 The north elevation of the nave has a shallow chimney breast with a buttress further east, supporting the wall which has a distinct vertical bow. Both are present on a 1902 plan depicting the church prior to restoration work (DHC 4084A/PY/5/1). To the east of the chimney breast there is a change from unevenly coursed small random rubble to regularly coursed random rubble incorporating larger stones, some of which are carved and indicative of re-use. To the east of the buttress the facing material is unevenly coursed and uncoursed small random rubble, incorporating some larger stones. The eastern 1.5m of the church is faced with regularly coursed random rubble which continues in the east elevation, incorporating larger blocks which also appear to be carved. Above the east window is a small carved seated figure, certainly re-used (**Plate 9**).

Plate 9. East end with seated figure above east window (from SE)

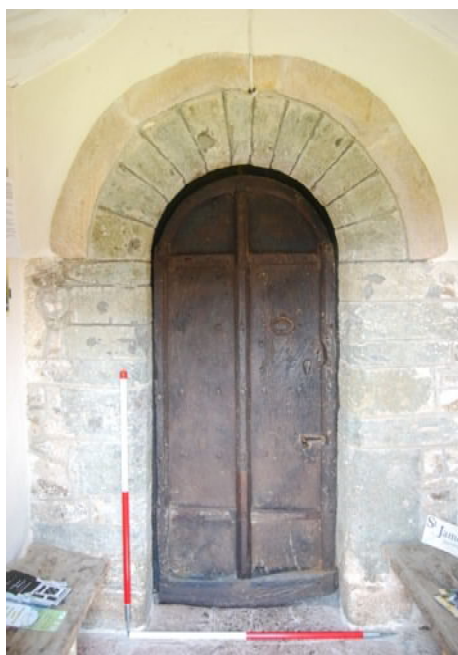
Plate 10. Norman south doorway within south porch (from S; 2 x 1m scales)

- 6.2 The south doorway is the only surviving *in situ* Norman feature and is of an undecorated form, with chamfer around the external jambs and arch and a deeply rebated internal arch. Generally, such simple forms are considered to be typical of the early Norman period (late 11<sup>th</sup> to early 12<sup>th</sup> centuries), although the remote rural location may reflect a delay in the spread of new architectural ideas. The western part of the south wall of the nave is contemporary with the south doorway along with the western part of the opposing north wall (**Plates 43 & 44**), although some re-facing may have taken place at a later date. The west ends of both walls curve in towards the 15<sup>th</sup> century tower; this may reflect re-modelling to accommodate the tower, nevertheless the position of the south doorway indicates that the western termination of the Norman church was in this location. The simple round-headed doorway of the south porch appears to be a re-set Norman doorway. Also, an external shoulder course above a 15<sup>th</sup> century window in the north elevation appears to re-use voussoirs from an arch which may have derived from a Norman window.

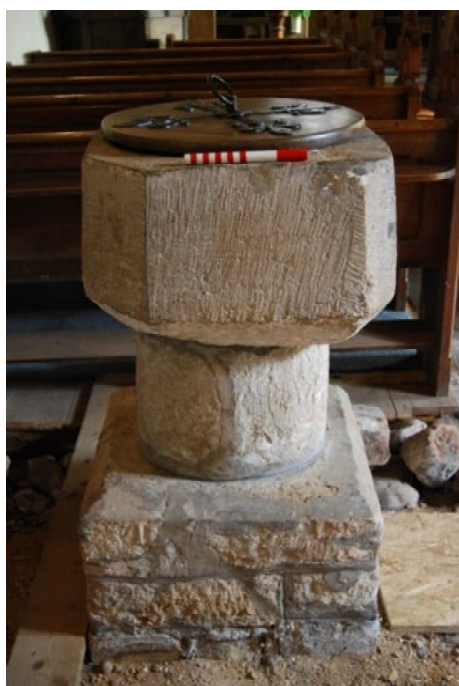
Plate 12. Norman font on later stone plinth (from W; 1 x 0.2m scales)

- 6.3 Within the nave, a free-standing crudely carved font is also likely to be early Norman, with chamfers to the angles and underside of the bowl, above a circular shaft set on a later square base. Standing outside the church, between the south porch and vestry, is a narrow rectangular stone-built structure topped by a slab with straight chamfer underneath (**Plate 43**). Too narrow to be a tomb and sharing the same simply-chamfered ornamentation as the font and south doorway, it is possible that this is the Norman altar perhaps re-sited following the 15<sup>th</sup> century work. If correct, the careful re-building and retention of this feature is interesting, perhaps providing spiritual agency to the renovated church.

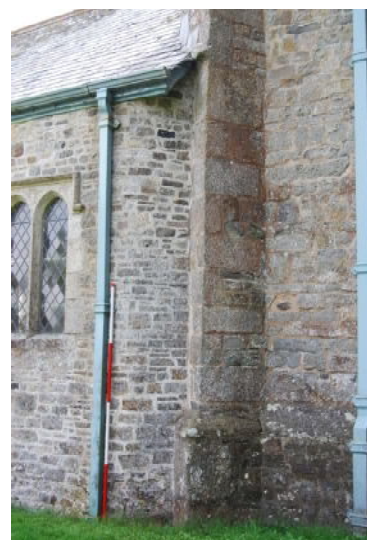
- 5.7 The western end of the nave is abutted by the 15<sup>th</sup> century tower; the nave walls curve inwards where they are abutted by the tower buttresses (**Plates 21 & 22**). The windows in the south side of the nave comprise a 15<sup>th</sup> century two-light cinquefoiled window at the west end (**Plates 23 & 24**); a 15<sup>th</sup> century three-light cinquefoiled window in the centre (**Plate 25**); and a 17<sup>th</sup> century two-light mullion window to the east (**Plate 25**). The windows in the north side of the nave comprise a two-light mullion window at the west end, erected in 1935 by the rector E. J. White as a memorial (**Plates 27 & 28**); a 15<sup>th</sup> century two-light mullion window with two-centred heads in the centre, the stained glass dating to 1887 (**Plates 29 & 30**); a 17<sup>th</sup> century two-light mullion window to the east with original stained glass (**Plates 31 & 32**) and a 1902 one-light cinquefoiled window at the east end. Re-set within the 1902 extension to the chancel is a three-light Perpendicular window with late 19<sup>th</sup> century stained glass (**Plates 33 & 34**).

Plate 22. North-east corner of nave showing curved nave walling adjacent to scales abutted by tower to right (from NW; 1 x 2m scales)

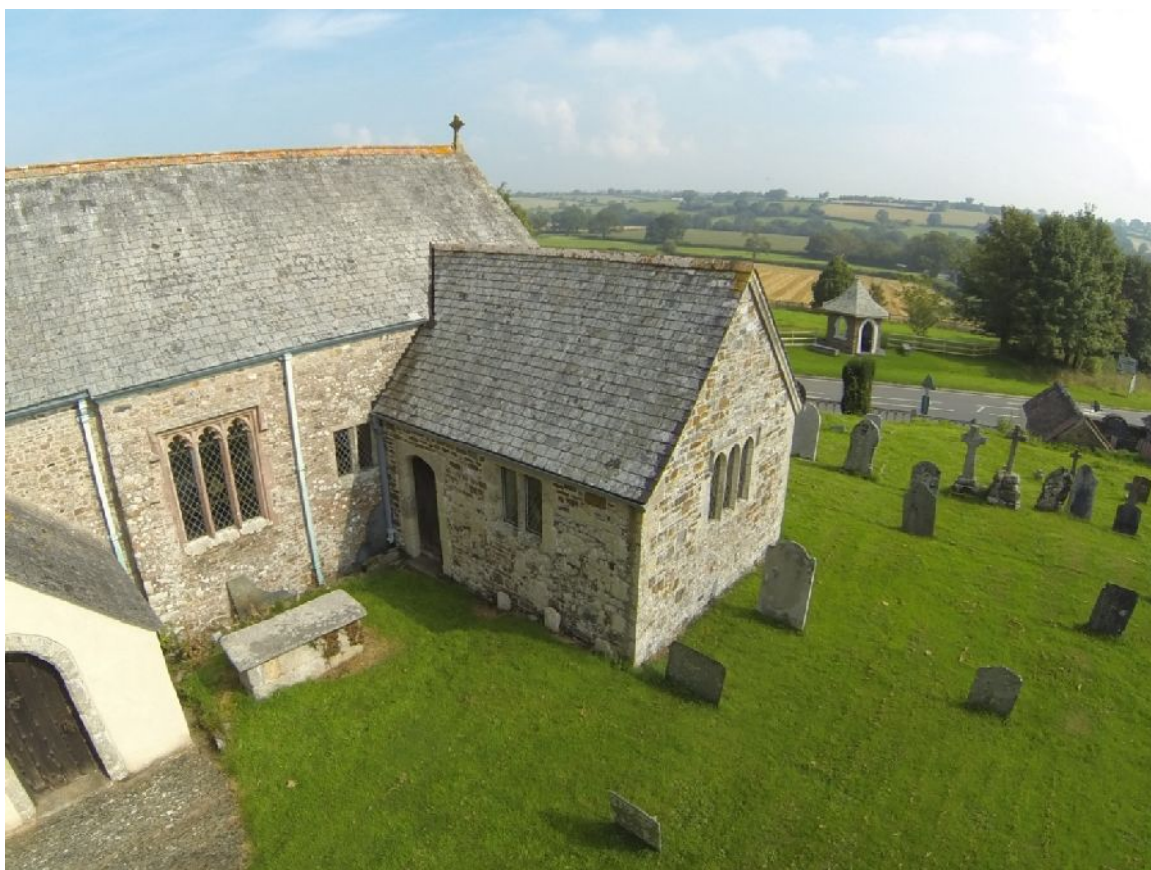
Plate 41. Oblique aerial of vestry on south side of chancel (from SW)

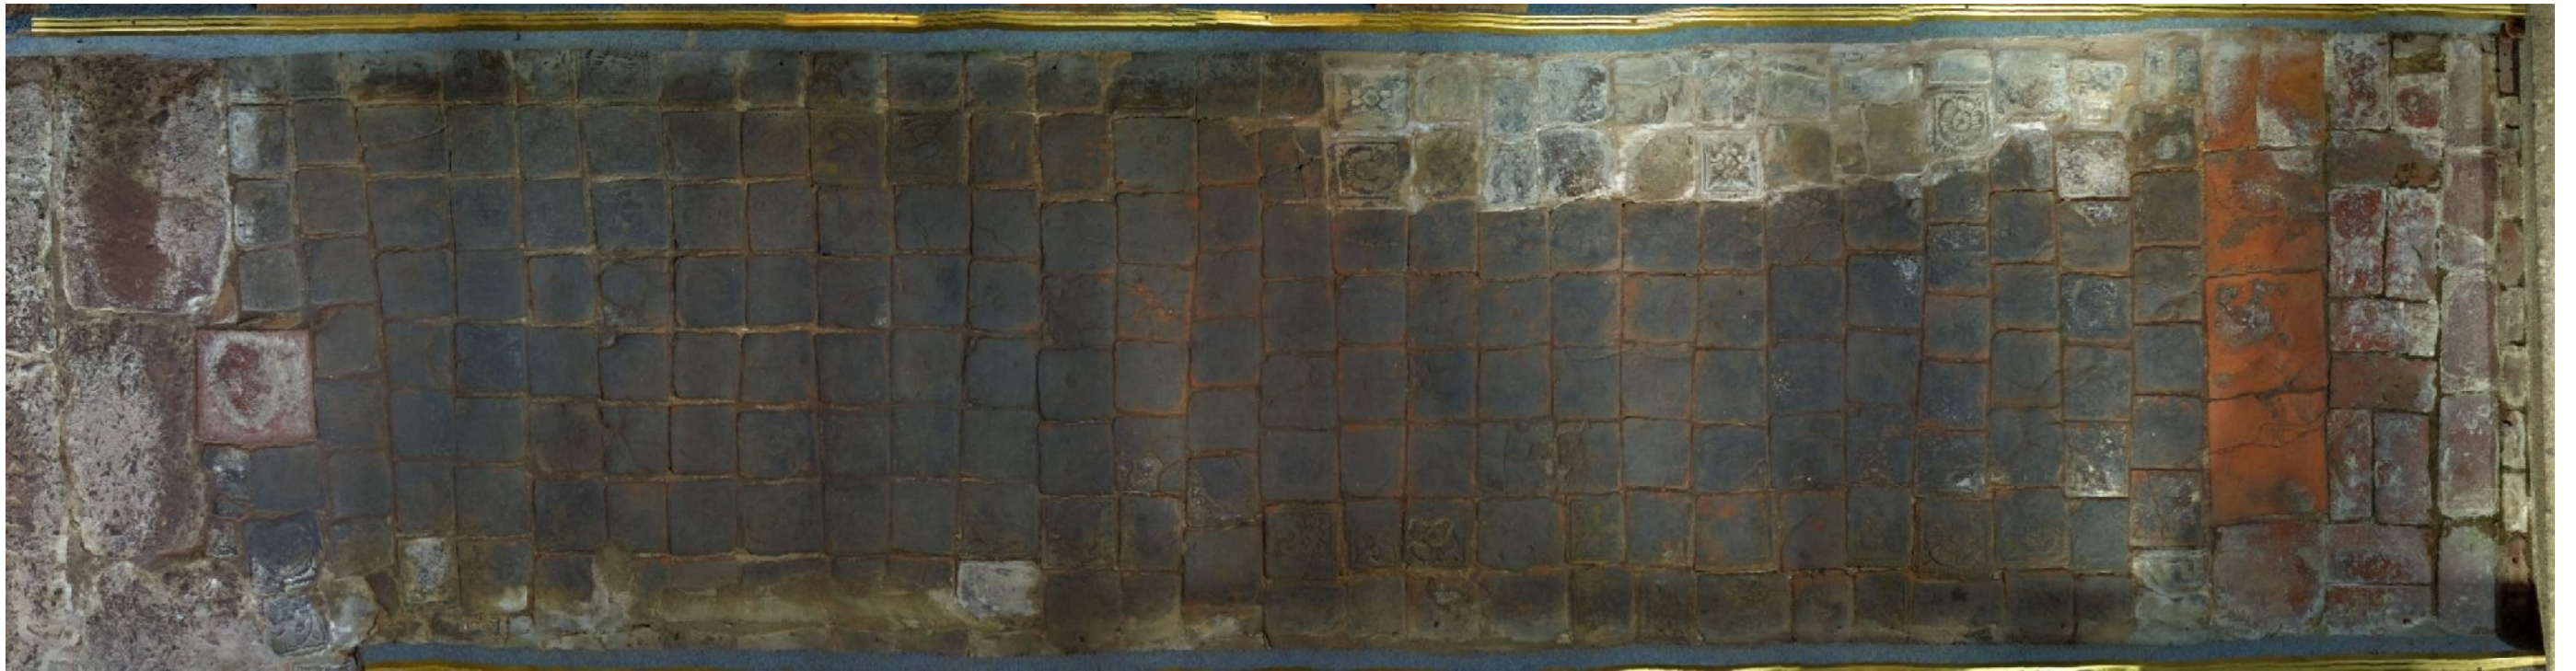
- 5.10 Between the extant pews in the nave aisle is a pavement of re-laid tiles known as the ‘Barum tiles’ (Plate 42). The majority of the tiles appear undecorated, although residues of green glazing and inlay on a number of these tiles reveal that this is mostly a result of wear. Fortunately, there are a number of tiles where the decoration is recognisable, particularly along the northern side of the pavement and to the west of the southern pew. Five different designs were recognised. The rose (Plate 42; a) comprises two rows of five-lobed petals (a popular motif from the early 14<sup>th</sup> century before it was adopted as the Tudor emblem in 1485). Tiles with a diamond and fleur de lys to each corner (Plate 42; c) are almost identical to a group of late 13<sup>th</sup> tiles used at Glastonbury Abbey (Harcourt forthcoming, design number 61, group 4b). These are described as ‘Central pierced quatrefoil within square set diamond fashion from each face out-turned fleur de lys to each corner. Large slender side petals arched not reflexed’. Similar tiles have also been identified at Muchelney Abbey, Cleeve Abbey and Wells Cathedral. Although no precise parallel could be identified for the cross flory (Plate 42; b), pelican (Plate 42; d) and lion passant (Plate 42; e), similar designs are recorded from 13<sup>th</sup> and 14<sup>th</sup> century monastic contexts.

Plate 42. Re-laid tiles within eastern half of nave central aisle

- 6.9 The tiles within the nave aisle are an important group with five different designs recognised, although many of the tiles are undecorated or the inlay has been worn away. The uneven laying of the tiles and the varied orientations of the designs prove they have been re-used from elsewhere. The designs date from the late 13<sup>th</sup> and early 14<sup>th</sup> centuries and comprise a rose motif (adopted as the Tudor emblem in 1485); the cross flory, pelican and lion passant also known from 13<sup>th</sup> and 14<sup>th</sup> century monastic contexts; and a diamond with fleur de lys to each corner, which date to the late 13<sup>th</sup> century at Glastonbury Abbey and have also been identified at Muchelney Abbey, Cleeve Abbey and Wells Cathedral. The elaborate designs would have required a high level of craftsmanship akin with a high status building such as a monastery or palace. *Note: since carrying out the survey the tiles have now been subject to a comprehensive assessment by John Allan and dated as mid-17<sup>th</sup> to early 18<sup>th</sup> century.*

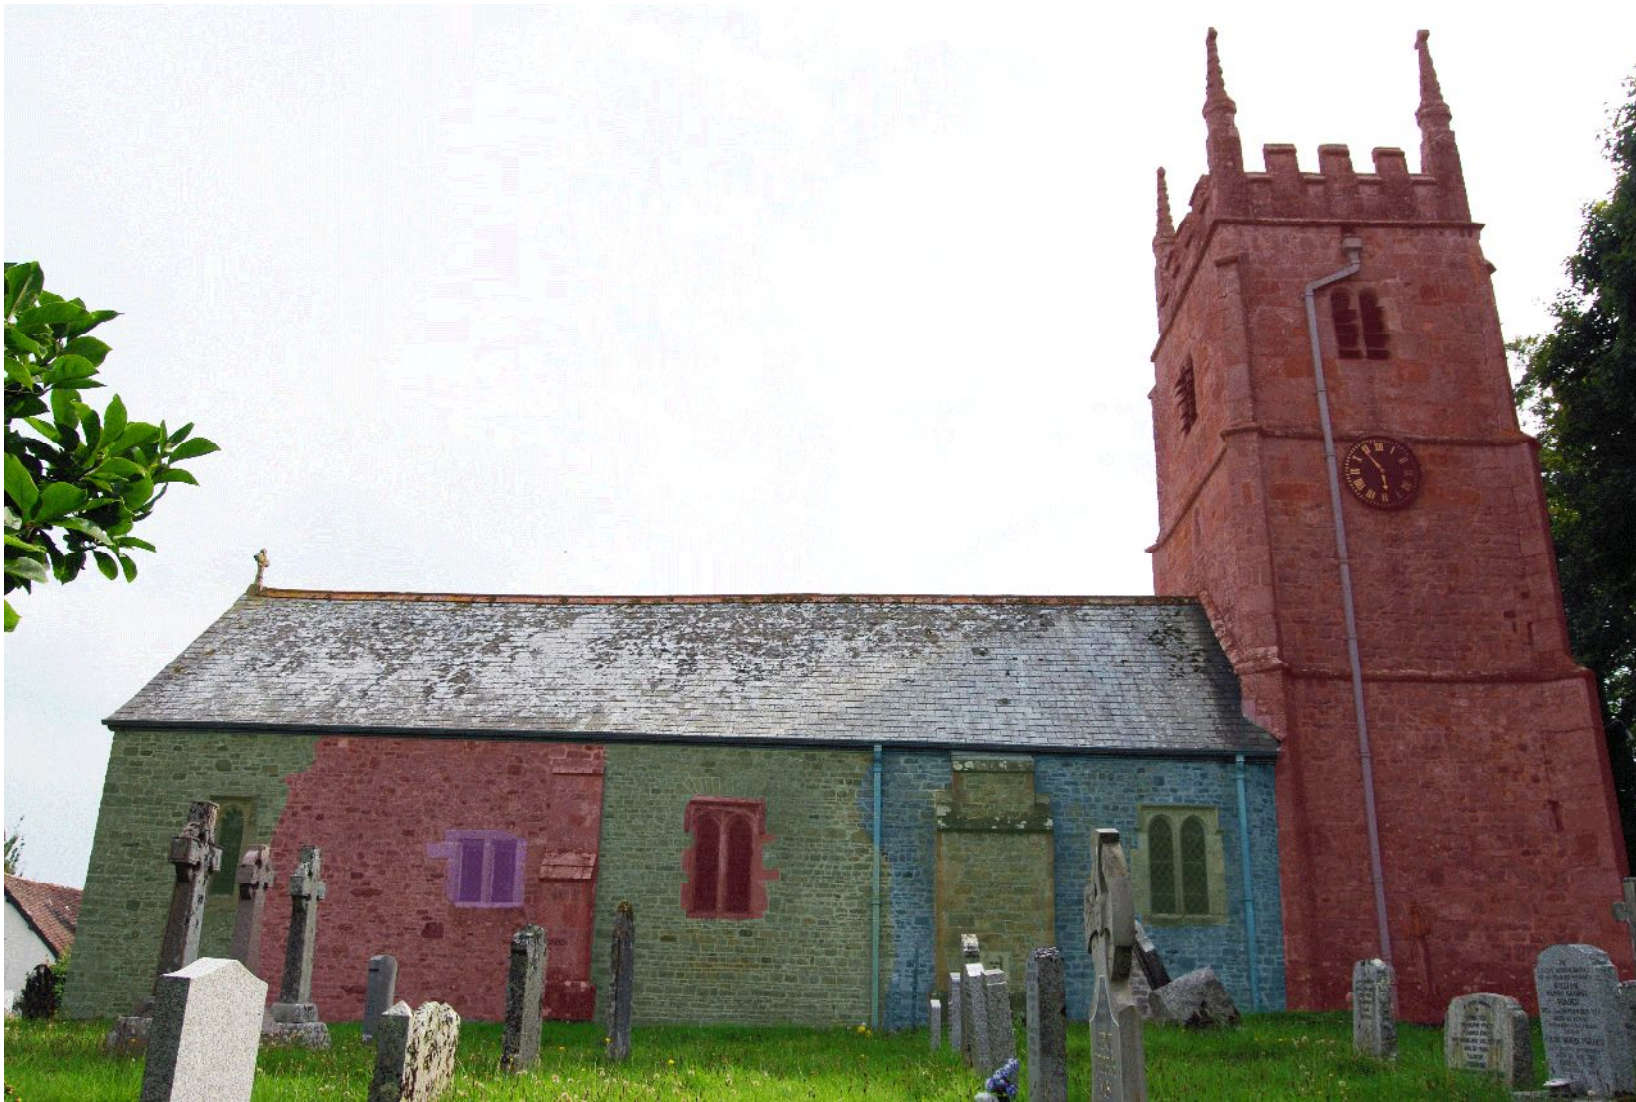
Plate 44. North elevation with approximate phasing, exterior (from N)
