Former Bridport Literary and Scientific Institute, 51 East Street, Bridport, Dorset

Historic Building Recording and
Archaeological Monitoring and
Recording

REPORT

April 2017

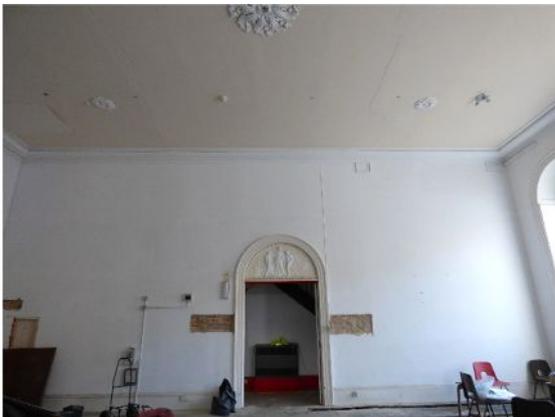
- 5.3 The door from the entrance hall into the Reading Room (G2) appears to be original, with a semi-circular plaster relief panel facing into the room (**Plate 3**). At the southern end of the room are three arched sash windows with panelled shutters and fan lights above (**Plate 4**), with a further identical window in the centre of the east elevation (**Plate 5**), and two further identical windows in the north elevation (one blocked) flanking a square-headed door which is a later insertion (**Plate 6**). Other original features comprise cornicing, deep skirting boards, a large plaster ceiling rose in the centre of the room and four smaller roses. In the east elevation, adjacent to the blocked arched window, is a rectangular wooden hatch leading into the lobby (G3) (see below). Removal of modern features has exposed two rectangular original brick fireplaces in the west elevation (**Plate 5**), the brick stacks of which are visible externally amongst the rubble walling (**Plate 7**).

Plate 3. Ground floor Reading Room showing exposed fabric of partition (from W)

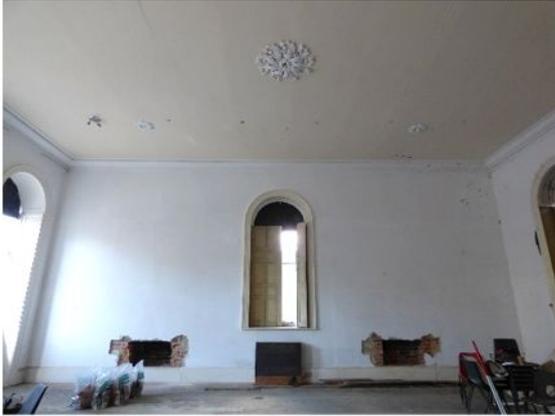
Plate 5. Ground floor Reading Room showing exposed fireplaces (from E)

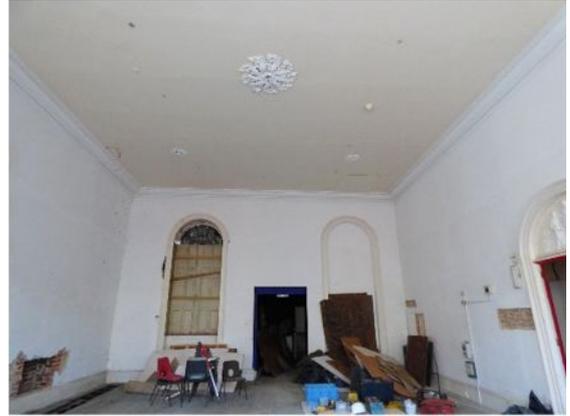
Plate 6. Ground floor Reading Room showing later doorway & blocked window (from S)

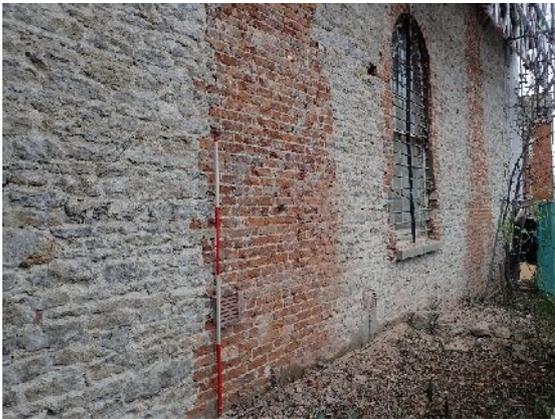
Plate 7. External west elevation showing brick chimney flues (from NW; 2m scale)

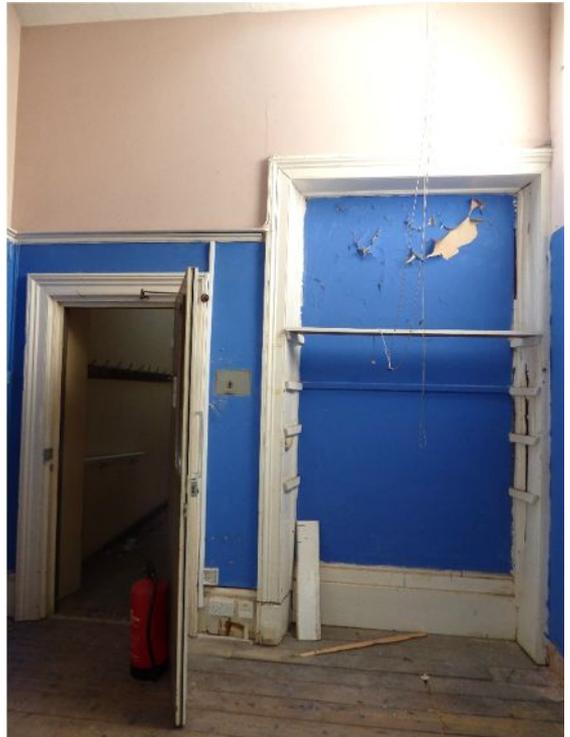
Plate 8. North Building before works showing blocked door & door to east corridor (from N)

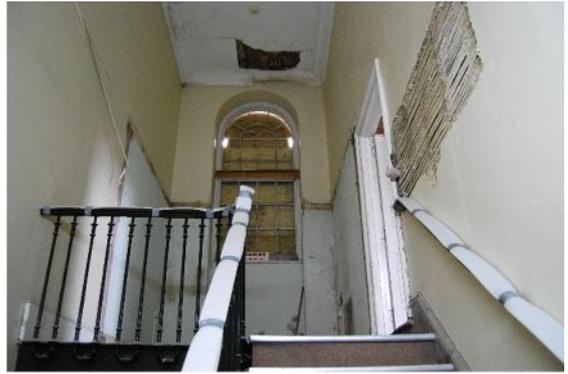
- 5.5 From the half landing (F1) are two arched doors lead into two WCs with individual entrance vestibules (F5) (**Plate 10**). Above the two arched doors, and overlooking the landing, is a niche containing a statue of Minerva (**Plate 11**). The stairs turn southwards and lead up to a wider first floor landing, where a later partition formed an office (F2) which on a subsequent monitoring had been removed exposing the sash window (**Plate 12**). A plaster ceiling rose is positioned above the stair well (**Plate 13**), and the landing areas and stair well retain original skirting with cornicing above, and original timber floor boards. Removal of small areas of wall plaster reveal that at first floor level the internal partitions are constructed of timber framing with lathe and plaster, the brickwork panels ceasing between the ground and first floor (**Plate 12**).

Plate 12. First floor landing showing exposed fabric of partition (from N)

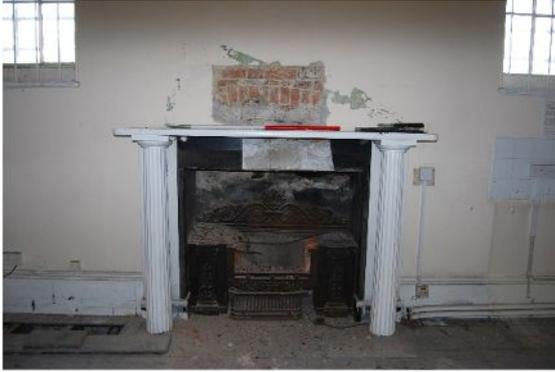
Plate 21. Later fireplace in first floor Lecture Room (from S)

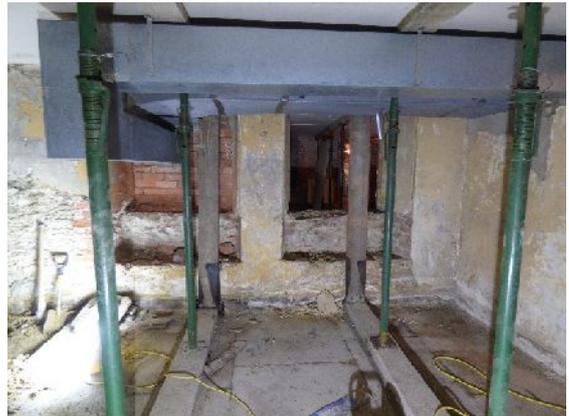
two windows in the western room (B3) had been blocked to varying degrees with modern bricks (**Plate 28**), and original features consisted of a flagstone floor and a brick-lined fireplace. The window in the eastern room (B4) was intact with a brick and stone sill (**Plate 29**).

Plate 28. Windows of north elevation from basement parlour (from S)

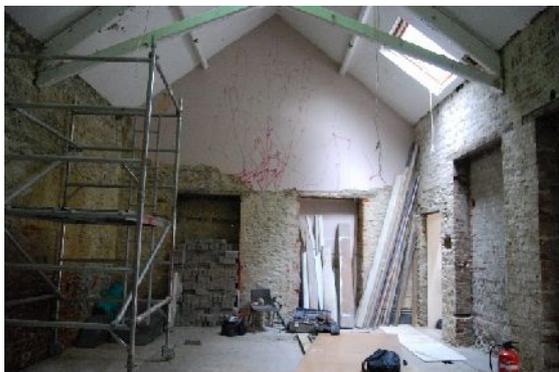
Plate 30. Ground floor of North Building showing brick arch above blocked door (from W; 1m scale)

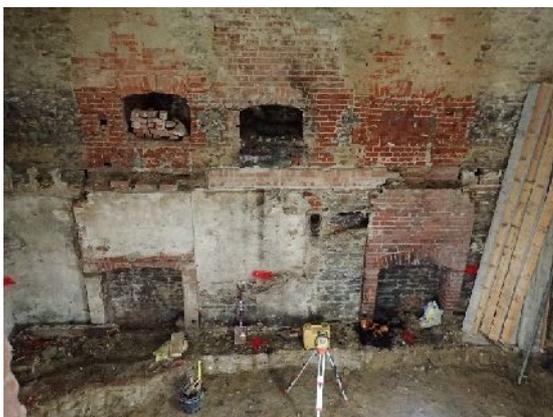
- 5.11 Within the south elevation are four square-headed doorways (**Plates 31 & 32**). Two are very tall, the eastern one being the blocked opening which once led to the courtyard (**Plate 8**), while the other is partially blocked and houses a smaller doorway. The blocked high doorway is adjacent to the door leading to the hallway G5, the rubble surrounding the doorframe testimony to its later insertion. This indicates that the hallway (G5) is a later addition to the North Building, its construction making the large door redundant. The east elevation also contains a pair of blocked high square-headed doorways again with timber lintels, a brick arch above the northern of these doors suggesting the presence of an earlier opening (**Plate 30**). Within the west elevation are a pair of identical blocked doors (**Plates 33 & 34**). Three fireplaces have been exposed in the north elevation (see below) (**Plate 35**).

Plate 35. Internal north elevation of North Building showing fireplaces (from S)

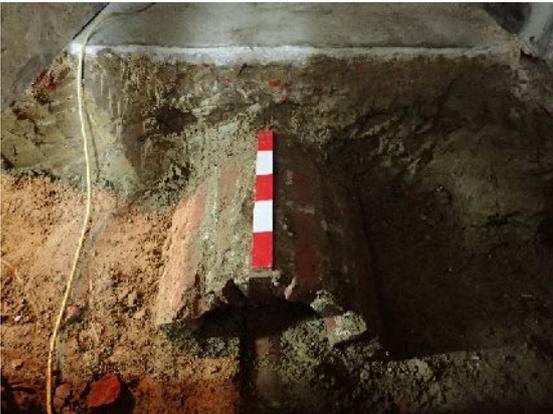
- 5.14 A brick culvert was discovered running beneath the basement hallway on the same north to south alignment. This turned out to be a modern brick arched construction measuring 0.0m wide and 0.35m high, and protected a modern service pipe (**Plate 41**).
- 5.15 A small trial hole measuring 0.60m by 0.40m and 1m+ deep was excavated in the re-entrant angle between the north-west corner of the Institute and the west wall of the courtyard. This revealed a buried brick retaining wall aligned north to south and running parallel and approximately 0.5m west of the courtyard wall (**Plates 42 & 43**).

Plate 41. Modern brick culvert beneath basement hallway (from S; 1m scale)

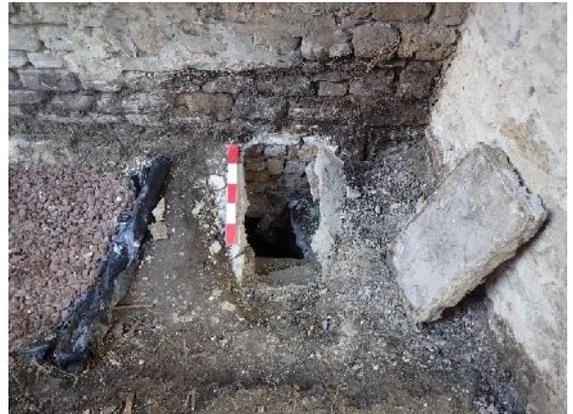
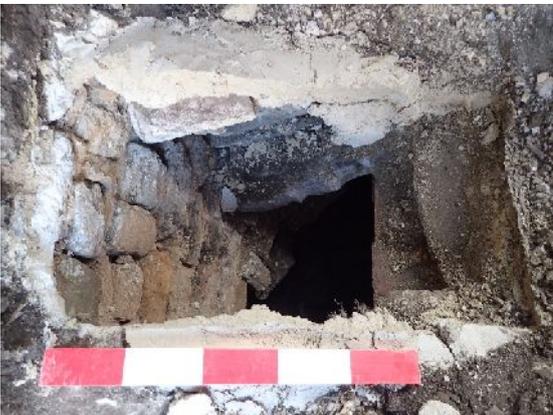
Plate 42. Brick retaining wall running north from NW corner of Institute (from W; 0.5m scale)

Plate 43. Brick retaining wall running north from NW corner of Institute (from N; 0.5m scale)
