Halberton Court Farm, Halberton, Devon

An Historic Building Assessment

COAS reference: C1/SBR/16/HFH

October 2016

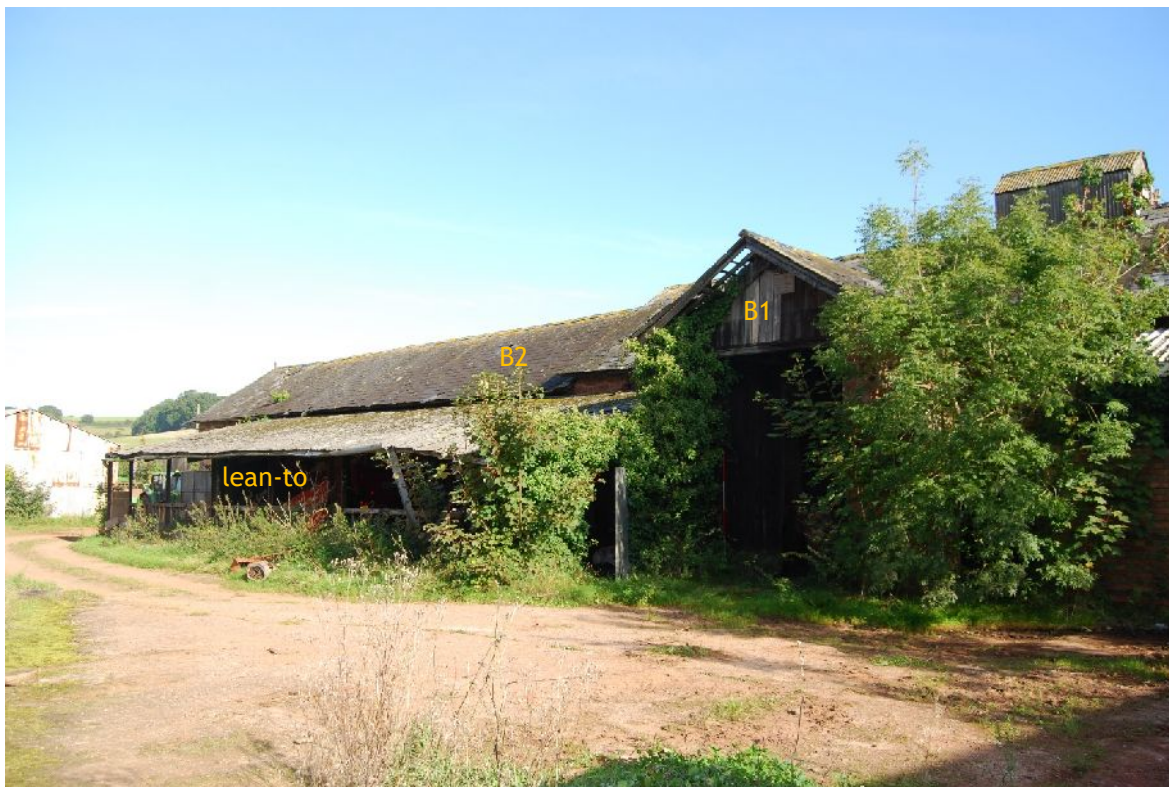
Plate 3. South-west elevation of B1 & B2 (from S; 2m scales)

4.2 The main barns pre-date 1814 and consist of two adjoining barns on the western side of the main farm track; B1 is earlier with the south-eastern end of B2 abutting the north-western end of B1. Externally, the roof and eaves level of B1 are slightly higher than those of B2, and the exterior faced with random rubble (**Plate 1**). Both roofs are covered with slate tiles, a corrugated iron ventilation structure on the roof of B1 representing a later addition (**Plates 2 & 3**).

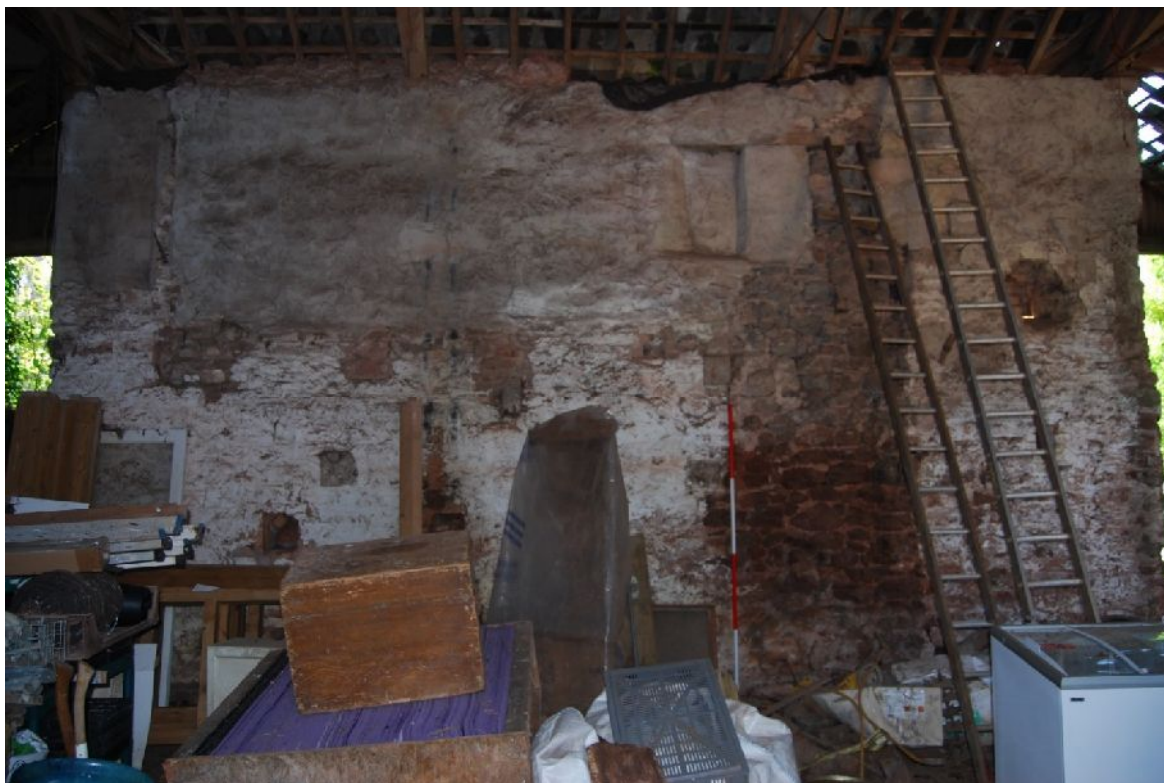
Plate 13. Central part of south-west interior elevation of B1 showing blocked window (from NE; 2m scales)

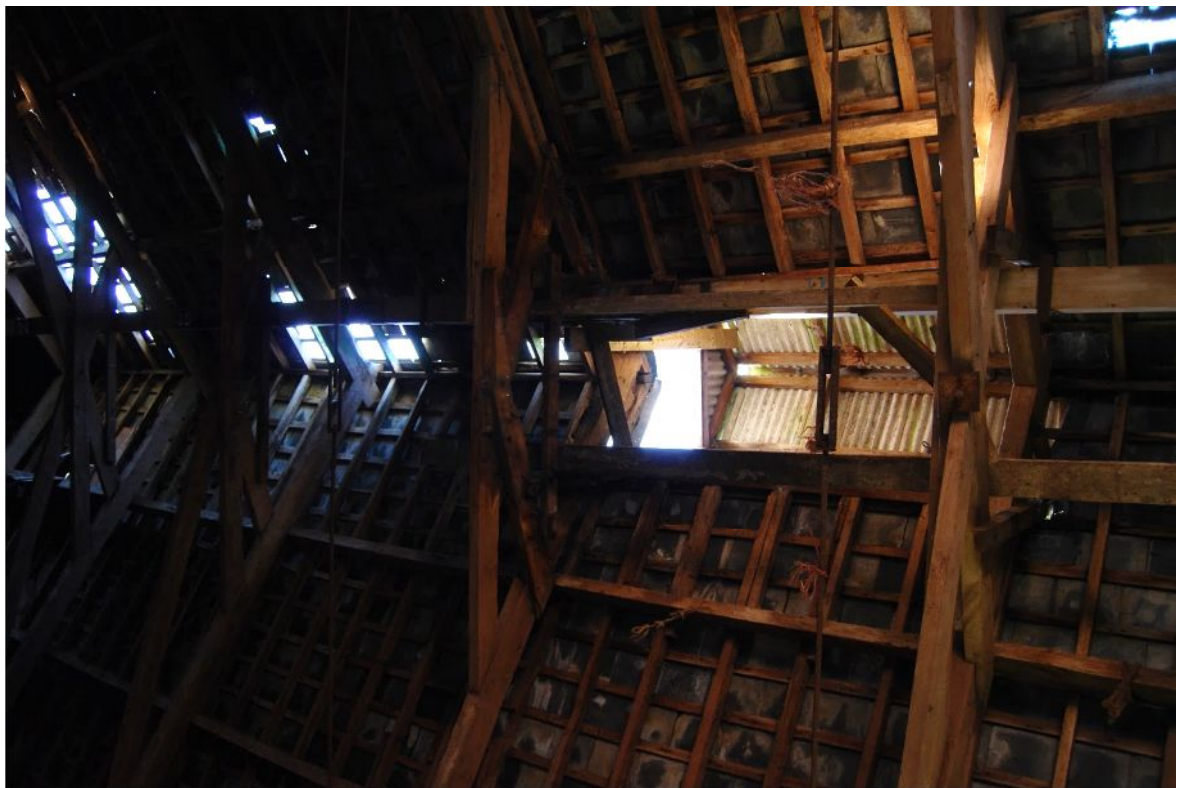
Plate 21. Roof of B1 showing scissor beam trusses & later corrugated iron ventilation structure on ridge (from below)

4.6 As for the exterior, the interior masonry of the porches abuts the south-west elevation (**Plates 19 & 20**), with blocked openings evident in the south-east and north-west sides of the northern bay. The other obvious addition is the ventilation structure, which rests on large beams inserted through the scissor beam trusses (**Plate 21**).

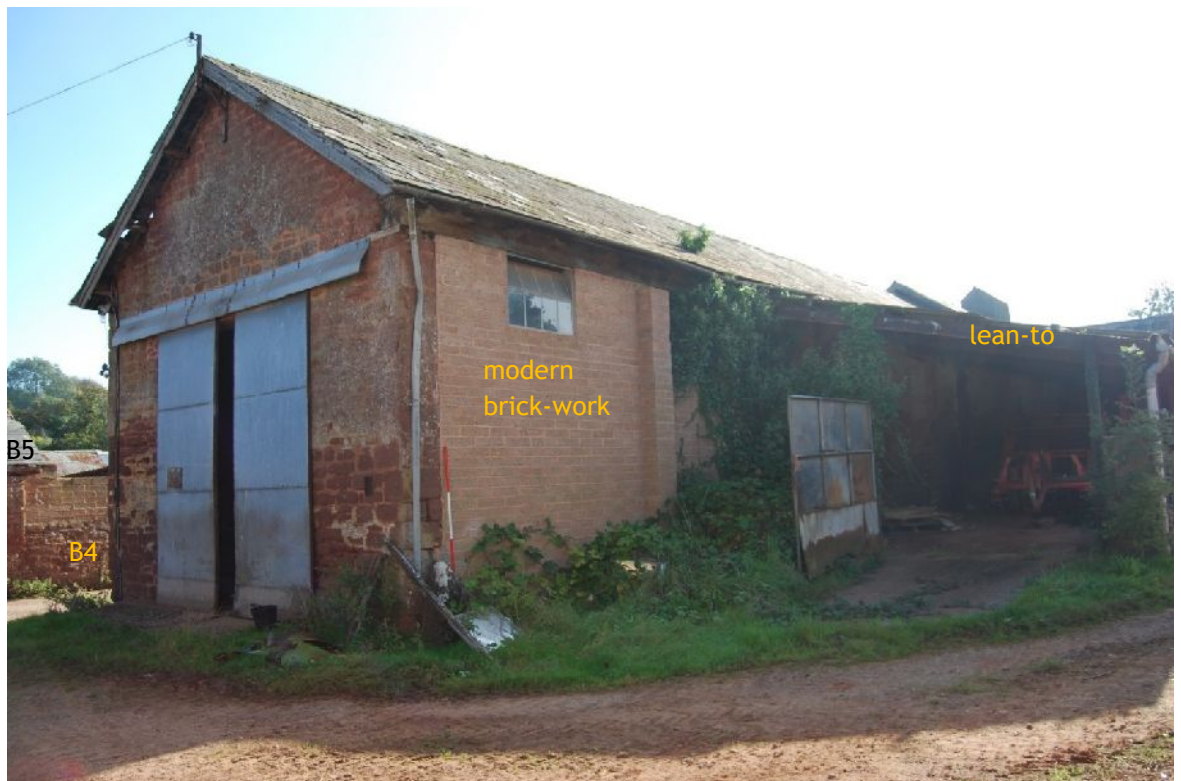
Plate 24. North-west gable of B2 & south-west elevation of B2 with roof of B1 in background (from NNW; 2m scales)

- 4.7 The northern end of B2 has been altered quite extensively. Firstly, the random rubble of the north-east elevation may not be original, as this part of the building once had a return (demolished by 1889). Unfortunately, it is not possible to compare the fabric with the remainder of the elevation as it is covered in render (**Plate 22**), although the north-west gable is of a similar construction, albeit now accommodating large sliding metal doors (**Plate 23**). The opposing south-west elevation has been re-built in brick (**Plate 24**).

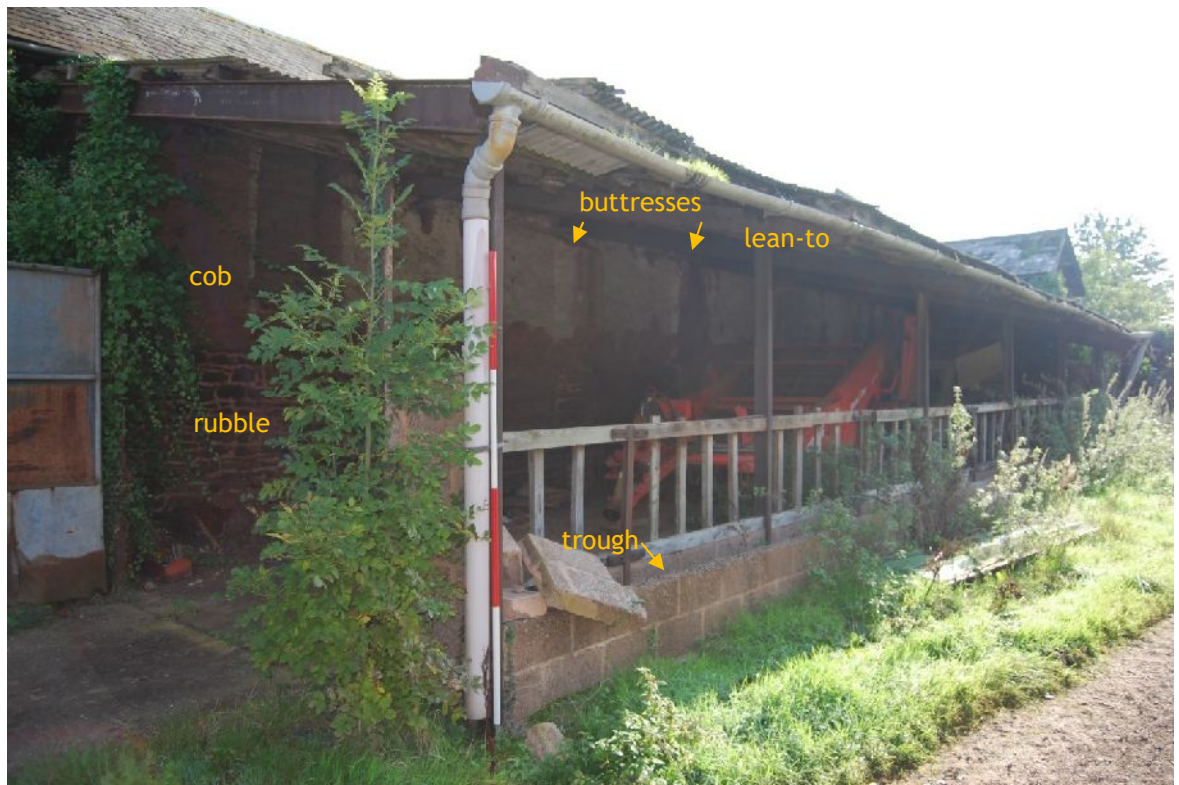
Plate 25. South-west side of B2 with roof of B1 in background (from NW; 2m scales)

- 4.8 The remainder of the south-west elevation is constructed of random rubble with cob above, with a series of buttresses of the same build (**Plate 25**). Erosion of the cob reveals the elevation was exposed to the elements before the open-sided structure was added by 1889. The open-sided structure has been renewed with steel beams and an asbestos roof, with wooden railings at the front through which livestock would feed from the concrete blockwork trough which runs along the outside of the structure (**Plate 26**). The lean-to also encloses the east end of B1 which is identical in construction on this elevation (**Plate 27**).

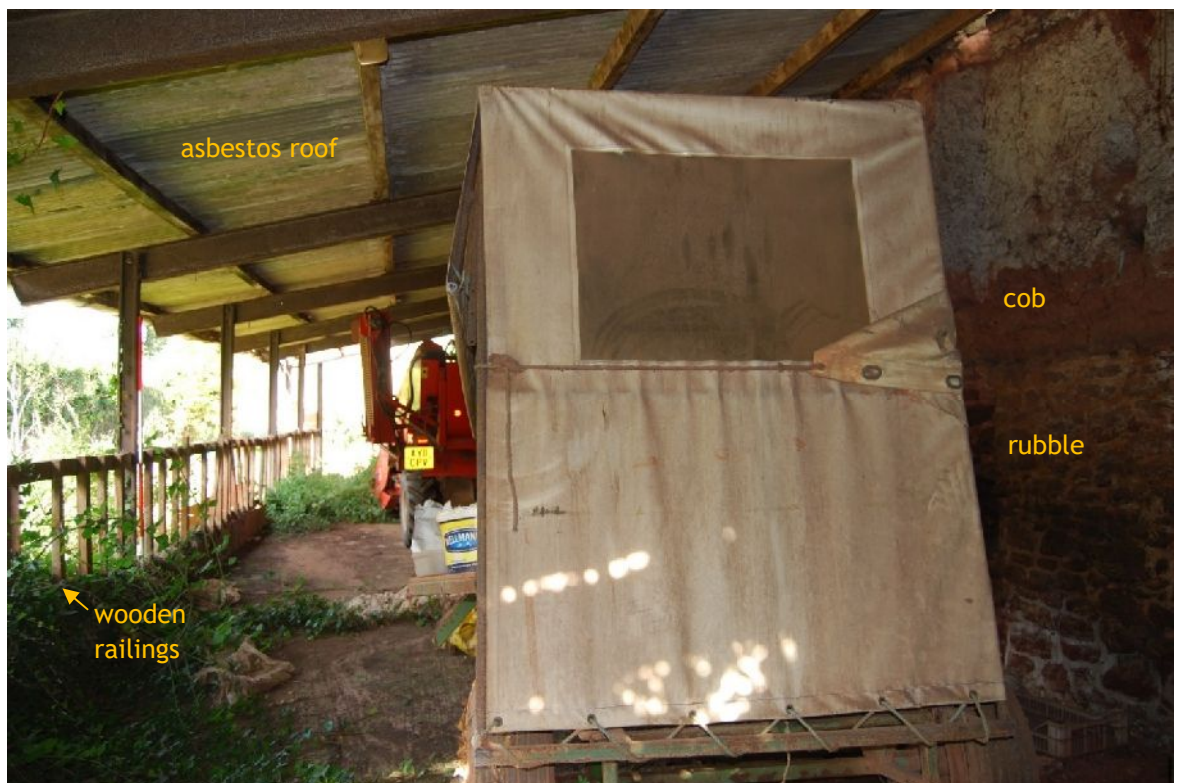
Plate 26. South-west side of B2 showing lean-to cattle shelter (from SE; 2m scales)

- 5.2 By 1889 a narrow structure had been added to most of the south-west side of B2, occupying the same footprint as the present lean-to. This dilapidated cattle shed retains elements of the 19th century fabric but is predominantly renewed with concrete block feeding trough, steel supports and a corrugated asbestos roof. By the late 19th century the south-west elevation of B1 had also been in-filled with a narrow structure/s, although the modern brick-built structure in this location is clearly a replacement.

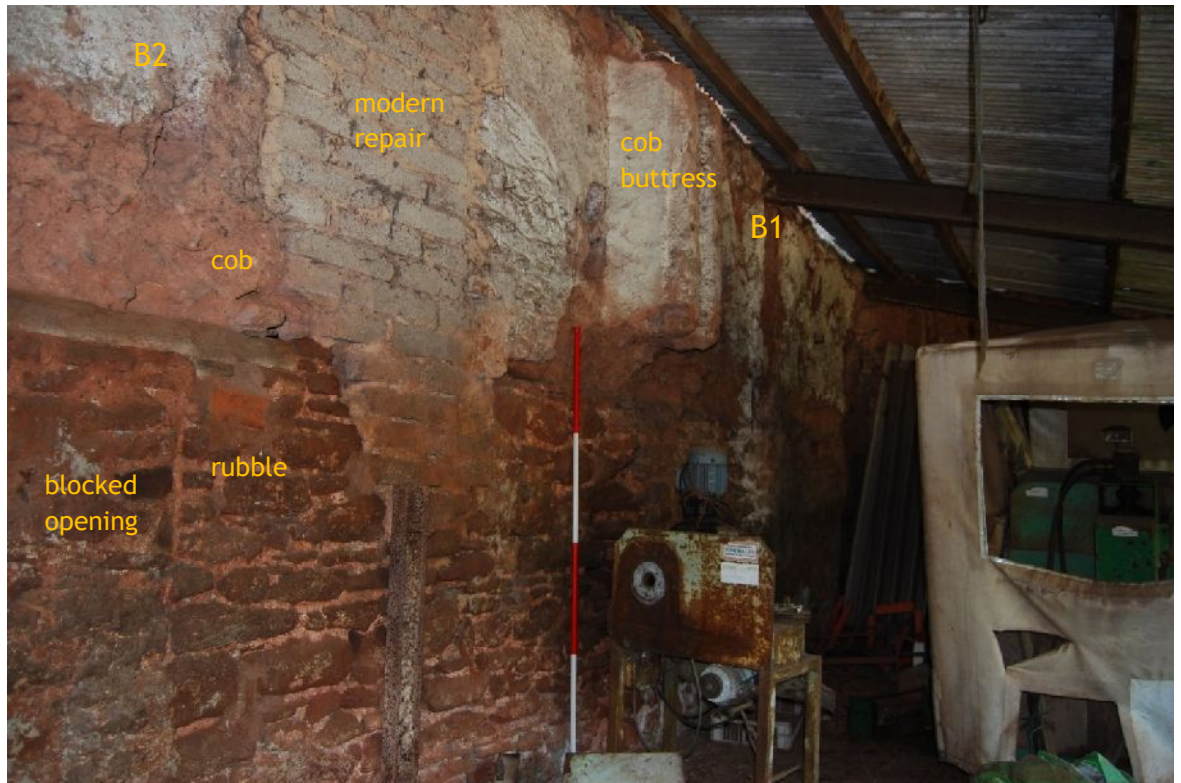
Plate 27. South-west exterior elevation of B2 & B1 (from NW; 2m scales)

- 4.10 In the south-west elevation there is evidence of three blocked doors, a blocked window and a first floor blocked window (**Plates 27, 30 & 31**), while in the north-east elevation there are three blocked doors interspersed with two extant windows and two further extant windows above at first floor level (**Plate 32 & 33**).

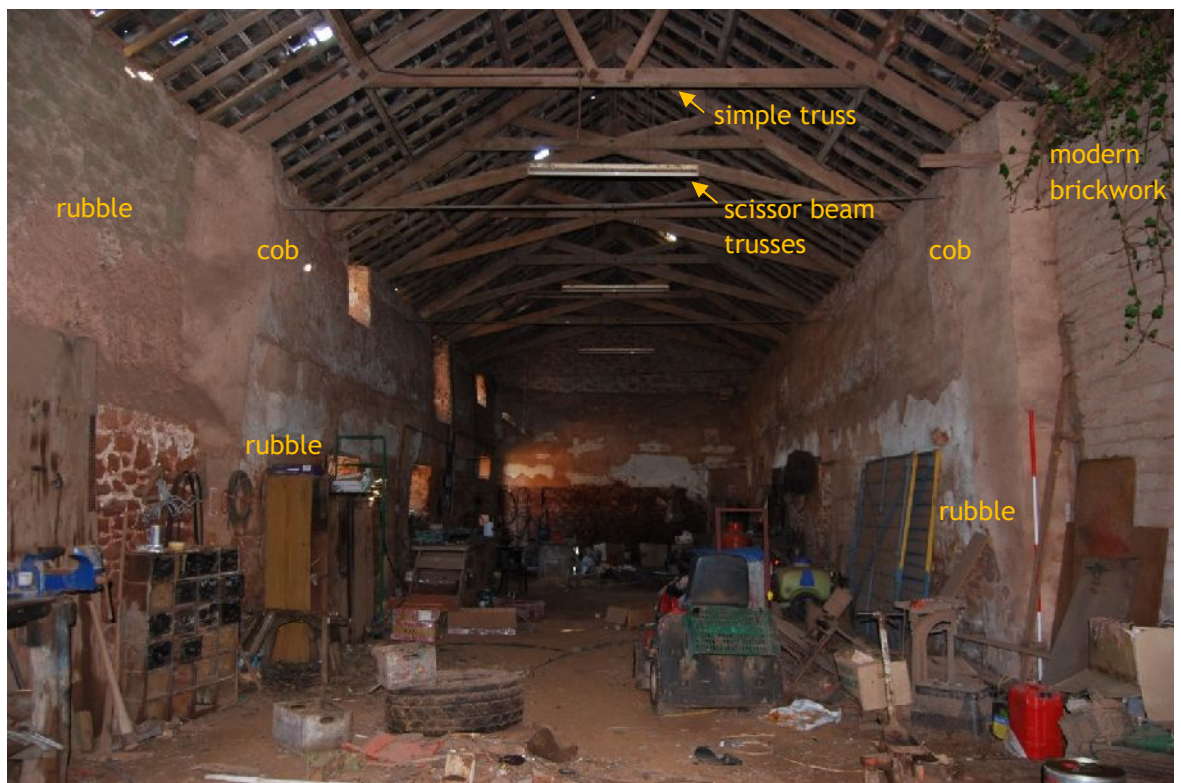
- 4.9 Internally, the change in build at the north end is not only marked by the use of different materials (see above) but the walls are also set back slightly (**Plate 28**). The original walling comprises random rubble with cob above and scissor beam trusses supporting the roof, with the single exception of a simple raised truss at the junction between the original fabric and the largely re-built north end (**Plate 29**).

Plate 28. Interior of B2 showing change in build at N end (from NW; 2m scales)

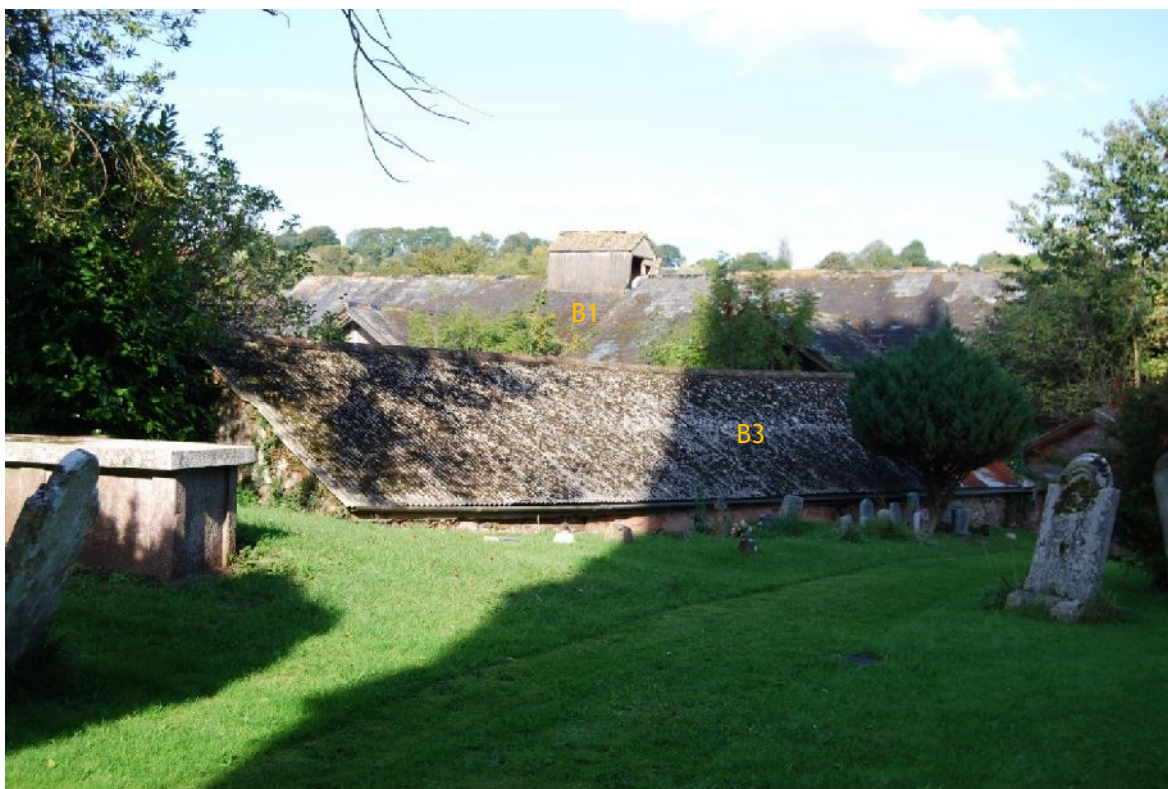
Plate 55. Roof of B3 adjacent to graveyard & roof of B1 beyond (from SSW)

- 6.2 The removal of modern agricultural buildings would vastly improve the appearance and setting of the historic farm buildings. From St Andrew's graveyard the roofs of these structures would no longer create an eyesore and their removal would open up rural vistas to the north (**Plate 57**). Views from the graveyard would also be improved by the removal of the lean-to attached to the south-west elevation of the main barns. This would also restore the overall impression of a single very long barn overlooking the farmyard and forming a visual focus both within and outside of Halberton Court Farm. It is recommended that the ventilation structure which has been added to the roof of the southern part of the main barn (B1) is removed, together with the modern brick structures along the south-west elevation. This would restore the original roof line and south-west elevation so that the projecting porches regain their significance. The appearance of the barns would also be improved by rendering the modern brickwork at the northern end of B2 or re-building this section of the wall so it is more in-keeping with the rest of the building. Evidence of blocked openings should be retained and existing openings re-used. It is doubtful that roof lights will be permitted on the side of the roof looking towards the church. The scissor beam trusses are a key element in the appreciation of these buildings and if possible should be left visible.
