173-181 Brandy Row  
Chiswell  
Portland  
Dorset

A PROGRAMME OF  
HISTORIC BUILDING  
RECORDING  
AND  
ARCHAEOLOGICAL  
MONITORING AND  
RECORDING

REPORT

June 2020

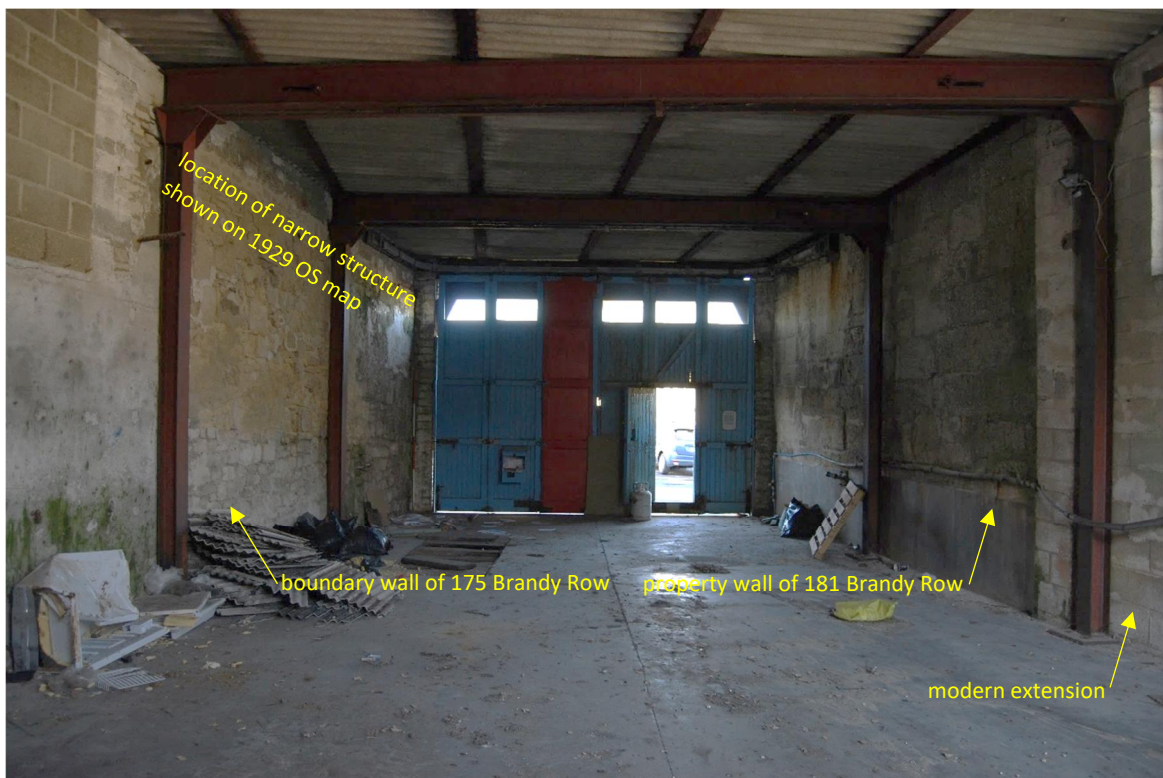
Figure 12. Building F with side walls formed by adjoining properties (2m scale, looking W)

between this house and another small property belonging to the terrace as shown on the 1892 and 1903 OS maps (**Figure 12**). The remainder of the wall follows an old boundary but has been re-built in concrete blocks (**Figure 13**). Similarly, the south wall is the boundary wall of 175 Brandy Row, the western end of which may possibly be a remnant of the cottage shown occupying this plot on the 1841 Tithe map (**Figure 12**). There are also marks from the long narrow structure built against the south wall before it was enclosed by an east wall (by 1959) and roofed (by 1973) (see **Appendix 2**). The east wall was partly constructed of stone rubble with concrete blocks making up the height and narrowing the yard entrance; this might suggest the latter was contemporary with the installation of the corrugated iron roof (**Figures 13 & 14**).

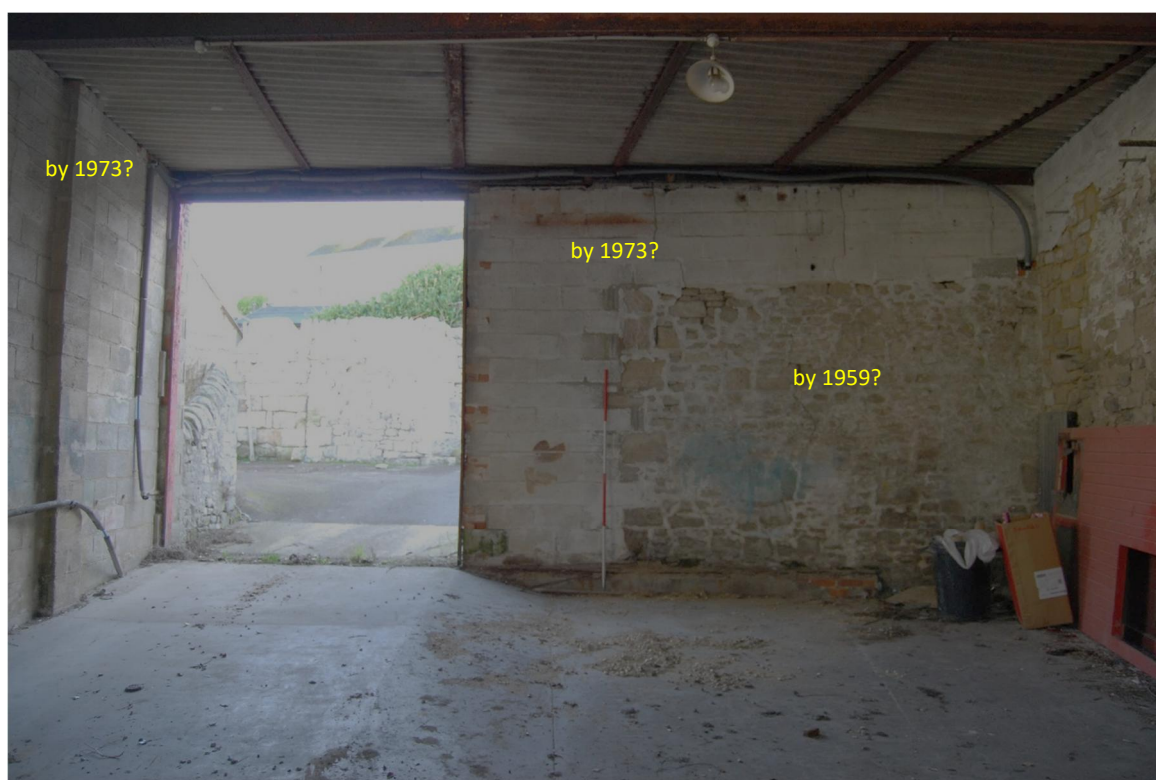
Figure 13. Building F with extended mid-C20 north wall & east wall (2m scale, looking E)

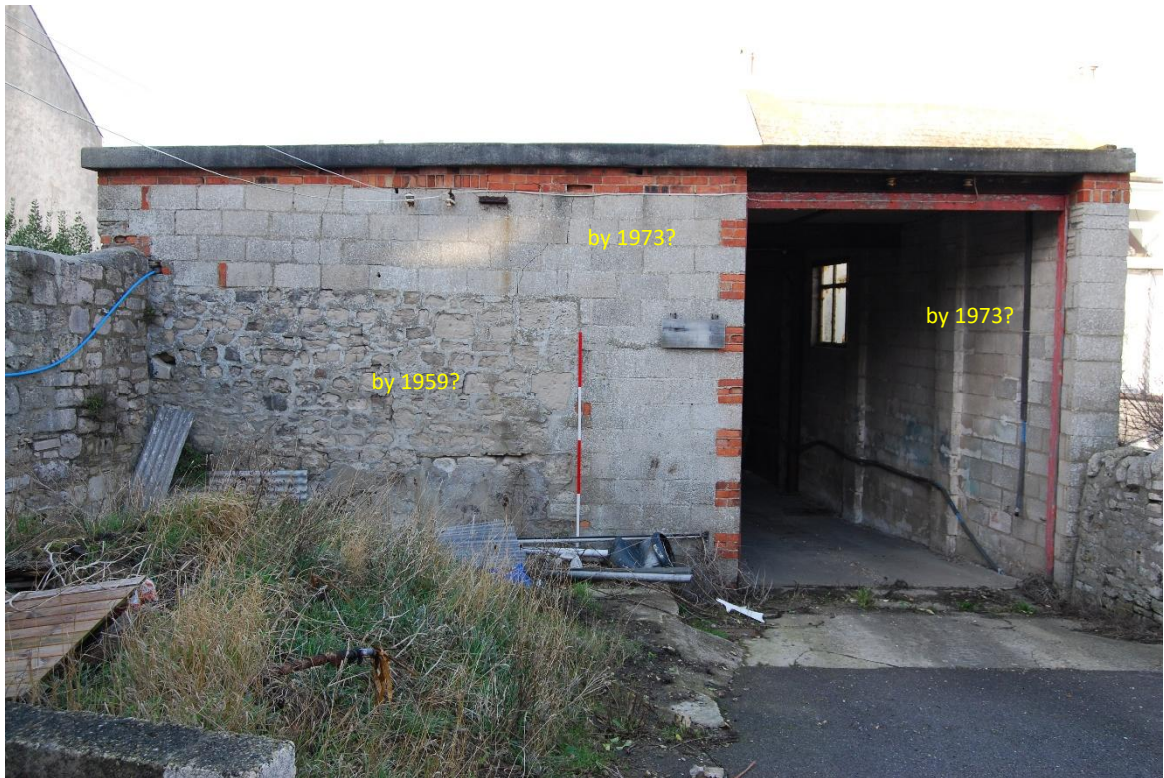
Figure 14. East end of Building F opening onto yard with extended mid-C20 north wall & east wall (2m scale, looking W)

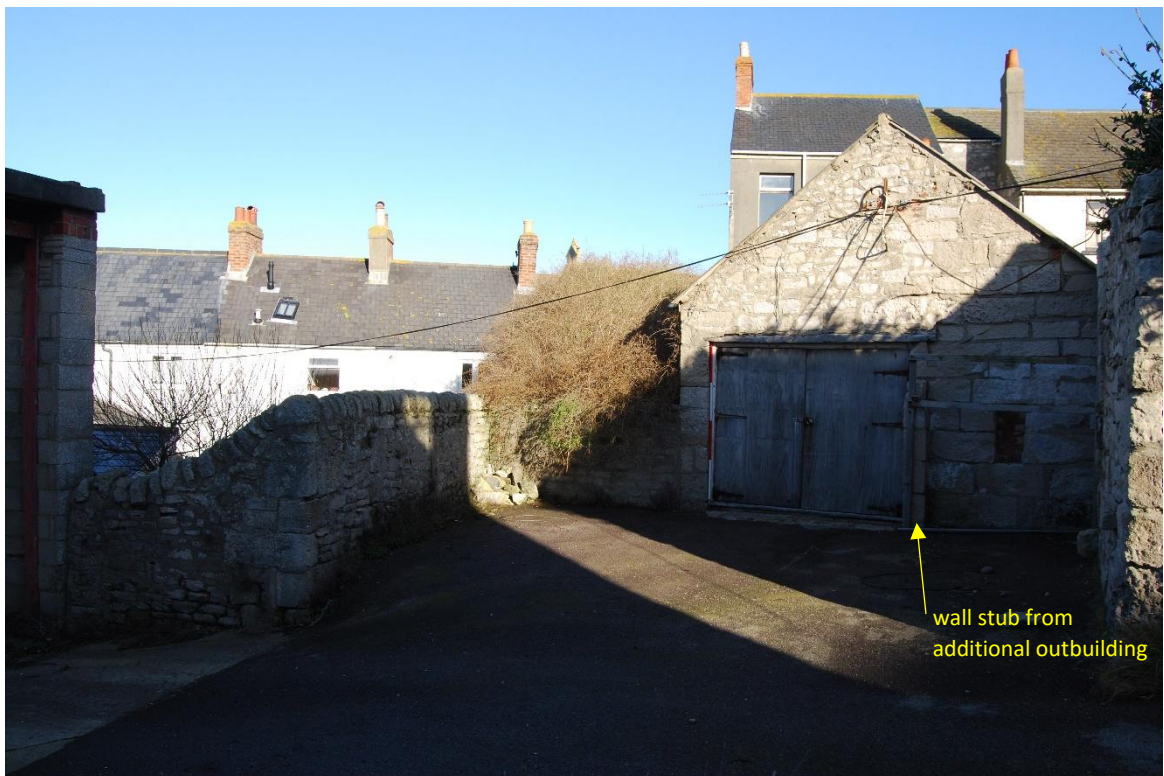
- 5.3 Building G is a single-storey pitched roof single room outbuilding, and is constructed of large dressed blocks of limestone (**Figure 15**). Only the south facing elevation was accessible, into which garage doors have been inserted. However, there is a small rectangular window opening that may be original, and a vertical line of protruding stones in the approximate centre (now forming the east side of the garage door) are a remnant of an additional small building as shown on the 1892 to 1929 maps, the roof line of which survives in the adjoining wall (**Figure 16**). The adjacent boundary wall is composed of random small rubble with some brick, with the eastern return incorporating another outbuilding of similar date to building G (but excluded from the development). Running along the south side of this building is a long, neatly constructed rubble wall separating the Site from the area to the north known as the Bull Ring (**Figure 17**). Finally, the high retaining wall along the east side of the Site is multi-phased, the original fabric no doubt represented by the coursed limestone rubble but with some areas of concrete blocks from more recent repairs (**Figure 18**).

Figure 15. Outbuilding at N end of Site with adjacent stone boundary walls (2m scale, looking N)

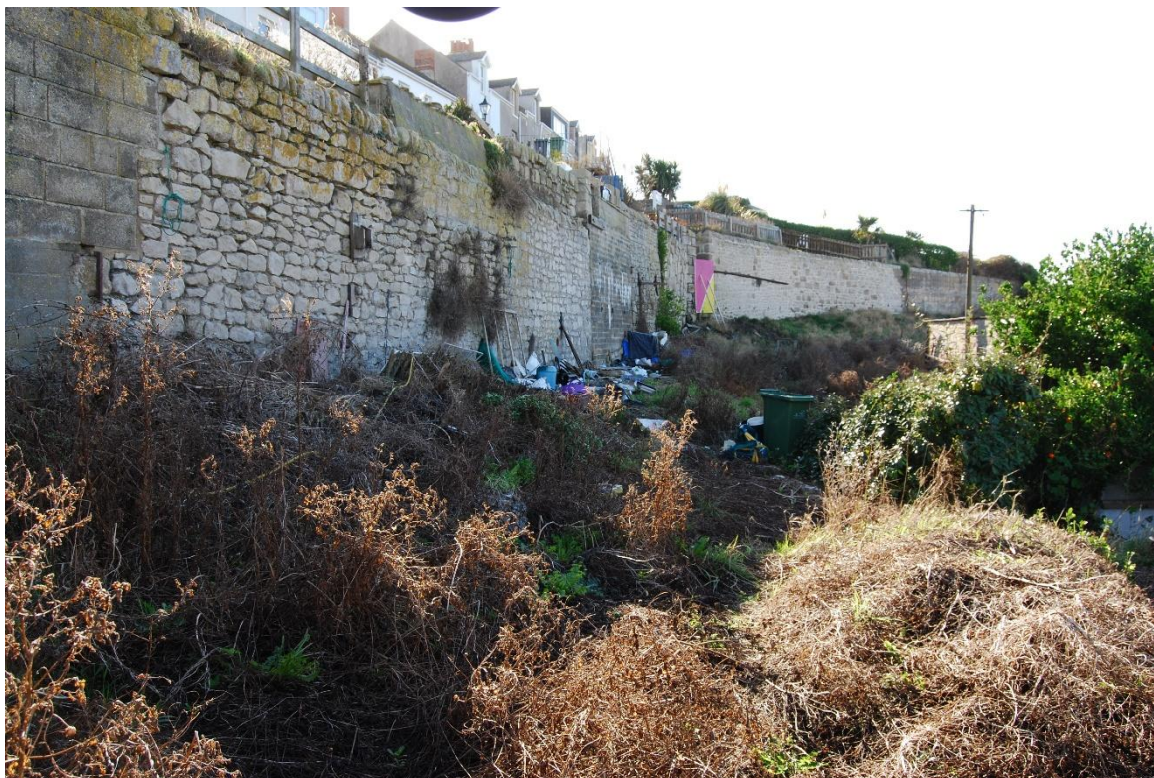
Figure 18. East retaining wall (looking S)

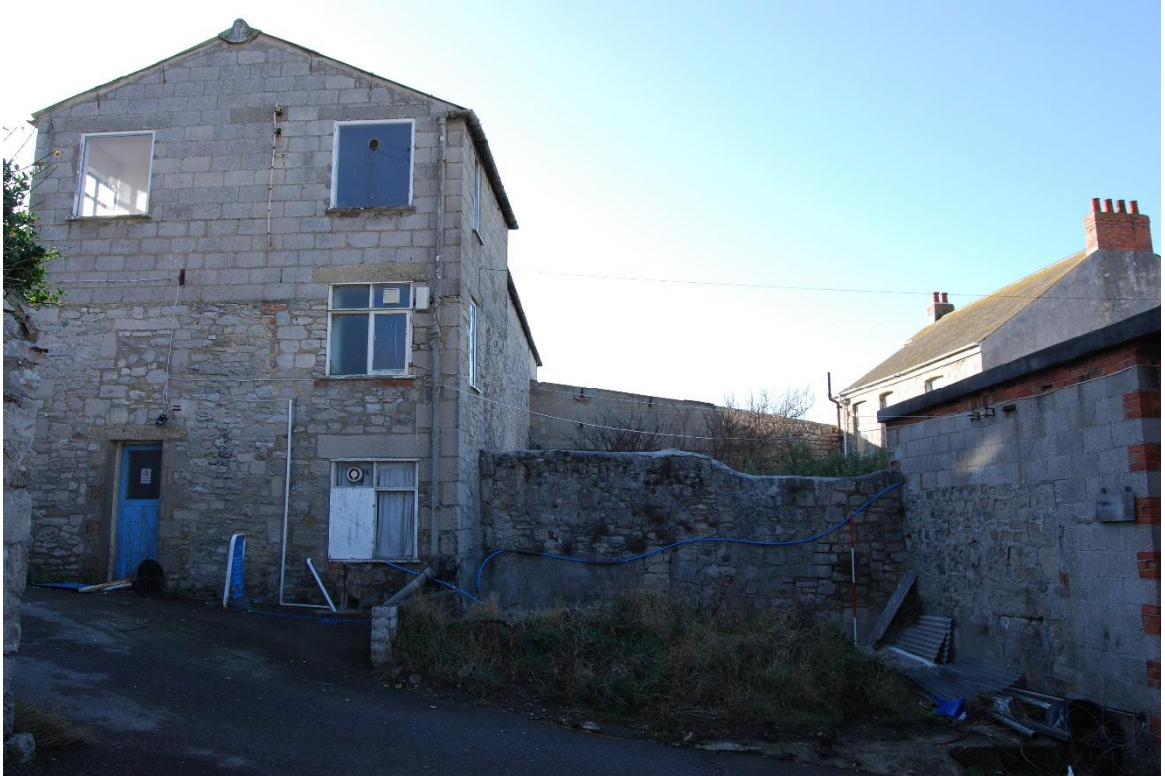
- 5.4 The complex was dominated by the two-storey building (building A) situated immediately east of building F (**Figure 19**). The north end of the building differed from the rest of the structure; it had a lower ground floor cut into the sloping ground, the upper storey had been re-built using concrete blocks whereas the lower storeys were of random rubble with larger limestone blocks for the quoins; and it was slightly wider with the west wall protruding from the main flank. The utilitarian windows were later inserts, although the ground floor window may have sat beneath an original lintel, and there was a small square blocked window at first floor level. By contrast, the main west elevation was predominantly of random rubble, with only three courses of concrete blocks at the top (**Figure 20**). No openings were observed however this wall directly overlooked the garden of 175 Brandy Row (doubling as its rear boundary wall) therefore this is not surprising. The east elevation was flush with the northern part of the building and was constructed of random rubble for the lower storey and concrete blocks for much of the second storey, with the exception of the southern end where only three courses of concrete blocks formed the upper part of the wall (**Figure 21**). The lower storey retained four original arched brick lintels for windows and one for a door; the door had been widened and one of the windows blocked with a widened doorway beneath recently blocked by concrete blocks. The upper storey had utilitarian windows and a double-opening timber loading door. The interior of building A mirrored the external observations, the upper storey of the main wing providing a large open space and the corrugated roof supported on an A-frame constructed of circular posts (**Figures 22 & 23**). This was accessed from the north end of the building via a wooden staircase (**Figure 24**), a solid stone wall dividing the southern wing from the wider north end (**Figure 25**). As mentioned above, the north end of the building has been subject to remodelling, with insertion of two floors used as offices and a lower ground floor for storage.

Figure 19. North facing gable of building A (2m scale, looking S)

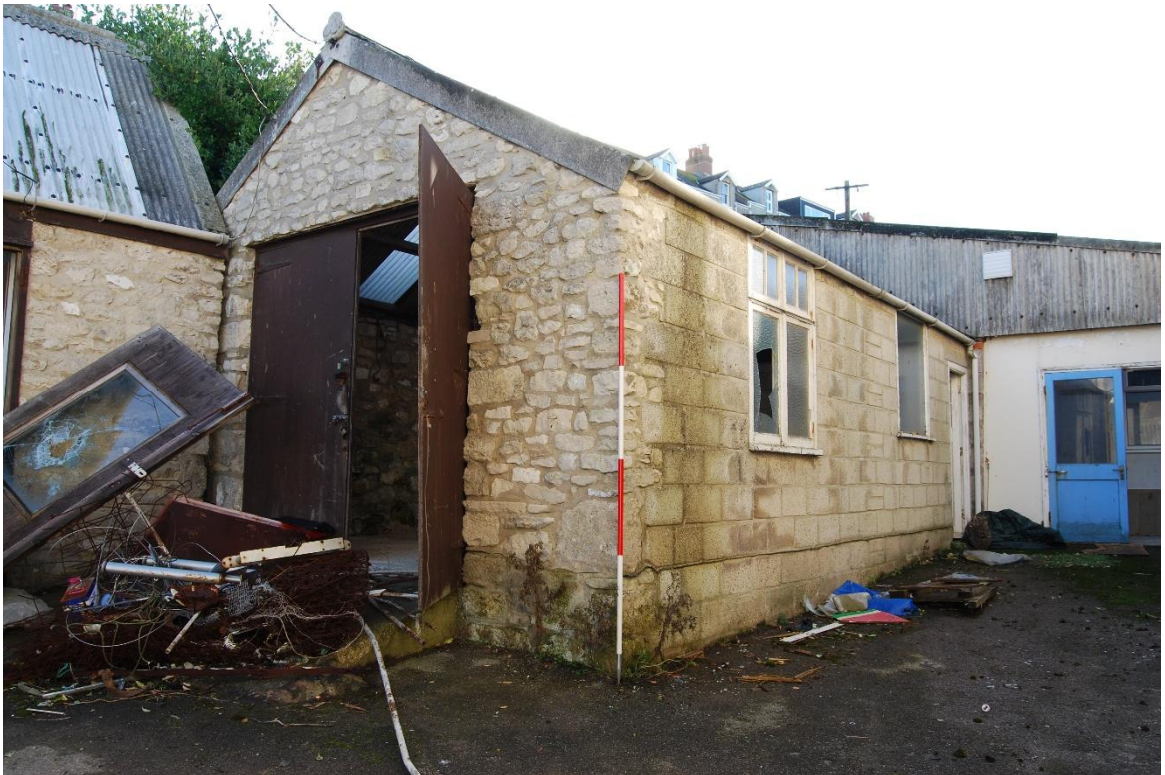
- 5.5 There were no distinguishing features to buildings B and C, which are most easily described as modern sheds utilising early 20<sup>th</sup> century walls of random rubble for the west, south and east sides (**Figure 9**). When the building was divided into two, as shown on the 1959 OS map, the unroofed central part of the south wall still served as a boundary. The buildings were reunited under one roof by 1973, at which time the connecting frontage was probably erected (**Figure 26**). Buildings D and E were simple pitched roof single room structures with no distinguishing features, and constructed of random rubble (although the west wall of building D had been largely rebuilt in concrete blocks (**Figures 27 & 28**)).

Figure 27. Building D (2m scale, looking SE)

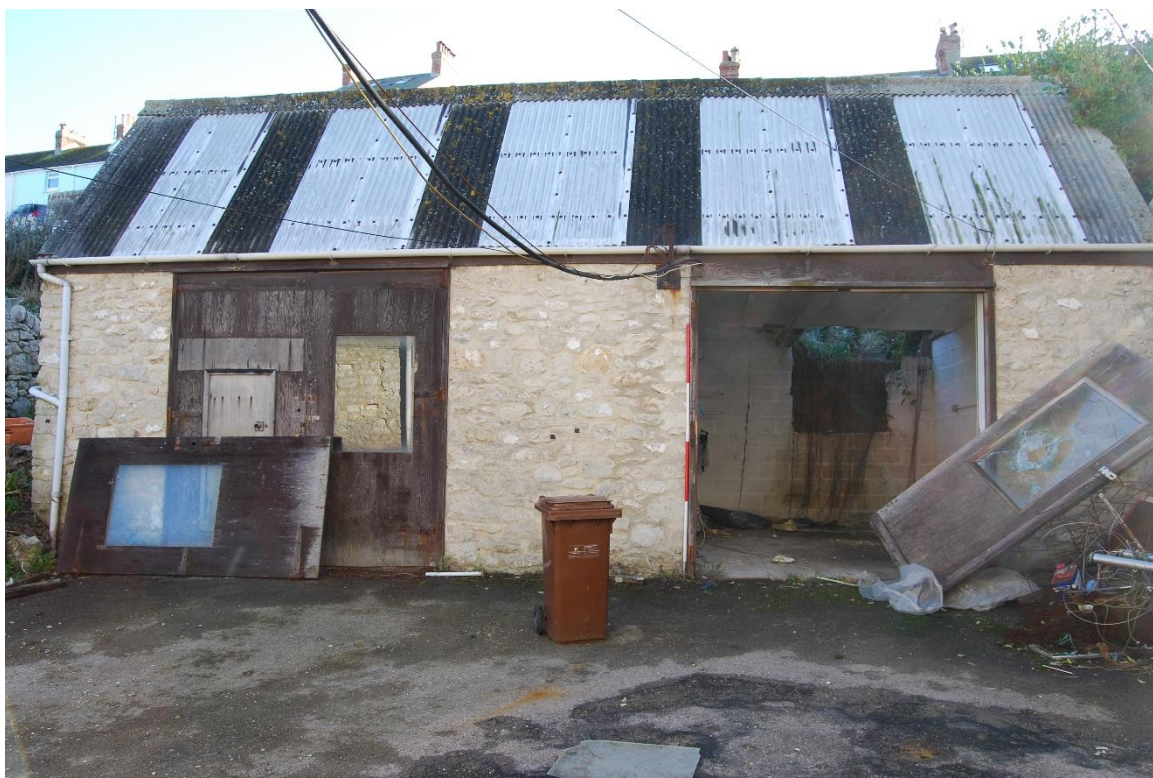
Figure 28. Building E (2m scale, looking E)

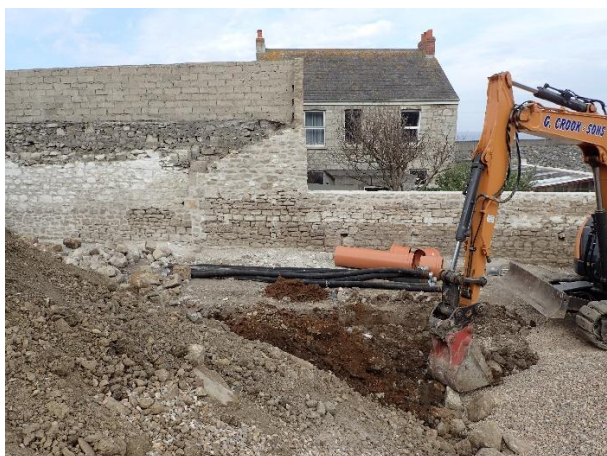
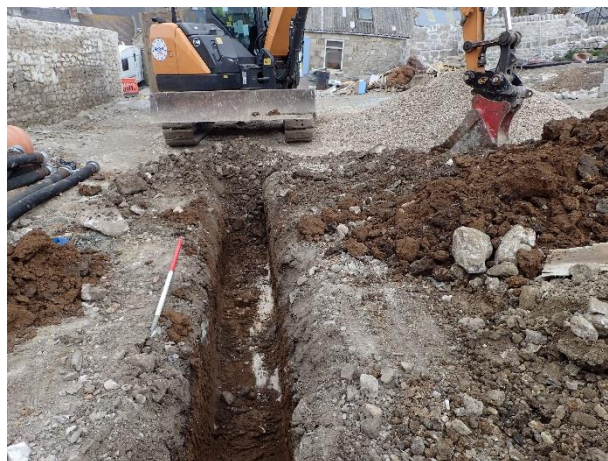
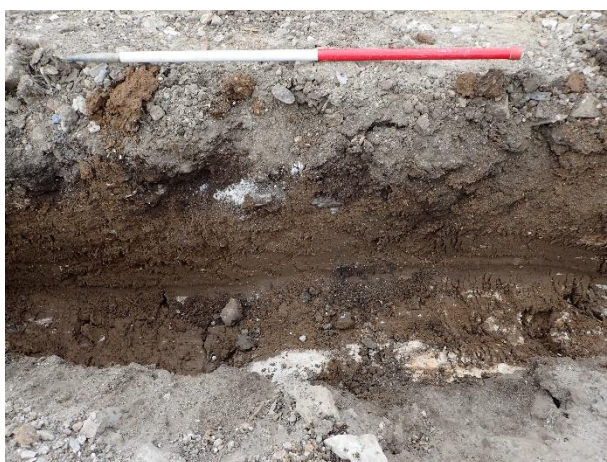
- 5.7 The trench was excavated within the area previously occupied by building A (**Figures 31, 32 & 33**). Directly beneath the base of the building was a 0.40m deep soil layer (100) containing fragments of Portland stone, shale and brick. As such, this may have been a make-up deposit associated with the construction of the building or simply a buried topsoil. This covered a 0.10m deep disturbed subsoil (101) which contained crushed Portland stone and shale but no brick. Beneath this was a layer of sterile natural silty clay (102) with a minimum depth of 0.10m; the underlying stone horizon rose up within the northern half of the trench. The borehole investigation undertaken a short distance to the south revealed made ground to a depth of 0.70m with a further 5.15m of landslip deposits (GA Site Investigation Ltd, December 2019). This would suggest that the deposits recorded in the archaeological trench relate to the same events, with the upper two layers (100) (101) forming 0.50m of made ground above landslip deposits. As such, the stone horizon encountered in the base of the trench was probably redeposited as opposed to solid bedrock.

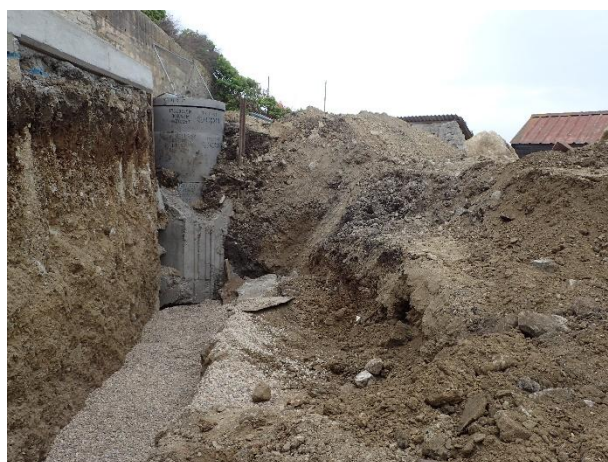
- 5.8 Piling along the eastern boundary of the Site revealed a c. 1.00m deep garden soil above at least 3m of landslip deposits (**Figure 34**). The loose nature of these deposits and the excavation depths negated more detailed recording.

Figure 34. Deep piling alongside E boundary wall (looking S)

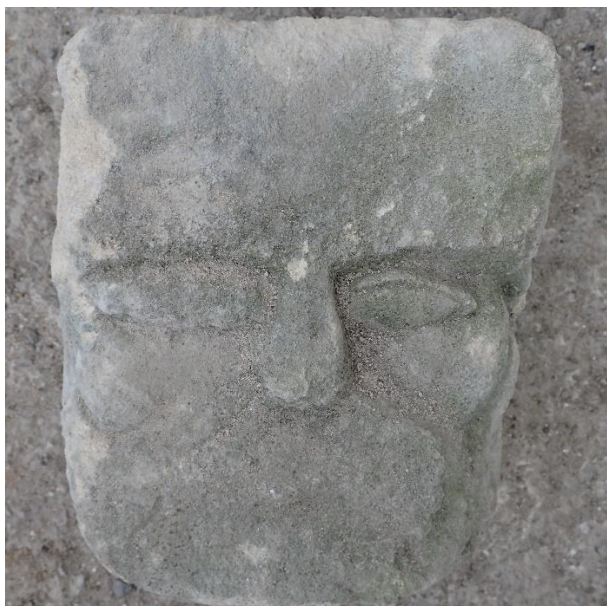
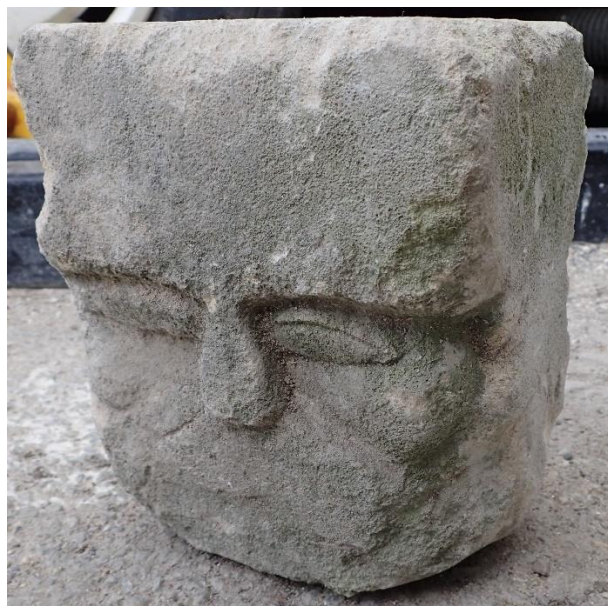
- 6.1 No finds were observed or collected during the course of the investigation, although a small stone sculpture of a head was recovered during renovation of building G and shown to the author by Stuart Wilson (**Figure 35 & 36**). Carved from Portland Stone and measuring 0.30m tall, it is an unfinished, schematic carving of a

face and may have been a practice piece or a waster. The object is being reincorporated into the building from which it came.
