Church of St Mary
the Virgin
New Park Street
Devizes
Wiltshire

ARCHAEOLOGICAL MONITORING & RECORDING

November 2020

C1 project code: C1/AMR/20/MDW

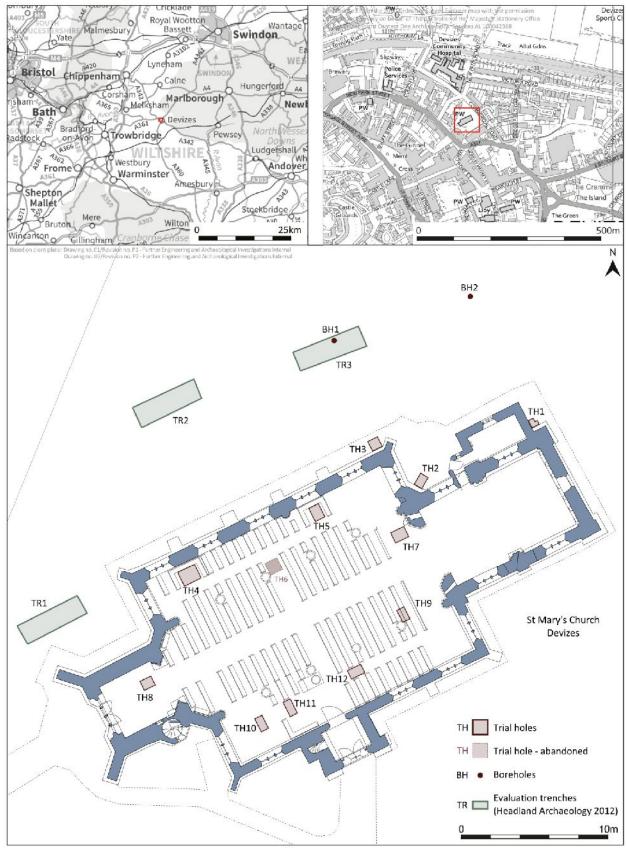
Figure 1. Site setting with trial hole and borehole locations

- 5.2 The three exterior trial holes were positioned along the north side of the nave and chancel, exposing variations in foundations relating to different phases of the church (Figure 1). The foundations of the Norman chancel adjacent to the vestry comprise a single course of oolitic limestone ashlar with diagonal tooling marks, below the plinth course and overlying a lower foundation of greensand rubble bonded by greensand (Figure 3). Despite having a Victorian construction date, the vestry foundation employs similar sized oolitic ashlar blocks to the chancel, also with diagonal tooling, but with three courses above a lower greensand foundation. At the east end of the north aisle TH2 exposed a 0.50m wide foundation of oolitic limestone rubble set within a soft yellow lime mortar (Figure 4). Within TH3 the north-east corner of the nave was observed to sit directly on a foundation comprising two courses of oolitic limestone rubble, over a lipped greensand foundation (Figure 5).

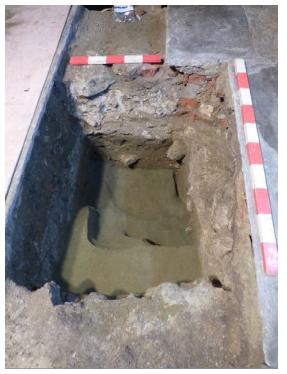
Figure 8. TH7 showing intercutting graves & intact coffin in S section (looking S; 0.50m & 1m scales)
