BARN, LAND EAST OF "ELLESMERE",
BACK WESTGATE, HORNSEA, EAST YORKSHIRE

ARCHAEOLOGICAL RECORDING

Report no: 2007/311.R03
Version: Final
Date: June 2009
Author: Shaun Richardson & Ed Dennison

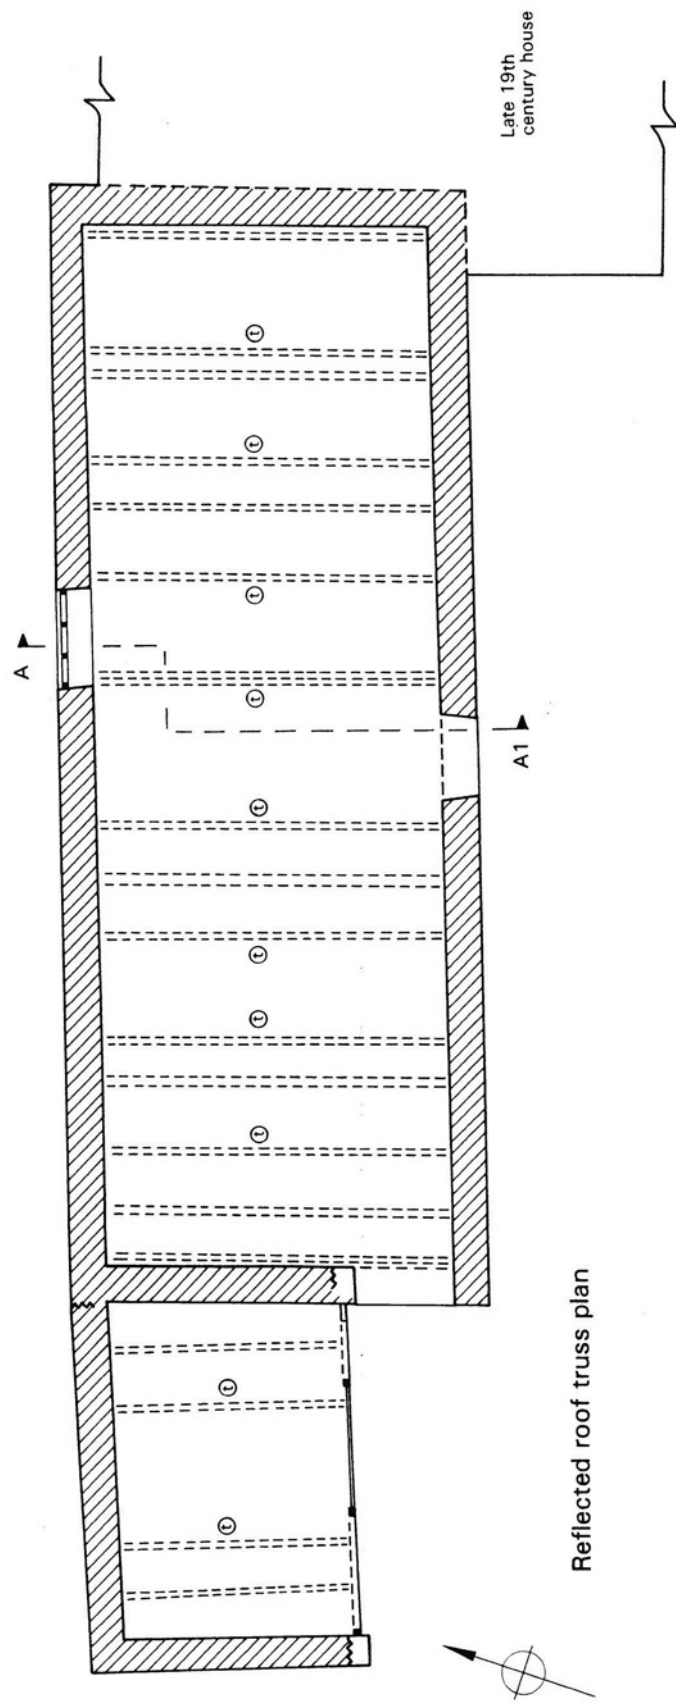
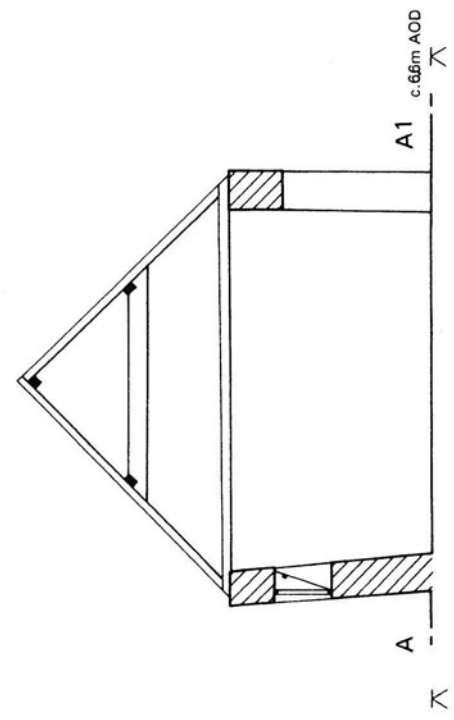
PROJECT	BARN, BACK WESTGATE, HORNSEA		
TITLE	ROOF TRUSS PLAN AND SECTION		
SCALE	AS SHOWN	DATE	JUNE 2009
EDAS		FIGURE	5

- 3.14 The principal surviving feature of interest to the barn's interior is the roof structure (1/09 to 1/11 and 4/12) (see plate 5). This is of two distinct phases. The earlier roof structure is divided into nine bays by common rafter trusses, placed at every fourth pair of rafters. The bays are all of approximately equal size, apart from that over the formerly opposed doorways in the north and south walls, where the trusses are set slightly further apart. The roof structure appears to be in softwood and is of nailed construction throughout, using large square headed hand-made iron nails. Each of the common rafter trusses has a raised plank collar, with a single purlin to each rafter set into a notch in the collar (1/12 to 1/14); the purlins are joined over the third truss from the east end of the roof using a simple splayed scarf. The rafters meet over a diamond-set ridge piece. There appears to be no surviving wall plate to the north wall, it perhaps having been replaced by the two courses of brickwork at eaves level, but there may be a wall plate surviving intermittently along the south wall. The later whitewashing of the roof timbers made the identification of any carpenters' marks and assembly marks difficult, but none were revealed following an examination using oblique torch light. Several of the collars do however preserve closely spaced vertical saw marks.

- 3.15 The earlier roof structure has developed a marked racking from east to west, and at a later date, several other timbers were laid between the tops of the walls to support props or struts rising to the purlins (2/00 and 2/0). These later timbers vary in scale from telegraph poles to narrow softwood planks, and are secured either to the wall or to the earlier trusses by wrought-iron straps of varying form (2/01 and 2/02) (see plate 6). Two closely-spaced later timbers at the west end of the roof structure support a small galvanised water tank, with water pipes running from the tank along the north and south walls of the interior.

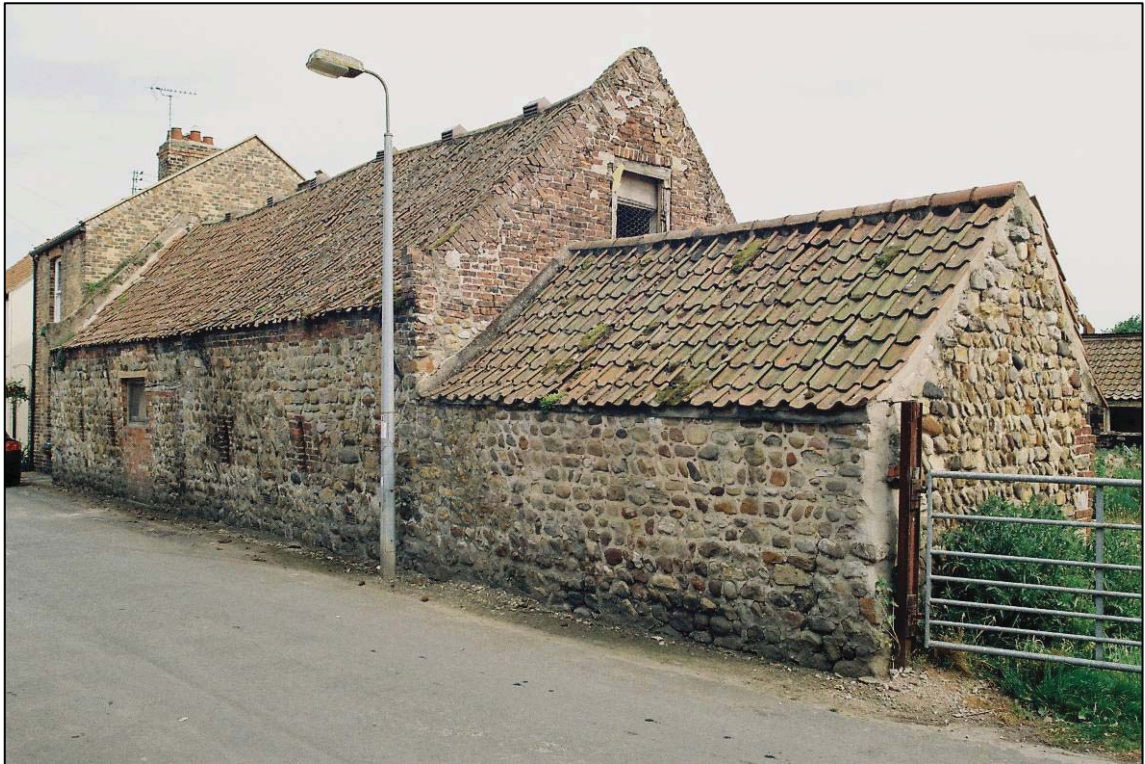
Plate 1: North elevation of barn and attached building, looking SE (photo 2/25).

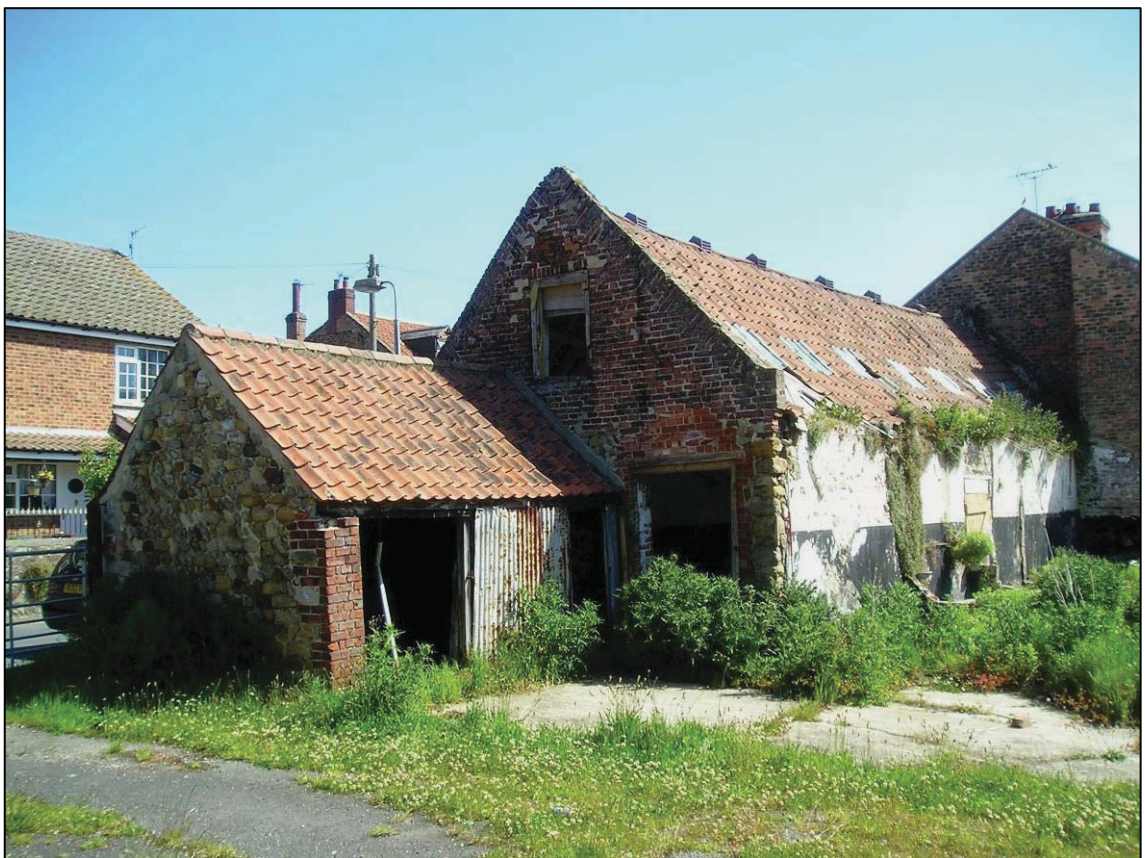
Plate 2: West and south elevations of barn and attached building, looking NE (photo 4/04).

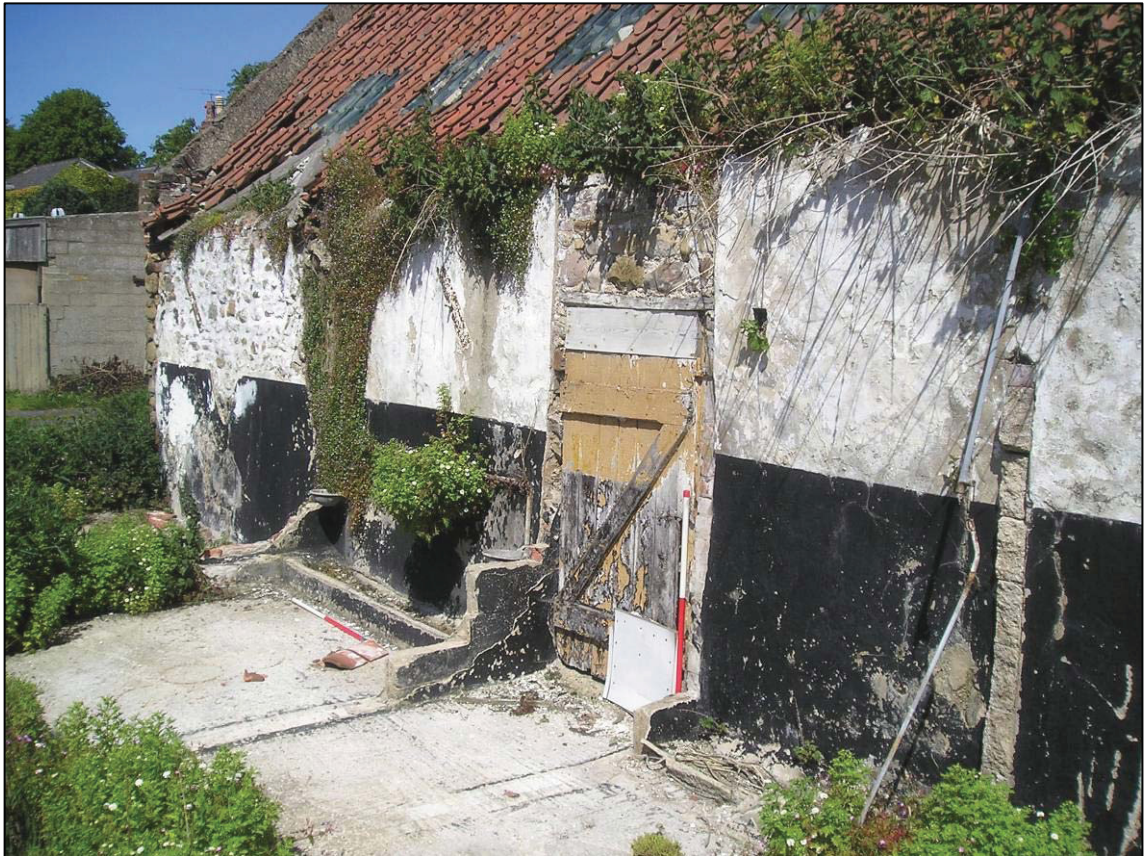
Plate 3: South elevation of barn, showing concrete troughs, looking NW (photo 4/10).

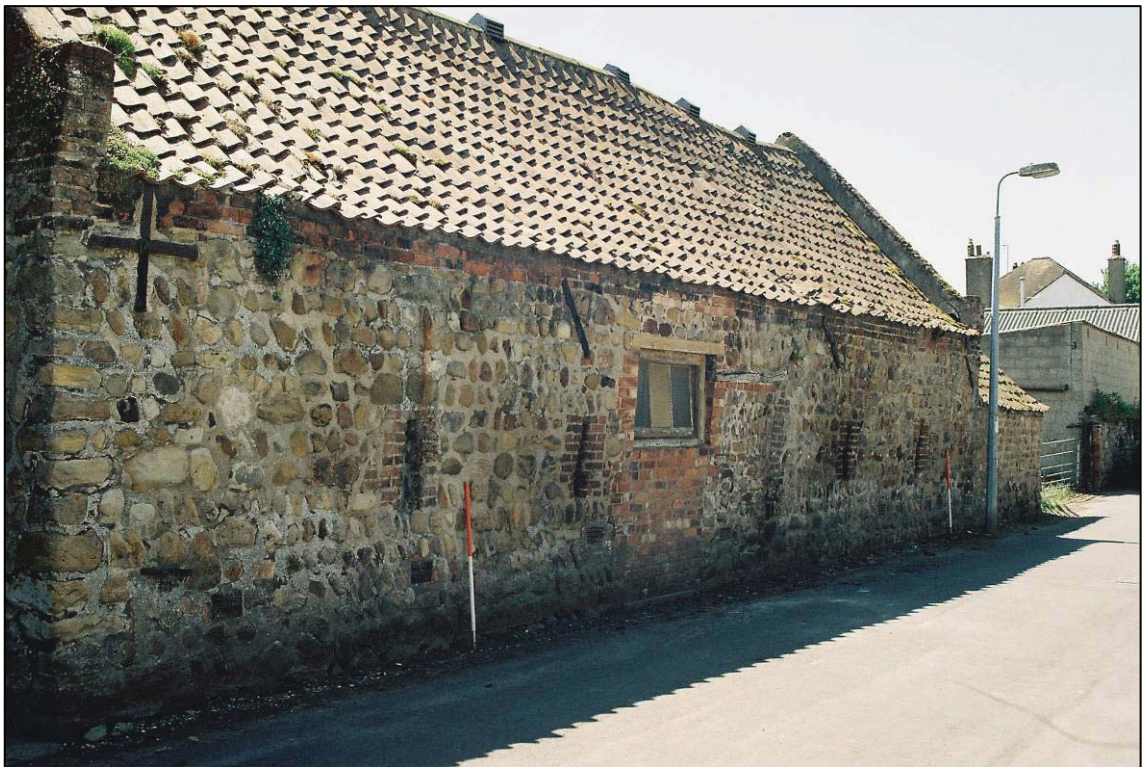
Plate 4: North elevation of barn, showing wall tie-plates, slit breathers and blocked doors, looking SW (photo 1/21).

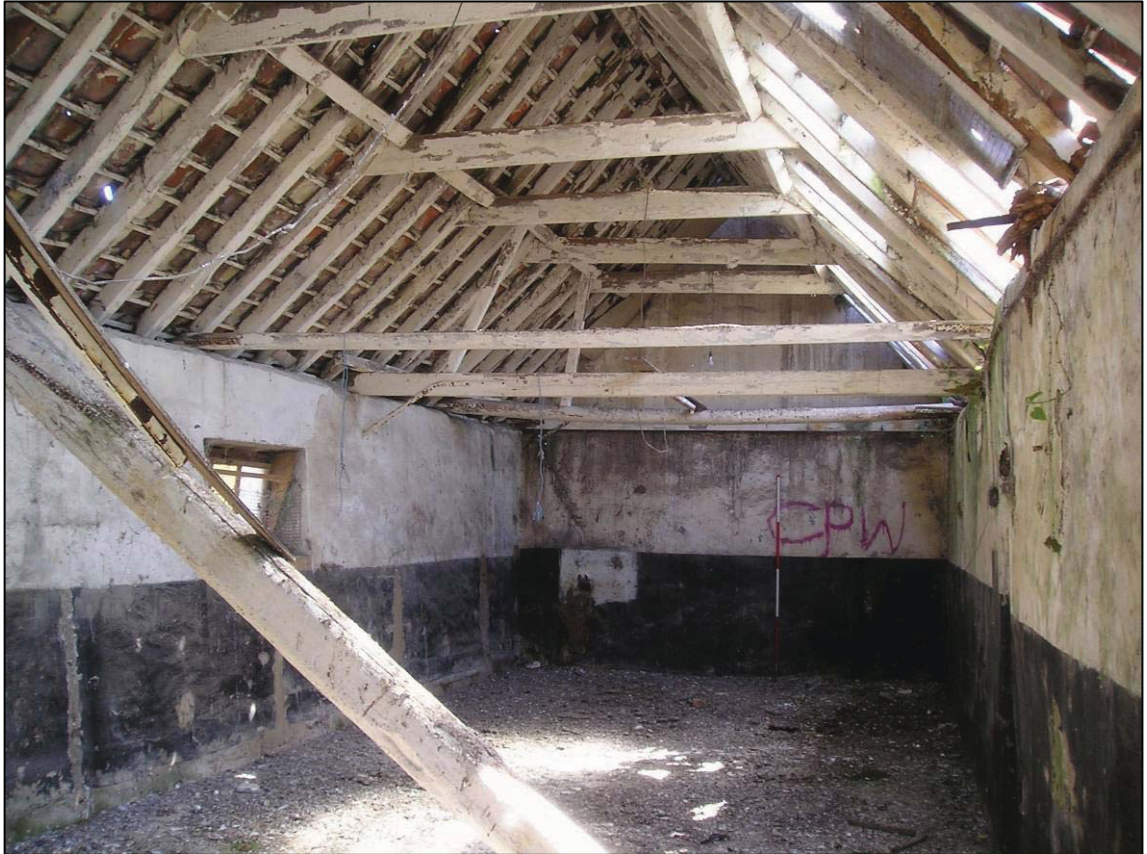
Plate 5: Interior of barn, looking N (photo 4/13).

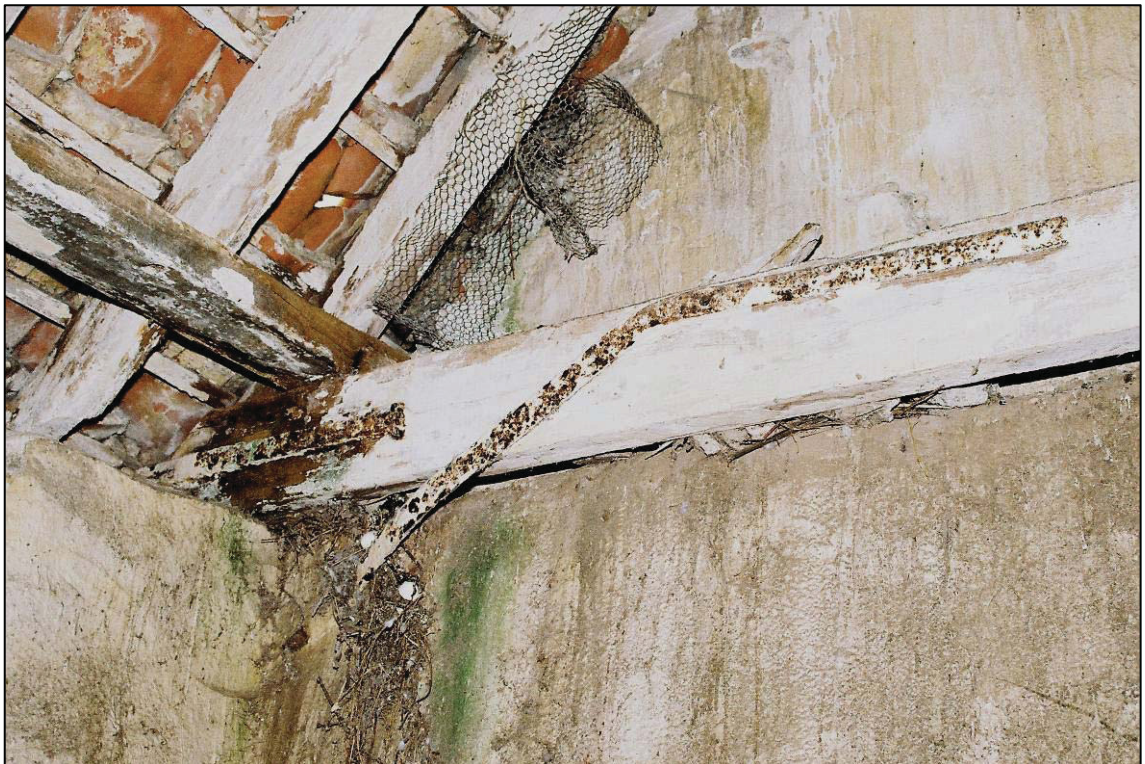
Plate 6: Brackets to later phase of roof timbers in barn, looking N (photo 2/02).
