ST GILES' CHURCH, BIELBY, EAST YORKSHIRE

ARCHITECTURAL AND ARCHAEOLOGICAL SURVEY

Report no: 2005/278.R01
Version: Final
Date: December 2009
Author: Ed Dennison & Shaun Richardson

St Giles' Church PCC
c/o Peter Gaze Pace Architects
The Old Rectory
Scrayingham
York YO41 1JD

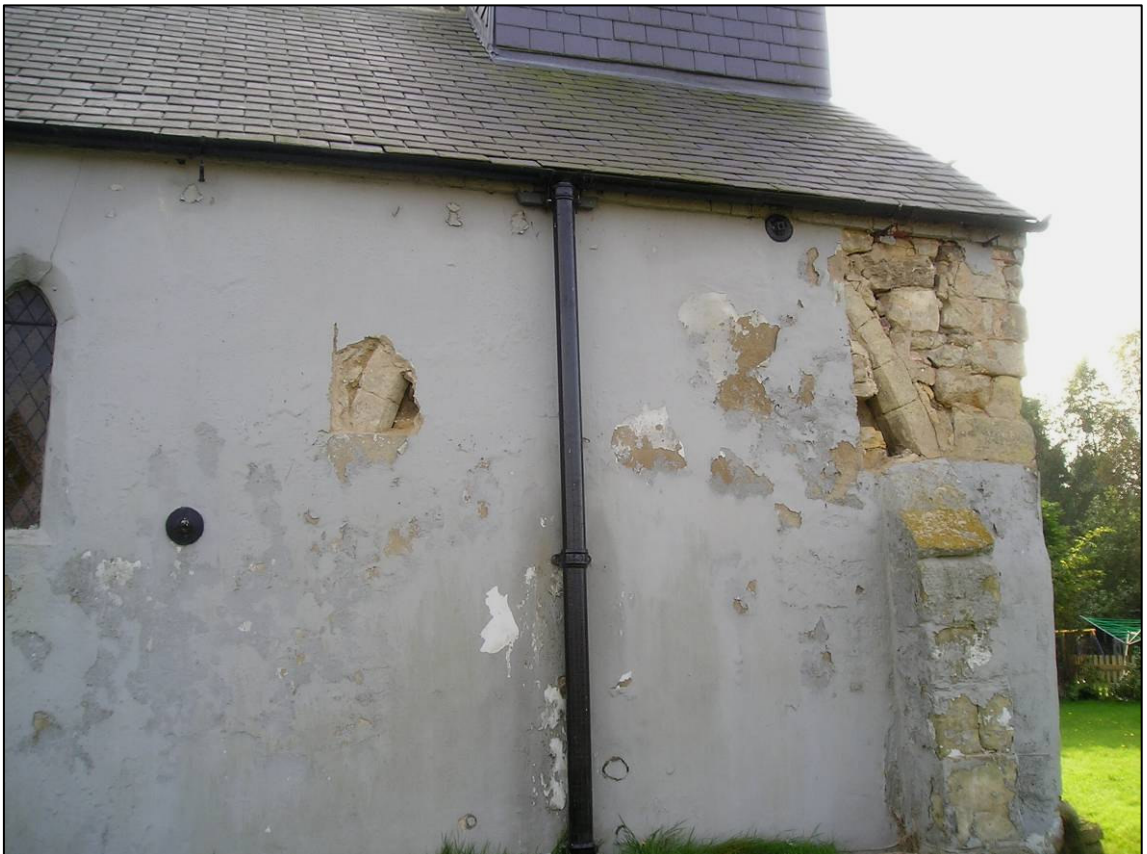
- 3.8 Prior to the removal of the render, the external appearance of the church was rather drab and primarily of the late 18th century, with the exception of some obviously re-used earlier fragments. However, earlier descriptions (for example, the Listed Building description made in 1967; see Appendix 2) noted the presence of *in situ* features which suggested that the former north aisle arcade survived intact, having been plastered over internally only as recently as 1965. The removal of sample areas of render prior to the main phase of works showed that it was between 0.12mm-0.75mm thick (see plate 2).

Plate 2: Sample render removal, west end of north elevation, looking SE.

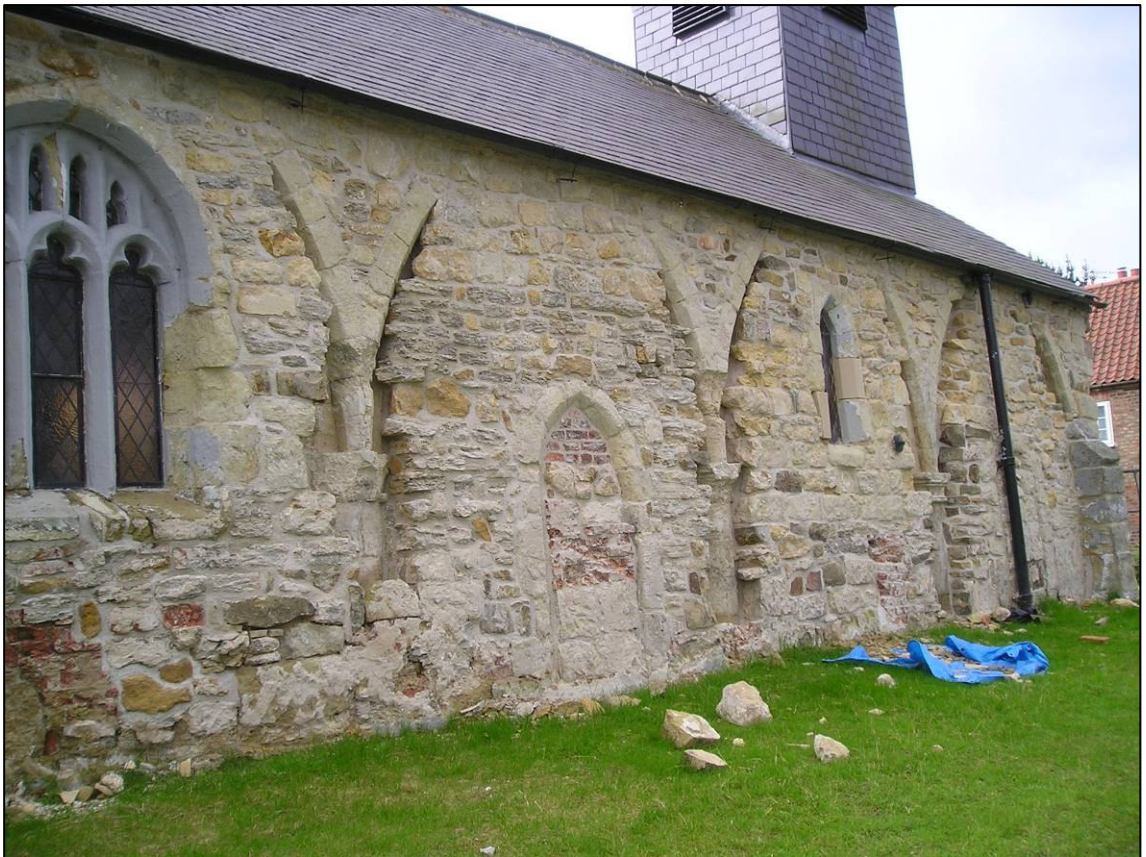
Plate 3: North elevation after removal of render and partial consolidation, showing exposed arcade, looking S.

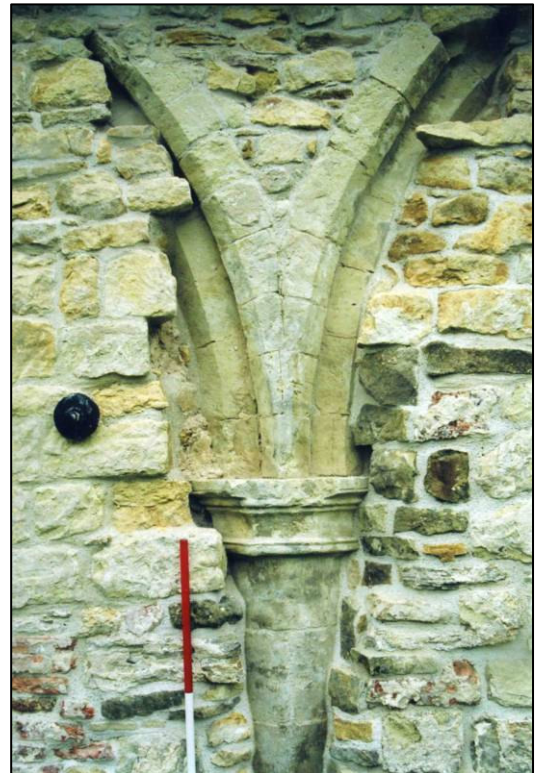
Plate 7: Detail of exposed arcade pier, after consolidation, looking S.

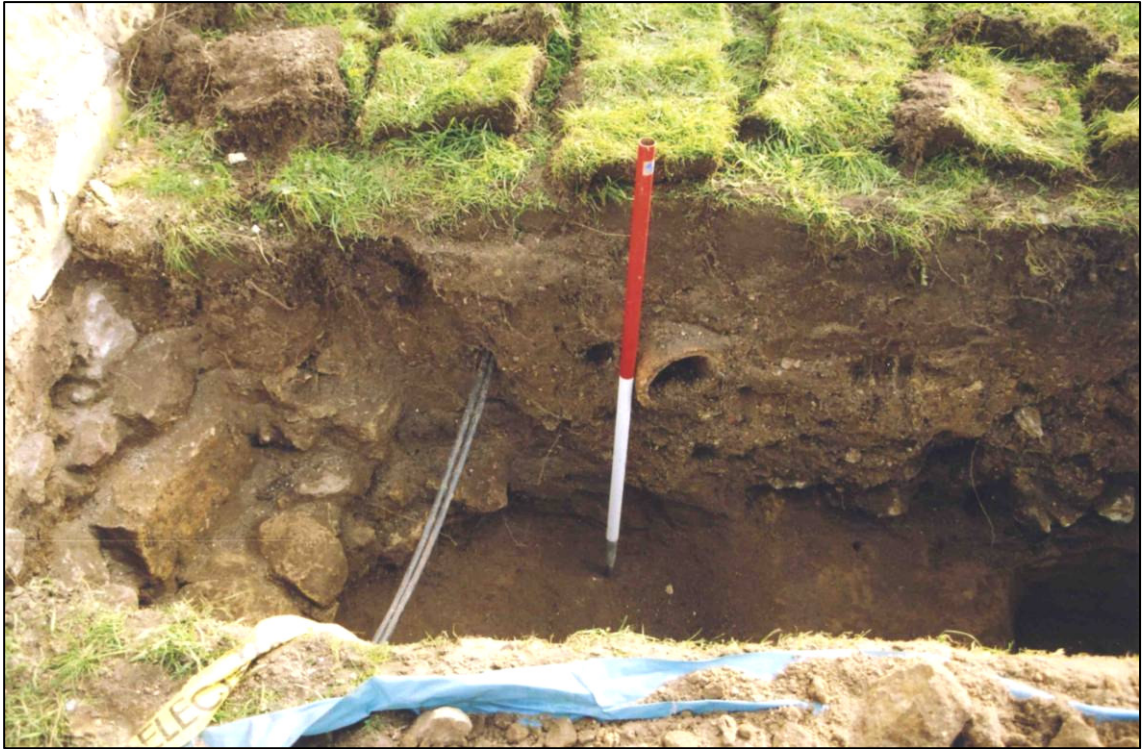
- 4.5 The gritty mid-brown silty sand (004) overlay a clean mid-brown sand (008), which was 0.24m deep and appeared to have been deposited over two areas of foundations. The first area (007) projected a maximum of 0.75m to the west of the north-west corner of the church, and the stonework was crudely stepped. These footings were a maximum of 0.70m deep and were comprised unmortared pieces of sandstone rubble, some of which were up to 0.30m long and roughly squared (see plate 8). They almost certainly once extended further to the west, but they had subsequently been truncated by a deposit of soft mid-brown sand (008). The second area of footings (009), which may once have been continuous with 007, was set c.1m to the west, and comprised a faint spread of unmortared sandstone and mudstone rubble (0.14m deep), more clearly visible in section than in plan. The soft mid-brown sand (008) then continued to the west. Both footings rested directly on the surface of a clean mottled orange/brown sand (010) which was exposed for a depth of 0.34m in the trench; this deposit was the natural geology which continued below the base of the trench. Unfortunately, the precise relationship between the soft mid-brown sand (008) and the two areas of footings (007 and 009) was not entirely clear, although the sand appeared to overlie the footings.

Plate 8: South side of Trench 1 showing footings (007), looking SE.

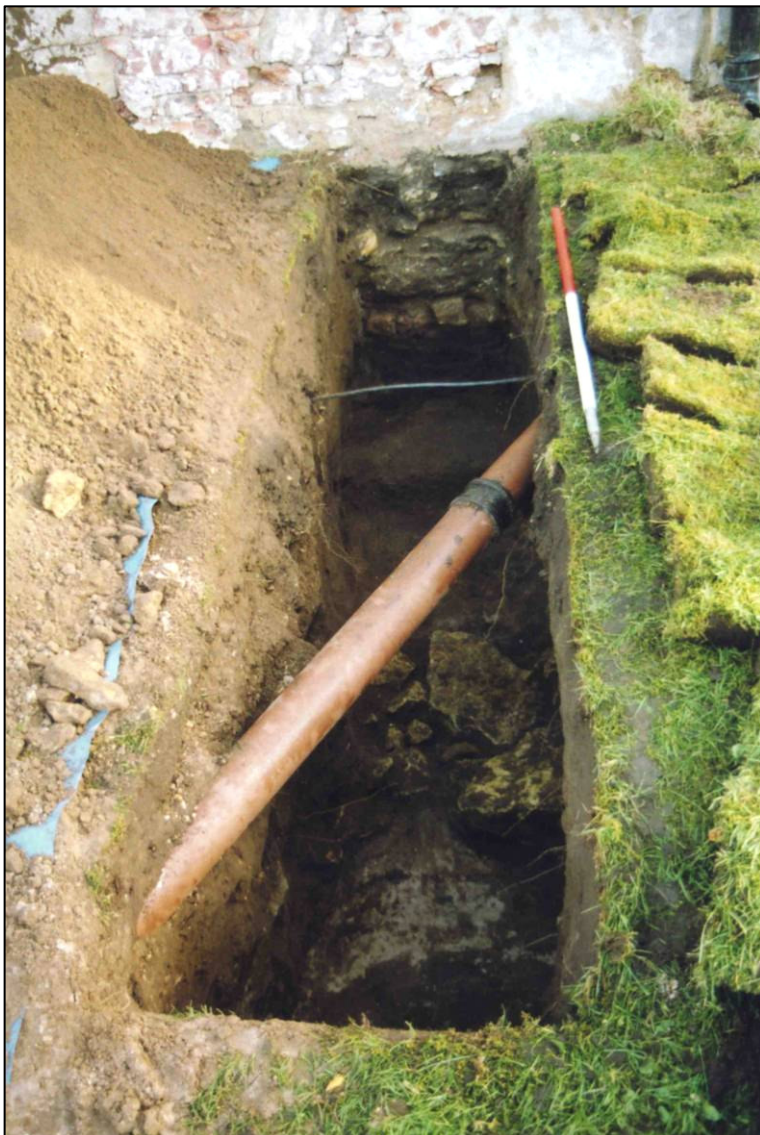
- 4.8 In the south section of the trench, the sand (014) was observed to run beneath the footings of the north elevation of the church (011). Within the trench, the footings comprised a single large sandstone slab, supporting the base of the arcade pier buried in the wall at this point, which rested on a level bed of squared sandstone rubble, some of which had been burnt. However, in the east and west sections of the trench, the sand (014) overlay a section of east-west aligned wall footings (015), 0.22m deep and running parallel to the church's north elevation. These footings were built of unmortared sandstone rubble, some roughly shaped into pieces c.0.30m square, and they lay directly on the surface of a soft greyish-light brown mottled sand (016) (see plate 9). This was only visible in the base of the trench and was a natural deposit.

Plate 9: Trench 2 after excavation, showing footings (015), looking S.

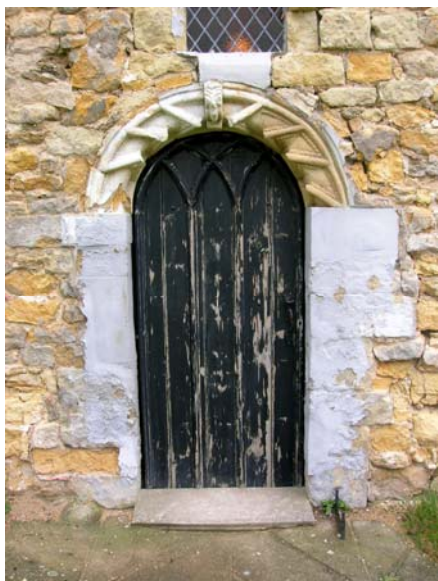
The stone surround to the arched doorway is painted in the same grey masonry paint as the window of the South-East, although the carved details of the upper elements are different, being decorated with a single chevron across the moulding and a beaked animal on the keystone. Stone repairs were executed to the moulded elements in 2003 in a sympathetic manner, but some of the repairs have since failed and further delamination of the stone has occurred, especially to the North side.

Photograph 1 – West elevation:
Doorway with chevron decoration and paint remains

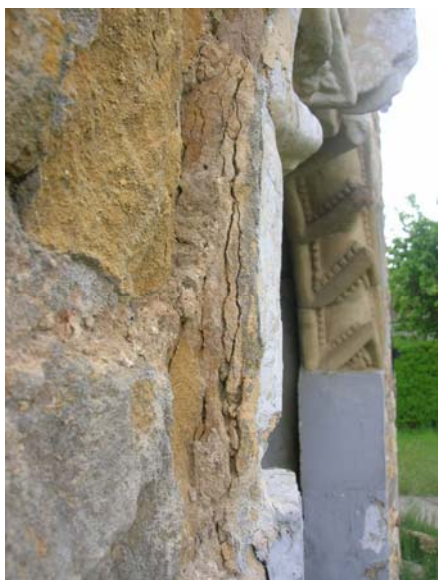
The North side of the door surround is coated with several different paint layers whilst the South side is exposed stone. The carved detail on this South side is in quite good condition and remains crisp apart from a few losses and some minor flaking. This part of the moulding is believed to have been replaced with a different stone material during the restoration phase of the 18th Century. However, the North side of the door surround is in extremely bad condition, with the zigzag profile completely lost and the stone below flaking and de-scaling to its core. The element above the door shows similar fractures and detachment, with the loss of larger elements and carved detail. Most of the damage is associated with moisture ingress and salt movement. At lower level, the stone shows some remains of render and possibly some previous repairs. The stone is in very bad condition.

Photograph 2 – West elevation:
Detail of deteriorating stone to the carving

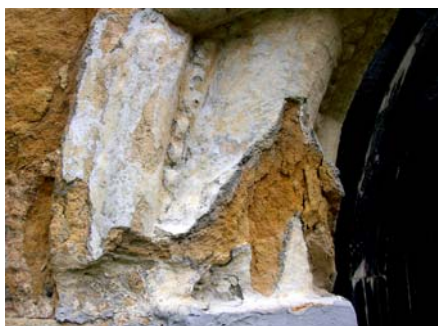
Photograph 3 – West elevation:
Detail of deterioration to the carvings of the West doorway

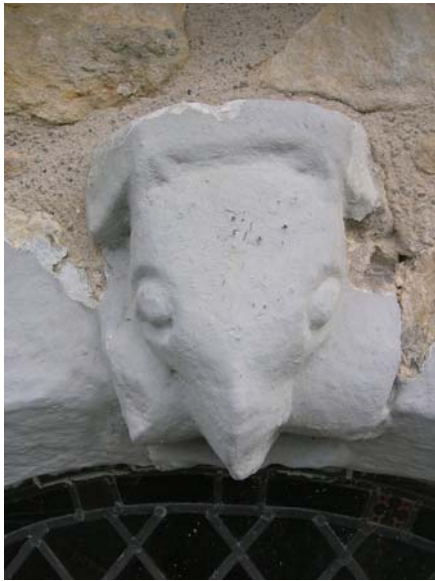
Photograph 4 – South elevation:
Keystone

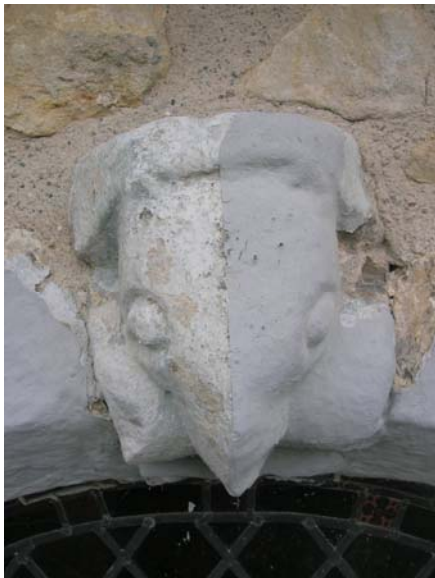
Photograph 5 – South elevation:
Uncovering trial to keystone revealing further layers of
paint

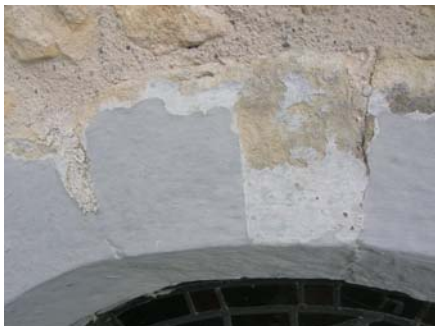
The stone window surrounds to the South elevation are currently painted in a grey coloured paint beneath which are visible several other paint layers. In most areas, the paint layers are flaking and are delaminating. The top grey layer appears to be a modern masonry paint while the layers below are most likely various limewashes of blue/grey colour. The same grey masonry paint has been applied to the buttress. The buttress has been added at a later stage as a structural support against the extensive monuments to the West wall, which have caused the North and South wall to clew away.

Photograph 6 – South elevation:
Uncovering trial to window stone surround

Some stones of the windows surrounds may require pinning with stainless steel pins.

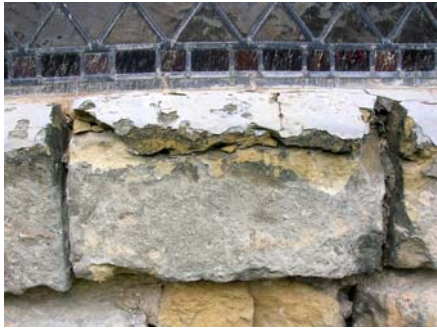
Photograph 7 – South elevation:
Detail of stone damage to the window sill

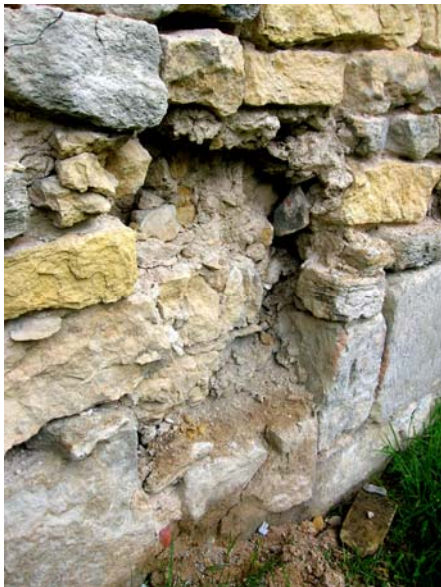
Removal of the render has revealed some structural problems, which include deteriorated stone blocks, particularly in the lower levels at South elevation to the West corner and within the West elevation where a large fracture that displays some movement is apparent. The East elevation is in generally good condition.

Photograph 8 – South elevation:
Detail, damage to the stone work at low level

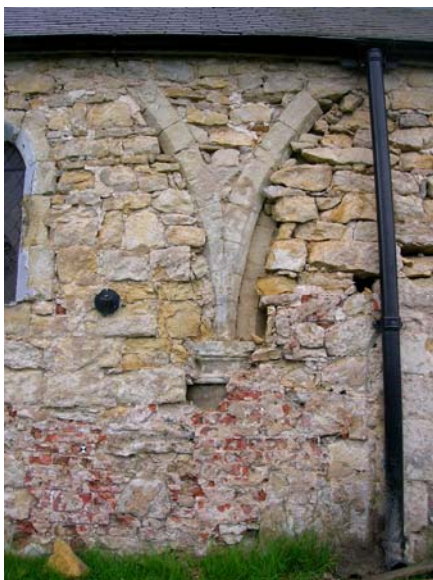
Photograph 9 – North elevation:
Blocked up arches with columns from the previous
North aisle

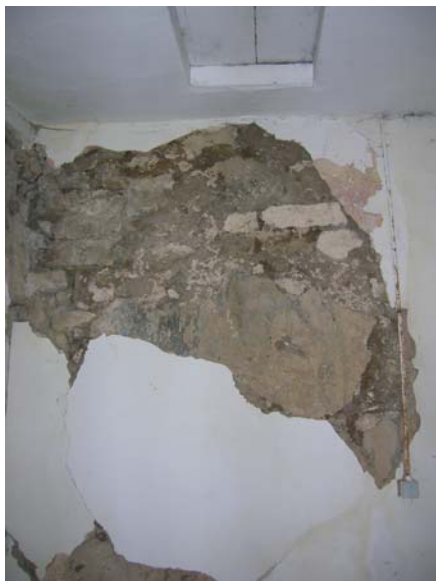
Photograph 10 – West wall:
Area with exposed fragment containing painted
decoration

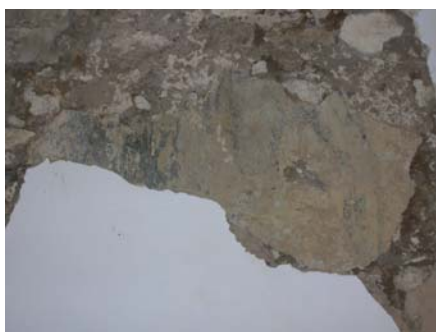
Photograph 11 – West wall:
Detail of the wall painting

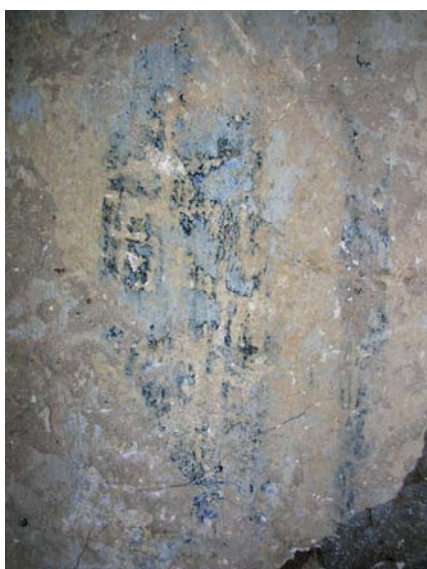
Photograph 12 – West wall:
Detail of the wall painting with over layers and dirt

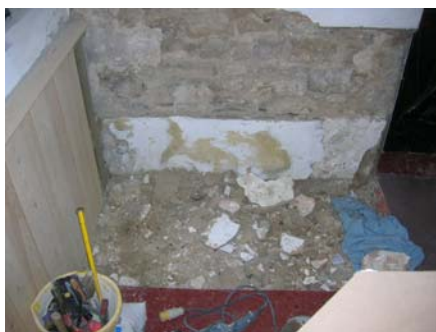
Photograph 13 – West wall:
Lower area showing fragments of detached plaster
fallen to floor

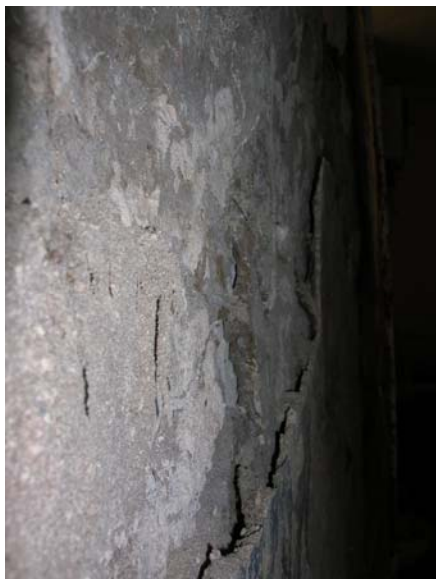
Photograph 14 – West wall:
Wall painting fragment; plaster detaching from the
substrate

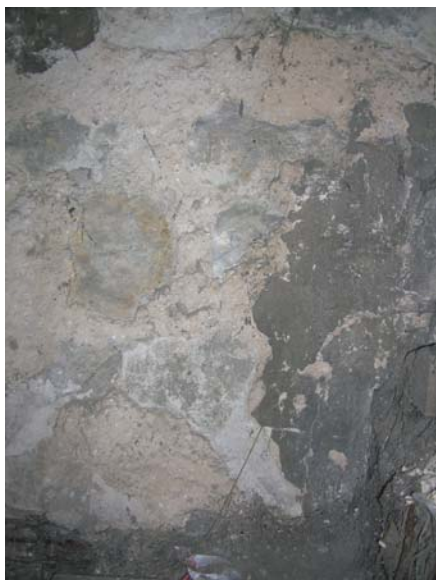
Photograph 15 – West wall:
Plaster fragments above the current ceiling showing
what appears to be a circular outlining
