AYTON CASTLE, WEST AYTON,  
NORTH YORKSHIRE:  
PHASE 1 REPAIRS

ARCHITECTURAL AND ARCHAEOLOGICAL RECORDING

Report no: 2005/263.R01  
Version: Final  
Date: October 2008  
Authors: Ed Dennison & Shaun Richardson

Scarborough Borough Council  
Property Services Department  
Town Hall  
St Nicholas Street  
Scarborough YO11 2HG

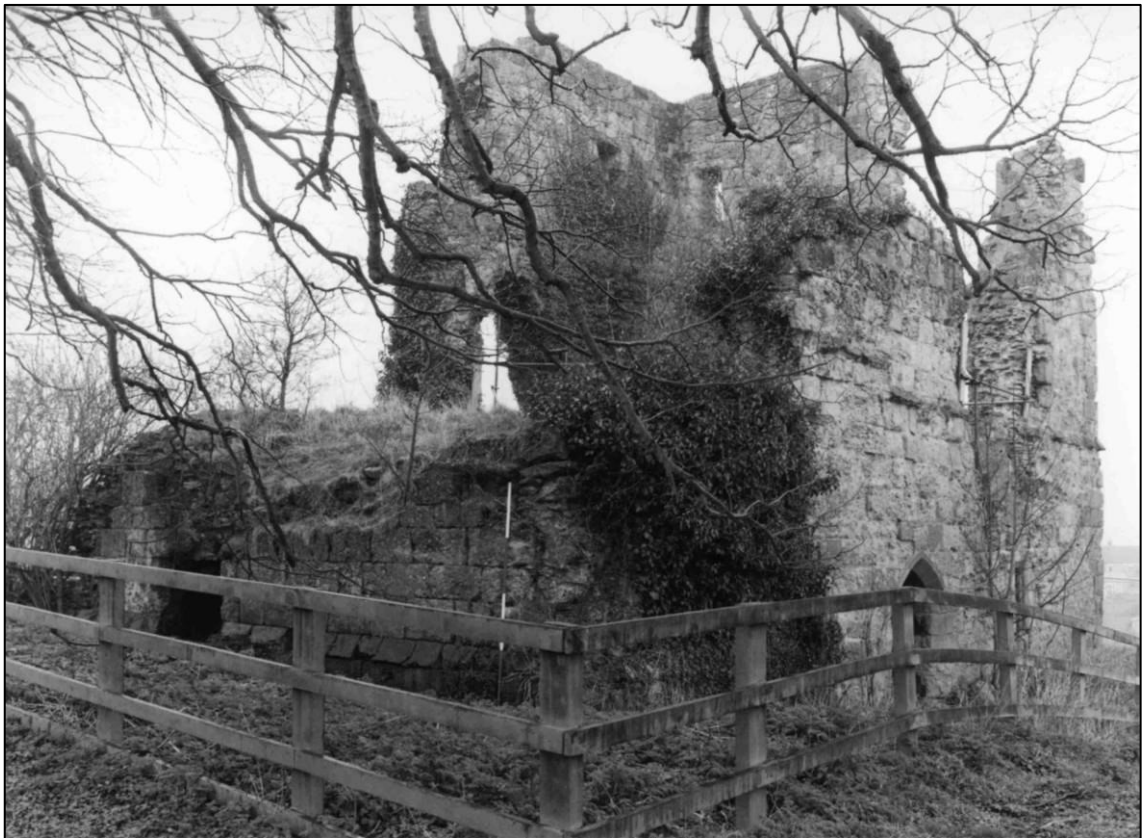
Plate 5: Ayton Castle looking east, prior to 2006 repairs.

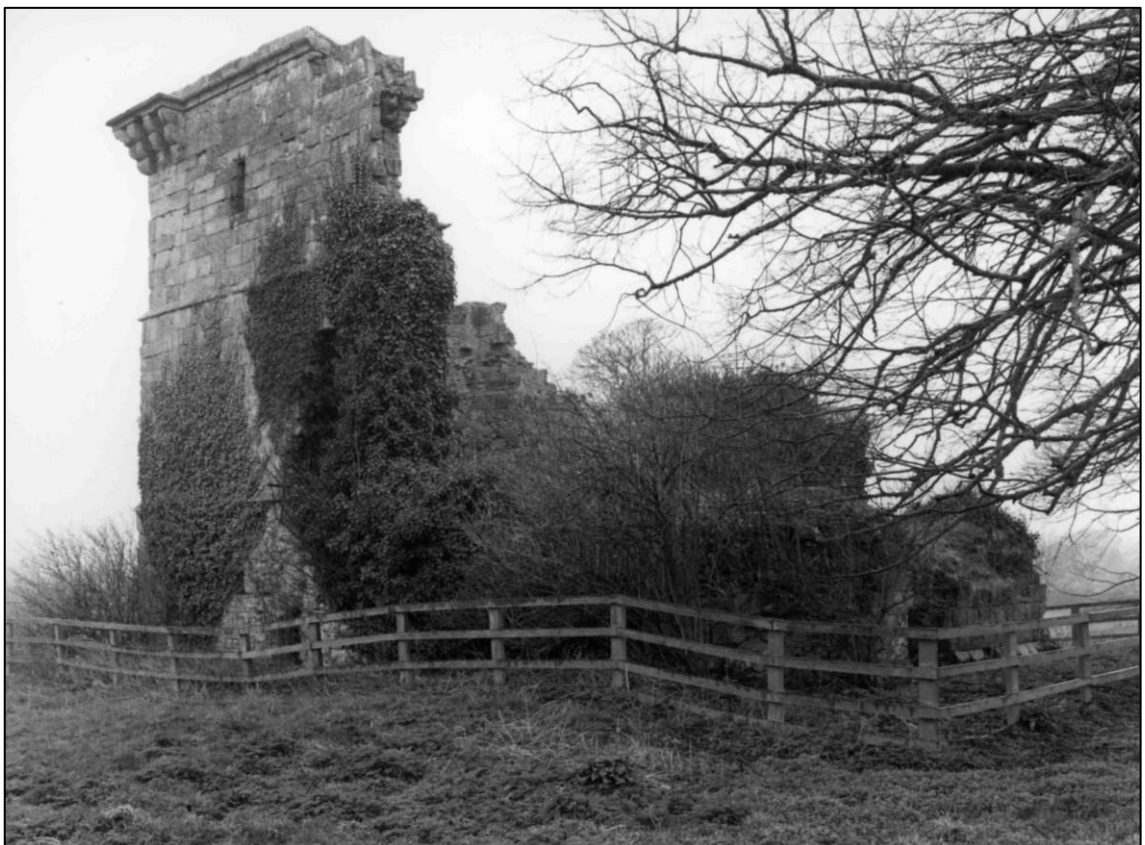
Plate 6: Ayton Castle looking south, prior to 2006 repairs.

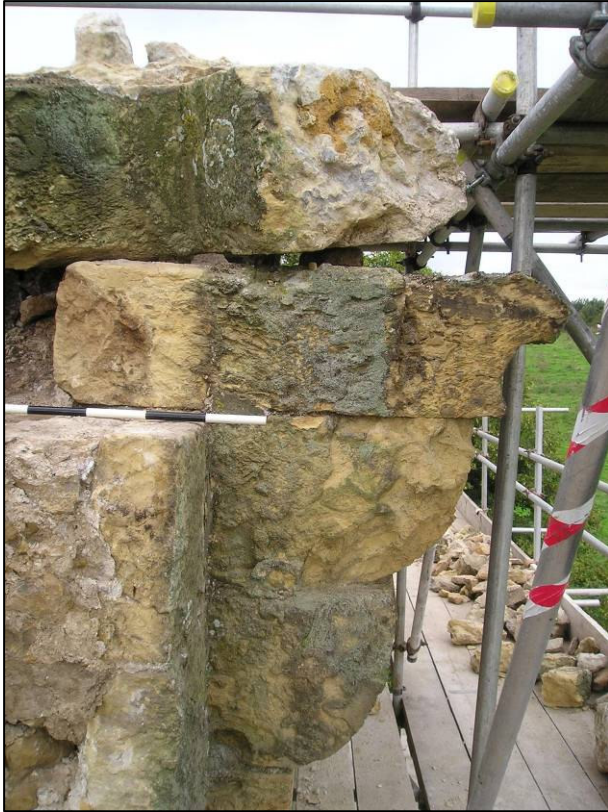
Plate 11: Detail of corbels and machicolations, prior to repair.

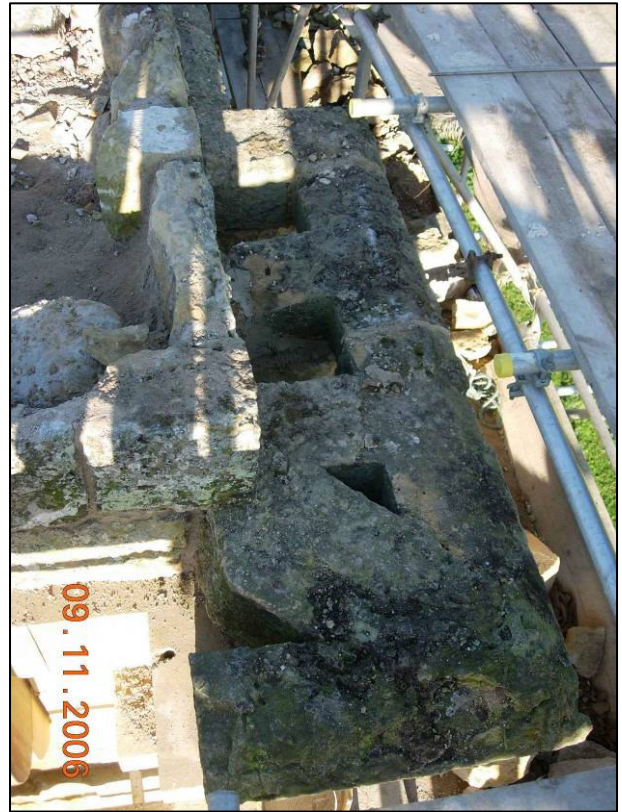
Plate 12: Detail of machicolations, prior to repair (photo courtesy of HPR).

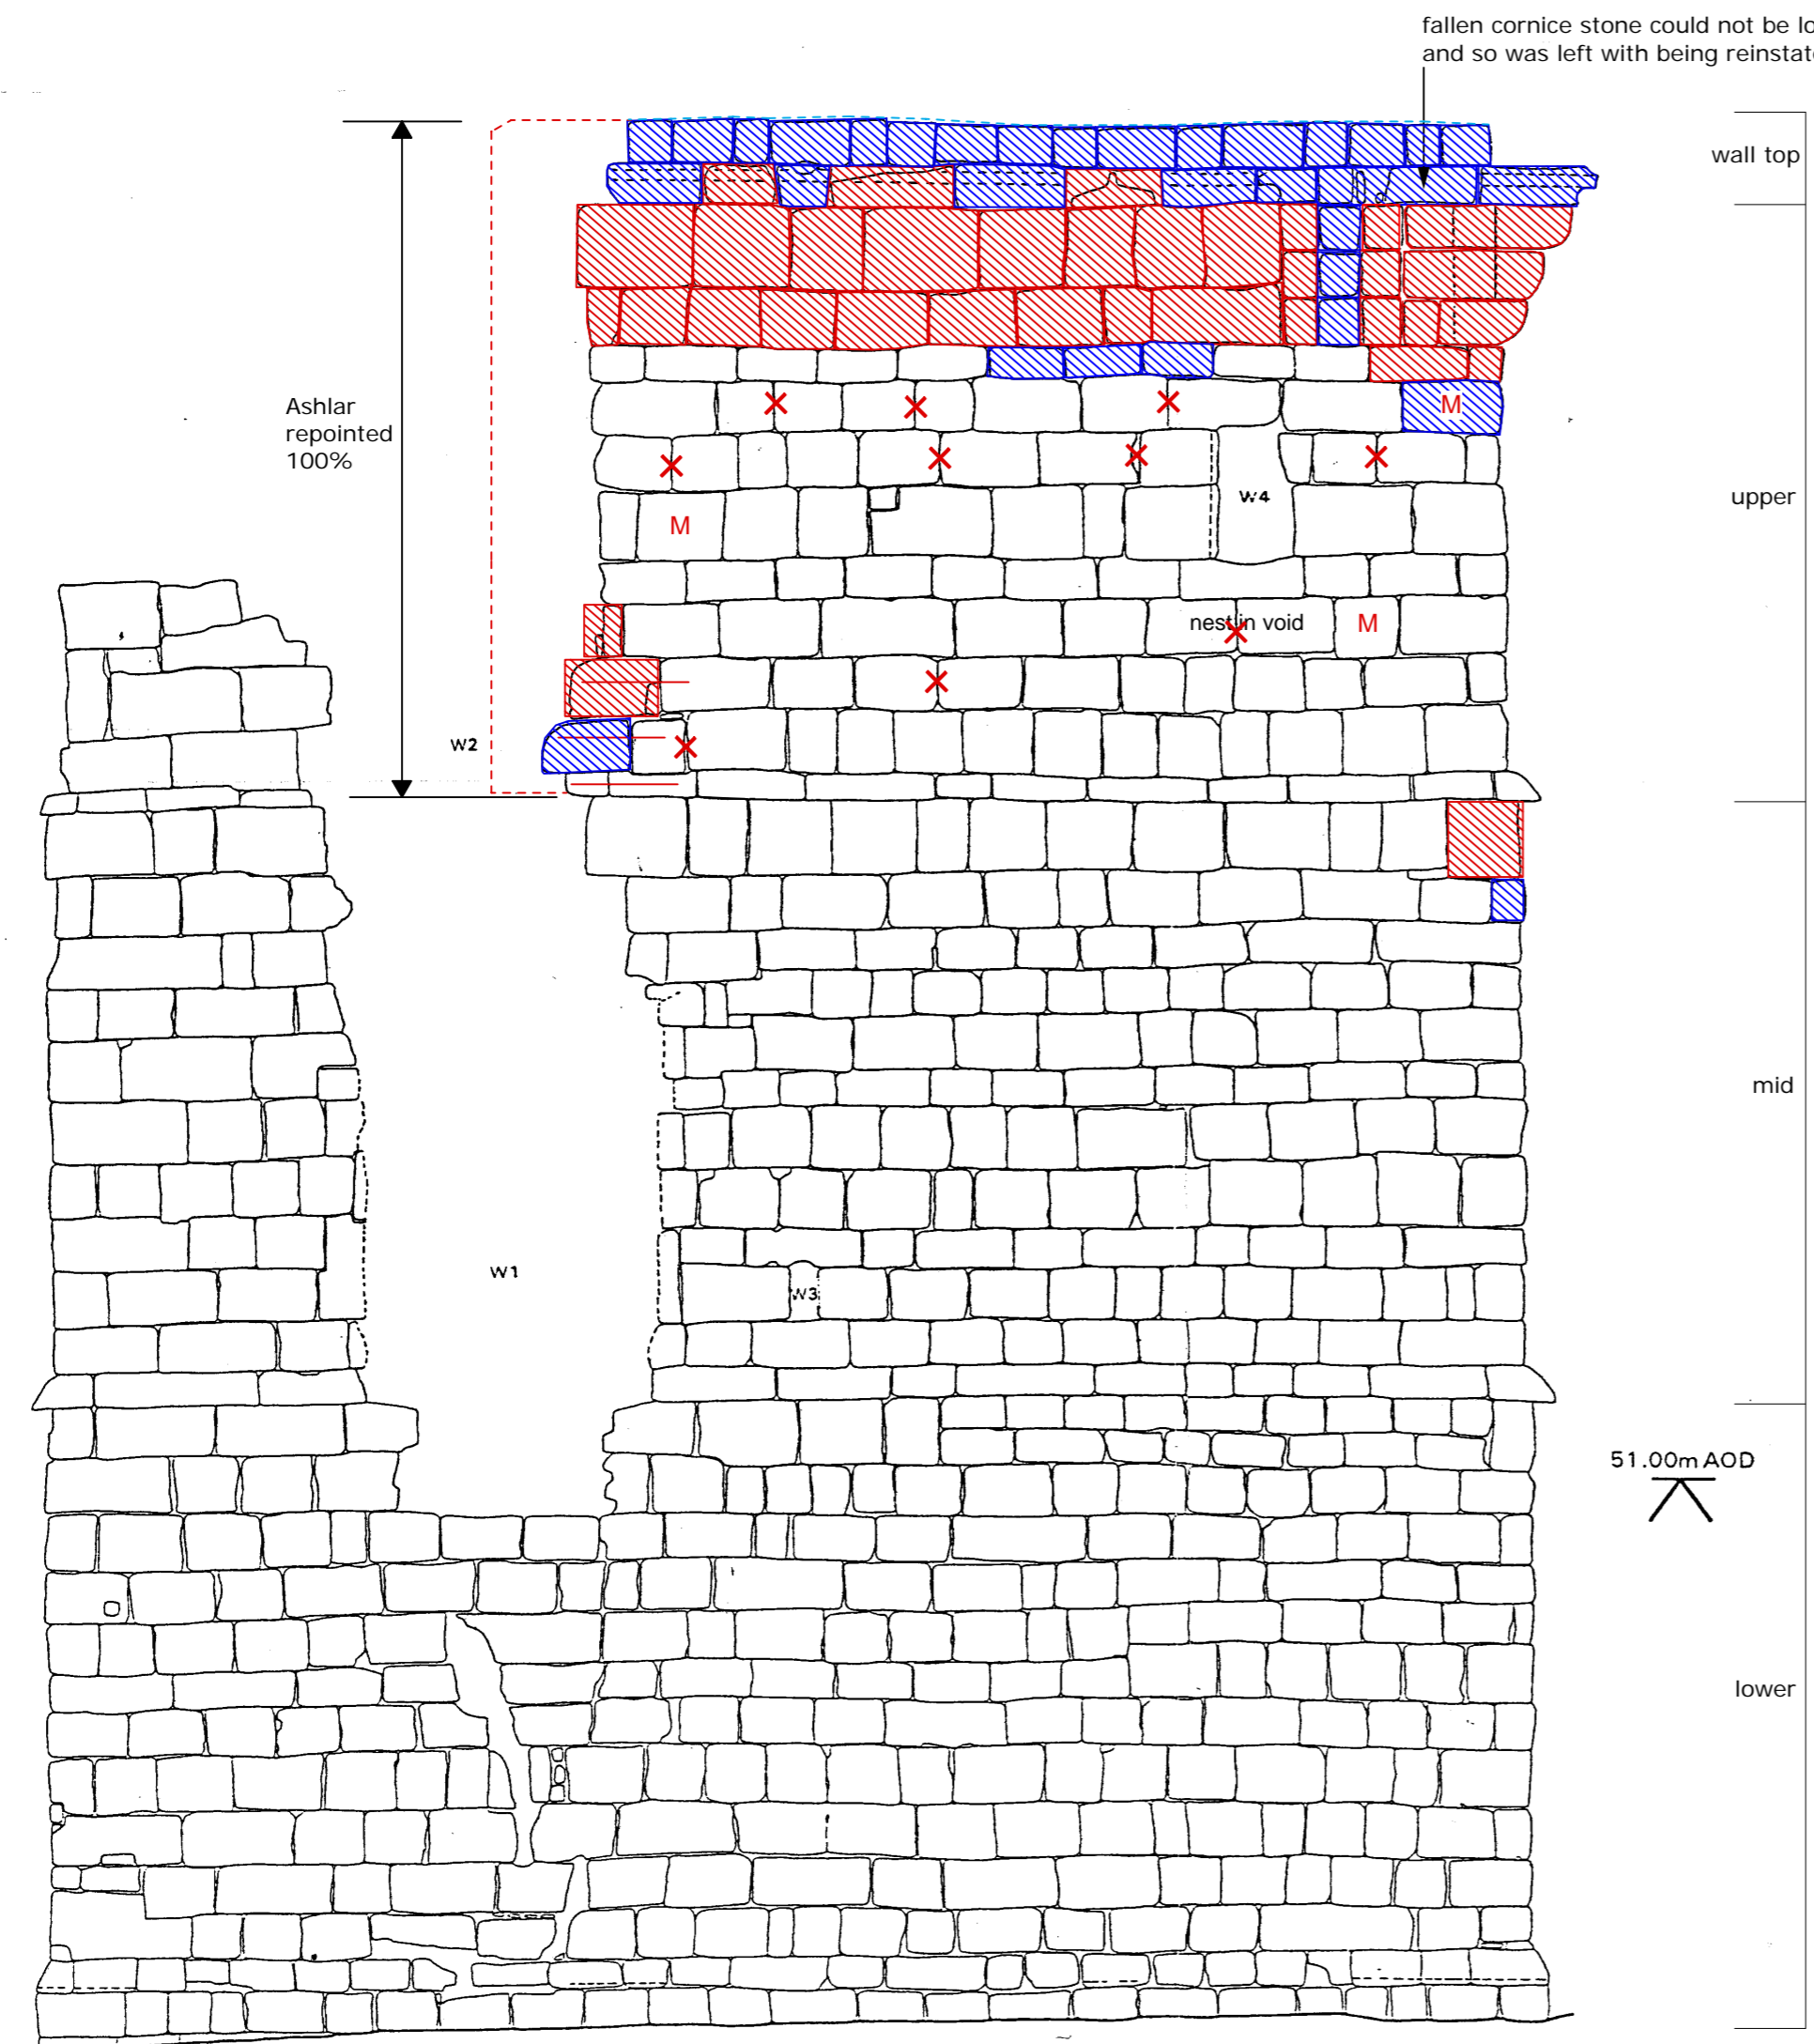
SOUTH EXTERNAL ELEVATION

fallen cornice stone could not be located  
 and so was left with being reinstated
