CART SHED AND BARN, WHARRAM PERCY FARM,  
WHARRAM PERCY, NORTH YORKSHIRE

ARCHITECTURAL AND  
WILDLIFE SURVEY

Report no: 2009/354.R01  
Version: Final  
Date: March 2010  
Authors: Shaun Richardson & Ed Dennison

The Birdsall Estates Company Ltd  
Estate Office  
Birdsall  
Malton  
North Yorkshire YO17 9NU

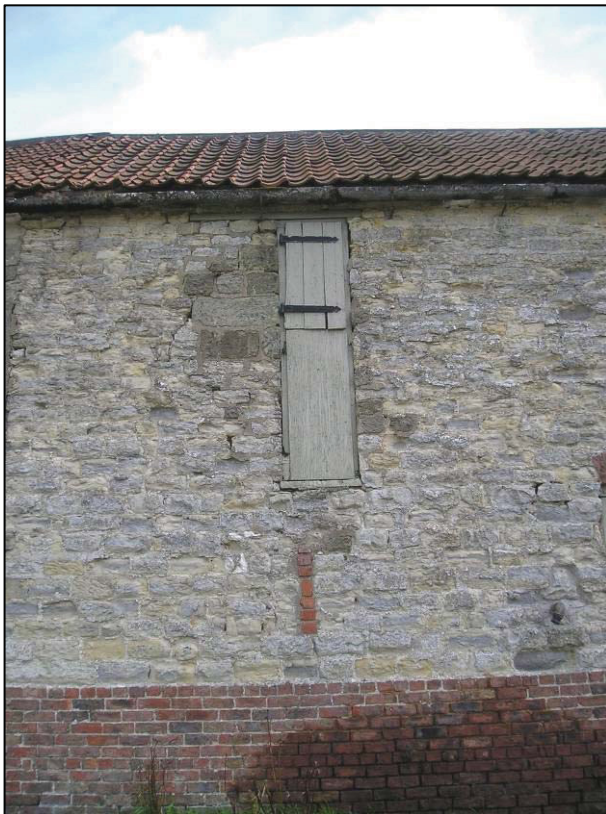
Plate 9: Possible belt drive opening, north end of west elevation of barn, looking E (photo 3/48).

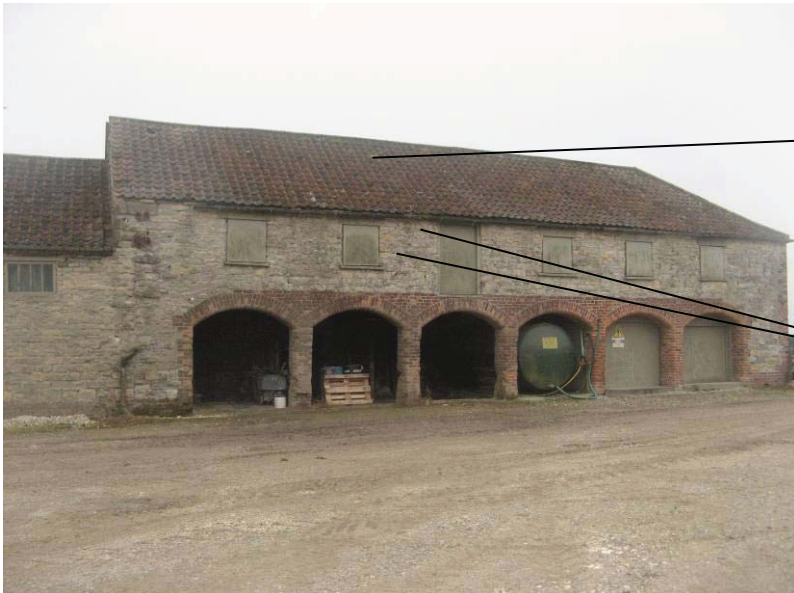
**Plate 1** Barn A - north elevation

A summer bat roost was located within the first floor roof

Scattering of 14 old bat droppings on the stone wall

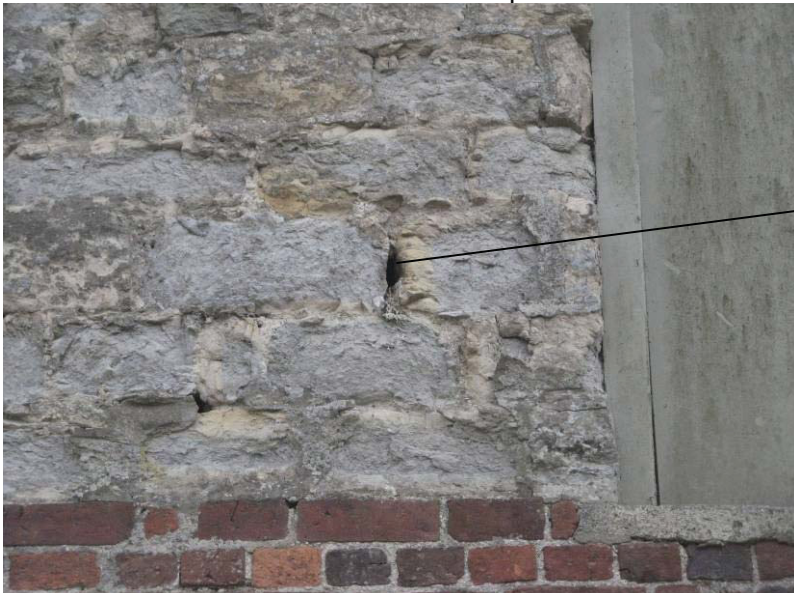
**Plate 2** Crevices for bat access into a potential bat roosts within the stone wall of Barn A (northern elevation)

Potential bat roost occupied by birds

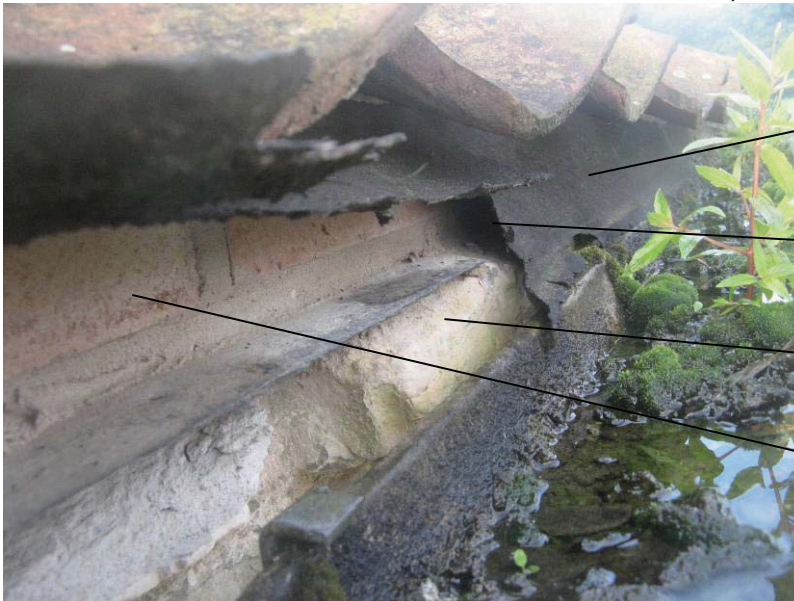
**Plate 3** Potential bat roost between the roof membrane, stringcourse and wall of Barn A (northern elevation)

Black roof membrane intact in places

Potential bat roost in the space between the wall, stringcourse and membrane

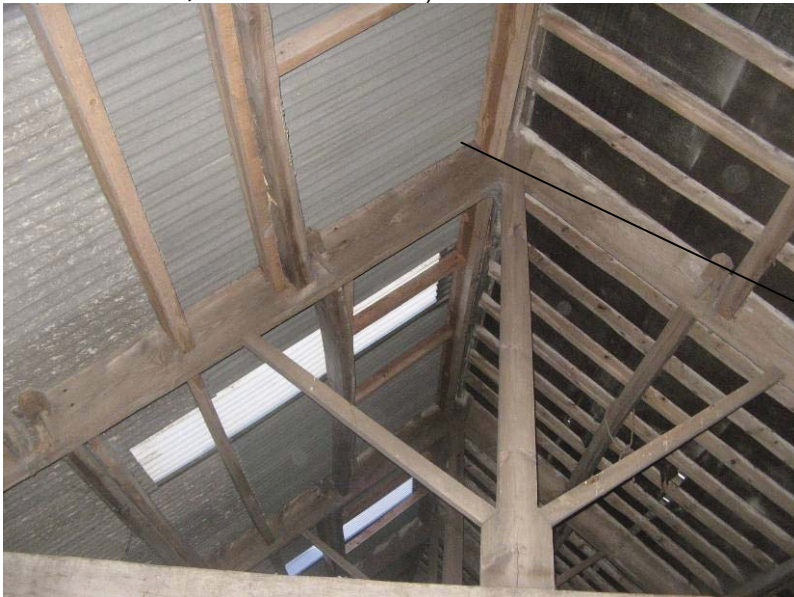
**Plate 4** Location of bat roost within the first floor of Barn A (looking towards the third king post and principal rafter, from the stairwell)

Location of a summer, common pipistrelle, bat roost

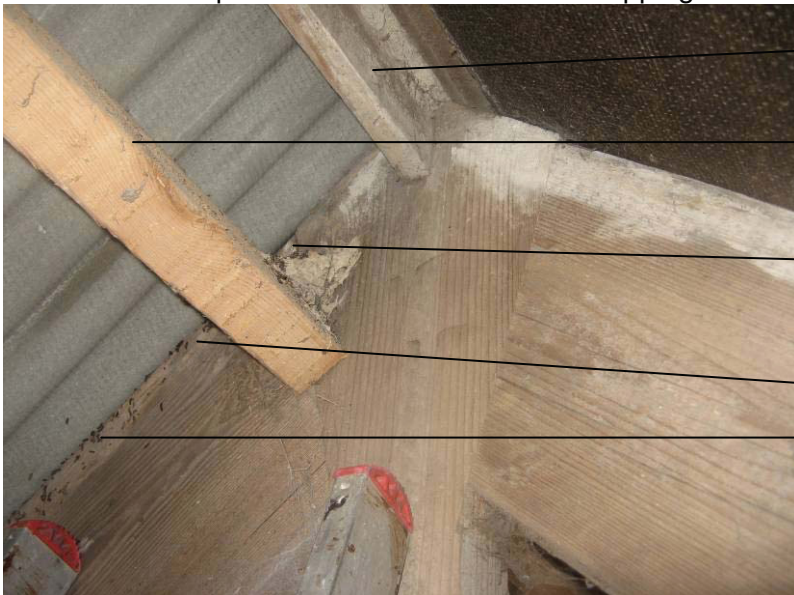
**Plate 5** Close-up of the bat roost – with bat droppings visible just below the corrugated sheet roof

Many bat droppings visible just below the corrugated sheet roof, on the principal roof rafter.

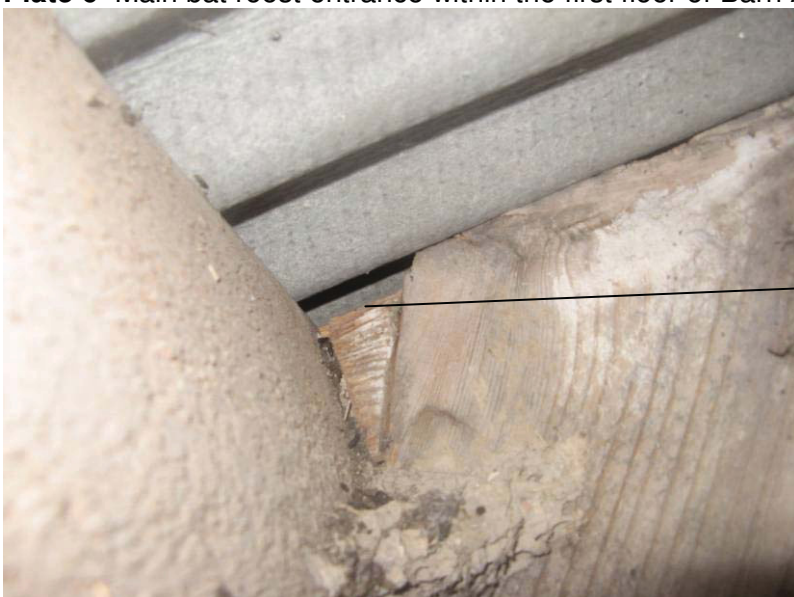
**Plate 6** Main bat roost entrance within the first floor of Barn A

Bat roost entrance
