BARN, NORTH-EAST OF HALL FARM COTTAGE,
MAIN STREET, HORKSTOW, NORTH LINCOLNSHIRE

ARCHITECTURAL AND
WILDLIFE SURVEY

Report no: 2009/362.R01
Version: Final
Date: April 2010
Authors: Shaun Richardson & Ed Dennison

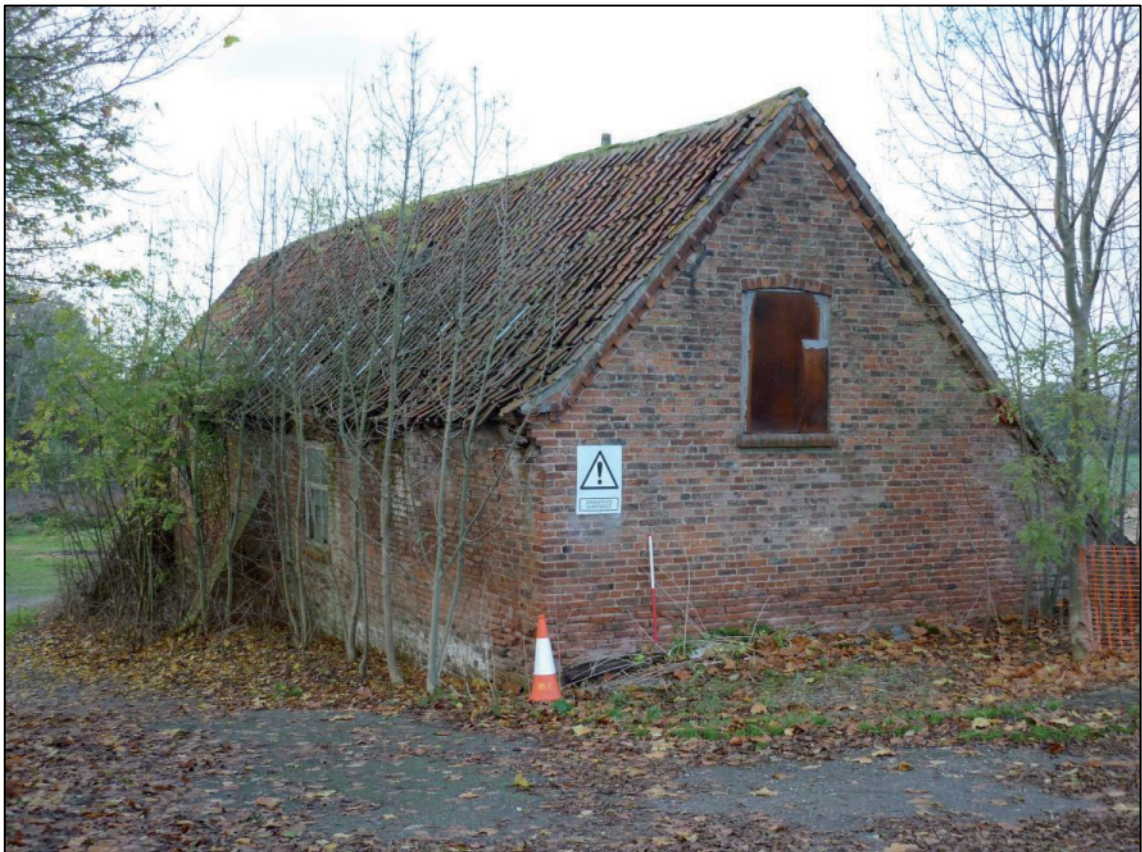
- 3.8 The lower part of the east gable is hidden by the raised ground level adjacent to the road. The visible upper part is built of the larger bricks noted above to the east of the doorway in the north elevation [1/348], but they are irregularly coursed; there are occasional partial header courses separated by three to five stretcher courses. There is a single window with a cambered head and projecting brick sill to the upper part of the gable, with a raking dentilled cornice above [1/349] (see plate 2).

Plate 2: East gable and south elevation of barn, looking NW (photo 1/348).

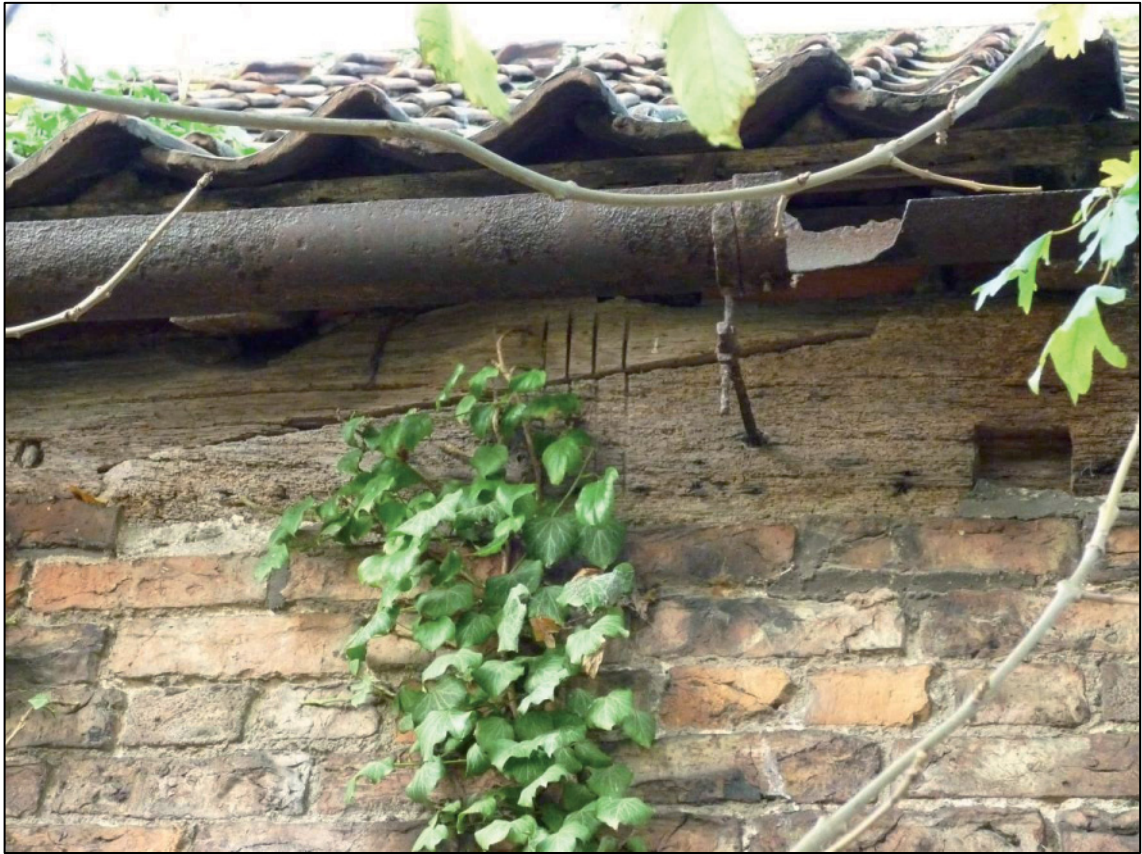
Plate 3: Exposed scarf joint to wall plate, south elevation of barn (east end), looking N (photo 1/356).

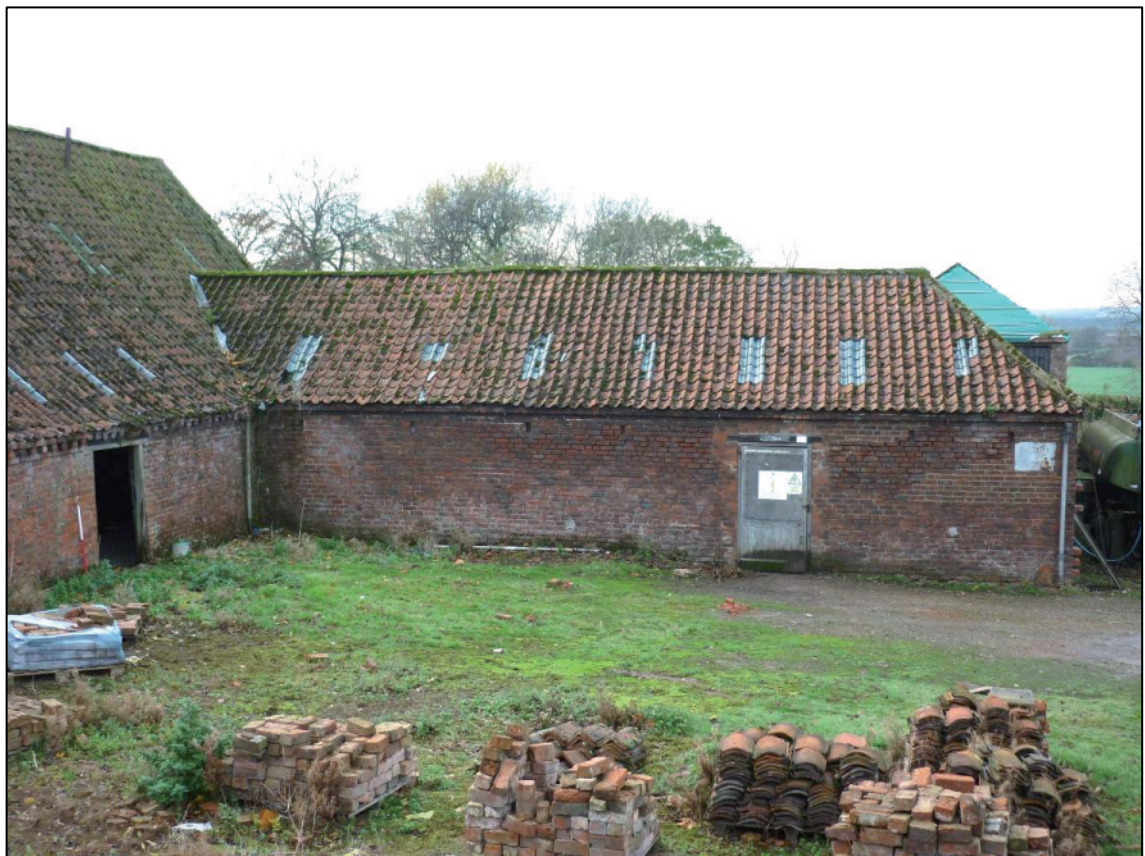
- 3.23 The east elevation of the stable is largely blank, broken only by a doorway towards the north end giving access to the north cell [1/329] (see plate 7). The brickwork within this elevation is laid in a distinctive bonding pattern, with three stretcher courses to a course of alternating paired headers and paired stretchers, rising to slightly projecting eaves. The eaves are carried around to the north elevation [1/337] but the bonding pattern is not; despite being built from the same bricks, the north elevation is laid in a variation of English garden-wall bond (two or three stretcher courses to each header course). Projecting bricks at the north-east corner of the stable mark where a modern wall formerly ran to the north. The north elevation has a ventilated window opening to the centre with a depressed arched head [1/338] while at the west end is the passage which marks the limit of the structures recorded during the current survey [1/339]. The doorway forming the

Plate 7: East elevation of stable, looking W (photo 1/329).

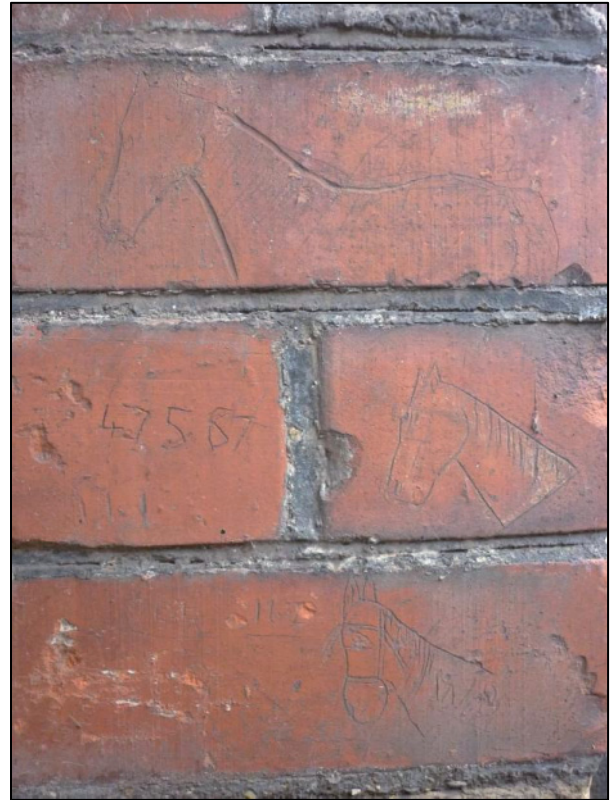
- 3.25 At the time of the survey, the only access to the south cell was through the doorway in the west elevation. The south jamb of the doorway retains a number of portraits of horses etched into the brickwork here [1/367 to 1/370] (see plate 9). The uppermost horse is shown in profile and faces left, with the head and back being drawn; there are a series of later pencilled numerals above. The middle horse appears as a head only, facing left and apparently wearing blinkers; the numerals '47 5 87' are carved into the adjacent brick. The lowest horse also appears as a head only, facing left and wearing a harness, perhaps again with blinkers. The initials 'J E R' and numerals '16 2' can be seen to the left of the horse, while the initials 'W B' are carved onto its neck. The exact date of the carvings is unknown, but they are likely to pre-date the Second World War. Shadows to the east and north walls of the south cell show that the interior once had stalls for horses positioned along the east side [1/372]. The timber partitions of the stalls sloped downwards from east to west towards a heel post which was set 3.05m to the west of the east wall [1/373].

Plate 9: Horse graffiti, south jamb of doorway in west elevation of stable, looking S (photo 1/367).

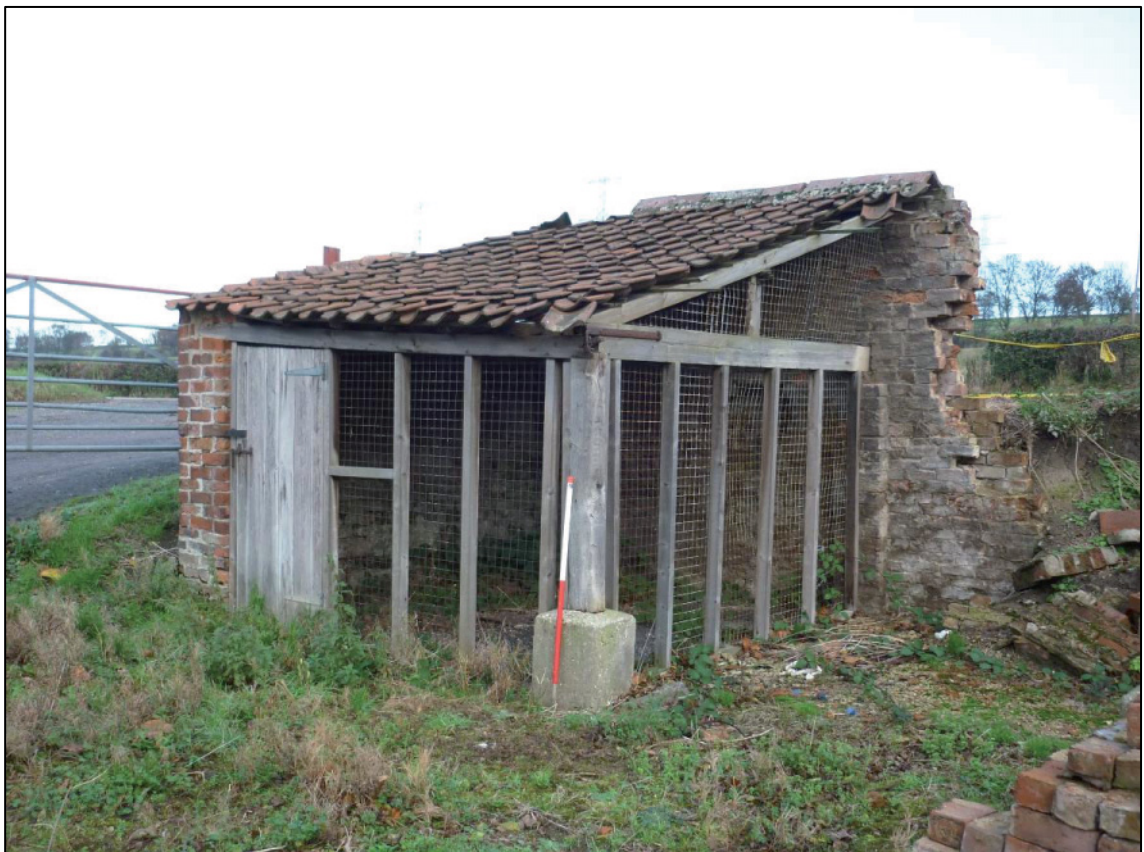
- 3.27 As has been noted above, the shed on the east side of the complex had collapsed at some point prior to the survey, following flooding. The remainder was then partially demolished, leaving only the very north [1/345] and south [1/347] ends still standing.

Plate 10: North end of shed, looking NE (photo 1/345).
