ST PETER'S CHURCH, BILTON,  
EAST YORKSHIRE

ARCHAEOLOGICAL OBSERVATION,  
INVESTIGATION AND RECORDING

Report no: 2010/372.R01  
Version: Final  
Date: October 2010  
Author: Ed Dennison & Kate Dennett

St Peter's Church PCC  
c/o Ferry & Mennim Ltd  
48 Goodramgate  
York  
YO1 7LF

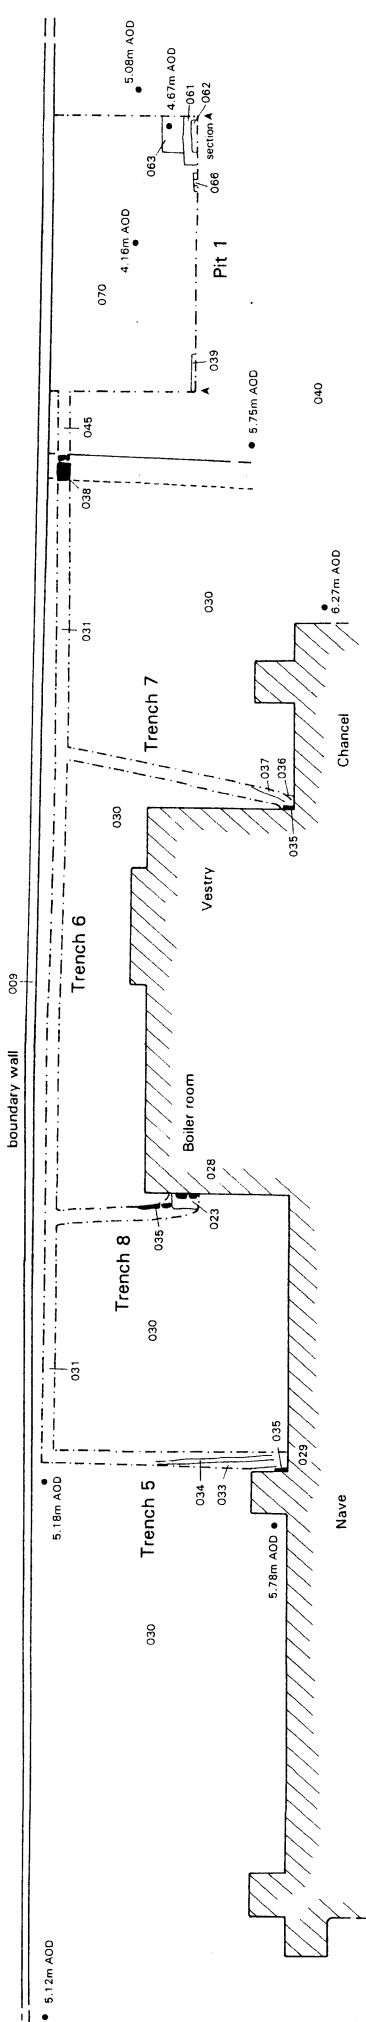
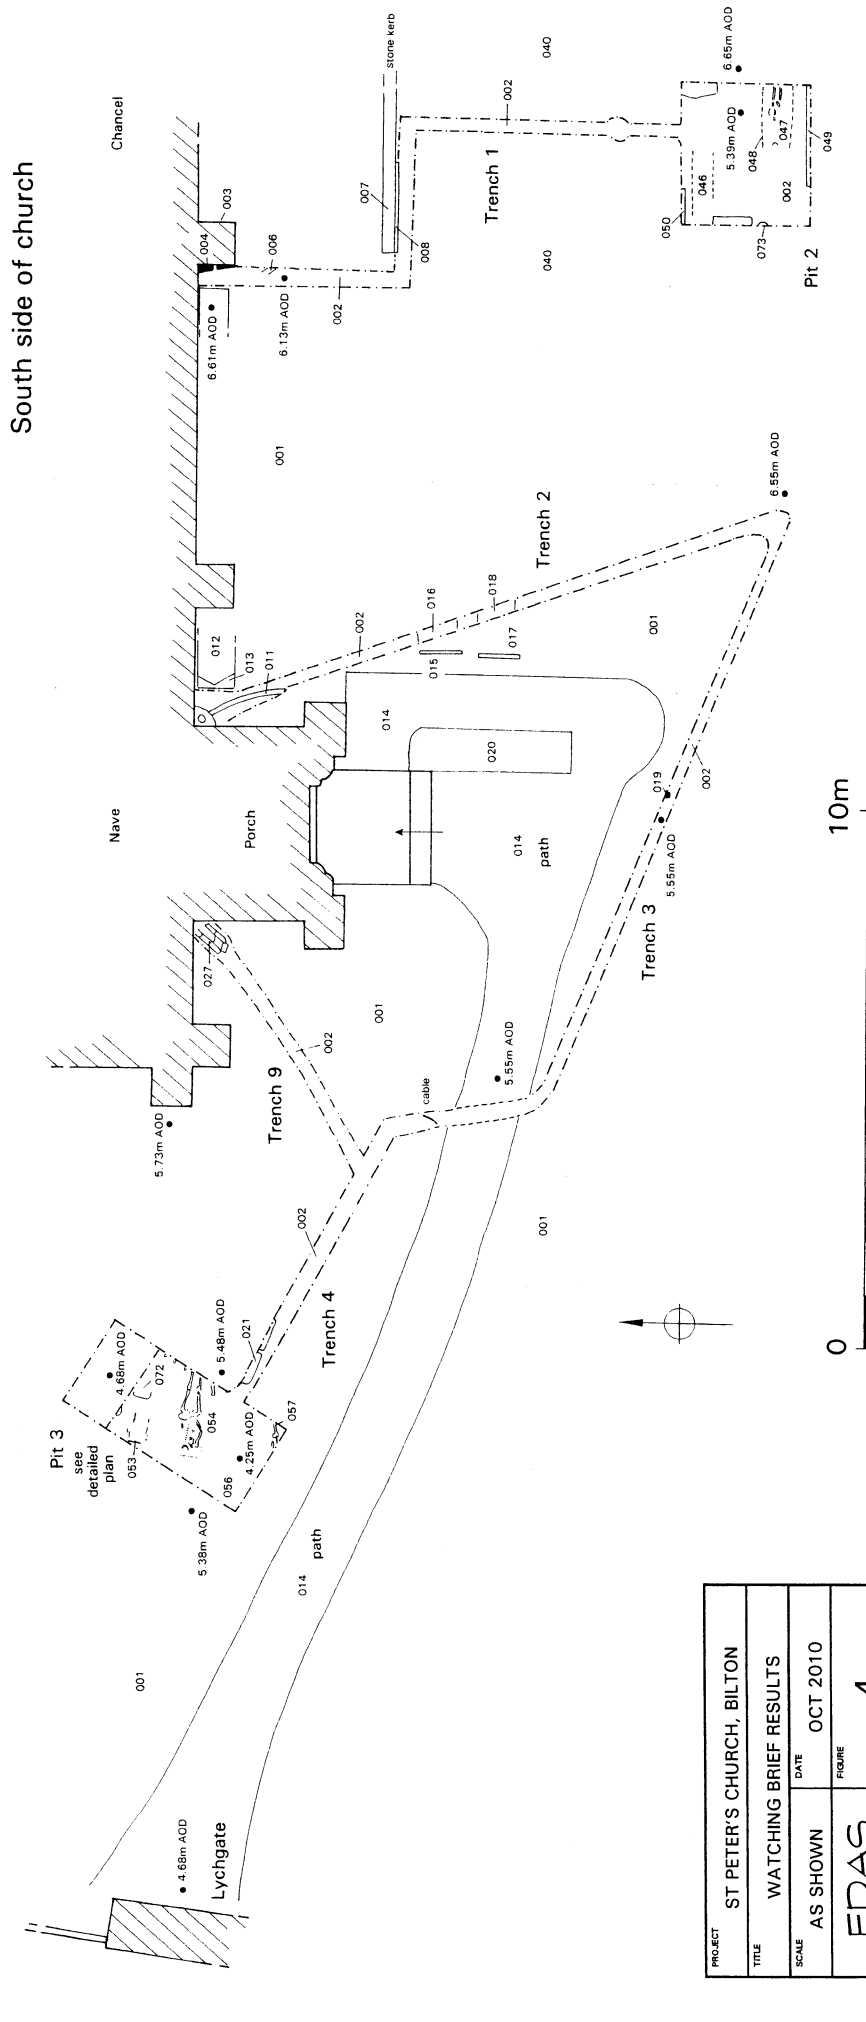
- 5.1 To the north of the church, a deposit of firm pink-red ashy loam less than 0.04m thick (032) was identified for a distance of c.13m in Trench 6 under the 0.07m deep turf and topsoil (030). This ashy material, which overlay a wet sticky dark brown loam subsoil (031) containing moderate amounts of mixed modern brick, tile, stone, plastic, slate and glass fragments, may represent part of a former path around the church. It was also necessary for the east end of Trench 6 to break through the southern end of a buried north-south aligned stone wall (038), close to the churchyard boundary wall (009), to link the pipe work into soakaway pit 1. At least four courses of lime mortared ashlar stone were exposed in the trench, at 0.48m BGL and with a combined width of 0.43m; the stones were roughly dressed and the construction included one brick, and the wall appeared to butt against the east-west brick boundary wall. Although the excavated section was buried under turf and topsoil (030), other parts of the wall alignment are exposed further to the south, effectively forming a low revetment between two parts of the churchyard. This boundary is shown on the Ordnance Survey 1856 6" map (see figure 3), as defining the east end of the churchyard, and the extension to the east was consecrated in 1905. There is no marked difference in the levels of the churchyard either side of the former boundary, that to the east being only c.0.26m lower than that to the west.

- 5.2 Also on the north side of the church, an unglazed flat-topped ceramic drain (033), 0.14m in diameter, was exposed for a distance of 2.4m in Trench 5 running away from the adjacent downpipe. The cut for the drain was not seen in the surrounding deposits (030 and 031), and it had been damaged by tree roots. The base of the drain lay 0.39m below ground level (BGL), and it was laid on two courses of unmortared 19th/20th century bricks (034). Similarly in Trench 7 to the east, another glazed ceramic drain (036) was partially exposed running north-east from the downpipe on the east side of the vestry, at a depth of 0.38m BGL; it partially overlay an earlier brick soakaway (037) running at a slightly different angle.

- 5.3 The foundations (035) of the north side of the church (029) were seen to step out by 0.12m, at a depth of 0.38m BGL, in Trenches 5 and 7. In Trench 8, on the west side of the boiler room (029), this plinth overlay a lower stone foundation (023) which stepped out by 0.28m at a depth of 0.51m BGL.

- 5.9 On the south side of the church, the two glazed ceramic drains (006 and 011) running from the downpipes on the east side of the south porch and that further to the east were blocked, although they were apparently in good condition beneath the ground where exposed in Trenches 1 and 2. In Trench 1, the c.0.28m wide cut (005) for the drain was visible in the east section, cutting through the loose friable brown loam subsoil (002) and dark brown topsoil (001). In Trench 9, to the west of the south porch, part of a dilapidated brick gully (027) with a stone base was exposed within a linear cut (026), although there was no evidence for a ceramic pipe.

- 5.10 In Trench 1, the rough undressed limestone foundation (004) for the ashlar buttress (003) at the junction of the nave and chancel was exposed at a depth of c.0.37m BGL. In order to avoid marked graves, the trench then took a right-angled course around a stone kerb (007) which defined the Raines family plot, located immediately south of the chancel; the south side of the kerb exposed in the trench was underlain by a single course of bricks (008) with the base at 0.33m BGL. It was noted that the earliest legible Raines gravestone within the plot was dated 1701, raising the possibility that the stones (and perhaps the burials) were re-erected/repositioned after the rebuilding of the church in the mid 19th century.

North side of church

South side of church

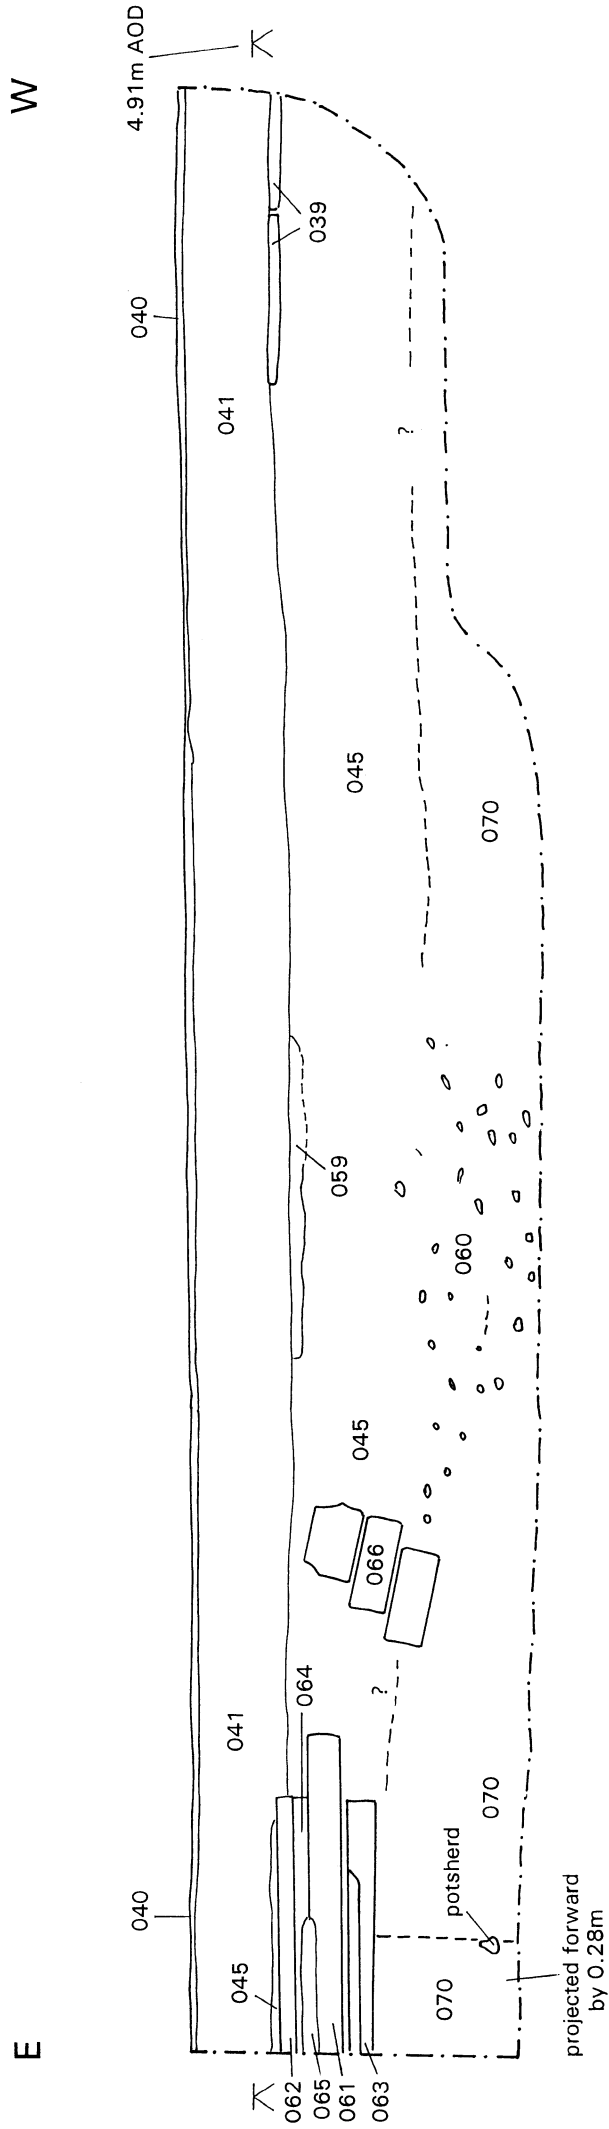
South side of Pit 1

- 5.5 Exposed in the southern section of the soakaway (see figure 5), at a depth of 0.70m BGL, was a disturbed firm brown-grey loam (060) flecked with numerous lumps of yellow-brown clay and stone fragments. This deposit, which was a maximum of 0.3m thick, slumped down slightly to the west, and so may represent the edge of the backfill of an unmarked burial to the south, although the cut was not visible and it was not excavated further. Above this deposit, at the junction between the dark brown loam (045) and the pale brown imported soil (041), lay a localised patch of a friable brown loam (059) containing numerous small stone fragments and gravel, 0.04m thick - this may be associated with a former grave slab now removed. Just to the east of this were the remains of a broken alabaster grave marker (066). This was broken into three pieces, which were stacked on top of each other, the whole tilting down towards the west (see plate 2); the lower two pieces were 0.10m thick and the base of the bottom piece lay at 0.65m BGL, while the slightly thicker top piece was carved into a foliate design - it may possibly have been disturbed during the digging of the burial represented by backfill 060.

- 5.6 Beneath the imported soil (041) at the east end of the south side of the soakaway, which here was c.0.20m thick, lay a number of broken alabaster grave stones and concrete slabs (061, 062 and 063) which appeared to have been placed to form a series of three steps cut into the surrounding dark brown loam (045) (see plate 2); the steps extended down to 0.41m BGL and a compacted brown loam with occasional small sandy mortar and stone/brick fragments (064) may have been used as a levelling layer. The central 'step' (061) contained the truncated inscription "Rosabella More .. / died September 24th ..", and this piece was subsequently extracted and placed adjacent to the churchyard boundary wall. Ceramic and glass sherds dating to no earlier than the late 19th/early 20th century were found in the dark brown loam (045) surrounding the steps. Under another concrete slab (065), adjacent to the steps and 0.8m to their north, a single rim sherd from a greenish-brown, internally-glazed ceramic dripping dish was found in the underlying wet sticky dark brown loam (070); the sherd is of late medieval, probably 15th/16th century, date with a Humberware type glaze (Peter Didsbury, *pers. comm.*). This dark brown loam (070), which was at least 0.4m thick with the top at 0.60m BGL, extended beyond the limit of excavation to the west, and it probably represents a former land surface.

- 5.7 At the west end of the southern section of the soakaway pit, approximately eight concrete and artificial stone paving slabs (039) were seen covering an area of c.2sqm to the east of the north-south aligned revetment wall (038) mentioned above. The slabs were 0.33m BGL, positioned between the imported soil (041) and the

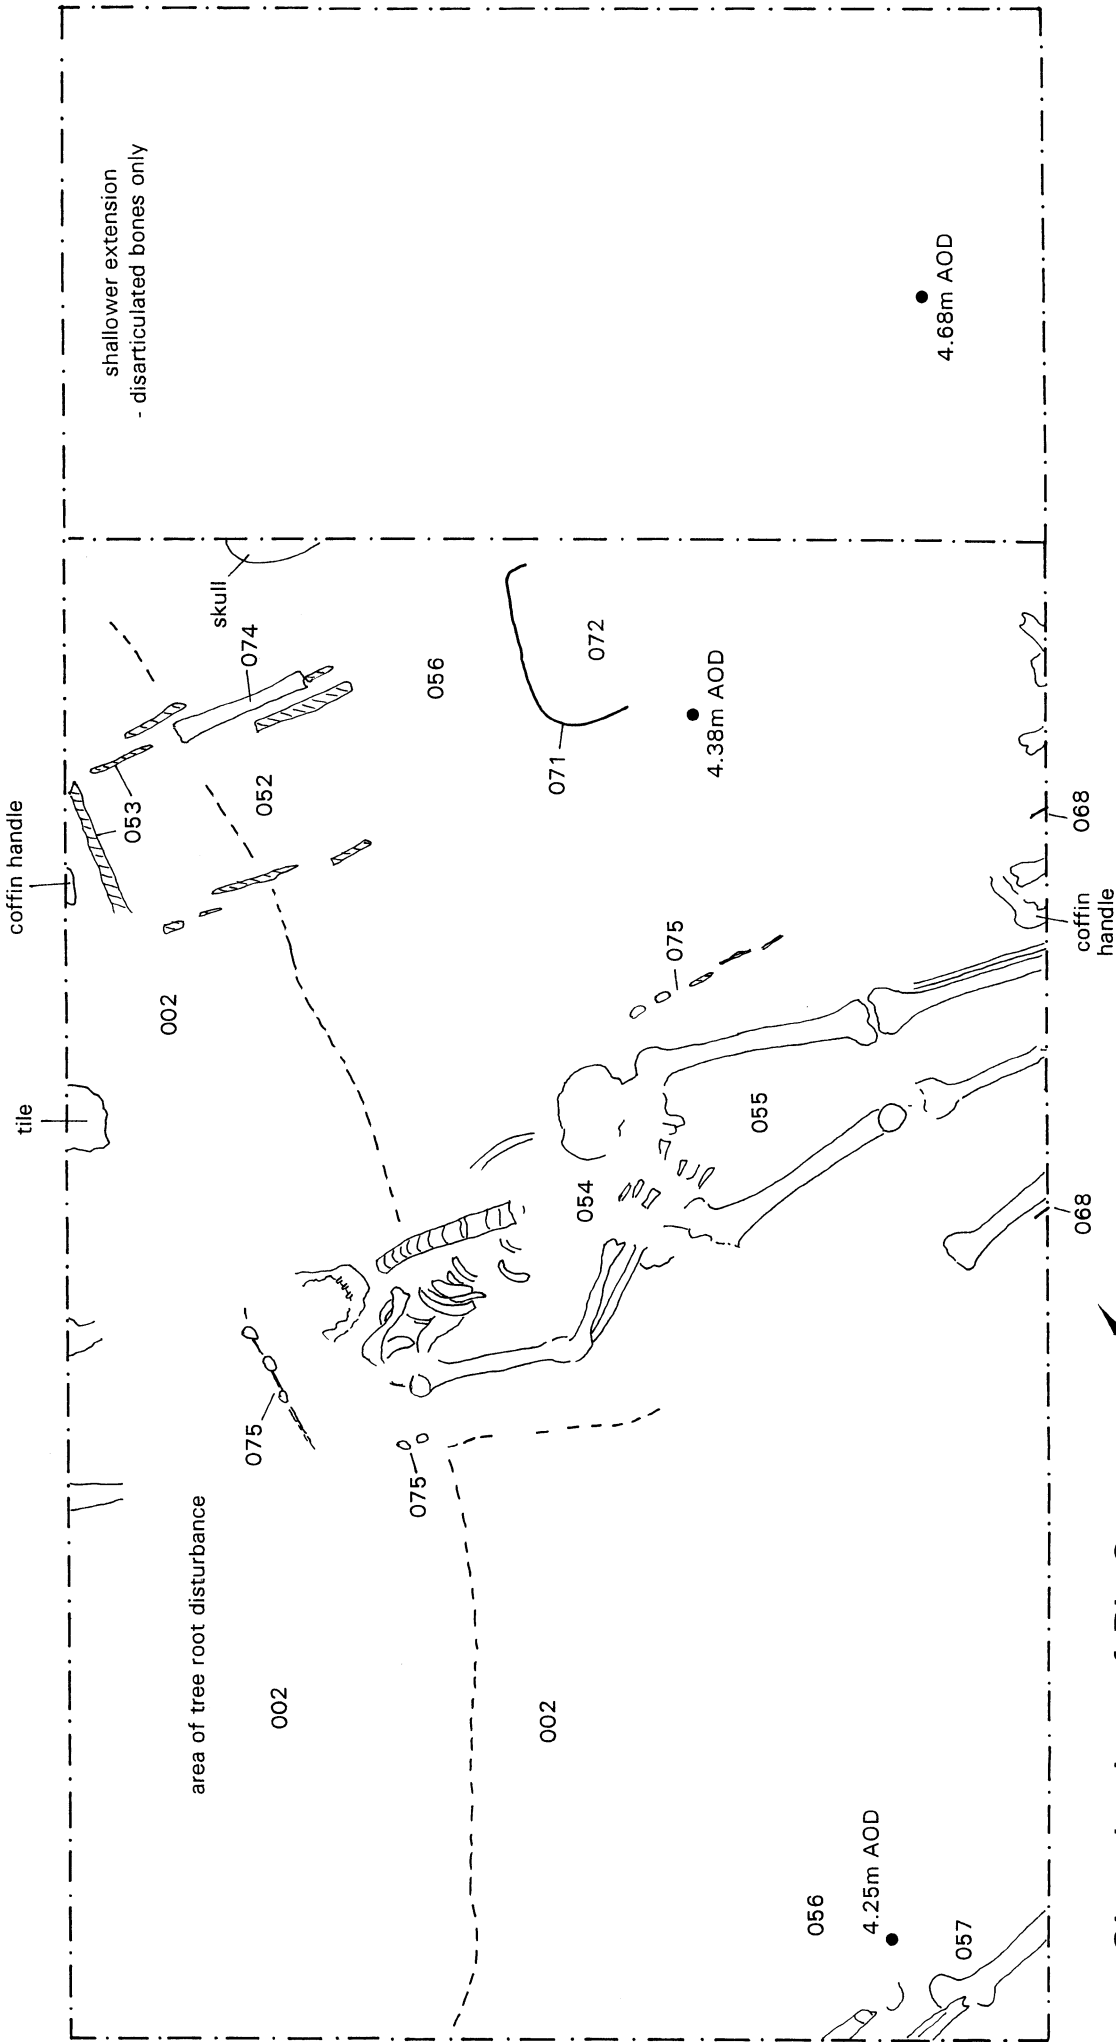
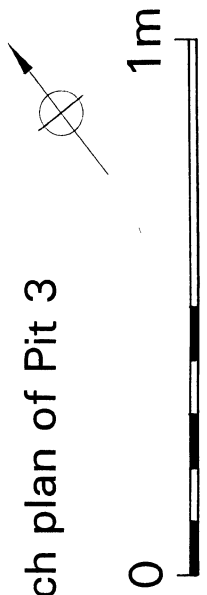
| TITLE | SKETCH PLAN OF SOAKAWAY PIT 3 | | |

- 5.19 Soakaway pit 3 measured 2.4m long by 2.68m wide and was dug to a maximum of 1.20m BGL (4.25m OAD) off the south-west corner of the church (see figure 6). As noted in Section 3 above, the north side of the pit was extended but at a higher depth.

- 5.20 Two east-west aligned *in situ* burials (054 and 057) were exposed in this pit, the graves having been dug as far as the solid natural yellowish brown clay (056) which lay at a depth of 1.13m BGL (4.25m OD). The nails and timber of the coffin (075) were discernible for burial 054, although they had been badly damaged by tree roots; the two sides of the cut (068) for the burial were only visible in the east section of the pit. The burial itself was mostly intact but it was not fully exposed or excavated, as it was not to be disturbed by the drainage works, merely being sketched and photographed before being covered with soil. The skull appeared to have been already displaced, but the mandible was visible, together with the majority of the right side and the pelvis and leg bones of the left side (see plate 5). The backfill (055) of the burial was a loose brown loam with moderate amounts of brick/tile/stone fragments and possible mica flakes. Burial (057) was only partially visible in the south-east corner of the pit and no coffin or cut could be defined; the exposed skeleton, which had been previously been damaged, comprised the right femur, radius, ulna and lower vertebrae and sacrum, was lying on the very firm yellowish-brown natural clay (056).

- 5.21 The western end of a second collapsed coffin (053) was exposed at the north end of the pit, at 0.88m BGL, with some of the skeletal remains (074) present and still aligned, though largely disarticulated; the remains comprised the right humerus, left radius and ulna, and a separated skull (which may or may not have been associated with this burial) lay just to the north under the north side of the pit. The burial (074) had probably disturbed an earlier burial to the east, evidenced only by an alignment of coffin nails (058) with traces of timber at a depth of 0.98m BGL and part of a grave cut (071) measuring 0.32m wide and filled with a friable brown loam (072), dug into the natural clay (056). None of the *in situ* burials in Pit 3 were marked at the surface.

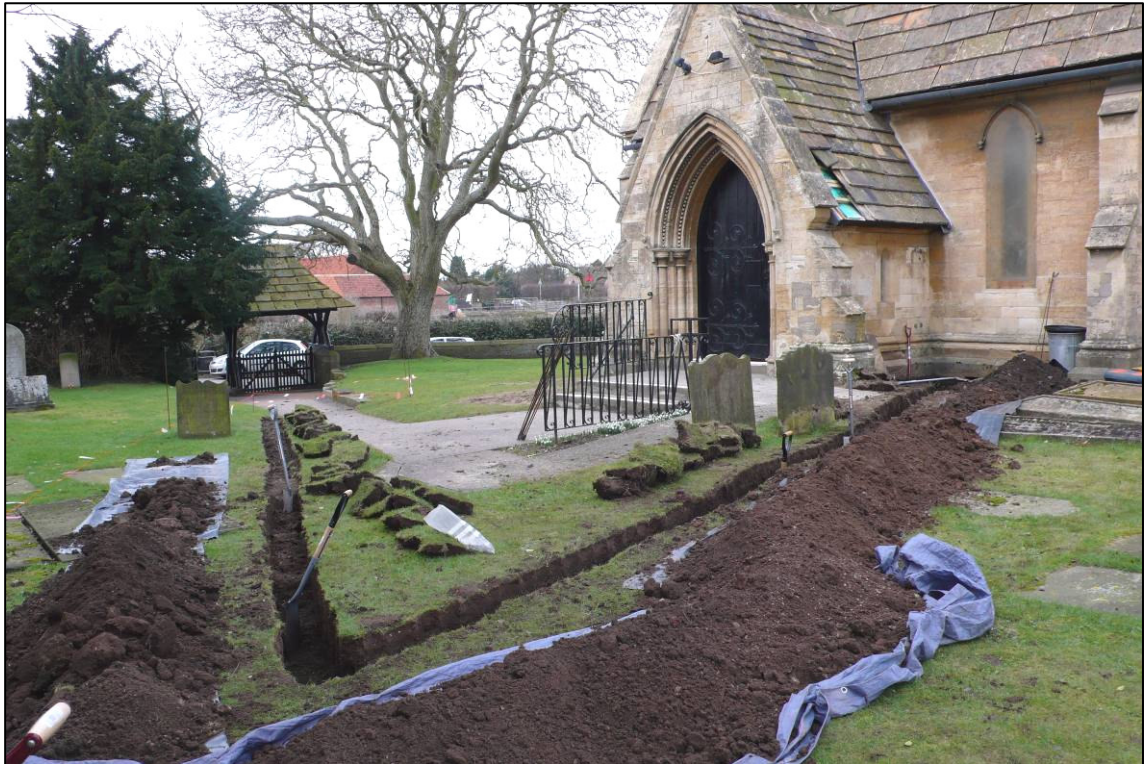
- 3.4 All the excavation work was carried out by hand by the drainage contractors, using ditching or standard spades as appropriate (see plate 1). Unfortunately, a number of problems were experienced during the excavations. Pit 1 on the north-east side of the churchyard was initially dug too deep, resulting in additional archaeological cleaning and recording. This overdigging also exposed the soil beneath the foundation of the adjacent boundary wall which resulted in potential instability, and so the pit was partially refilled and then extended in length and breadth, to ensure the required capacity. The proposed depth of Pit 2 to the south of the church would have necessitated the use of shoring for both the drainage contractors and the archaeologist, as well as resulting in the disturbance of *in situ* burials, and so it was decided to widen the pit to both the north and south. However, this revealed the presence of unmarked brick burial vaults and so the pit was extended to the east instead. The exposure of at least three *in situ* burials in the base of Pit 3 to the south-west of the church (see below) led to a decision to extend this pit to the north at a reduced depth. In retrospect, the use of the 'Waterloc' drainage system, which requires large soakaway pits, has considerable drawbacks in the context of a graveyard, both in terms of the amount of ground disturbance (and therefore archaeological work) required and health and safety issues relating to excavating in loose unconsolidated ground.

Plate 1: Trenches 2 and 3 under excavation, south side of the church, looking NW.

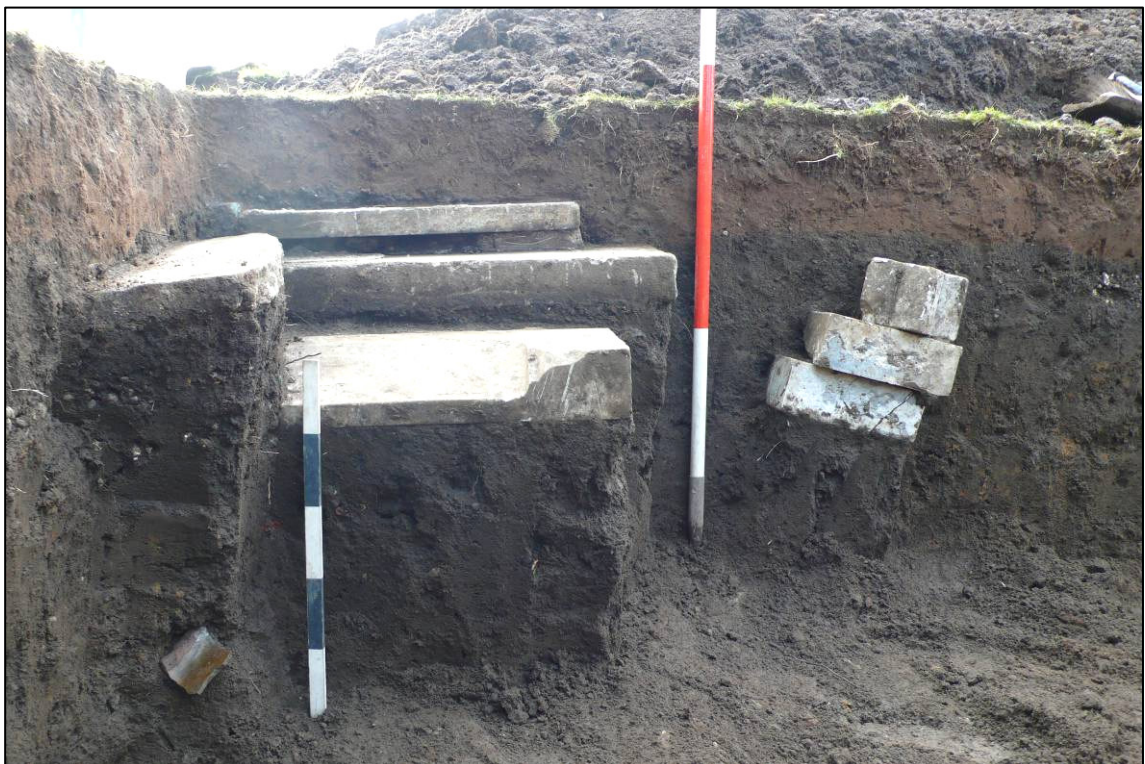
Plate 2: Re-used stones and slabs forming steps, with broken memorial to W, in south-east corner of Soakaway Pit 1, looking S.

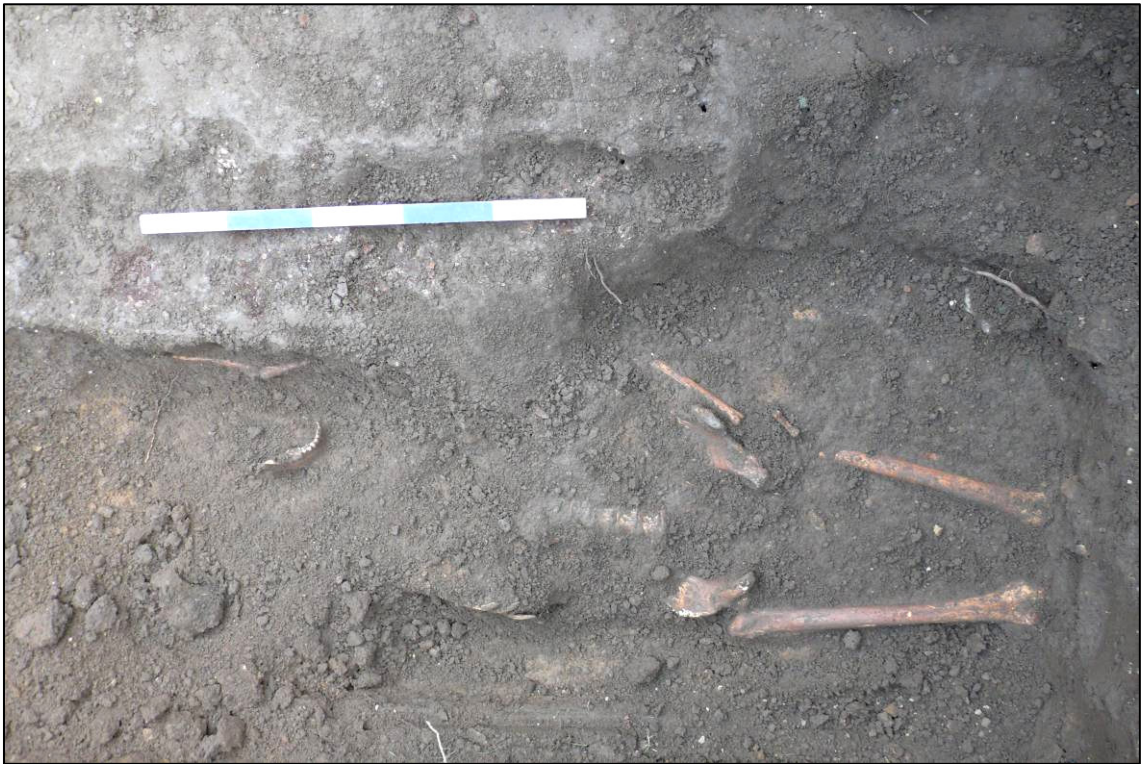
- 5.15 An intact *in situ* burial (047) on the south side of the pit included remnants of the coffin, nails and corroded coffin plate fragments (048). The skeleton, which lay at 1.10m-1.27m BGL, was extended, facing east, and the lower mandible, some ribs, the lower vertebrae, sacrum, parts of the pelvis and the femurs were exposed, but the skull was missing (see plate 3). The backfill of the burial was a friable loose grey-brown loam containing brick rubble, sand and mortar fragments (069). The length of the femurs would suggest that the burial was that of an adult, and the coffin furniture implied a fairly recent, possibly 18th or 19th century burial. Due to the safety considerations of working at that depth in relatively unstable ground conditions, the burial was not fully cleaned and exposed, but was photographed and then re-covered with soil.

Plate 3: Initial exposure of *in situ* burial 047 in Soakaway Pit 2 (E to right).

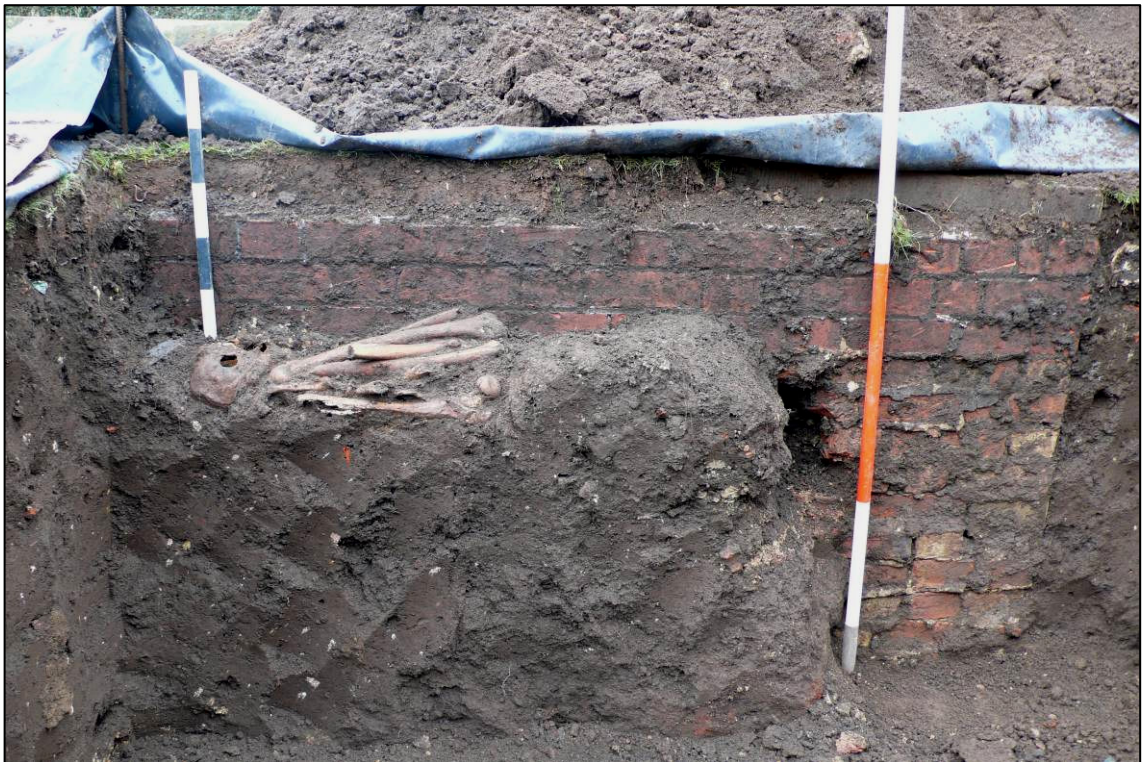
- 5.16 Only 0.20m to the south of burial 047, a damaged brick vault (049) was exposed, in the south side of the pit. At least 12 courses of brickwork were revealed, with a stone slab placed over the top; the top of the slab lay just under the turf (040) and so was not visible at the surface. A neatly stacked cache of bones (051), consisting of a skull, long bones and other disarticulated bones of an unusually sturdy individual, was found only 0.30m BGL in front (north) of the vault (see plate 4); after excavation, the remains were re-buried in the base of the pit.

Plate 4: Burial vault (049) and cache of human bones (051) in south side of Soakaway Pit 2, looking S.

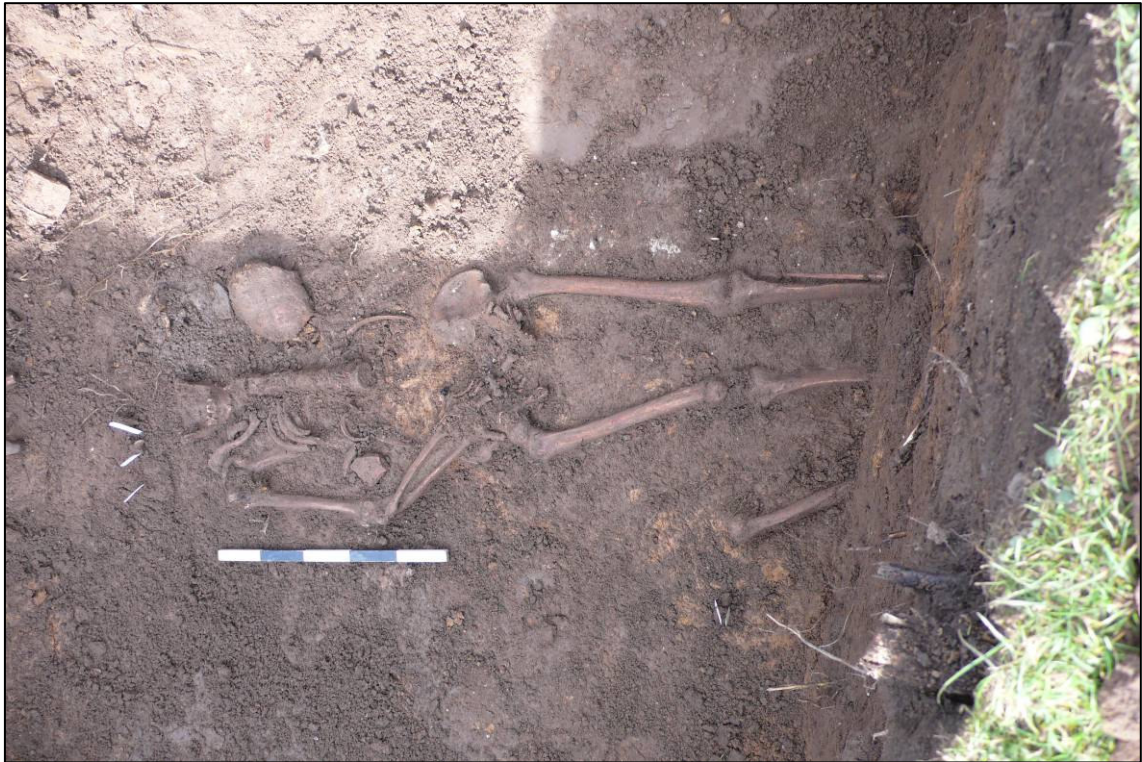
Plate 5: Burial 054, coffin remains 075 and backfill 055, in base of Soakaway Pit 3.

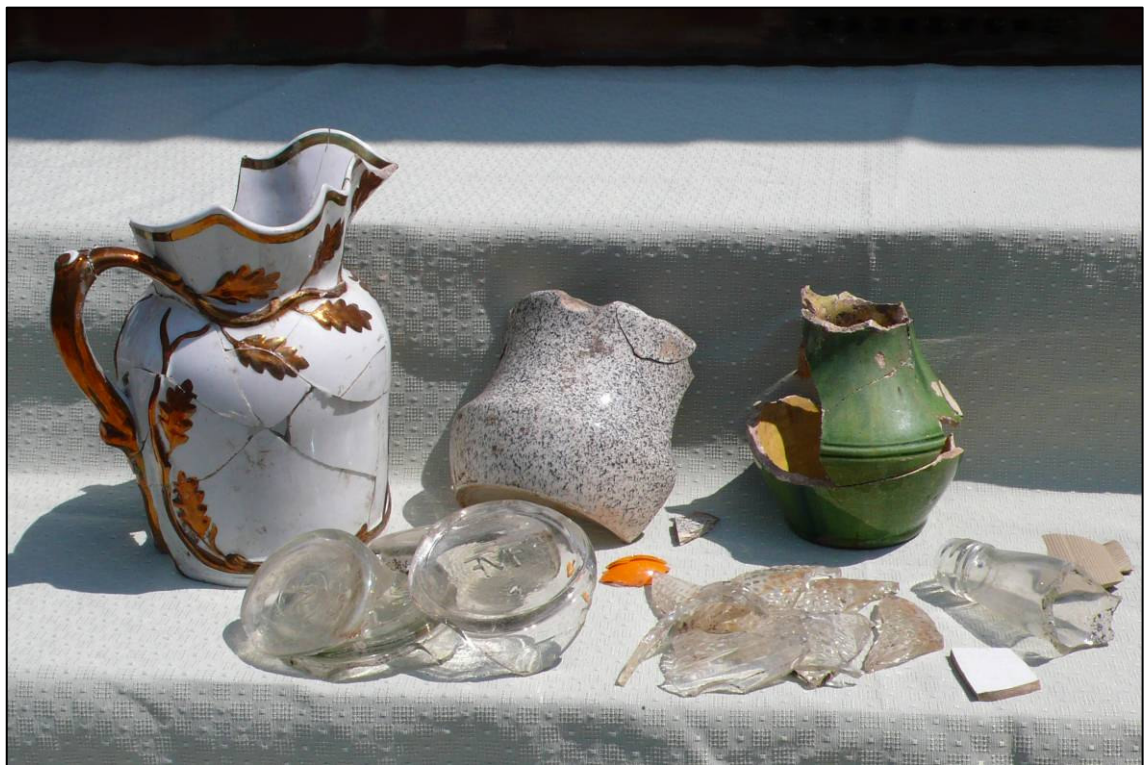
5.23 Apart from the single piece of late medieval pottery, probably of 15th/16th century date, found in context 070 (see above), the majority of artefacts were recovered from the small pit 043 identified in soakaway pit 1 off the north-east corner of the church (see plate 6). These finds included the following:

- fragments from a small thin plain glass vessel lined with orange glass;
- fragments of at least eight glass jars bearing, on the base, the trade mark 'FMF', in which the first F is reversed. The Food Manufacturers' Federation, Inc., of 22 Buckingham Gate, London SW1, applied for use of this trademark in 1928 (*Pottery Gazette and Glass Trade Journal*, August 1st 1928, p1233; Peter Didsbury, *pers. comm.*);

Plate 6: Post-medieval material recovered from rubbish pit 043 in Soakaway Pit 1.
