44 EASTGATE, BEVERLEY,
EAST YORKSHIRE

ARCHITECTURAL AND ARCHAEOLOGICAL
OBSERVATION, INVESTIGATION AND RECORDING

Report no: 2006/294.R01
Version: Final
Date: February 2011
Author: Ed Dennison & Shaun Richardson

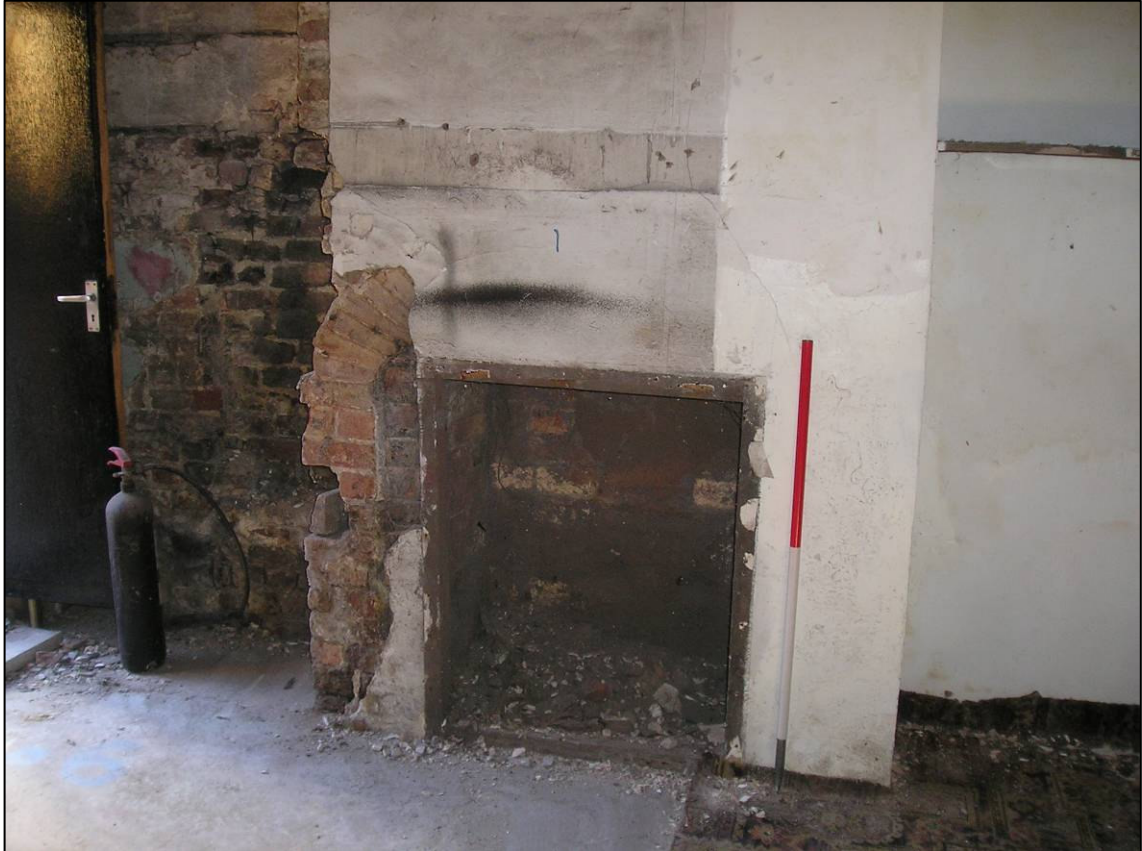
Plate 5: Fireplace in GF4 west wall, looking south-west.

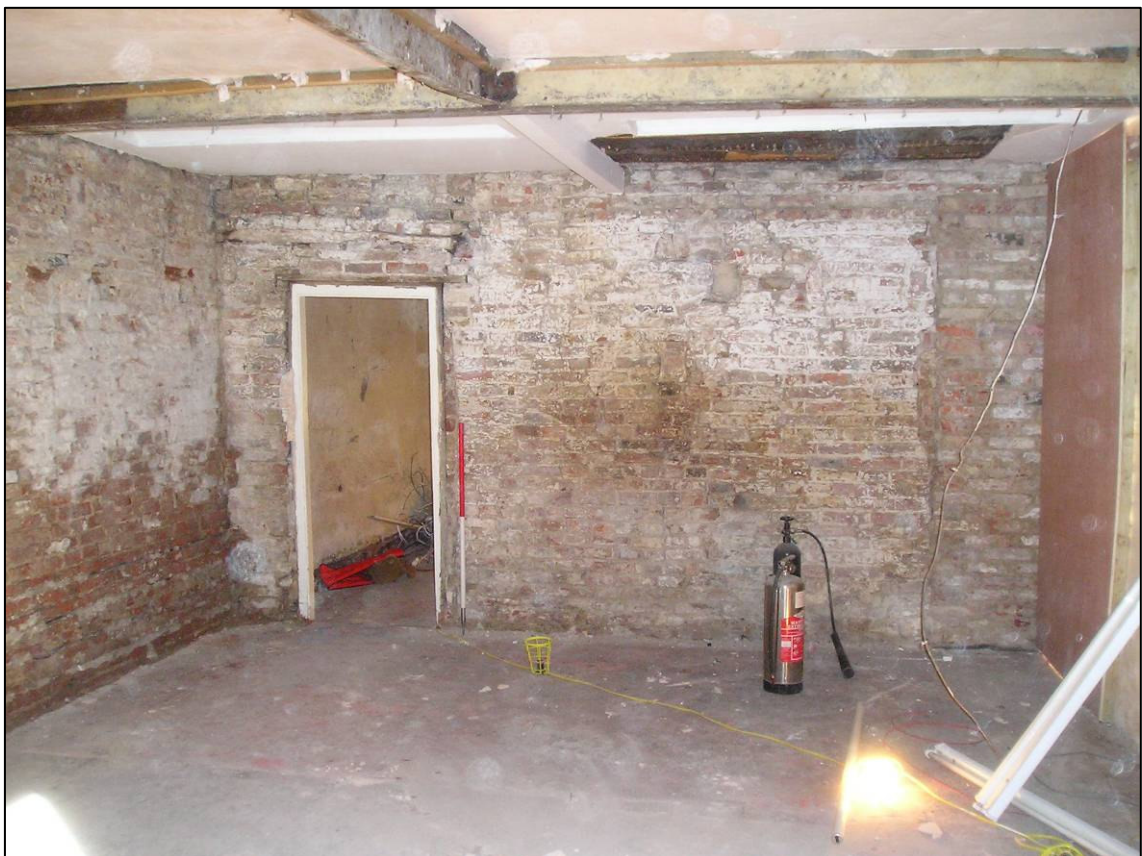
Plate 6: GF4 east wall, looking north-east.

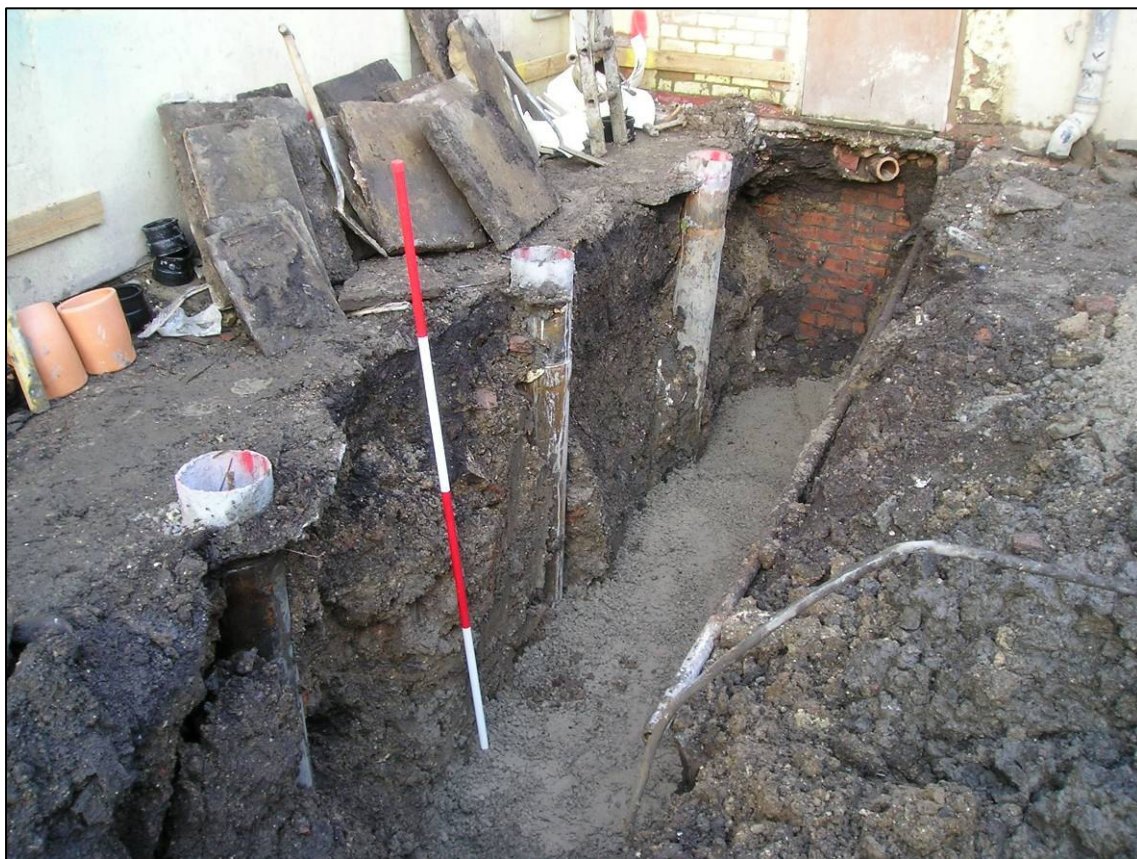
Plate 7: East end of main trench, south facing section, looking north-east.

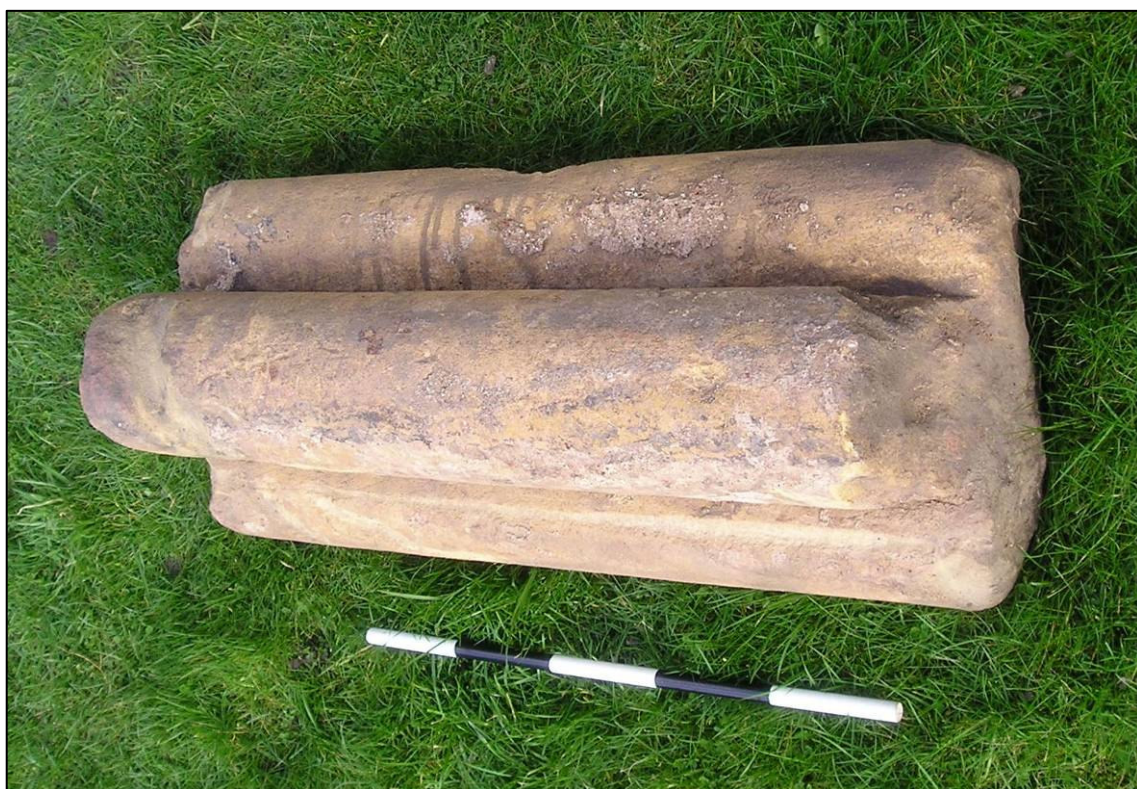
Plate 8: Moulded stone fragment recovered from context 010, after cleaning.

This is a section of a clustered shaft bearing three rolls, which was probably used within the interior of an ecclesiastical building. This fragment has been reused and bears traces of mortar on the decorated surface. The reddish discolouration of the piece also indicates that it has been burnt at some point in time.

Stylistically the fragment possesses a potential date range of the 12th to early 13th century. The introduction of claw tooling to the region is thought to occur in the later 12th century, becoming the dominant type in York c.1200 (Kemp and Graves 1996, 227). The fragment from 44 Eastgate bears worn fine ?striated tooling on the moulded surfaces and rough diagonal striated chisel tooling on the rear.

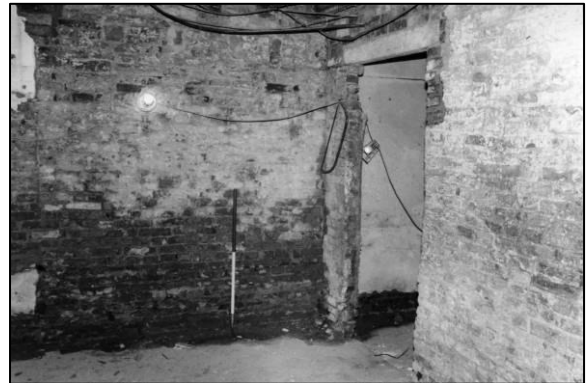
- 3.18 A possible straight joint was visible in the brickwork of the north wall of this space (GF4), towards its east end (**3/14a**); where the plaster was removed, the bricks were seen to be red, handmade (average dimensions 240mm by 150mm by 60mm), laid in no particular pattern (but with occasional stretches of headers) and set with a lime mortar. By contrast, the brickwork of the east wall was very similar to that noted in the south range's west elevation, although it incorporated a number of re-used bricks of late medieval / early post-medieval appearance (**1/9-1/10**, **1/12-1/13**, **2/15a** and **3/15a-3/16a**) (see plate 6). Removal of the ceiling revealed

Photo 3/14a: North wall of GF4 (east end), looking N.

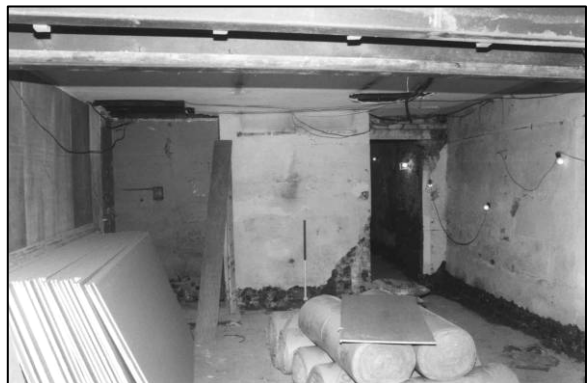
- 3.16 Beyond the west end of the room, the rear range changes angle slightly in plan. It is probable that there was once a more substantial cross wall here, separating room GF2 from GF3 to the west. This cross wall is shown on the Ordnance Survey plans of 1854 and 1892, although it is interesting that only the later edition depicts the change in angle, and then only on the north side of the building (see figures 4). This cross wall had been removed at the time of the survey, and had been replaced by three parallel I-section steel girders in the ceiling on the same alignment. The main surviving feature within room GF3 was the projecting chimney breast / fireplace in the west wall, flanked by an existing doorway to the north and a tall but narrow blocked opening to the south; when viewed from within GF4, it was noted that the north doorway was once wider and had been narrowed. No details of the fireplace were revealed during the conversion works (**3/19a**).

Photo 3/19a: West wall of GF4, looking S.
