GRIMWITH HOUSE, GRIMWITH RESERVOIR,  
APPLETREEWICK, NORTH YORKSHIRE

ARCHITECTURAL ASSESSMENT

Report no: 2010/371.R01  
Version: Final  
Date: January 2011  
Author: Shaun Richardson & Ed Dennison

Yorkshire Dales National Park Authority  
Yoredale  
Bainbridge  
Leyburn  
North Yorkshire DL8 3EL

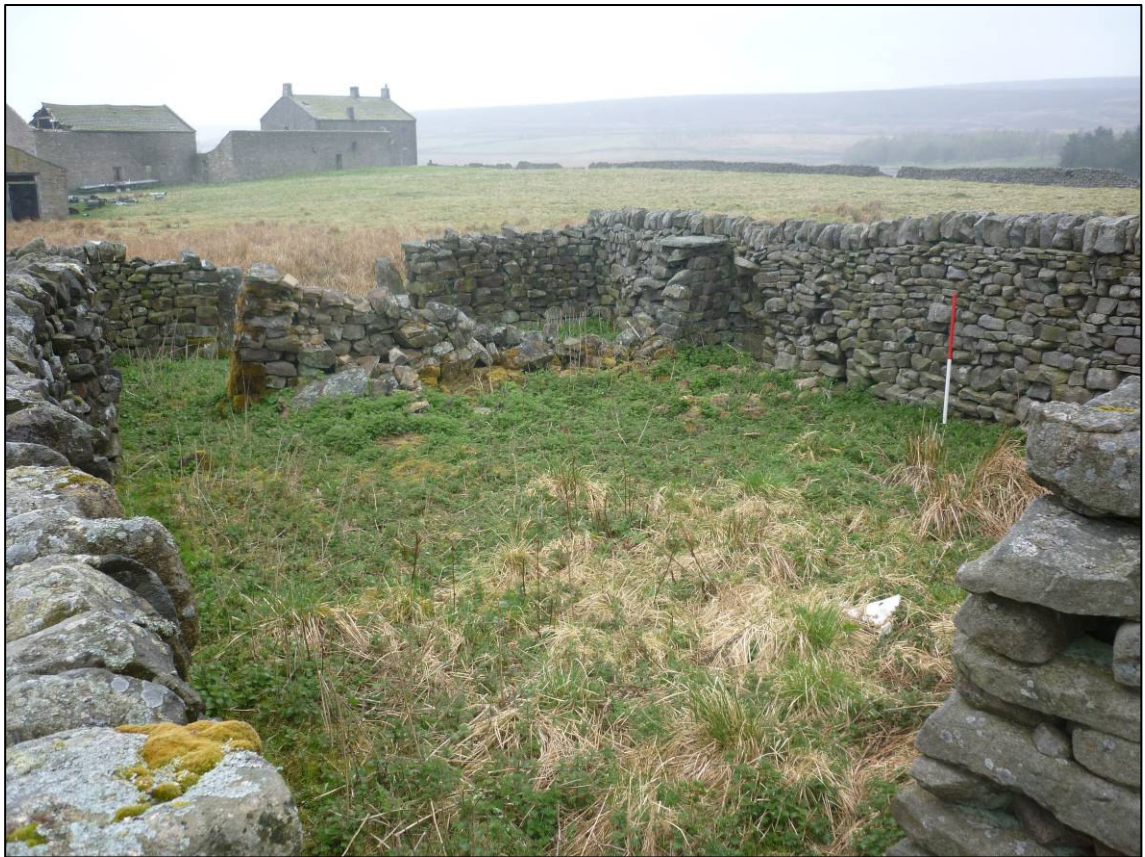
Plate 4: Sheepfold in south-east corner of enclosure, looking NW (photo 1/320).

- 4.10 There appear to be few management issues associated with the enclosure to the east of the farm complex, although some sections of the boundary wall are beginning to deteriorate, as are those walls forming the sheepfold in the south-east corner of the field, for example the recent internal dividing wall (see plate 4). The majority of the issues relate to the standing buildings. While most are in a reasonable condition, their isolated location and potential for human and natural erosion means that they are at risk. The roofs of the structures are, in most cases, sound, although those forming the southernmost bay of the barn and the northern cell of the east range have collapsed and there are smaller holes evident in the east range and the house; a simple comparison between the aerial photograph taken on 2nd July 2009 (see plate 1) and the ground view taken on 6th May 2010 (see plate 2) shows how the roof collapse at the south end of the barn has significantly increased. The walls of the various structures are generally sound, although there is the potential for further collapse and deterioration of some parts, for example around the hole adjacent to the arched entrance in the yard wall (see plate 5), the northernmost cell of the east range (see plate 10), and above the door

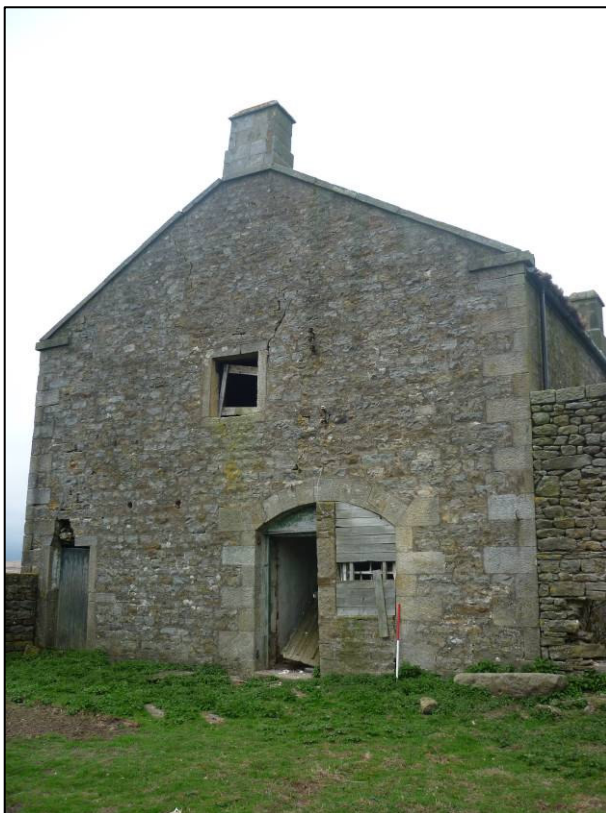
Plate 8: South gable of house, looking NW (photo 1/403).

to the stable in the south gable of the house (see plate 8). It would be appropriate to undertake some sympathetic consolidation and repair of all these elements. Without some form of intervention, the buildings will continue to deteriorate at an increasing rate, leading to eventual collapse.

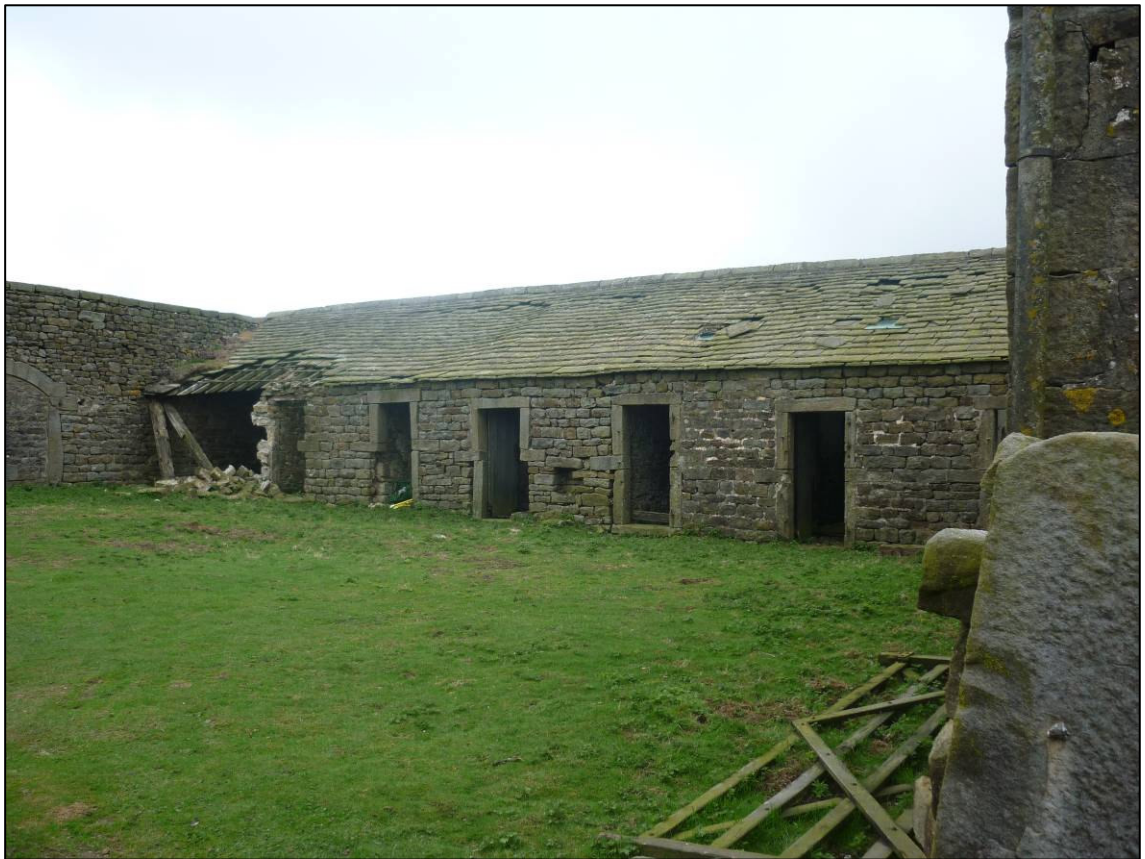
- 3.25 The west elevation [1/380 and 1/383] is formed by a series of six surviving doorways which give access to the individual cells (see plate 10); there was almost certainly a seventh doorway at the north end, but this has been removed by later alteration. The doorways are all of similar form, with well dressed lintels and interrupted jambs [1/388]. The doorways leading to the three southernmost cells [1/389] were all formerly fitted with stable-type doors, hung on external iron pintles [1/390]; however, patterns of wear and small cut-outs to the jambs suggest that this might not have been the original arrangement.

Plate 10: West elevation of east range, looking N (photo 1/380).

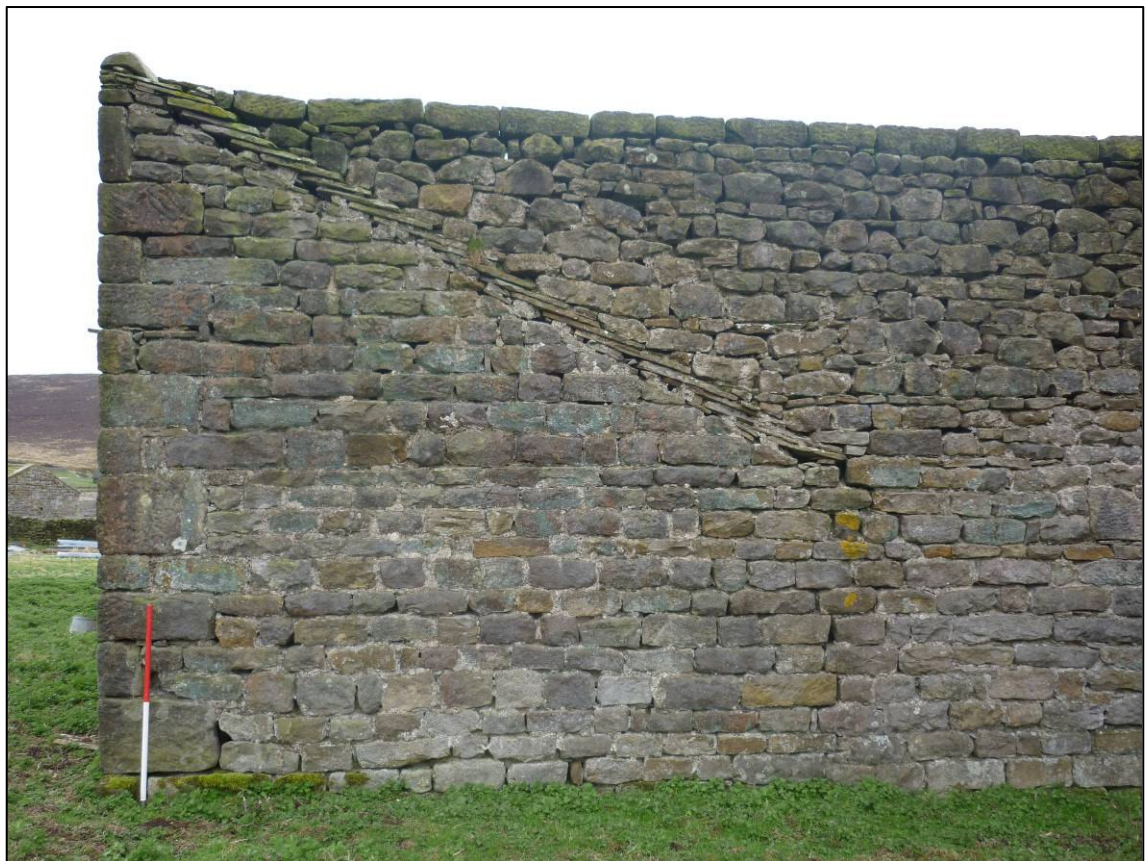
- 3.24 As has already been noted, although there is perhaps some evidence for a ragged joint between the two, the north gable of the range appears to be contemporary with the lower half of the north yard wall [1/355]. The upper part of the yard wall is however clearly built over the single pitch roof of the range; the stone slates have been retained (see plate 11). There are no openings in the north gable.

Plate 11: North gable of east range, looking S (photo 1/355).

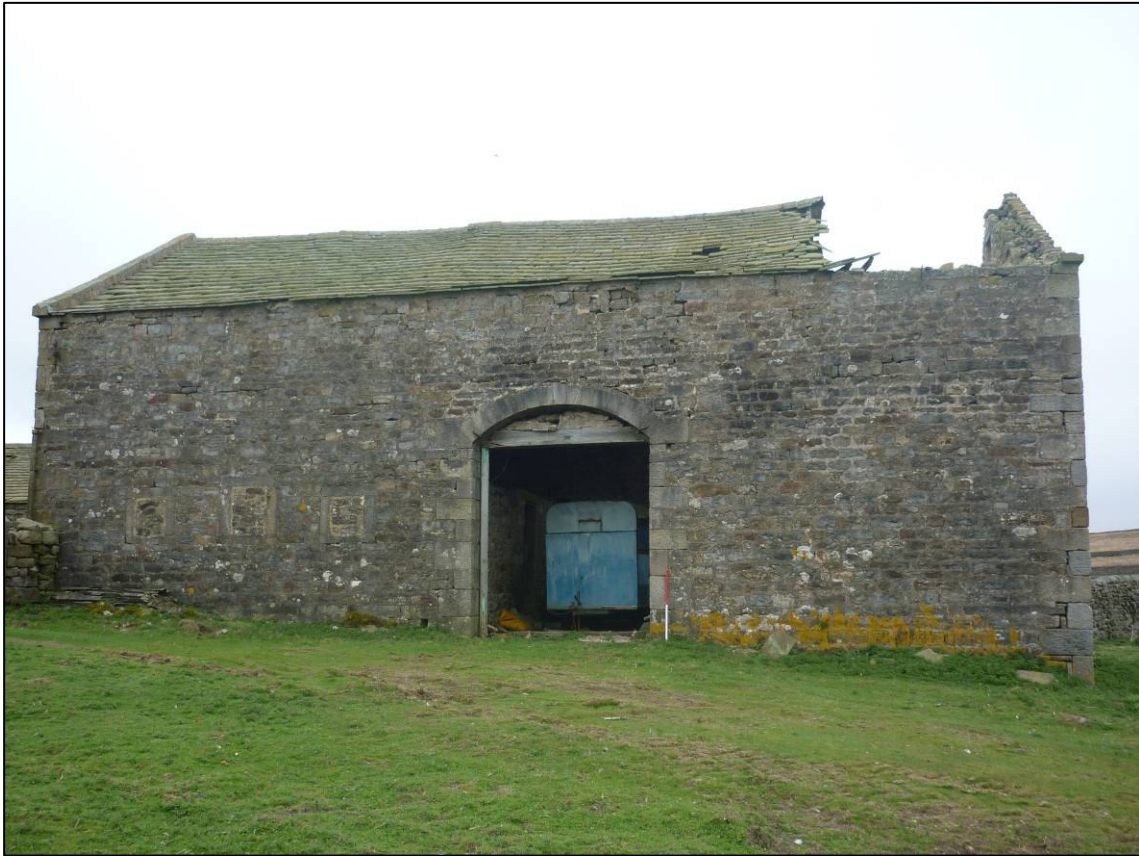
- 3.35 The roof structure of the barn is clearly visible through the cart entrance, and formerly comprised four substantial softwood queen-post trusses of bolted and strapped construction; the second truss from the south end has been subsequently replaced by a modern softwood king-post truss. Some of the purlins supported by the principals of the queen-post trusses appear to be re-used, while at least one of the trusses retains incised assembly marks. The roof to the south of the southern truss has fallen [1/375].

Plate 12: Barn, W elevation, looking E (photo 1/375).
