RETAINING WALL, OLD GANG SMELT MILL,
SWALEDALE, NORTH YORKSHIRE

ARCHAEOLOGICAL RECORDING

Report no: 2011/401.R01
Version: Final
Date: July 2011
Author: Shaun Richardson & Ed Dennison

Yorkshire Dales National Park Authority
Yoredale
Bainbridge
Leyburn
North Yorkshire DL8 3EL

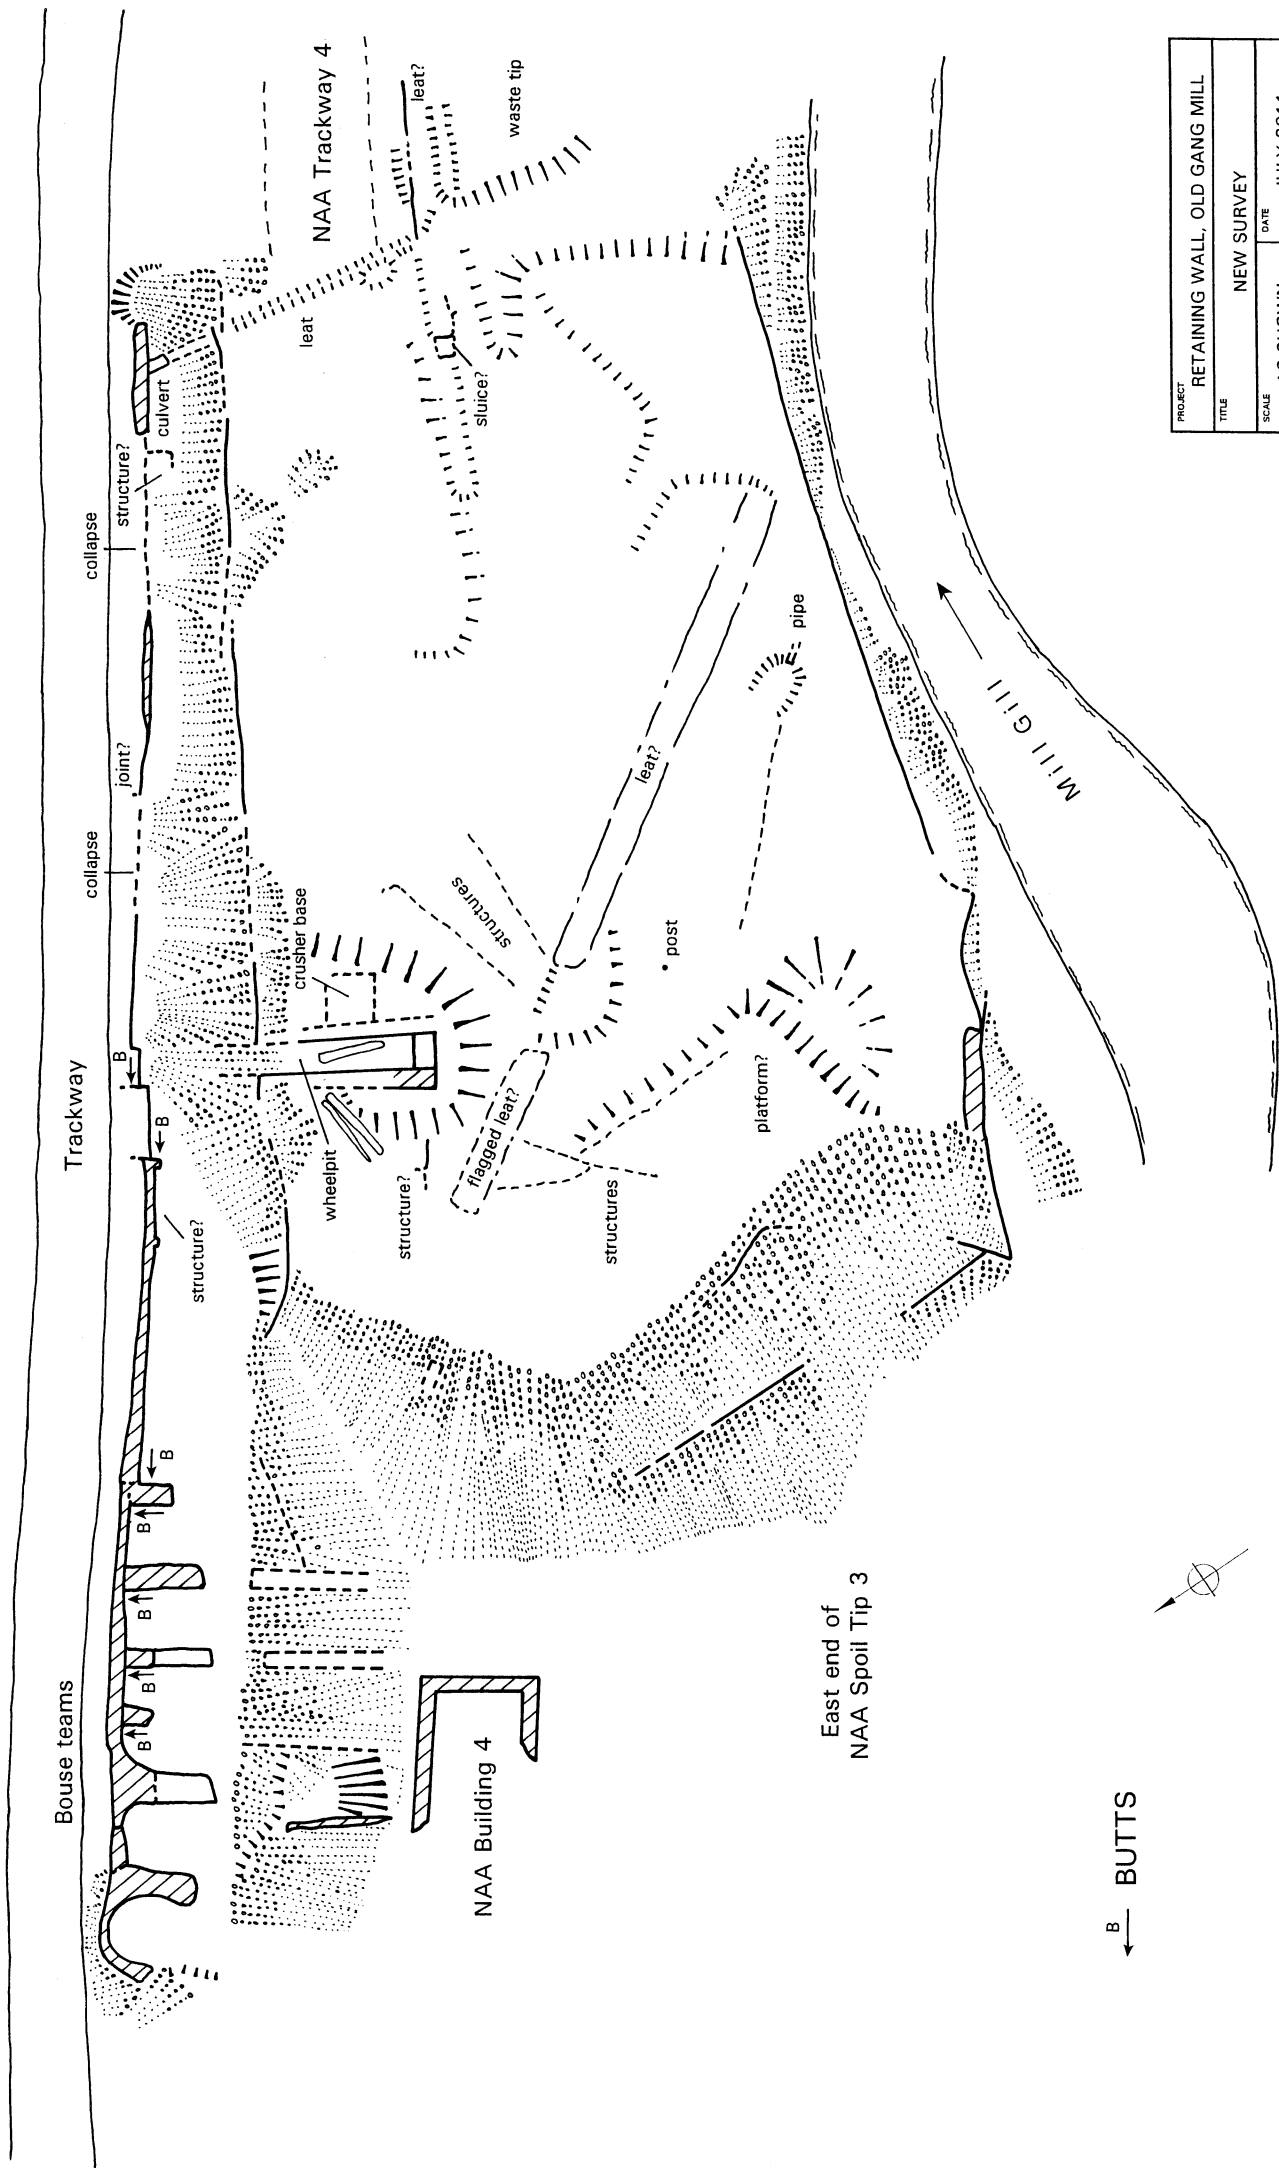
PROJECT	RETAINING WALL, OLD GANG MILL		
TITLE	NEW SURVEY		
SCALE	AS SHOWN	DATE	JULY 2011
	EDAS	FIGURE	4

4 RESULTS OF THE ARCHAEOLOGICAL RECORDING (see figure 4)

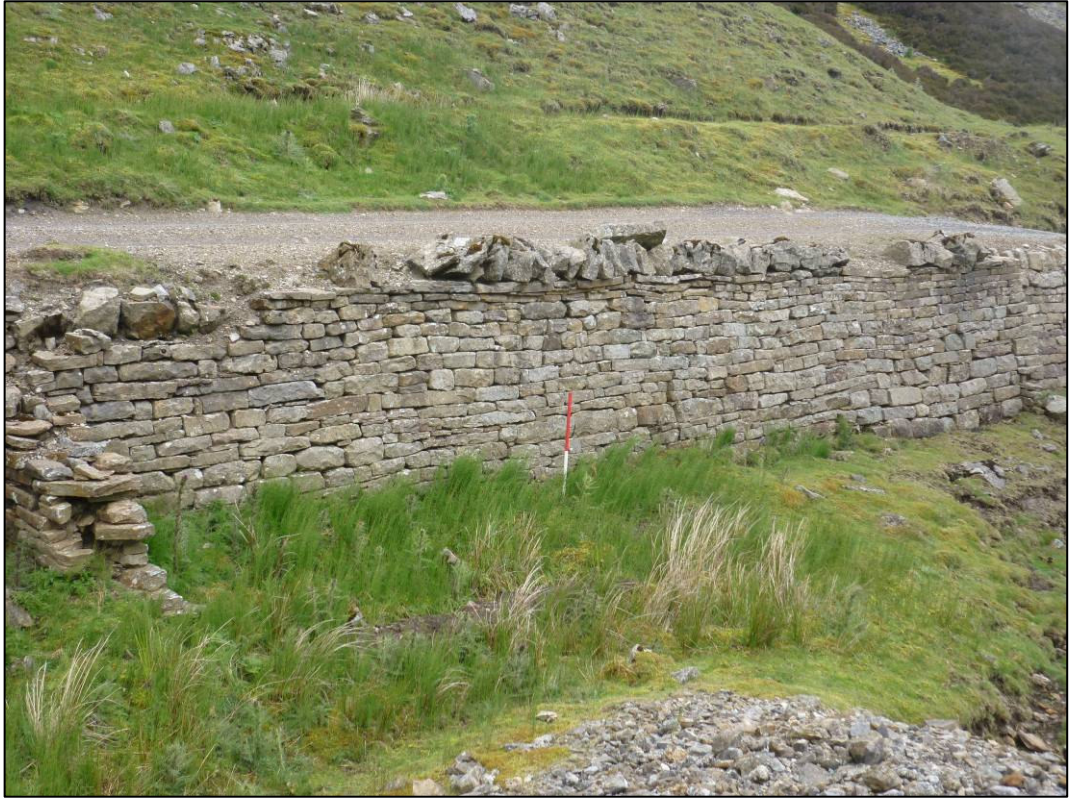
- 4.4 The easternmost stub wall of the bouse teams is butted by the section of retaining wall to its immediate east. This section of wall is c.12m long and stands to a maximum height of 2.20m [1/392] (see plate 1). It is built to a battered profile from coursed squared stone with upright coping. At the end of this section, low level projecting stubs suggest that there may once have been a small structure set against the wall, measuring c.3m long, perhaps a former bouse bin. To the east of this possible structure, the wall face steps back 0.30m to the north and butts the retaining wall to the west [1/394] (see plate 2). This recessed section forms a discrete length of wall 2.60m long, of similar form to that to the west but standing only 1.70m high [1/395]. This section of retaining wall is in turn butted by the wall to the east, where the wall face again steps back to the north by 0.30m. This creates a separate section of wall 1.40m long [1/396], perhaps connected to a wheelpit to the south (see below). At the east end of this section there is another small step to the north, after which the wall continues east for c.4.8m before terminating at a 4m long area of collapse [1/397] (see plate 3). On the east side of the gap, there may possibly be a butt joint, but this is not certain. The retaining wall can then be traced east for a further 7.00m, before encountering another c.6m wide area of collapse. Within this section of collapse, there is a 1m wide strip of level ground at the base of the wall before the ground surface falls off very steeply to the south, and the remains of a small attached structure may be visible here. Beyond the second area of

Plate 1: Retaining wall immediately to east of bouse teams, looking E (photo 1/392).

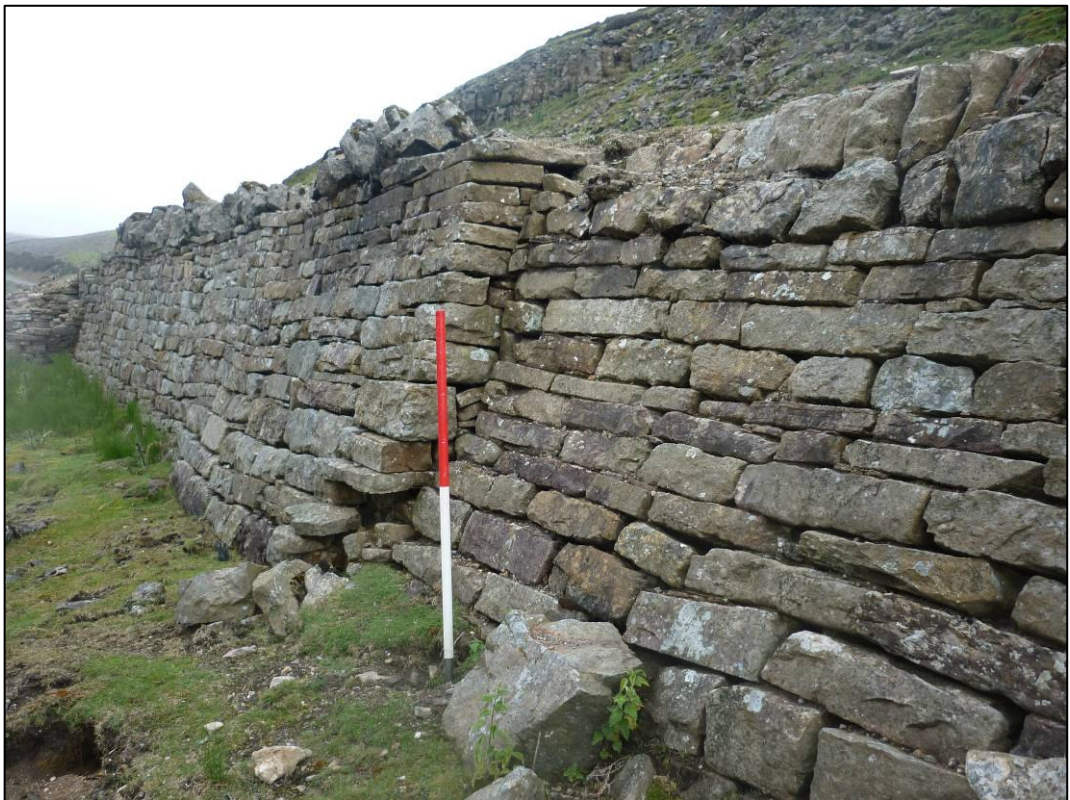
Plate 2: Step in retaining wall, looking N (photo 1/394).

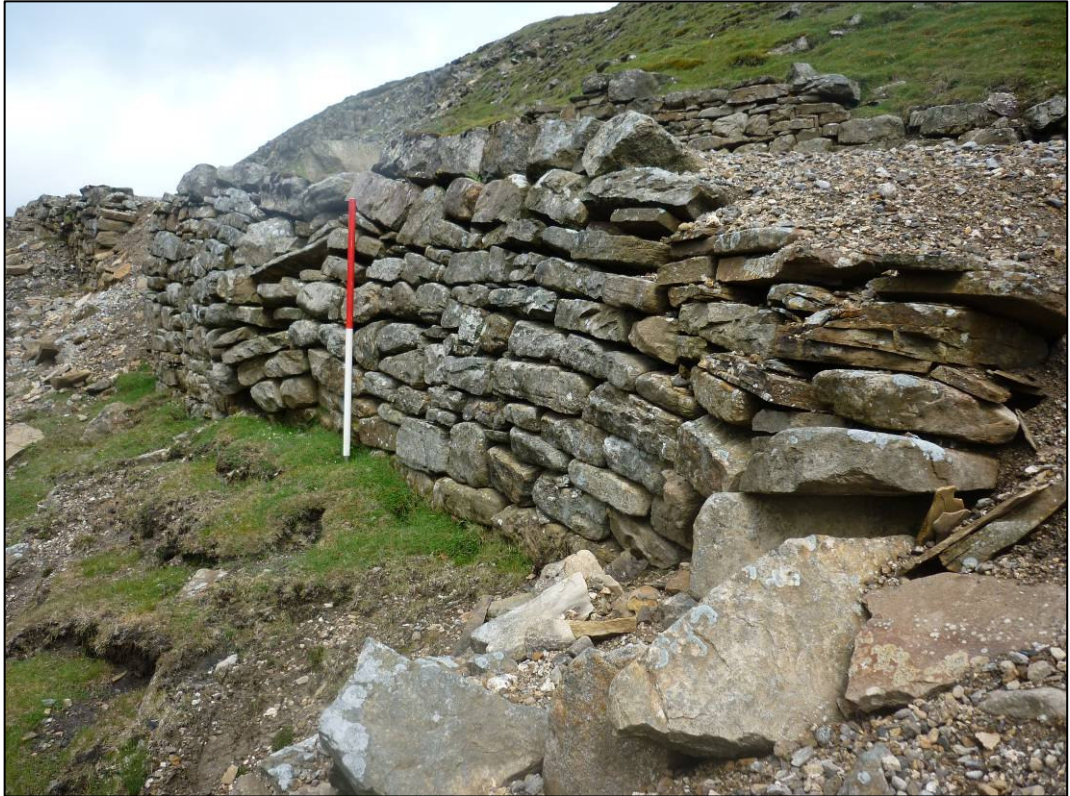
Plate 3: Central part of retaining wall between collapses, looking NW (photo 1/397).

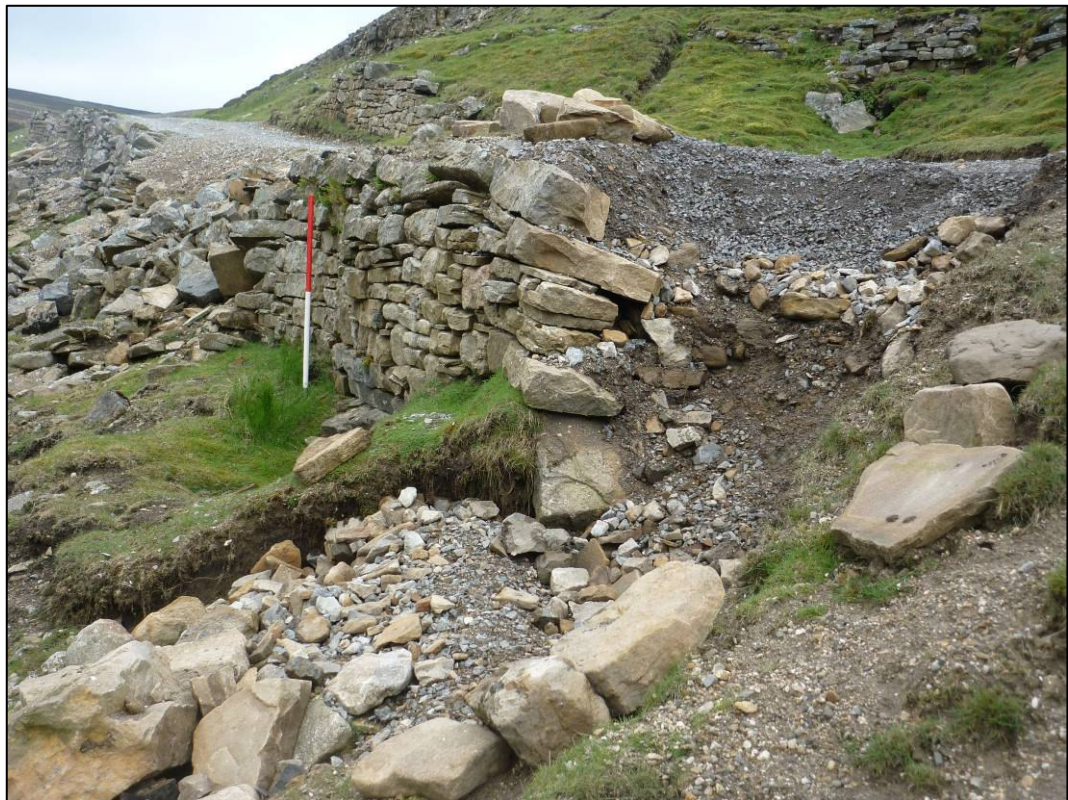
collapse, the wall stands up to 1.40m high, and has a culvert emerging from the base [1/398]. Shortly beyond this culvert, the retaining wall has collapsed completely, as has the ground immediately behind, creating a near vertical south-facing scarp [1/399] (see plate 4).

Plate 4: Collapse at east end of retaining wall, looking N (photo 1/399).

- 3.1 The condition of the retaining wall had been a matter of concern for some time, and it was anticipated that intensive use in the summer of 2011 by the Reeth Shooting Estate to bring in stone for track maintenance might cause further collapse. In order to ensure continued safe access by those using the track, it was proposed to take down and partially rebuild two sections (c.4 and 12m in length respectively) of the retaining wall and repair two sections of collapse (each c.3m in length). A culvert that runs beneath the eastern end of the wall would also be unblocked.

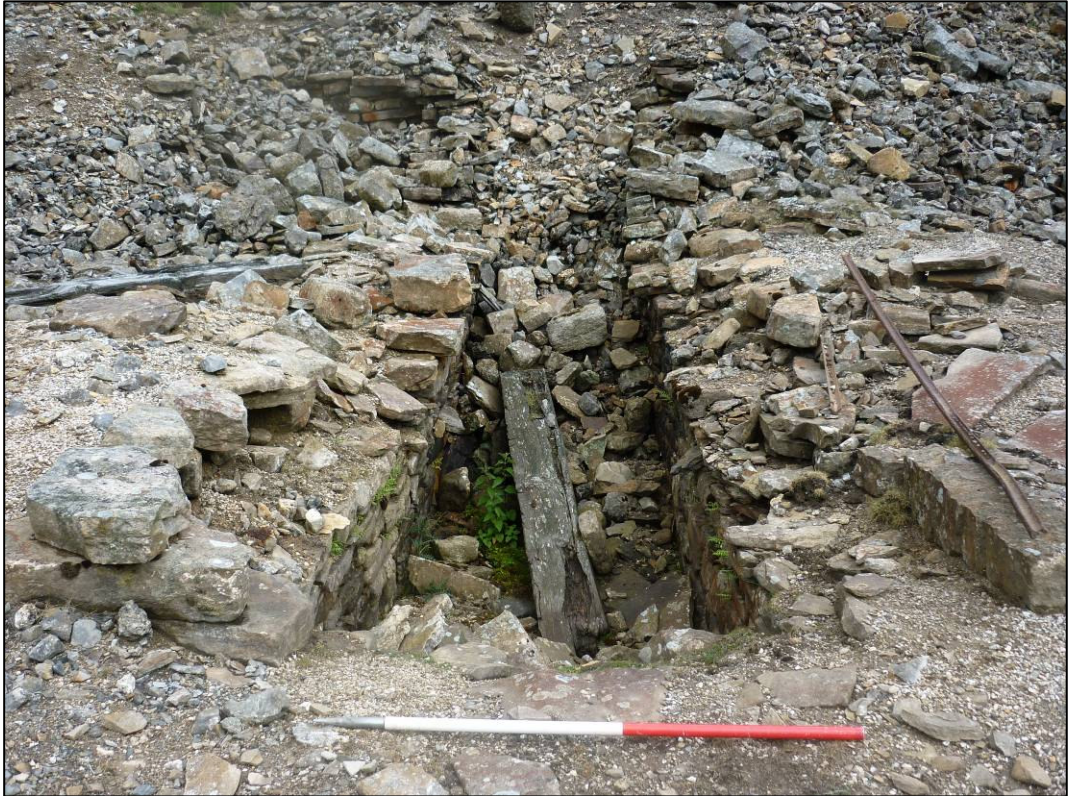
Plate 5: Wheelpit, looking NE (photo 1/405).

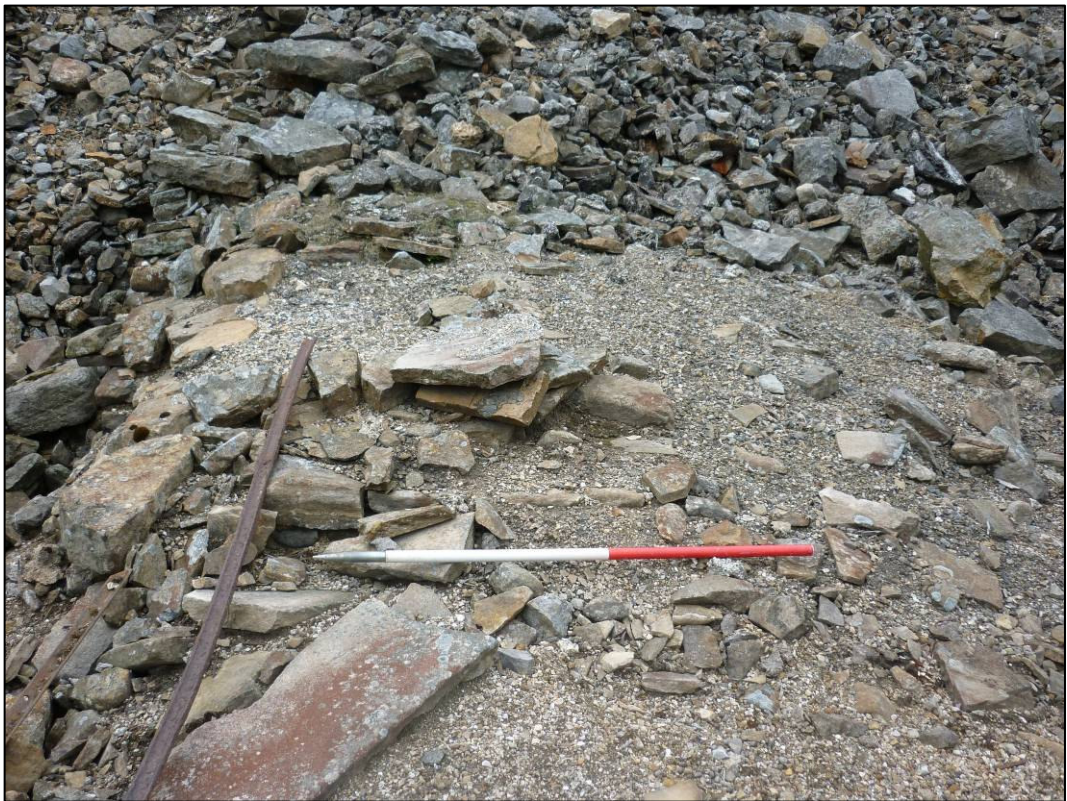
Plate 6: Probable crusher base on E side of wheelpit, looking NE (photo 1/406).

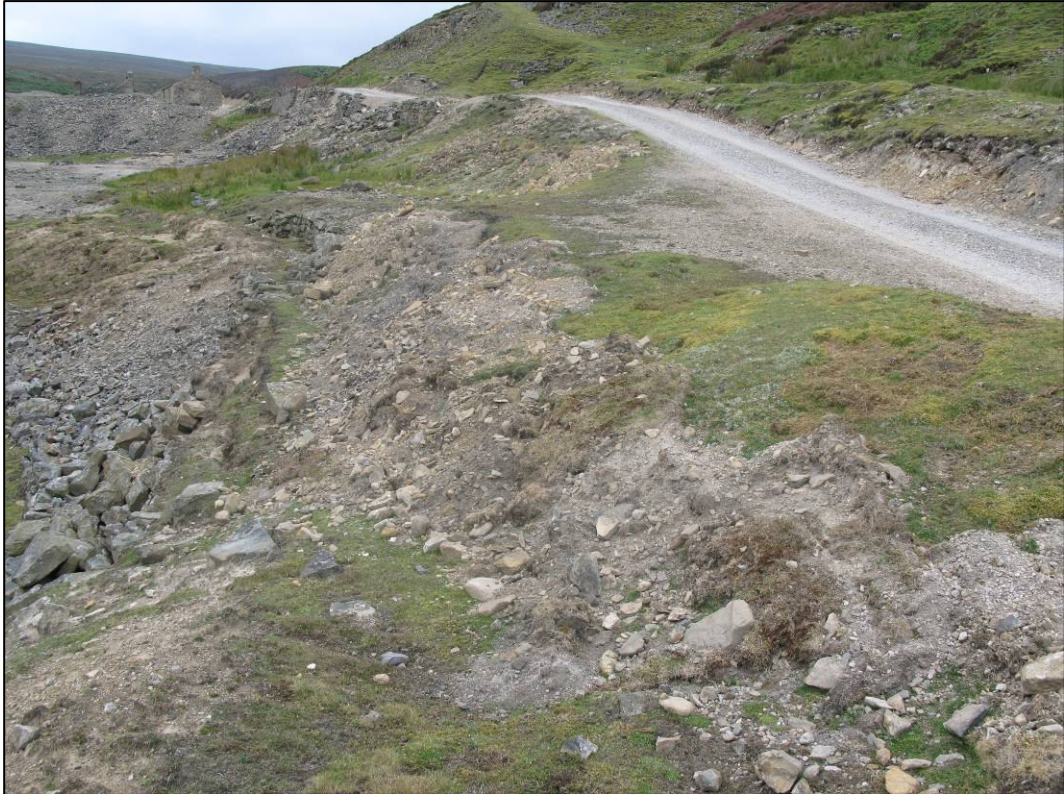
been subject to relatively recent disturbance, including some modern debris washing off the adjacent track and perhaps some dumping of material resulting from unauthorised drainage works on the north side of the track in 2007 (see plates 7 and 8).

Plate 7: Dumping of material from unauthorised drainage works, September 2007 (YDNPA photo 1630).

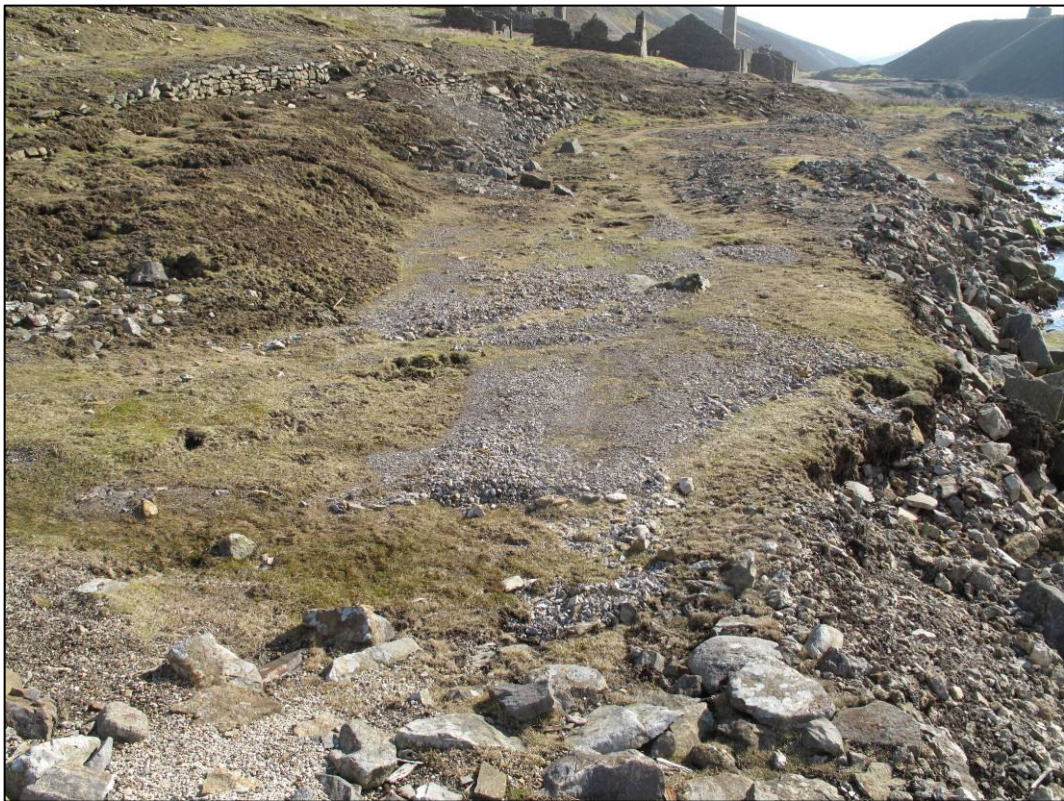
- 5.3 The current survey has also identified a number of fragmentary flagstone and timber structures within the area of the dressing floor, concentrated to the south and south-east of the waterwheel pit. It is probable that these represent the remains of structures which dressed varying grades of material after it had passed through the crushers. This area appears to have been drained by both the tail race from the wheelpit and a smaller culvert/leat running south-east. The fine nature of much of the dressing waste in this area means that continuing erosion resulting from rainfall and water flow is likely, and so more information relating to these structures will continue to be exposed over time. However, the proposed repairs to the retaining wall should help to limit run off onto the sensitive parts of the complex, for example limestone chippings from recent track repairs are starting to spread over parts of the dressing floor and bouse teams.

Plate 8: Limestone chippings washed off track onto dressing floor, March 2011 (YDNPA photo 2041).

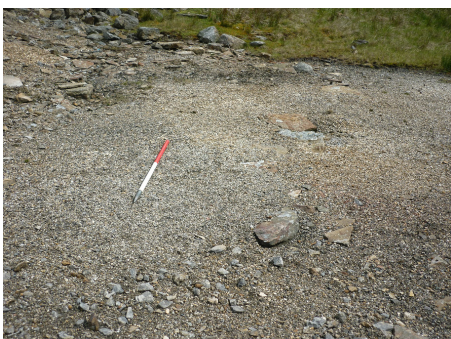
1-400.JPG

- 4.7 There appear to be further flagstone and timber structures to the south-east of the wheelpit [1/400 and 1/401], set on a north-east / south-west alignment, with possible fragmentary structures beyond these to the north of the possible leat identified by NAA. This area of the dressing floor is particularly confusing, with several different grades of dressing wastes having washed over here, which appear to have then
