GUNNERSIDE GILL, MELBECKS,  
NORTH YORKSHIRE  
ARCHAEOLOGICAL EROSION SURVEY

ARCHAEOLOGICAL EROSION SURVEY

Report no: 2009/363.R01  
Version: Final  
Date: July 2011  
Author: Ed Dennison & Shaun Richardson

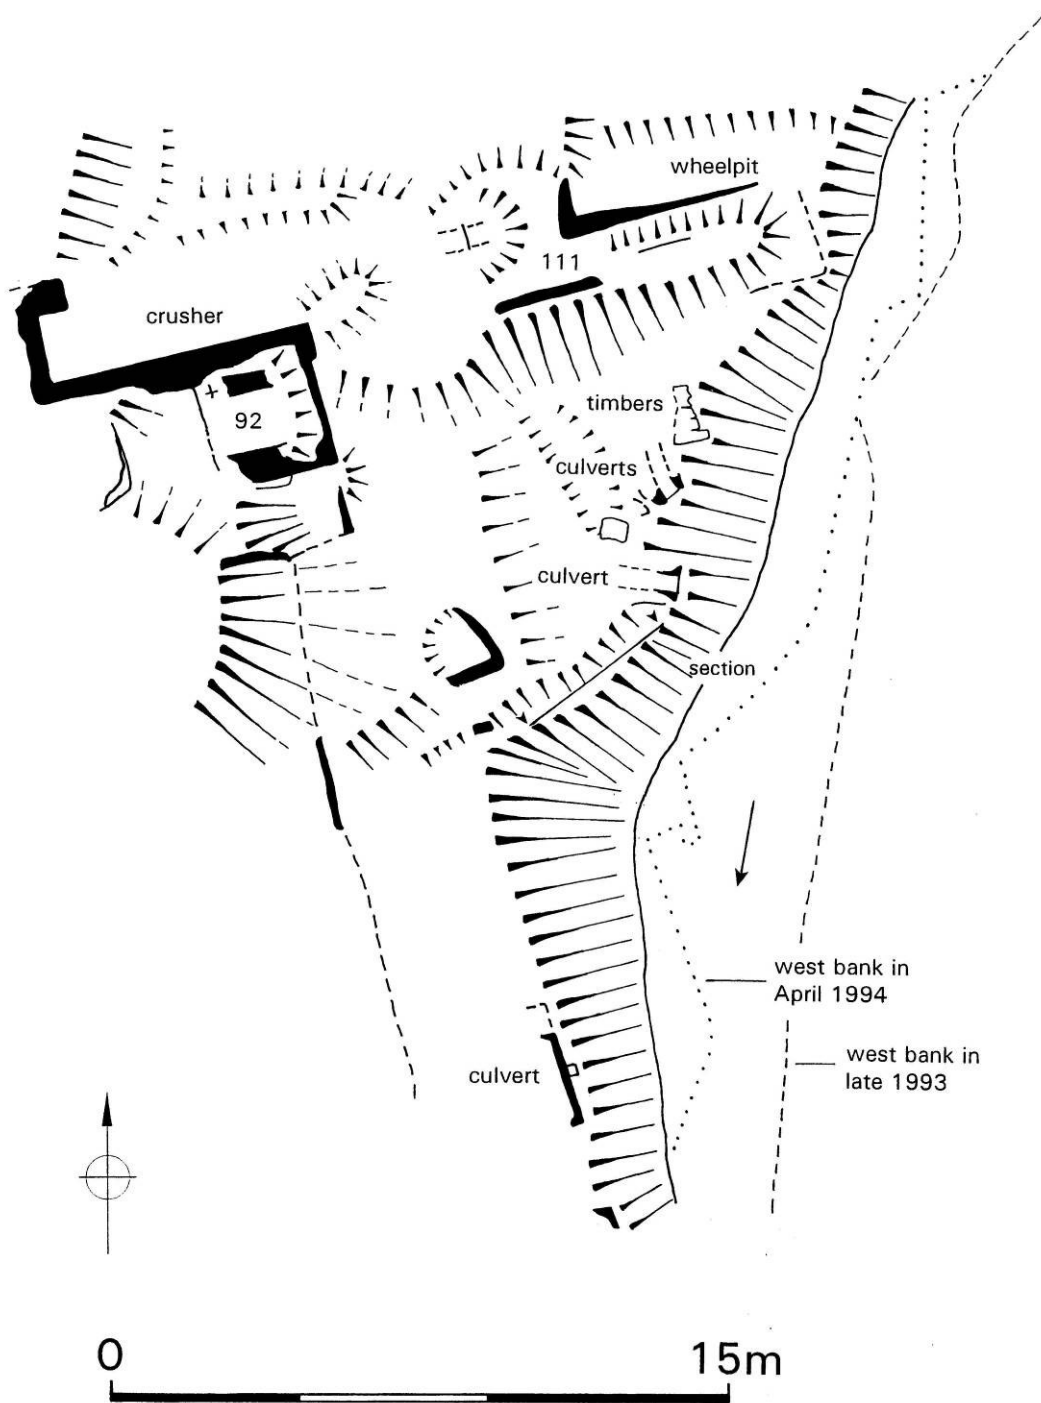
PROJECT EROSION SURVEY, GUNNERSIDE GILL	
TITLE AREA 1 SURVEY	
SCALE AS SHOWN	DATE JULY 2011
EDAS	FIGURE 2

- 4.2 As previously stated, Area 1 was located at c.320m AOD on the west side of the Gunnerside Beck (at NGR SD 940 998 centred) and formed part of the former dressing floor associated with the Sir Francis Mine. It was situated within the 1993 Phase 1 survey area, adjacent to a large meander in the course of the beck, and consisted of a stretch of actively eroding bank c.50m long (north-south) (see figure 2).

- 4.5 To the north, the loss of ground since April 1994 has been significant, with the east-facing scarp containing wall faces (Site 96) having been cut back up to a maximum of 8m by the beck in the past 15 years. The direction of the beck, curving into the west bank here, has created a steep south-east-facing scarp, which has exposed a well-preserved stratigraphic section [2/770, 2/771, 2/773 and 2/775]. The section is c.5.40m long and stands to a maximum height of 1.20m, sloping steeply downwards from west to east (see figure 3). At the south-west end, there is a 0.25m deep layer of turf and topsoil, which overlays a 0.70m deep deposit of light brown/greyish silt with a bank-like profile. The silt incorporates frequent inclusions of angular stone rubble, and also appears to contain a relatively high proportion of fine to medium dressing waste, defined as Type C waste by the Phase 1 survey (Cranstone & Instone 1994, 187). This silt overlays the surface of a fragmentarily surviving flagstone surface, c.1.65m long, and defined at the north-eastern end by a 0.30m high rubble wall, probably a former revetment. Beneath the flagstone floor, a firm base had been created using angular stone rubble set within a light brown/greyish sandy silt, while 0.60m to the south-west, the remains of another probable stone revetment are visible, set slightly higher than that with the flagstone surface. The rubble base of the flagstone surface overlies a relatively level narrow band of compacted gritty light grey fine dressing waste. This dressing waste overlies a layer of loose light brown/orange silt containing much stone rubble, which continued beneath the base of the section, and was at least in part re-deposited natural material, perhaps the product of old landslips.

- 5.2 A decision will need to be made soon for this part of the Sir Francis Mine complex - should the erosion be allowed to continue unchecked, or should a more permanent solution perhaps involving the partial canalisation of the beck or the construction of retaining walls be adopted? It is possible that the latter options would prove too costly and would perhaps be environmentally unacceptable, and so it is likely that the dressing floor will continue to erode, either slowly year-on-year or more rapidly during periods of flood. Some channelling at the south end of the complex was undertaken during the 2002 consolidation works, but this appears to have had only limited success and the mineshop has suffered significant loss in recent years. If the dressing floor is to be 'written off', it is suggested that there should be a suitable level of archaeological recording done soon, including excavation, so that information relating to the structures and the methods of working is recovered. At present, no lead mine dressing floors in North Yorkshire have been archaeologically excavated, and the methods employed in dressing are largely inferred from other sites outside the county.

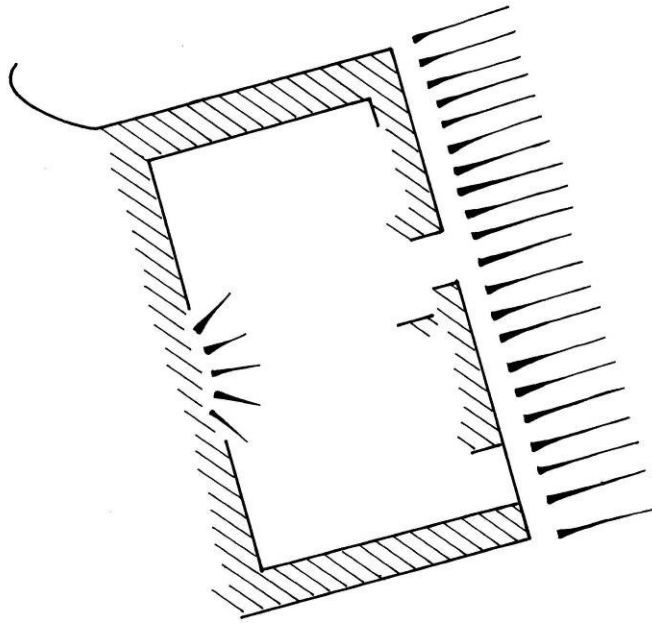
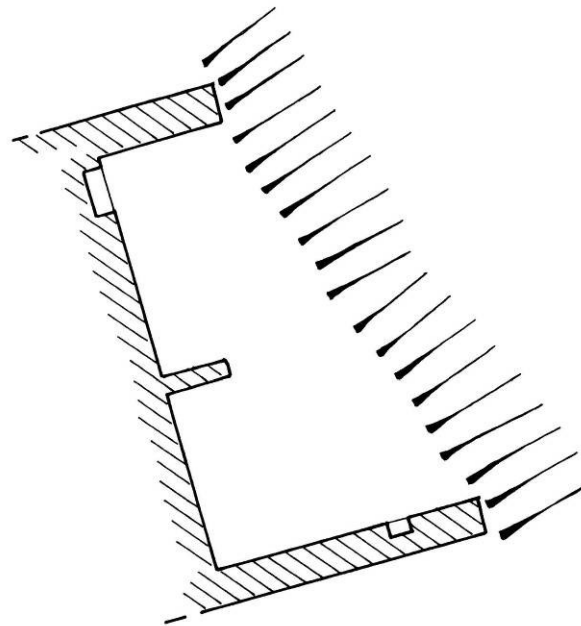
PROJECT EROSION SURVEY, GUNNERSIDE GILL	
TITLE AREA 1 MINESHOP	
SCALE AS SHOWN	DATE JULY 2011
EDAS	FIGURE 4

- 4.12 The mineshop has now been seriously undermined since the consolidation works took place, and the east wall has now been completely destroyed, together with approximately half the length of the north wall, the internal elevation from 4.50m in 1993 to 2.50m in 2009 [2/791 to 2/799, 2/803 and 2/804] (see plate 7). Comparison with YDNPA photographs shows that this erosion has occurred since late 2005 (see plate 8).

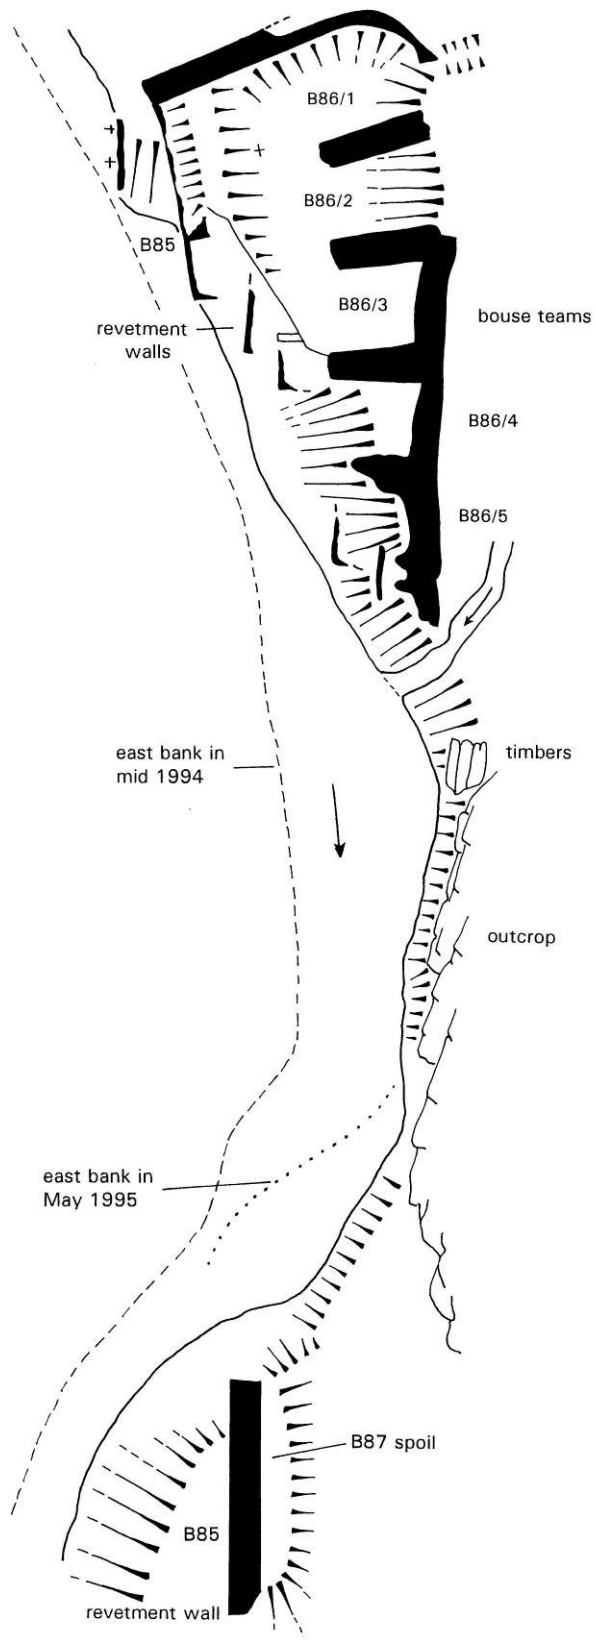
PROJECT <b>EROSION SURVEY, GUNNERSIDE GILL</b>	
TITLE <b>AREA 2 SURVEY</b>	
SCALE <b>AS SHOWN</b>	DATE <b>JULY 2011</b>
<b>EDAS</b>	FIGURE <b>5</b>

- 4.13 As previously stated, Area 2 was located at c.400m AOD on the east side of the Gunnerside Beck (between NGR SD 93928 01130 and SD 93927 01108) and formed part of the former dressing floor associated with the Sir George Level, below (west of) the remains of the bouse teams. It was situated within the Phase 2 archaeological survey area, and consisted of a stretch of actively eroding bank c.50m long (north-south) (see figure 5).

- 5.3 The total volume of ground removed by the beck within Area 2 over the last 15 years is much less than within Area 1, principally as a result of the beck now running up against an outcrop within the survey area. However, there have still been significant losses. The southern 5m of the Sir George Level bouse teams have been lost, and it is only the presence of a revetment wall (Site B85) which has prevented further damage. This is itself continuing to erode slowly from the southern end, and once it has collapsed, it is likely that erosion of the bouse teams themselves will accelerate. Once this occurs, there will be no stone structures to retain the spreads of fine wastes in the area immediately to the east, and it is likely that these will begin to wash into the beck. A number of probable wooden dressing structures are visible within this area, and it is suggested that a more detailed record is made of them, preferably through detailed survey and excavation, before the bouse teams begin to collapse further. It would also be advantageous to undertake some rebuilding and consolidation to both sections of the main revetment wall (Site B85) so that it affords a greater degree of protection to the bouse teams and related structures.

- 5.4 If none of these mitigation works are possible, a formal system of monitoring and recording should be set up, to ensure that the remains of the sites are surveyed prior to their destruction. The informal photographic monitoring undertaken by the YDNPA has been useful in assessing the levels and rates of erosion over time, but a more detailed and systematic approach is needed, involving new and repeated archaeological and photographic surveys, perhaps at yearly intervals.

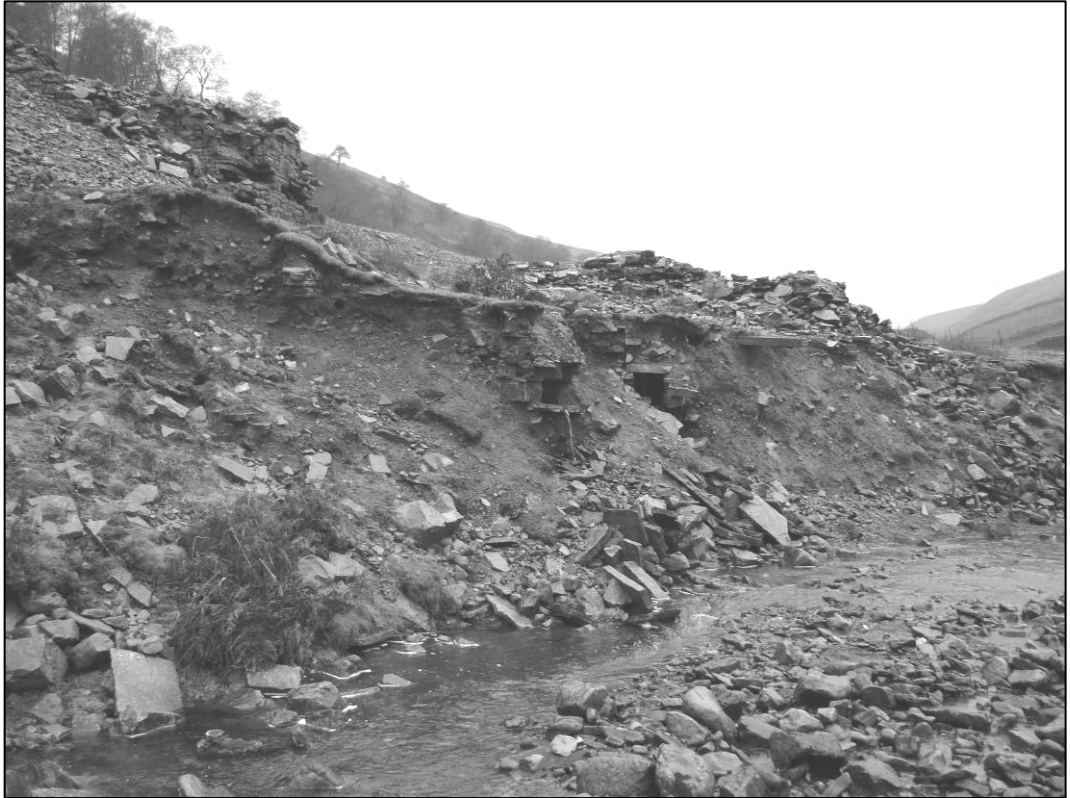
- 4.4 The southern end of the survey area is formed by a near vertical east-facing scarp, standing c.1.50m in height (see plate 3). The top of this scarp is set almost 5m further west of that recorded in August/October 1993, and several of the features recorded here by the Phase 1 survey (e.g. culvert 94 and launder 95) have been completely destroyed; comparison with the YDNPA photographs suggest that the main phases of erosion took place in 1995 and 2000 (see plates 1 and 2). At the time of the December 2009 survey, the main feature exposed in the existing scarp was a coursed squared rubble wall, 2.40m long and 0.75m high, which returned to the west at its north and south ends [2/767 and 2/769]. A small stone culvert, 0.15m square, emerges from beneath the base of the centre of the wall. This culvert is on a similar alignment to culvert 'a' recorded in May 1995 (BHWB 1995,

Plate 3: General view of eroding structures on Sir Francis Mine dressing floor, looking NW, December 2009 (photo 2/770).

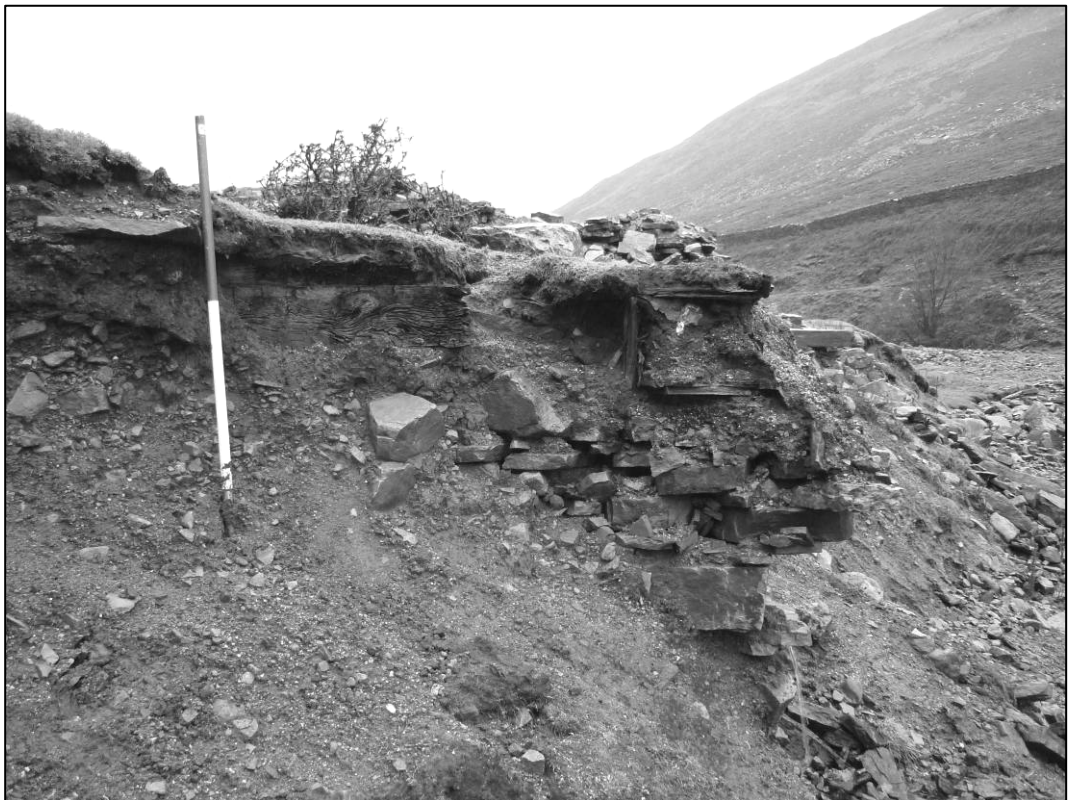
- 4.6 The light grey dressing waste noted above continues to the east of the low revetment wall associated with the flagstone surface. To the east, it starts to rise, overlying another level flagstone set immediately beneath the turf and topsoil; a hole in this area resembles a culvert, but on closer investigation was found to be a rabbit hole. Further east, a 0.70m length of level softwood timber supports one end of a series of 0.10m deep north/south aligned softwood planks, again set immediately beneath the turf and topsoil. Just beyond the timber, a closed wooden launder, choked with silt, was visible (see plate 4). This launder was 0.25m high and c.0.35m wide, with the base formed by a double plank thickness. Its size, construction and orientation all strongly suggest that it is a remnant of a wooden launder (Site 95) recorded in 1993-94 (Cranstone & Instone 1994, 55) and still visible projecting from the section in May 1995 (BHWP 1995, 3).

Plate 4: East end of eroding section, revealing timber launder, looking NW, December 2009 (photo 2/775).

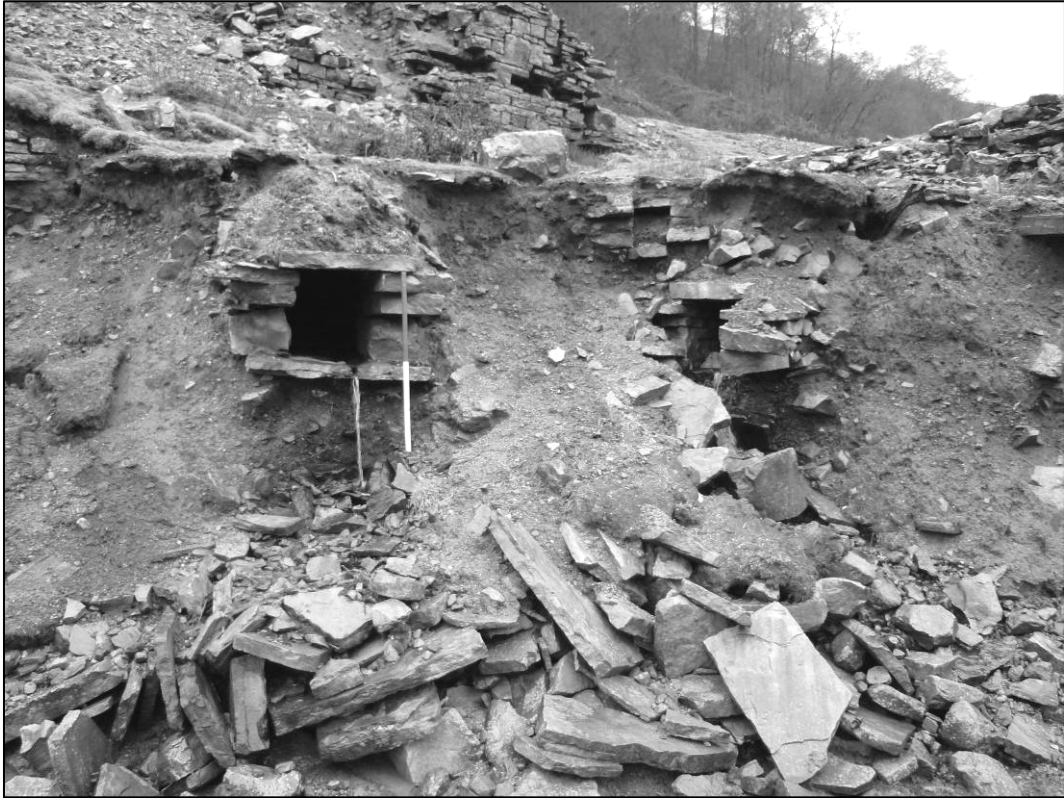
- 4.8 This culvert is one of three such features to emerge from the scarp at this point [2/776]. To the north, there is a smaller culvert, set at approximately the same level and of similar construction [1/780], but on an almost north-south orientation (see plate 5). It is on the same general alignment as culvert 94 described in the Phase 1 survey and in the 1995 erosion survey (but now set c.7m back due to the erosion), although this had an arched head (Cranstone & Instone 1994, 55; BHWB 1995, 3) (see plate 2). It is however possible that the two culverts are the same feature, with the arched section originally nearer the beck perhaps being a later addition as an earlier flag-topped length was encroached on by dressing waste. The third culvert is set immediately above and immediately to the south of the second, and much closer to ground level. At 0.20m square, it is smaller than the other two, although of similar construction, and appears to be on a north-west/south-east orientation.

Plate 5: Culverts exposed in eroding bank of Sir Francis Mine dressing floor, looking NW, December 2009 (photo 2/776).

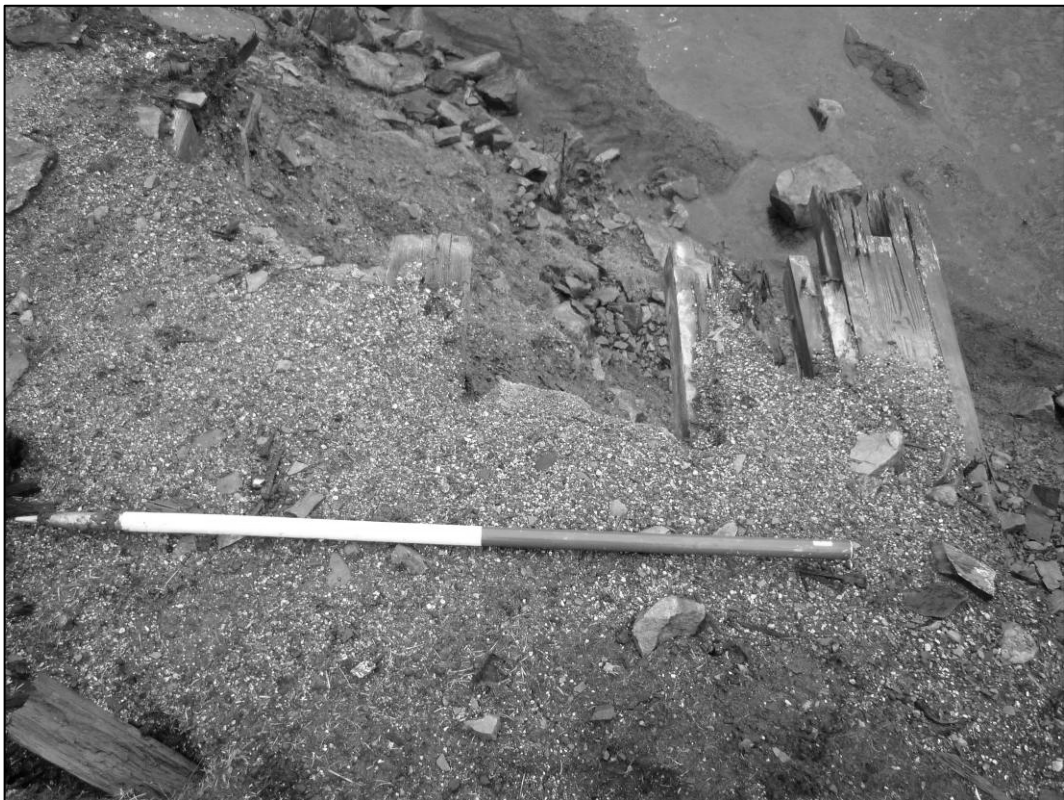
- 4.9 To the north of the culverts, the extent of erosion has not been quite so marked as to the south, although between 2m to 4m of the bank have still been lost since 1994. The wooden structure (Site 93) noted in the Phase 1 survey and recorded in detail in 1995 (BHWB 1995, 3-4), possibly the base of a mechanical jigger, has now been lost, as have sections of wall face (Site 96) to the west. In their place, a series of 0.10m deep east-west aligned timbers have been exposed just below the existing ground surface [2/785 and 2/786] (see plate 6). The timbers have a total width (north-south) of 1.80m and there are a number of square headed nails, round headed nails and square headed bolts projecting from their upper surfaces; the southernmost timber projects further to the east than the rest, and retains part of a mortice.

Plate 6: Eroding timber structure, Sir Francis Mine dressing floor, looking E, December 2009 (photo 2/785).

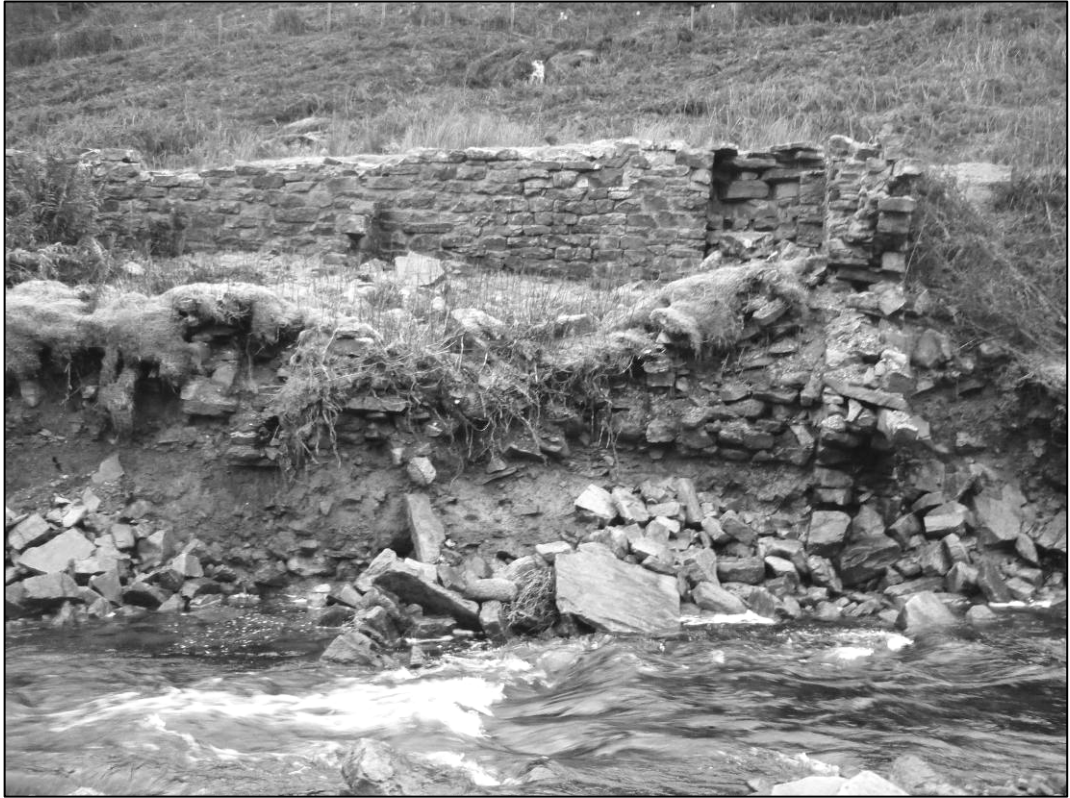
Plate 7: Area 1 Mineshop, looking W, December 2009 (photo 2/804).

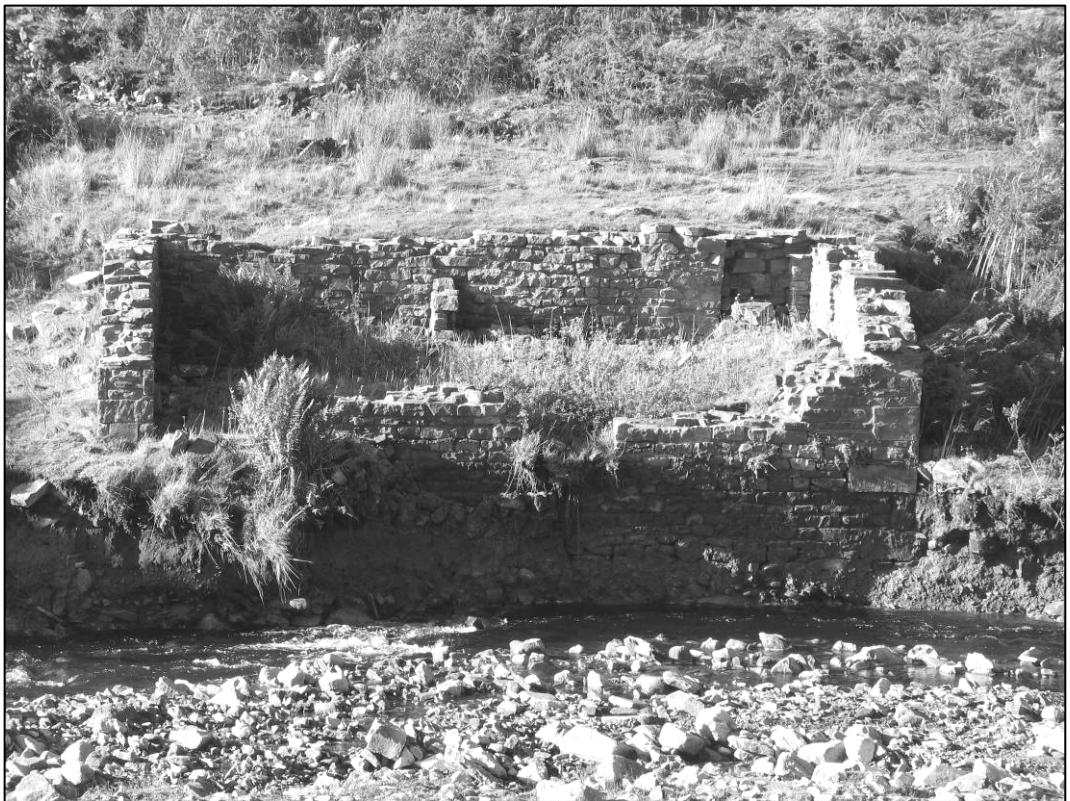
Plate 8: Area 1 Mineshop, after consolidation and prior to erosion, looking E, October 2005 (YDNP IMG 4462).

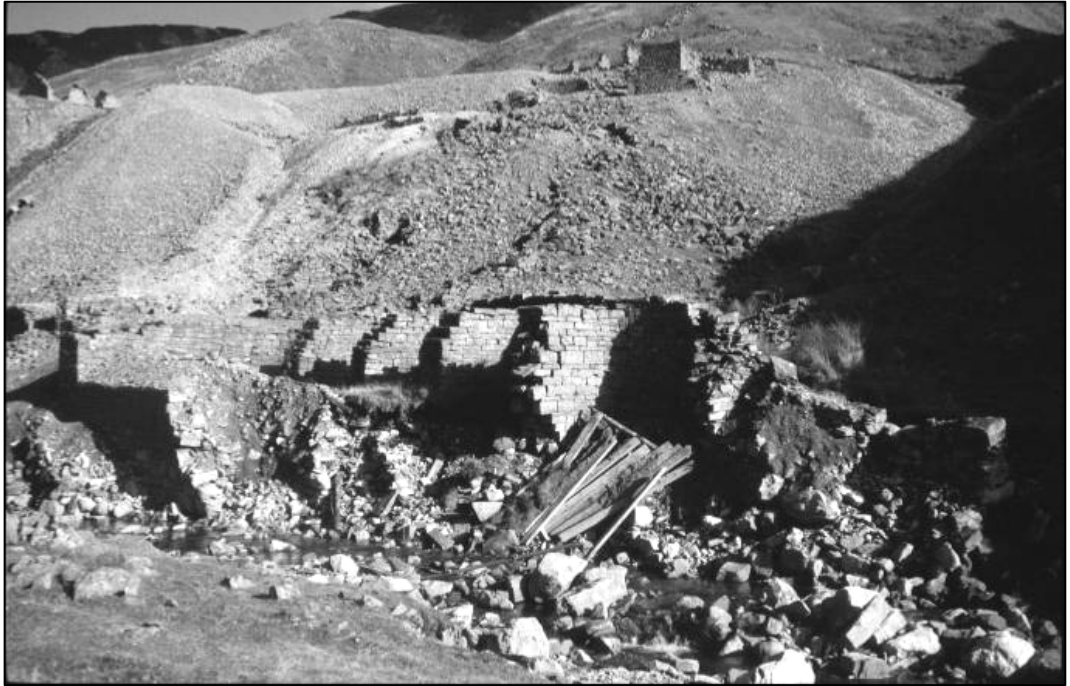
- 4.17 The eastward movement of the beck has removed c.5m of the southern end of the Sir George Level bouse teams (Site B86) since May 1994 [1/707 and 1/708] (see plates 9 and 10). Although it was not commented on by the Phase 2 survey, the spacing of the former walls here suggests that they may have represented the remains of an additional pair of bins, making a total of seven once serving the Sir George Level. As a result of the erosion, the stream (Water Sikes) which formerly ran around the southern end of the bouse teams in May 1994 has now found a new route down the steeply sloping ground here, some 6m to the north of its earlier position [1/721 and 1/725]. The timber floor of the southernmost surviving bin (Site B86/5) [1/718] has been completely destroyed, as has a 2m length of the dividing wall between it and the bin to the immediate north (Site B86/4) (see plate 11); this

Plate 9: Sir George Level bouse teams, looking NE, October 1997 (YDNPA GG359).

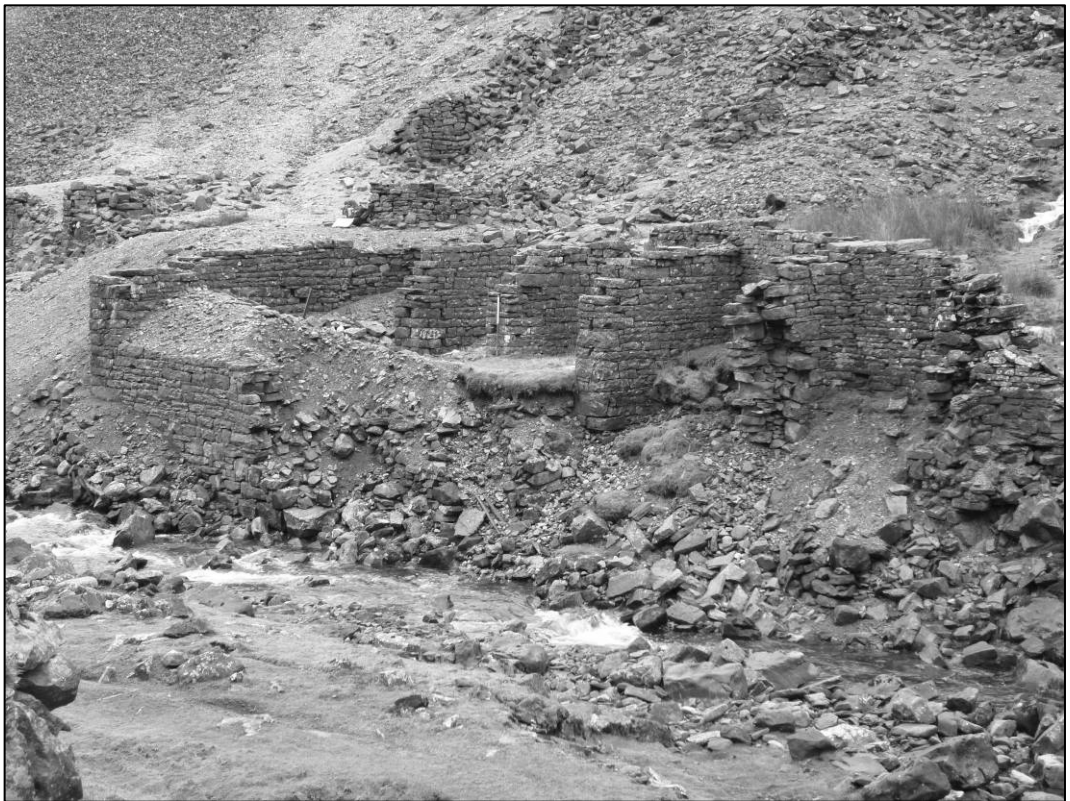
Plate 10: Sir George Level bouse teams, looking NE, December 2009 (photo 1/704).

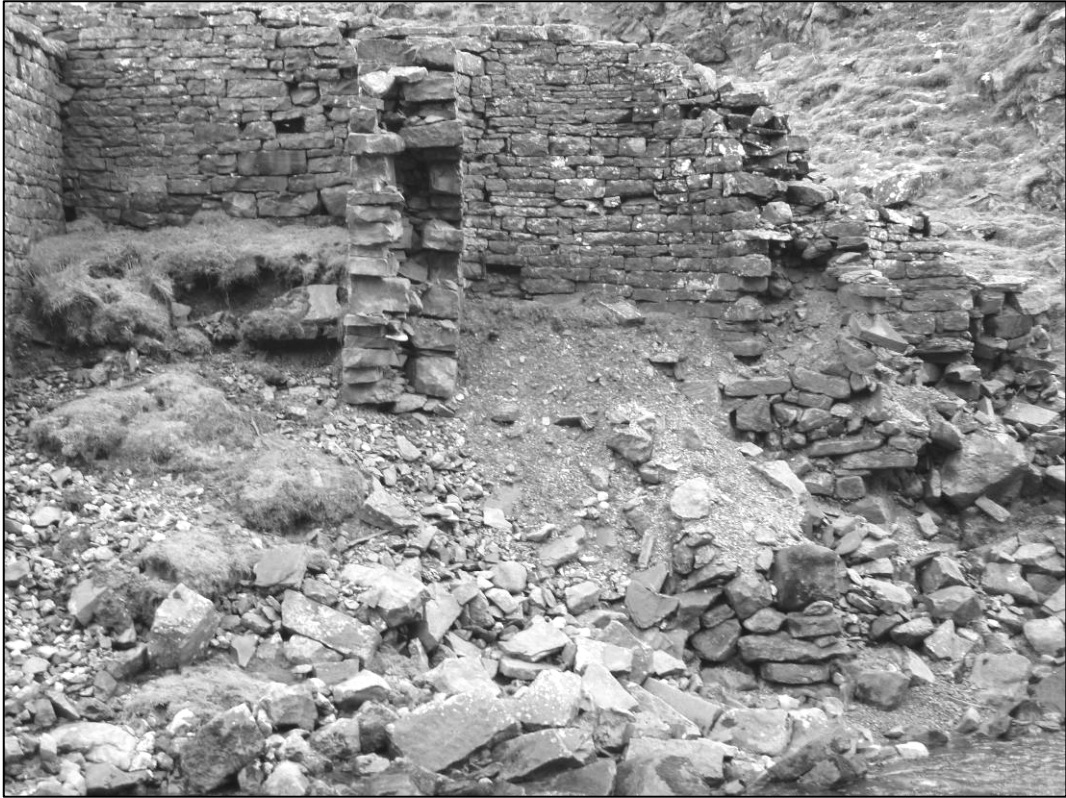
dividing wall was being undermined in May 1995 (BHWP 1995, 5). The grassed floor of the latter has been cut back since May 1995, although the structure of both it and the bin to the north (Site B86/3) remained intact at the time of survey in December 2009 [1/707 and 1/711]. The rear (east) wall of bin B86/2 to the north has either collapsed or been buried under spoil since May 1995, while the northernmost bin (Site B86/1) remains as surveyed in May 1994.

Plate 11: Eroding wall between bins B86/4 and B86/5, Sir George Level Bouse teams, looking E, December 2009 (photo 1/718).

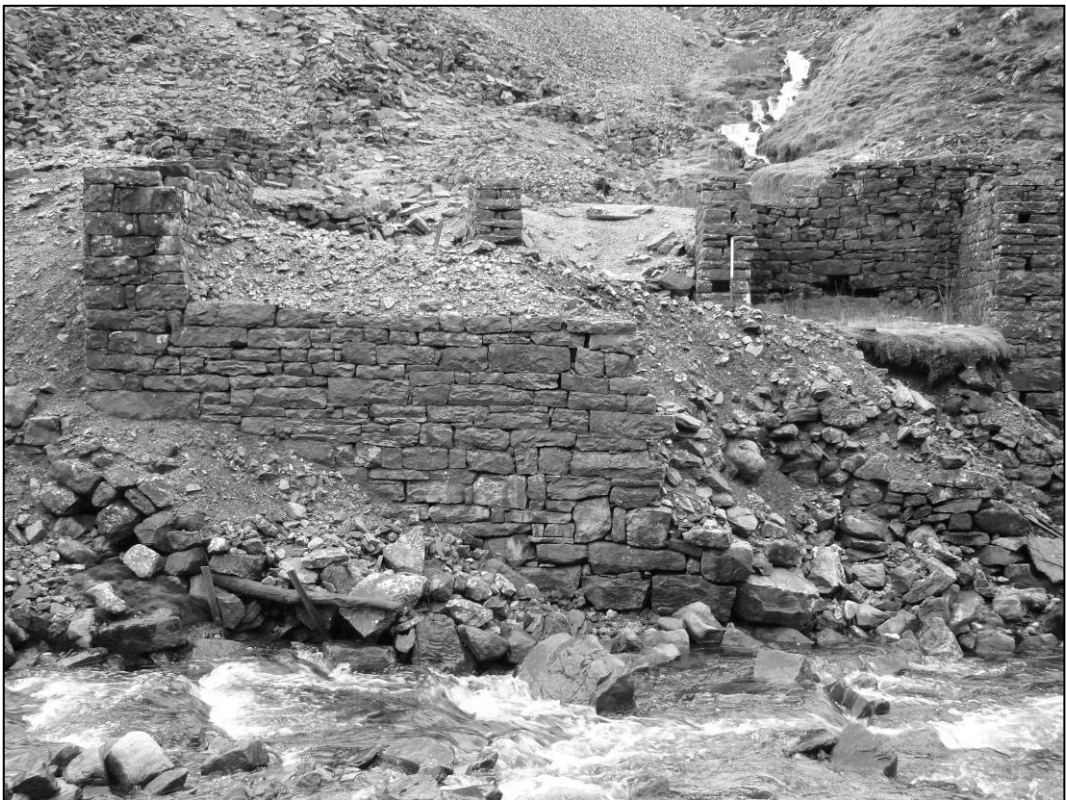
- 4.18 To the west of the bouse teams, the northern part of the revetment wall (Site B85) is continuing to collapse at its south end as a result of erosion by the beck [1/710 and 1/712], although there has not been any significant loss since May 1995 (see plate 12). The continuing erosion has exposed a number of small sections of revetment wall to the west of the bouse teams, running approximately parallel to the main revetment wall [1/713]. One of these revetments supports a horizontal timber that may once have formed part of a floor for bin 86/3, similar to that recorded to bin 86/5 in May 1994 (BHWP 1996, figure 17). The other revetment walls may represent earlier phases of revetment for the bouse teams prior to the erection of the main wall (Site B85), or were associated with the dressing floor and/or a tramway which took hand-sorted material from the bouse teams for the area to south; a rail and wooden sleepers were noted here in May 1994. It was also noted that to the immediate east and north-east of the bouse teams, water movement is continuing to cause dressing wastes from the very large spoil heaps of the Bunton Level dressing floor (Site B51) to wash over the structures at their feet [1/726 to 1/728].

Plate 12: Revetment wall B85, Sir George Level bouse teams, looking E, December 2009 (photo 1/712).

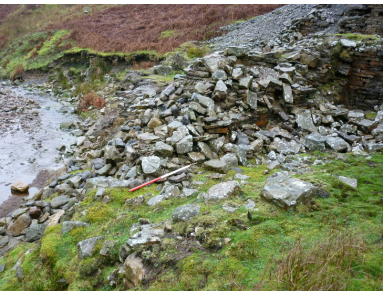
2-790.JPG

- 4.10 At the north end of Area 1, the east end of the Sir Francis wheel pit (Site 111) has been substantially undermined by the beck, and c.2m of the structure has collapsed since 1995 [2/790], burying a wooden structure recorded on its south-east corner (Site 136) in 1993; the walls 'c' and 'e' and the planked floor 'd' recorded to the immediate north (BHWB 1995, 4) have also gone. The large crusher base (Site 92) to the west, away from the beck, has not suffered any serious decay since 1994, although weathering has exposed some timbers that were not previously visible [2/781 to 2/784].

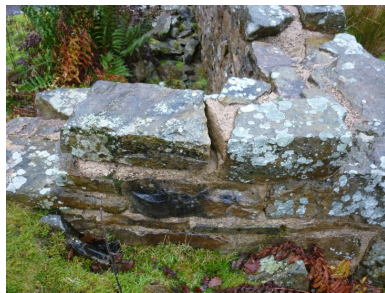
2-799.JPG

2	799	Mineshop, failing repointing at SW corner	-
2	803	Mineshop, looking W	-
2	804	Mineshop, looking W	-
