ELLERTON PRIORY, SWALEDALE,
NORTH YORKSHIRE

ARCHAEOLOGICAL SURVEY

Report no: 1996/19.R01
Version: Final
Date: September 2011
Author: Ed Dennison

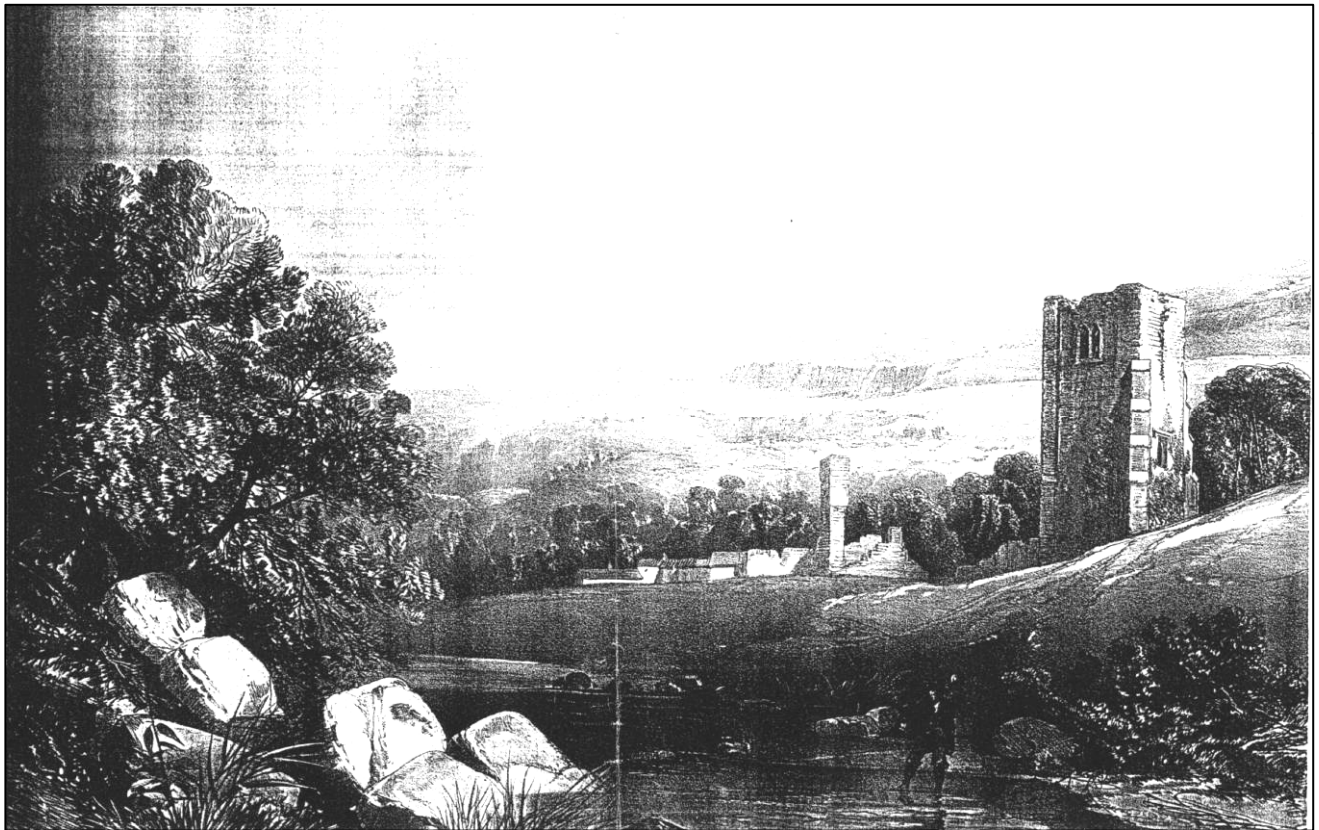
Top: Sketch of Ellerton Priory by William Richardson 1843.
 Left: "Remains of Ellerton Priory Church" 1911 (Russell 1914, 226).

- 2.16 The 1843 depiction (figure 5) shows an apparent buttress at the tower's north-east corner rising to the full height of the tower, and a two-light mullioned, pointed headed window at the top of the tower's north elevation. Only one single light window is shown in the west elevation, possibly at a slightly lower height than the existing opening. There is also a large crack at the top of this elevation and although unclear, the north wall of the nave appears to have collapsed. There is also some standing masonry depicted at the east end of the church, apparently a large buttress and low walls, with roofed buildings behind. The latter are presumably Abbey Farm but it is not clear whether the buttress and other walls are part of the church; they may be the result of artistic licence.

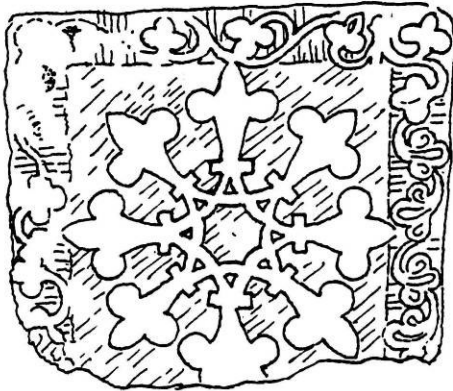
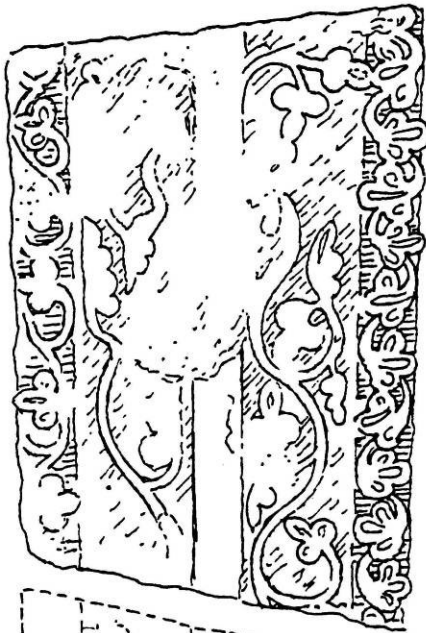
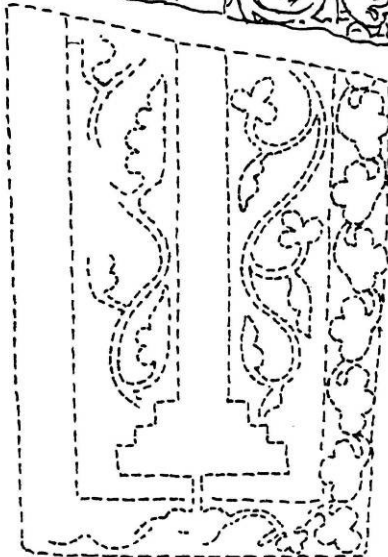
Stones 1 and 2.
Bottom piece now missing.

- 4.48 The four surviving fragments in the tower appear to be from a variety of sources. Nos 1 and 2 represent the remaining two parts of a decorated slab which had been broken into three pieces by 1963 with the lower portion having been lost by 1979 (Ryder 1986, 35). The two remaining pieces were photographed *in situ* next to the north wall of the nave, adjacent to piece no. 5, in July 1983 (YDNP 643/19) and November 1986 (YDNP 1396/9). They appear to have been subsequently moved into the tower, probably during the consolidation works in 1987; the YDNP specification notes that 'gravestones to be removed by owner's agents prior to works starting' (YDNP 1987). These two fragments were recorded by Ryder in August 1979, and added to the lower fragment which was sketched in 1963 but which had subsequently been removed from the site (Ryder 1986, 35 & figure 2b; see figure 12). The elaborate slab has an interlaced diamond cross head without a central rosette or overlying ring, having terminals of trefoil rather than a fleur-de-lys type; this indicates a date of c.1250-1300. The flanking leaf scrolls are more open and the marginal chamfer bears a running band of trefoil leaves, alternately facing in and out from the slab. The broad cross shaft rises from a three step Calvary base of unusual form. The whole design is carved in bold relief on a grey fine-grained sandstone, and has been a piece of high quality work.

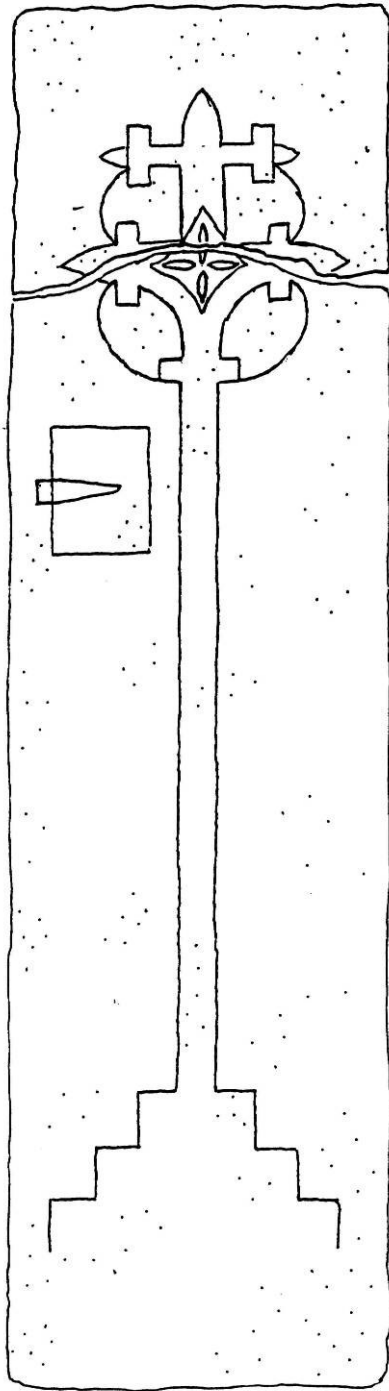
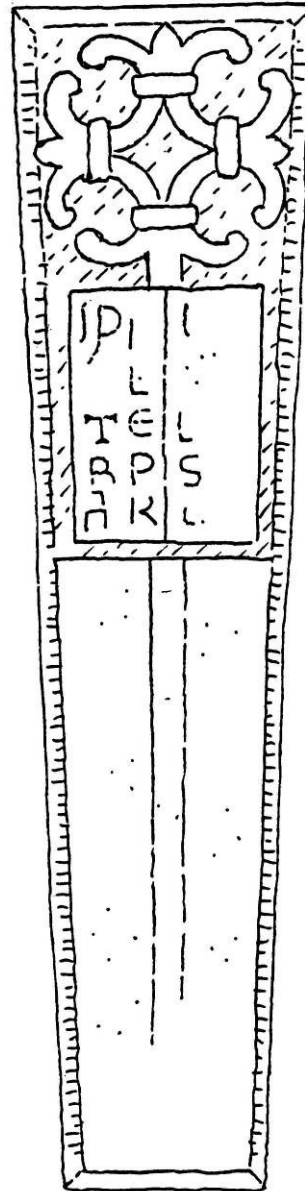
Both stones recorded by
Ryder in 1963, now removed
from site.

- 4.47 Two stone coffin lids were found in 1827 during clearance and dismantling works in the nave (Urban 1827; Pontefract & Hartley 1934, 166-167). One was supposed to be that belonging to the founder of the priory, being engraved with a cross with the inscription "HIC IACET WIMERVVS P'SONA". The second was also inscribed "PETRONILE PRIORISE", Petronilla being a prioress in the mid 13th century. Urban notes that the lids, which were found near the south wall, were in very good condition, but that the workmen who uncovered them split the former and scattered the underlying skeletons. Hartley and Pontefract record that these stones were replaced within the nave, and in 1963 Ryder produced a sketch of the Petronilla slab (see figure 13) and noted that it has since been removed from the site.

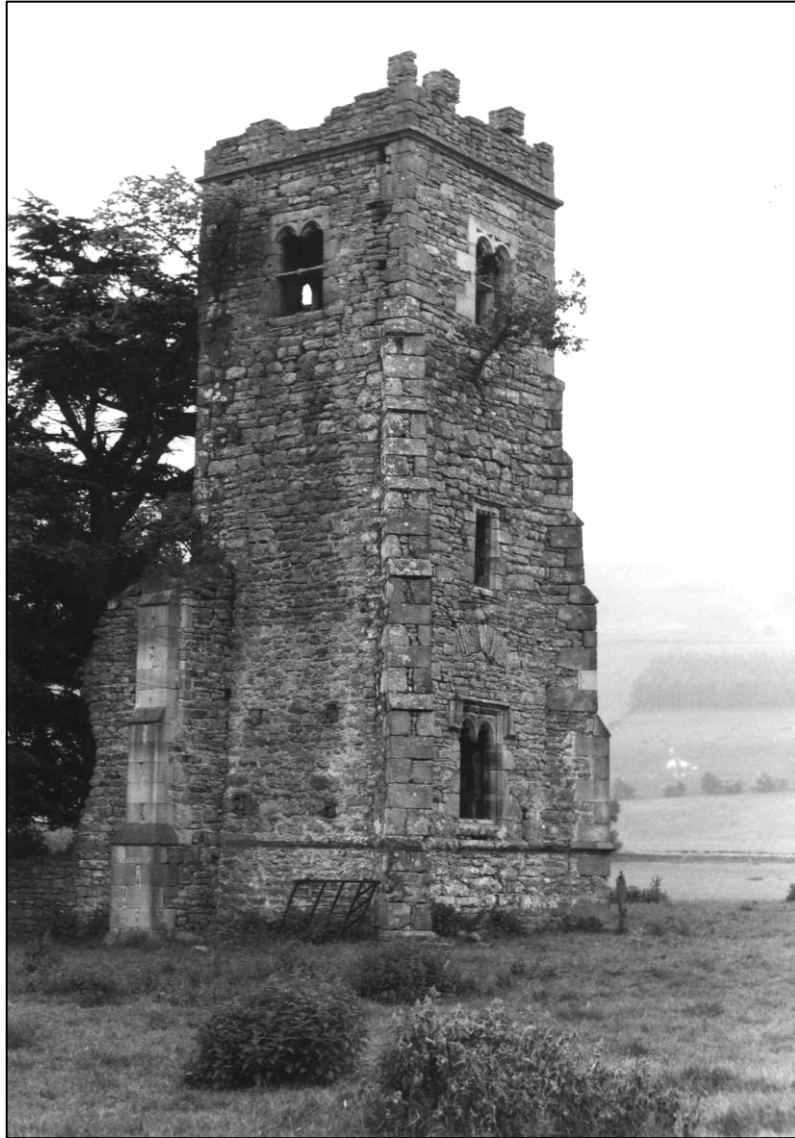
Plate 3: Church tower, looking SE (YDNP 643/15
March 1983).

- 2.20 The English Heritage November 1983 inspection report noted that there were no major structural problems in the tower, although trees and other vegetation was starting to gain a hold on some of the elevations (see plate 3). The major recommendations were that all vegetation should be removed, that the tower roof be replaced and covered with aluminium to reduce the risk of theft, that two pine logs that served no tying function should be taken down from the interior of the tower, that the top courses of the north nave wall should be secured, that the arch over the south door should be strengthened with the insertion of a concrete lintel, and that some of the trees in the interior of the nave should be cut down.

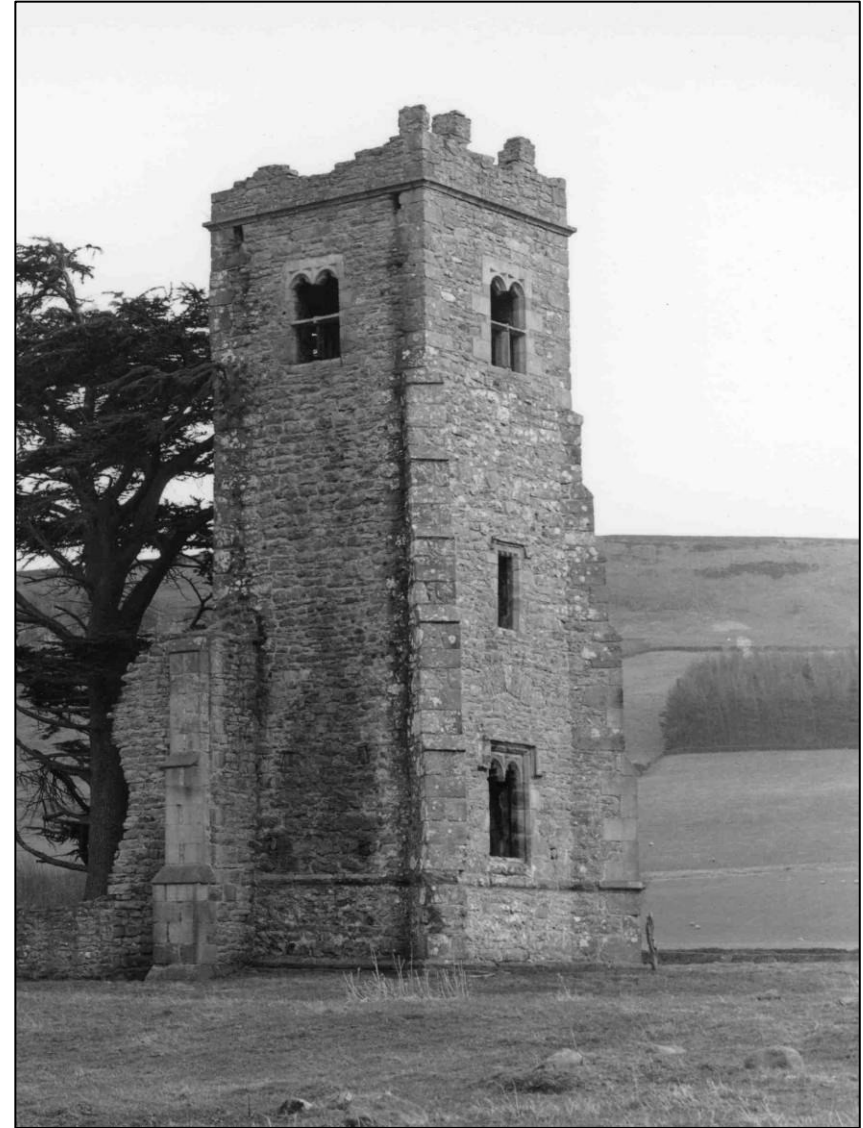
Plate 4: Church tower, looking SE (February 1999).

- 4.32 The north face of the tower (elevation 3) is stepped back from the north wall of the nave by 1.0m (see plates 3 and 4). It contains no openings at ground floor level but two rows of two voids, 2.0m and 3.6m above ground level can be seen; they had been infilled with loose stones by November 1986 (YDNP 1396/17-18). These holes pass through the wall thickness and so presumably held substantial timbers, possibly for an adjacent structure, or were perhaps used for putlogs.

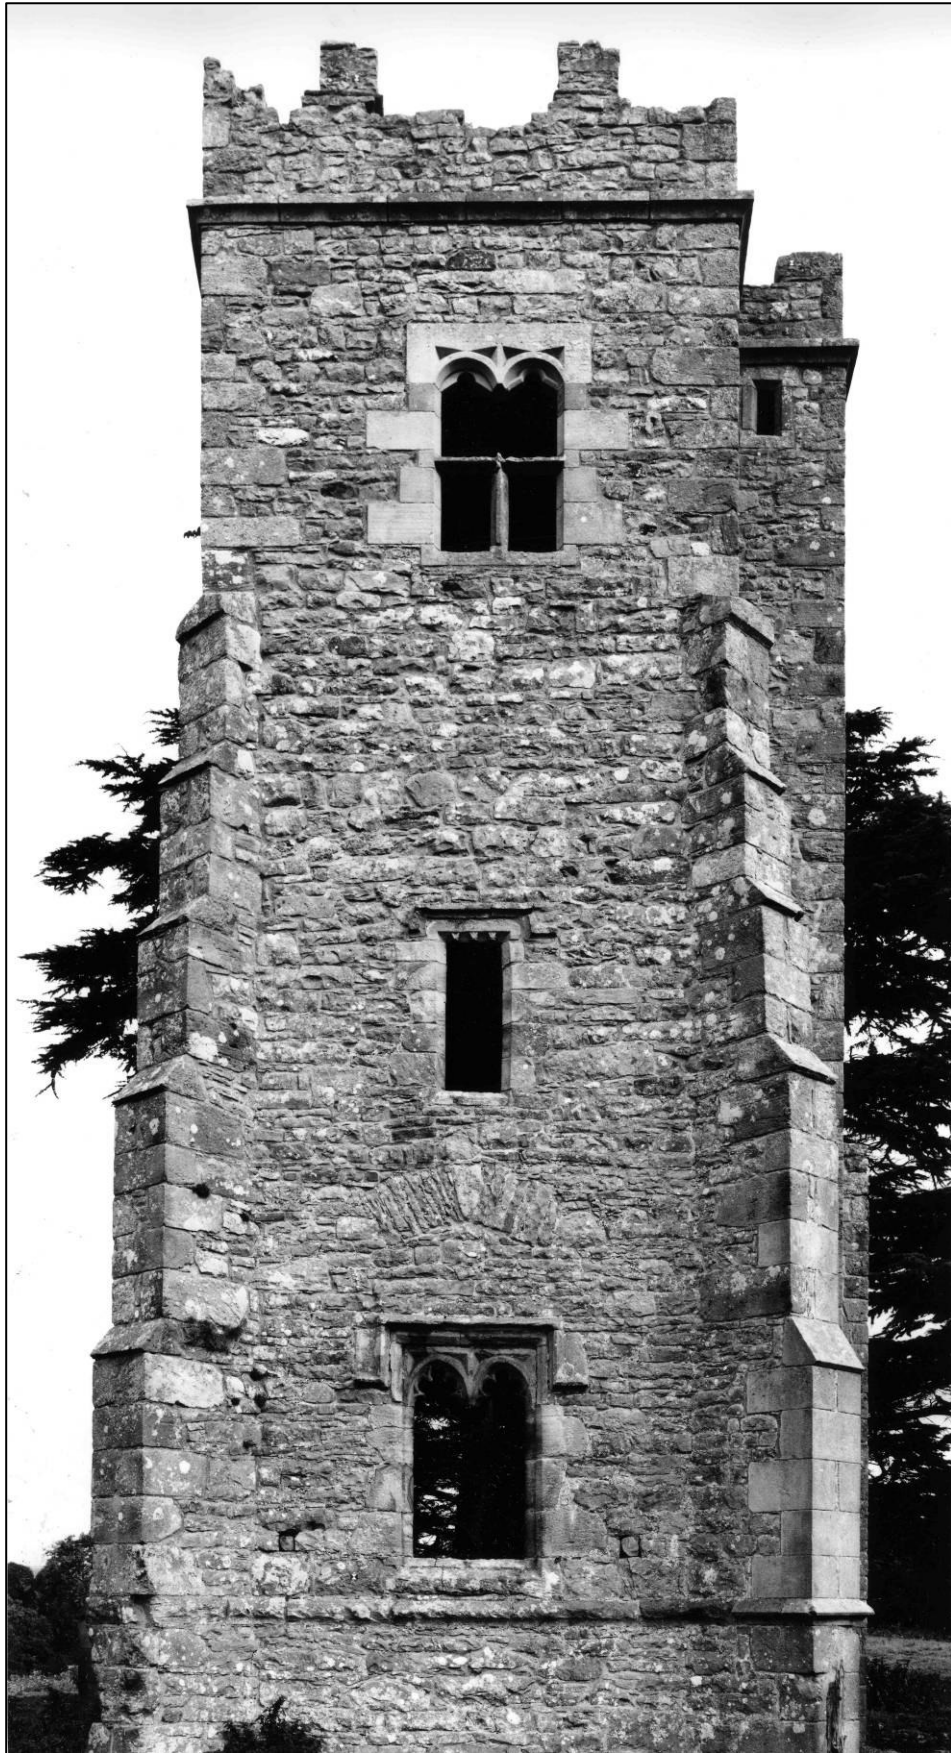
Plate 7: West elevation of tower (photo 1/3 September 1996).

- 4.27 The west wall of the tower, flanked to each side by angle buttresses, contains three window openings (elevation 5) (see plate 7). At ground floor level is a central former two-light window, with two cinquefoil heads with sunken spandrels, and stepped sill and splayed interior; there are four horizontal bar holes in each jamb. The mullion has gone, and is shown as missing in the 1911 sketch (Russell 1914, 226) (see figure 5). A hood mould survives over this window, and the degree of weathering suggests that the dressings have not been replaced. The form of this window suggests a 15th century date. There is a rubble relieving arch over the window, c.1.0m above its lintel; this relieving arch appears to be carried through the wall thickness, as it is visible on the inside face of this wall.

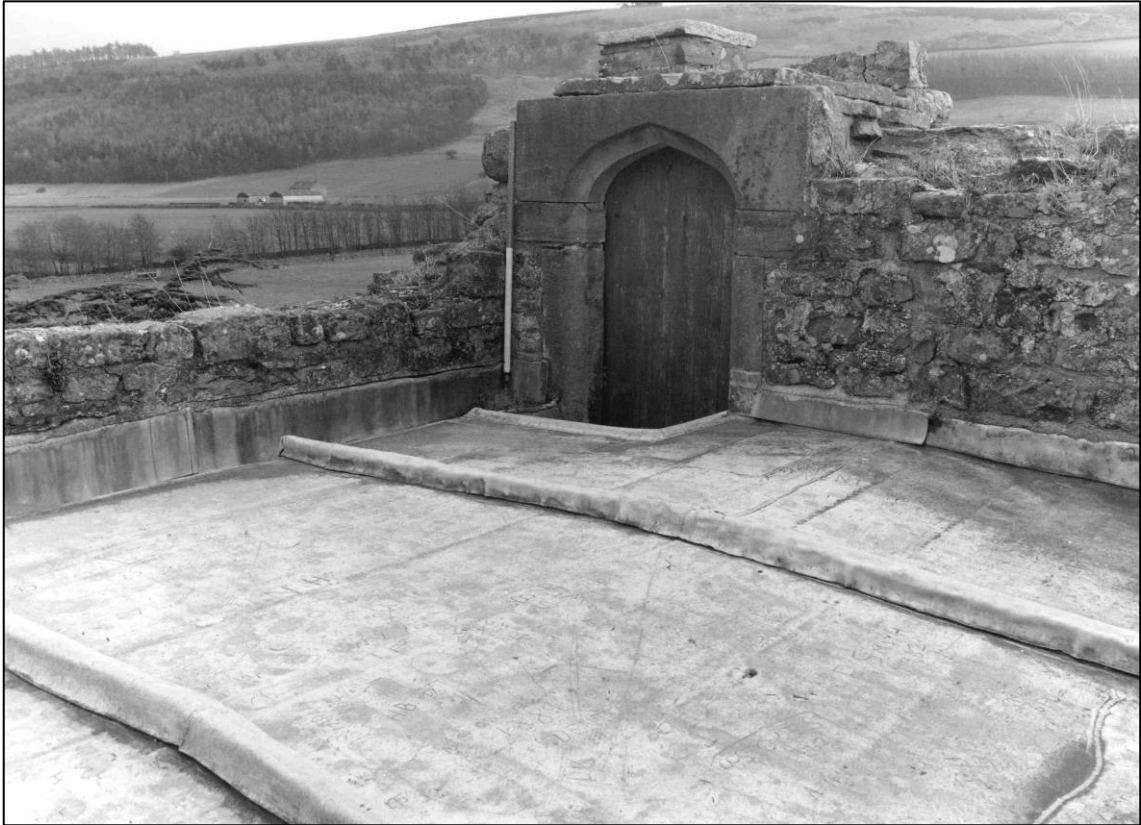
Plate 8: Ellerton Priory church roof, looking SE (February 1999).

- 4.45 The roof is enclosed within a low parapet, between 0.5m and 1.6m high, which is shown as being battlemented by 1911 (Russell 1914, 226). Now only a few of the merlons survive (as noted above) and coping remains in only one or two places. The battlements appear to have continued around the perimeter of the tower, including the stairs projection on the south side. At the south-west corner of this projection, the wall has been capped with part of a window head, which is badly weathered, but appears to be cinquefoil headed, with sunken spandrels, closely

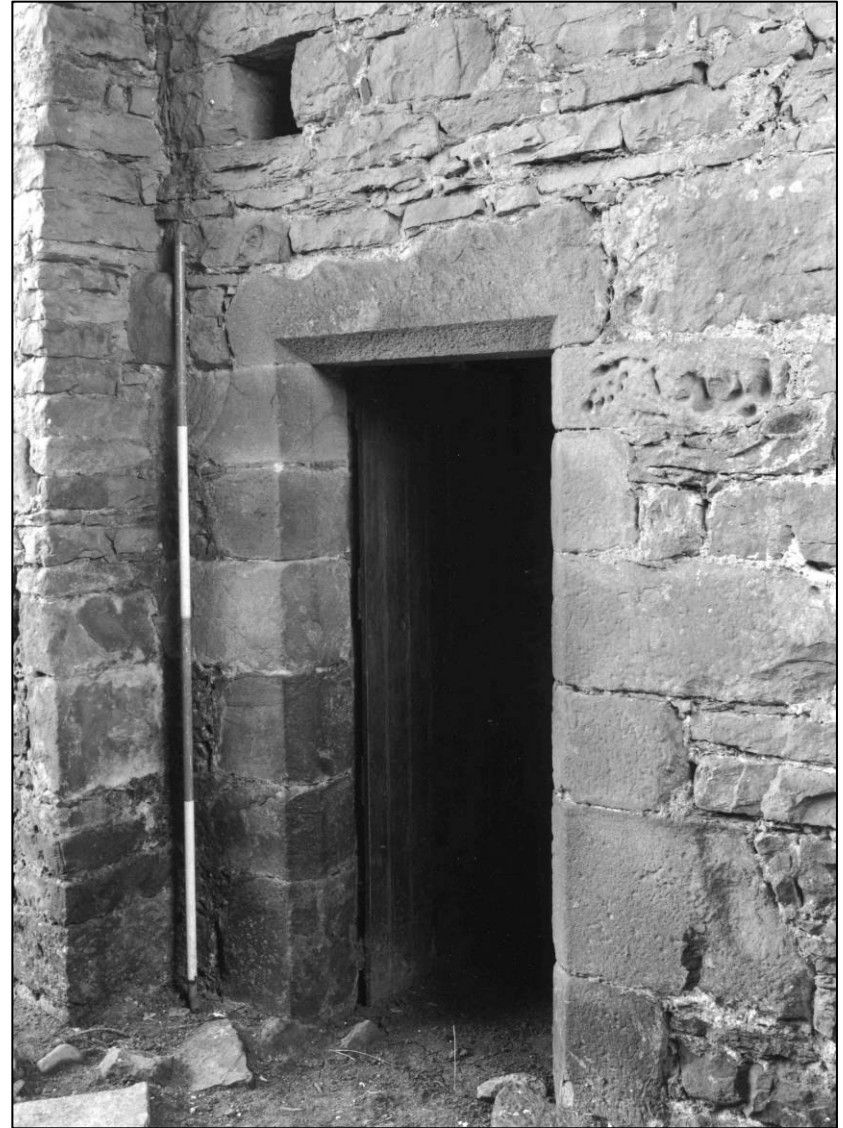
Plate 11: Door to stair annex, south internal wall of tower,
looking SE (February 1999).

- 4.37 At ground floor level a plain chamfered doorway in the south wall, 1.8m high and 0.7m wide, leads to the stairs; there is a modern board door *in situ* (see plate 11). A newel stair, ascending in an anti-clockwise direction, gives access to the upper parts of the tower. The steps are of stone, with the lowest three being of single cut blocks, the step integral with the central column of the newel. Above these, the steps are mostly made of a number of sandstone blocks, with a central softwood post, which was replaced in 1984. It is possible that this difference in the steps results from a rebuilding of the earliest stairs. The stairs are lit by the four slits described above, each of which is splayed on the interior. Doorways of a similar form give access to the former floor levels; the bases of these doorways have been blocked with upright stone slate slabs. The stairs emerge via a fourth doorway with wooden door onto the roof (see plate 8).
