MIDGE HALL FARM POND,
ROSEDALE EAST, NORTH YORKSHIRE

ARCHAEOLOGICAL INVESTIGATIONS

Report no: 2012/423.R01
Version: Final
Date: September 2012
Author: Shaun Richardson & Ed Dennison

Mr Paul Metcalf
Kiln View, Midge Hall Farm
Daleside Road
Rosedale Abbey
North Yorkshire YO18 8RL

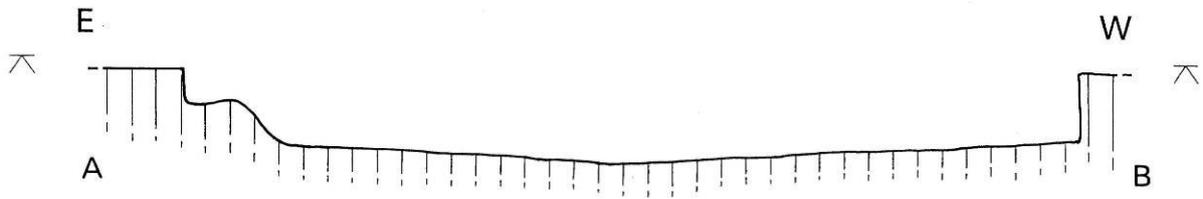
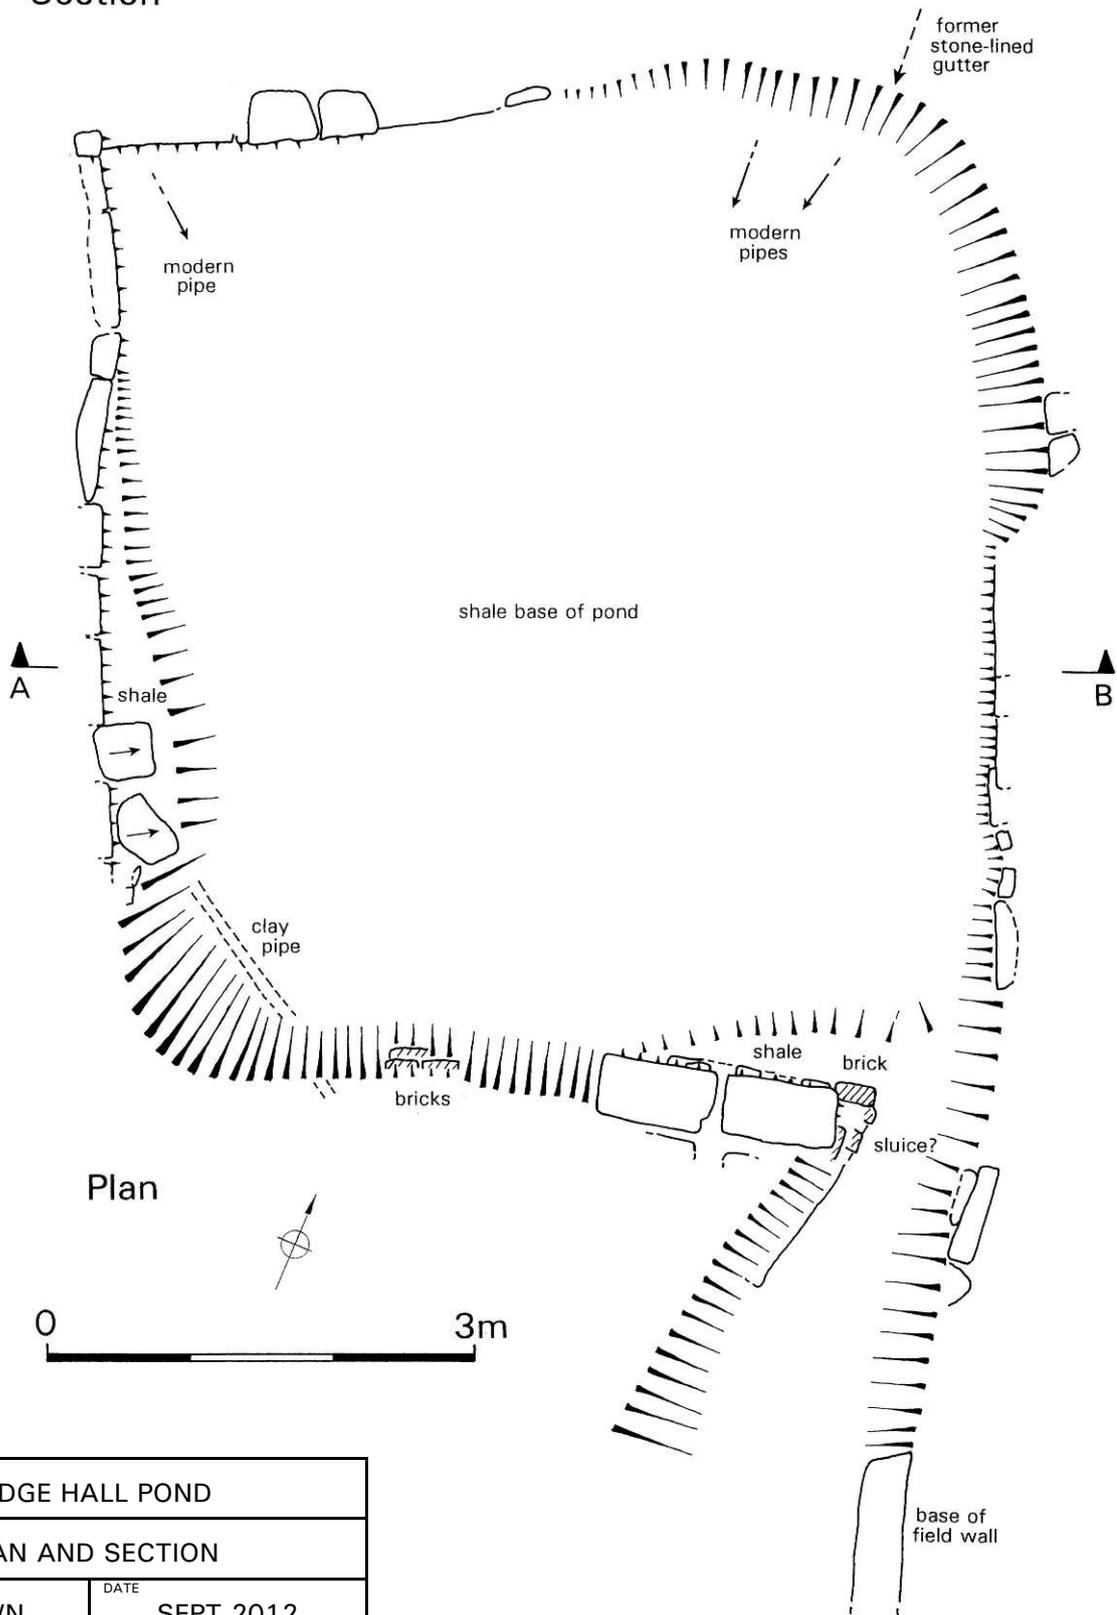
PROJECT		MIDGE HALL POND	
TITLE		PLAN AND SECTION	
SCALE	DATE	AS SHOWN	SEPT 2012
EDAS	FIGURE		4

- 4.10 Following excavation, the pond was found to have a more sub-square plan, measuring 6.60m north-south by 6.20m east-west and. The base sloped gently from either side towards the centre to an average of 0.7m deep, although there were slightly deeper pockets giving depths of up to 0.9m deep in places due to variations in the shale base (see figure 4). There was a gap in the pond wall in the south-east corner, 0.80m wide across the top, leading into the aforementioned drain or ditch. The east side of the gap was formed by a steep earthwork scarp, while the west side was of brick and stone construction [1/246] (see plate 4). The unmortared brickwork comprised buff to light brown handmade bricks (average dimensions 230mm by 100mm by 60mm), very roughly laid. They returned to the south for a length of 0.45m at their east end, and their line appeared to be continued to the south-west for a further 1.10m by a low stone rubble wall [1/250]. In the base of the gap, there were fragments of a salt-glazed ceramic pipe, which may possibly have replaced a simple sluice positioned here. To the west of the brickwork, there were three courses of squared unmortared sandstone, with a total height of 0.65m; a deeper base course, resting directly on the shale (003), below two shallower upper courses. The uppermost course comprised a pair of capping stones, each measuring 0.80m long by 0.40m wide, apparently representing the original top of this side of the pond.

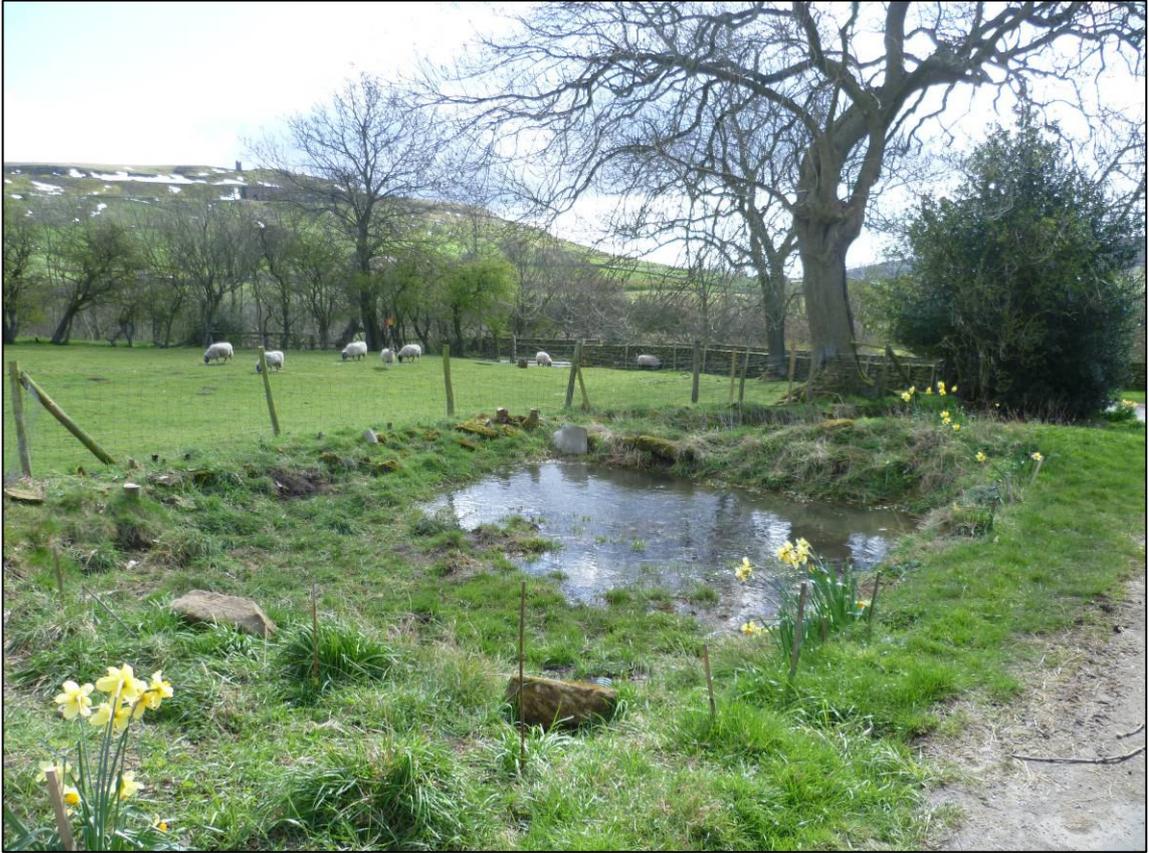
- 4.6 Prior to excavation, the pond was formed by a sub-rectangular depression, measuring c.6.0m north-south by 5.5m east-west, heavily vegetated and up to a maximum of 0.7m in depth [1/232, 1/233 and 1/235] (see figure 4 and plate 1). Coursed sandstone lining was visible close to the south-east corner [1/237] (see plate 2) and along the west side [1/236], but otherwise the sides comprised steep vegetated scarps. Modern ceramic and plastic pipes entered the pond at both the north-east and north-west corners respectively.

Plate 1: General view of pond in advance of investigation, looking SE.

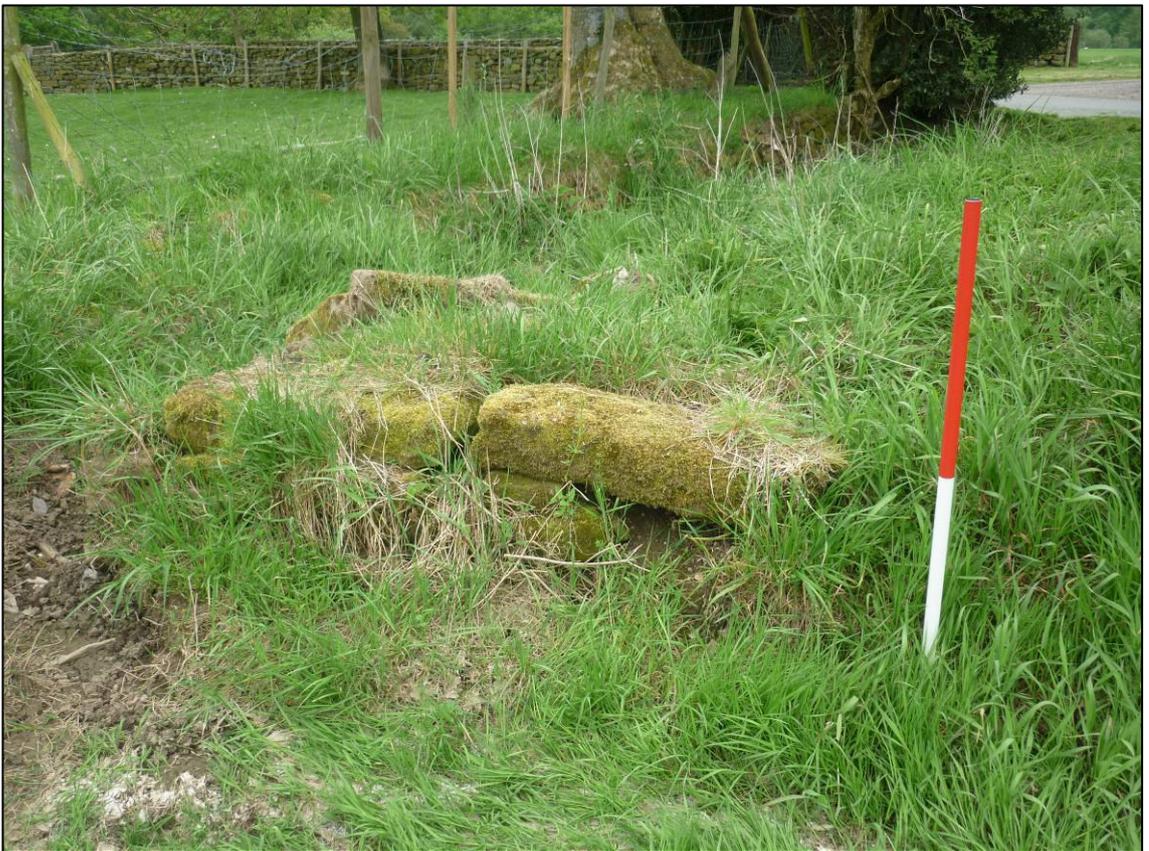
Plate 2: Stone lining at south-east corner of pond prior to excavation, looking SE (photo 1/237).

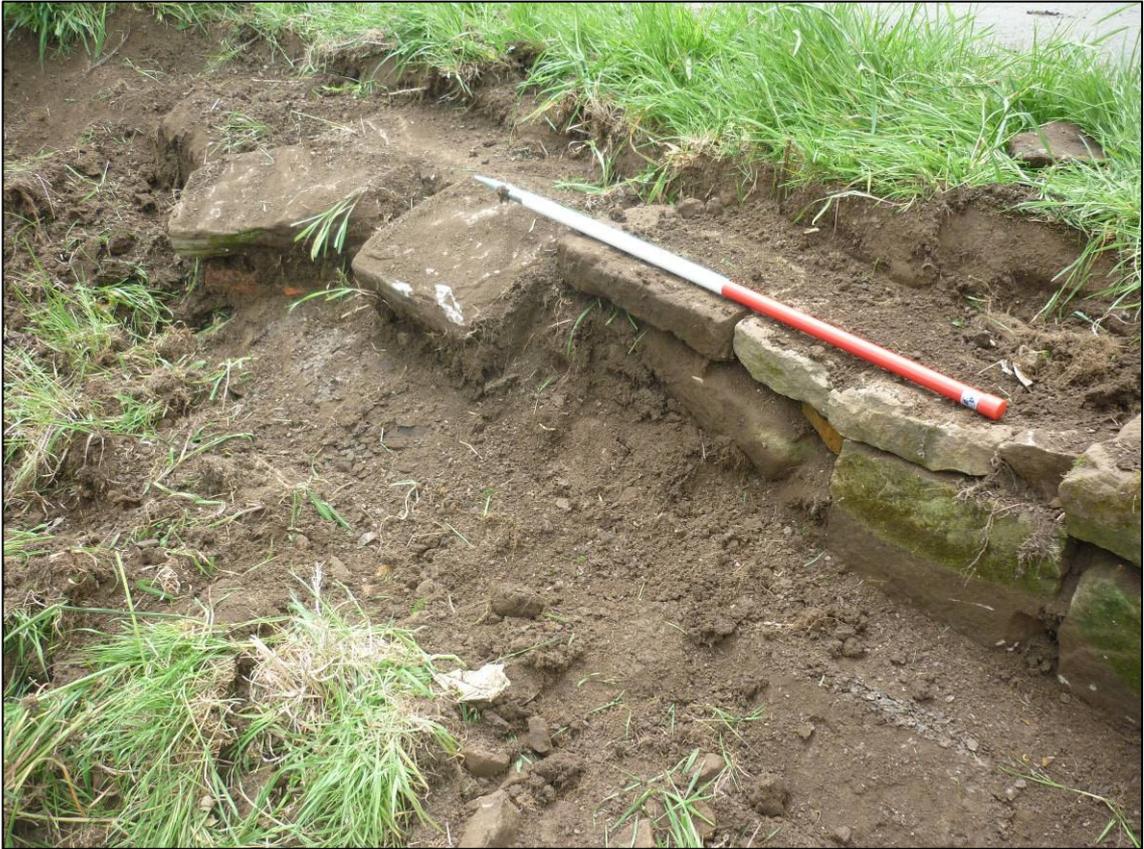
- 4.12 The west side of the pond retained the remains of its stone lining for much of its length [1/240 to 1/243], comprising two courses of squared unmortared sandstone, with a total height of 0.50m; a deeper base course, resting directly on the shale (003), below a single shallower upper course (see plate 3). Towards the southern end, the uppermost course may have included a pair of slipped capping stones. There was a slight step in the shale base of the pond to the immediate east of the stone lining of the west side.

Plate 3: West side of pond under excavation, looking S (photo 1/242).

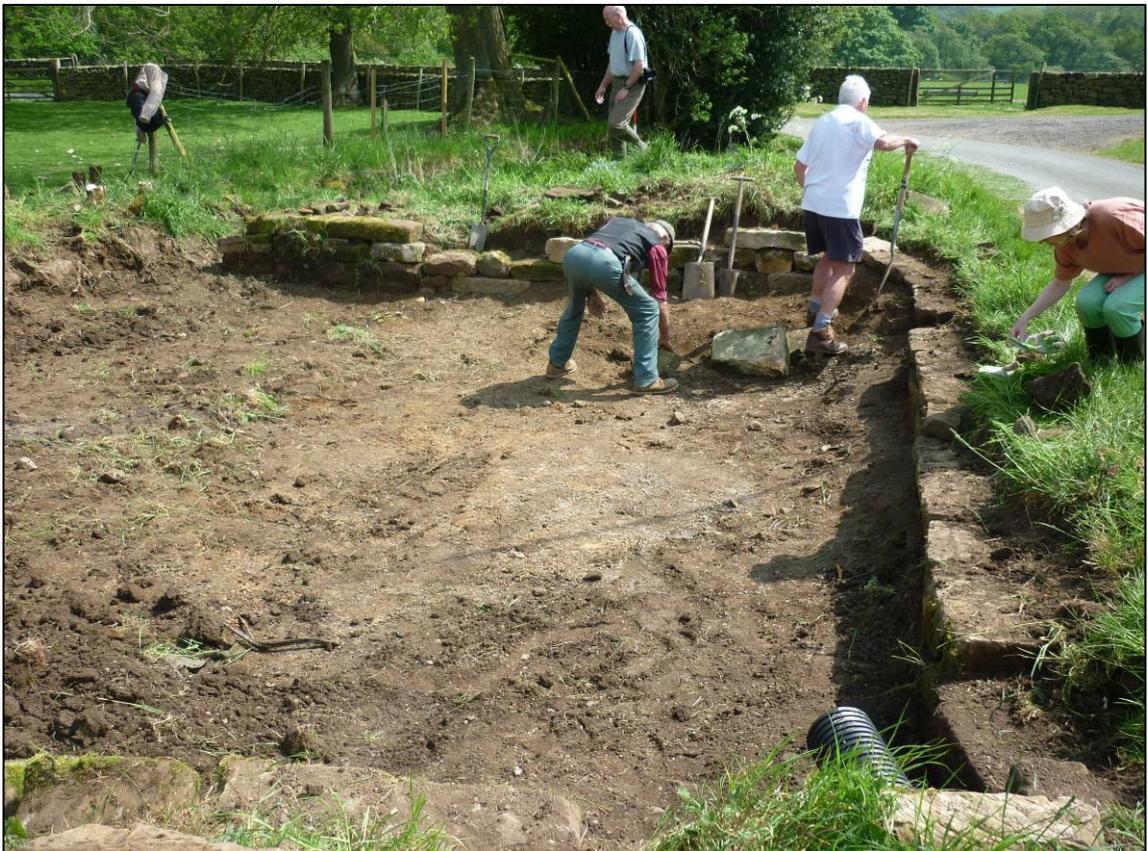
Plate 4: Pond under excavation and west wall partly rebuilt, looking S (photo 1/246).

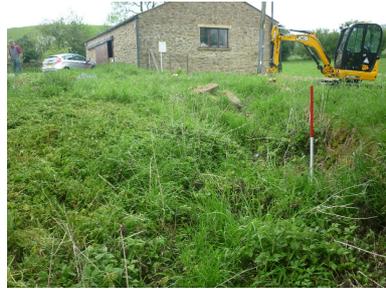
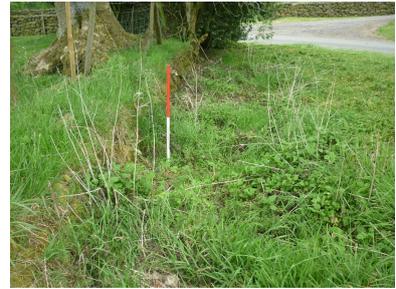
- 4.7 A drain or ditch left the south-east corner of the pond to run south [1/238 and 1/239]. This drain was steep-sided, measuring up to 1.0m deep and with an average width of 1.5m across the top. The west side was formed by a steep vegetated scarp, while the east side was lined with roughly coursed and squared sandstone rubble. The rubble was a remnant of the drystone field wall which formerly ran along the east side of the pond. It is believed that the drain enters an underground drain or culvert, the line of which is marked by several cast-iron roadside grids; the underground culvert curves to the south-east, crossing beneath the metalled Daleside Road, and then discharges into an open watercourse (Local information, *pers. comm.*).

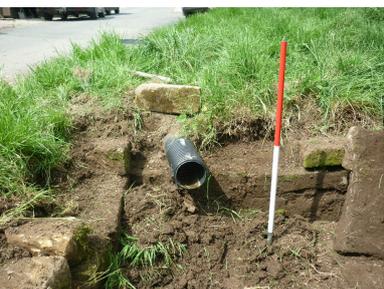
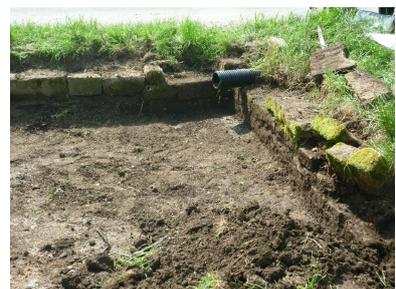
- 4.13 At its north end, the stone lining returned to the east, and appeared to be contemporary with the stone lining of the pond's north side [1/244 and 1/247]. The latter comprises three courses of squared unmortared sandstone, with a total height of 0.50m, again having a deeper base course surmounted by shallower upper courses. The stone lining could be traced approximately half way across the pond's north side, where it faded out, to be replaced by a steep south-facing earthwork scarp. The majority of the pond's east side lacked any surviving coursed squared lining, being largely formed by hard-packed earth and rubble [1/245], but with traces of more regular stonework towards the southern end. A second line of stone, running parallel to the pond's east side, but set back from it, probably represents the remains of the drystone wall formerly located here.

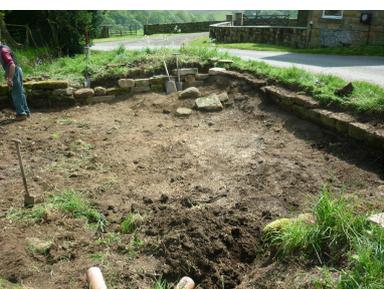
1-248.JPG

- 4.11 To the west, beyond the western capping stone, the stone lining of the south side of the pond ran out [1/248], and was replaced by a steep north-facing earthwork scarp up to 0.70m in height. There were traces of brickwork within the scarp, the bricks being of the same form and size as described above, while to the south of the scarp there was a slight mound apparently containing a high proportion of stone rubble. The south-west corner of the pond was crossed by a ceramic pipe with a slightly flattened profile, measuring 0.14m across, and believed to be of local manufacture [1/249]. It was set c.0.50m below the ground level here and placed on a north-west/south-east alignment.
