EXTERNAL DRAINAGE WORKS,
ALL HALLOWS' CHURCH, WALKINGTON,
EAST YORKSHIRE

ARCHAEOLOGICAL OBSERVATION,
INVESTIGATION AND RECORDING

Report no: 2012/435.R01
Version: Final
Date: December 2012
Author: Ed Dennison & Kate Dennett

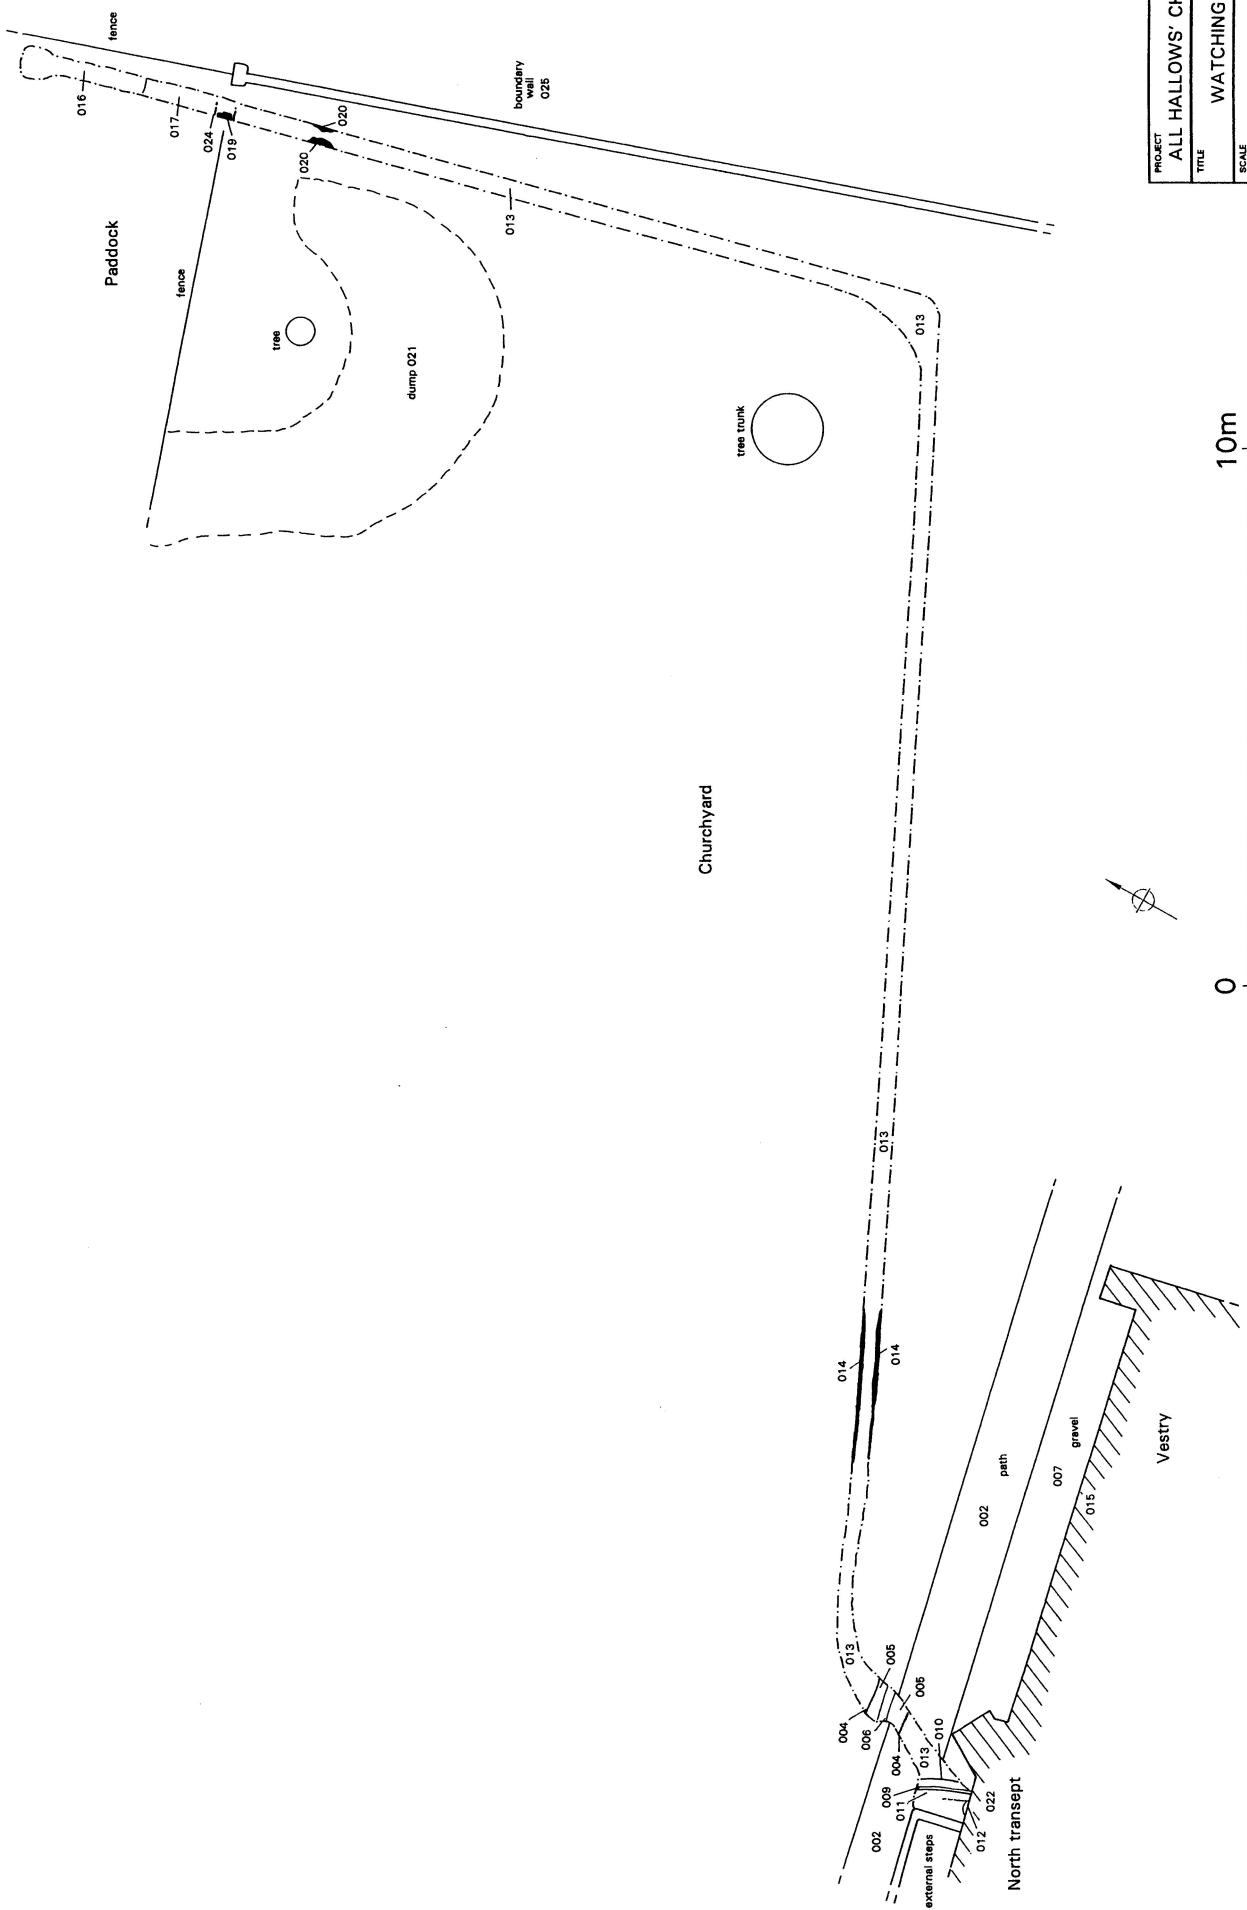
PROJECT	ALL HALLOWS' CHURCH, WALKINGTON		
TITLE	WATCHING BRIEF RESULTS		
SCALE	AS SHOWN	DATE	DEC 2012
	EDAS	FIGURE	3

- 4.1 The initial part of the trench, adjacent to the north-east corner of the north transept, exposed deposits previously disturbed during the installation of a gas pipe in 2001, namely the limestone foundation (023) and the brick (015) of the transept wall, with a small section of earlier chalk foundation (012) below; the previously laid gas pipe (009) within its own trench (010) filled with a loose dark brown loam (011) was also exposed. The new hole for the sewer pipe was cut at an oblique angle through both the foundations (012/023) of the transept and the brick wall of the adjacent boiler room (022), on the east side of the external steps.

- 4.2 Immediately north of a 1.40m wide concrete path (002) laid since the 2001 installation of the gas pipe, an east-west linear cut (004), 0.60m wide and with a bowl-shaped profile, and filled with a loose creamy-brown sand containing brick and chalk rubble fragments (005), was evident. This contained a brown-glazed ceramic land drain (006), which had been seen slightly further to the west during the previous 2001 excavation. The backfill (005) was very loose, resulting in a slightly less neat excavation at this point, compared to elsewhere along the drainage run. The concrete path was founded on a thin layer of brick rubble hardcore (003) and compacted brown loam (008), and there was a 0.04m layer of gravel (007) between the path and the church wall.

- 4.3 It was noted that over the churchyard in general, the topsoil (001), a friable grey-brown loam less than 0.12m thick, was unusually clean and fine textured for a graveyard soil. Along the excavation approximately 5.00m north-east of the path, a very firm dense grey chalky loam lens-like deposit less than 0.23m thick (014) containing small fragments of chalk rubble, but with also some larger pieces more than 0.20m long, was encountered immediately below the topsoil (001) at 0.12m BGL (see plate 3). This deposit, which extended for a distance of c.3.00m along both sides of the trench, is likely to represent an infill or levelling deposit, laid in relatively recent times, although it could possibly be indicative of an earlier, now unmarked, burial plot beneath. No further archaeological features or deposits of significance were noted in the rest of the trench until the north-east corner of the churchyard - throughout this length, the trench cut through the c.0.12m thick topsoil (001) and firm brown sticky loam subsoil containing moderate amounts of chalk gravel (013); the base of the subsoil (013) was not reached by the excavations.

- 4.4 In the north-east corner of the graveyard, directly beneath the existing boundary fence, the base of a c.0.28m wide brick wall foundation (019) was visible at 0.70m BGL (see plate 2); it lay within a vertical-sided 0.38m wide cut of undetermined depth (024) which had been excavated through the overlying soils (013/017). The bricks of this earlier boundary, apparently on the same alignment as the existing fence, were substantial, 84mm thick and 124mm wide and bonded with lime mortar.

- 4.5 Within the graveyard, but 1.90m south of the north boundary fence and adjacent to a surface dump of spoil resulting from previous grave digging (021), the remains of what might have been a stone wall less than 0.60m wide were exposed in both sides of the trench, at a depth of 0.70m BGL. Pieces of undressed limestone c.0.16m deep and 0.35m wide within a loose brown loam (020) were excavated, but the soil was dry, loose and unstable at this point and so further cleaning or investigation was not possible. The stone may be associated with the remains of an earlier boundary wall forming the east side of the churchyard, before the existing brick retaining wall (025) was built on a slightly more easterly alignment; the 1910 Ordnance Survey 25" map (see figure 2) does show a kink in the field boundary to the north which might suggest that the east side of the churchyard was re-aligned at some point in the later 19th century.

- 4.6 Within the paddock, at the deepest and most northern extent of the trench, what appeared to be the natural chalk (016) was exposed at a depth of 1.22m BGL. The blanket subsoil layer overlying the chalk, within the paddock area, was a firm yellow-brown clayey loam with occasional chalk fragments (017), which was notably lighter in colour, less loamy and more clayey than that seen within the graveyard (013). Over this subsoil was a c.0.33m thick loose dark brown loamy topsoil layer (018).

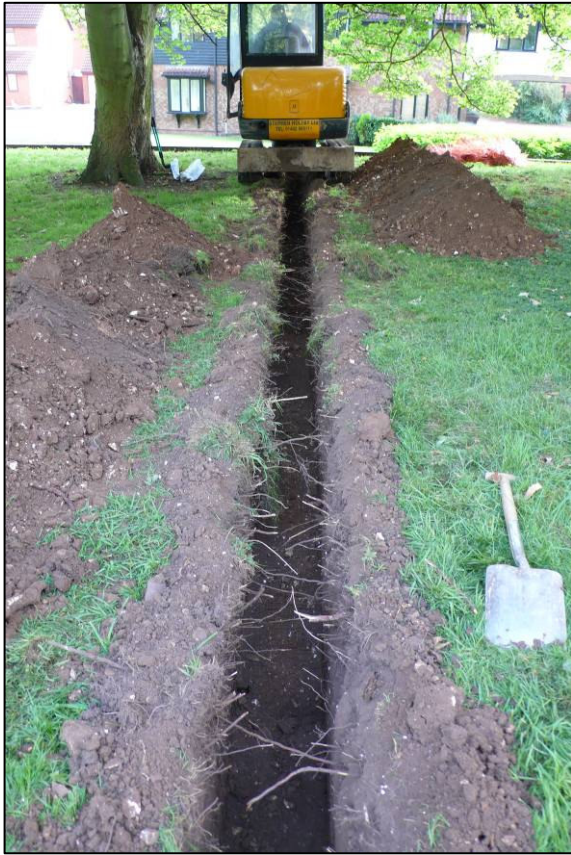
Plate 1: Excavations in progress, looking north-east.

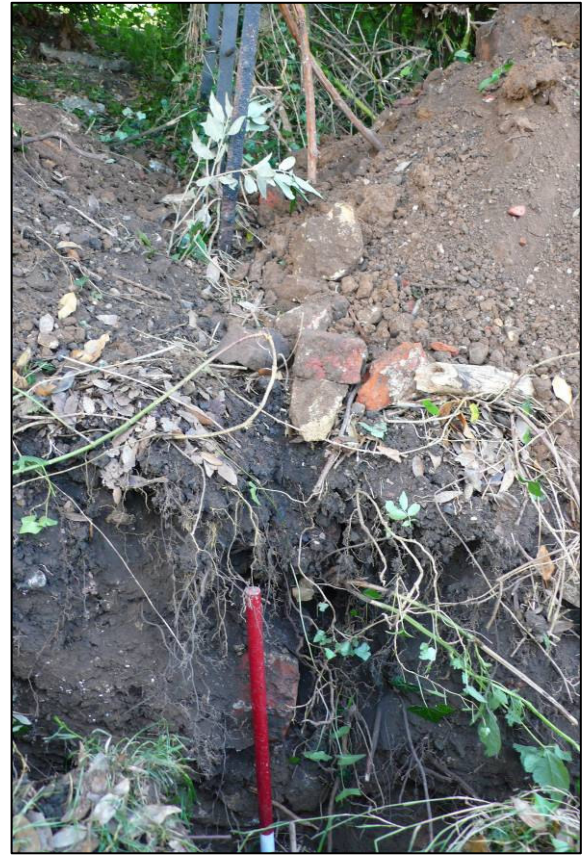
Plate 2: Brick wall foundation (019) under north boundary fence of churchyard, looking west.

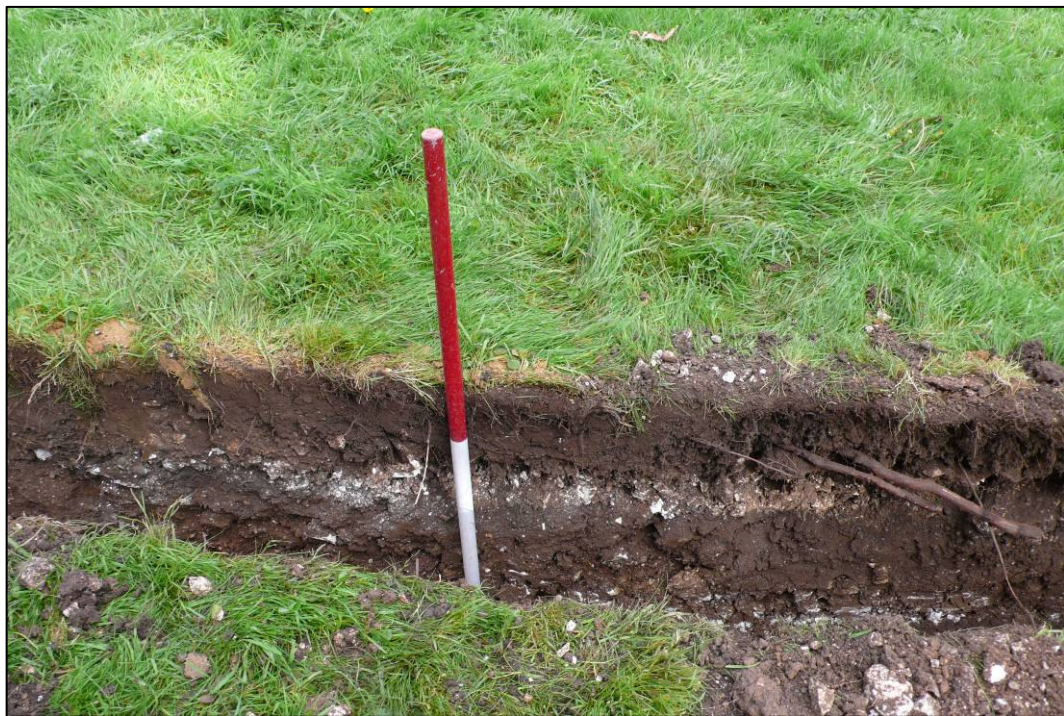
Plate 3: Lens deposit of chalky loam (014) exposed on both sides of trench immediately below topsoil (001), looking north.
