RIEVAULX ABBEY PRECINCT BOUNDARY
(NORTH-WEST SECTION),
RIEVAULX, NORTH YORKSHIRE

ARCHAEOLOGICAL WALKOVER SURVEY
AND MANAGEMENT RECOMMENDATIONS

Report no: 2013/444.R01
Version: Final
Date: March 2013
Author: Ed Dennison & Shaun Richardson

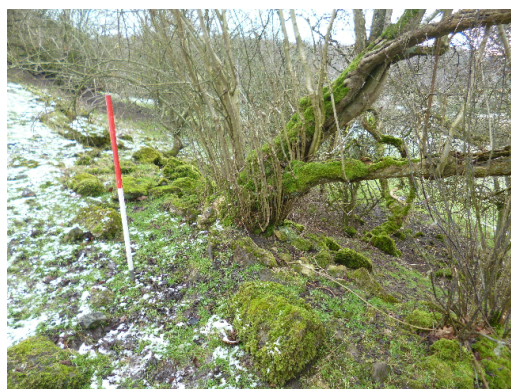
1-745.JPG

- 3.14 Beyond these stock-erosion tracks, as far as c.182m east of the cross-wall and c.60m west of a right-angle bend (see below), the precinct boundary wall is again in poor condition (**Section H**). Rather than once being a free-standing structure, as observed further to the west, it appears to have partly retained or revetted the ground to the north, effectively creating a lynchet - there is a difference of at least 1m in height between the ground to the north and the ground to the south. Subsequent collapse or demolition of the wall has created a south-facing scarp with a high rubble/stone content, placed at the top of the more substantial scarp to the south of the boundary line. The north face of the wall is visible only intermittently here, but as it moves east the wall becomes slightly better preserved. Occasionally both faces are visible (largely in plan only), set c. 1m apart [1/746]. In very limited stretches, the south face of the wall survives up to two courses (0.70m) in height [1/749; 1/750]. There are many small hawthorn trees with exposed roots on or very close to the wall line within this section of the boundary [1/752; 1/753]. At least one larger example of these trees has recently blown over, dislodging some of the stone blocks in the process, and the gap has allowed a minor but active stock-erosion path to become established (**H3**) [1/747]. The same vegetation continues down the c.2.50m high scarp to the south of the wall line, which is also burrowed by rabbits in several places. Approximately half way along this section, the precinct boundary is crossed by a minor stock-erosion track (**H1**) [1/751], and there is another more recent track adjacent to the wind-blown tree noted above. The east end of this section is marked by a leaning coppiced hazel/alder (**H2**), growing on the wall, and with a stool measuring 0.70m across [1/745].

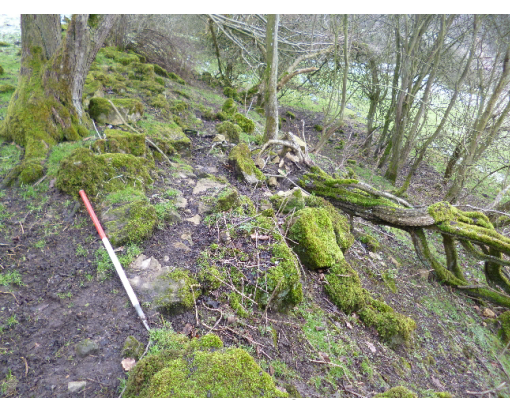
1-747.JPG

- 4.7 There is relatively little evidence for former damage caused by vegetation, such as tree-pulls resulting from wind-throw, apart from one hawthorn in Section H [1/747]. There are however several locations in Sections B (specifically B1), C and E where there is the potential for such damage to occur. Many of the walling stones, whether part of the free-standing sections or fallen, are also covered with a thick coating of moss [1/762; 1/770]; this may have ecological importance as well as a

- 4.8 There are a number of large mature, potentially veteran, trees growing directly on the wall line. Many exhibit evidence for historic management, such as coppicing, which may also be of historic interest [1/780]. Most of the trees on and immediately adjacent to the alignment appear stable [1/766], and their size means that removal may well cause damage to the stonework contained within their root systems. It is always possible that some of these trees will be susceptible to windthrow, but the same could be said for all the trees in the vicinity. There is evidence of at least one tree in Section E having been cut/snapped off in the past [1/768], and one having blown over in Section H [1/747].

- 4.9 Nevertheless, there are a number of dead or dying trees along the whole alignment which could be cut down, and any young trees and elder/hawthorn scrub should be cut and removed before they become established and begin to cause problems in the future. The former can be seen in Sections D and E [1/768; 1/772], while the latter is visible in Sections B, D and F [1/762; 1/773; 1/784; 1/786; 1/793]. The single hawthorn tree at the north end of Section J should also be cut down [1/731], as should the leaning tree over the revetment in Section K [1/806], although this will need some care. Scrub located just off the alignment, for example in Section H [1/751], is not considered to be a problem, and this may in fact deter stock from trying to cross the boundary (see below). It is recommended that a qualified tree surgeon or forestry officer, perhaps from the NYMNP, be asked to look at the various trees to decide which are at most risk from potential windthrow and what management action would be appropriate; it might, for example, be possible to re-coppice some of the older coppiced trees to preserve their historic interest and reduce the canopies to let in more light and increase stability.

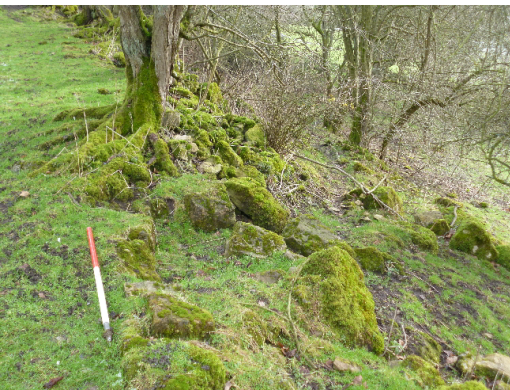
1-754.JPG

- 3.13 To the east of the stock-erosion track (F1), as far as c.145m east of the cross-wall, the precinct boundary wall is in very poor condition (**Section G**). The north face is visible only intermittently [1/759; 1/761; 1/762], but much of the main body of the wall appears to have collapsed/eroded down the scarp to the south side [1/760], which increases in height as it moves east; some of the rubble has tumbled up to 4m south away from the main alignment. The vegetation on the boundary line also gradually increases as it moves east, with a mixture of elder, hawthorn and rose-hip scrub [1/757]. At the east end of this section, two stock-erosion tracks (**G1**) cross the boundary line; the eastern of the pair is the more substantial, being up to 0.70m across [1/754; 1/755].

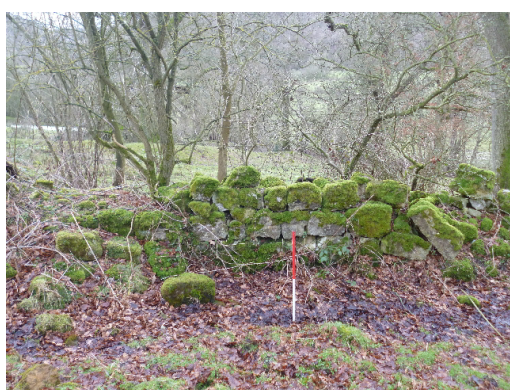
1-775.JPG

- 4.5 It could be recommended that some sections of the free-standing wall alignment, particularly those in Sections B and D, and the cross-wall in Section A, would benefit from some limited and localised consolidation [1/775; 1/793]. If so, any such consolidation should be restricted to tamping lime-based mortar and small stones for strength into the large joints and voids between the stones, taking care to ensure minimal disturbance to the mossy vegetation etc. The inserted mortar should also be slightly recessed from the wall face, so that it does not stain and detract from the overall visual appearance of the fabric. However, it could equally be argued that such consolidation work would have only a limited value - to be really effective, the stones would have to be lifted and re-bedded (effectively a rebuilding operation), and this is not considered to be appropriate or cost-effective in this case. In addition, any decision for consolidation may be outweighed, or influenced, by other considerations such as ecology.

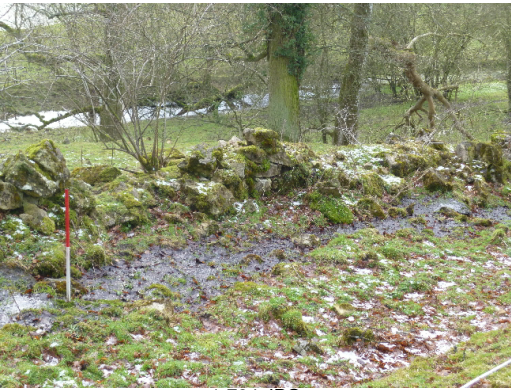
1-784.JPG

- 4.4 Many lengths of the free-standing wall alignment (Sections B to E) are associated with collapsed stonework, with large blocks of stone now lying adjacent to or obscuring the wall faces [1/784]. In one of two cases, these blocks have tumbled some distance away from the wall [1/779], especially on the south side where there is a marked bank [1/778]. On the less steep sections of bank, it might therefore be appropriate to gather this fallen material, and replace it closer to the wall alignment, adjacent to where it may well have originated. However, it is not recommended that any stonework is replaced directly onto the alignment, so as to rebuild the wall; as it cannot be certain precisely where the stonework fell from, any such rebuilding would be subjective (however well informed) and potentially historically damaging. Nevertheless, banking stone against free-standing lengths would help to stabilise those three or four courses that remain and prevent further collapse. It might also deter stock from crossing the alignment (see below).

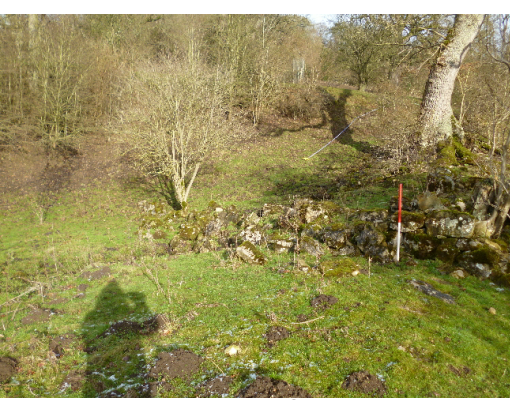
1-797.JPG

- 3.5 To the south of the precinct bank, the cross-wall is largely marked by an intermittent line of hawthorn trees [1/798], but across the bank and to the north, it is evident that the precinct boundary wall was demolished, and stone taken from it to build the cross-wall [1/795]. This section of cross-wall is crudely faced immediately adjacent to the precinct boundary, the facing standing up to two courses in height [1/796] but it deteriorates into little more than a west-facing rubble scarp as it moves northwards [1/797].

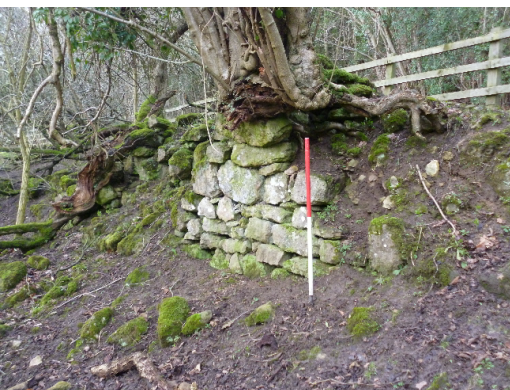
1-804.JPG

walls are likely to continue to decay though weathering, as although the scarp to their immediate south is partly stabilised principally through hawthorn and elder scrub, much of the soil surface forming it is bare and in places additionally disturbed by rabbits. The surviving parts of wall facing recorded in Section K [1/804] are particularly vulnerable to collapse.

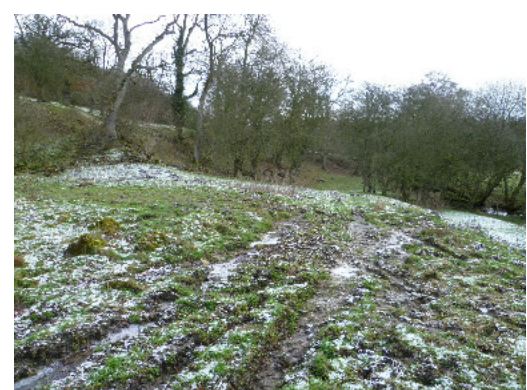
1-813.JPG

- 4.15 In Section A, near the river, it was noted that one part of the earthwork bank on which the wall was set had been slightly damaged/disturbed by rutting caused by vehicles [1/813; 1/814]. This is due to agricultural vehicles having to cross the alignment to gain access into the pasture on the south side of the boundary. Discussion with the tenant farmer established that the wet ground in this part of the site is partly due to a broken or blocked drain on the north side of the bank.
- 4.16 It is accepted that such vehicular movement is a requirement of any agricultural regime, and there is little specific action that can be taken to prevent this. However, it might be possible to minimise damage by spreading movement across a broader zone, rather than keeping to one or two routes, and trying to avoid

1	813	Section A, vehicular rutting across bank, looking E	-
1	814	Section A, vehicular rutting across bank, looking E	-
1	815	West end of canal, looking SE	-
1	816	Footpath crossing west end of canal, looking N	-

movement in periods of exceptionally wet weather. Alternatively, another sacrificial layer of soil and/or turf could be used to afford some protection to the underlying deposits. The repair or renewal of any broken/blocked field drains would be an obvious benefit to the area, and this should be investigated with the relevant authorities without delay.

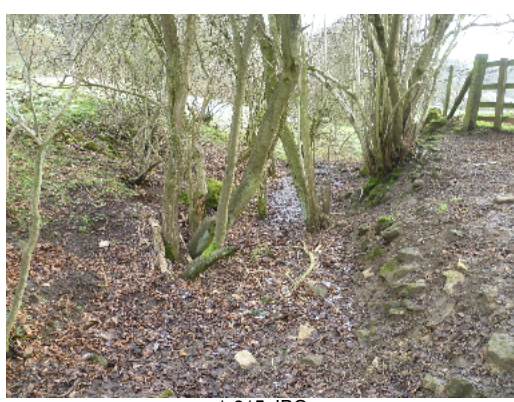
1-815.JPG

- 3.3 Within the survey area, the very western c.5m end of the precinct boundary appears to run as a spread bank alongside, above and parallel to the northern side of the straight valley-bottom watercourse sometimes known as the 'canal'. Traditionally suggested to have been used to transport stone from quarries to the claustral complex, this canal could also have supplied water to the Abbey's mills and internal water supply system (Caroe & Partners 2000, vol 2, 20). The published plan of the precinct boundary (Fergusson *et al* 2006, 30; see figure 3) suggests that the canal extended further to the west, just beyond the junction with the boundary. However, the precise relationship between the end of the canal, any channel/sluice arrangement adjacent to the river, and the end of the precinct boundary is difficult to determine without a detailed survey, partly because of an eroding footpath which crosses the very western end of the canal [1/816]; some stone in the south side of the canal may be associated with the precinct wall, but it is difficult to be sure [1/815].
