GUNNERSIDE GILL, MELBECKS,  
NORTH YORKSHIRE  
FURTHER ARCHAEOLOGICAL EROSION SURVEY

FURTHER ARCHAEOLOGICAL EROSION SURVEY

Report no: 2012/442.R01  
Version: Final  
Date: January 2013  
Author: Shaun Richardson & Ed Dennison

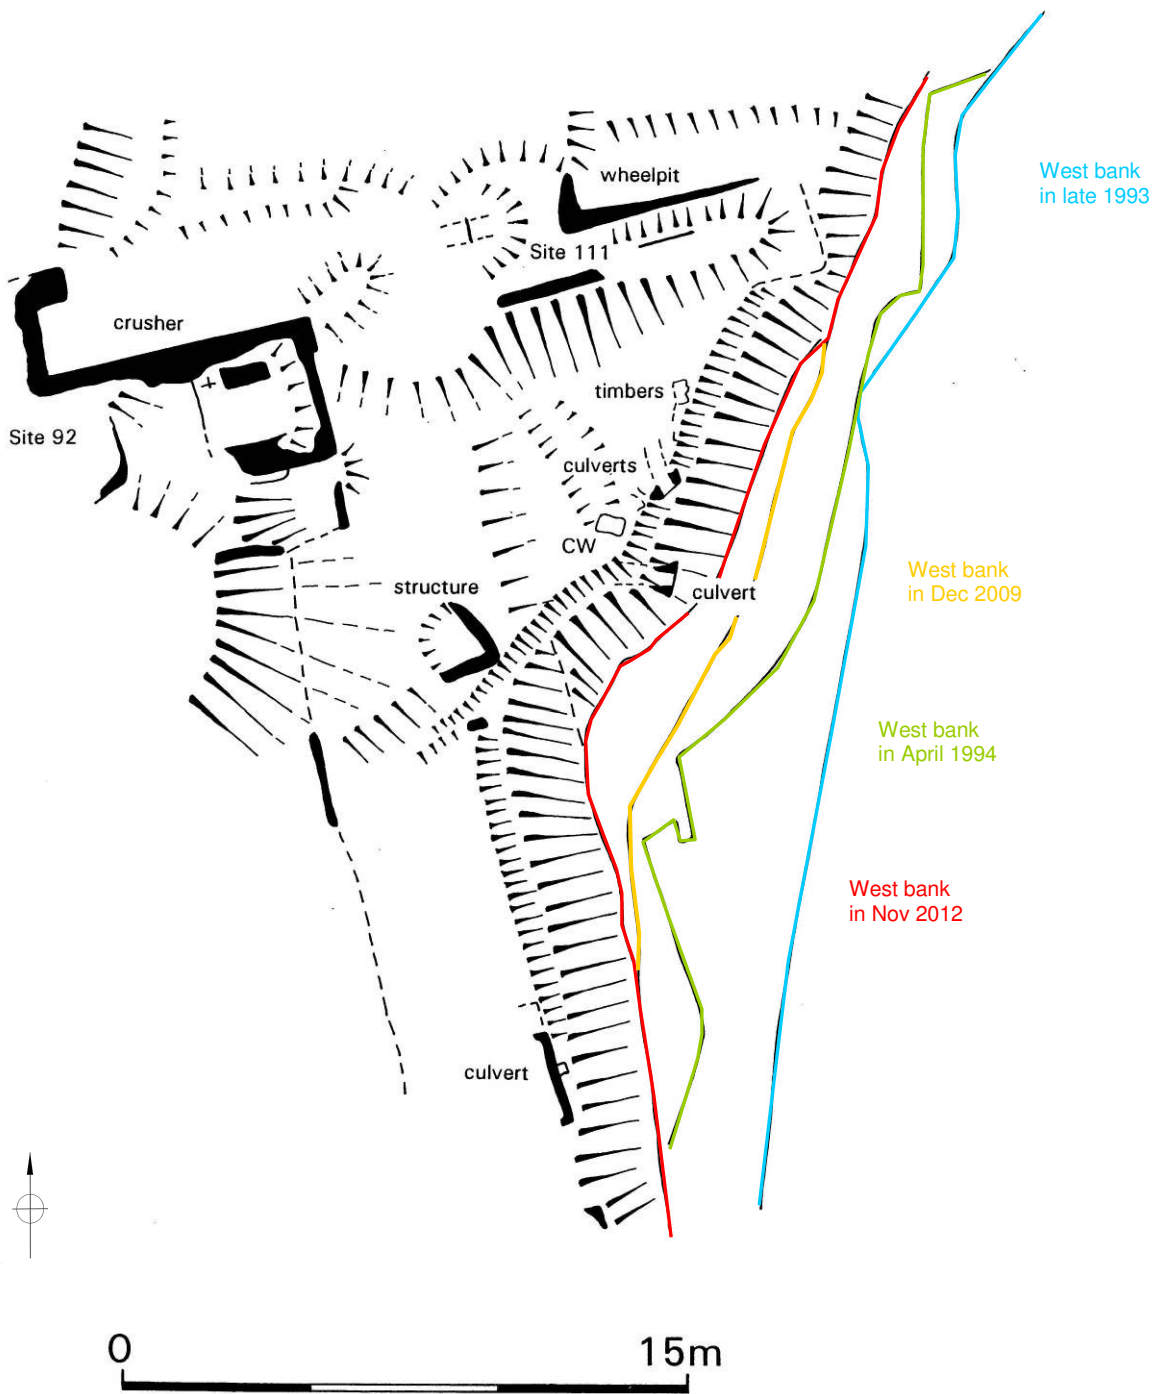
PROJECT EROSION SURVEY, GUNNERSIDE GILL	
TITLE AREA 1 SURVEY	
SCALE AS SHOWN	DATE JAN 2013
EDAS	FIGURE 2

- 3.2 As previously stated, Area 1 was located at c.320m AOD on the west side of the Gunnerside Beck (at NGR SD 940 998 centred) and it formed part of the former dressing floor associated with the Sir Francis Mine. It was situated within the 1993 Phase 1 survey area, adjacent to a large meander in the course of the beck, and consisted of a stretch of actively eroding bank measuring c.50m long (north-south).

- 3.3 This was the only area noted during the field visit where significant change had occurred since December 2009. When it is in spate, the Gunnerside Beck is running south-westwards across an area of stones and soil normally above water level [1/233 and 1/235]. It then curves around the eastern end of the Sir Francis wheelpit (Site 111) on its west bank and is cutting into the area of fine to medium dressing wastes and soils to the immediate south-west. Although, at a lower level, the beck has not moved much more than 1.0m westwards since December 2009, at an upper level, this movement has produced a near vertical scarp (see plate 4). The section recorded here in 2009 has now collapsed, although many of the features described in 2009 are still eroding out of the new section created by the collapse, including the two culverts [1/200, 1/201, 1/203, 1/208 to 1/210, 1/213 and 1/215] (see plates 1 and 2). Undercutting of the near vertical scarp means that features such as the crusher weight to the south-east of the crusher base (Site 92) [1/191 and 1/192] ('CW' on figure 2), and a sub-square stone structure to the south-west of the crusher weight [1/193], are now less than 0.30m away from the scarp's face (see plate 3). To the north, some of the timbers recorded in late 2009 as overhanging the beck side have fallen. The near vertical scarp continues south, as far as the coursed squared rubble wall and culvert noted previously in 2009 [1/211 and 1/212].

- 4.2 If erosion continues at a similar rate, one might predict that by 2025 the beck could have reached the crusher (Site 92) on the west side of the dressing floor. A decision will therefore need to be made for this part of the Sir Francis Mine complex - should the erosion be allowed to continue unchecked, or should a more permanent solution, perhaps involving the partial canalisation of the beck or the construction of retaining walls, be adopted? As previously reported, it is possible that the latter options would prove too costly and would perhaps be environmentally unacceptable, and so it is likely that the dressing floor will continue to erode, either slowly year-on-year or more rapidly during periods of flood. If the dressing floor complex is to be 'written off', it is suggested that there should be a suitable level of archaeological recording done soon, including excavation of all or parts, so that information relating to the structures and the methods of working is recovered. At present, no lead mine dressing floors in North Yorkshire have been archaeologically excavated, and the methods employed in dressing are largely inferred from other sites outside the county.

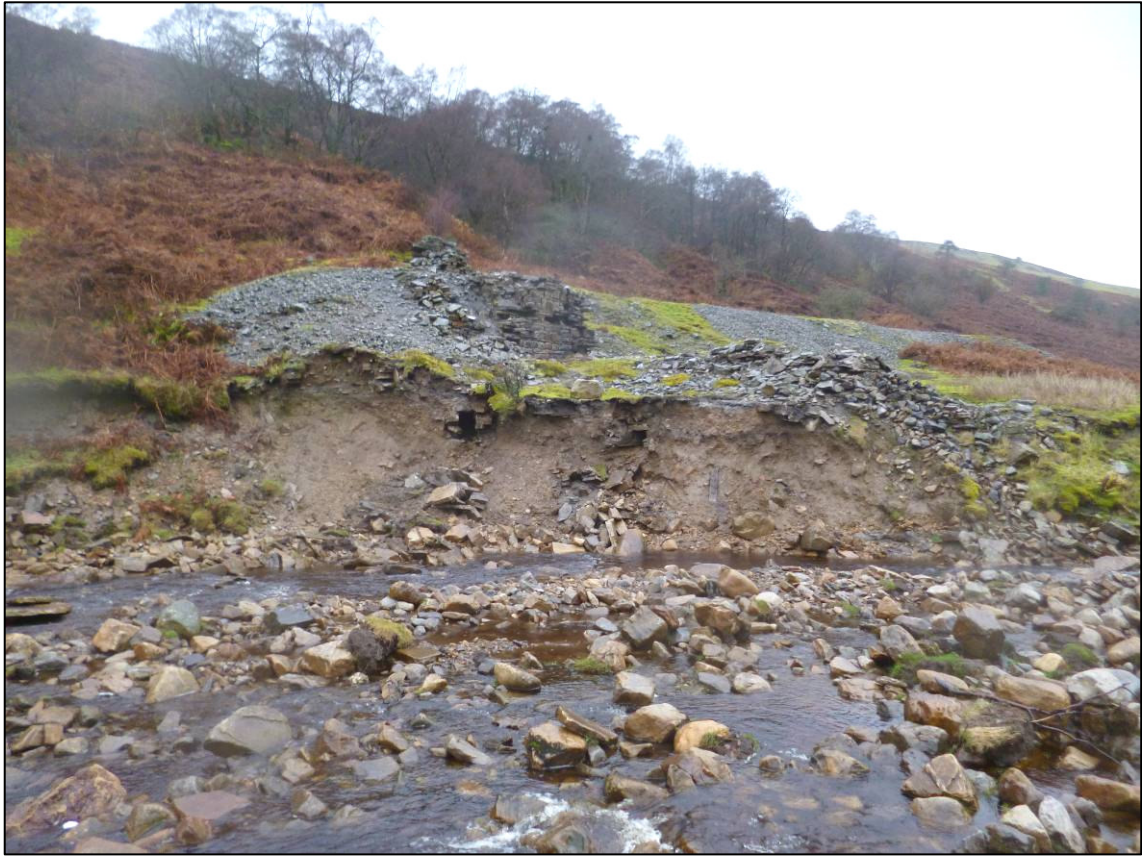
Plate 1: General view of eroding structures on Sir Francis Mine dressing floor, looking NW, November 2012 (photo 1/208).

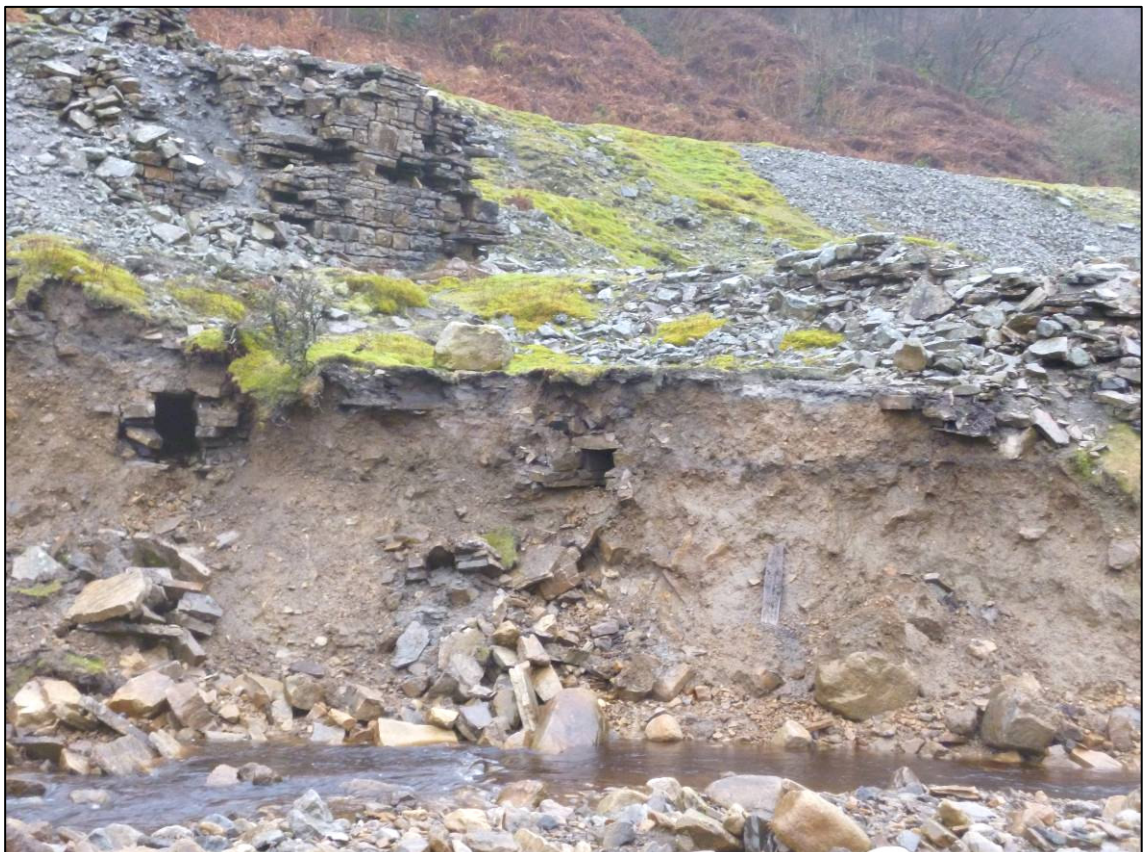
Plate 2: Detailed of eroding structures on Sir Francis Mine dressing floor, looking NW, November 2012 (photo 1/209).

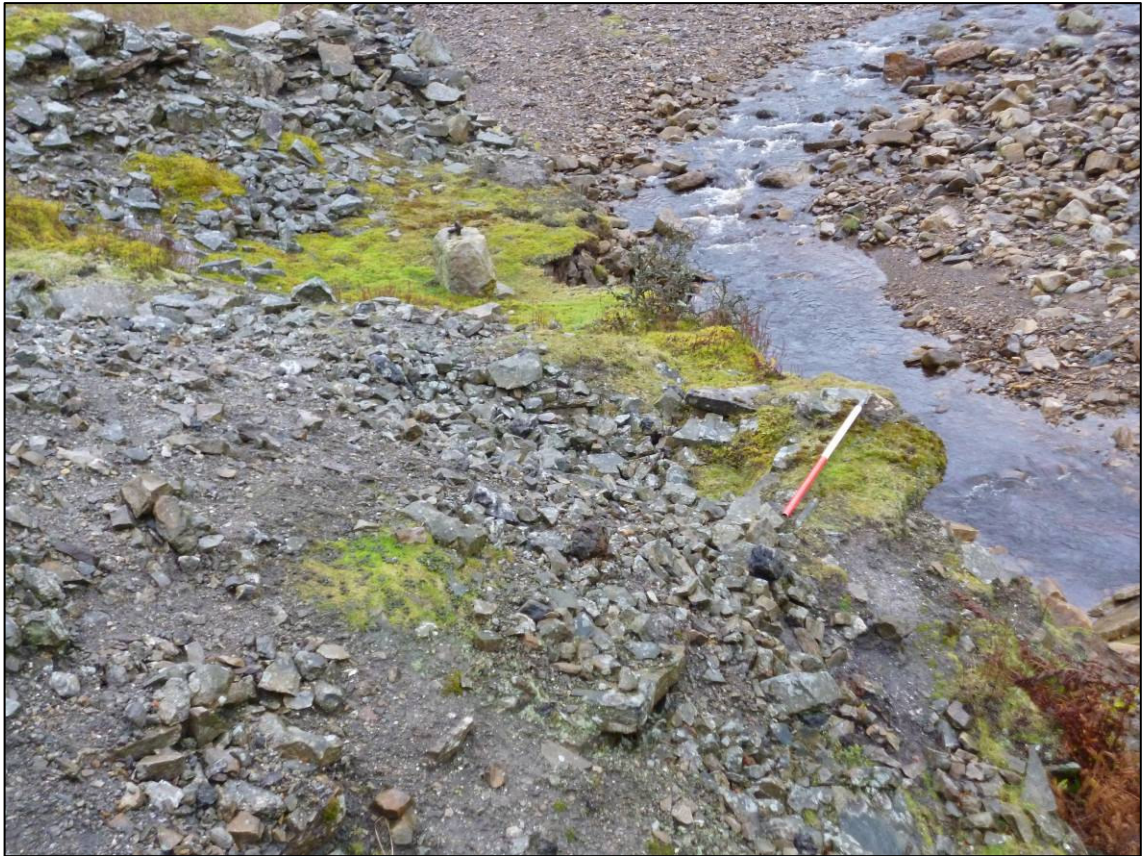
Plate 3: Crusher weight and sub-square stone structure on Sir Francis dressing floor in danger of erosion, looking NE, November 2012 (photo 1/193).

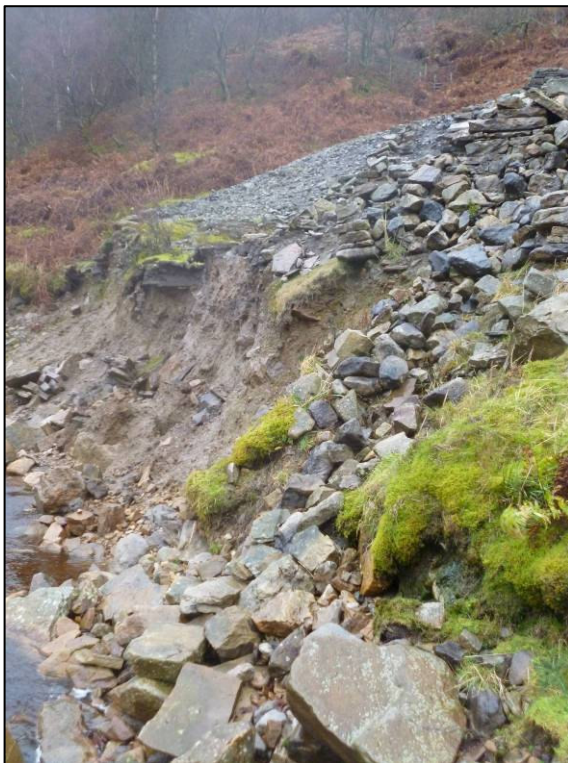
Plate 4: Eroding west bank of gill, cutting into Sir Francis dressing floor, looking SW, November 2012 (photo 1/200).

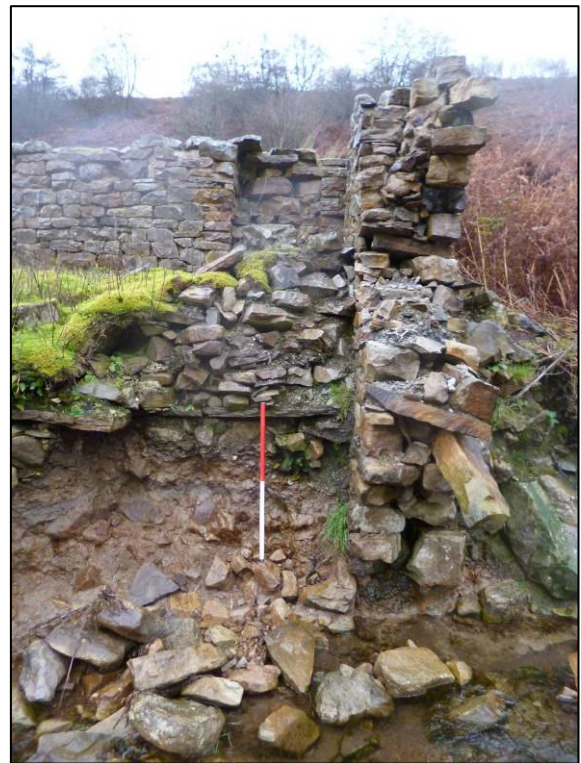
- 3.4 The mineshop (Site 73) to the south of the Sir Francis Mine has not changed significantly since 2009, although further minor erosion at the north-east end of the northern wall has revealed the internal remnants of a flagstone floor [1/197 to 1/199, 1/204 to 1/207] (see plate 5).

Plate 5: North end of Sir Francis mineshop, looking W (photo 1/205).

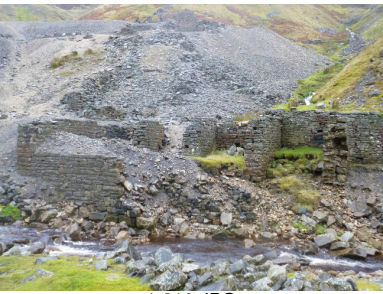
1-216.JPG

- 3.7 There had been little significant change since December 2009, and what has occurred has taken place around the bouse teams (Site B86). There has been some further minor collapse of the remains of the southernmost bin (Site B86/5), together with further minor erosion of the bank edge to the north [**1/216 to 1/218, 1/220 to 1/222 and 1/230**]. However, the timbers recorded in 2009 to the south of the bouse teams are now collapsing into the beck. There is no significant further collapse to the north end of the revetment wall (Site B85) or the adjacent spoil heap (Site B87) [**1/226 and 1/228**].
