EXPLOSIVES STORE, MEAL BANK QUARRY,
INGLETON, NORTH YORKSHIRE

ARCHAEOLOGICAL SURVEY

Report no: 2013/462.R02
Version: Final
Date: August 2013
Author: Shaun Richardson & Ed Dennison

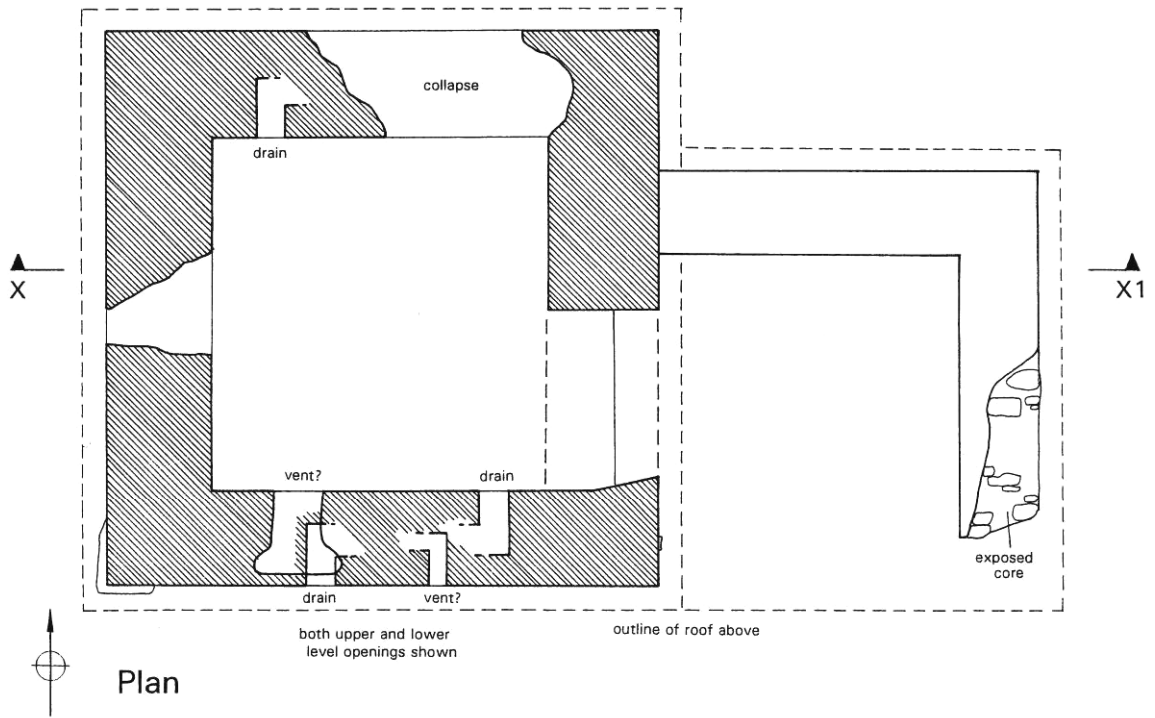
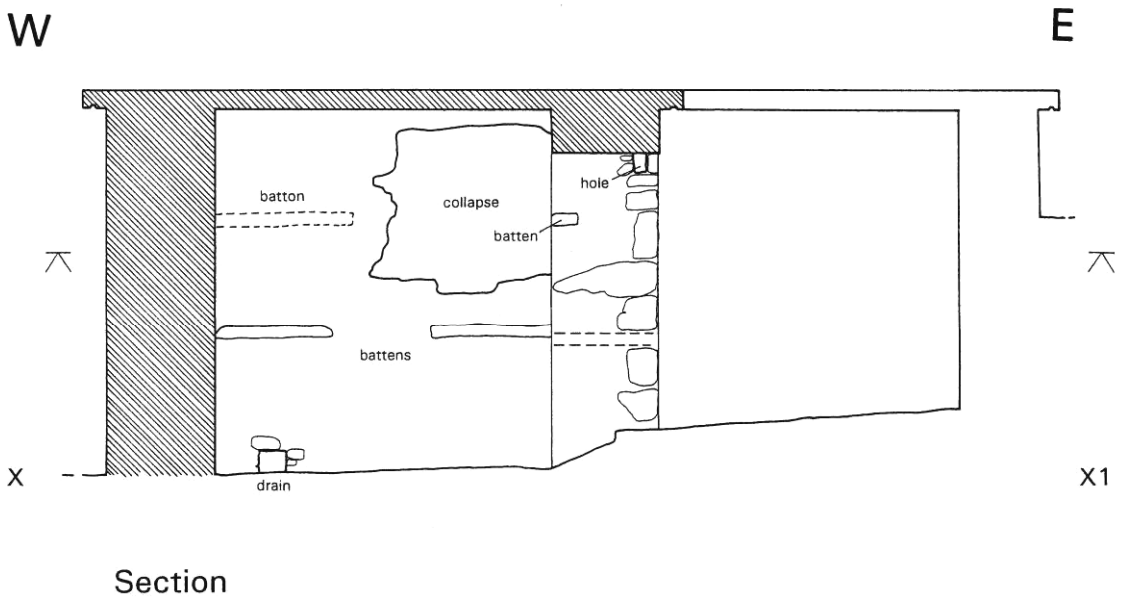
PROJECT	
EXPLOSIVES STORE, INGLETON	
TITLE	
PLAN AND SECTION	
SCALE	DATE
AS SHOWN	AUG 2013
EDAS	FIGURE
	2

ORIGINAL STRUCTURE

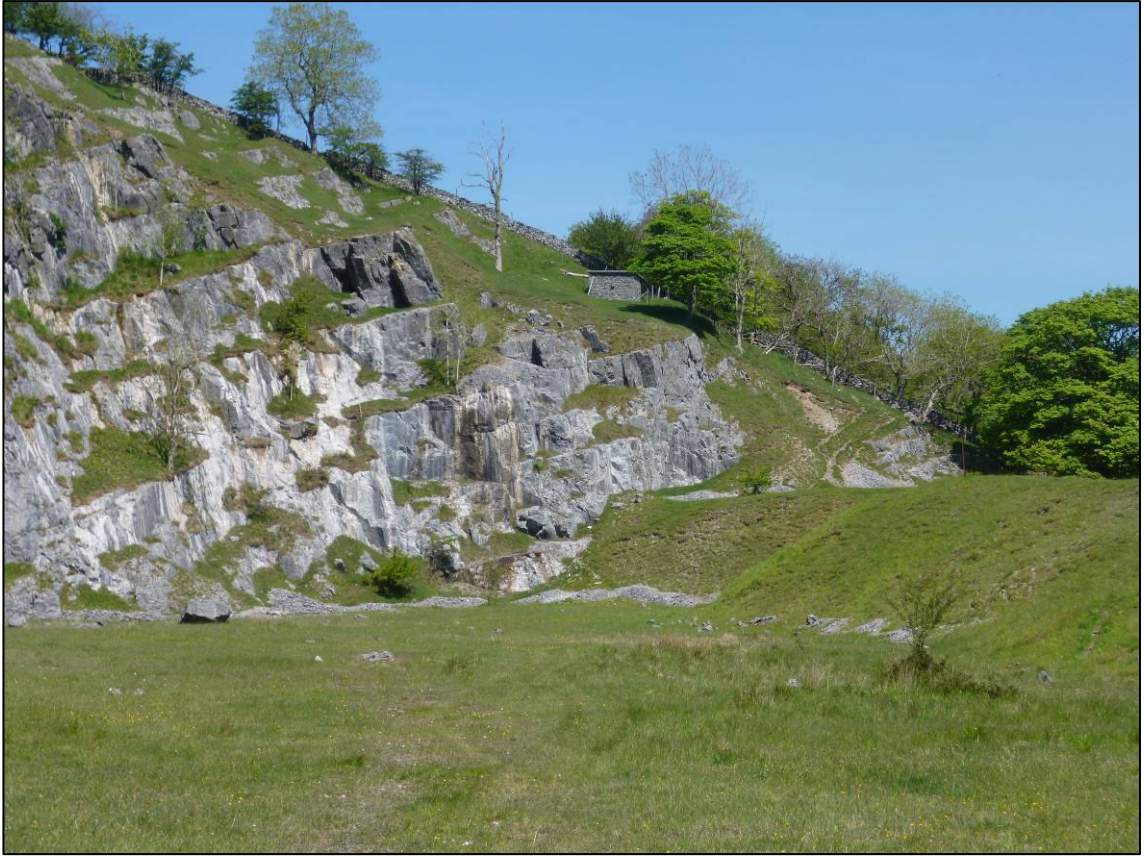
- 4.3 The structure is positioned above the north-east end of the quarry, above a steep benched face, close to a drystone field wall which forms the northern limit of the quarry area [1/724, 1/725, 1/726] (see figure 1 and plate 1). The structure has been terraced into the ground surface, which steps down from north-west to south-east in a series of broad terraces. As a result, the ground level to the immediate north of the structure is higher than to the other three sides, partly obscuring the north elevation [1/685, 1/686, 1/690]. There is a slight embankment around the

Plate 1: General view of structure within quarry setting, looking NE (photo 1/724).

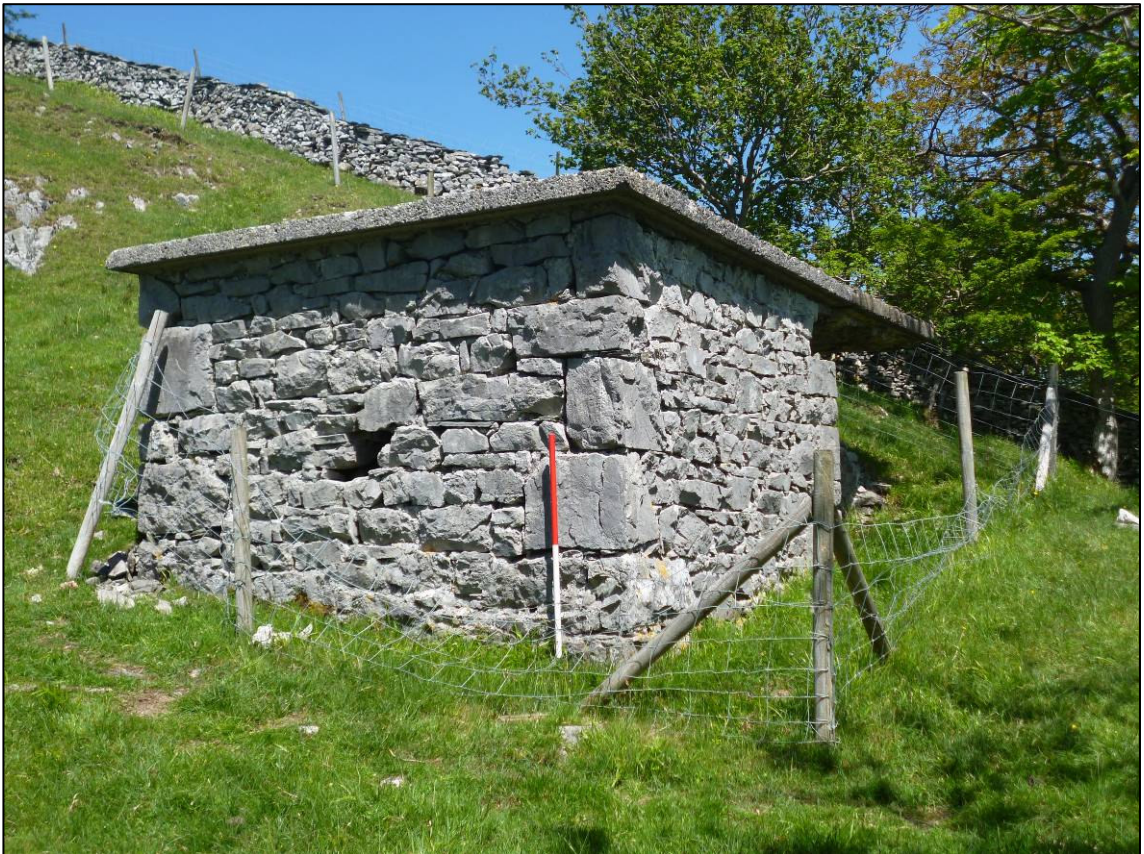
- 4.5 The walls of all parts are built of roughly coursed and squared limestone rubble, laid to a watershot profile, and set with a lime mortar [1/683] (see plate 2). There are very substantial quoins to all four corners of the west cell, and the south-west corner rises from a slightly projecting footing at the very base. Both parts of the structure have separate flat reinforced concrete roofs, averaging 0.095m thick [1/689, 1/691, 1/692, 1/693]; there is a straight joint between the two [1/704] (see plate 3). The roofs project by 0.12m around all sides of the structure and there is a drip channel to the underside [1/703, 1/705] (see plate 6).

Plate 2: General view of structure, looking NE (photo 1/683).

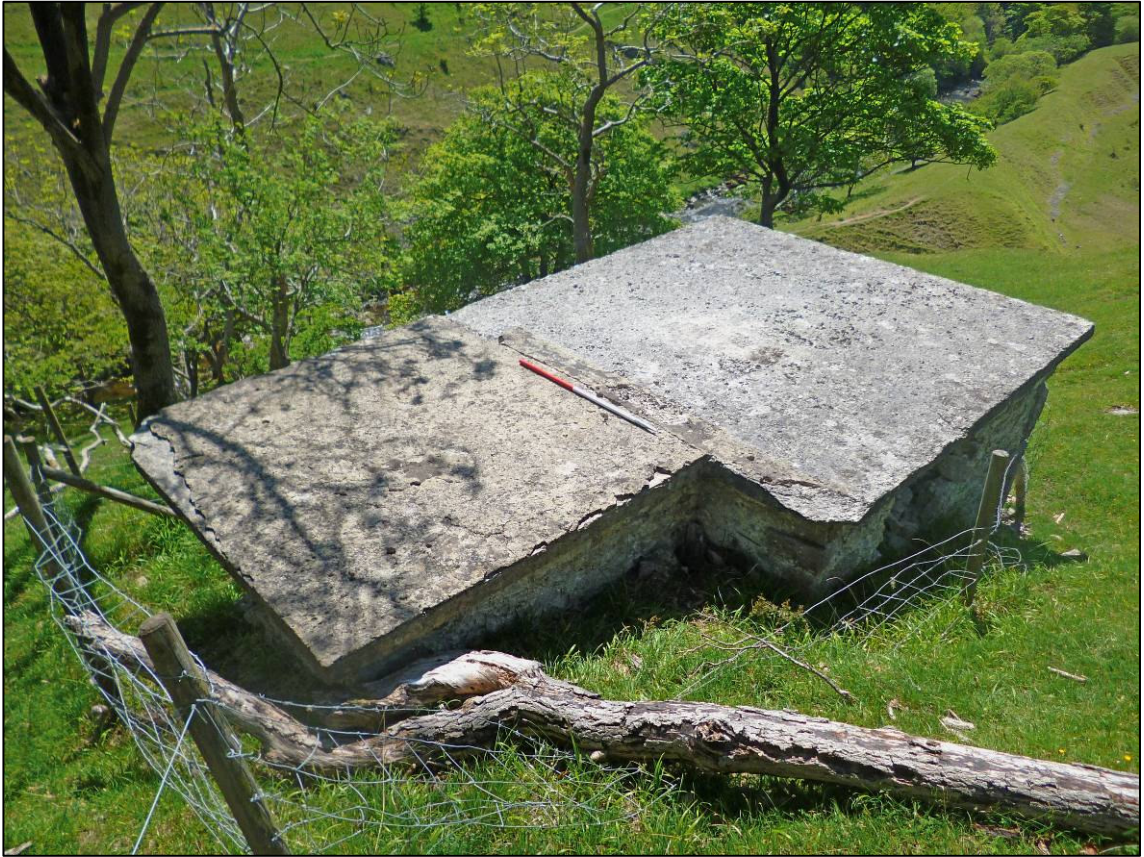
Plate 3: View of roof structure, looking SW (photo 1/691).

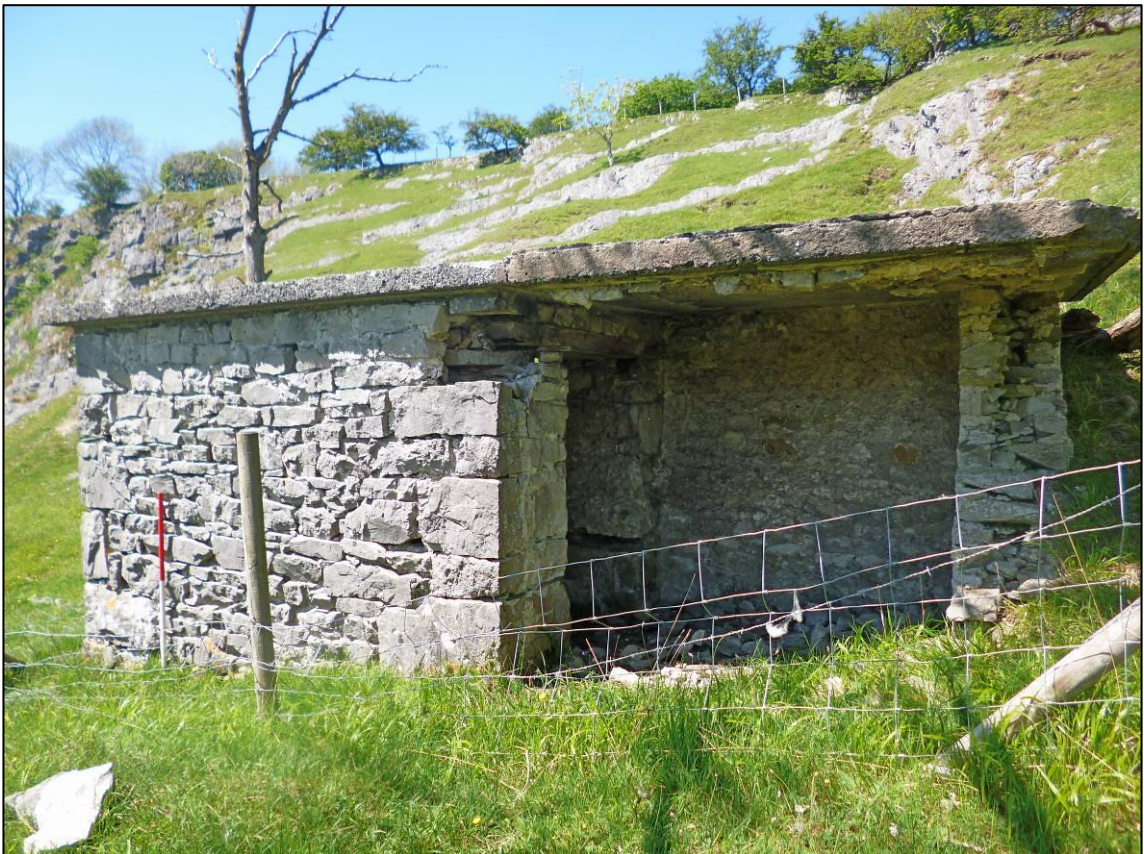
- 4.6 The external elevations of the newer, eastern, cell are featureless [1/694, 1/695]; the south wall has largely either collapsed or been demolished [1/698], removing all evidence for the form of the doorway here, which replaced the original entrance (see below) when the east cell was built (see plate 4).

Plate 4: South elevation, looking NW (photo 1/698).

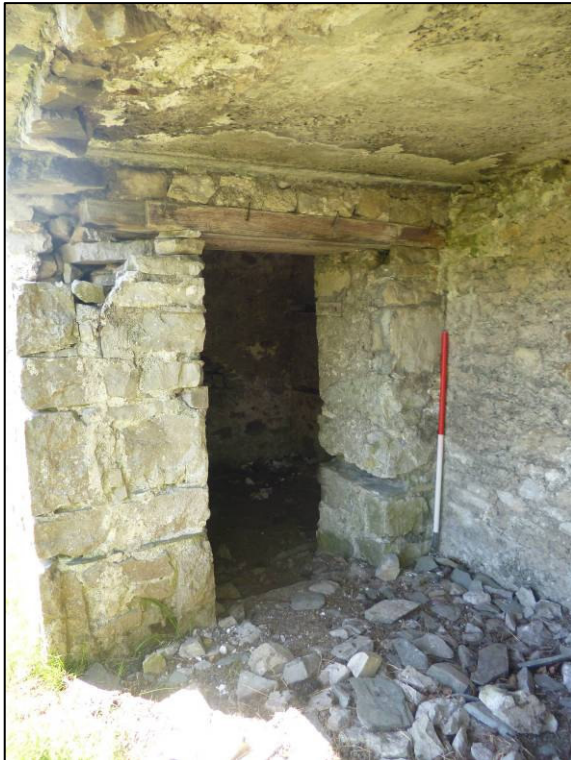
Plate 5: Internal west wall of east cell, looking NW (photo 1/700).

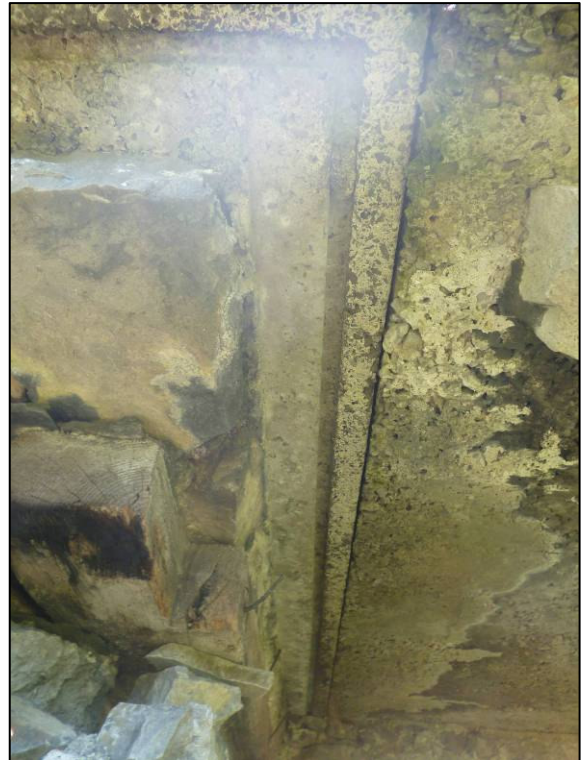
Plate 6: Roof drip line, east cell roof, looking N (photo 1/704).

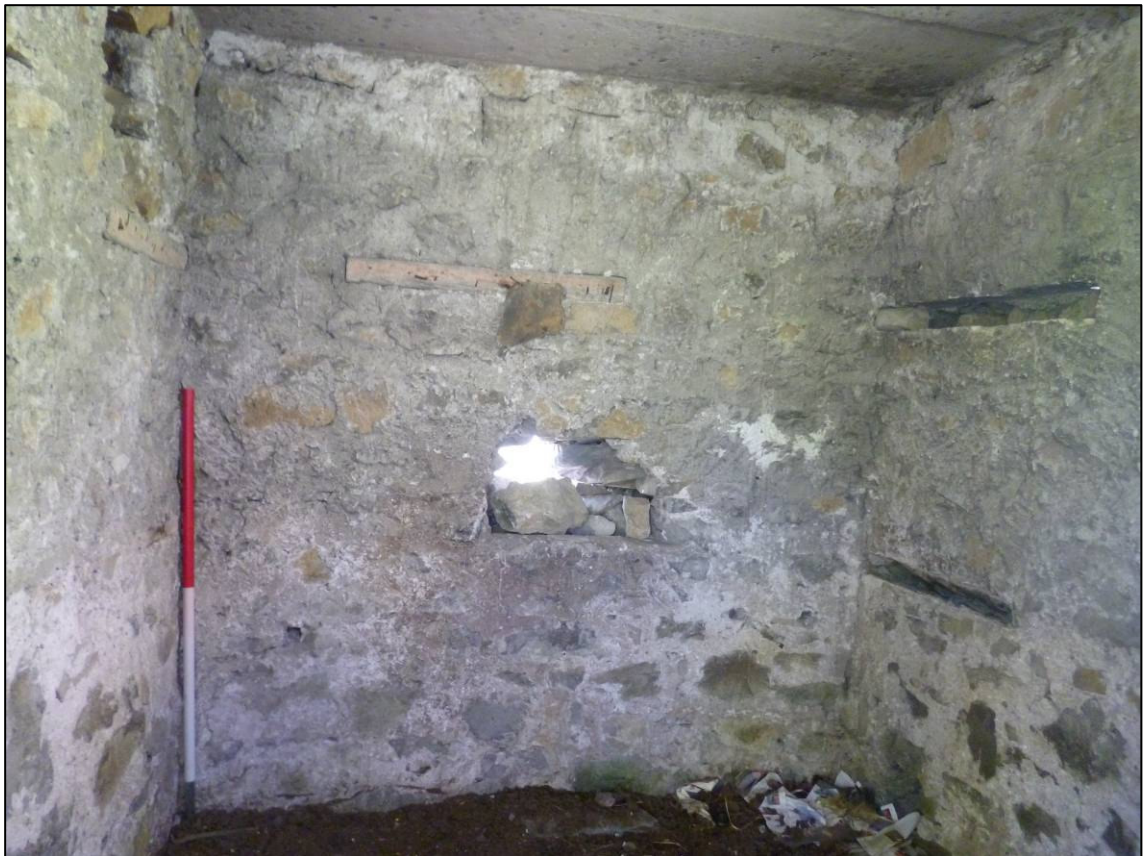
- 4.11 The east wall [1/710] contains no features not already described, while the west wall [1/706] has a single timber batten towards the centre, set at approximately the same height as the higher battens to the south wall [1/707] (see plate 7); one of the nails projecting from the batten has a piece of roofing slate pushed beneath it. Below the batten, a recess or void has been crudely cut through the wall thickness to the exterior. The north wall has the same pattern of battens as on the south wall [1/708, 1/709]. There is a large area of either collapse, or a crudely cut opening, to the eastern half of the wall. At the west end, at the base, there is a drain-like opening which appears to run back 0.33m from the wall face before turning through a right-angle to the east, as the similar features do to the south wall. It appears that all four internal walls of the west cell were once rendered or white-washed, and it is noticeable that there is a change in this coating to all four walls at c.0.75m above floor level [1/716] i.e. the same height as the lower battens to the north and south walls.

Plate 7: Internal west wall of west cell, showing battens, looking W (photo 1/707).
