BENT RIGG RADAR STATION,
SOUTH-EAST OF RAVENSCAR, STANTON DALE,
NORTH YORKSHIRE

ARCHAEOLOGICAL MONITORING OF
2013 REPAIR WORKS

Report no: 2011/410.R02
Version: Final
Date: September 2014
Author: Ed Dennison

National Trust (Yorkshire Region)
Goddards
27 Tadcaster Road
York
YO24 1GG

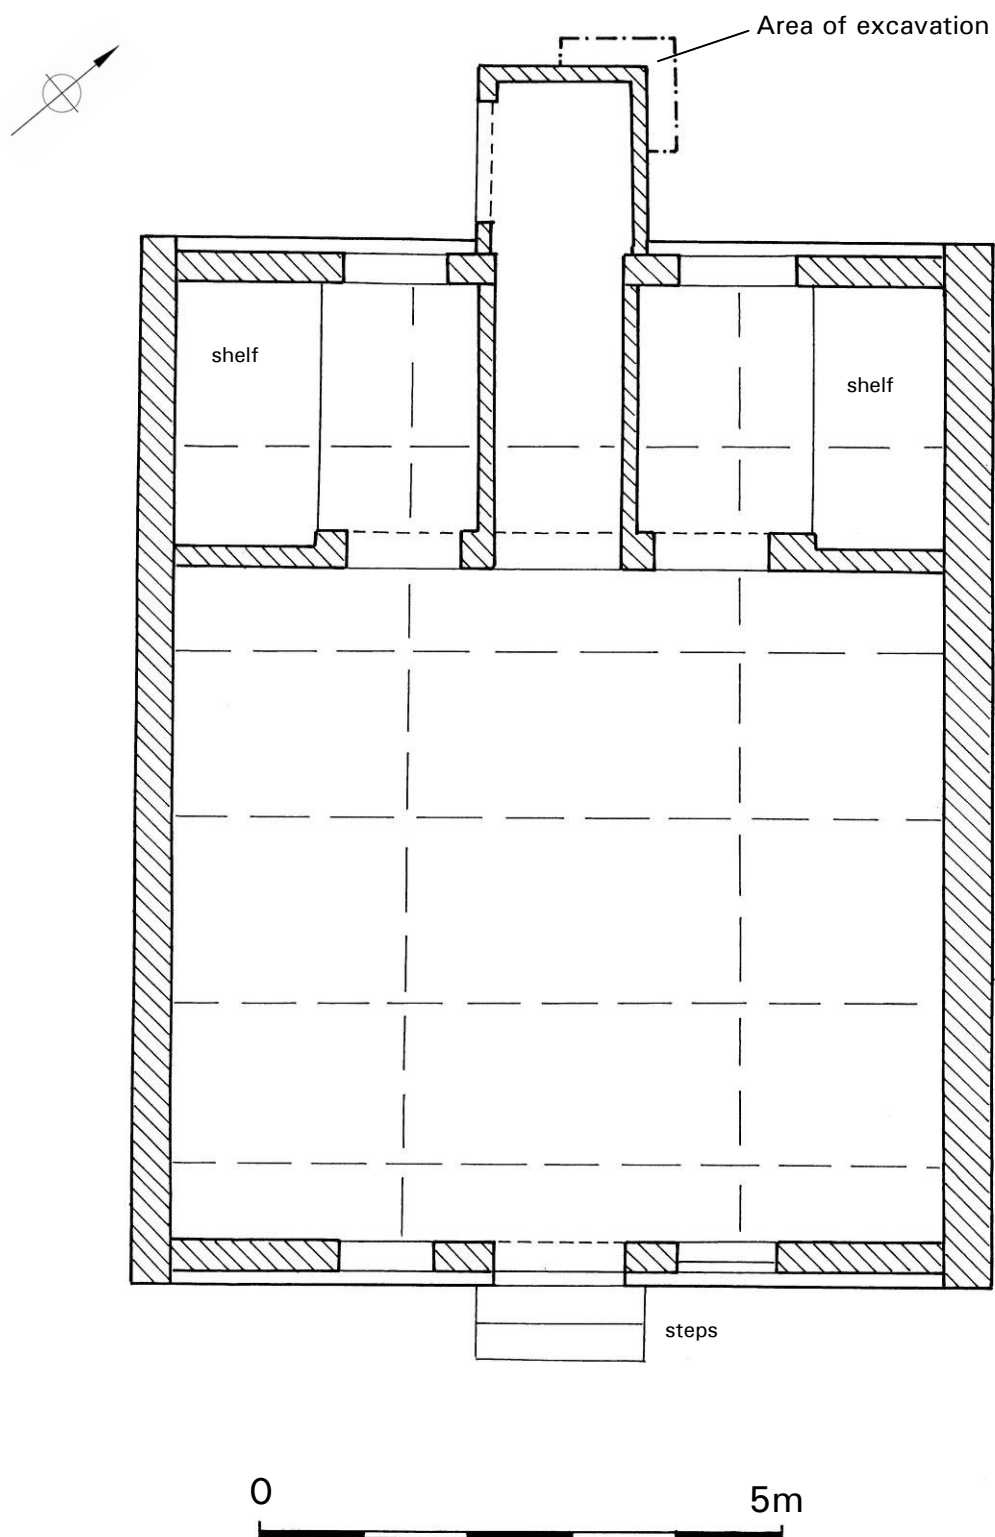
PROJECT BENT RIGG WATCHING BRIEF	
TITLE BUILDING R3 PLAN	
SCALE AS SHOWN	DATE SEPT 2014
EDAS	FIGURE 5

- 5.7 The long axis of the building is set at right-angles to the other brick and concrete structures in the radar complex, and it has maximum external dimensions of 7.40m (24.2ft) east-west by 5.70m (18.6ft) north-south (see figure 5). Prior to the start of this phase of repairs, the external elevations remained largely as previously recorded in November-December 1997 and described in June 2000, although the windows in the north elevation and the doors and windows in the south elevation were blocked with brick and the frames taken out during the late 2000 conservation works, and the ventilation openings over the two doors were bricked with honey-comb brickwork.

- 5.8 As noted above, the amount of actual ground disturbance work was limited to a small trench dug around the north-east corner of the north porch. The small brick-built porch is founded on a concrete base and measures 1.15m east-west by 1.37m north-south, with a doorway in the west side; the porch was possibly built at a later date than the rest of the building as there is a straight joint between the two. The L-shaped excavated trench measured 0.75m along the long sides, 0.30m along the short sides and was a maximum of 0.30m deep, slightly undercutting the corner of the porch [1/901-1/906] (see figure 5 and plate 6). A 0.30m depth of dark brown clay topsoil with no inclusions was revealed, with occasional small stones in the base of the trench; it is unlikely that these formed any sort of foundation, and it was clear that the 0.40m thick concrete slab at the bottom of the porch had been founded directly onto the topsoil. Once recorded, the trench was filled with concrete to form a firm foundation [2/673] (see plate 7).

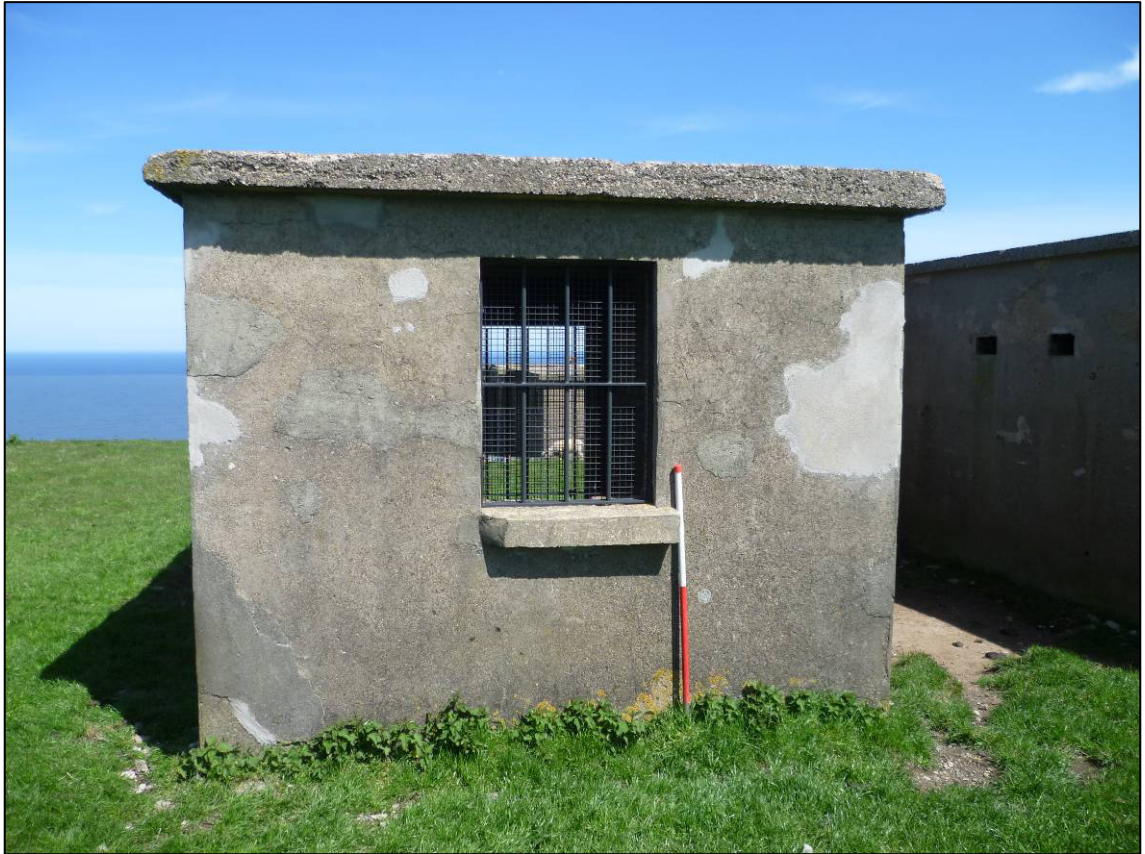
Plate 1: Repairs to render and inserted window screen, W side of Building R1, looking NE (photo 2/658).

- 5.3 The repair works comprised the treating of all exposed metalwork, including the steel rods visible on the eroded roof edges, the patching of several areas of eroded/spalled concrete render (c.0.25m thick) to the external wall faces [1/919, 1/920; 2/656, 2/658, 2/660, 2/706] (see plate 1, the repair of eroded roof edges [2/657], the removal of the rotted frame and glass to the window in the west elevation, and the repainting of the door frame in the east elevation [2/654]. New steel grilles were also added to the window and door openings to prevent unauthorised access [2/655, 2/659] (see plates 1 and 2).

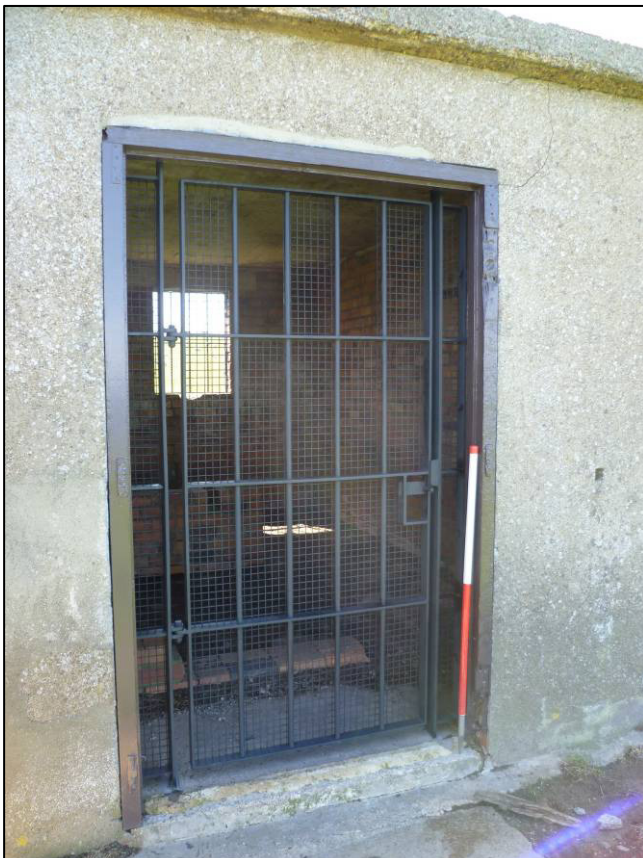
Plate 2: Inserted door screen to Building R1, looking SW (photo 2/655).

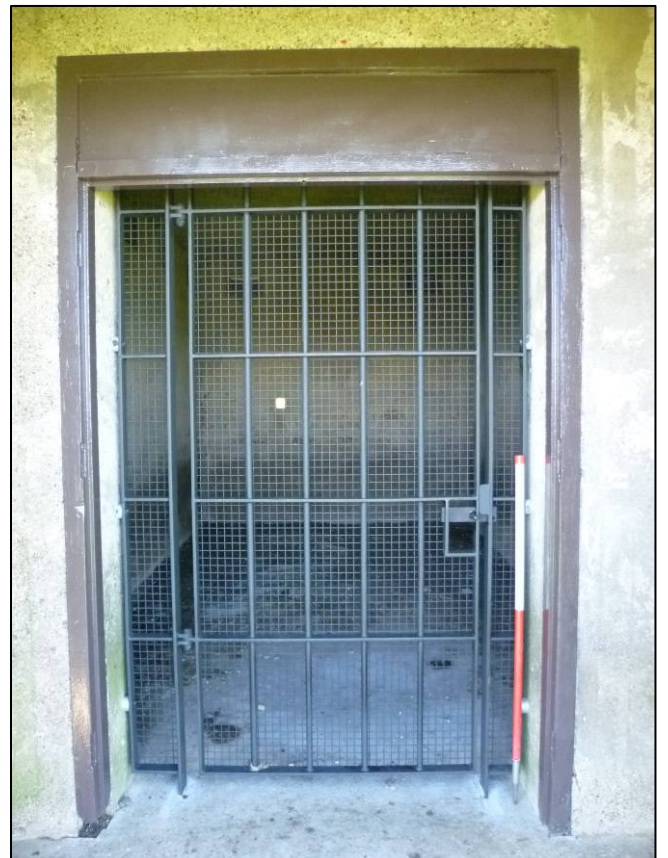
Plate 3: Inserted door screen to Building R2, looking SW (photo 2/662).

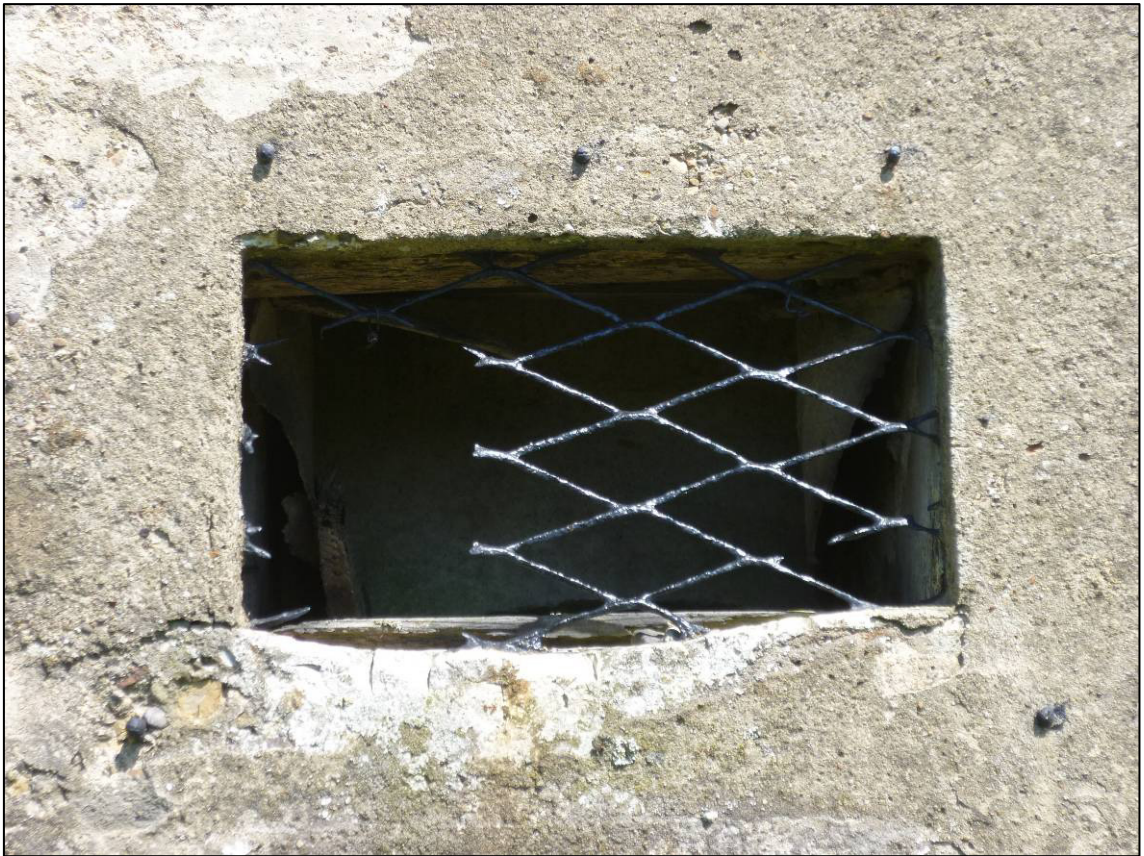
Plate 4: Repairs to vent grill on W side of Building R2, looking NE (photo 2/666).

- 5.5 As with Building R1, the repair works involved the treating of all exposed metalwork, including the steel rods visible on the eroded roof edges, the patching of several areas of eroded/spalled concrete render to the external wall faces [2/665, 2/667, 2/668], the repair of eroded roof edges, and the repainting of the internal door frame in the east elevation. The mesh grilles to the wall vents were treated with a rust inhibitor and repainted [2/664, 2/666, 2/669] (see plate 4), and a new steel grille was added to the internal door opening to prevent unauthorised access [2/661, 2/662] (see plate 3). Once repairs were complete, the building's appearance was much improved [2/670, 2/697, 2/705] (see plate 5).

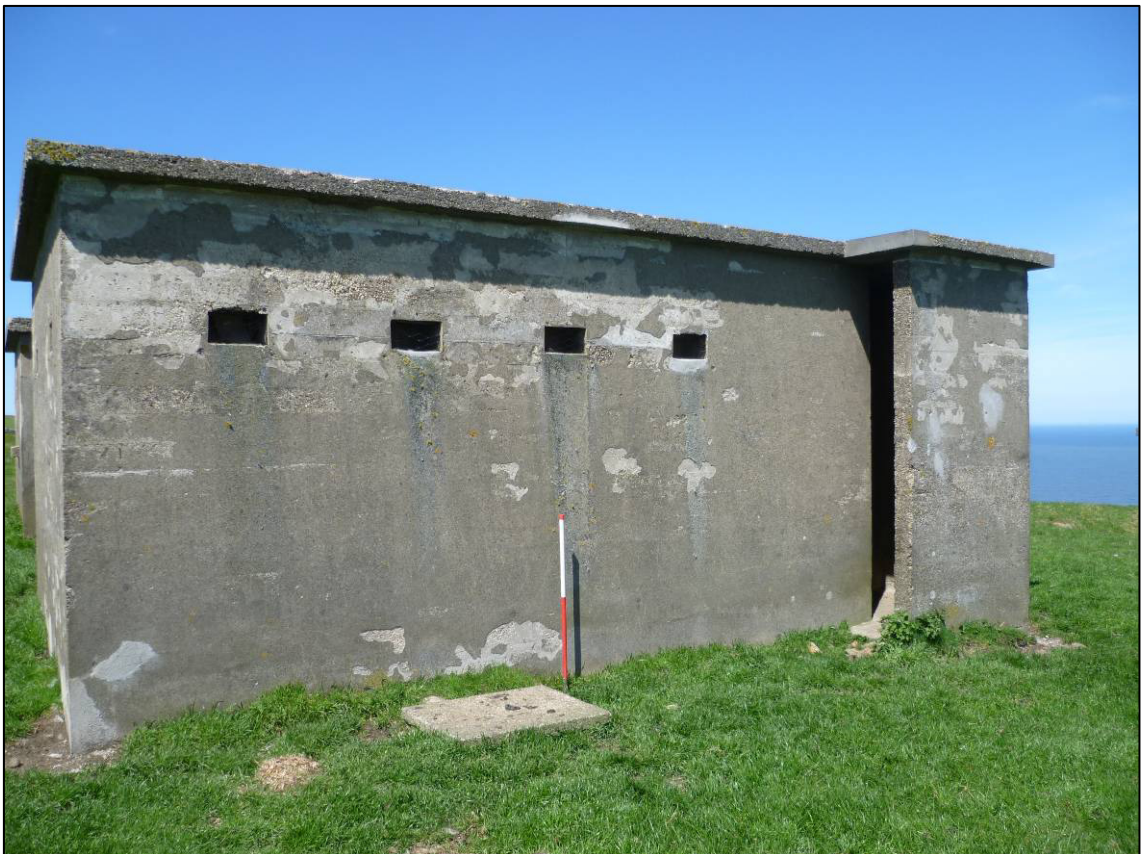
Plate 5: Repairs complete to S side of Building R2, looking NW (photo 2/668).

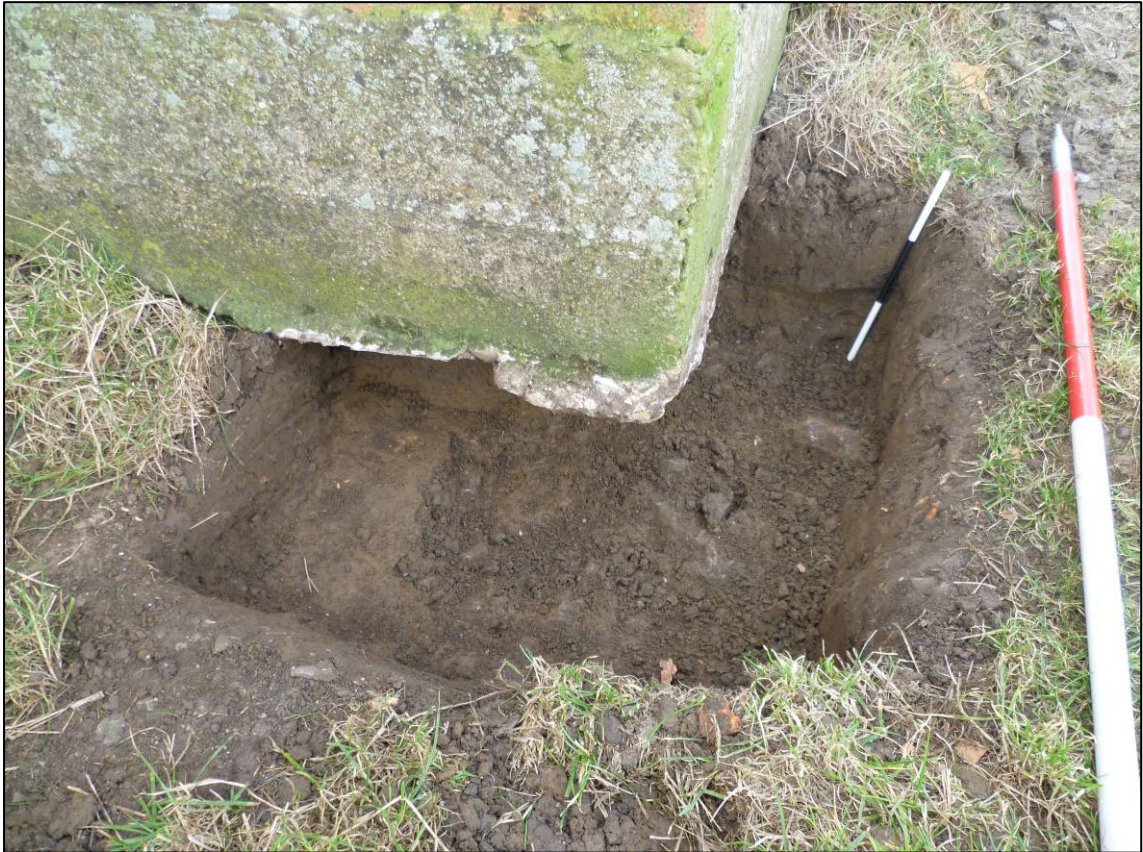
Plate 6: Completed excavation for new foundations under porch of Building R3, looking SW (photo 1/906).

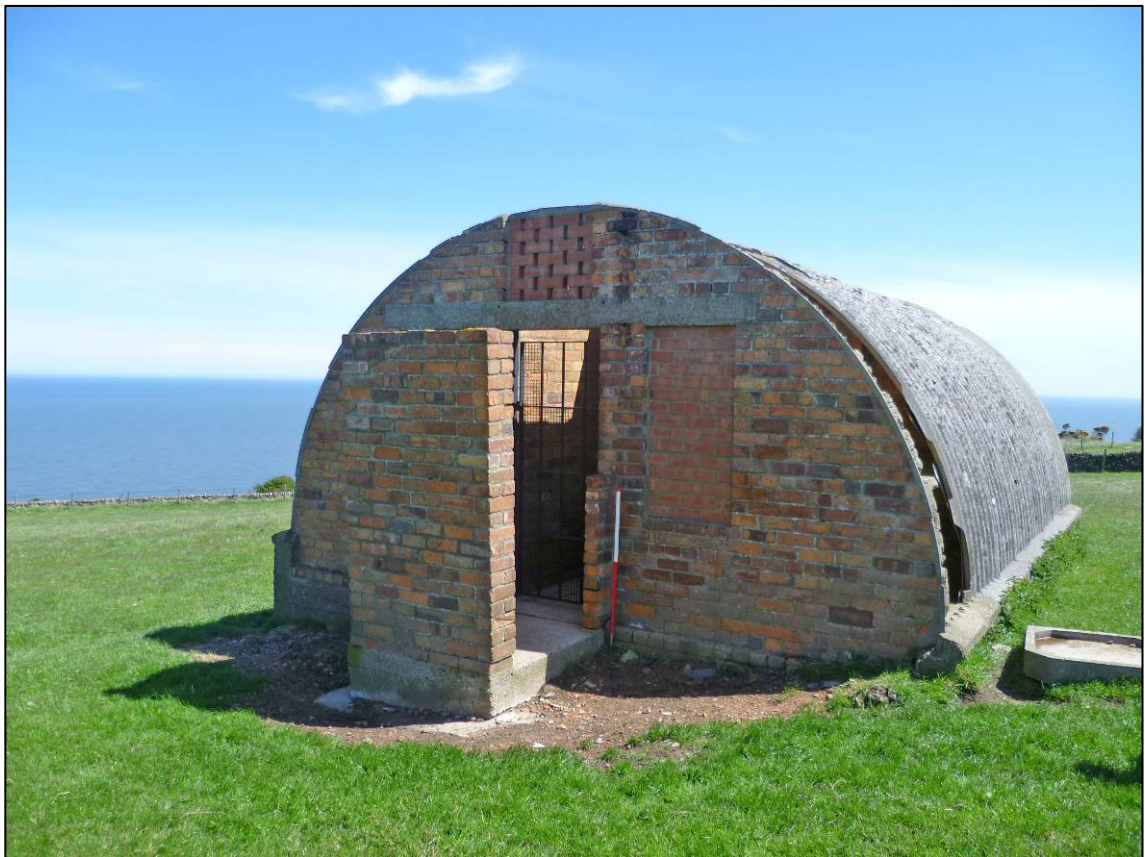
Plate 7: Repairs complete to north end of Building R3, looking SE (photo 2/672).

- 5.10 Once repairs were complete, the building was much improved, although the unrepaired asbestos roof still detracted from its overall appearance [2/674, 2/678, 2/698] (see plates 7 and 8).

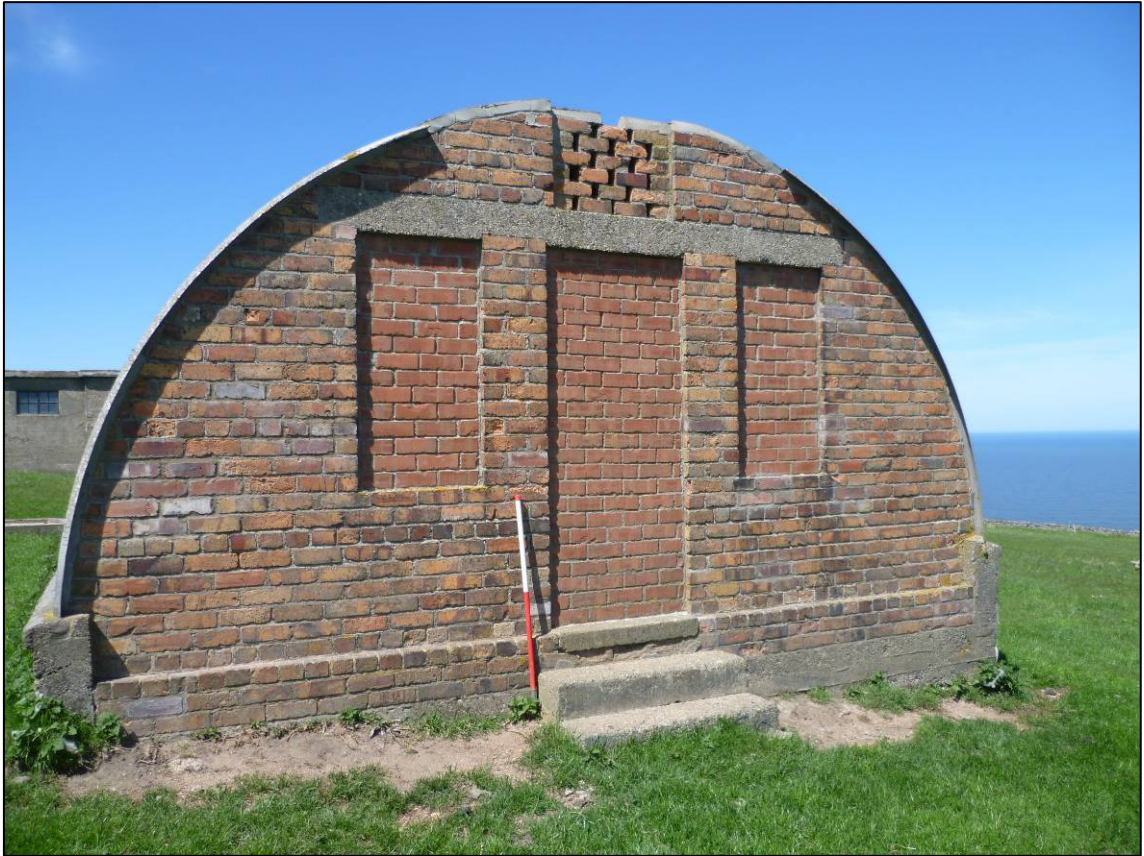
Plate 8: Repairs complete to S end of Building R3, looking N (photo 2/675).

- 5.9 Other work at this building comprised the small-scale replacement of eroded brickwork to the south gable and around the porch, and selective areas of repointing. On the south gable, the eroded brickwork had to be cut out using a jack hammer because of the hardness of the cement mortar, and 'new' matching bricks were inserted [1/907, 1/912, 1/913]. This was not done on the single skin porch walls because it was feared that the vibrations from the hammer would cause damage - instead, the porch was tied into the main building using stainless steel ties. Some repointing was done inside and outside the porch, as well as on the south gable [2/672, 2/675-2/677]. Finally, a new metal screen was fitted to the internal doorway of the building [2/679].

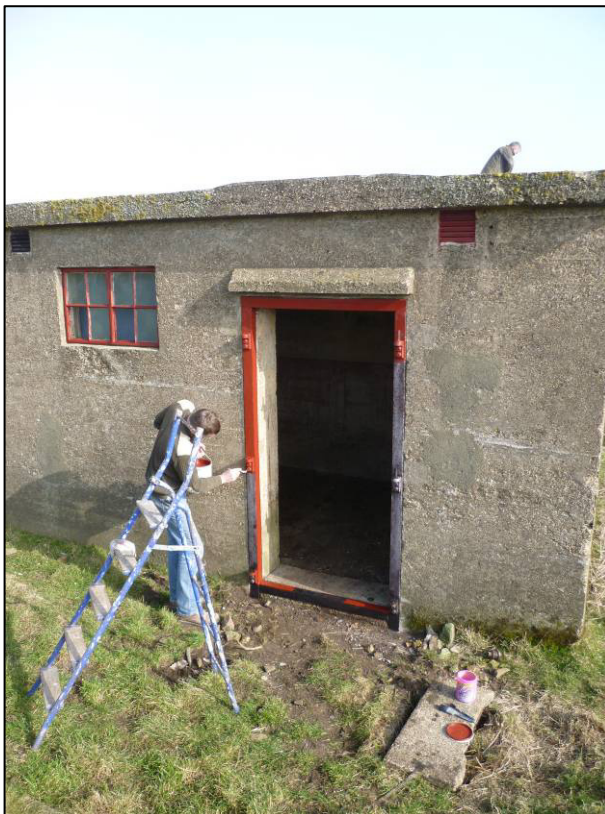
Plate 9: Work in progress to doorway D2 of Building R4, looking N (photo 1/908).

- 5.12 The main works to this building involved the two external steel sheet blast doors, in the north and west elevations (D1 and D2 respectively) which were in a poor condition. In each case, the surviving leafs and frames were sanded down, the rusting sections repaired using new steel sheets and flush welded joints, repainted with appropriate red-oxide primer, undercoat and topcoat, and then rehung [1/908, 1/916] (see plate 9); the 'new' doors are a significant improvement [2/680, 2/681, 2/688, 2/693] (see plate 10). On door D1, where only one of the two leafs remained, a new metal screen was inserted [2/689, 2/692] (see plate 14).

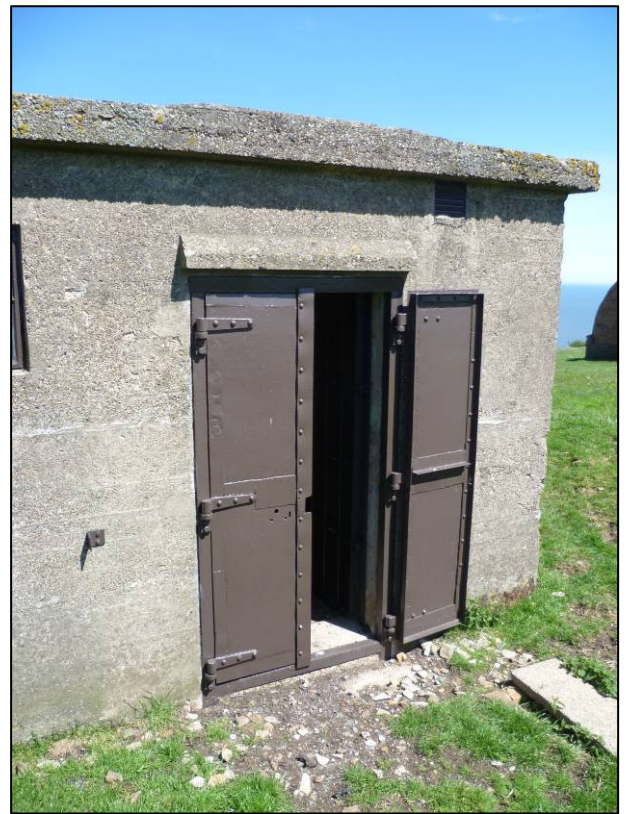
Plate 10: Repairs complete to door D2 in Building R4, looking E (photo 2/693).

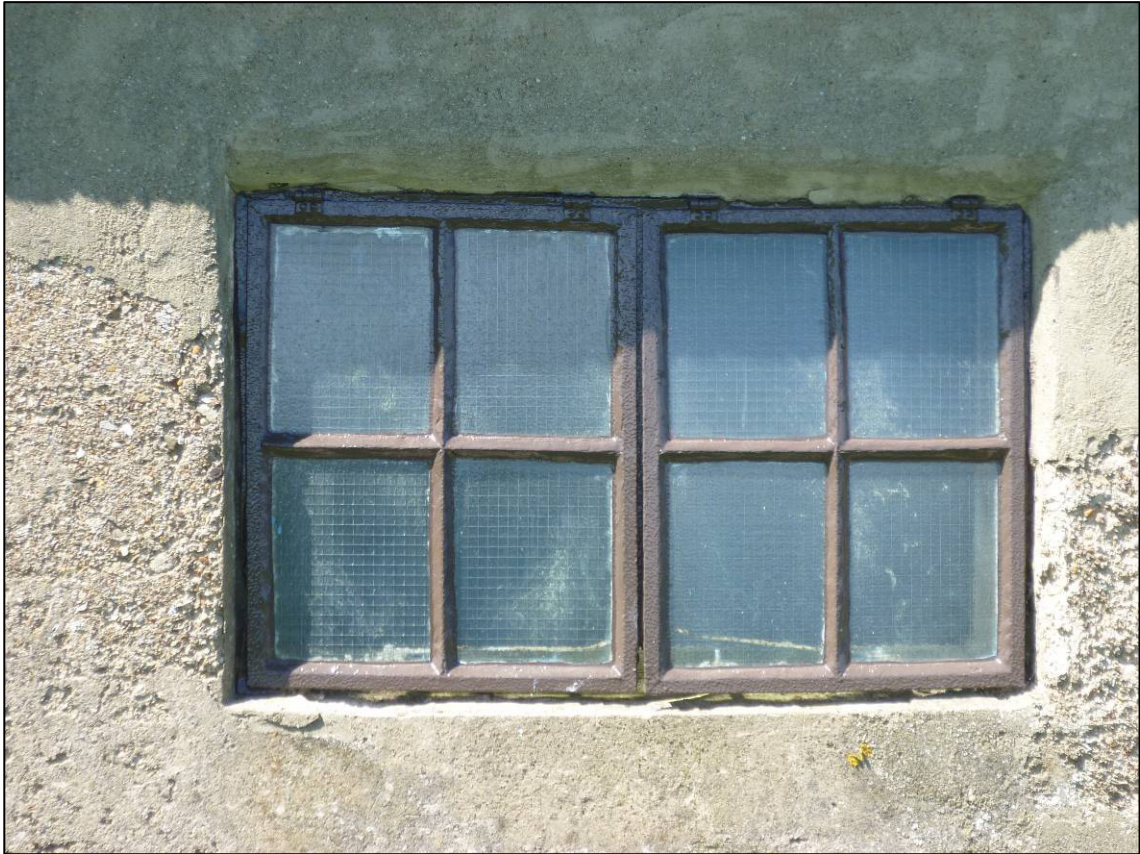
Plate 11: Repairs complete to window W1 in Building R4, looking NW (photo 2/683).

- 5.13 Elsewhere on the building, the metal frames to windows W1, W2, W4 and W8 were sanded, treated and repainted, and Georgian 5mm wire glass replaced [1/914, 1/915; 2/683] (see plates 11 and 12). In windows W3, W5, W6 and W7, the previous plyboard blocking was replaced with a 5mm thick steel plate, and repainted to match the other window frames [1/909; 2/686, 2/691]. The various grilles over the wall vents were also treated with a rust inhibitor and repainted to match the window frames. Some cracks and fractures in the more modern render were also repaired, and some small areas were re-rendered, for example around window W2 and under window W8. On the roof, the exposed metalwork and bolts of the radar fixings were treated, and the ceramic cable vent was capped to prevent rainwater entry. Several eroded/spalled areas of the concrete roof were also re-rendered [1/910, 1/911; 2/694-2/696, 2/699] (see plate 13), and the eroded roof edges were repaired [2/684, 2/703]. Internally, the wooden frames to the vents and shutters to windows W3, W4 and W7 were treated, and the exposed hinges were rubbed down, treated with a rust inhibitor and repainted. The eroded concrete cable duct adjacent to door D2 and window W8 was also repaired. Once repairs were complete, the building had a much improved appearance [2/682, 2/685, 2/687, 2/690, 2/704] (see plates 14 and 15).

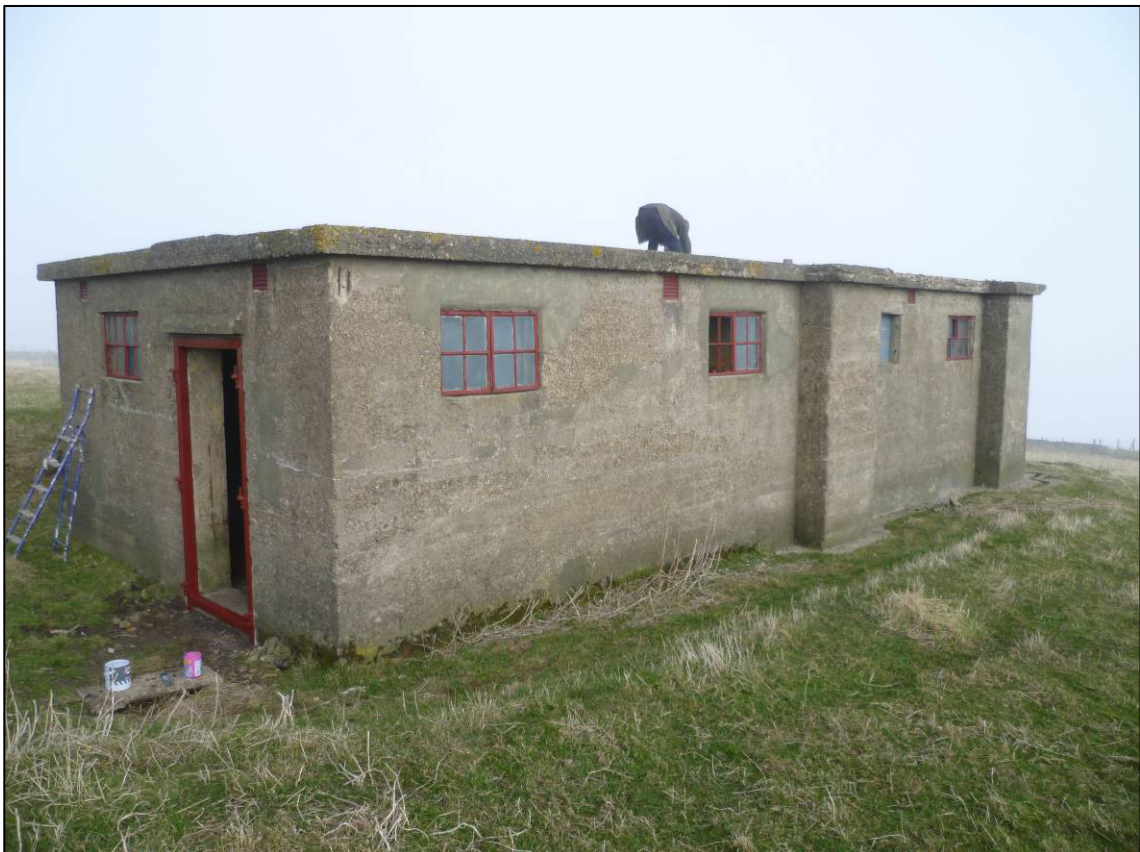
Plate 12: Repairs in progress to Building R4, looking N (photo 1/914).

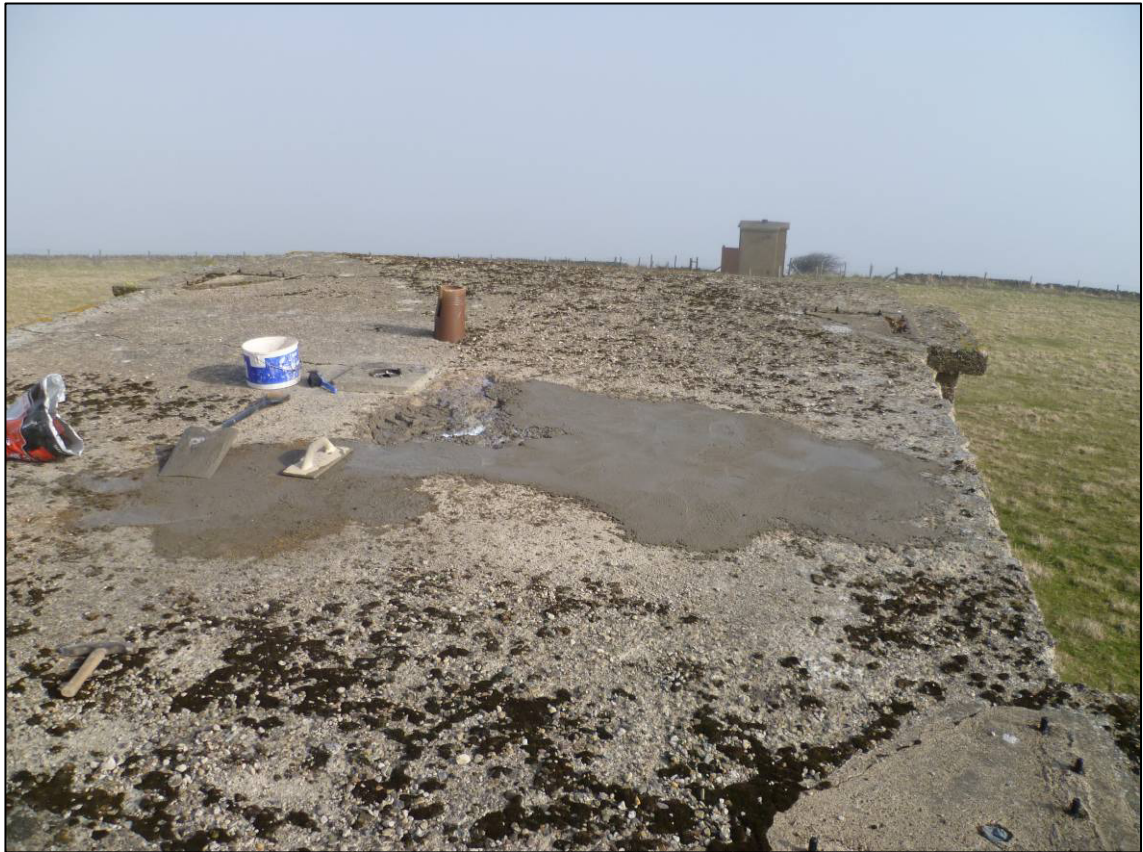
Plate 13: Repairs in progress to roof of Building R4, looking NE (photo 1/911).

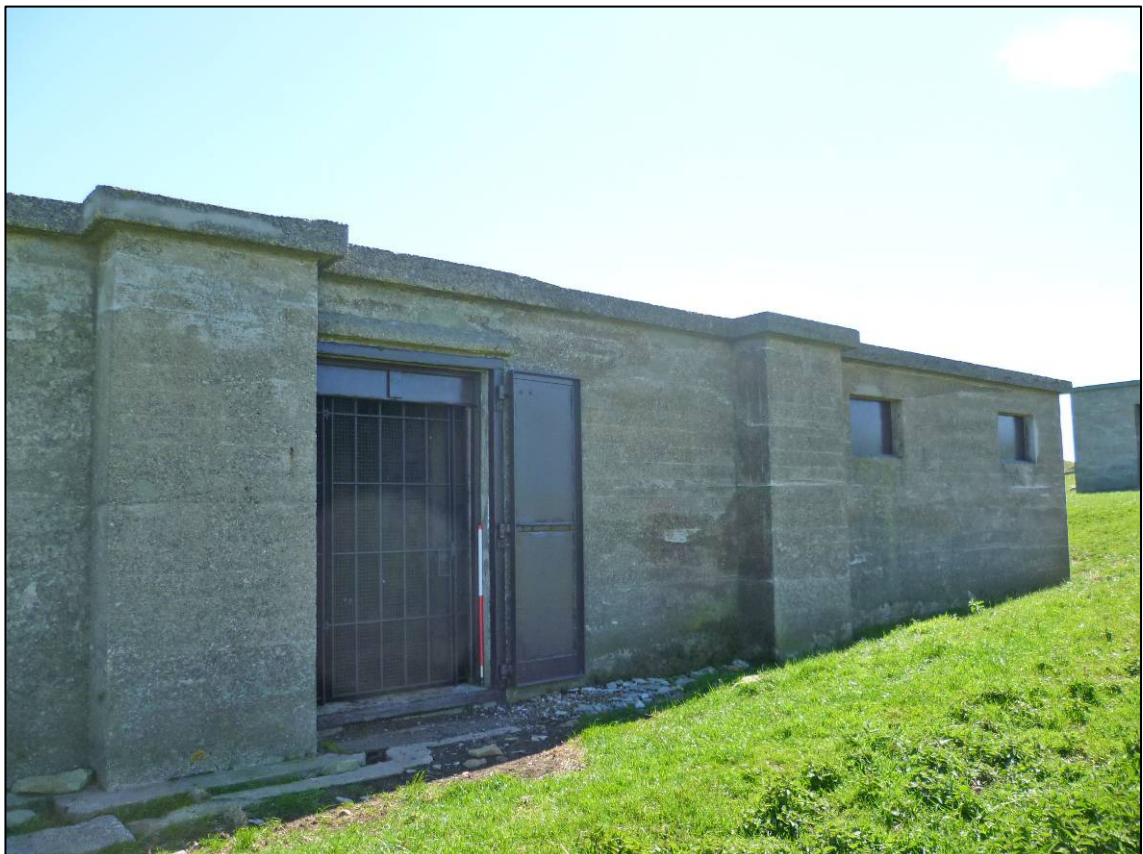
Plate 14: Repairs complete to N side of Building R4, looking SW (photo 2/687).

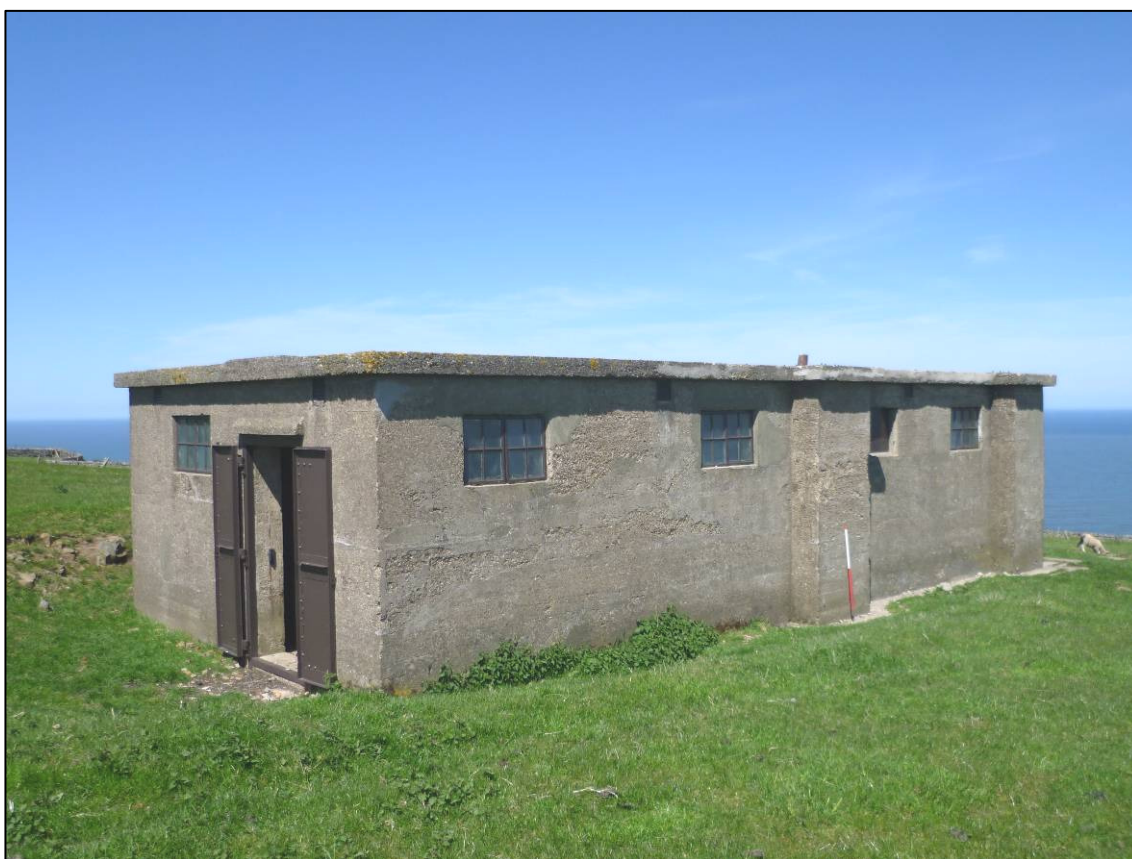
Plate 15: Repairs complete to Building R4, looking N (photo 2/682).
