REPAIRS TO DAM RETAINING WALL,
MOUSEHOLE FORGE, MALIN BRIDGE,
SHEFFIELD

ARCHAEOLOGICAL OBSERVATION,
INVESTIGATION AND RECORDING

Report no: 2014/488.R01
Version: Final
Date: February 2015
Author: Ed Dennison

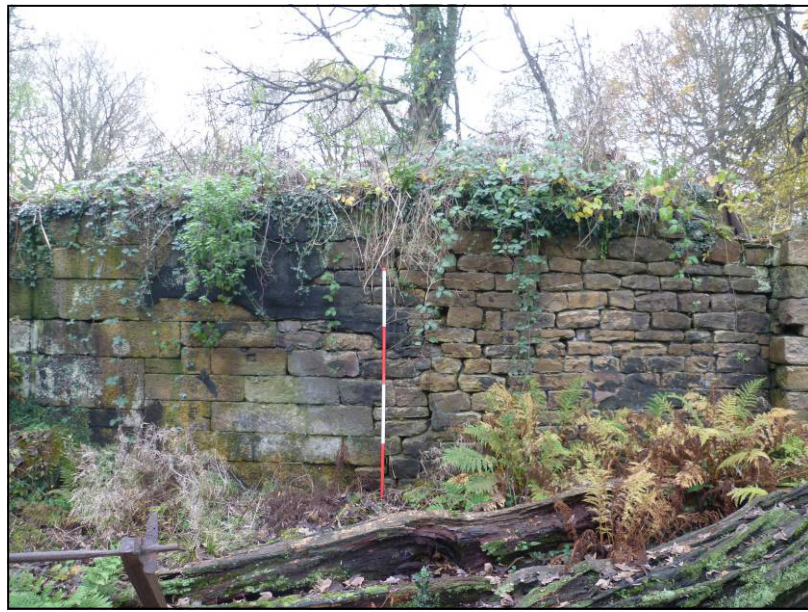
- 5.2 Area 1 lay towards the north-west end of the dam wall, behind the remains of the west hammer (see figure 3), where there was a significant fracture in the mortar joints and some outward displacement/bulging, most likely as a result of root damage from mature trees growing on top of the wall; the fracture occurred at the junction of coursed rubble to the left (west) and larger ashlar masonry to the east in the 2.80m high wall [1/373-1/378]. The 2014 archaeological appraisal considered that the ashlar stonework represented the original dam wall construction, while the smaller coursed stonework was probably a rebuild (Dawson 2014, 13). As previously noted, the trees on top of the dam had been cut down in an earlier operation. The pointing was to be raked out along this section of wall, as well as either side of the large fracture, and 6mm HeliFix HeliBars were to be inserted and grouted into the horizontal bedding joints. The remainder of this section of wall was then required to be repointed.

Plate 1: Area 1 dam wall prior to repair, looking S (photo 1/373).

- 5.3 Plates 1 to 3 depict the section of dam wall prior to the start of work, while plates 4 and 5 show work in progress with some of the overhanging vegetation cut back and the defective mortar in the joints between the coursed rubble having been raked out [2/411-2/412]. Some of the ashlar on the left side of the vertical fracture was covered with a tar-like substance, but this was not required to be removed as

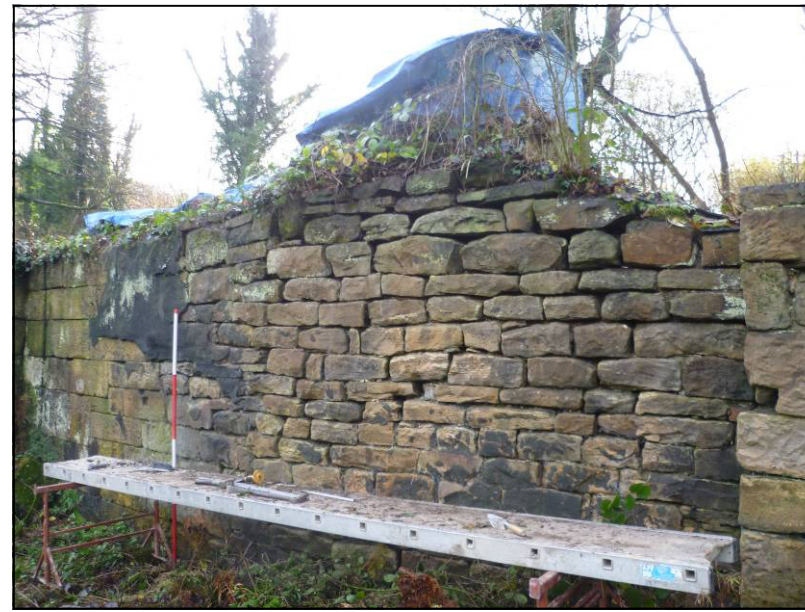
Plate 4: Area 1 dam wall, work in progress, looking SE (photo 2/412).

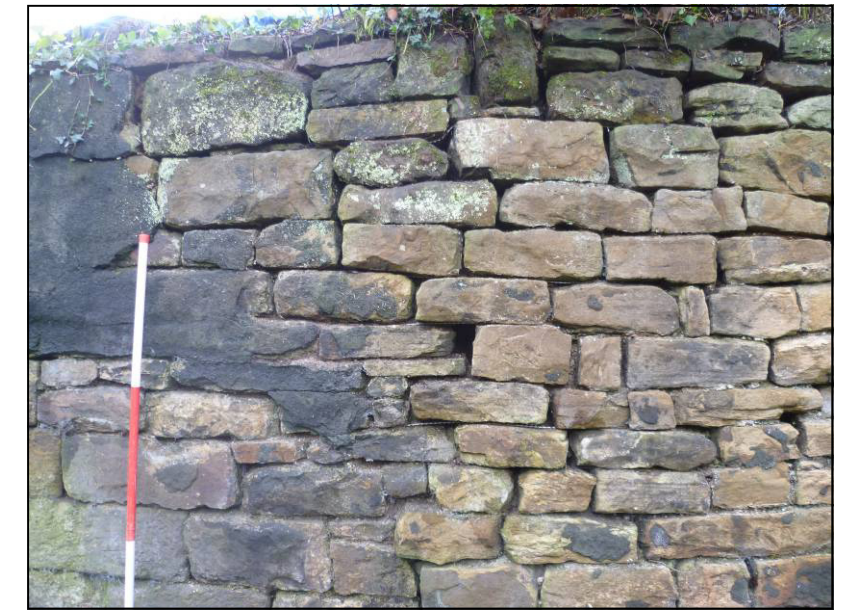
Plate 5: Area 1 dam wall, detail of vertical fracture, looking S (photo 2/413).

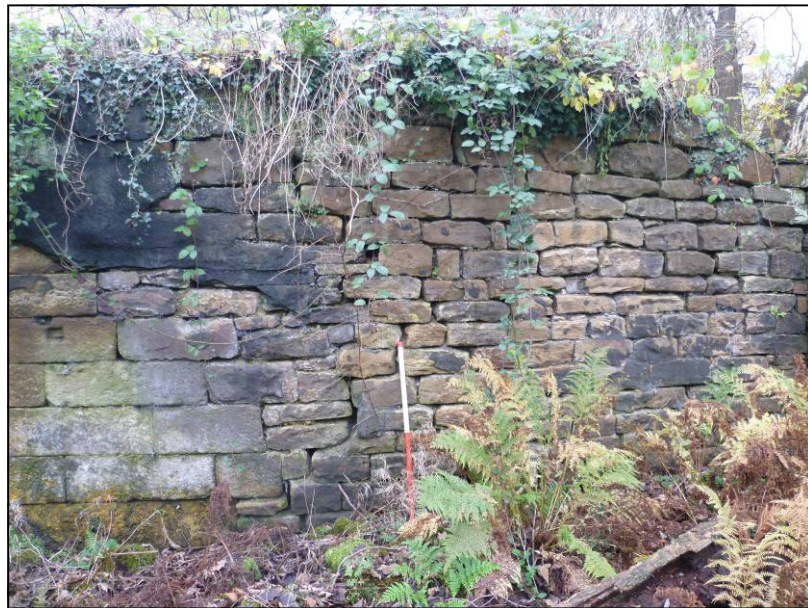
Plate 2: Area 1 dam wall prior to repair, showing vertical fracture, looking S (photo 1/377).

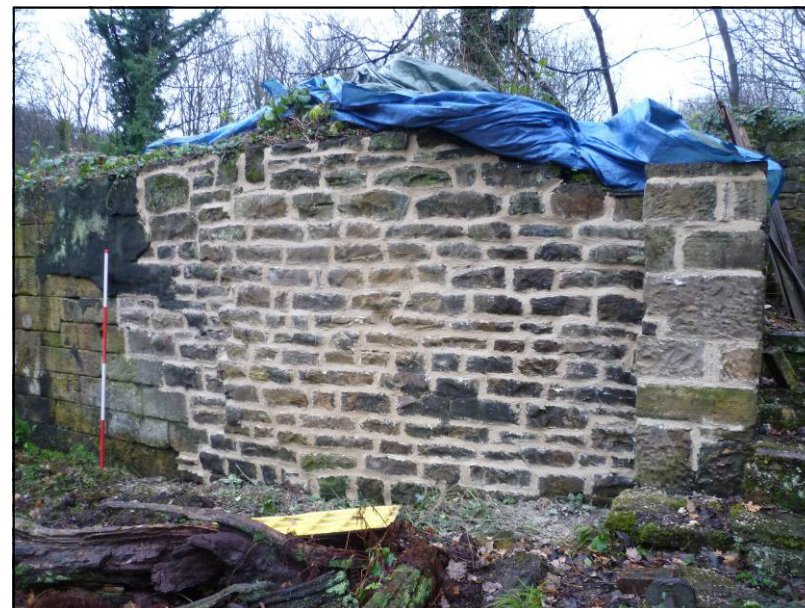
Plate 7: Area 1 dam wall immediately after repointing, looking SE (photo 3/508).

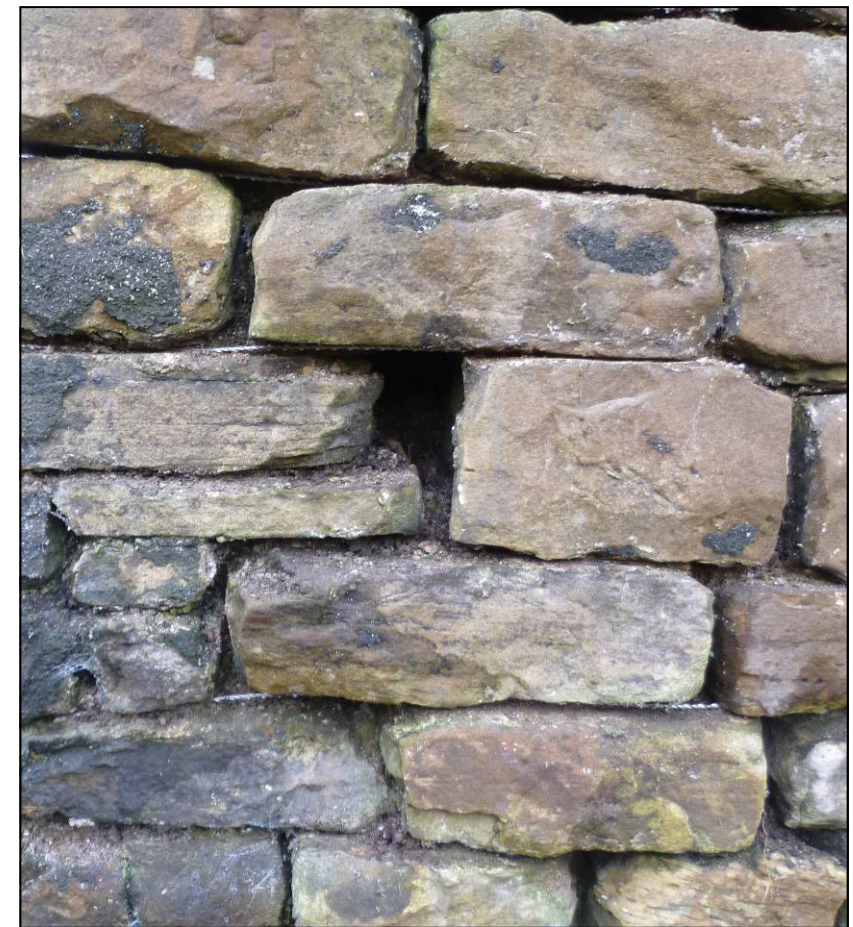
Plate 6: Area 1 dam wall, detail of embedded tie bars, looking S (photo 2/414).

part of the repair work. A total of ten 1.00m long HeliBars were inserted across the fracture along various bedding joints [2/413-2/415] which were then grouted/mortared in (see plate 6). The repointing work covered an area measuring c.5.0m wide, extending to and including a buttress at the west end of this section of dam wall (see plate 7) [3/506-3/509]. In accordance with the English Heritage specification, the new mortar was flush with the surrounding wall face, was tamped and brushed to create an appropriate finish, and protected from frost once in place [3/513]. Plate 8 depicts the repointing two months after completion [4/681-4/685, 4/688-4/689]. Nothing of archaeological importance was disturbed during the repair/consolidation work.

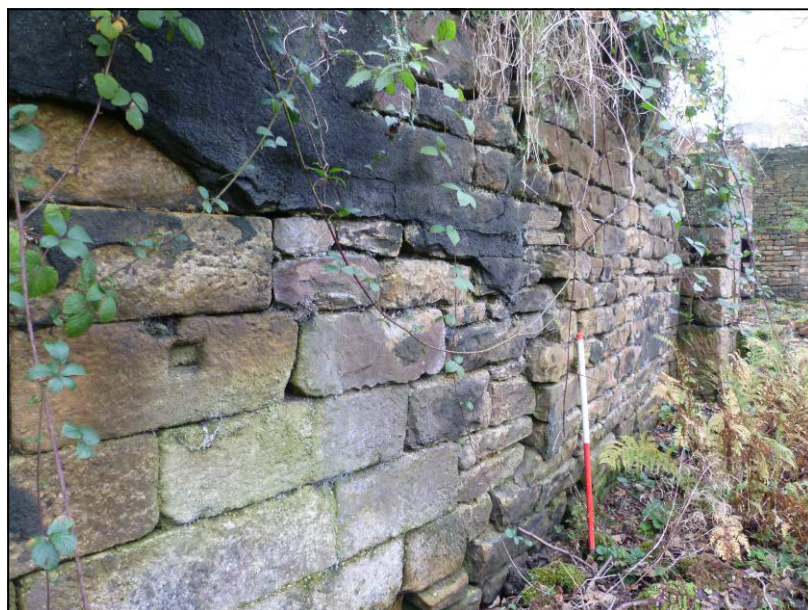
Plate 3: Area 1 dam wall prior to repair, showing displacement at fracture, looking W (photo 1/375).

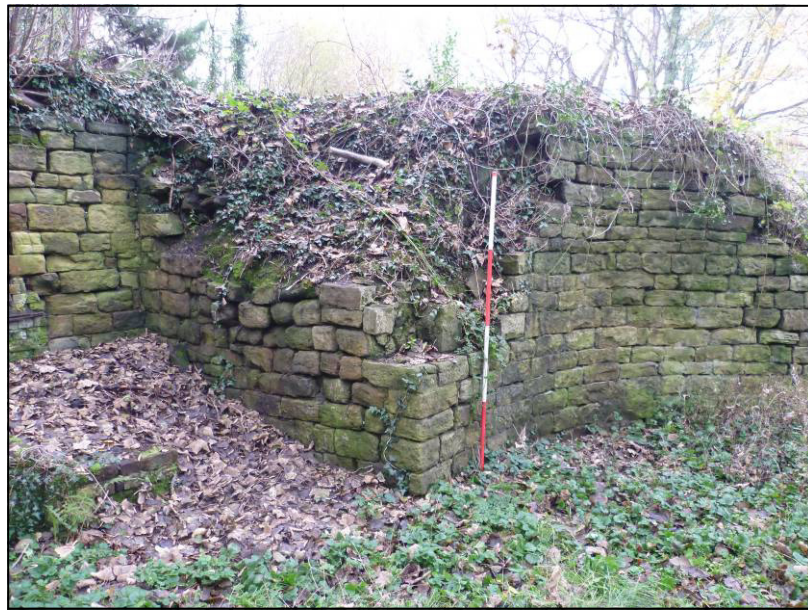
- 5.5 Prior to repair, the adjacent sections of the dam wall measured 2.60m high while the right-angled corner was only 0.85m high (five courses); the right-angled section projected 2.10m out (north) from the main dam wall, and then returned to the west for 1.0m before curving round to the north-west (see plate 9) [1/379-1/380, 1/382-1/383, 1/389]. The right-angled wall was well constructed with some stones acting as quoins at the corner, presumably for stability (see plate 10) [1/381]. As required by the English Heritage specification, the overhanging vegetation and soil behind the wall was cut back by c.0.5m to allow the right-angled stonework to be rebuilt [2/416-2/424]. This did not reveal any evidence for stratigraphy in the dam structure, but the infill was formed from a loose dark brown/black silty clay with mortar flecks, and contained some loose rubble including fragments of broken brick. The covering vegetation was predominantly ivy with brambles, and there was considerable root penetration (see plate 11). The removal of the soil revealed that the face of the right-angled wall was 0.65m-0.70m wide, with a rubble core behind, and also suggested that the east side of the wall butted up to the face of the main east-west aligned dam wall, although considerably more excavation would have been required to confirm this [2/427-2/428]. The loose mortar in the wall faces requiring repointing was then raked out, in accordance with the English Heritage specification. Loose stones from the wall top and infill were collected for later rebuilding [2/425-2/426], although additional stone needed to be sourced from a heap at the east end of the dam wall.

Plate 9: Area 2 dam wall prior to repair, looking SW (photo 1/379).

- 5.6 The right-angled wall was rebuilt using the sourced stone to match the height and coursing of the main dam wall, with a number of larger stones acting as quoins or capping (see plates 12 and 13). Ten 1.00m long HeliBars were also inserted along various horizontal bedding joints to tie the new build into the existing, and these were grouted/mortared in. The soil was then reinstated behind the new build,

using additional soil from the base of the wall as necessary. The subsequent repointing work covered all of the right-angled wall, and extended to all of the curving section to the west, although existing sound mortar was retained (see plate 14) [3/499-3/501, 3/504-3/505]. Again, in accordance with the English Heritage specification, the new mortar was finished flush with the surrounding wall face, was tamped and brushed, and protected from frost once in place [3/514-3/515]. Plates 15 and 16 depict the repointing two months after completion [4/672-4/673, 4/675, 4/677-4/680, 4/690]. Apart from the features noted above, nothing of archaeological importance was disturbed during the repair/consolidation work.

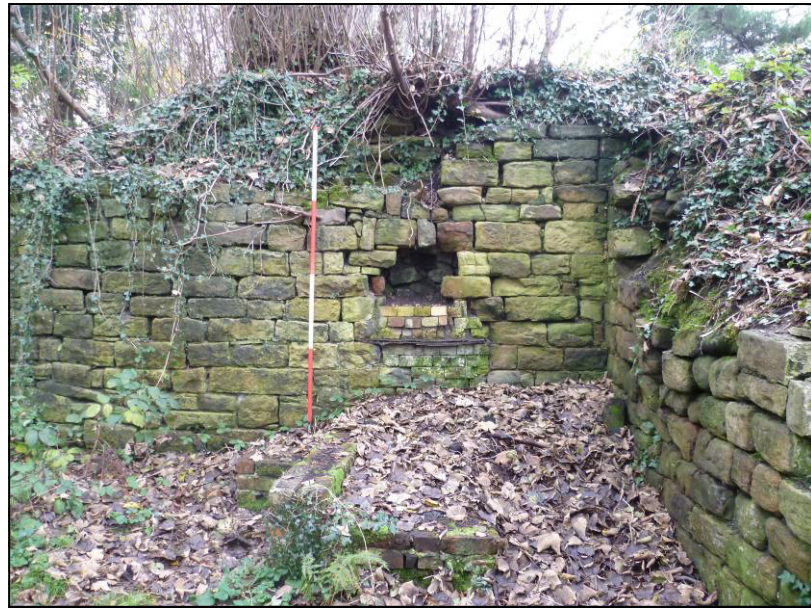
- 5.7 This area lies immediately to the east of Area 2, and represents a small coursed rubble section of the dam wall containing various voids and stepped cracking. All the debris and loose masonry was to be removed and the joints raked out, and any missing stones were to be reinstated and re-bedded using stone salvaged from the vicinity. Some 6mm HeliFix HeliBars were to be inserted where appropriate and the area repointed.

Plate 17: Area 3 dam wall prior to repair, looking S (photo 1/386).

- 5.9 The loose mortar in the wall face surrounding the opening was raked out, in accordance with the English Heritage specification, the hole was infilled with end-on bricks and small stones, and the whole area repointed. It is not known whether any HeliBars were used. The whole of the wall face around the opening was repointed, as far as the right-angled wall to the west (see plate 20) [3/502-3/503]. The new mortar was flush with the surrounding wall face, was tamped and brushed to create an appropriate finish (see plate 21) [4/676], and protected from frost once in place. Plate 22 depicts the repointing two months after completion [4/672, 4/674]. Nothing of archaeological importance was disturbed or uncovered during the repair/consolidation work, although in retrospect perhaps the void above the brick-blocked opening should perhaps have been filled with coursed rubble rather than brick, and the right-hand vertical joint below the horizontal ironwork left unmortared to maintain the visual impression of the blocked opening.

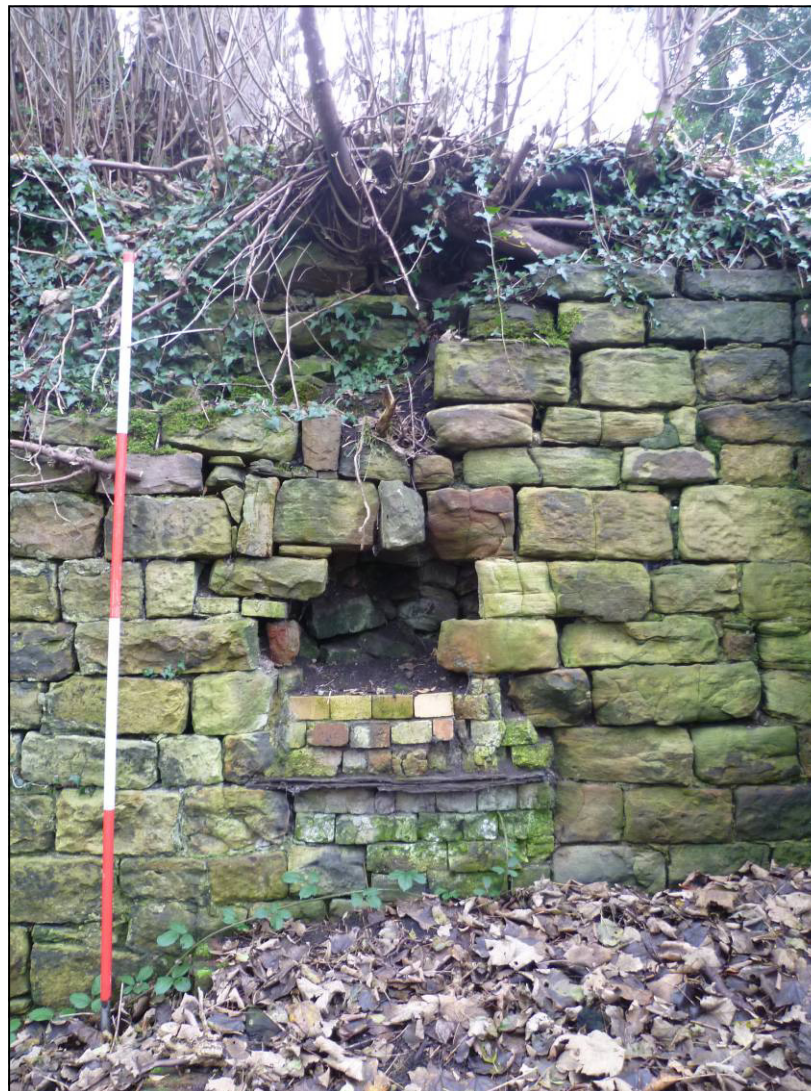
- 5.8 This section of coursed rubble wall contains an opening half way up its 2.60m height, the base of which is partially filled with brick above and below a piece of horizontal ironwork; there are straight joints in the wall below the ironwork [1/384-1/388], suggesting an opening 0.75m wide. The brickwork appears to be blocking this opening, with the stone above having fallen out to create a void - the void measured 0.60m wide by 0.42m high (see plate 18). The function of this opening is unclear, although it presumably relates to a small structure visible as a brick-defined platform to the front of the wall (see plates 16, 17 and 19) [4/673]; this platform was not specifically identified in the previous survey of the site, although it does lie within a general area labelled as 'anvil hearths' (see figure 3).

Plate 18: Area 3 dam wall prior to repair, looking S (photo 1/387).

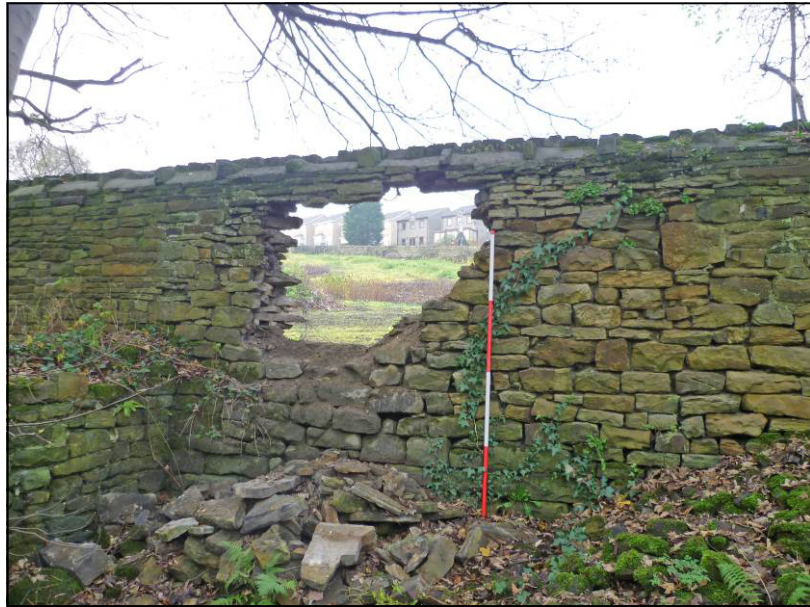
- 5.12 Since the production of the repair specification (see Appendix 2), more damage had occurred, so that the collapsed section of wall now measured 1.80m wide and 1.40m high internally (see plate 23) [1/363-1/365, 1/371]; the collapse also allowed the construction of the wall to be seen, with two skins separated by a rubble-filled core (see plate 24) [1/366-1/367]. As noted above, there are several areas of different build and mortar along this inside section of wall, suggesting several phases of repair or rebuild [1/369-1/370]. Suitable stone for the repair work was sourced from the collapse inside the wall (see plate 23) and an adjacent spoil heap, from the area which was previously determined to be a Phase 4 storage building (see figure 3) [1/368, 1/372].

Plate 23: Area 4 boundary wall (internal) prior to repair, looking W (photo 1/363).

- 5.13 Rebuilding and repointing was carried out in accordance with the English Heritage specification. Care was taken to ensure that the existing larger stones and coursing on the inside face of the wall, and the much more thinly bedded thinner stones on the outside, were matched. The new stonework was bedded in with new lime mortar, finished so as to be flush with the surrounding wall face, and it was tamped and brushed to create an appropriate finish (see plates 25 and 26) [3/495-3/498, 3/510-3/512], and protected from frost once in place. The repaired and repointed area measured 2.20m wide by 1.60m high internally, and 1.70m wide by 1.40m high externally. Plates 27 and 28 depict the repointing two months after completion [4/686-4/687, 4/691-4/692]. Apart from the minor structural information relating to the construction of the wall noted above, nothing of archaeological importance was disturbed during the repair/consolidation work.

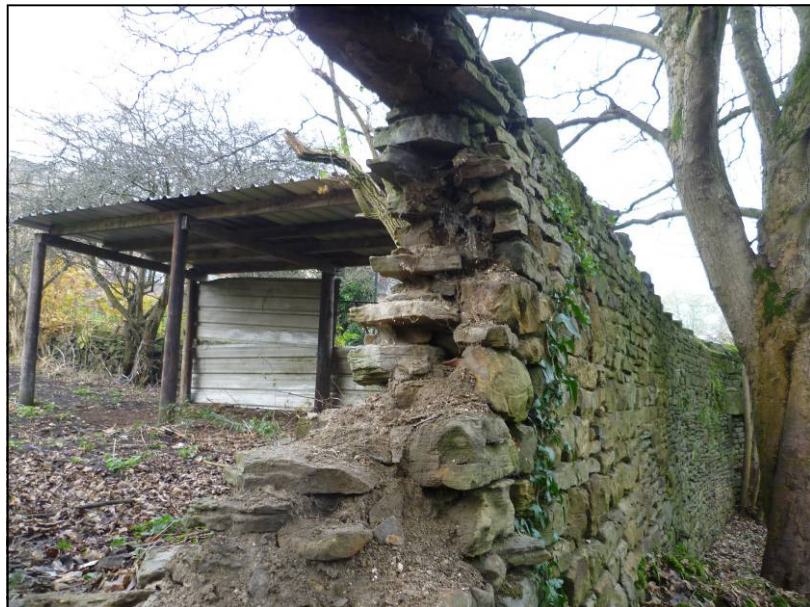
Plate 24: Area 4 boundary wall prior to repair, showing double skin and core, looking NW (photo 1/367).

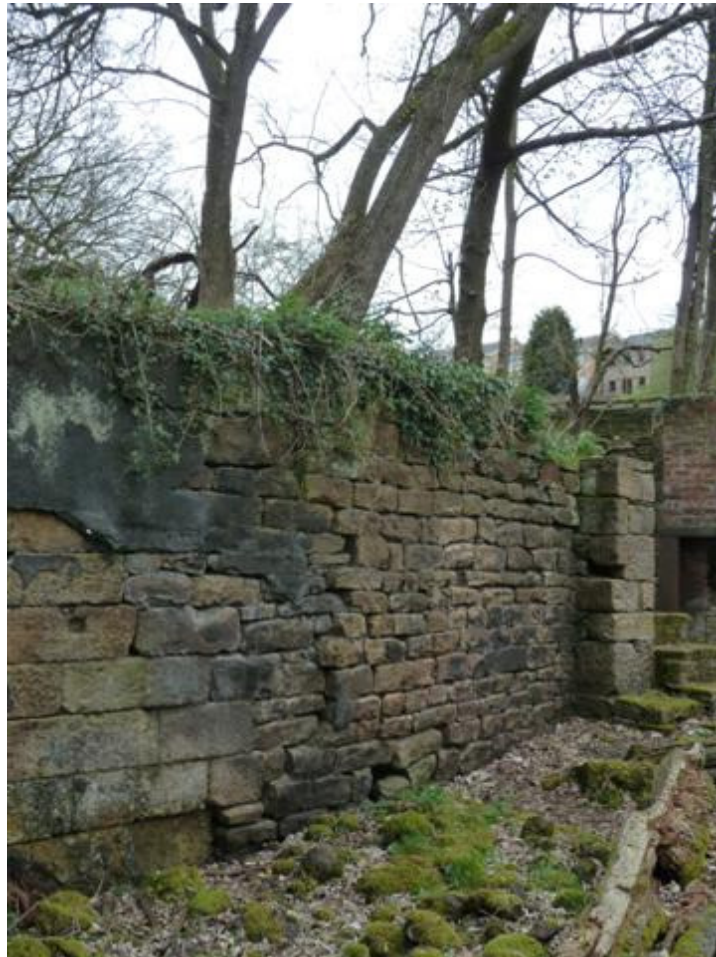
AREA I – junction of coursed rubble and ashlar where outward displacement of the rubble masonry has occurred. This area is to be re-pointed and strengthened with bed joint reinforcement where displacement has occurred

The masonry of Area I exhibits stepped cracking through its mortar joints and outward displacement, most likely as a result of tree root damage from the mature trees growing atop the retaining wall in close proximity to the structure. The trees are to be felled and poisoned to prevent regeneration (specified elsewhere). The wall is not felt to be structurally compromised to such a degree that rebuilding is required and the felling of the trees will remove some of the outward pressure on the structure, however, the wall is bowing outwards and it would be prudent to tie across the fracture to reduce the likelihood of further displacement. Prior to re-pointing the area of retaining wall identified as Area I:

3.1	Rake out slots to a depth of approximately 40mm at regular intervals in the horizontal mortar joints in the area of displacement. Exact locations will be determined by the coursing but generally at 450mm vertical centres and extending a minimum of 500mm to either side of the fracture.	
3.2	Remove all dust and mortar from the slots and thoroughly flush with clean water.	
3.3	Provide and install 6mm HeliFix HeliBars into the slots in full accordance with manufacturer's recommendations (appended).	
3.4	Allow grout to set and re-point as Section 2.0.

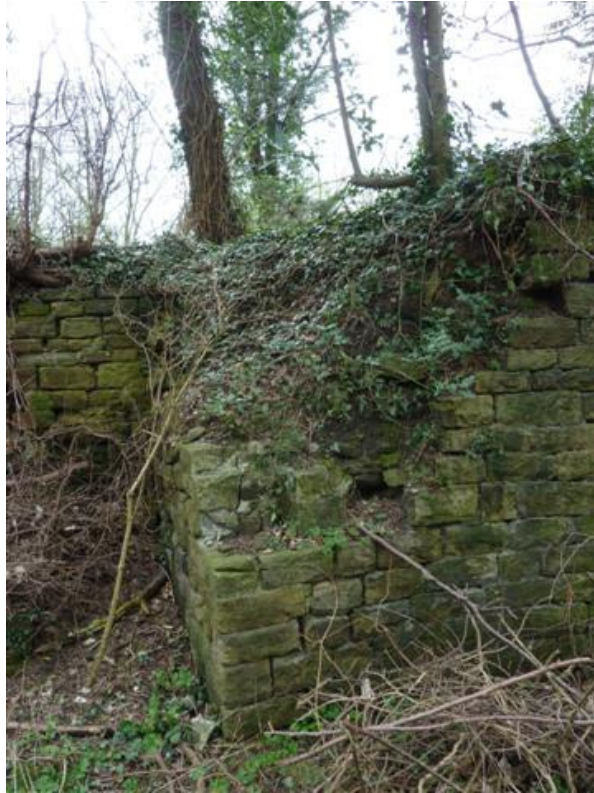
AREA 2 – coursed rubble wall section with collapsed corner. This corner is to be rebuilt to the height of adjacent wall sections, strengthened using helibars and re-pointed

4.1	Carefully remove any slipped soil to expose the top of the masonry retaining wall.	
4.2	Take off, clean and re-bed loose stones.	
4.3	Using salvaged stone that has been retained on site rebuild the collapsed sections of wall to the height of the adjacent wall sections. Ensure that the wall sections are tied together using masonry or, if a sufficient bond cannot be achieved, using suitable stainless steel wall ties.

4.4	Rake out slots to a depth of approximately 40mm in the existing low level masonry. These are to be at regular intervals in the horizontal mortar joints in the areas of stepped fractures (i.e. to either side of the external corner). Exact locations will be determined by the coursing but generally at approximately 450mm vertical centres and extending a minimum of 500mm to either side of the fractures. Note: where this would extend beyond the end of the wall the slot is to be formed so that it continues a minimum of 100mm around the corner.

4.5	Remove all dust and mortar from the slots and thoroughly flush with clean water.	
4.6	Provide and install 6mm HeliFix HeliBars into the slots in the existing masonry and continue to install HeliBars at approximately 450mm intervals up through the newly re-built masonry to the top of the wall, all in full accordance with manufacturer's recommendations (appended) and bending the HeliBars around the corner of the wall as required.

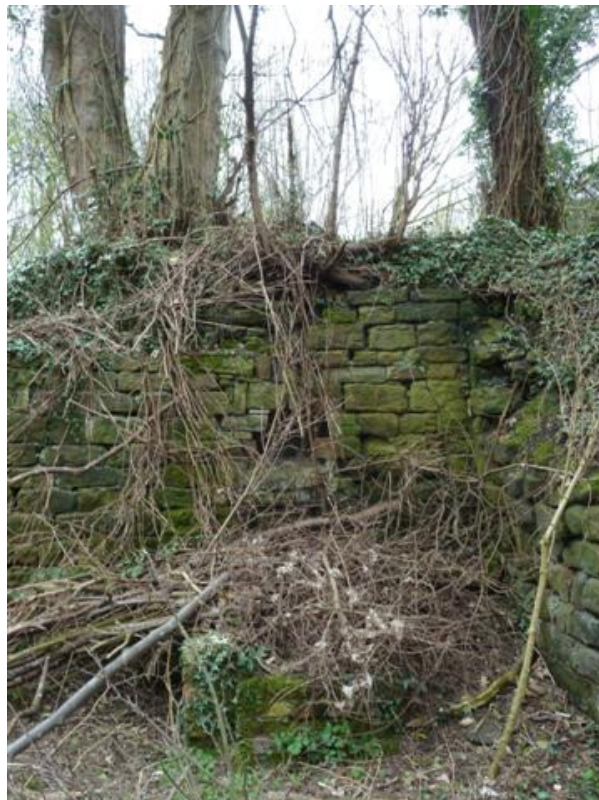
AREA 3 – coursed rubble section with voids and fractures, This section is to be re-pointed, cracks are to be repaired and missing stones are to be reinstated

There is a significant void in the masonry in this area and stepped cracking has occurred through the mortar joints. It is proposed to introduce bed joint reinforcement to the fractured area and to reinstate missing masonry. Prior to re-pointing the area of retaining wall identified as Area 3:

5.1	Remove all foliage and vegetation which is currently obscuring the wall.	
5.2	Remove all debris and loose materials from the voided area of masonry. Reinstate and re-bed missing stones, it is likely that salvaged stone that has been retained on site will be available in sufficient quantities.	
5.3	Rake out slots to a depth of approximately 40mm at regular intervals in the horizontal mortar joints where stepped cracking has occurred. Exact locations will be determined by the coursing but generally at 450mm vertical centres and extending a minimum of 500mm to either side of the fractures.	
5.4	Remove all dust and mortar from the slots and thoroughly flush with clean water.	
5.5	Provide and install 6mm HeliFix HeliBars into the slots in full accordance with manufacturer's recommendations (appended).

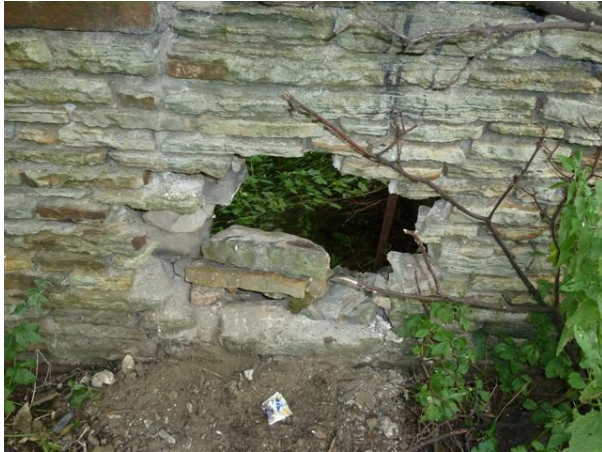
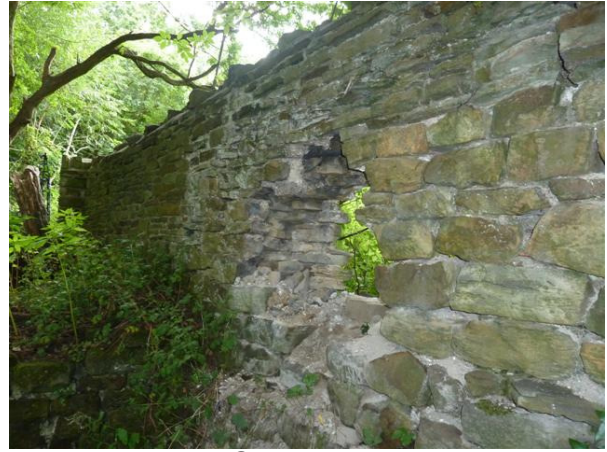
AREA 4 - section of perimeter wall which has been pushed in.
This section is to be repaired using displaced stones
which are believed to be stored on site

6.1	Remove all debris and loose masonry from the area of collapse. Note: it may be necessary to take down some of the adjacent standing masonry in order to successfully rebuild the wall section. Sort through the salvaged stone to identify facing masonry, core rubble, through stones etc, clean off and set aside for reuse.	
6.2	Carefully rebuild the collapsed wall section using the salvaged masonry available on site, construction is to match exactly the existing standing masonry adjacent to the area of collapse. Allow for bedding on lime mortar as required and pointing up joints as appropriate.	
6.3	On completion ensure that the wall is stable and structurally sound, plumb with, and tied into, the adjacent standing masonry with no voids or loose stones which are vulnerable to theft.
