GOTHIC SUMMERHOUSE, BRAMHAM PARK,  
BRAMHAM CUM OGLETHORPE, WEST YORKSHIRE

2003 PRE-INTERVENTION  
BUILDING RECORDING

Report no: 2003/190.R01  
Version: Final  
Date: April 2016  
Authors: Ed Dennison & Shaun Richardson

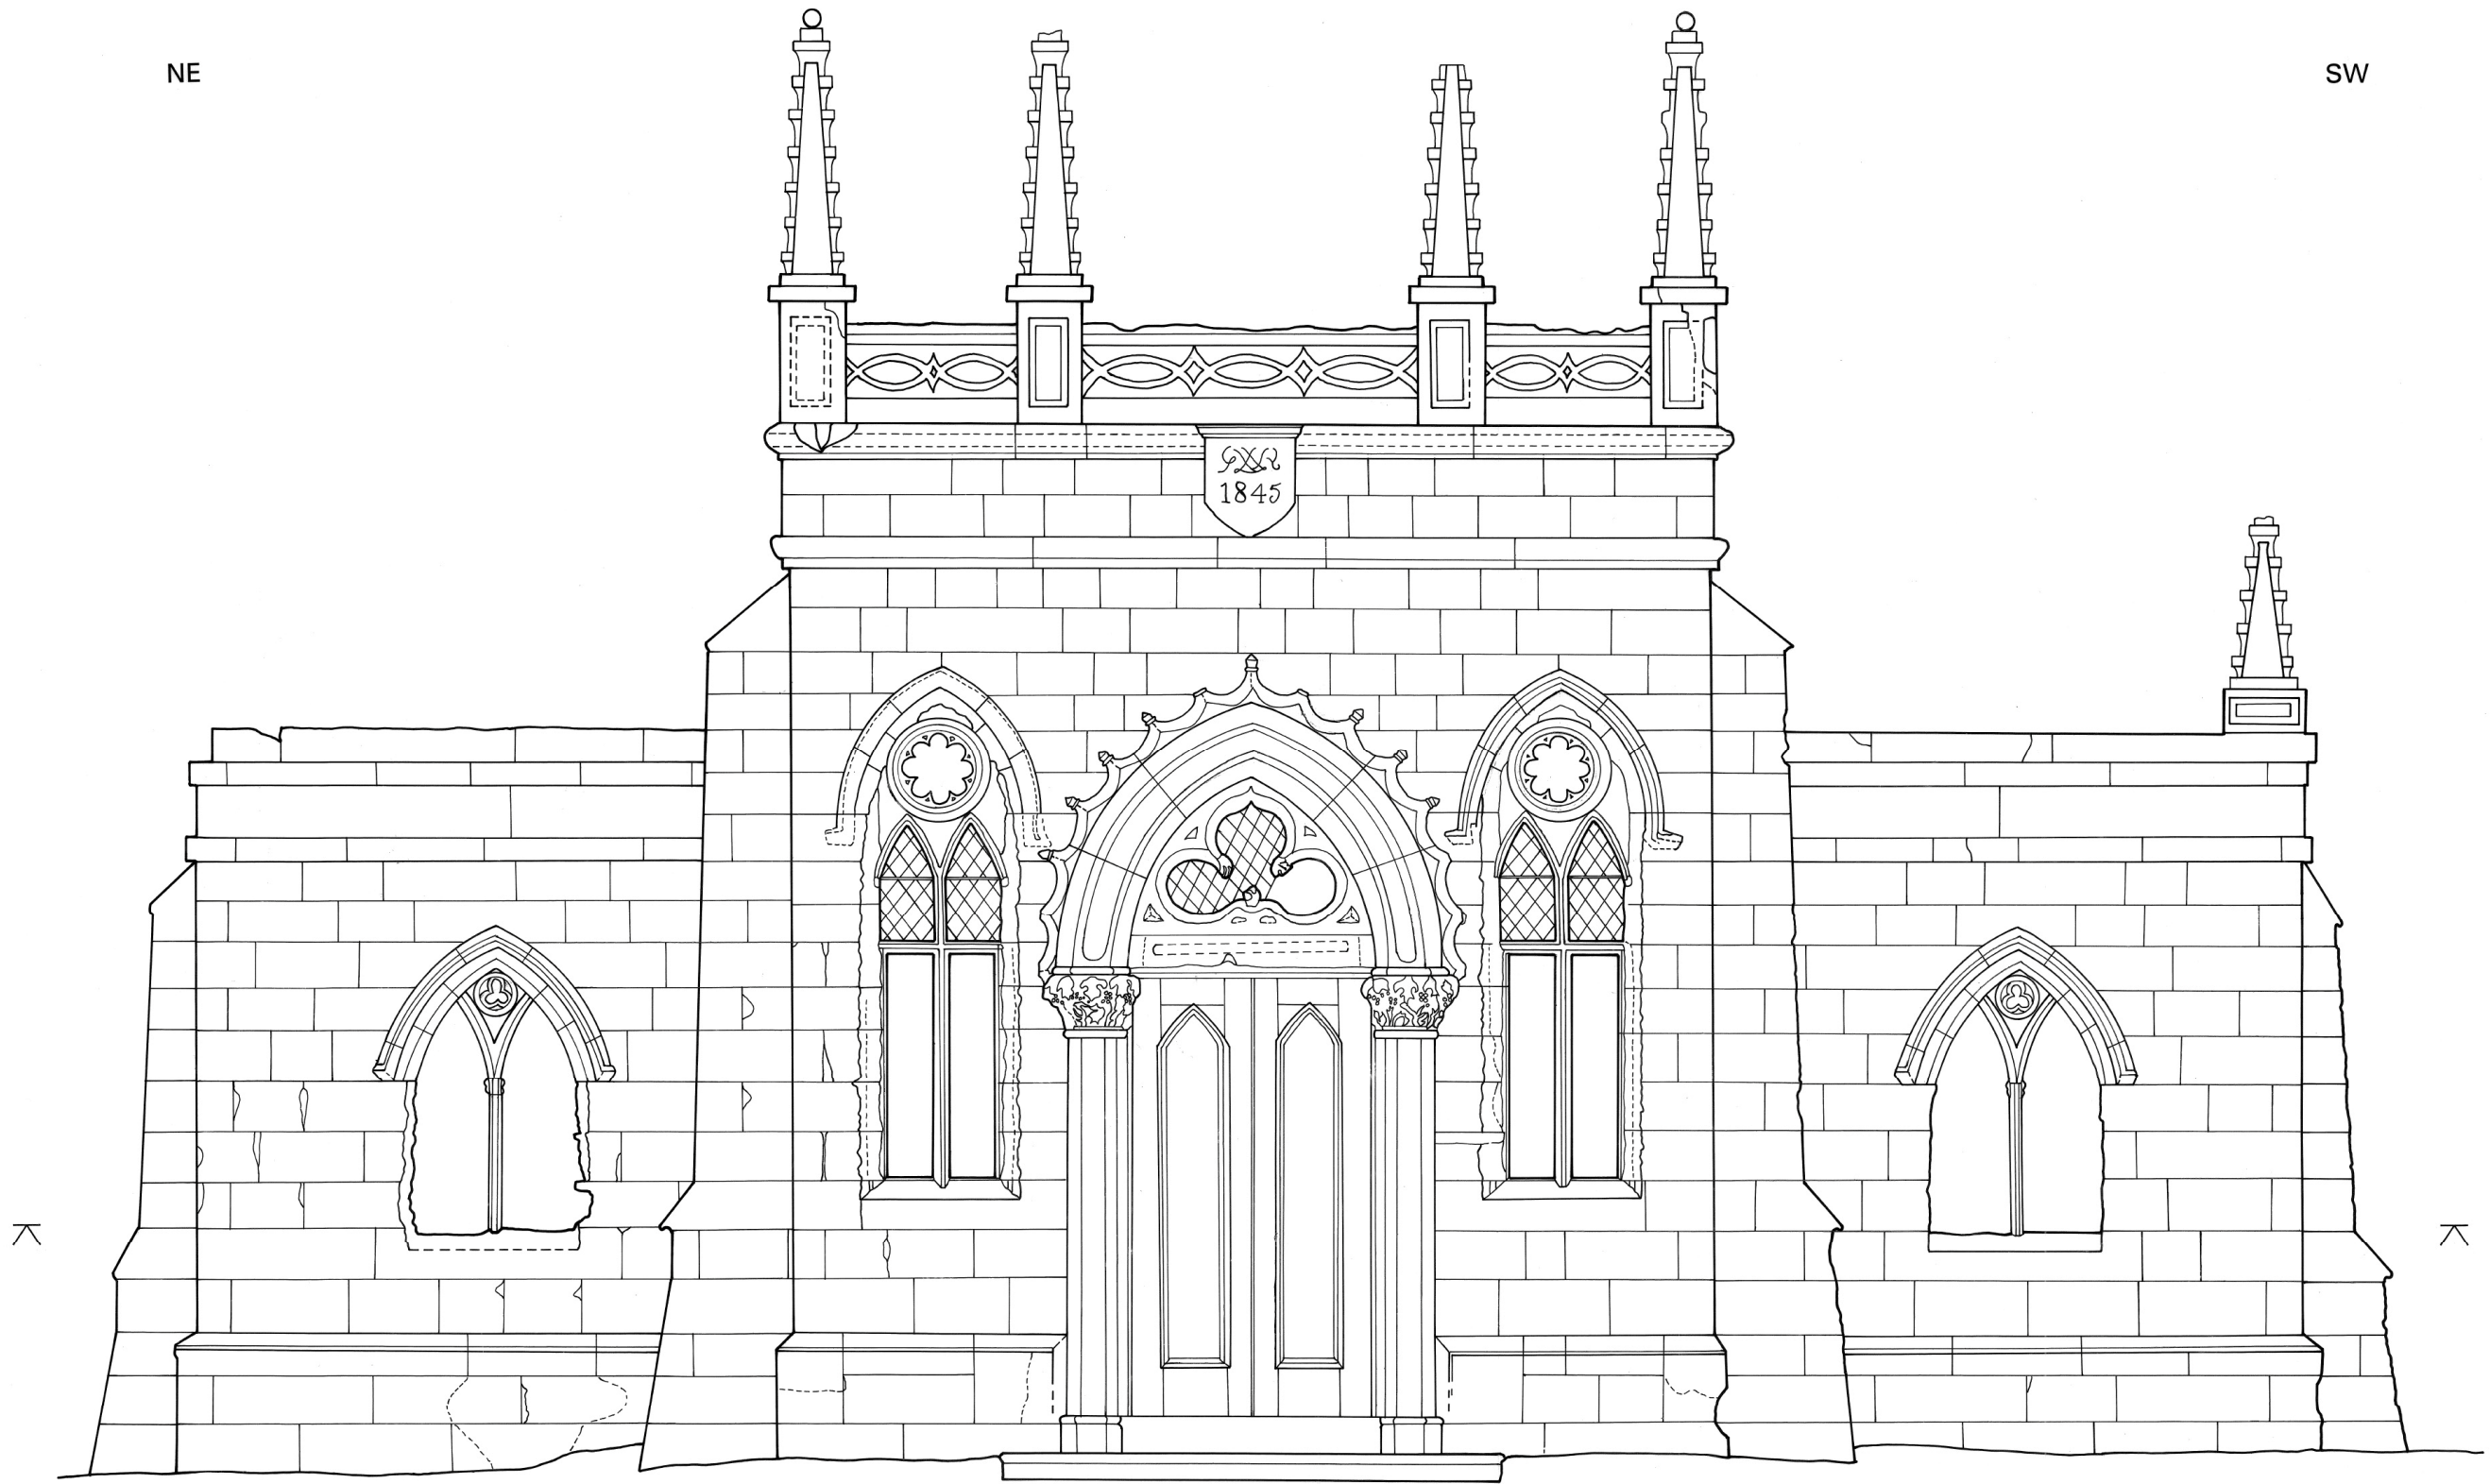
PROJECT		BRAMHAM PARK SUMMERHOUSE	
TITLE		NORTH ELEVATION	
SCALE	AS SHOWN	DATE	APR 2016
EDAS		FIGURE	7

- 3.10 The principal elevation of the summerhouse faces north-west and, like the rest of the exterior, is of symmetrical appearance [1/6; 4/05, 4/10], with the flanking wings recessed slightly from the centre [2/10, 2/12, 2/16, 2/17]. All three parts are buttressed and rise from a chamfered vermiculated plinth [2/7] (see plate 9); this plinth is interrupted by the buttresses. The taller central cell has shallow steps leading up to a tall two-centred arched central doorway, retaining the original pair of tall softwood doors at the time of the EDAS survey. This doorway is framed by engaged columns with shafts surmounted by foliate caps [3/8] (see plate 5). These support the moulded head, with its trefoil fanlight and cusped cresting; the fanlight retains some of its original leaded glazing. The central doorway is flanked by a tall two-centred arched window to either side, originally equipped with hoodmoulds terminating in chamfered stops, although the former are now badly eroded. At the time of the EDAS survey, the windows were infilled with boards

- 3.11 Above the doorway and windows, the central part of the north elevation rises to a moulded stringcourse, above which there is a plain frieze with a shield to the centre bearing the neatly incised date '1845' and what appear to be the initials 'GWR' or 'GLR' in rather florid scrip; given the date of the building, 'GLF' (for George Lane Fox) might be considered more likely. The frieze supports a parapet formed by four upright rectangular panelled bases, with a pattern reminiscent of late 18th century Chinoiserie or Gothick running between [1/16]. The panelled bases are surmounted by tall crocketed pinnacles. These were originally topped by a small stone ball but these only now survive to the outer pinnacles (see plate 7).

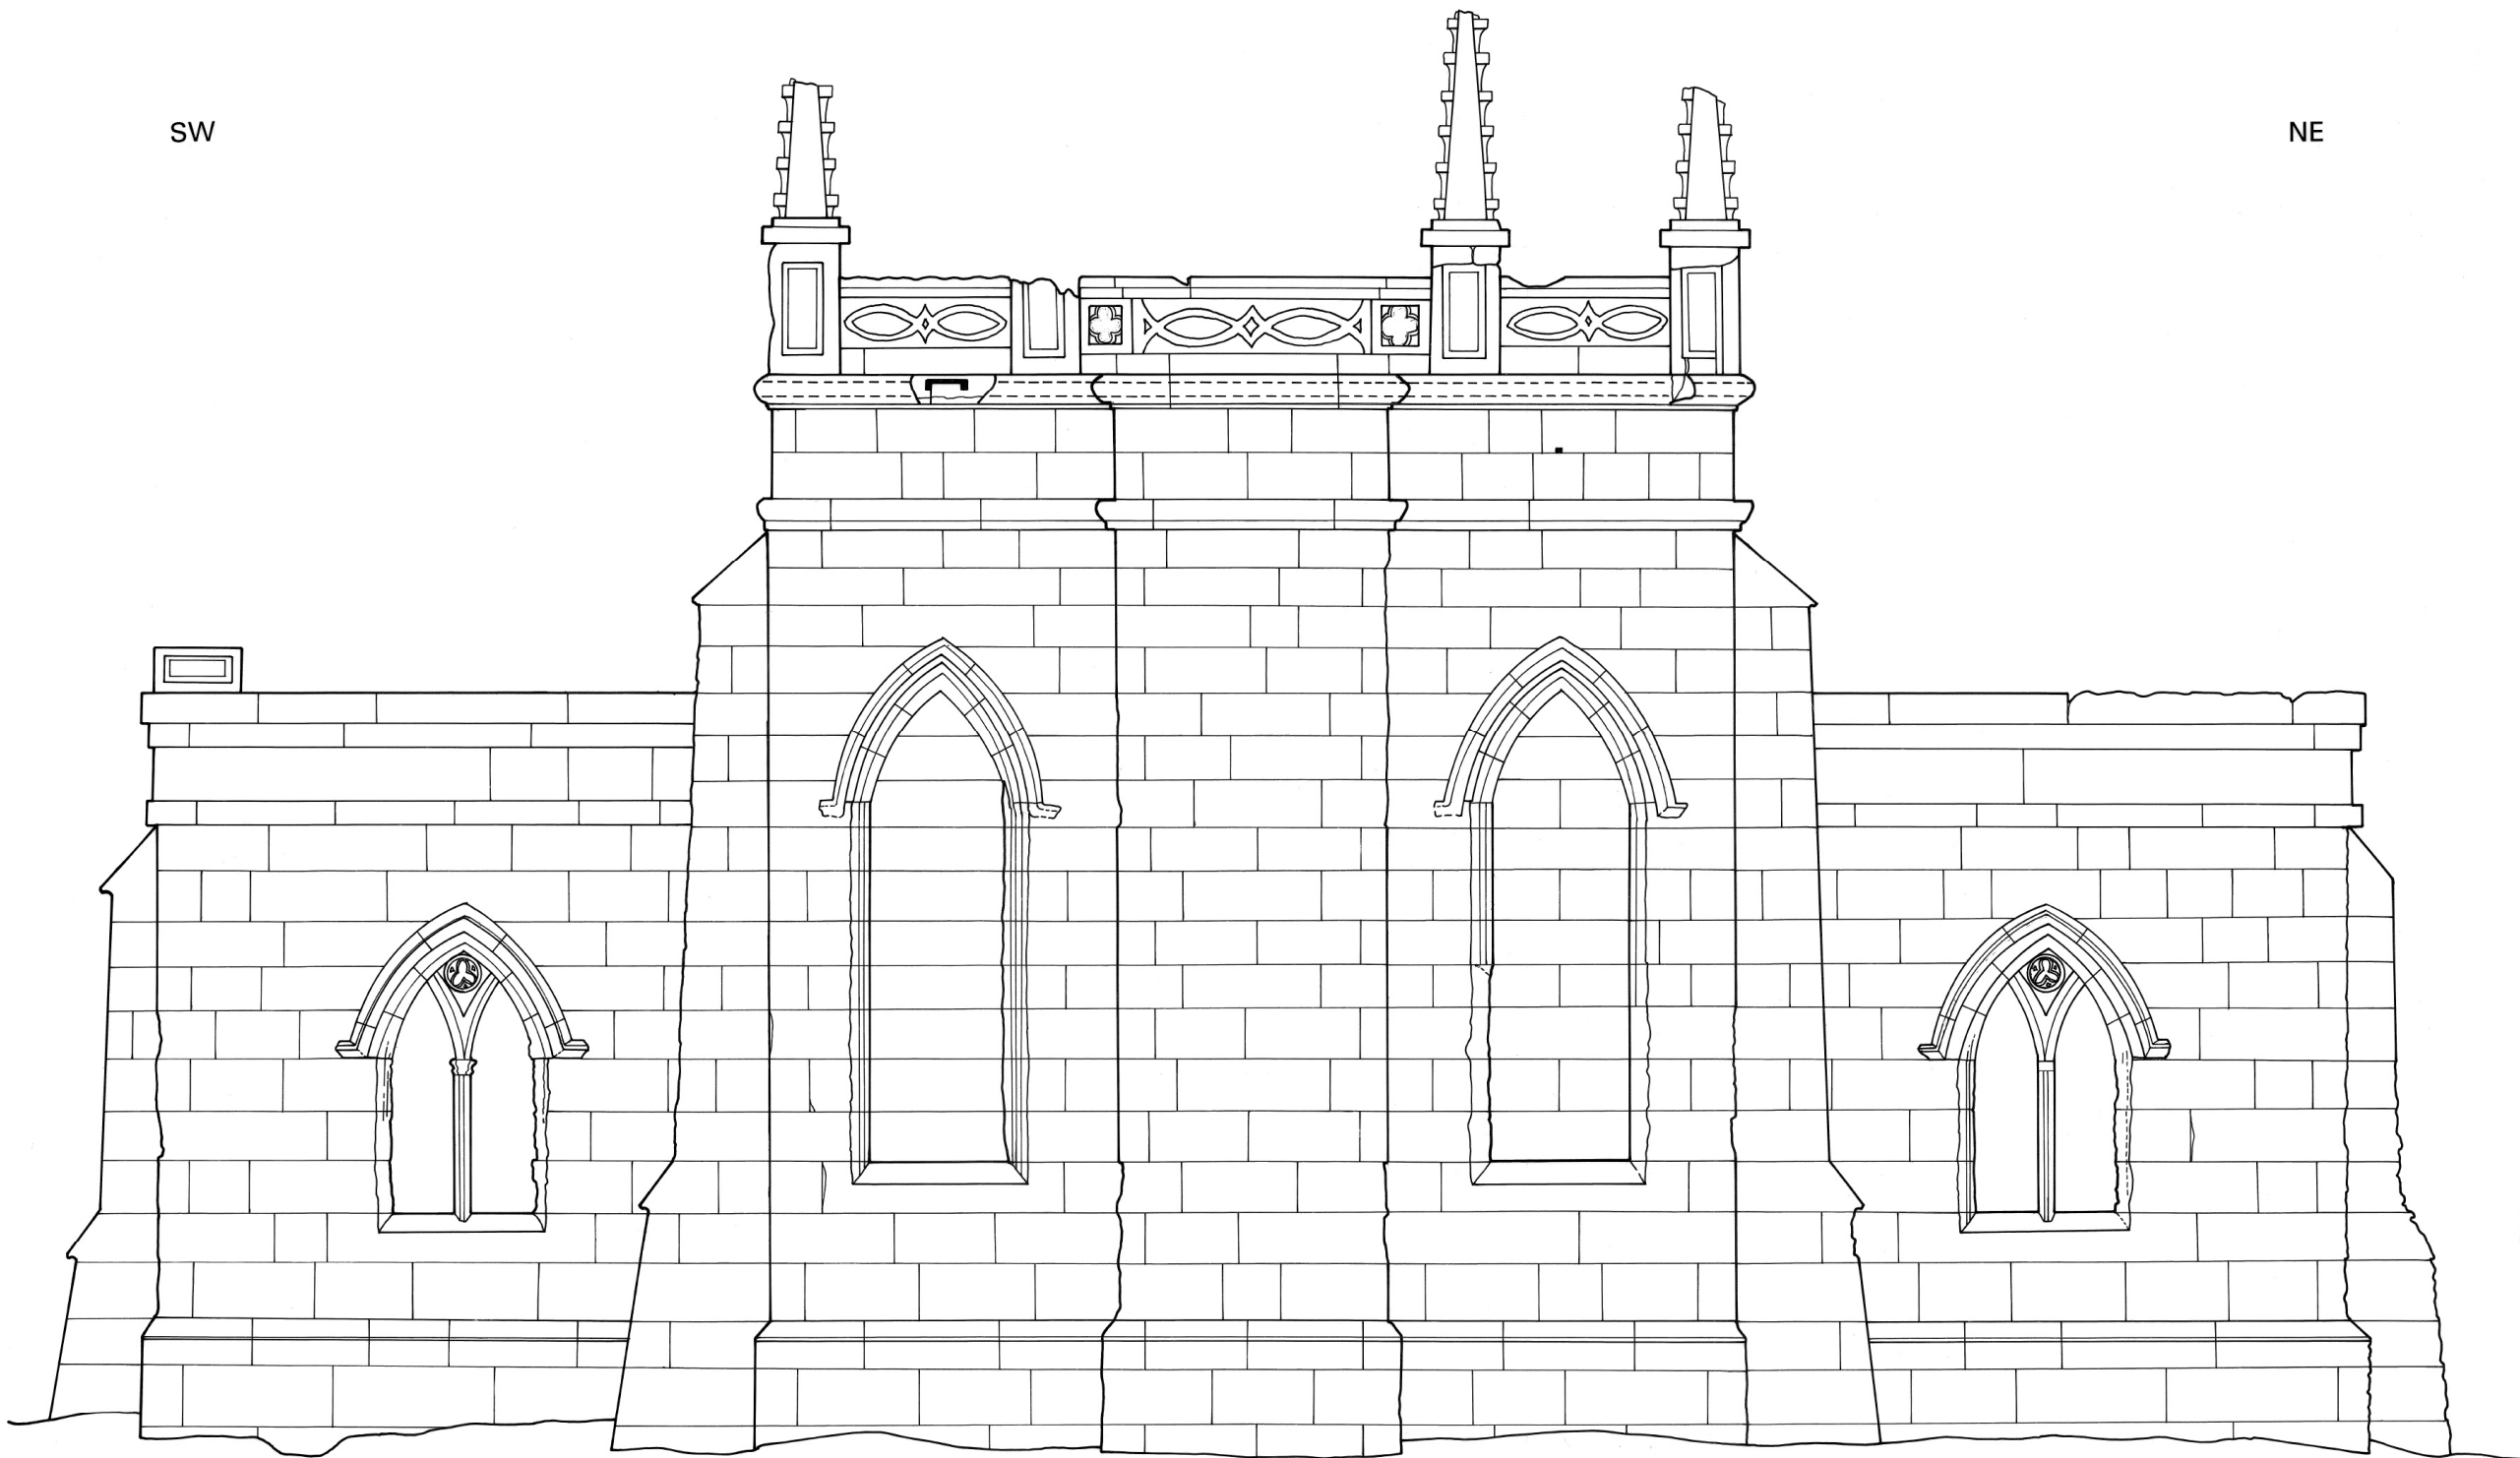
PROJECT	
BRAMHAM PARK SUMMERHOUSE	
TITLE	
SOUTH ELEVATION	
SCALE	DATE
AS SHOWN	APR 2016
EDAS	FIGURE
	9

- 3.14 The south elevation of the summerhouse is symmetrically organised in a similar fashion to the north elevation [1/8]. Again, all three parts are buttressed and rise from a chamfered vermiculated plinth. The taller central cell has a slightly projecting central stack flanked by tall blind two-centred arched windows with hoodmoulds [1/18]. The face between the windows has been subject to an extremely harsh repair, possibly using Cadby Magnesian limestone, which forms a stark and visually intrusive contrast to the rest of the weathered elevation (see plate 3). The stack rises to parapet level; all stringcourses etc are carried around the stack, and at parapet level the corners are embellished by quatrefoils. The stack's flue was sub-square in plan internally [5/37] which became circular when it passed through the parapet [5/36] (see plate 10). It was probably originally surmounted by a decorative stack or pot but this has long since disappeared. The adjoining wings [1/17, 2/1] are as described for the north elevation, and all three parts of the elevation retain small iron hooks and loops formerly used to secure netting.

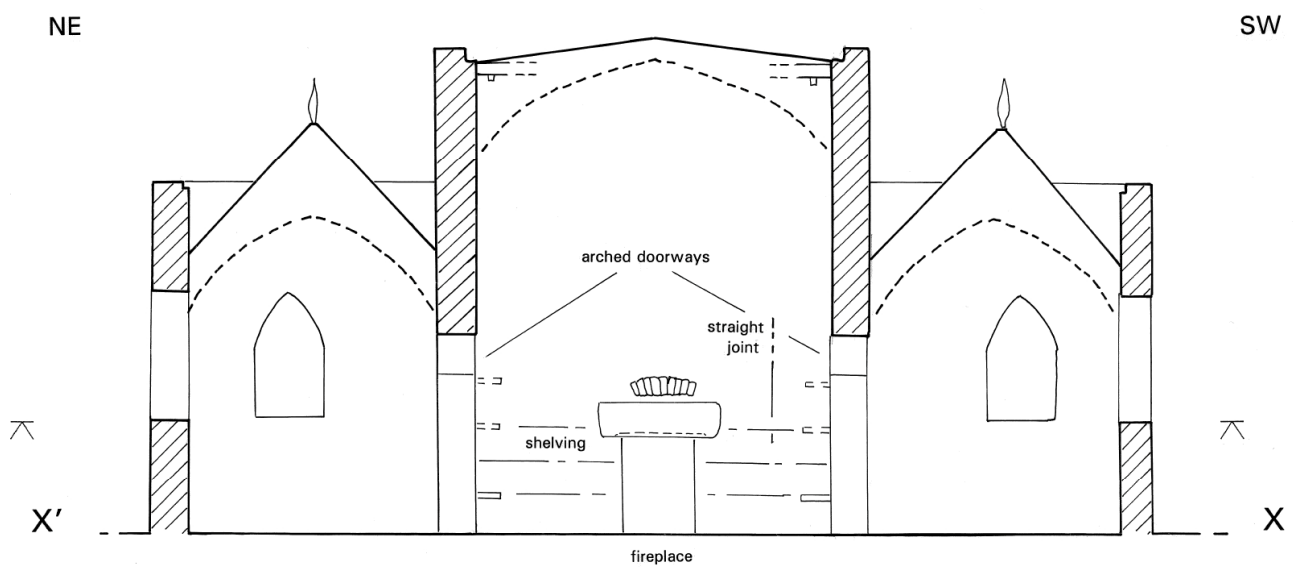
PROJECT	
BRAMHAM PARK SUMMERHOUSE	
TITLE	
SECTION	
SCALE	DATE
AS SHOWN	APR 2016
EDAS	FIGURE
	10

Section X-X' showing presumed vaults and reconstructed roof lines.

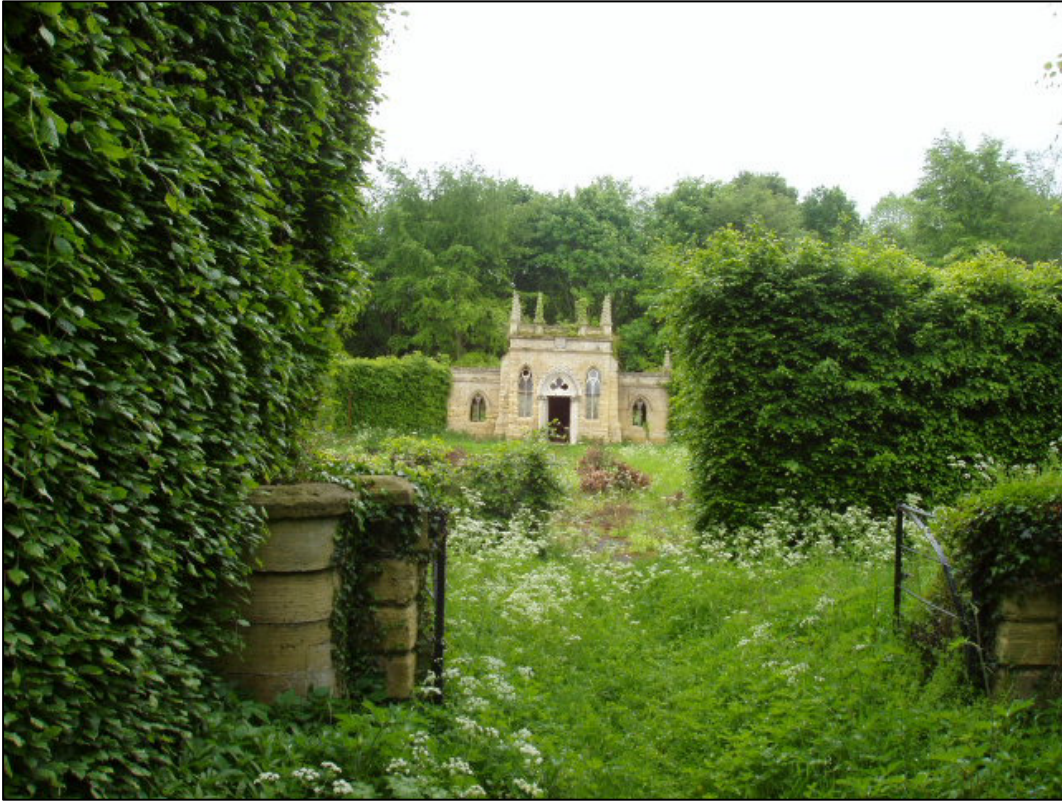
Plate 1: View towards main (north) elevation, looking SE (Peter Pace photograph).

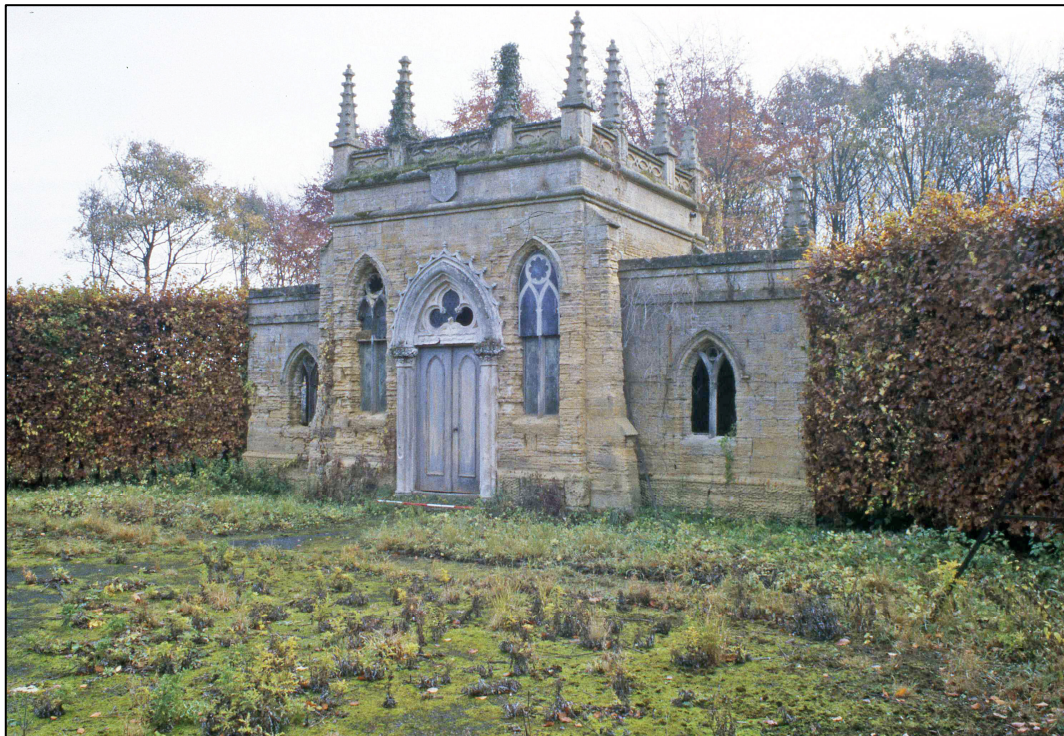
Plate 2: North elevation, looking E (photo 4/09).

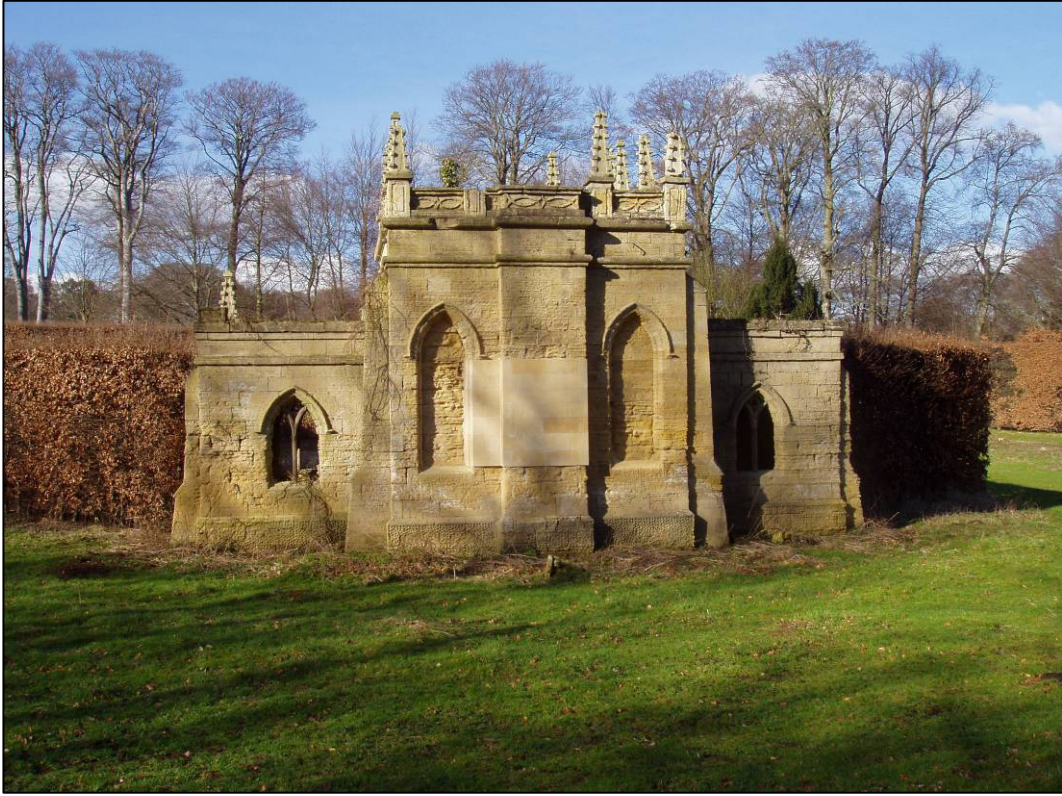
- 3.7 The summerhouse is faced on all sides with a yellowish Magnesian limestone ashlar, vertically tooled. The same stone has been used internally, but it was originally hidden by plaster and so was squared and coursed rather than ashlar. The surround of the central doorway in the north elevation is whiter in colour and perhaps of Cadby Magnesian limestone; a similarly coloured stone has been used for recent repairs to the south elevation [4/01] (Proctor 2002, 4) (see plate 3).

Plate 3: South elevation, looking NW (Peter Pace photograph).

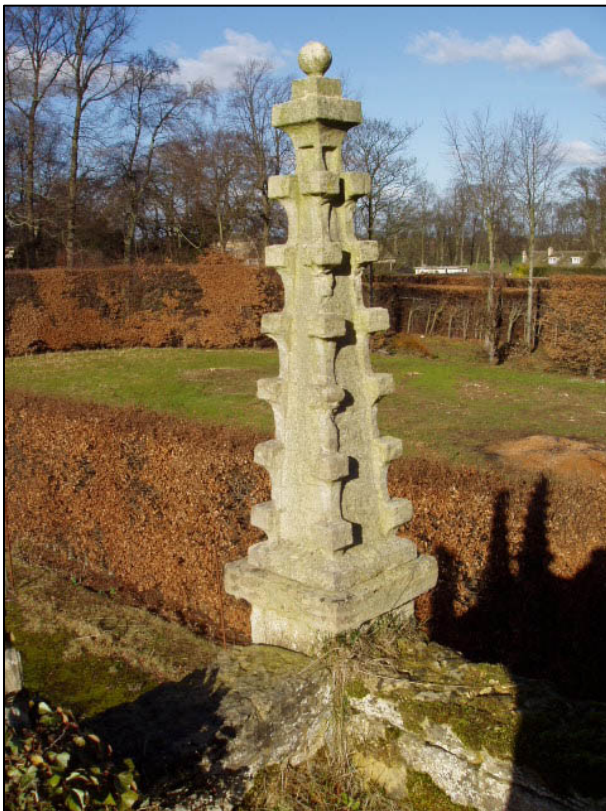
Plate 7: Typical pinnacle in corner of central cell, looking NW (Peter Pace photograph).

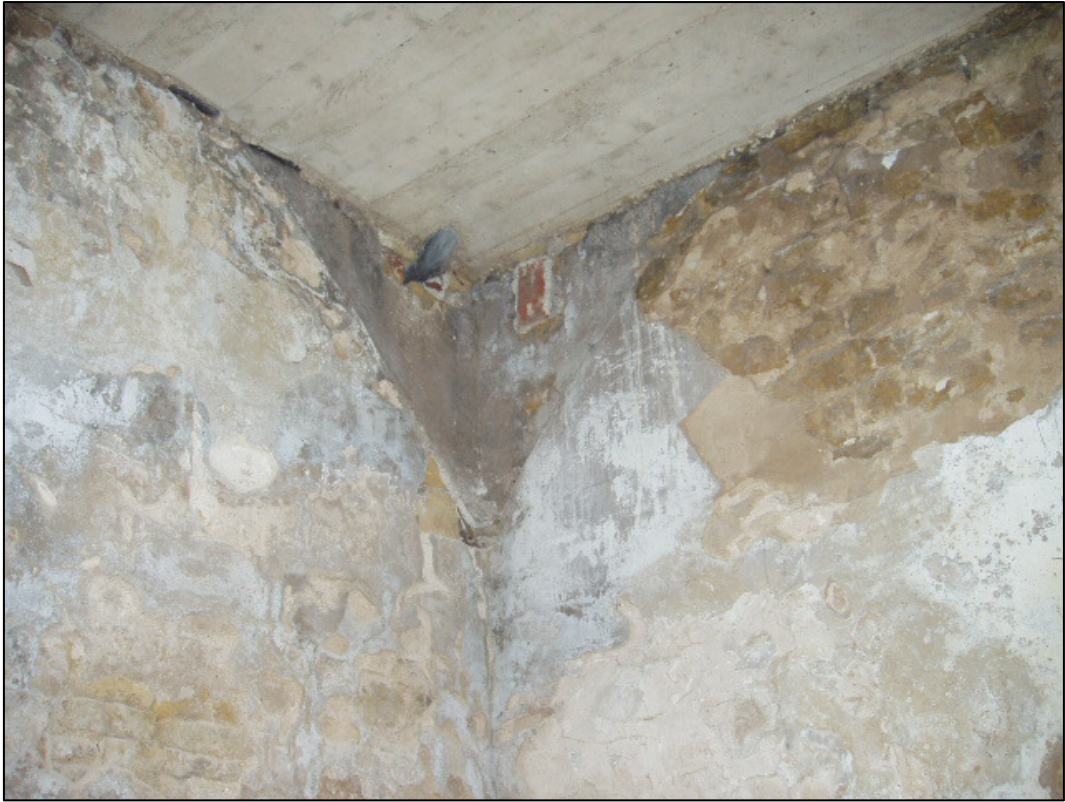
Plate 11: Profile of former cross-vault over central cell, looking SE  
(Peter Pace photograph).

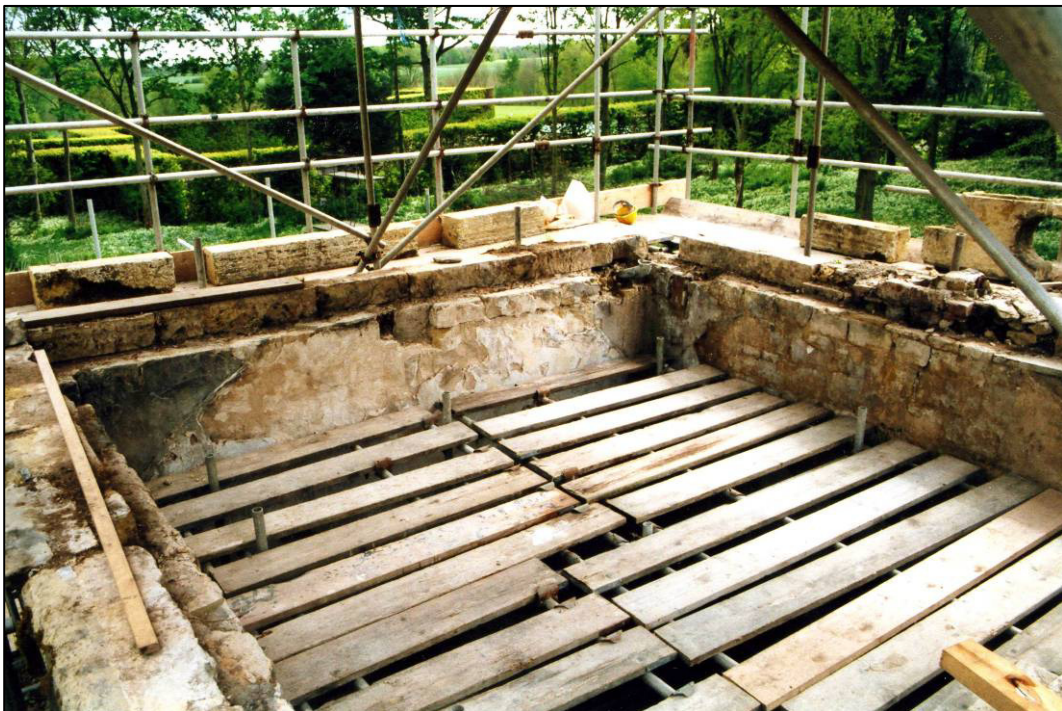
- 3.16 At the time of the initial EDAS survey visit, the interior of the central cell was boarded out [3/11] and the former internal doorways to the wings were blocked with breeze-block [3/15, 3/16]. However, all these were removed during the repair and renovation works, exposing the original internal wall surfaces. In the central cell, the internal walls retained large areas of wall plaster with a high horse-hair content, applied to a depth of up to 0.07m in places [6/6]. The uppermost parts of the plaster preserved the profile of the former cross-vault over the centre [6/14], which sprang from a height of c.4.11m above the limestone flag surface and was presumably carried upwards into the interior of the pyramidal roof (see plate 11); this was most easily seen after the concrete roof had been removed [5/32, 5/33, 5/34] (see plate 12).

Plate 12: Central cell after removal of concrete roof, showing profile of former cross-vault,  
looking E (photo 5/34).

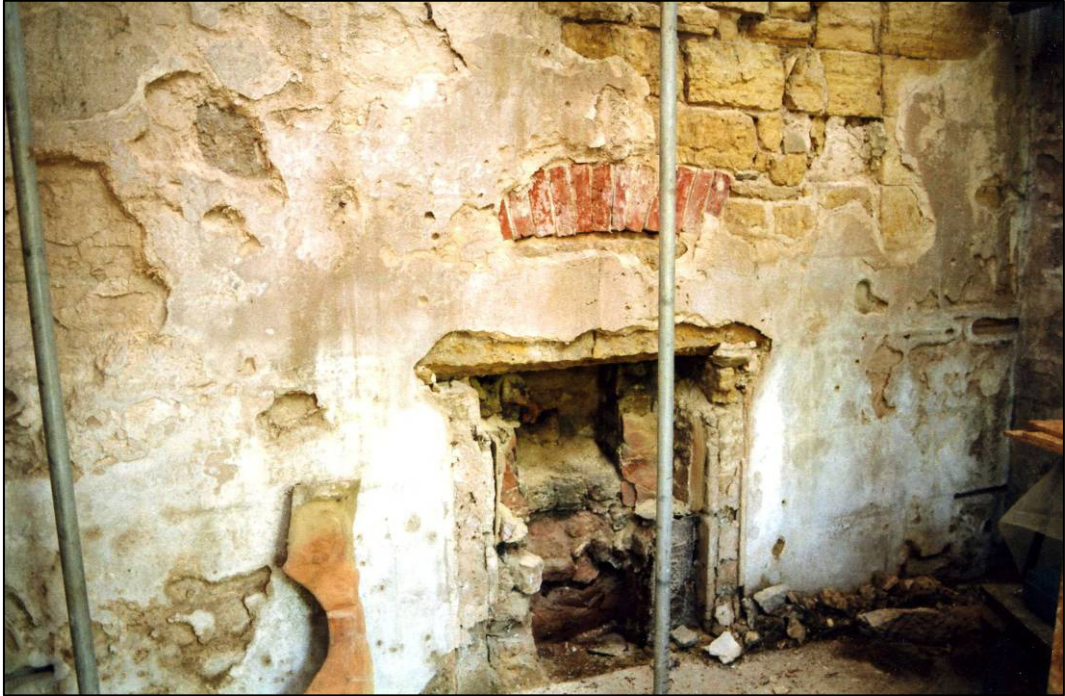
- 3.17 In the centre of the south wall, the remains of a partially blocked fireplace were exposed [6/15]. The surround had been removed some time before, exposing the substantial stone lintel and brick relieving arch over [6/8]. Marks in the wall plaster indicated that the fireplace was once flanked by three or four stage shelves or cupboards rising to 1.64m above the internal floor level [6/10, 6/11, 6/12] (see plate 13). A straight joint was also partly visible in the south wall c.0.80m to the west of the fireplace, rising to at least 2.00m above the internal floor level [6/13]; its purpose and origin are uncertain. There was no indication of a similar feature to the east of the fireplace, although it may have been obscured by surviving plaster here. No evidence was uncovered to suggest that the blind windows of the central cell's south elevation were ever open, although the above-mentioned straight joint is aligned approximately on the external east side of the west window. It is possible that the windows were once meant to be open but that there was a change in design during construction, and they were left blank. Small pieces of timber set into the plaster at the north end of the east wall are suggestive of studs, either for panelling [6/7] or perhaps more likely to support cupboards or shelving similar to that once flanking the fireplace [6/22, 6/23].

Plate 13: Internal south wall of central cell during renovation, showing fireplace and shelf scarring, looking SE (photo 6/10).

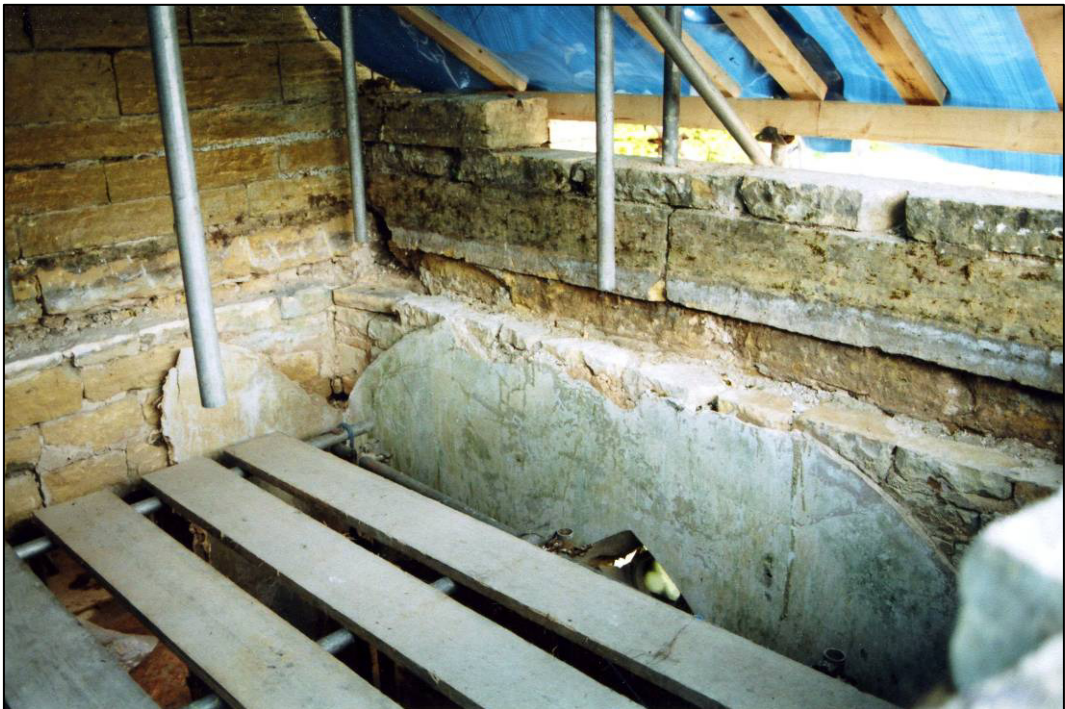
- 3.18 As stated above, the doorways leading to the adjoining wings had been blocked with breeze-block and then boarded over, making the wings totally inaccessible. When these blockings were removed, the original doorways were seen to be 2.22m in height, fitted with a wooden lintel to the west door [6/17] and a steel lintel to the east door [6/9]. However, the slight traces of a curve in the plasterwork around the doorways showed that they both once had two-centred arched heads like the windows to the external elevations. The internal walls of the two wings retained similar plaster to that described in the central cell. They were also once crossed by cross-vaults, springing from 2.37m above the internal floor level and presumably rising into the interior of the octagonal roofs here [3/12, 3/13, 3/17; 4/06; 6/18, 6/19, 6/20]. Again, these were most easily visible after the concrete roof had been removed, particularly within the west wing [5/28, 5/31] (see plate 14).

Plate 14: West wing after removal of concrete roof, looking NW (photo 5/31).
