REPAIRS AND ALTERATIONS TO THE  
PRIEST'S HOUSE AND CHAPEL,  
BARDEN TOWER, BARDEN, NORTH YORKSHIRE

ARCHITECTURAL AND ARCHAEOLOGICAL  
OBSERVATION, INVESTIGATION AND RECORDING

Report no: 2015/510.R01  
Version: Final  
Date: December 2016  
Author: Ed Dennison & Shaun Richardson

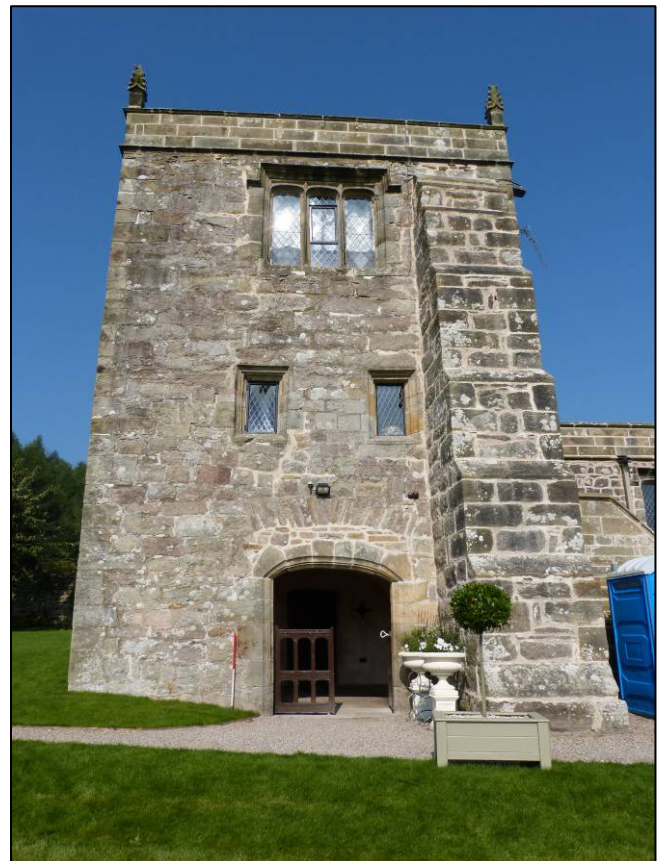
Plate 8: Tower, south elevation, after repair and conservation works, looking NW (photo 7/578).

- the cutting out and repointing the whole of the tower's south-east buttress, the repairing of movement fractures in the south elevation, and the pinning of a crack on a dropped voussoir to the ground floor doorway;

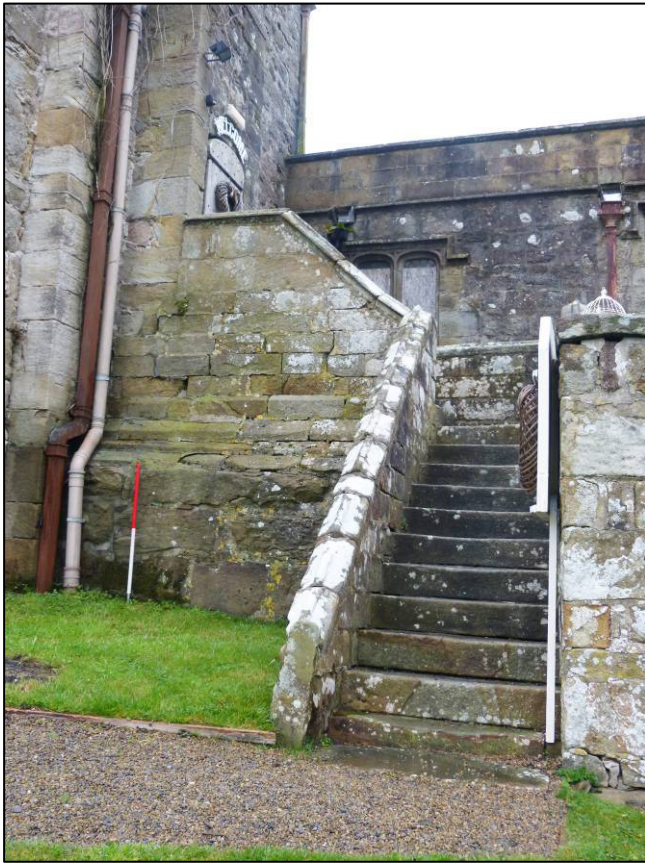
- 3.20 The east side of the tower has a double flight of right-angled stone steps attached to it, enclosed by low parapet walls with moulded coping [1/157] (see plate 9); these are of uncertain date, but might have been added during the 18th century (Pacey & Bedford-Payne 2016, 33), although more recent repairs are also visible. To their south side, the steps rise over a plinth incorporating several chamfered offsets. Below the offsets, the masonry of the plinth is rather crude and comprises large stone blocks, but above it is coursed and squared [1/158]. This upper masonry appears to butt the quoins to the south-east corner of the tower [1/159]; one of the quoins bears the carved initials 'I B', being the same as those observed

Plate 9: Tower, staircase on east elevation, looking NW (photo 1/157).

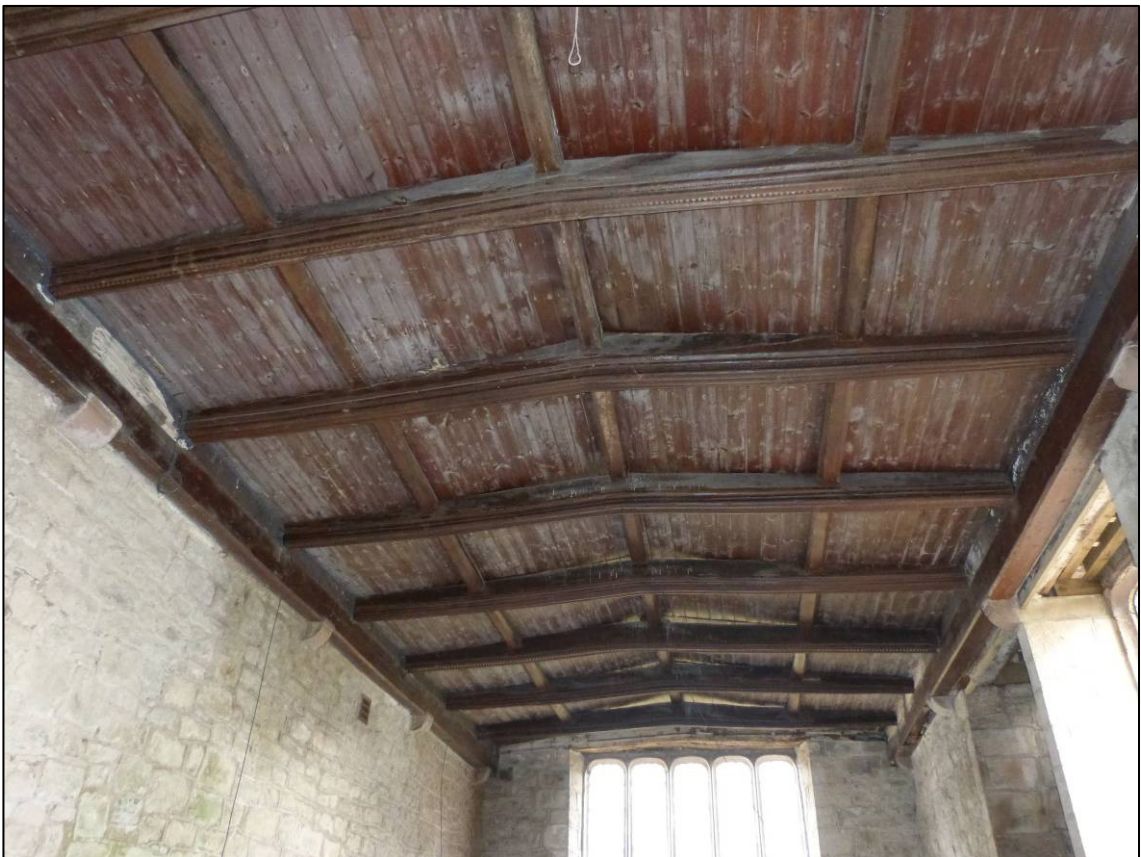
- 3.30 The chapel is crossed by eight transverse roof beams, spaced at broadly equal centres [5/896] (see plate 23); it was formerly suggested that these were not original, and that they were probably replaced during the 1860s restoration works (YVBSG 1989, 4). Each beam is slightly cambered, supporting a ridge-piece and two purlins or joists. The ends of the beams rest on substantial wall beams, which are in turn each supported by four curved stone corbels. There are no rafters, but instead wooden boards which run east-west between the beams. The beams are decorated on their faces with rounded and nail head mouldings, starting with nail head mouldings to the easternmost beam and then alternating between the two as one moves westward. In 1989 it was noted that the third and seventh beams from the east wall were stopped at each end with a triangular pattern (YVBSG 1989, 4).

Plate 23: Chapel, roof structure, looking NE (photo 5/896).

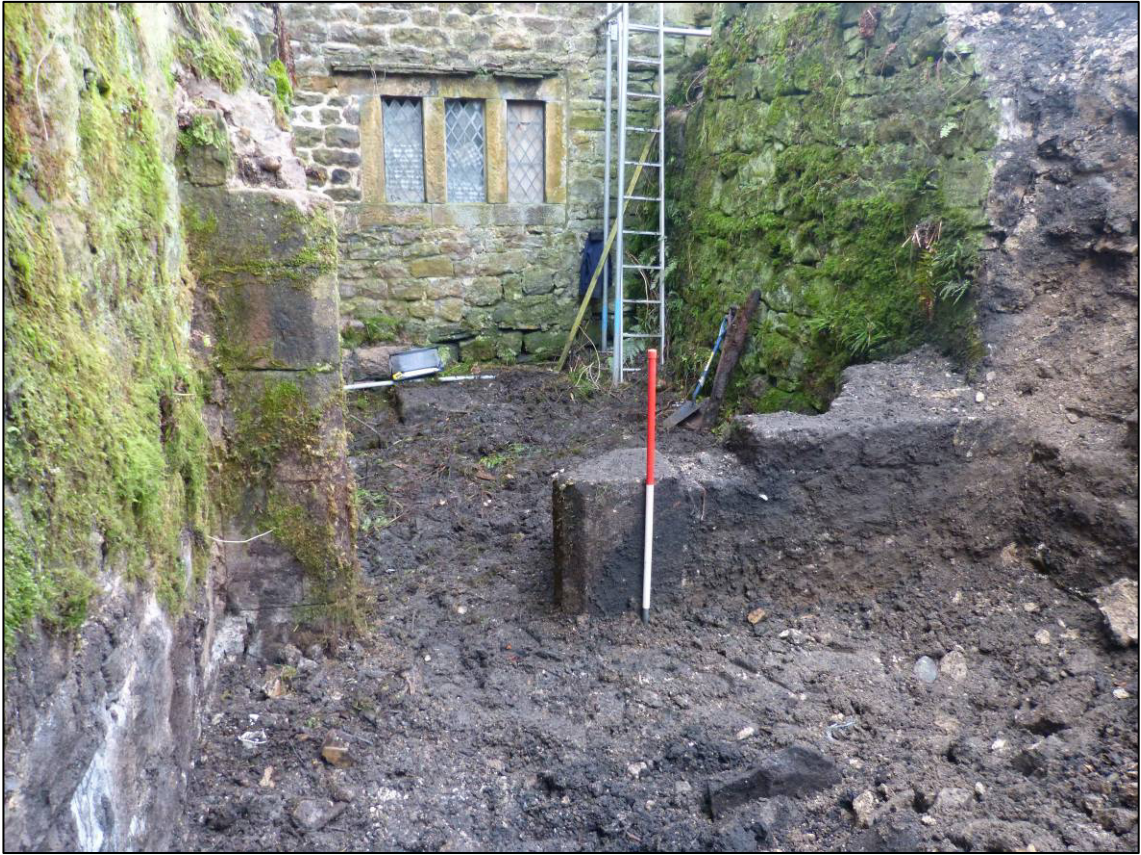
Plate 29: Sunken area to north of chapel, excavated cross wall, looking SW (photo 3/408).

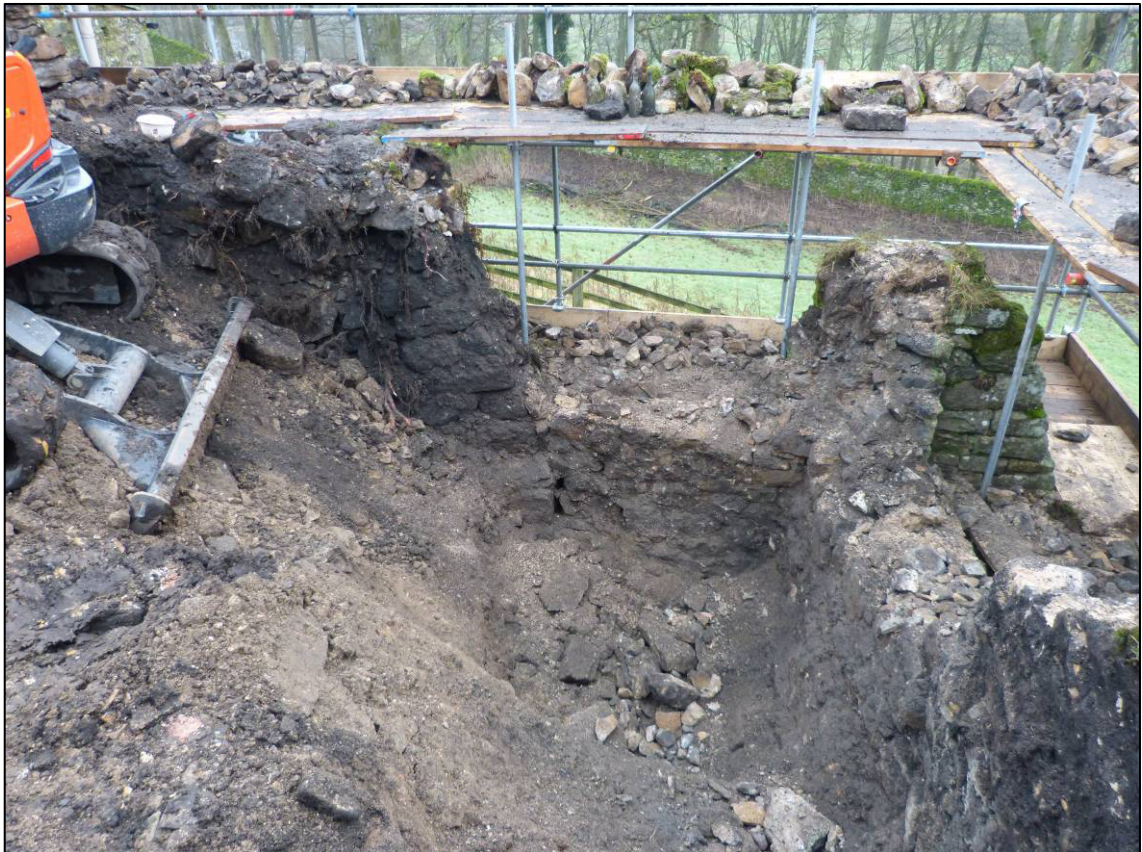
Plate 30: Retaining wall, north-east of chapel, dismantling wall showing earlier buttress, looking NE (photo 4/443).

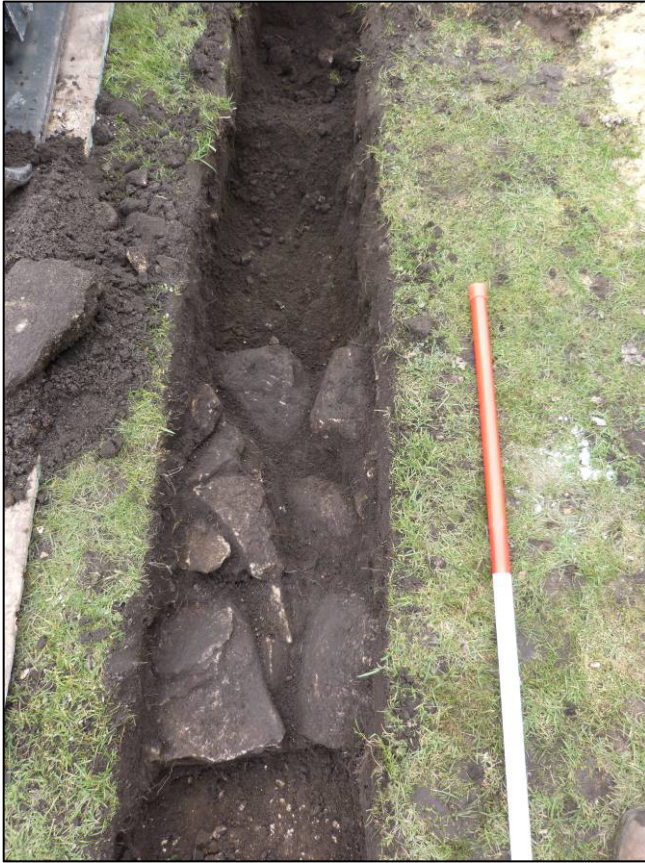
Plate 34: Drainage trench T2, wall footings (004), looking SW (photo 5/899).

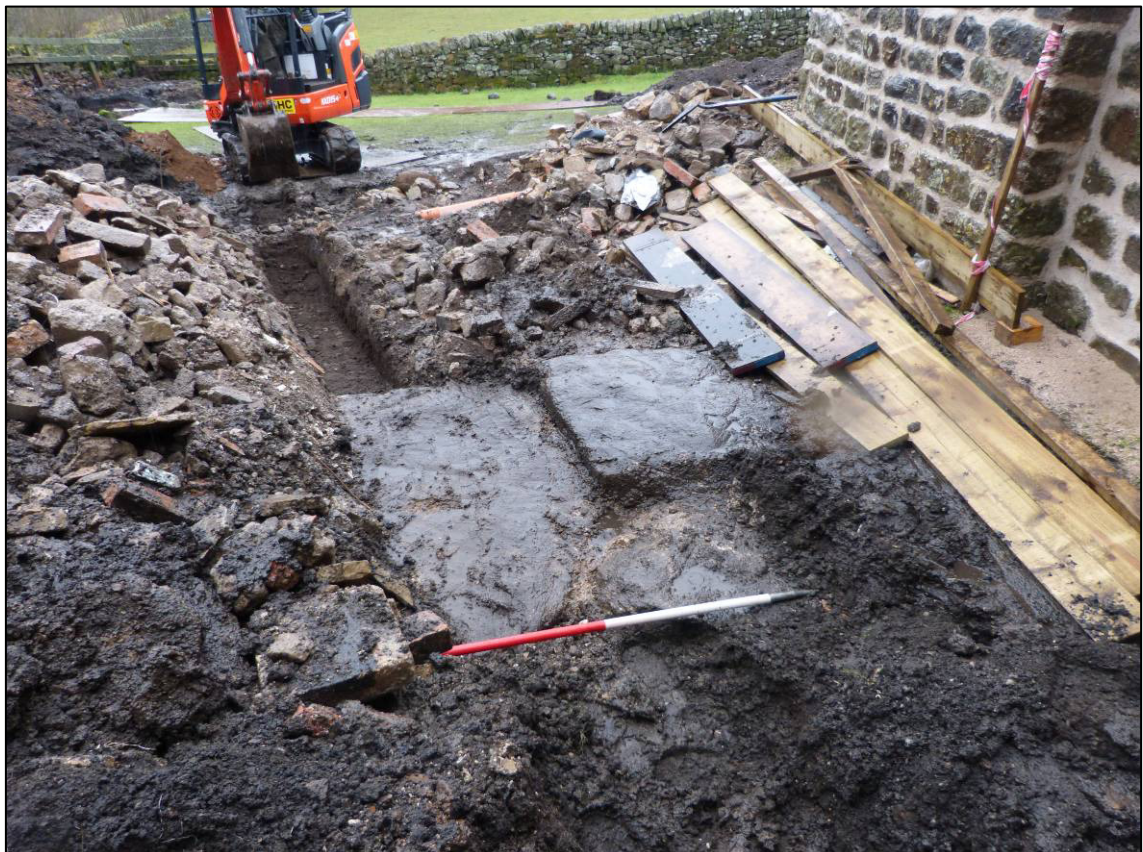
Plate 36: Drainage trench T4, wall footings (008), looking S (photo 6/923).

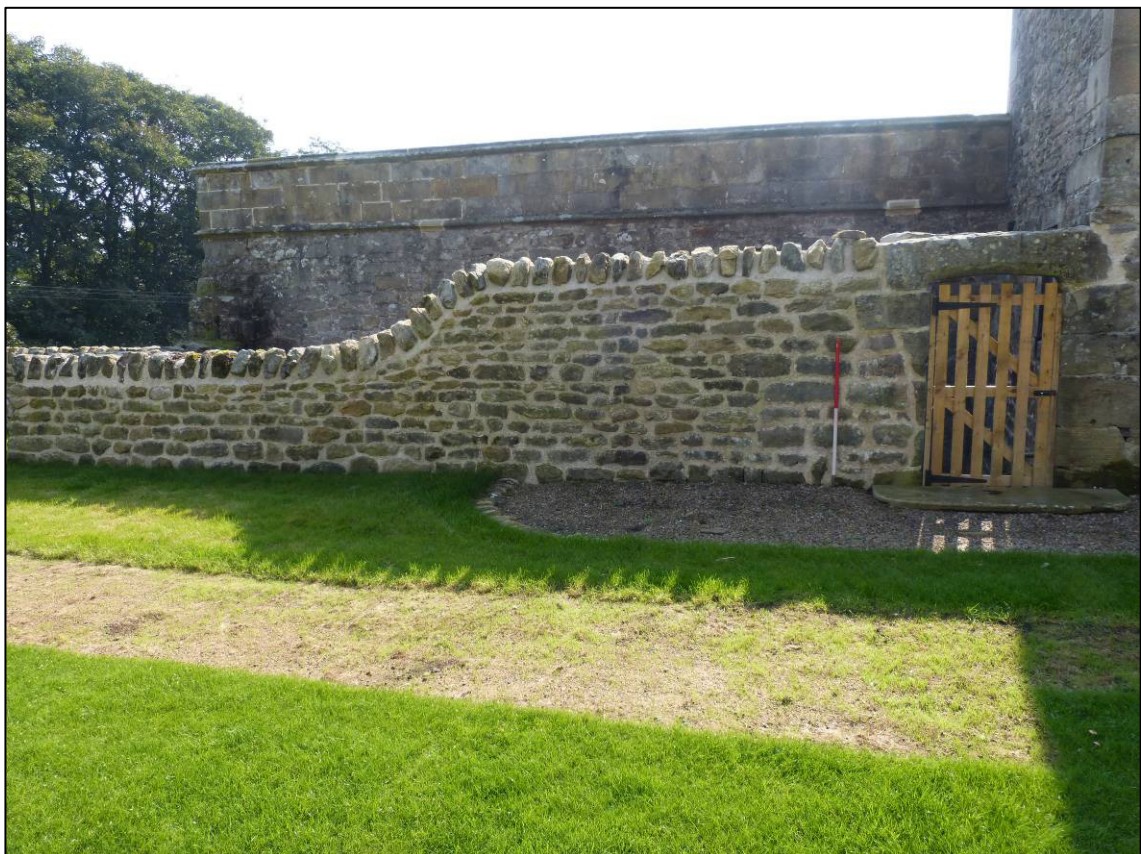
Plate 42: Sunken area to north of chapel, rebuilt doorway in west end of revetment wall, looking SE (photo 7/571).
