EXTERNAL DRAINAGE WORKS,
ST JOHN'S CHURCH, SALTON,
NORTH YORKSHIRE

ARCHAEOLOGICAL OBSERVATION,
INVESTIGATION AND RECORDING

Report no: 2017/540.R01
Version: Final
Date: October 2018
Author: Shaun Richardson & Ed Dennison

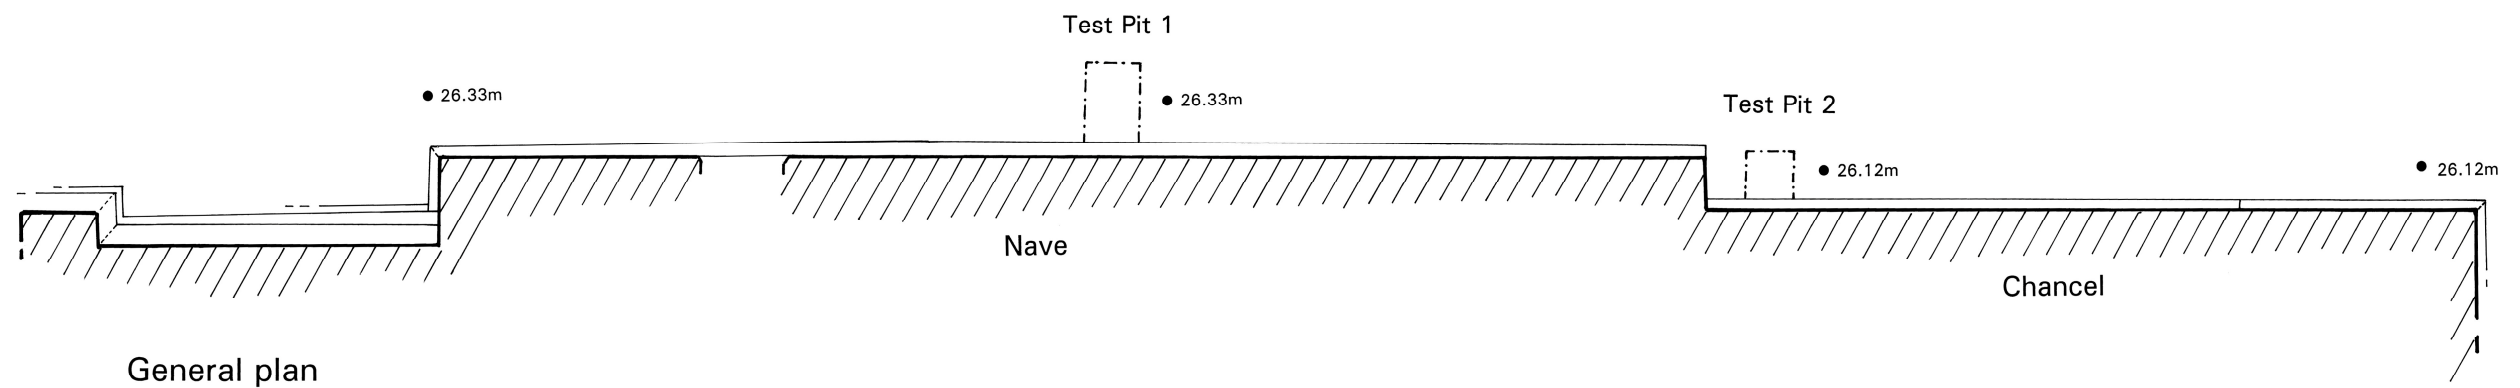
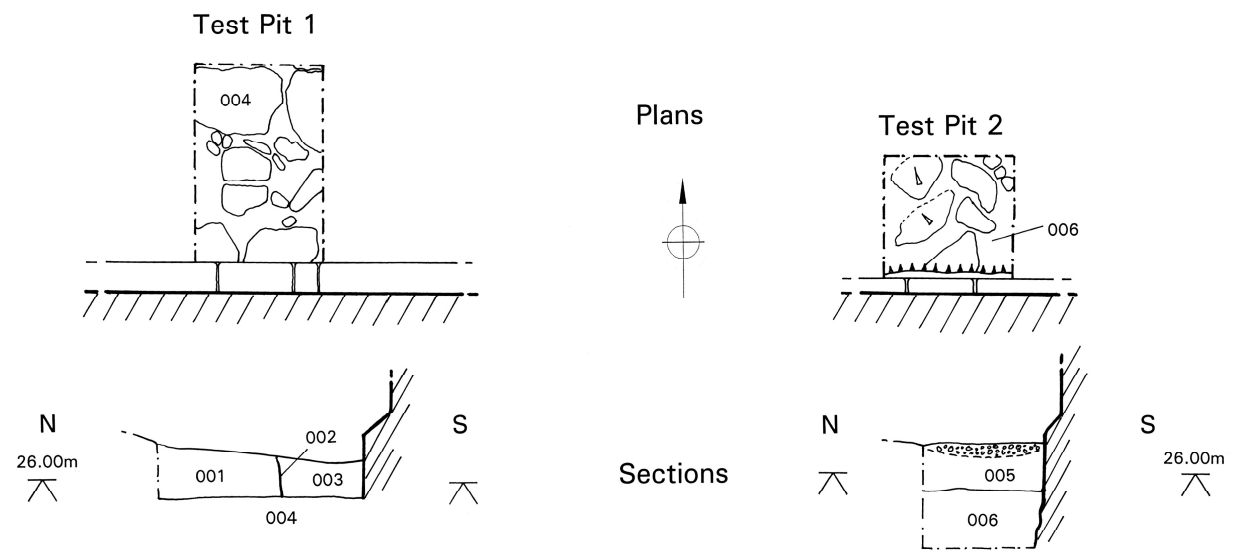
PROJECT		ST JOHN'S CHURCH, SALTON	
TITLE		ARCHAEOLOGICAL TEST PITS	
SCALE	AS SHOWN	DATE	OCT 2018
EDAS		FIGURE	3

- 5.1 On 10th May 2017, EDAS excavated two test pits against the north side of the nave and chancel, in order to investigate the nature of any pre-existing drainage and the form of the wall foundations here. Both pits were excavated by hand.

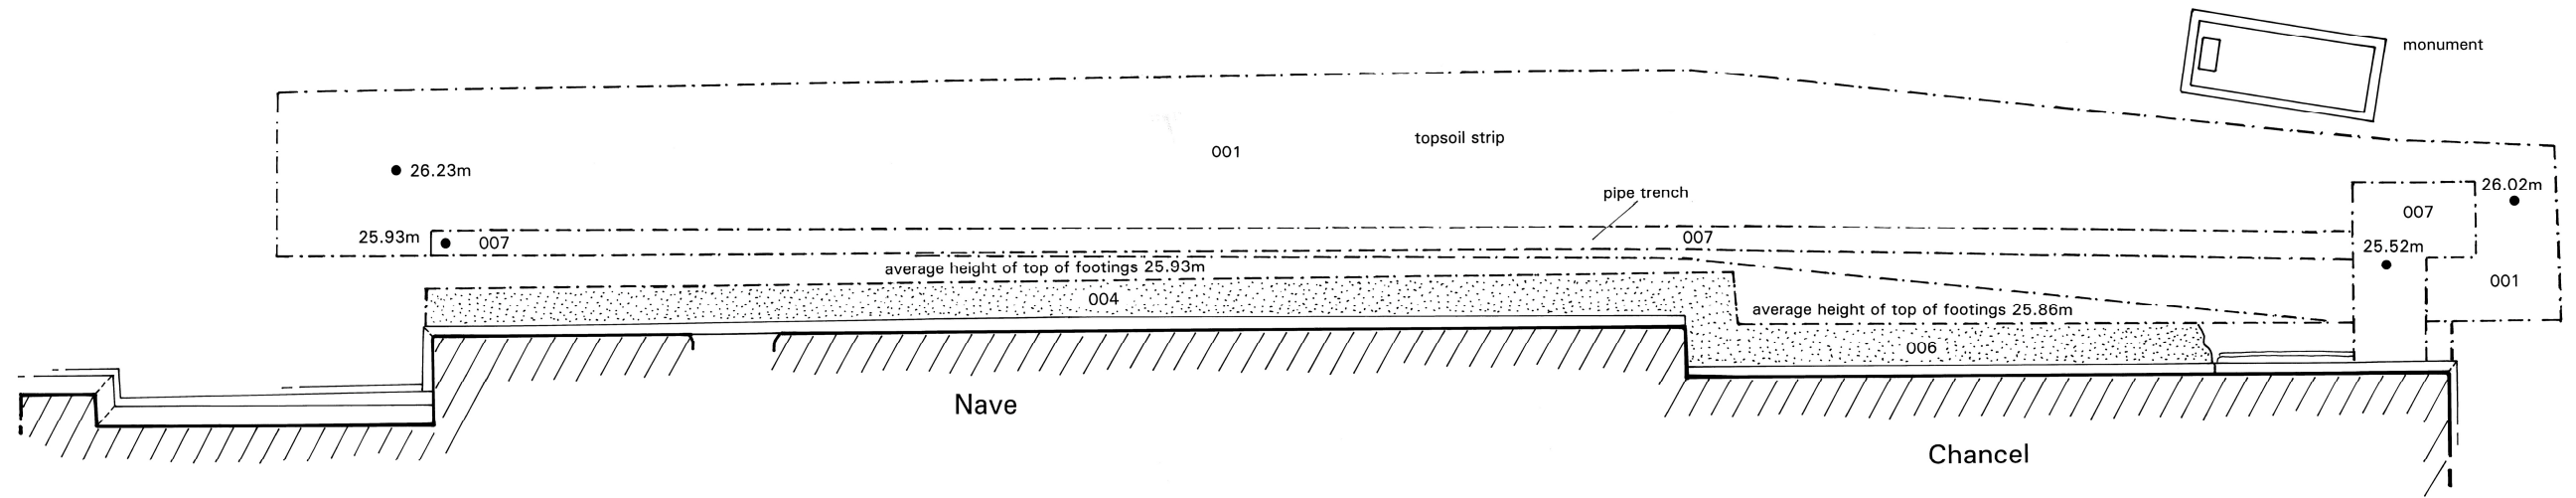
Phase 2 plan

- 5.6 On 25th September 2018, EDAS undertook a watching brief associated with topsoil stripping and drainage work on the north side of the chancel and nave.

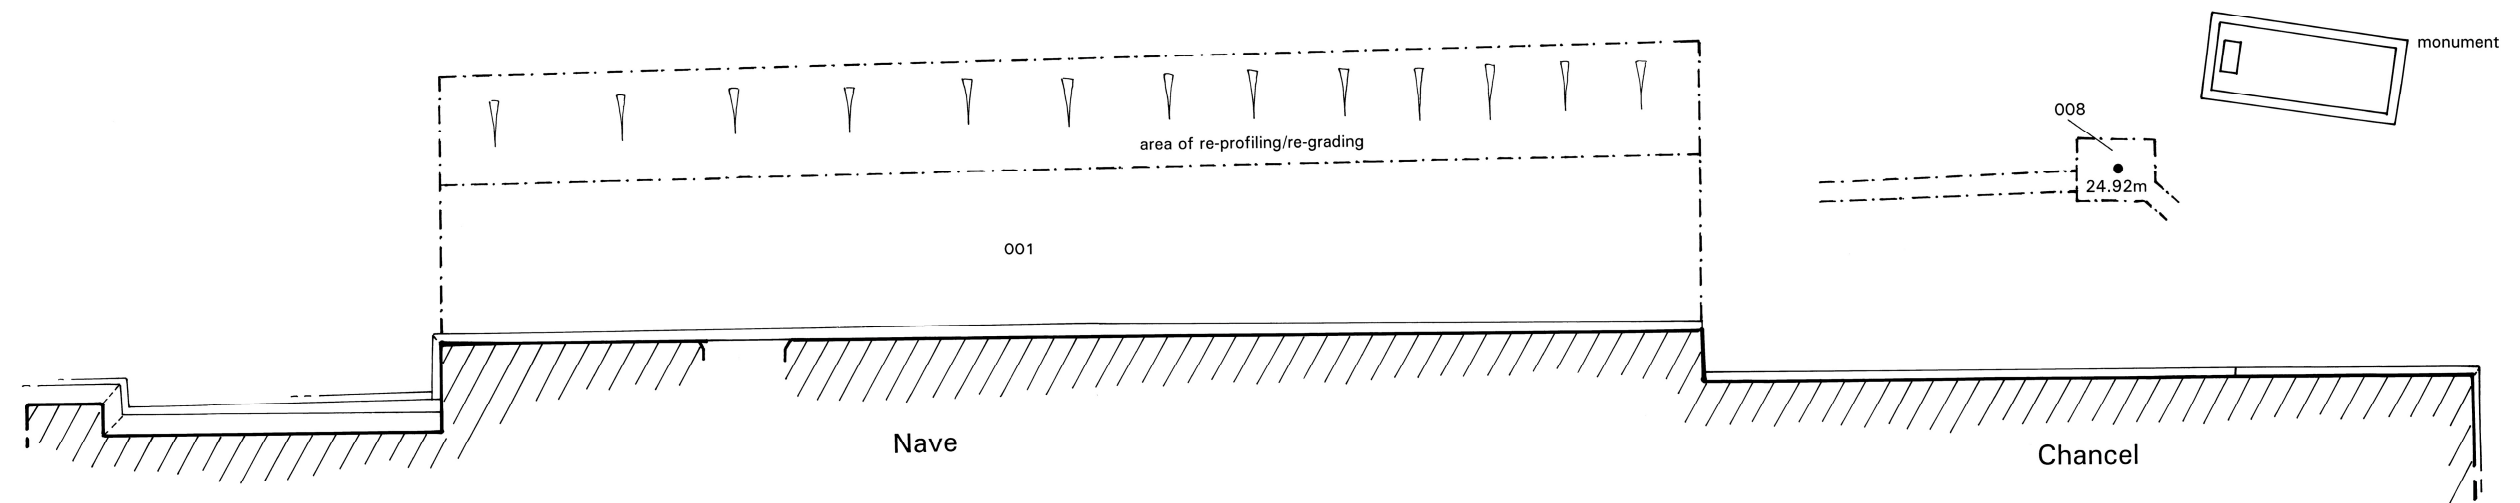
Phase 3 plan

- 5.11 On 4th October 2018, EDAS monitored the work associated with the re-grading of the existing ground levels along the north side of the church to facilitate water movement away from the building.
- 5.12 An area on the immediate north side of the nave, measuring c.16.0m east-west by 3.5m north-south was re-graded. A 1.40m wide strip along the north side of the re-graded area was sloped gently downwards from north to south; the remaining part of the re-graded area was then levelled off, with the maximum ground reduction being 0.30m (see plate 7). Only the previously described topsoil (001) was encountered. It had been thought that there might be a need to temporarily dismantle a monument adjacent to the east end of the chancel to facilitate the re-

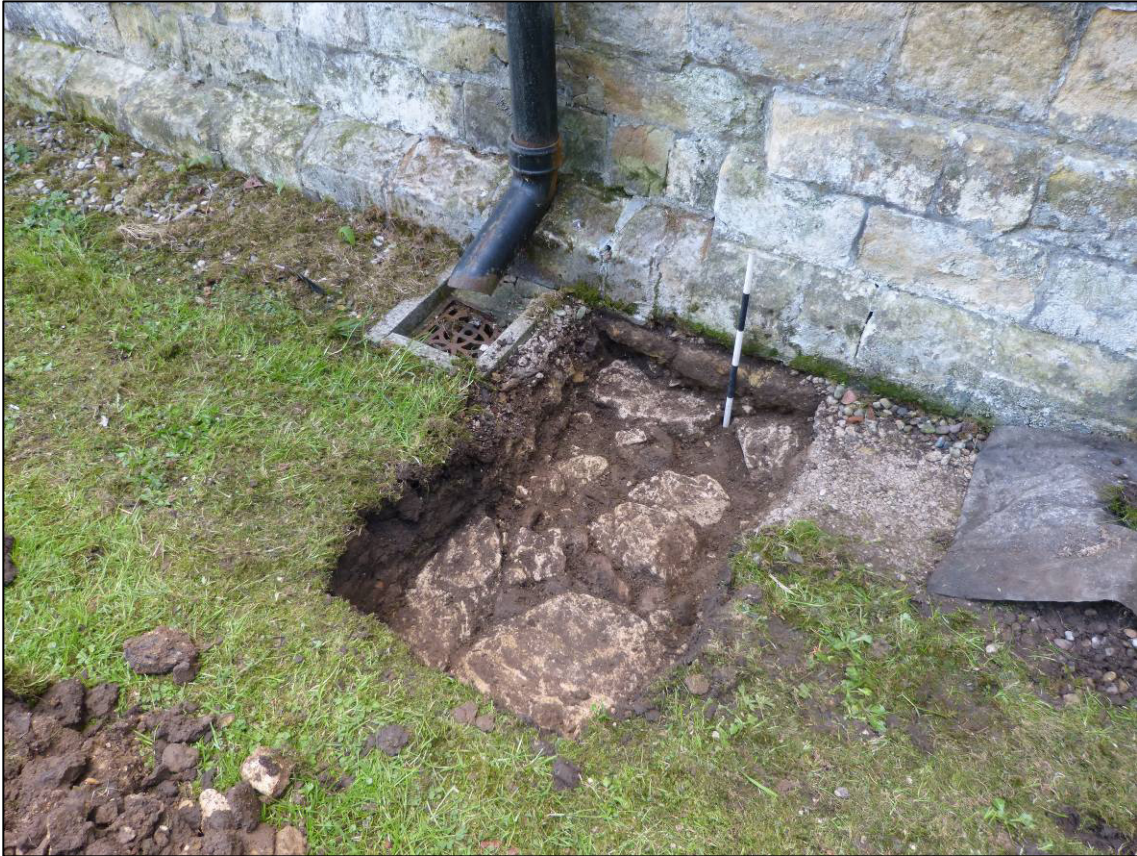
- 5.2 Test Pit was excavated adjacent to the base of a rainwater pipe, situated approximately half way along the north wall of the nave. A chamfered plinth, averaging 0.15m wide, formed the base of the wall here. The pit had maximum dimensions of 0.65m east-west by 1.15m north-south, and was excavated to a maximum depth of 0.28m below ground level (BGL) (25.93m AOD). A straight-sided cut [002] had been made for the existing French drain against the chamfered plinth; the cut was 0.40m wide and extended to 0.20m BGL. The upper part of the fill of the cut (003) comprised a layer of loose gravel chippings 0.05m deep over a membrane; the lower part comprised small angular pieces of concrete and stone. The cut had been excavated through a mid-brown clayey sandy silt topsoil (001) containing occasional inclusions of abraded red brick.

- 5.3 Both the sandy silt topsoil (001) and the fill of the drain cut (003) overlay the medieval footings of the nave (004). The surface of these footings was set at c.25.93m AOD, or 0.28m below ground level; there was only a single, very shallow course of dressed stone between the base of the chamfered plinth and the top of the footings. The footings (004) were formed by hard packed pieces of angular stone, up to 0.35m long, and smaller rounded cobbles, sometimes with a thin layer of clay adhering to the surface and as a binding matrix (see plate 1). They clearly continued beneath the base of the wall, whilst their outer edge was apparently set

0.95m north of the face of the chamfered plinth; they continued below the base of the test pit. No finds were revealed in the test pit.

Plate 1: Phase 1 excavation complete in Test Pit 1, showing nave foundations (004), looking SE.

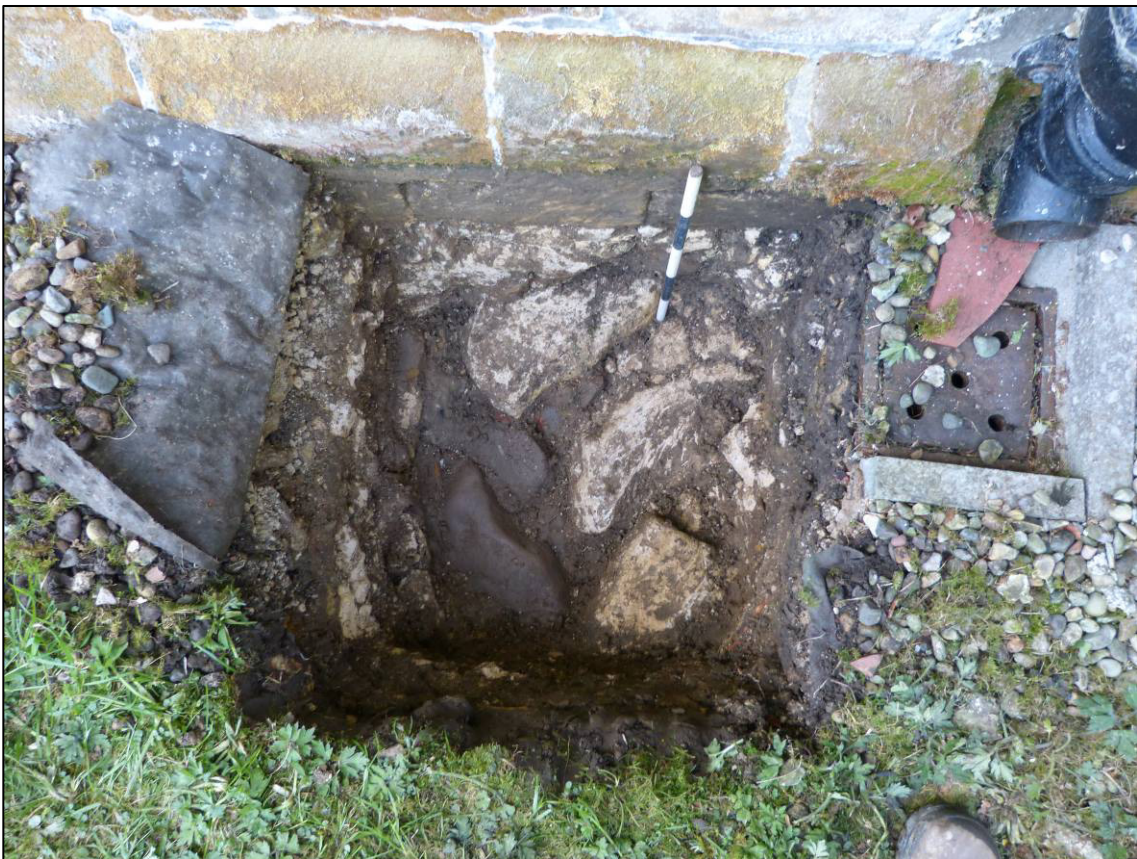
- 5.4 Test Pit 2 was excavated adjacent to the base of a rainwater pipe, situated at the west end of the north wall of the chancel. A chamfered plinth, averaging 0.08m wide, formed the base of the wall here. The pit was 0.65m square, and was excavated to a maximum depth of 0.55m below ground level (BGL) (25.60m AOD). The uppermost deposit was formed by the existing French drain (005), which extended to 0.25m BGL. The upper part comprised a layer of gravel (0.05m deep) over a membrane, below which there was a layer of limestone chippings. No cut for the Trench drain was exposed in the test pit.

- 5.5 The French drain overlay the medieval footings of the chancel (006). The surface of the footings was set at c.25.86m AOD, or 0.20m below ground level; there was a single course of dressed stone between the base of the chamfered plinth and the top of the footings. The footings (006) were formed by hard packed pieces of angular stone, up to 0.30m long, and smaller rounded cobbles, sometimes with a thin layer of clay adhering to the surface and as a binding matrix (see plate 2); the upper 0.25m of the footings was generally of smaller pieces of stone, and these were partly removed during the process of excavation until the larger stones were encountered. The footings clearly continued beneath the base of the wall and below the bottom of the test pit, and their outer (northern) edge was not located. As with Test Pit 1, no finds were revealed in the test pit.

Plate 2: Phase 1 excavation complete in Test Pit 2, showing chancel foundations (006), looking S.

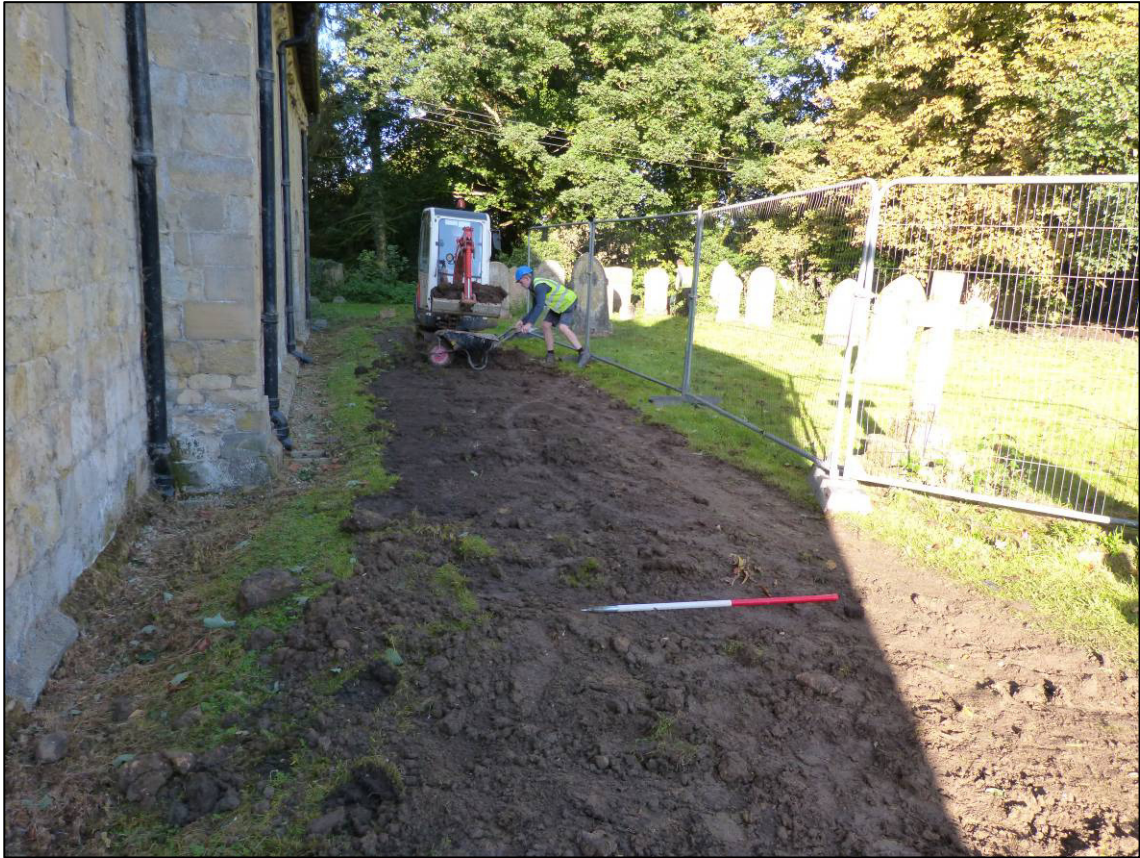
- 5.8 The area of topsoil stripping measured c.29.40m long, with an average width of between 2.30m to 2.50m. Over the majority of this area, only the turf and a very shallow depth of underlying topsoil (001) was removed (see plate 3); the topsoil (001) was formed by the same mid-brown clayey sandy silt with occasional inclusions of abraded red brick noted in Test Pit 1. At the north-east corner of the chancel, an L-shaped excavation, measuring 2.25m north-south by 1.60m east-west had been dug to a maximum depth of 0.60m BGL (c.25.52m AOD) to replace an existing drain and install a new plastic circular inspection chamber. This excavation was not monitored, as it had previously been agreed that the replacement of existing drains would not be of archaeological interest (see above), but the contractors reported that they had had to move a wooden cross in order to undertake the excavation. The wooden cross bore the inscription "In Memory of Roy Brown died 16th Nov 1946 Aged 4 Years 10 Mts"; no human remains were reported to have been encountered during the excavation work. The topsoil (001)

Plate 3: Phase 2 topsoil stripping in progress, looking W.

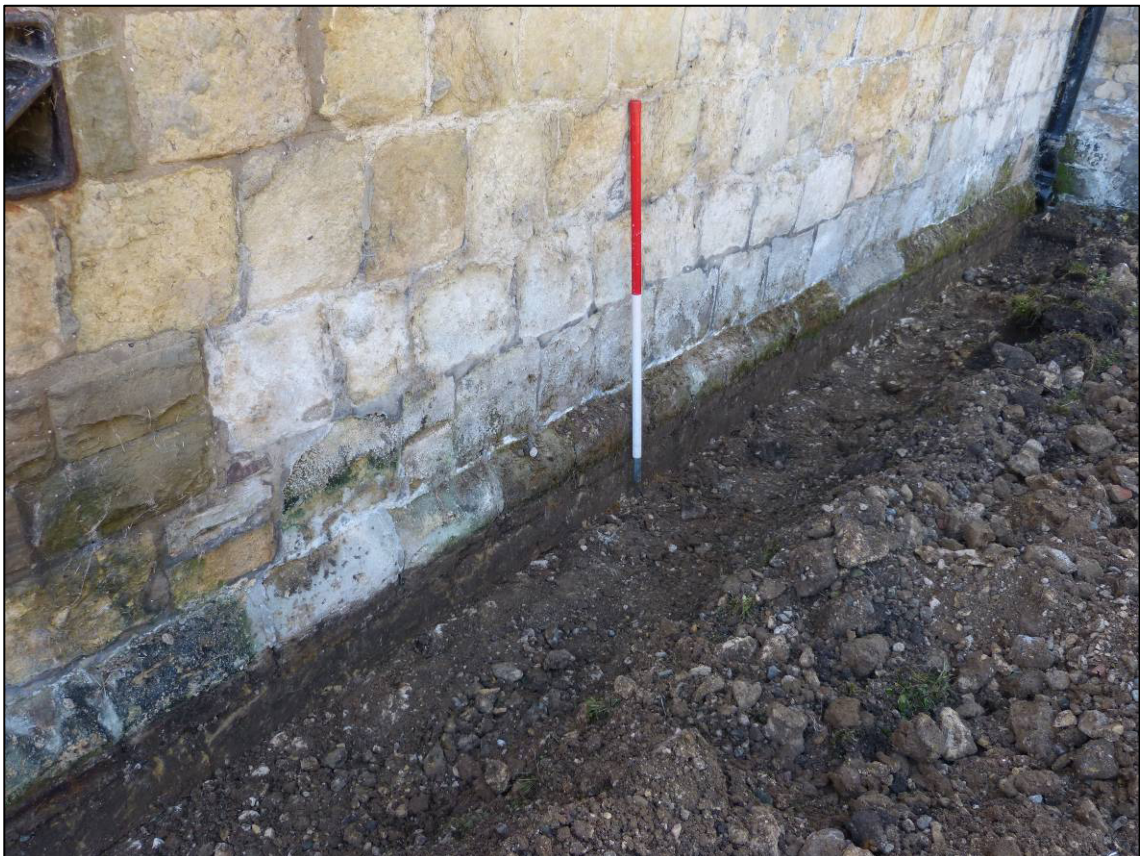
- 5.9 Once the topsoil strip was complete, a new drainage trench averaging 0.50m wide, was excavated along the base of the chamfered plinth that ran the complete length of the nave and chancel. This was to be filled with clay, to provide a waterproof barrier to prevent damp seeping through the church's north wall. The trench was excavated to the level of the top of the footings (004 and 006) previously described under Test Pits 1 and 2 above (on average at c.25.90m AOD) (see plate 4). The easternmost c.3m of the chancel's chamfered plinth is set 0.26m higher than the top of the plinth to the west, and there is a ragged joint between the two. When the trench was excavated, it was revealed that, rather than the projecting rubble footing previously described in Test Pits 1 and 2, the footings (006) continued as roughly coursed stone, stepping outwards only very slightly to each course and continuing to at least 25.74m AOD, and terminating 3.00m from the east end of the wall. It is assumed that this gap in the footings derives from a re-building of the north-east corner of the chancel, and also explains why no footings were visible in the excavation for the replacement drain and new inspection chamber here. As before in Phase 1, the outer edge of the rest of the chancel footings (006) was not exposed in the trench, although a brief hand-excavated investigation suggested that they extend c.0.95m from the base of the chamfered plinth like those to the nave. There was no clear junction or joint between the nave and chancel footings (004 and 006). No features were observed in the trench, and no *ex situ* human remains or other finds were uncovered.

Plate 4: Phase 2 drainage trench excavated along chancel north wall, looking SW.

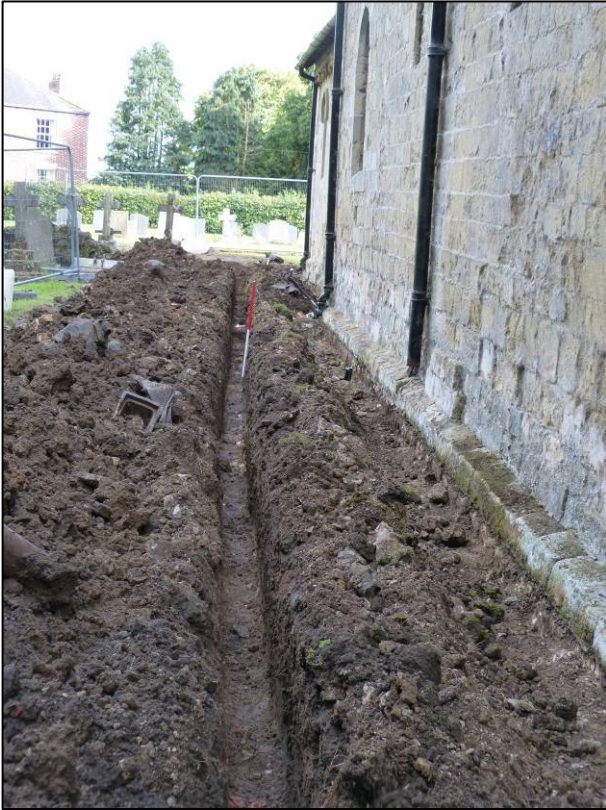
- 5.10 A second drainage trench was dug, broadly parallel to the north wall of the nave and chancel and previously excavated trench, to replace an existing drain, although in the event it did not follow the earlier line exactly (see plate 5). A number of very short cuts were made from existing down-pipes to join up with the main drainage trench. The main trench was 24.70m long, with an average width of 0.30m, and it linked up with the new inspection chamber at the chancel's north-east corner; the trench was placed 1.00m to the north of the nave, and 1.60m to the north of the chancel. The trench was excavated to a maximum depth of 0.60m BGL (c.25.52m AOD) at the east end where it met the inspection chamber, sloping shallowly upwards to 0.40m BGL (c.25.93m AOD) at the west end. Only two deposits were observed, the aforementioned mid-brown clayey sand silt topsoil (001), which extended to 0.30m BGL and overlay the sticky light to mid brown sandy clay (007); the clay continued beneath the base of the trench. No features, including grave cuts, were observed in the trench, and no *ex situ* human remains were uncovered, or indeed any other finds.

Plate 5: Phase 2 drainage trench excavated north of north church wall, looking E.

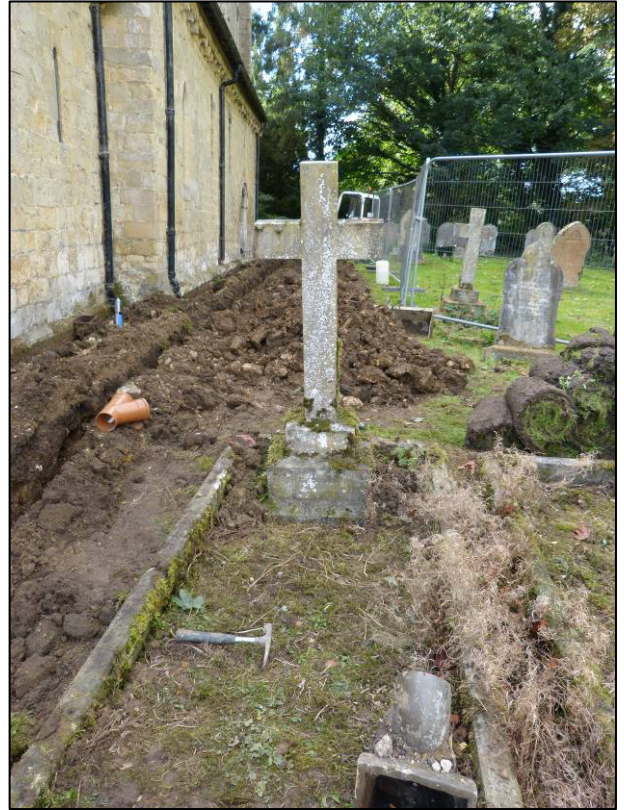
grading work. The monument was represented by stone edging to the burial plot, with a cross on a stepped plinth at the west end of the plot. The inscription to the cross was faded, but appeared to read "In Memory Of William, Second Son of George and Tamar Marton of Salton Manor, who died 11th November 1918 Aged 39 Years" (see plate 6). However, in the event, when the re-grading work was undertaken, there was determined that there was no need to move the monument.

Plate 6: Monument, north of east end of the chancel, looking W.

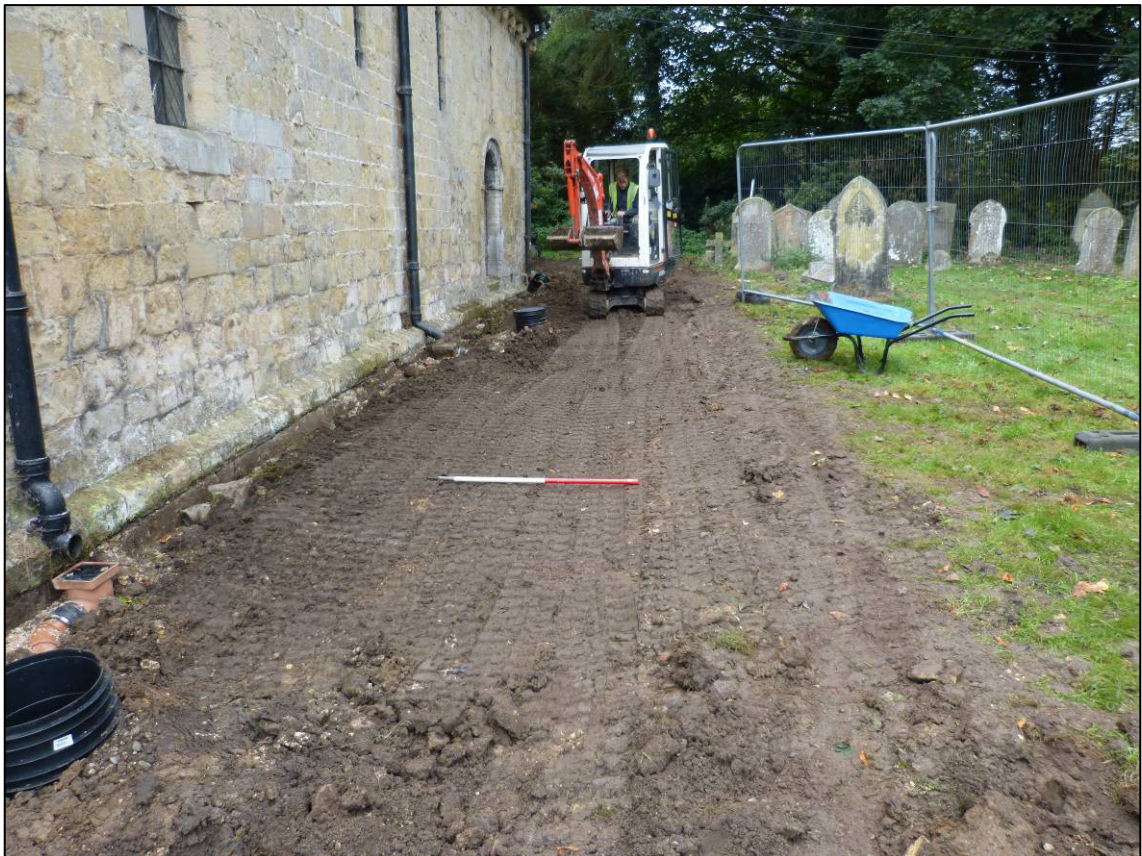
Plate 7: Phase 3 re-profiling work along the north wall of the church, after completion of drainage excavations, looking W.

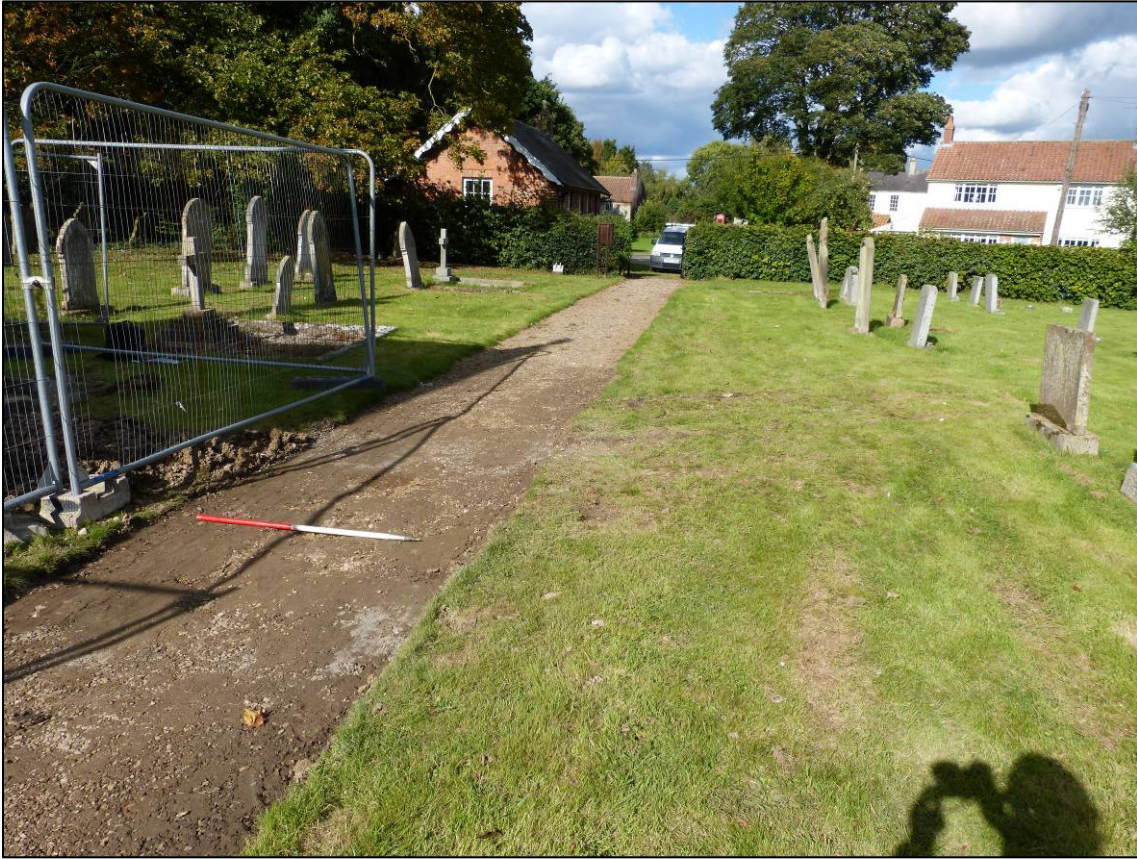
Plate 8: Position of new inspection chamber adjacent to footpath to the east of the church, looking N.

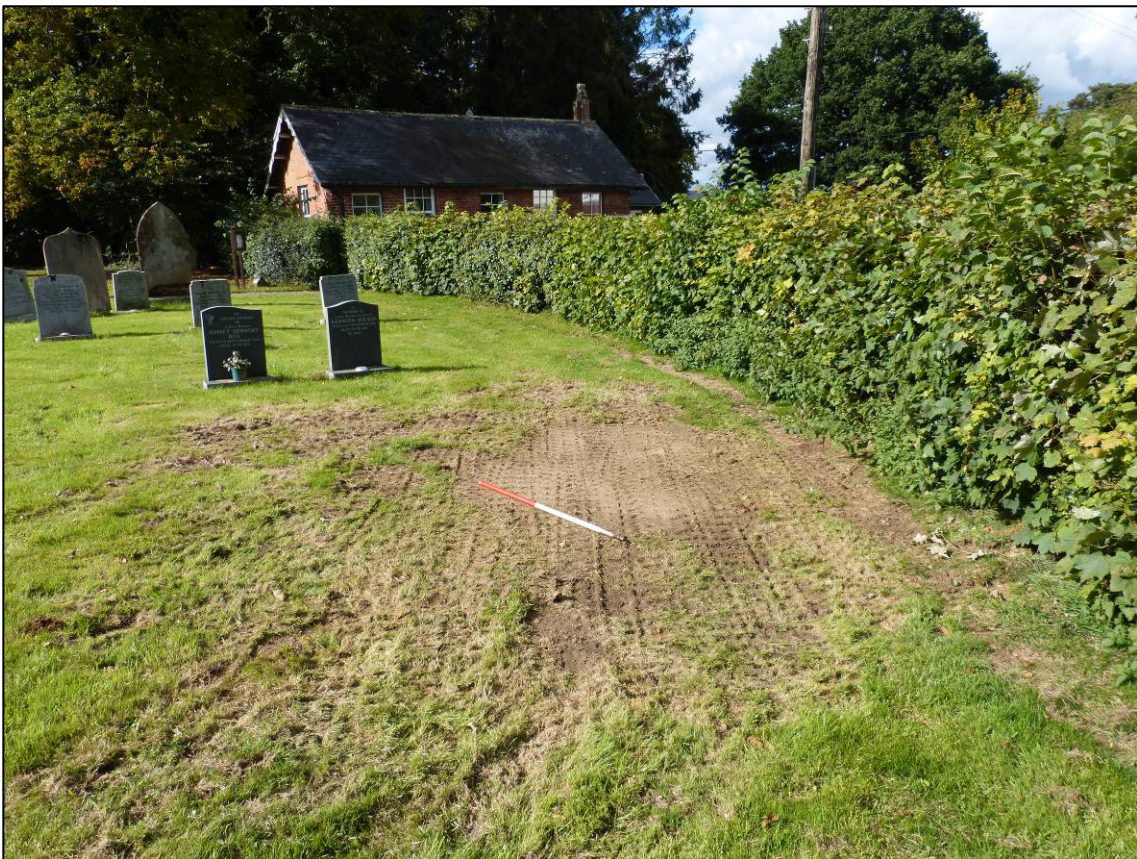
- 5.14 A brief photographic record was made on 25th September 2018 of other works which had been undertaken around the churchyard and which, by agreement, had not been subject to archaeological monitoring. These were the replacement of an existing drain at the nave's south-west external corner, the replacement of an existing drain to the approximate centre of the nave's south wall, the investigation of the connection between two existing drains and the installation of new inspection chamber adjacent to the footpath to the east of the church (see plate 8), and the excavation of a new inspection chamber at the north-east corner of the churchyard (see plate 9).

Plate 9: Position of new inspection chamber in north-east corner of churchyard, looking N.
