FYLING DEER PARK WALL,  
FYLINGDALES, NORTH YORKSHIRE

ARCHAEOLOGICAL RECORDING  
AND MONITORING OF 2016-17 REPAIRS

Report no: 2016/527.R01  
Version: Final  
Date: February 2018  
Author: Ed Dennison

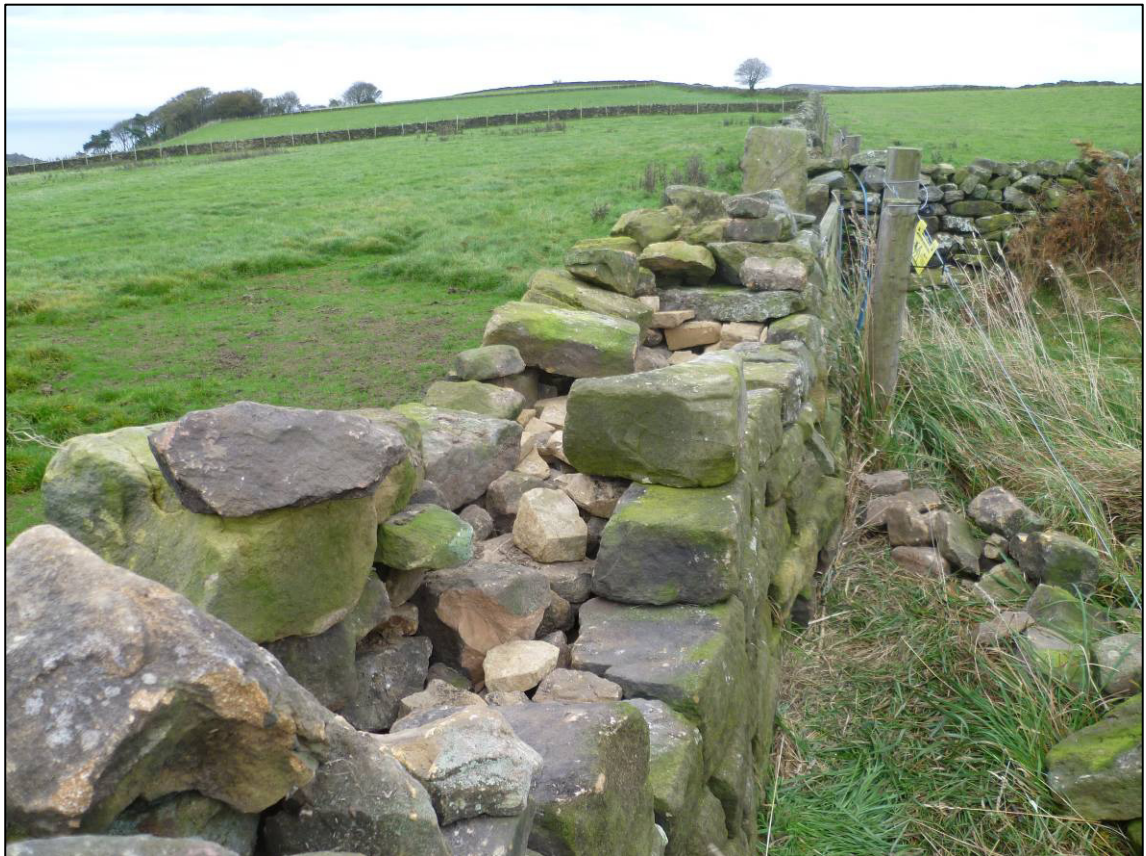
Plate 5: Repairs in progress, east of cross 5, looking E (photo 1/270).

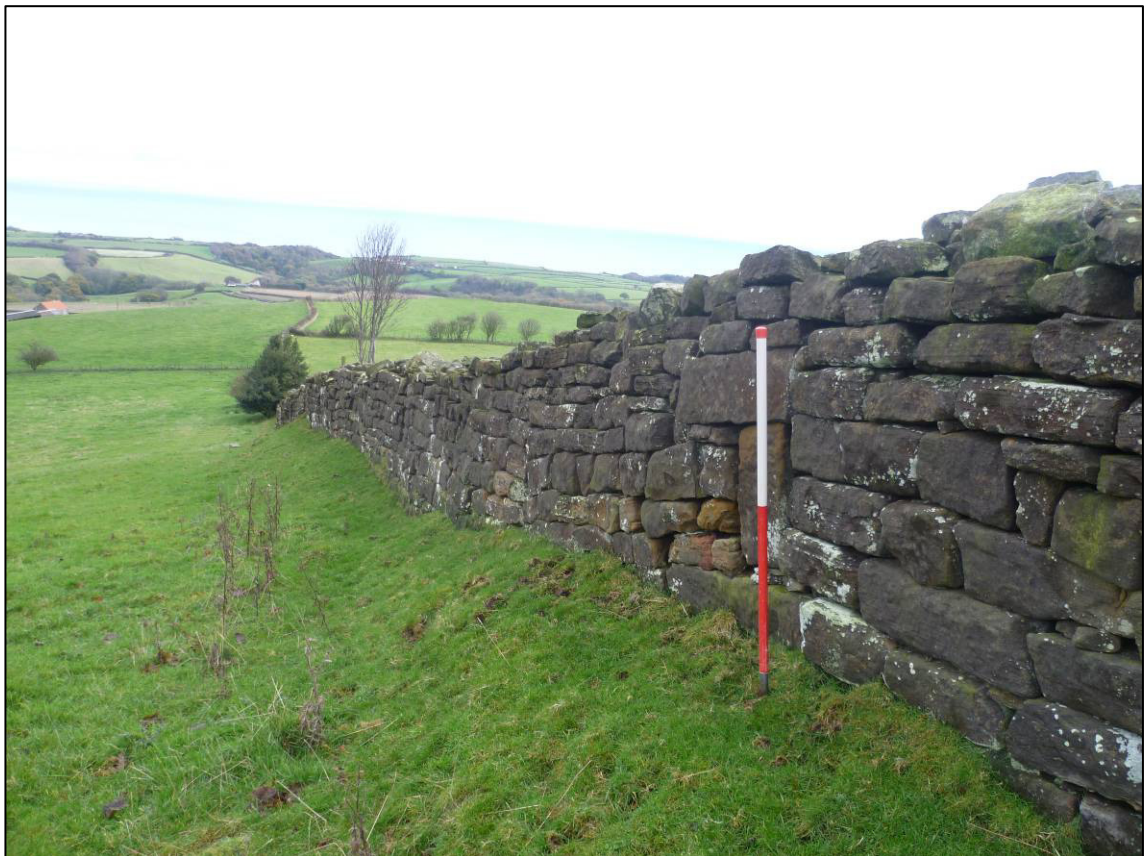
Plate 6: View of north side of wall on bank, east of cross 37, looking NE (photo 2/461).

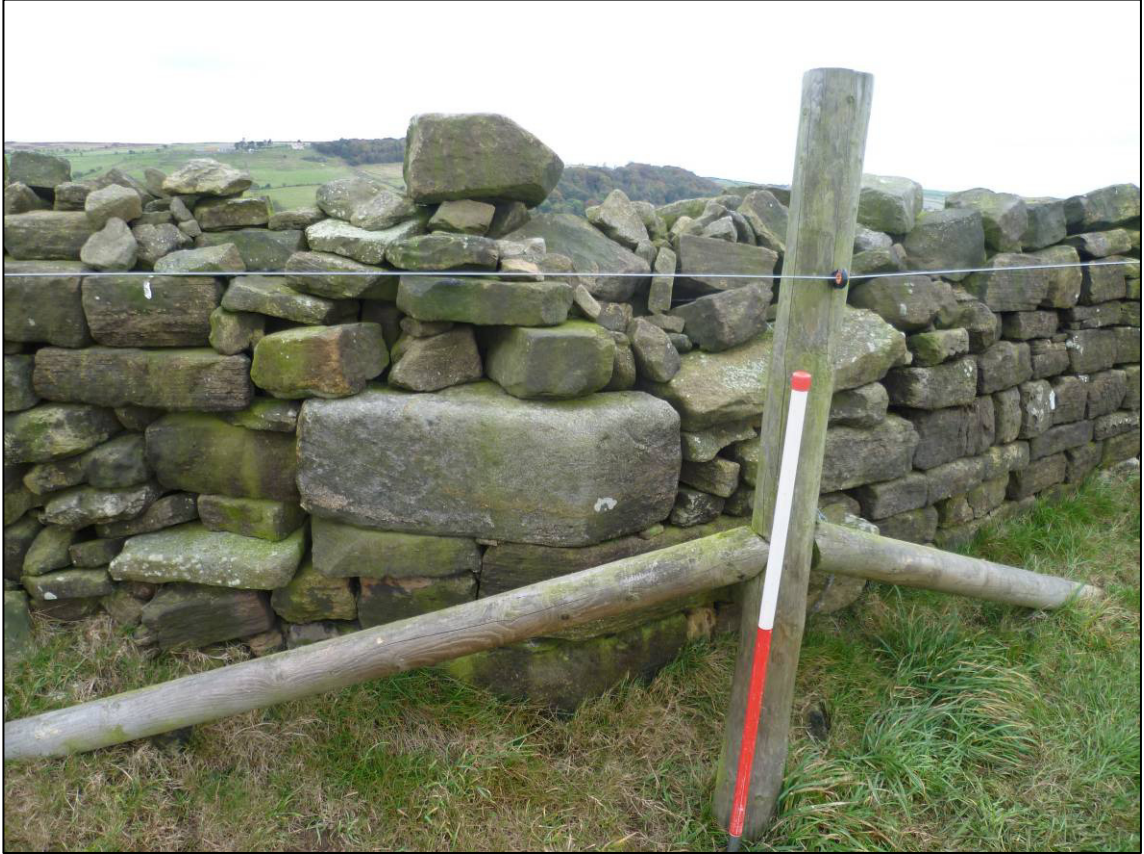
Plate 7: Angled quoins at change of angle, between crosses 27 and 28, south side, prior to repair (photo 1/295).

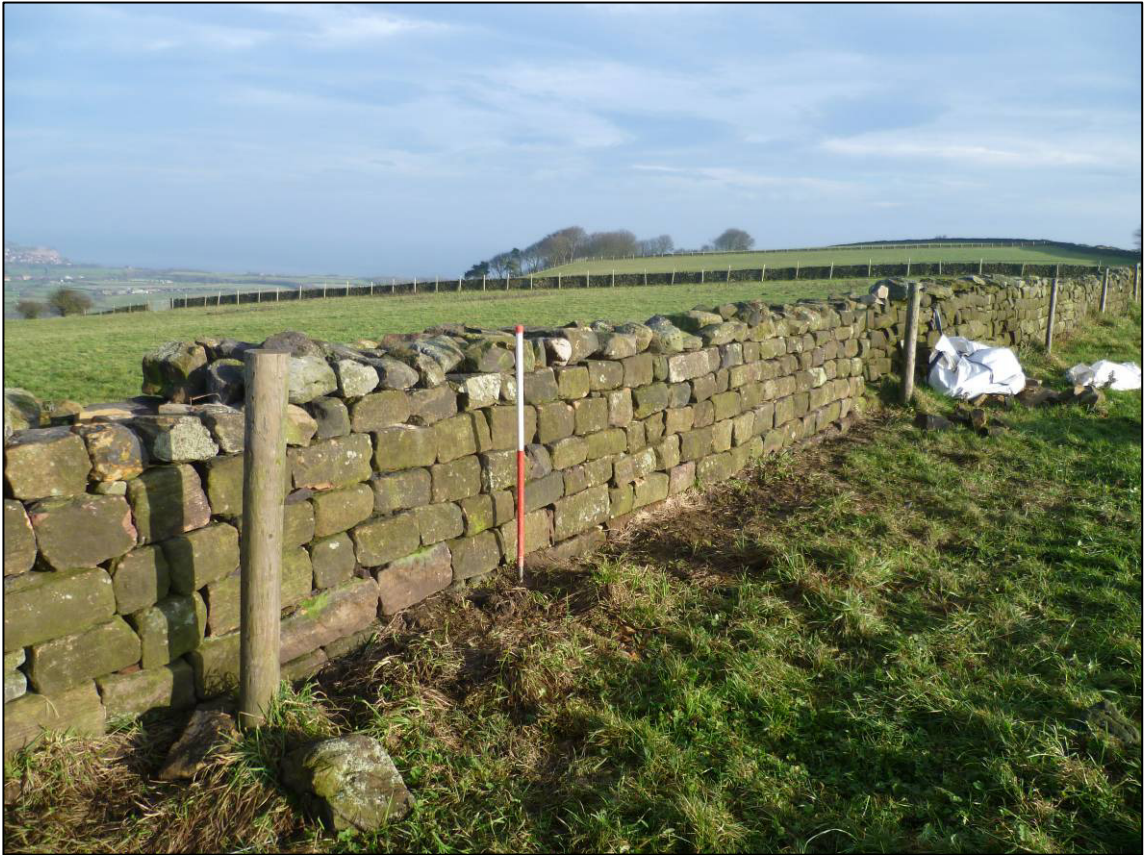
Plate 11: Section of completed repairs, between crosses 8 and 9, south side (photo 3/606).

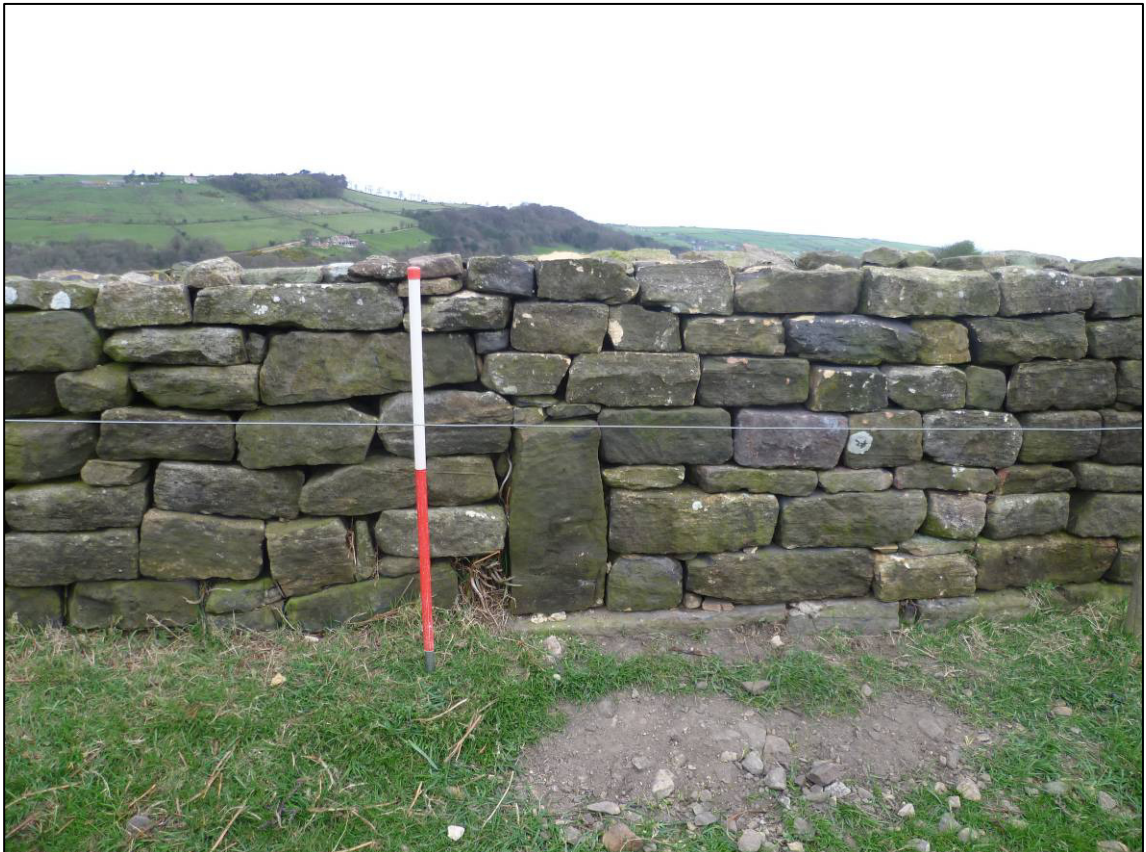
Plate 12: Cross 20, S side, after repairs to adjoining courses (photo 4/031).

<b>20S</b>	Only presumed lower through visible, fairly tall, partly hidden by vegetation. Lower lintel exposed following repairs, with through resting on W end. No upper lintel or through visible. 2016-17 repairs done to wall either side (4/032*-033).	1/287 (S) before* 4/031 (S) after*

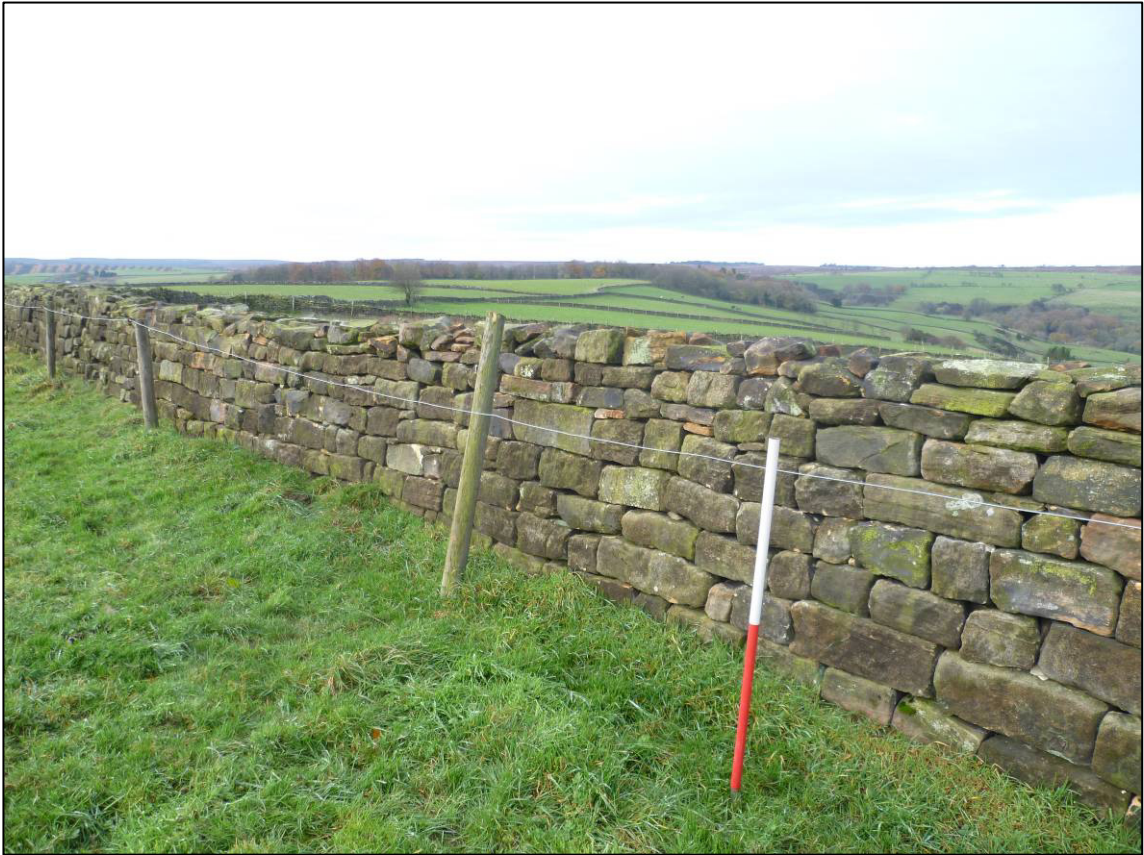
Plate 13: Repaired wall alignment, W of Cross 29, S side, looking W (photo 5/200).

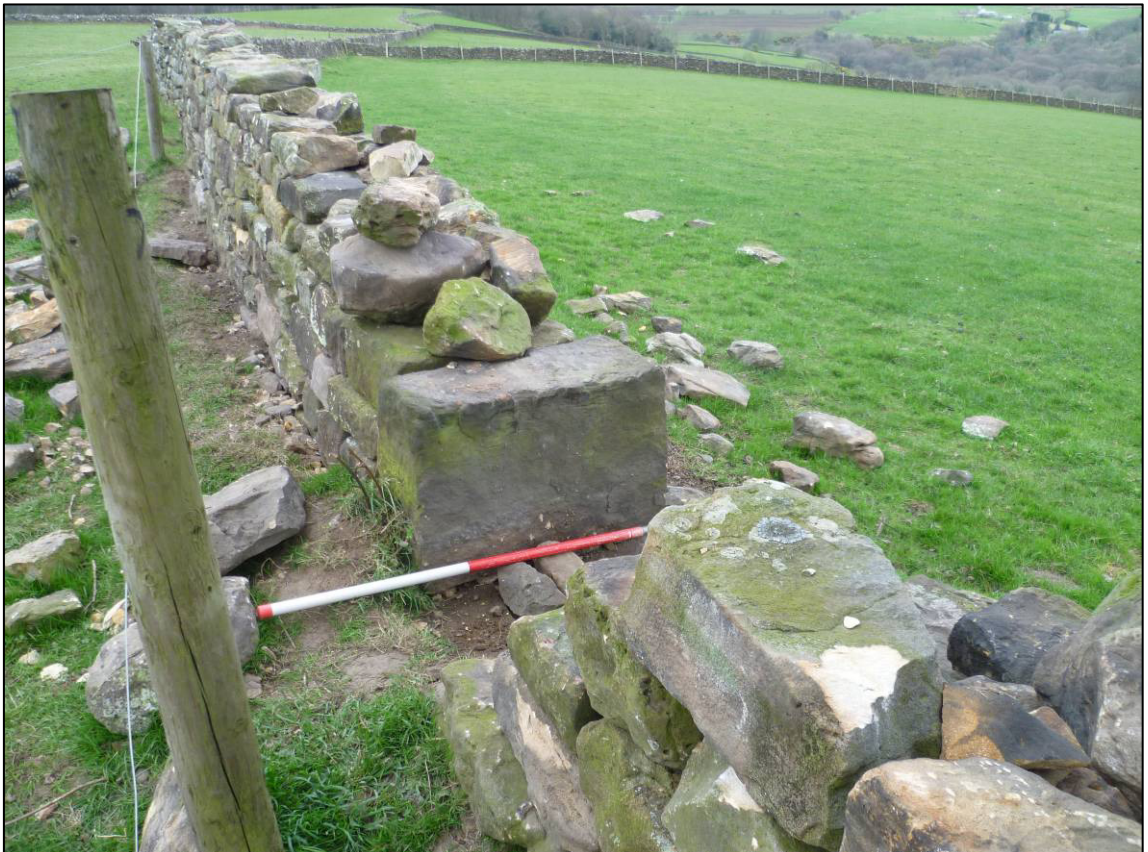
- 5.22 Relatively few crosses were subject to repair or rebuilding, as the current walling project concentrated on the wall structure itself. However, rebuilding work at cross 18 allowed the massive lower through to be seen in its entirety [4/023] (see plate 18) while collapse at crosses 50 and 51 allowed some of the elements to be seen [2/439; 1/313]. The limited repairs that were undertaken to the crosses included the replacement of an upper lintel to cross 9S (almost certainly not with the original stone) [3/611] (see plate 19), the replacement of the upper through to cross 42S (but not with the original stone, and not as a through) [1/304; 5/173], the addition of an upper through to cross 44S [1/305; 5/170], and the addition of upper lintel and upper through at cross 46 when the adjacent wall opening was infilled [2/445; 5/167].

Plate 18: Cross 18, repairs in progress (photo 4/023).

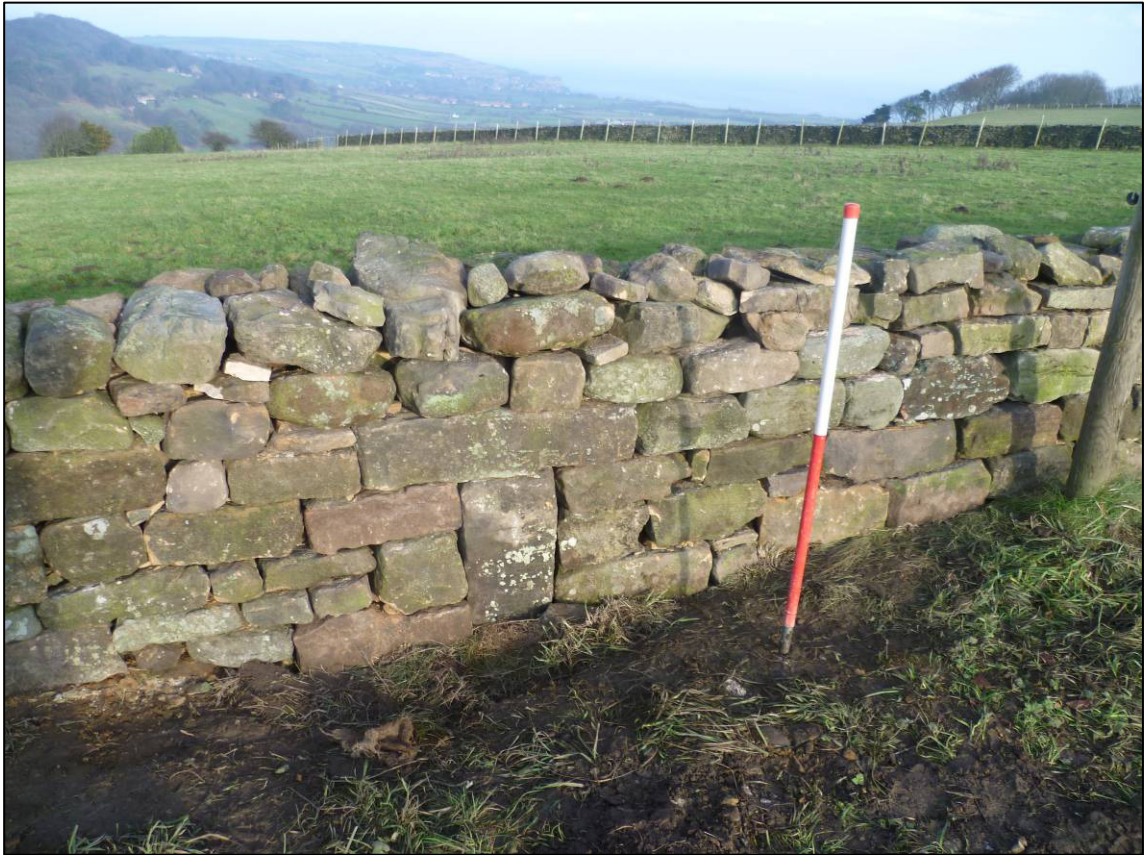
Plate 19: Cross 9, south side, after repairs (photo 3/611).

<b>9S</b>	Lower lintel not visible, lower through visible in area of old wall repair. Upper elements not visible. Repaired 2016-17 with thin upper lintel (possibly not original) added. Courses to E rebuilt (3/613*). Repairs done in 1991 either side of cross up to cross 10S.	3/611 (S) after*

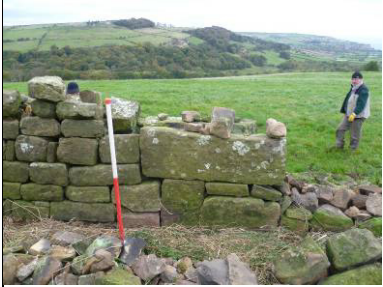
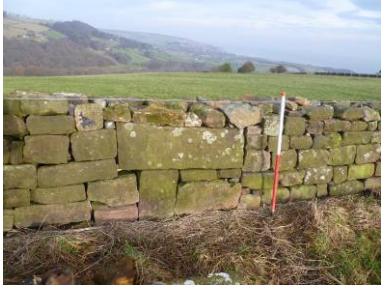
<b>Cross</b>	<b>Description</b>	<b>Photo</b>	<b>Photo before</b>	<b>Photo after</b>	<b>Other photo</b>
<b>4S</b>	Repairs in progress 27/10/16. Adjacent to section of rebuilt wall. Lower lintel not visible, upper lintel markedly off centre to lower through. No upper through. Fall of 0.9m between N & S sides of wall. Characteristics retained in 2016-17 rebuild (3/602).	1/243 (S) in progress* 2/498 (S) after 3/601 (S) after*

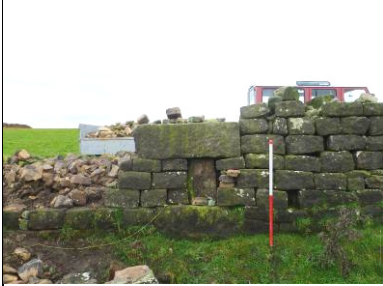
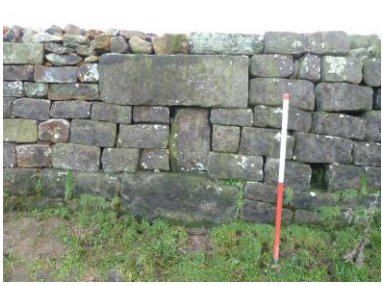
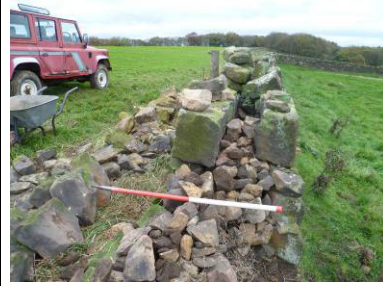
<b>4N</b>	Repairs in progress 27/10/16 (1/249*). Adjacent to rebuilt section of wall. Two lintels, lower through slightly set back from wall face. Upper lintel slightly off centre. Upper through missing. Characteristics retained in 2016-17 rebuild.	1/248 (N) in progress* 2/495 (N) after 2/496 (N) after* 3/594 (N) after 3/595 (N) after

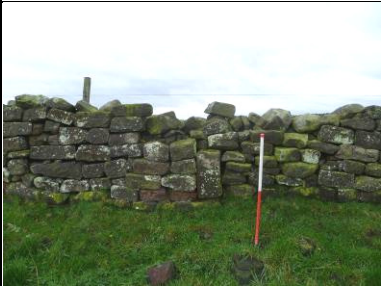
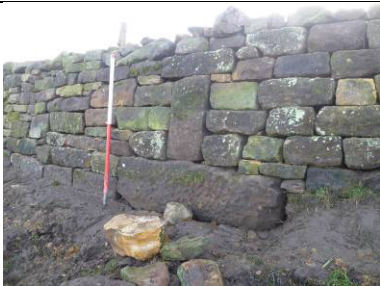
<b>9N</b>	Lower lintel mostly buried, tall lower through visible. Remainder lost in area of old wall rebuild. 2016-17 rebuild revealed full extent of lower lintel, lower through turned round as part of repairs. Small upper lintel (not original) added.	1/255 (N) before* 3/612 (N) after*

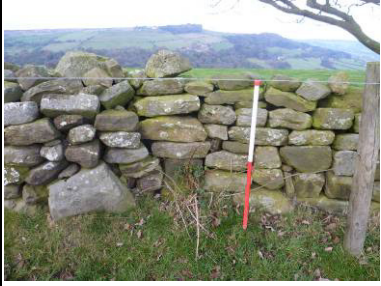
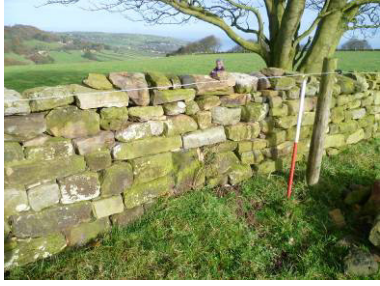
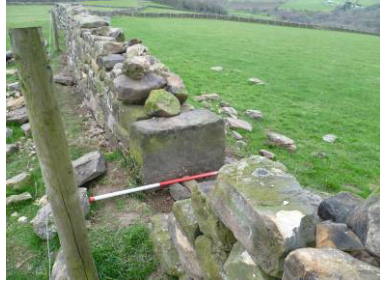
<b>18S</b>	Only lower through visible with small bramble in front, lower lintel hidden, upper lintel and through missing in area of old rebuild. 2016-17 repairs in progress 4/4/17 (4/023*), lower through exposed, measures 0.72m long (through wall) x 0.32m wide x 0.50m high. Rebuilding of courses above lower through and wall tops reset. Some rebuilding to W (5/217). Rough rebuilding to E in 1991.	2/487 (S) before* 5/216 (S) after*

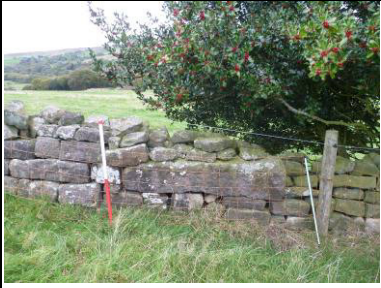
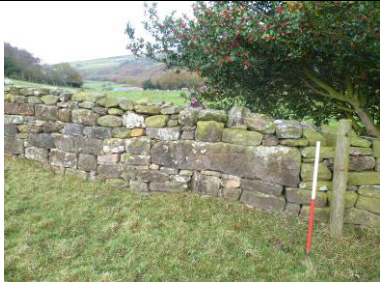
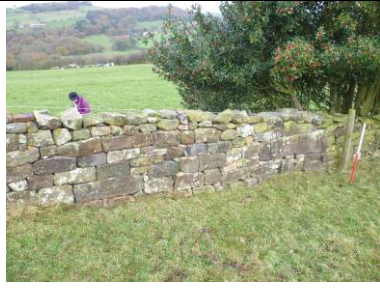
<b>44S</b>	Adjacent to holly tree (right). Lower through partly buried, overly long off centre upper lintel above. No upper through. Old rebuilding all around, random stones on wall top. Repairs done 2016-17. Adjacent wall tops rebbed and wall to W repaired (5/172*). New upper through placed on top of massive upper lintel.	1/305 (S) before* 5/170 (S) after*
