FLAMBOROUGH CASTLE, TOWER STREET,  
FLAMBOROUGH, EAST YORKSHIRE

ARCHAEOLOGICAL SURVEY  
AND MONITORING OF 2017-18 REPAIRS

Report no: 2017/538.R01  
Version: Final  
Date: December 2018  
Author: Ed Dennison & Shaun Richardson

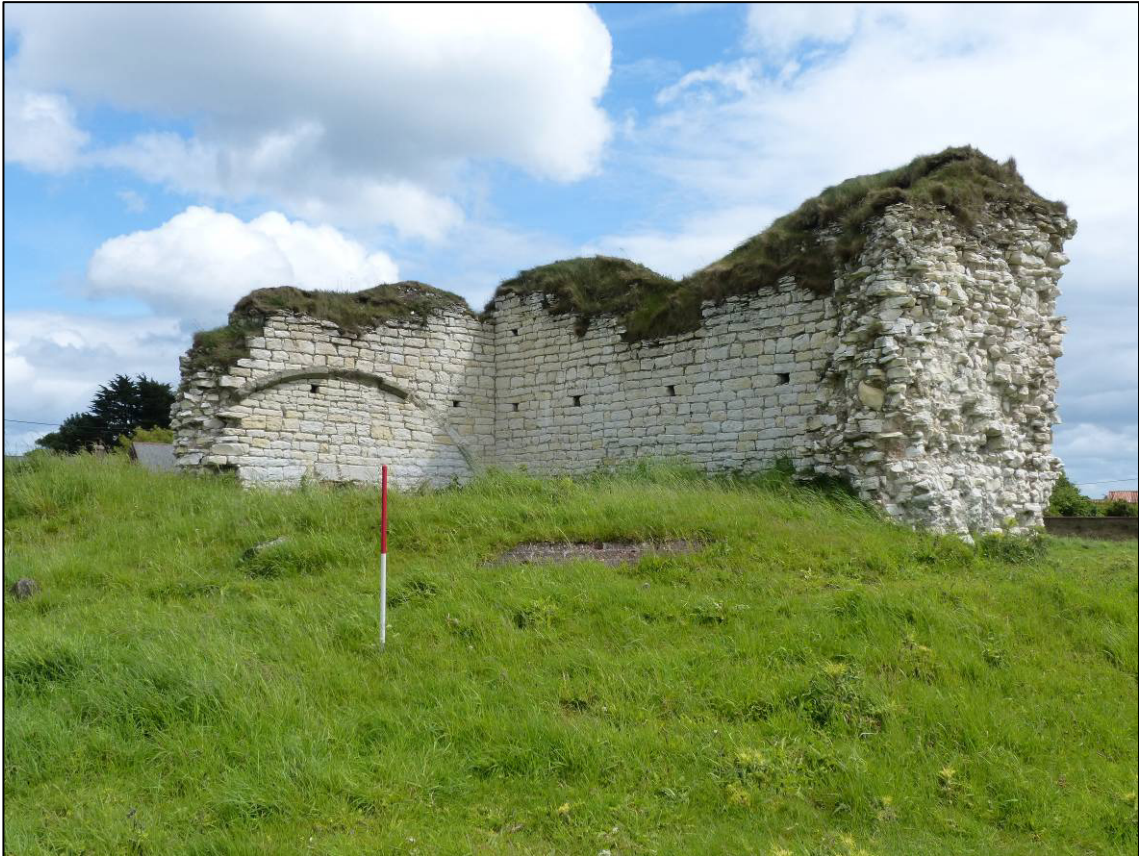
- 3.41 At the base of the south wall, the wall face steps out by 0.14m, the step being visible across the whole elevation. Three chamfered sandstone springers for the vault ribs survive *in situ* at the eastern end of the step, possibly with a fourth truncated example to the west [1/808; 4/797] (see plate 35). There are two damaged areas to the west end of the step at the same spacing as the surviving springers, and it appears that there were eight transverse ribs in all, set at 1.10m centres. The ribs supported a chalk vault over; a chamfered chalk springer course for the vault sat directly on top of the step, although the only remnants are a block to either end. It is curious that, above the step, there is no clear evidence for any damage left by the removal of the floor supported by the vault. The wall face is very clean, with no indication that there was ever corework over the vault which was tied into the wall, or even evidence for a timber floor laid above the vault. There are three lines of putlog holes visible, five to the lowest line, five to the middle line, and two to the upper line [1/801; 3/278] (see figure 12E) (see plate 25).

Plate 25: Castle (Site 6G), internal elevations, looking SE (photo 1/815).

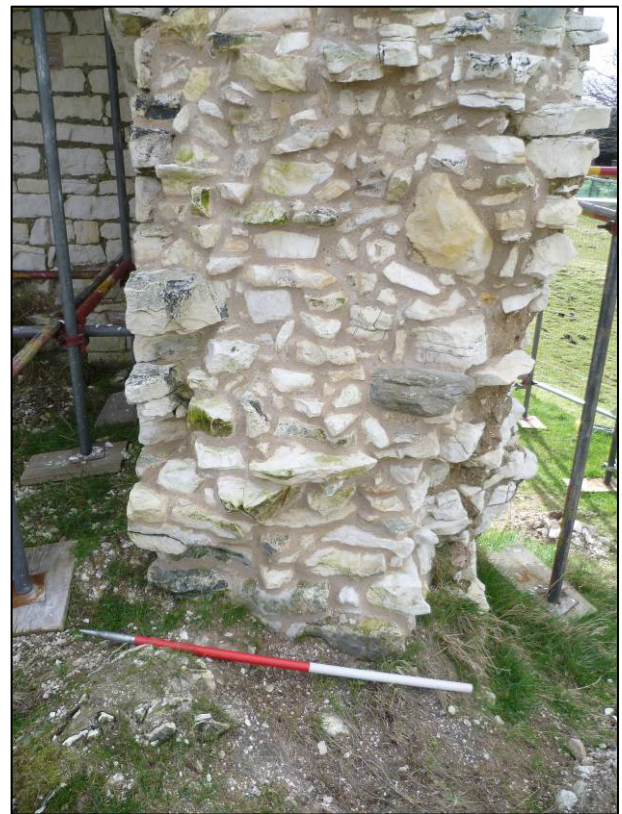
Plate 27: Castle (Site 6G), north end of west wall, window opening, after repair, looking S (photo 4/798).

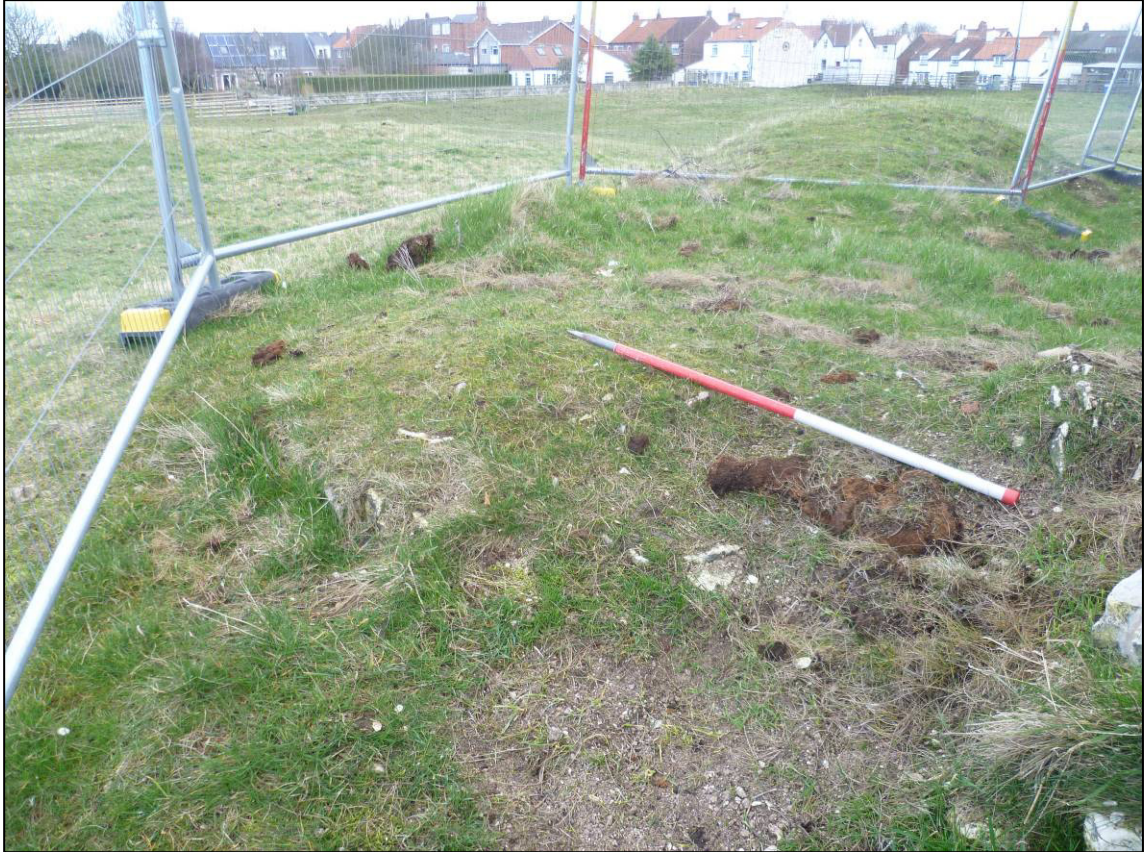
Plate 28: Castle (Site 6G), remains of former buttress at north-west corner, looking NE (photo 5/809).

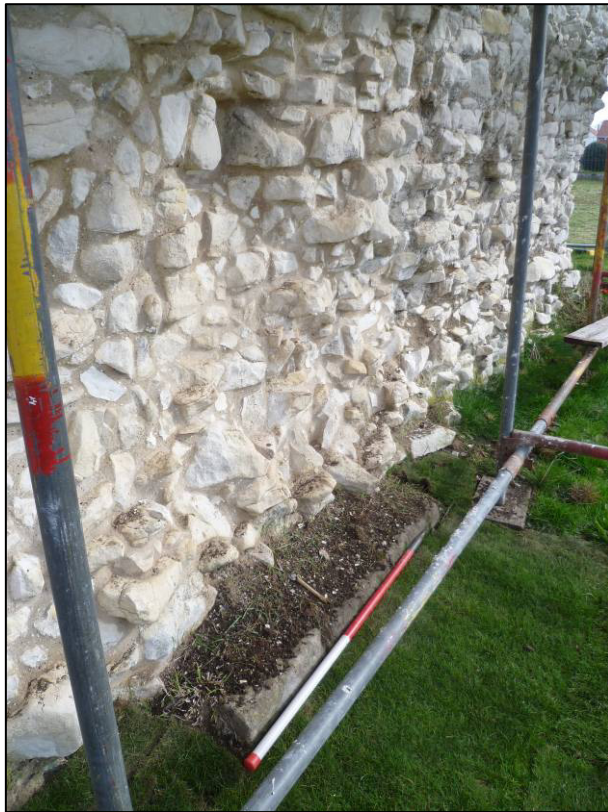
Plate 29: Castle (Site 6G), south external elevation, exposed plinth at base of wall with area of returfing, looking NE (photo 5/832).

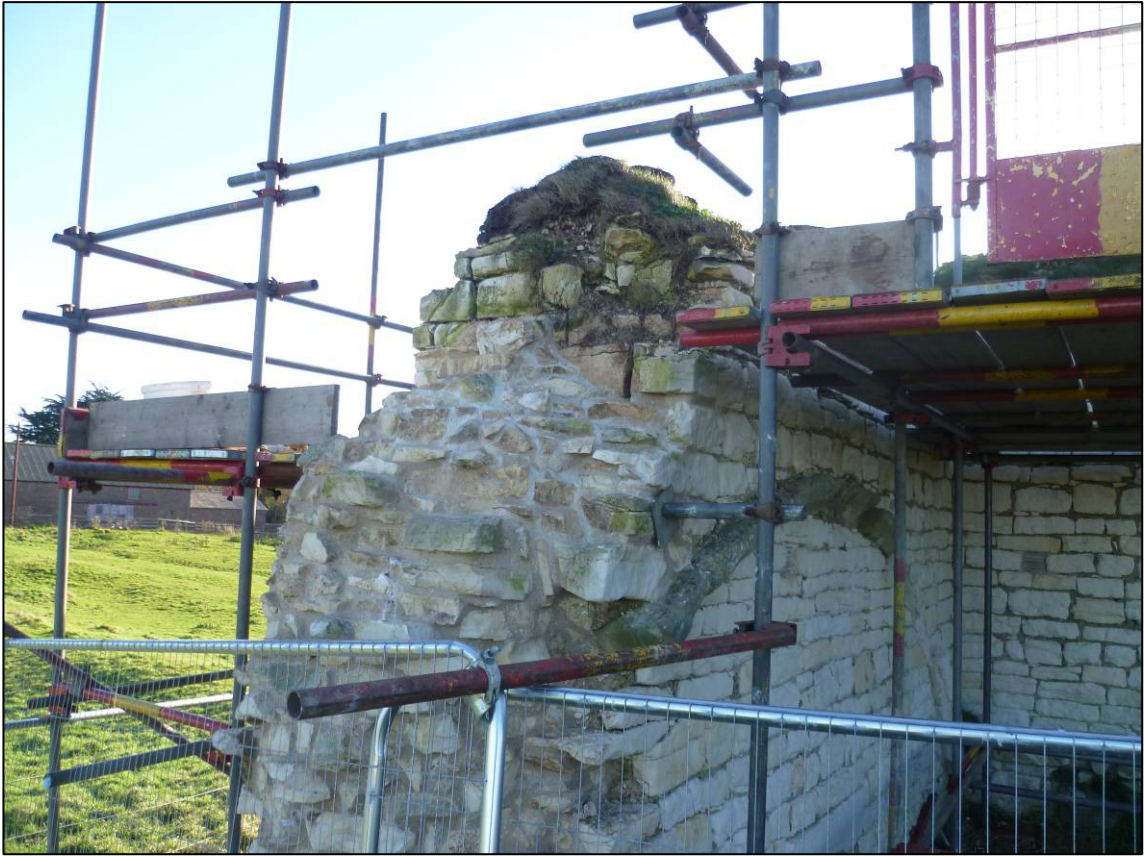
Plate 33: Castle (Site 6G), east elevation, doorway at north end of elevation under repair, looking S (photo 3/314).

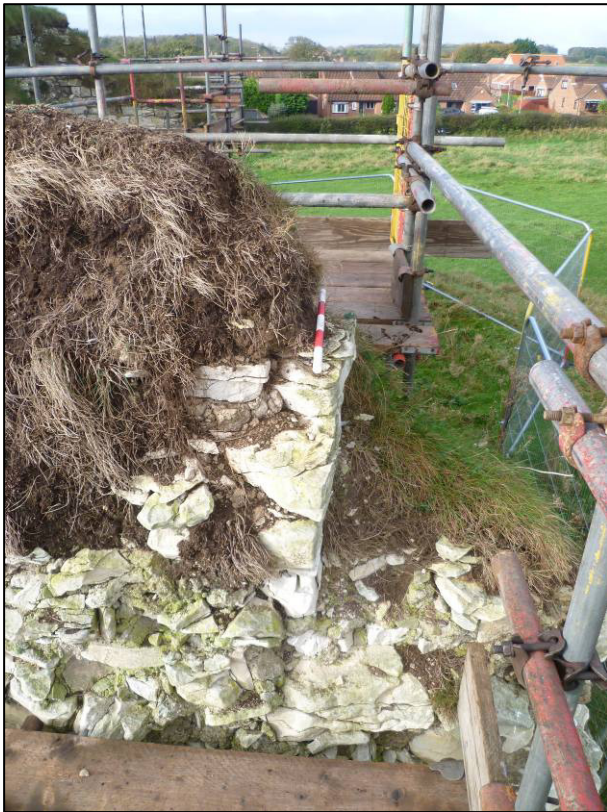
Plate 34: Castle (Site 6G), east elevation, doorway at north end prior to clearance, looking W (photo 2/972).

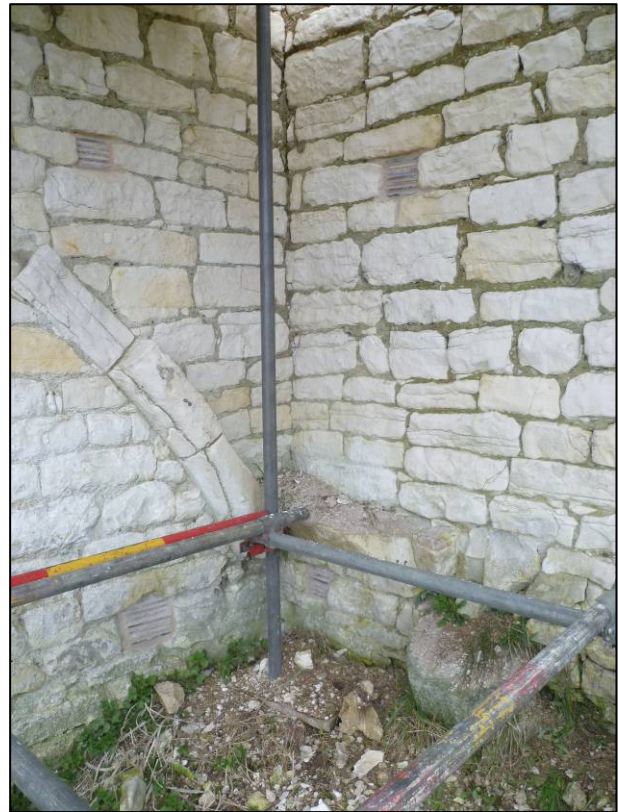
Plate 35: Castle (Site 6G), internal south-east corner after repair, showing springer for vault, looking SE (photo 4/797).

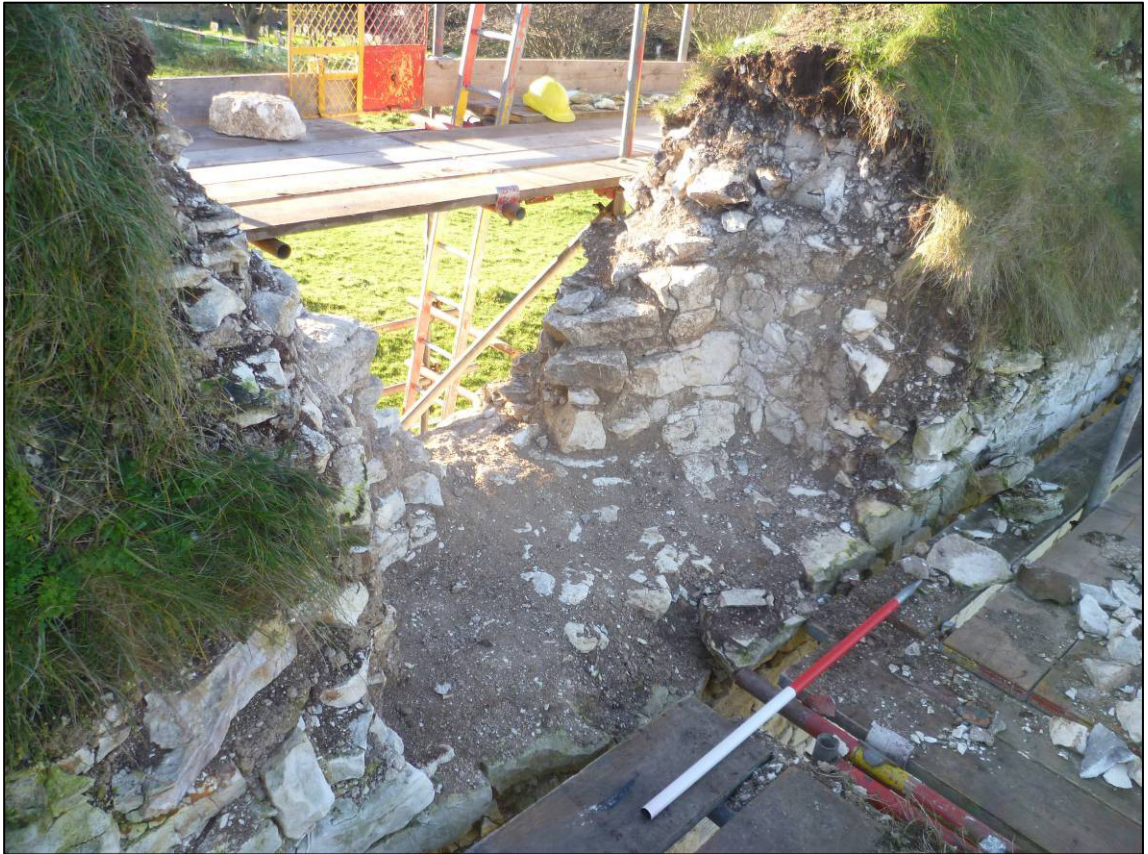
Plate 36: Castle (Site 6G), south internal wall top, window after clearance, looking SW (photo 3/270).

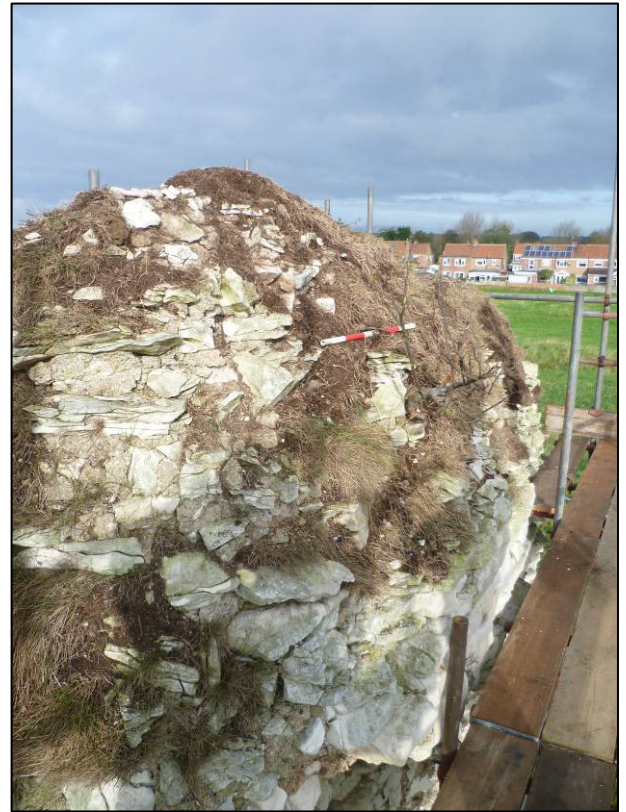
- 3.46 In order to facilitate the repair works, the castle ruins were scaffolded, although only the upper level was boarded out as this is where the majority of the works were due to be carried out [2/960, 2/983-2/985; 3/319, 3/320, 3/323, 3/325, 3/328, 3/332-3/334; 4/801; 5/869, 5/874]. The tops of the surviving three walls forming the tower were covered with a dense mat of grass vegetation, some of which was already dead [2/977, 2/979-2/982, 2/991, 2/992, 2/996-2/999; 3/284-3/286, 3/295, 3/296, 3/298, 3/299, 3/301-3/303] (see plate 40). There were also some areas of decaying concrete, for example around the southern wall top window opening [2/989]. Underneath this, the chalk was very loose and heavily fragmented, to a depth of about 0.7m [2/964-2/967] (see plate 39).

Plate 39: Castle (Site 6G), east elevation wall top prior to clearance, looking N (photo 2/966).

- 3.47 The repair works involved stripping off this material and the underlying loose debris until a firm or stable wall top was reached. Some limited rebuilding and chalk replacement was done to maintain the original profiles, and the uppermost courses to the internal and external faces were repointed [3/290; 4/763, 4/770-4/778, 4/780, 4/782, 4/783, 4/788-4/790] (see plate 41). New soil was then put in place on the wall tops, and a new covering of turf laid over the top; the turf was held in place using short lengths of bamboo cane [5/811, 5/812, 5/815-5/818, 5/822, 5/824-5/831, 5/836, 5/872, 5/876] (see plate 42). Some spare turf was placed around the base of the castle [5/832], and within the newly exposed window reveal [5/823] (see plate 44). Most of the putlog holes, internal and external, were also blocked with recessed clay tile slips as part of the repair works to prevent water ingress and nesting birds [3/277, 3/307, 3/310, 3/316, 3/321; 4/799] (see plate 41). The north end of the west wall was also consolidated in its entirety [3/280, 3/317; 5/835] (see plate 43), although the remainder of the wall faces, below the level of scaffolding, were not repointed [4/791] (see plate 45).

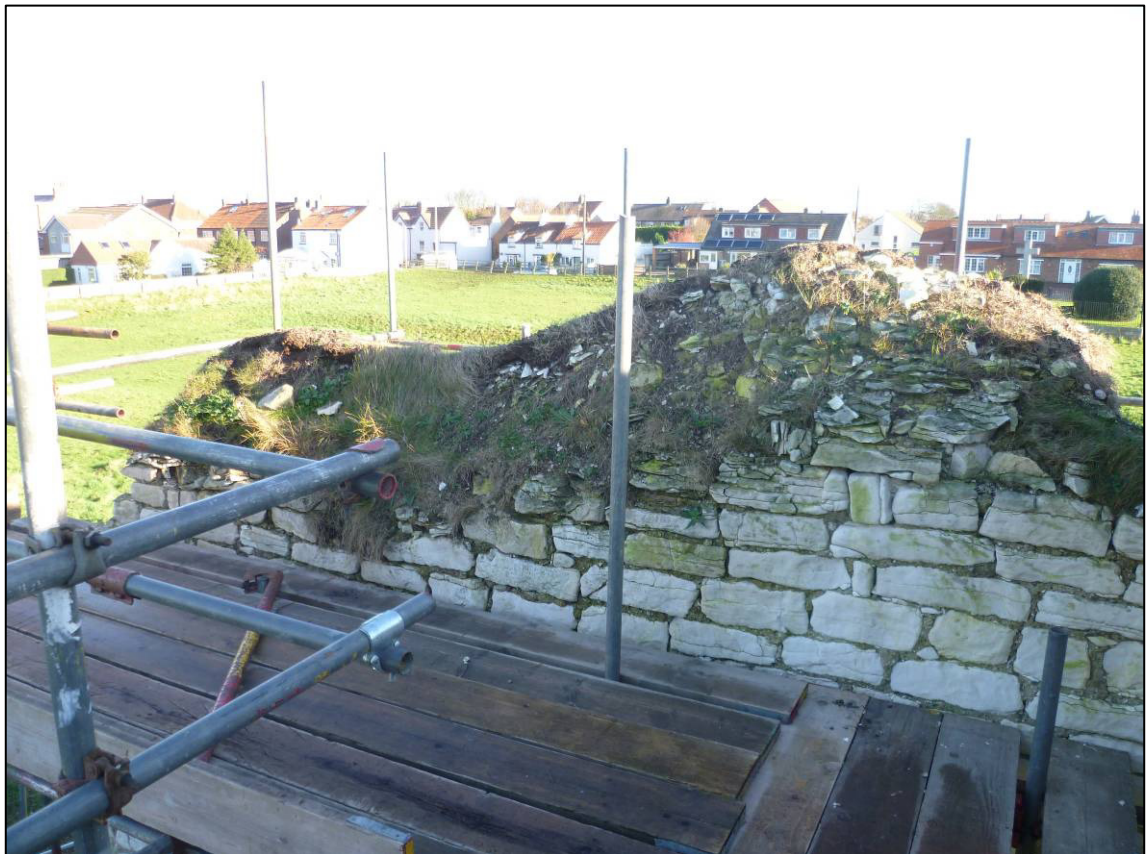
Plate 40: Castle (Site 6G), east internal wall top prior to clearance, looking SE (photo 3/301).

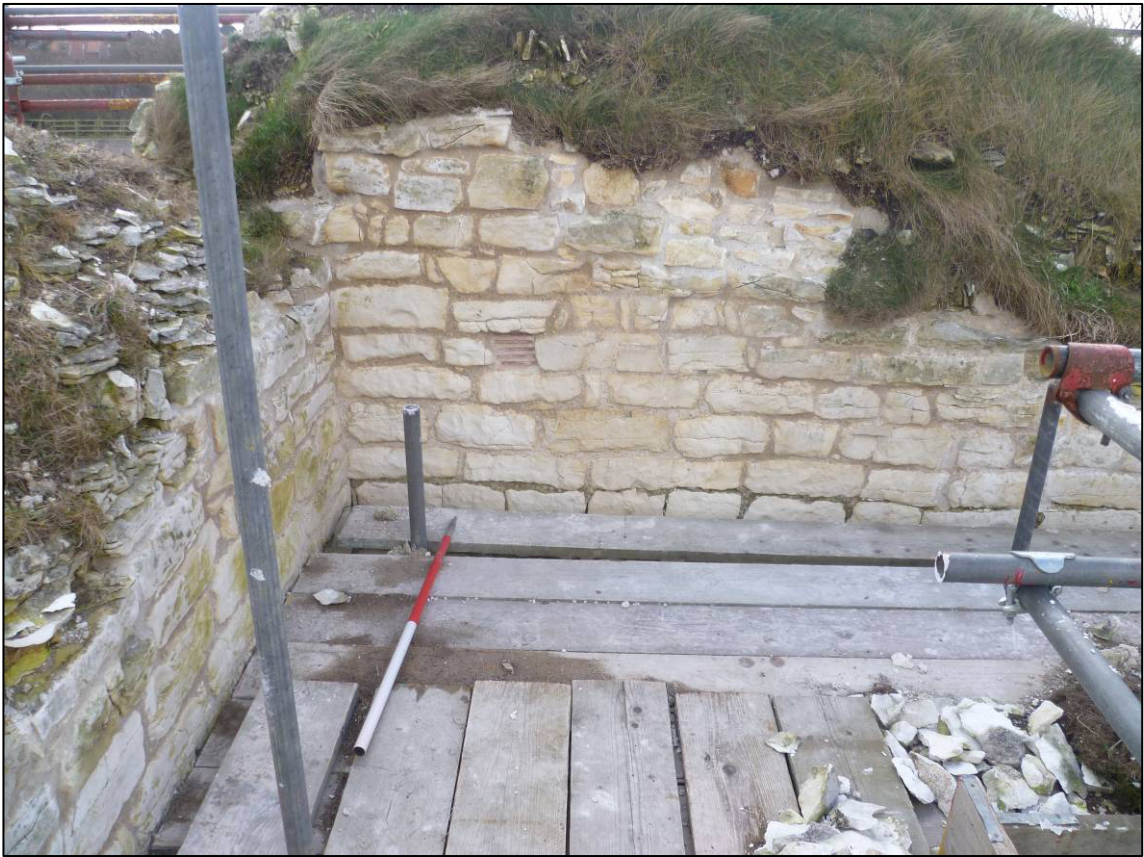
Plate 41: Castle (Site 6G), south internal wall top, east end, after repointing, looking S (photo 4/772).

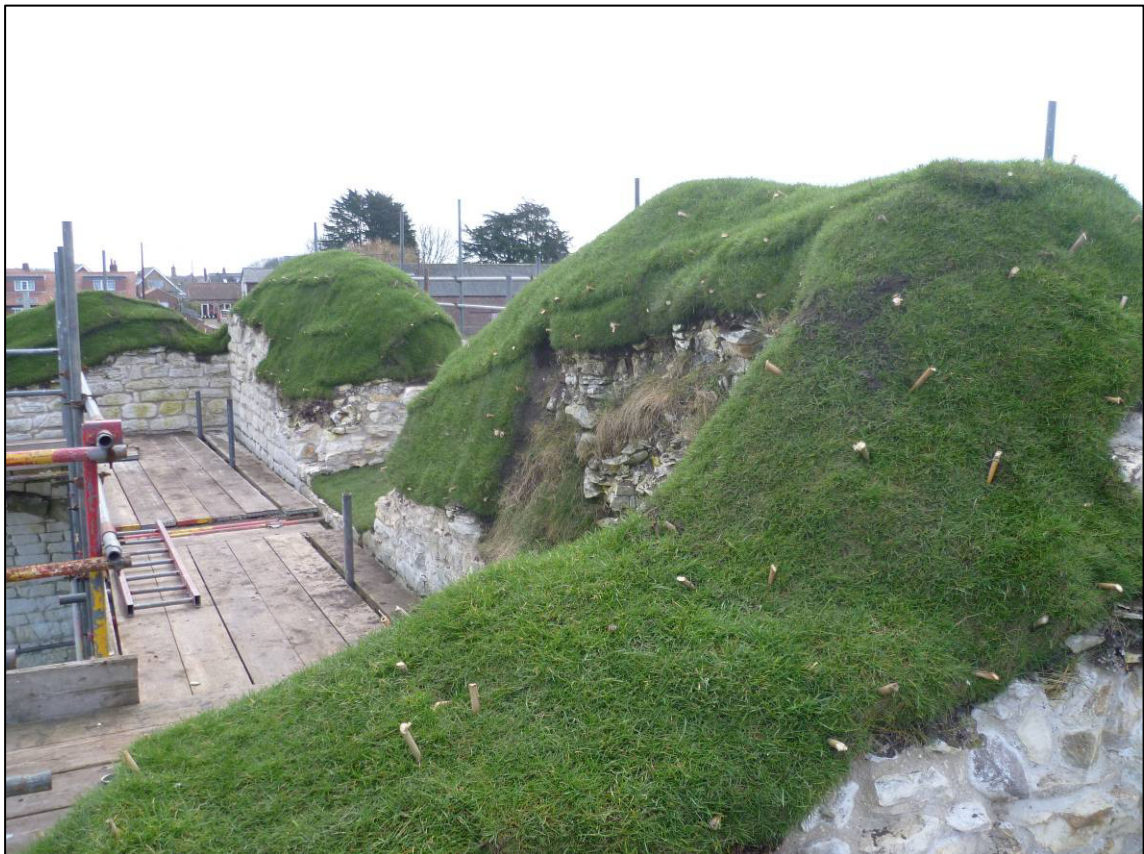
Plate 42: Castle (Site 6G), general view of soft capping, looking SE (photo 5/822).

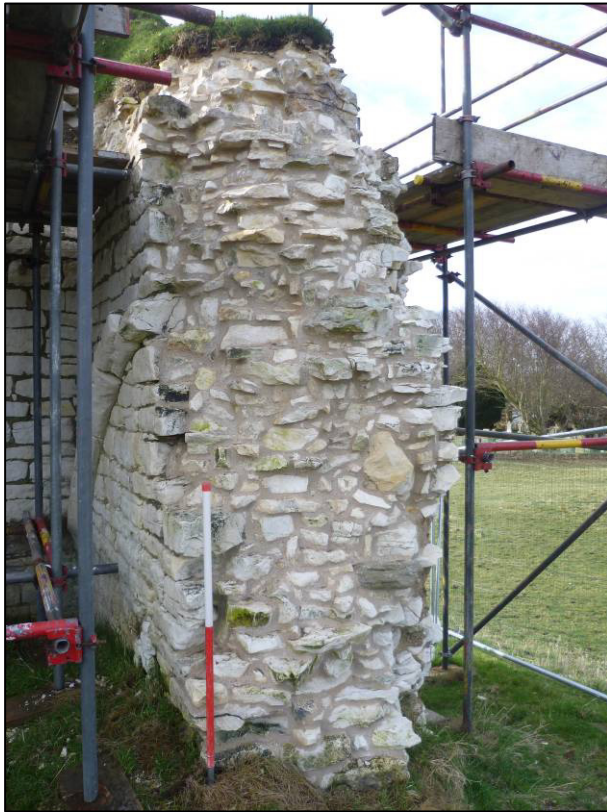
Plate 43: Castle (Site 6G), north end of west wall after repairs and soft capping, looking S (photo 5/835).

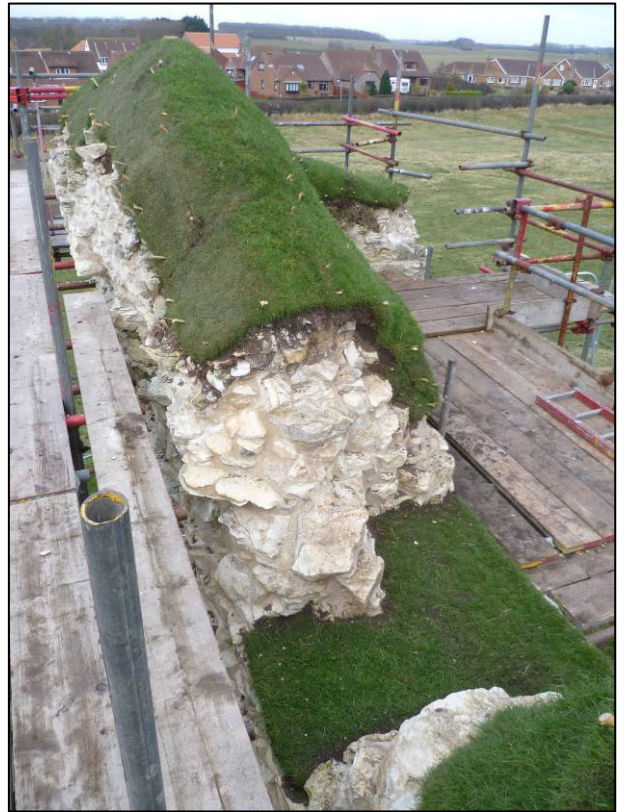
Plate 44: Castle (Site 6G), south elevation wall top, window opening after soft capping, looking E (photo 5/817).

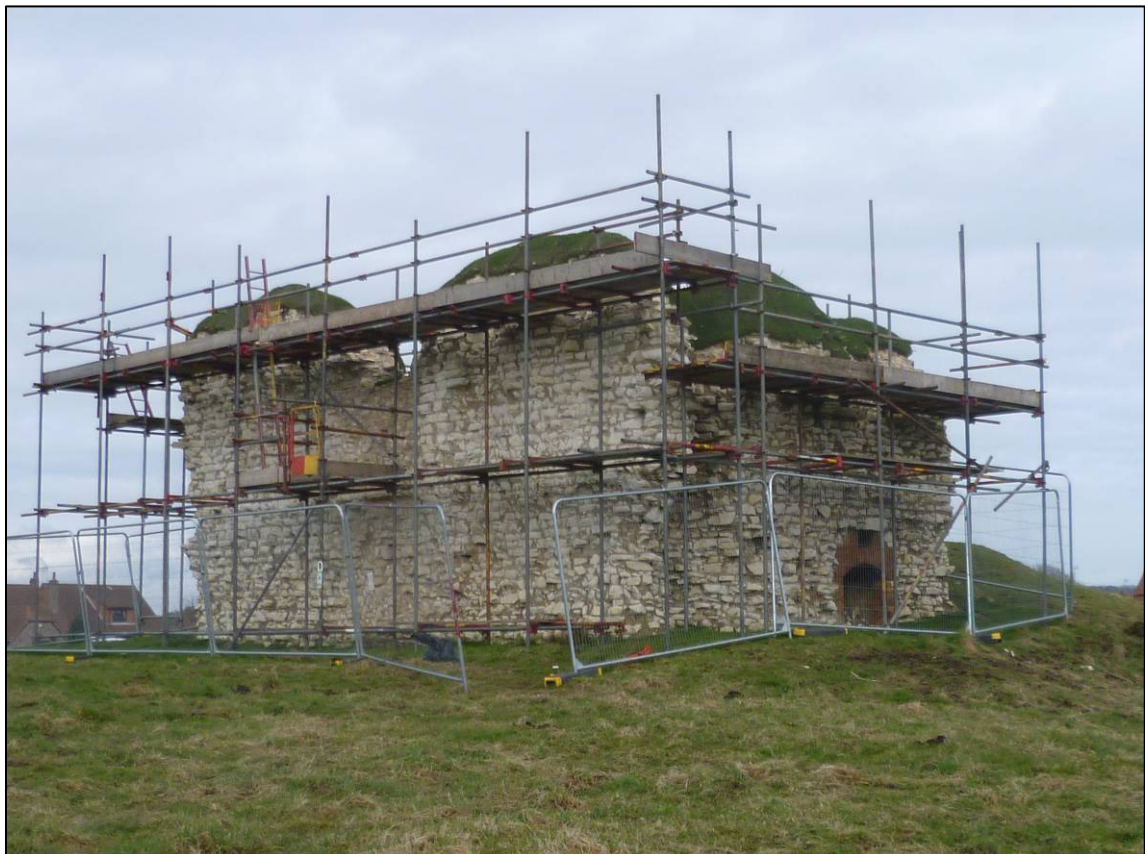
Plate 45: Castle (Site 6G), south and east elevations with soft capping, looking NW (photo 5/874).
