YEDINGHAM PRIORY,
YEDINGHAM, NORTH YORKSHIRE

ARCHAEOLOGICAL AND ARCHITECTURAL
OBSERVATION, INVESTIGATION AND RECORDING

Report no: 2017/535.R01
Version: Final
Date: January 2018
Author: Ed Dennison & Shaun Richardson

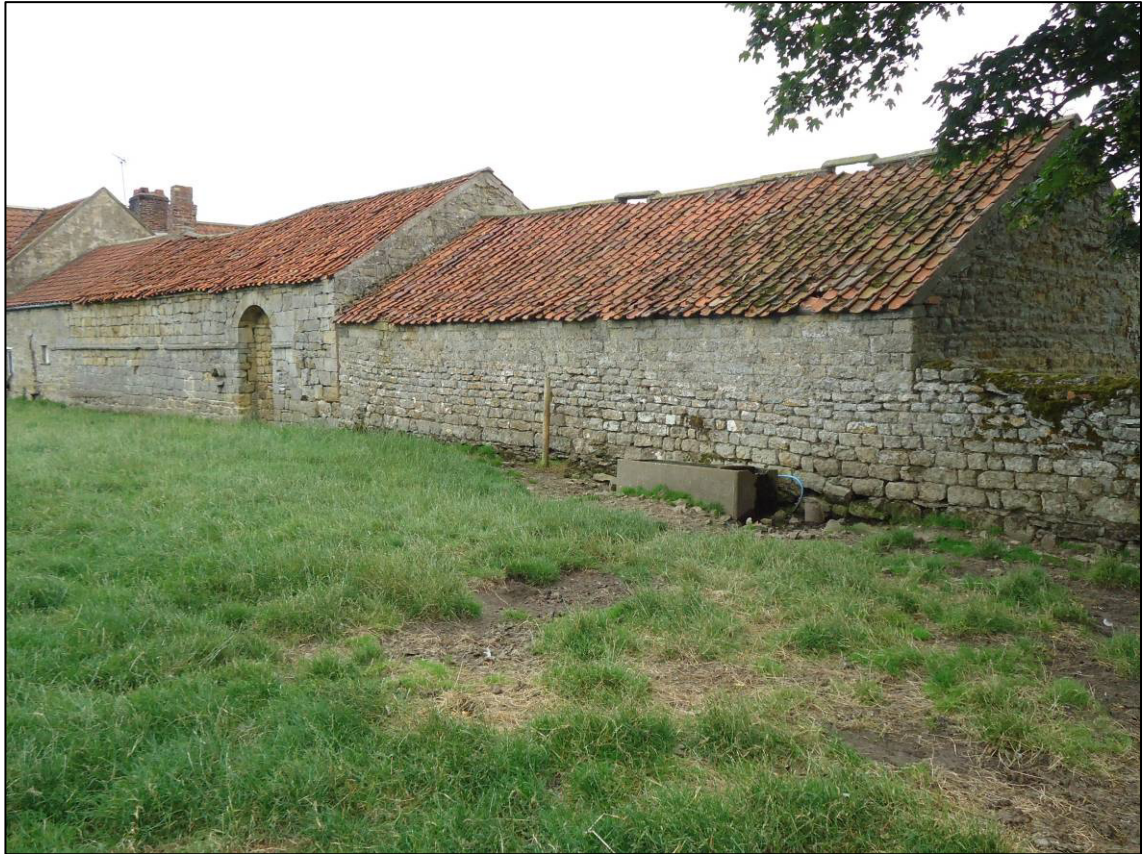
- 3.11 The north elevation of the cart shed [1/310; 3/909-3/911, 3/913; 4/145] is generally built of coursed and squared stone, set with a lime mortar (see plates 7 and 8). Three different phases can be seen within the 2.08m high wall. The base of the wall (0.28m) is founded on several thin uneven courses, above which is c.1.0m of larger more regular and squared stones, the courses becoming progressively thinner from bottom to top, while the final four or five top courses are altogether larger, squarer and much more regular; prior to repointing, the upper courses were well mortared compared to the courses below. The coursing in the lowest two phases runs directly through into the adjacent field wall while above this the west end of the cart shed ends with quoins [4/146]. This suggests that the north wall of the cartshed was raised from the height of the existing field wall when it was built, possibly with reclaimed priory stone, while the lowest courses may be an earlier phase or a foundation. Although some detail has been lost following the repointing, the three phases in the wall face can still be seen.

Plate 7: North elevation of cart shed, prior to repointing, looking SE
(photo courtesy Peter Pace).

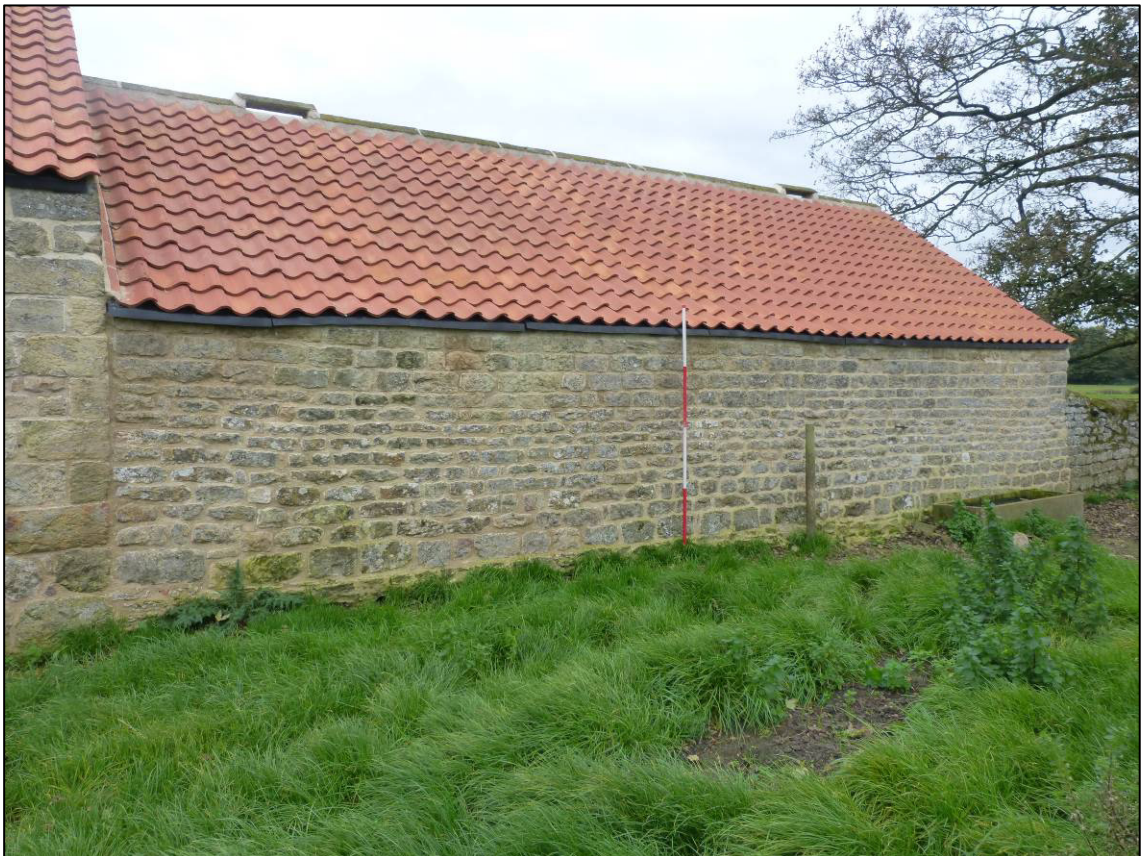
Plate 8: North elevation of cart shed, after repointing and re-roofing,
looking SW (photo 3/909).

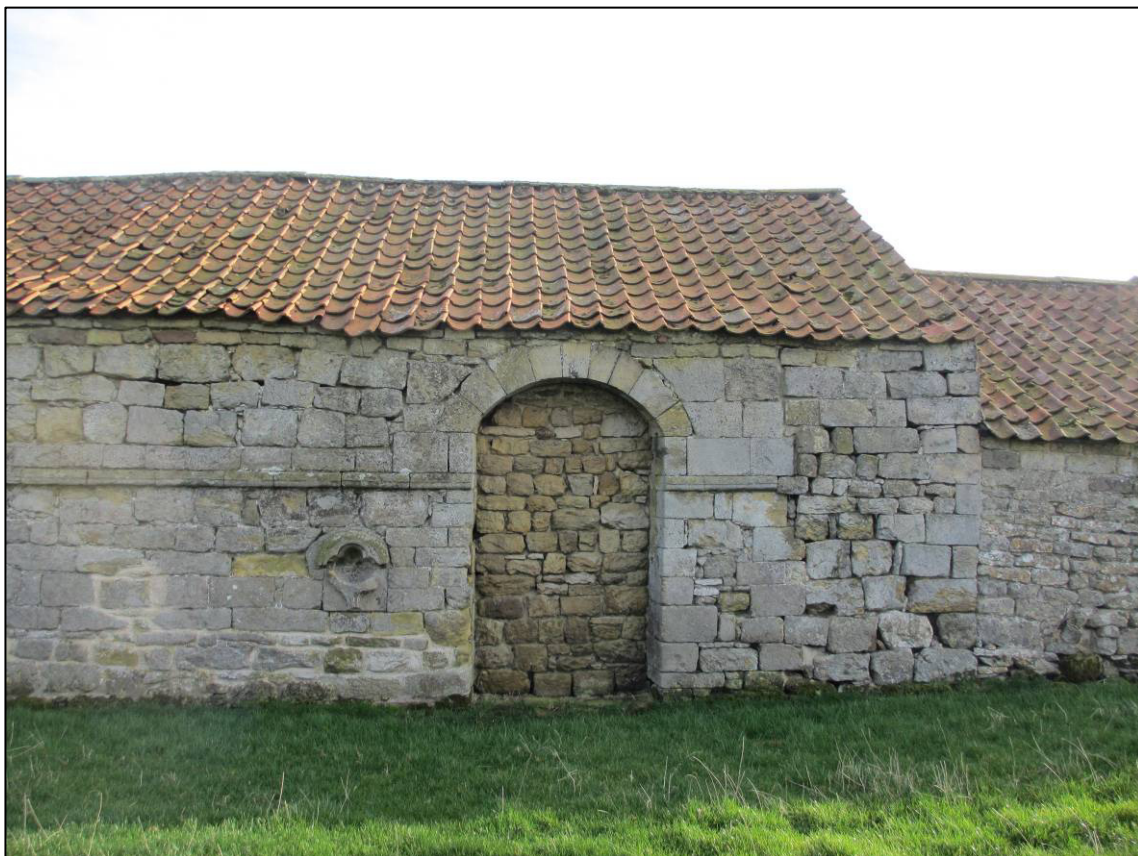
- 3.12 At the west end of the barn's north elevation, there is a slightly ragged joint, set 1.00m to the east of the north-west corner; the coursing to the east of this joint does not match that to the west (see plate 9). It has been suggested that the different masonry marks the former return of the church's west wall (Proctor 2014); the upper part of this area was rebuilt as part of the repair works [2/258]. The coursing to the west of the joint does not flow through to the north wall of the cart shed, including the thin foundation level, and the east end of the barn is finished with quoins. The YVBSG noted that the stones to the west of the joint are not laid with the best side facing outwards (Bishop *et al* 1993).

Plate 9: West end of north elevation of barn, prior to repointing and rebuilding, looking S (photo courtesy Giles Procter).

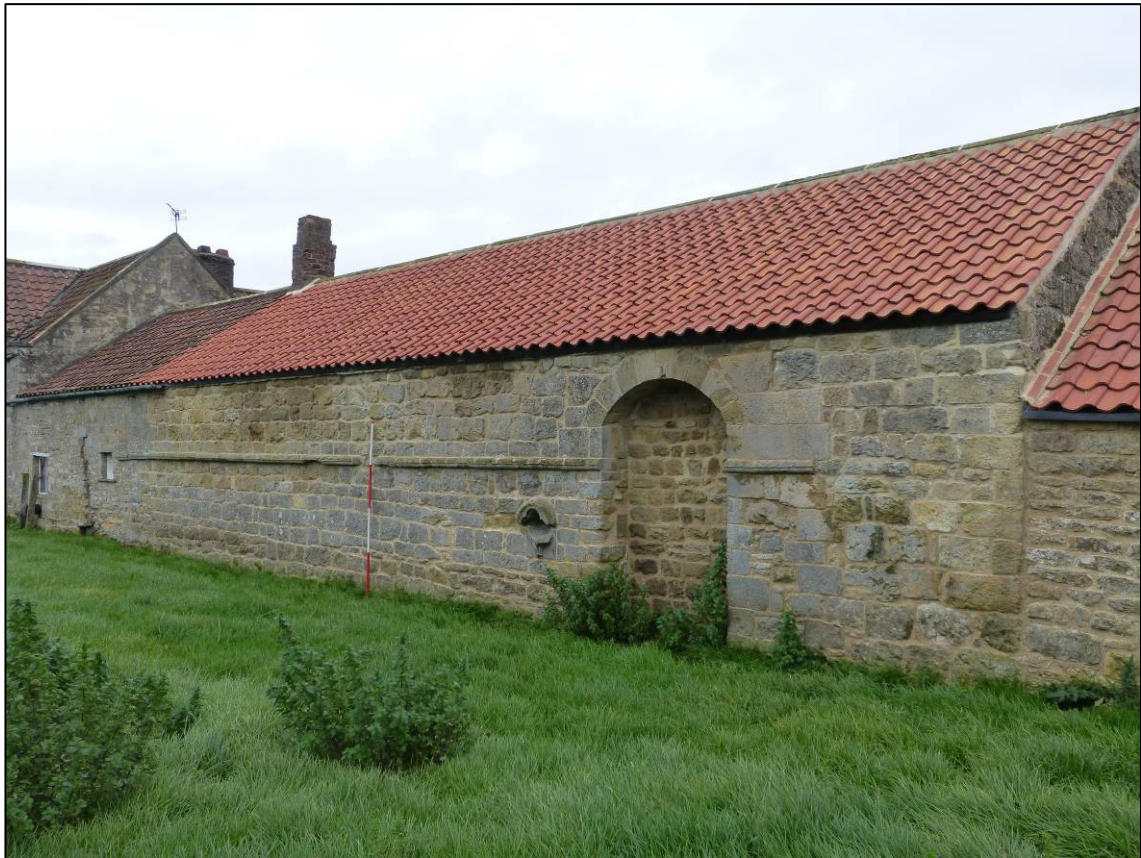
- 3.15 To the east of the blocked door, the coursing below the stringcourse is of irregular-sized blocks, with uneven coursing, including some thinner stone towards the base (see plate 11). Above the stringcourse, there is one course of regular stones, with four or five courses of larger more crudely worked masonry up to the eaves line; prior to repointing, these upper courses were less well mortared. Further to the east, there is 0.30m gap in the moulded stringcourse, but this appears to result from damage rather than a deliberate architectural feature, and it then continues along the elevation, beyond what appears to be a staggered joint aligned with a change in wall thickness, but ends just short of a small inserted window. Beyond the window, in what is now the lower part of the house's service range, there is a 2.90m long section of wall face rebuilt with smaller stone, rising from a crude stepped plinth and projecting very slightly beyond the wall face to either side; the rebuilt section of wall contains a small sliding sash window, which conceals a medieval door internally (see below) (see plate 12). To the east of the rebuilt section, the wall face of the north elevation steps in by 0.30m, in line with the east side of the wall forming the west gable of the taller part of the service range [1/302-1/304] (see plate 13).

Plate 11: North elevation of barn, after repointing and rebuilding, and re-roofing, looking SE (photo 3/904).

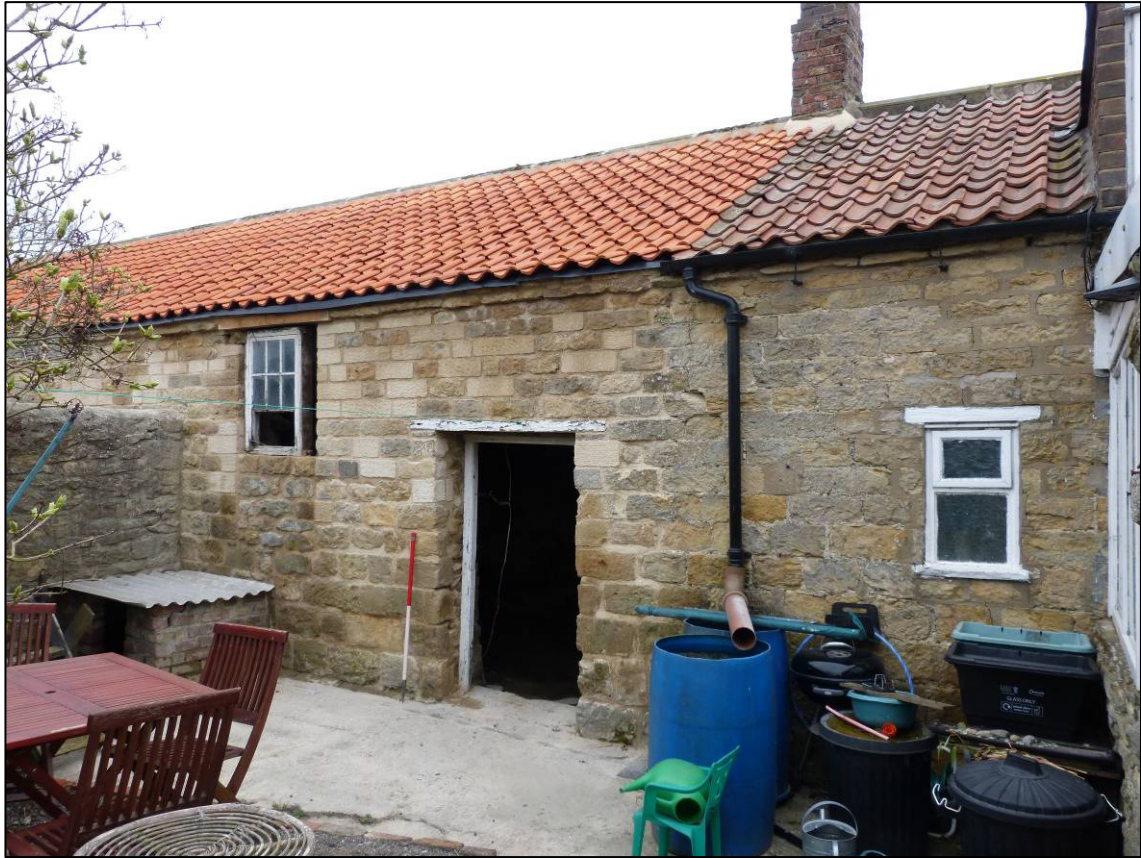
Plate 15: East end of south elevation of barn, after repair works, looking NW (photo 1/297).

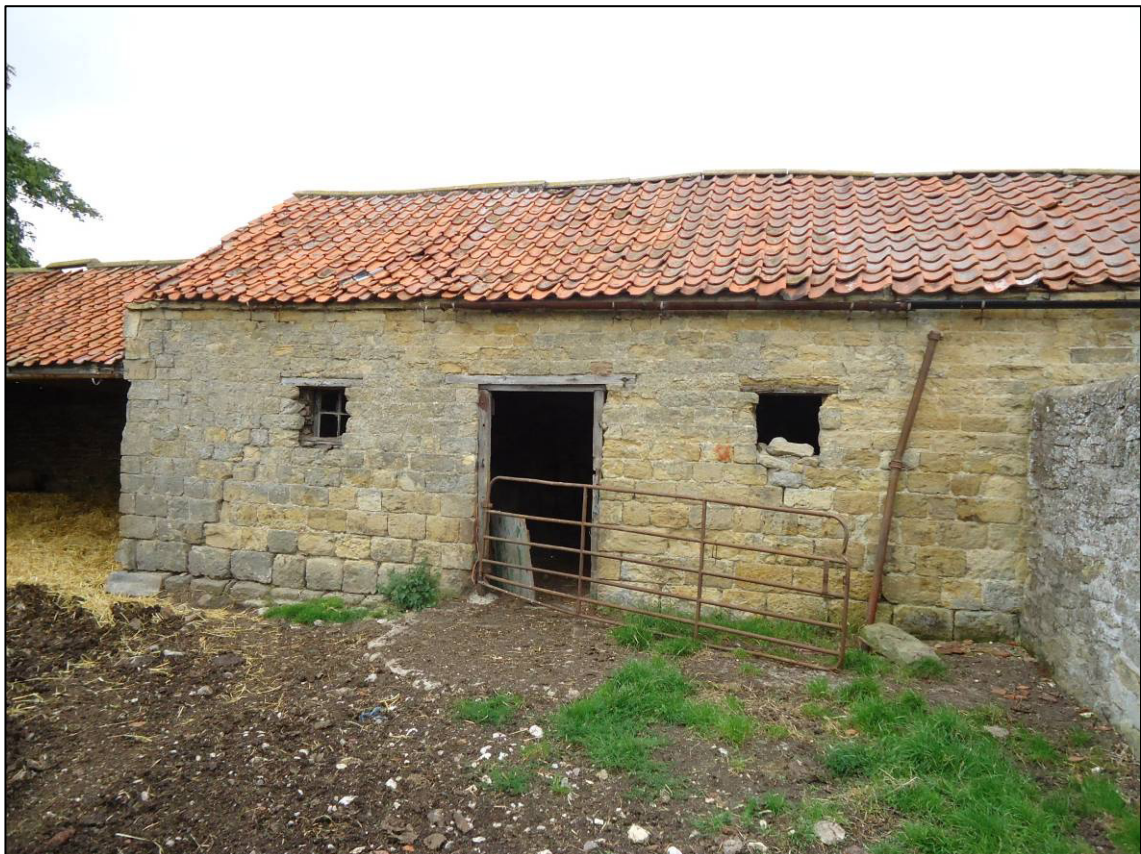
Plate 16: West end of south elevation of barn, prior to repairs, looking N (photo courtesy Peter Pace).

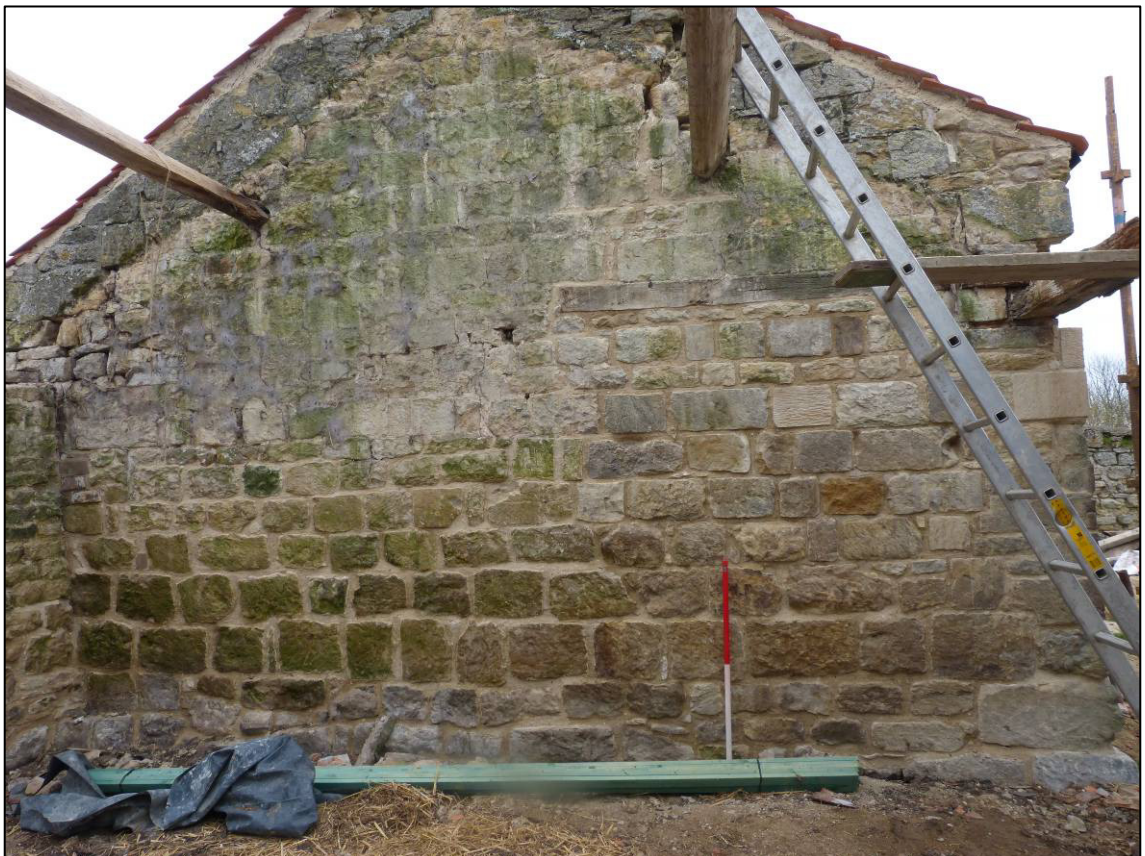
Plate 18: West gable of barn (internal to cart shed), after repair and rebuilding, looking E (photo 1/314).

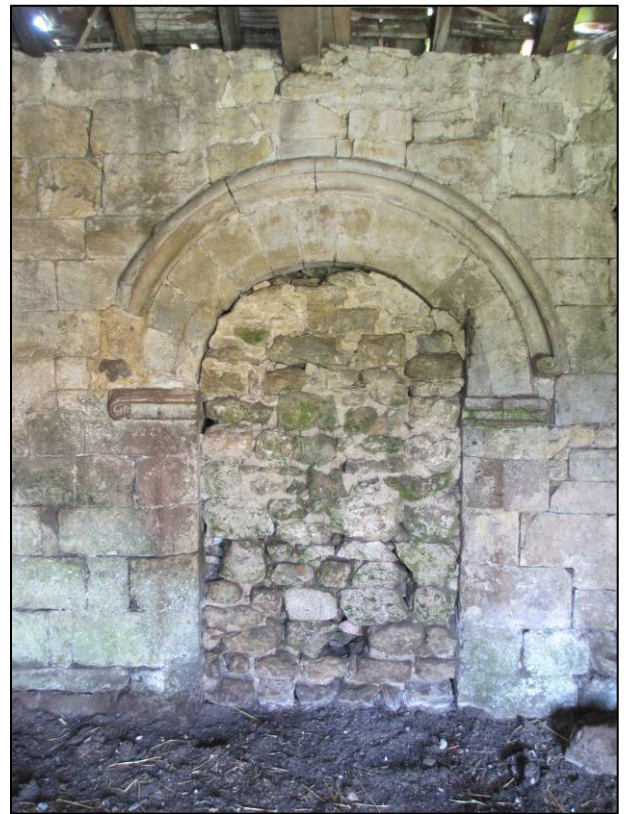
Plate 20: Blocked medieval doorway at west end of barn's north wall (internal view), prior to repair, looking N (photo courtesy Giles Procter).

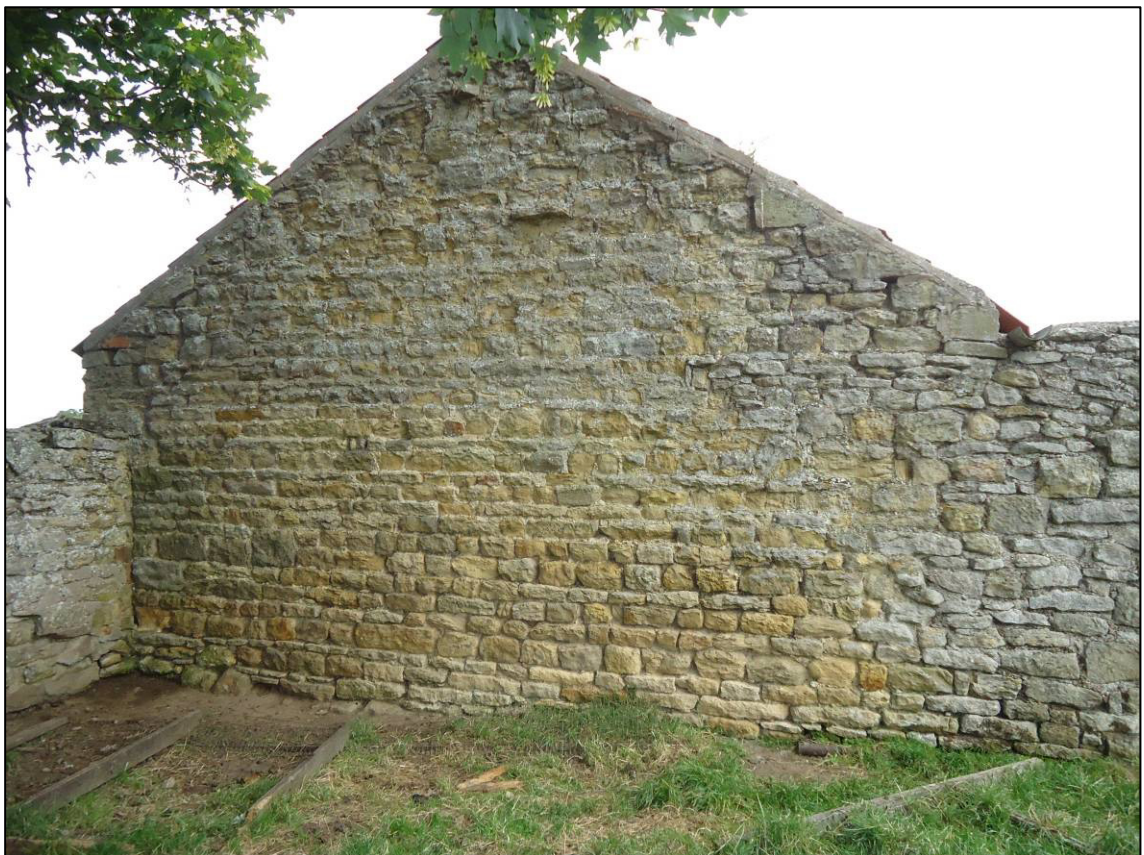
Plate 21: Exterior of west gable to cart shed, prior to repair and rebuilding, looking E (photo courtesy Peter Pace).

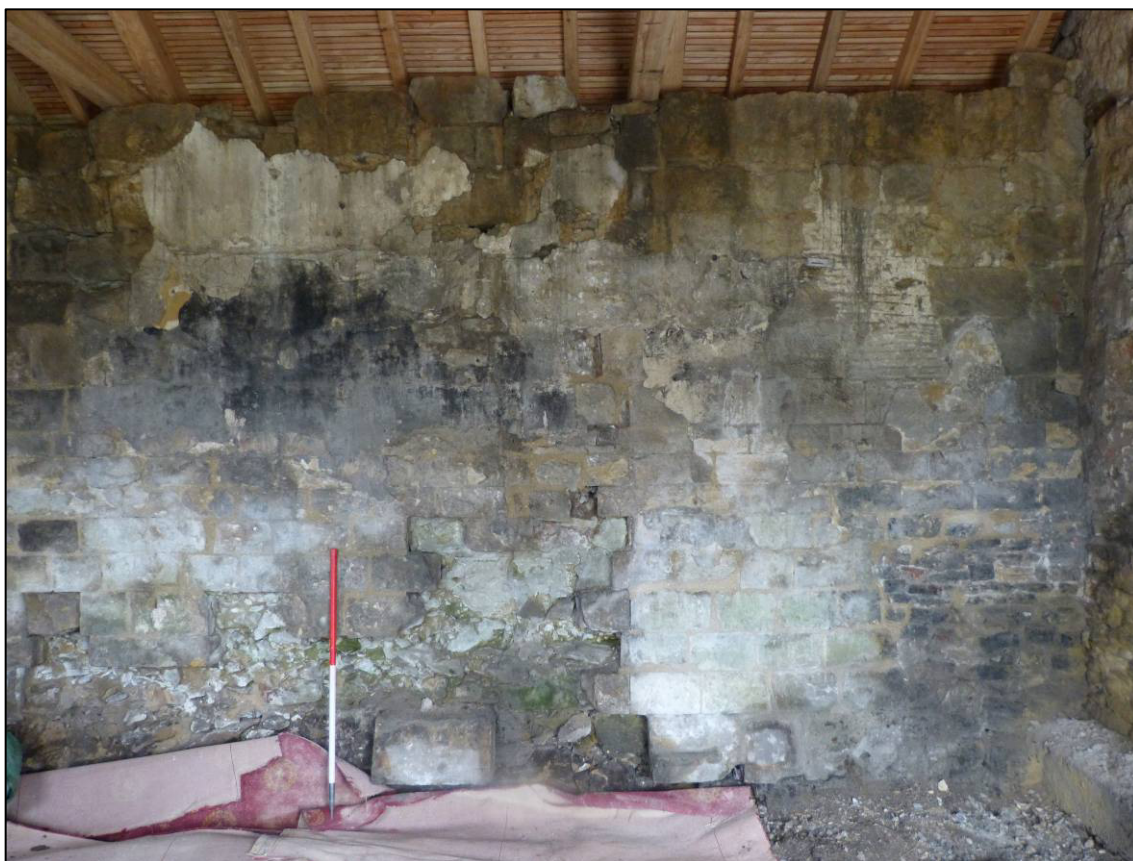
Plate 22: Position of former buttress, towards east end of internal elevation of barn's north wall, prior to repair and rebuilding, looking N (photo 1/321).

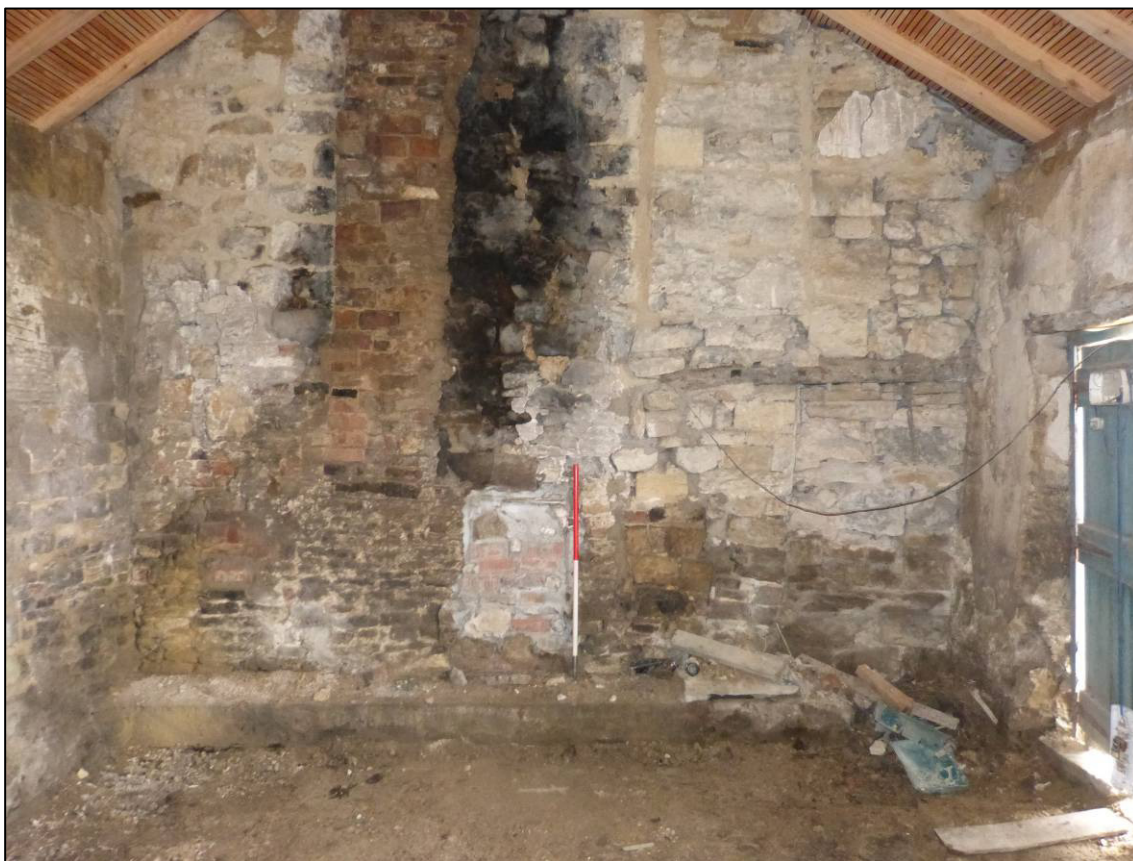
Plate 23: Internal east gable of barn, prior to repair, looking E (photo 1/319).

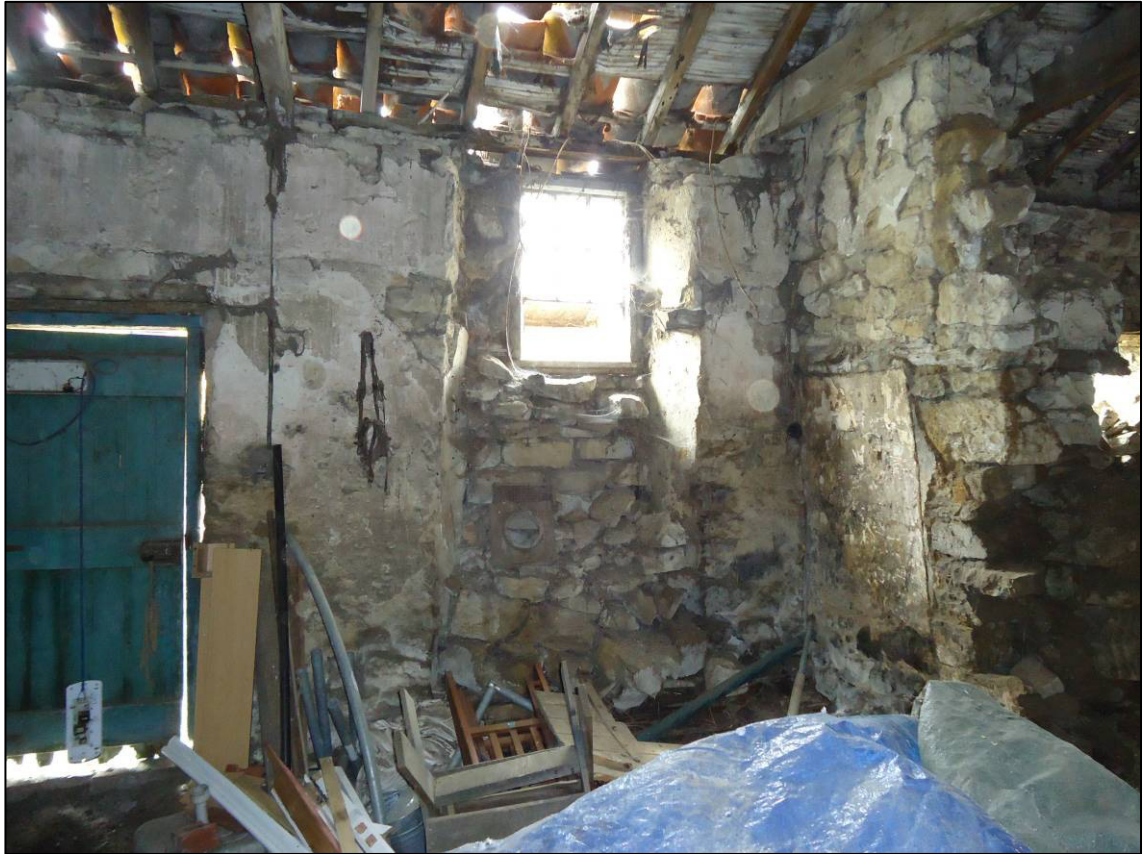
Plate 24: Former doorway at east end of south wall of barn (internal), prior to repair, looking S (photo courtesy Peter Pace).

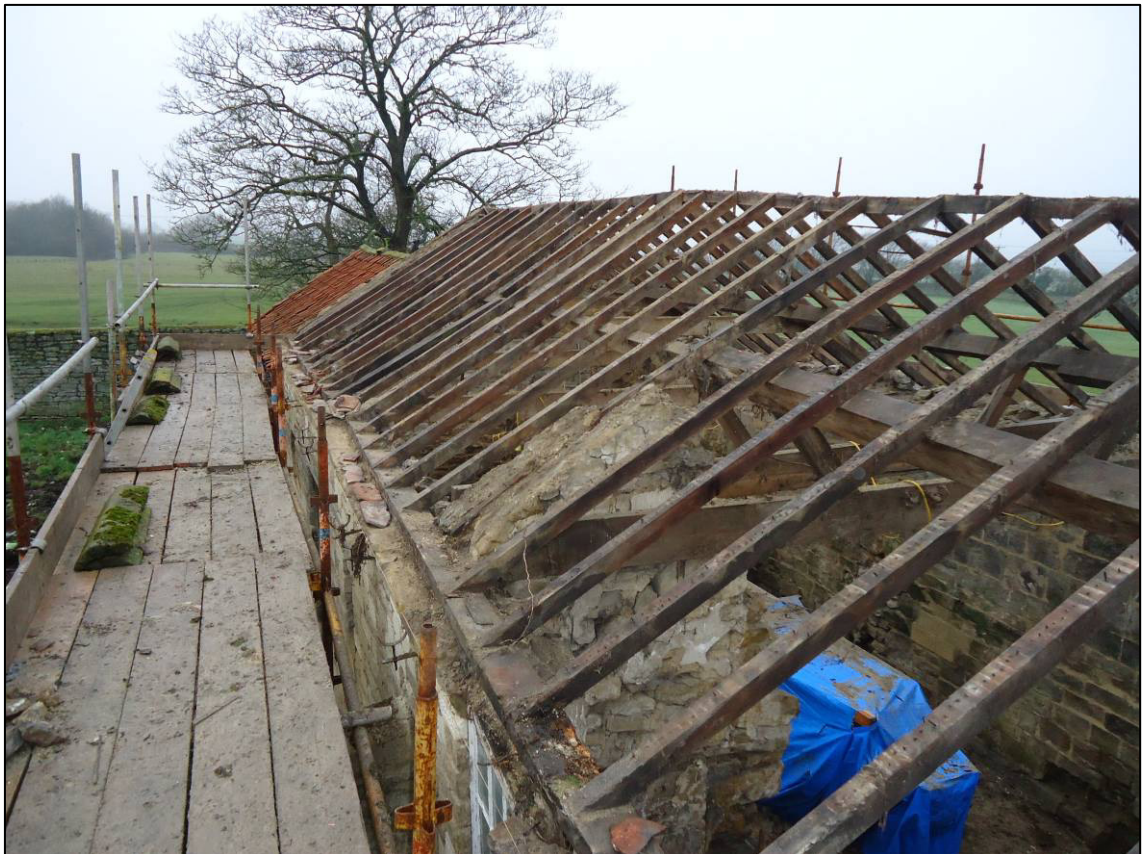
Plate 28: Repairs to barn roof, looking W (photo courtesy Peter Pace).

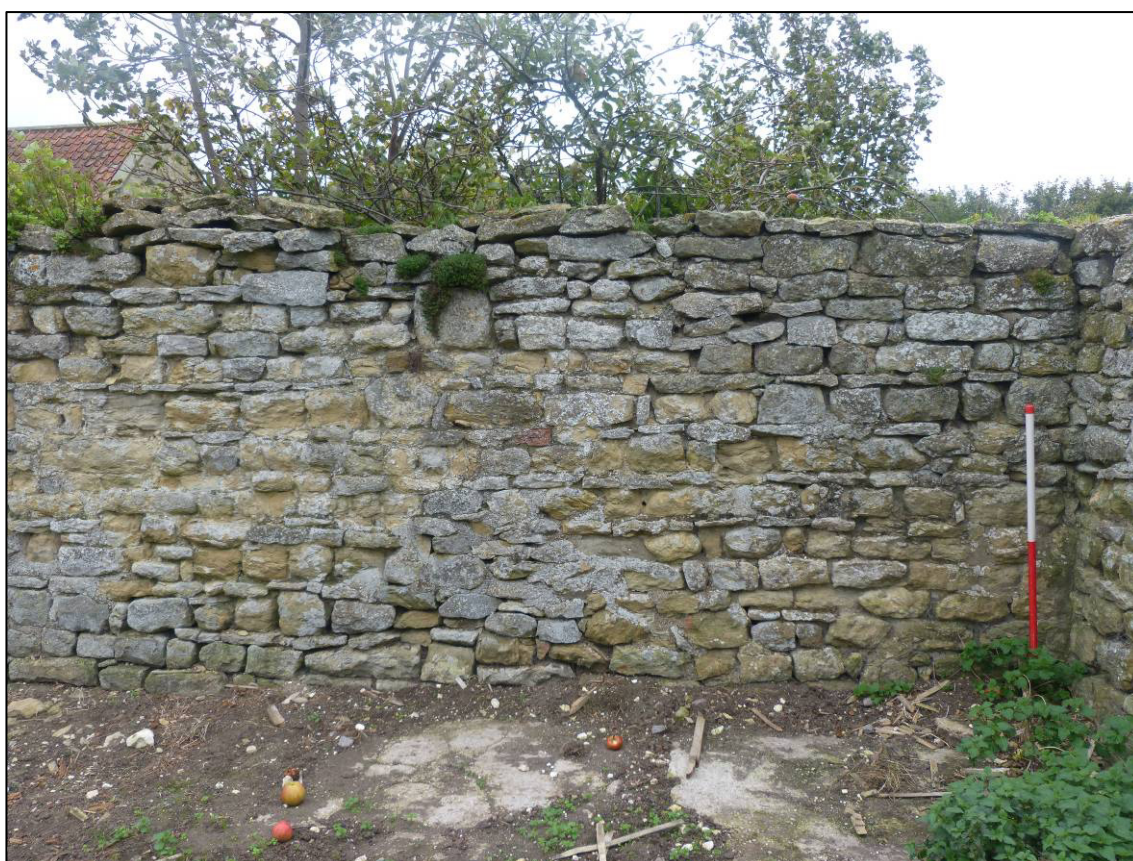
- 3.42 The internal face of the east yard wall is badly weathered, but probably preserves the distinctive coursing pattern noted above better than any other of the yard walls [3/940-3/945] (see plate 34). It stands to an average height of c.2.00m. The southern half of the wall contains two square stones to the upper part, each 0.35m wide by 0.25m high, with the base set c.1.60m above ground level [3/992]. Like the similar stone described to the west wall, they are distinct from the surrounding masonry, and might represent former sockets that have been blocked [1/341-1/343] (see also plate 34). Beginning at the southernmost square stone and running northwards, a plinth of larger stones, projecting 0.10m, is visible at the base of the wall. This plinth can be traced to within 3.70m of the blocking at the north end of the east yard wall. To the immediate south of the blocking, the quoins of the lean-to structure on the east side of the wall are visible [3/946] (see plate 35). As with the corresponding blocked opening at the north end of the west wall, the 2.25m wide former gap or opening at the north end of the east wall, butting the barn's south elevation, is believed to have been put in place by the then farmer during the 1950s. As was noted above, the alignment of this wall continues into the interior of the barn.

Plate 34: South end of east yard wall (internal face), showing differential coursing pattern and possible former socket, looking W (photo 3/940).
