CONSTRUCTION OF WC EXTENSION,
PRIEST'S HOUSE AND CHAPEL,
BARDEN TOWER, BARDEN, NORTH YORKSHIRE

ARCHITECTURAL AND ARCHAEOLOGICAL
OBSERVATION, INVESTIGATION AND RECORDING

Report no: 2018/582.R01
Version: Final
Date: June 2019
Author: Ed Dennison & Shaun Richardson

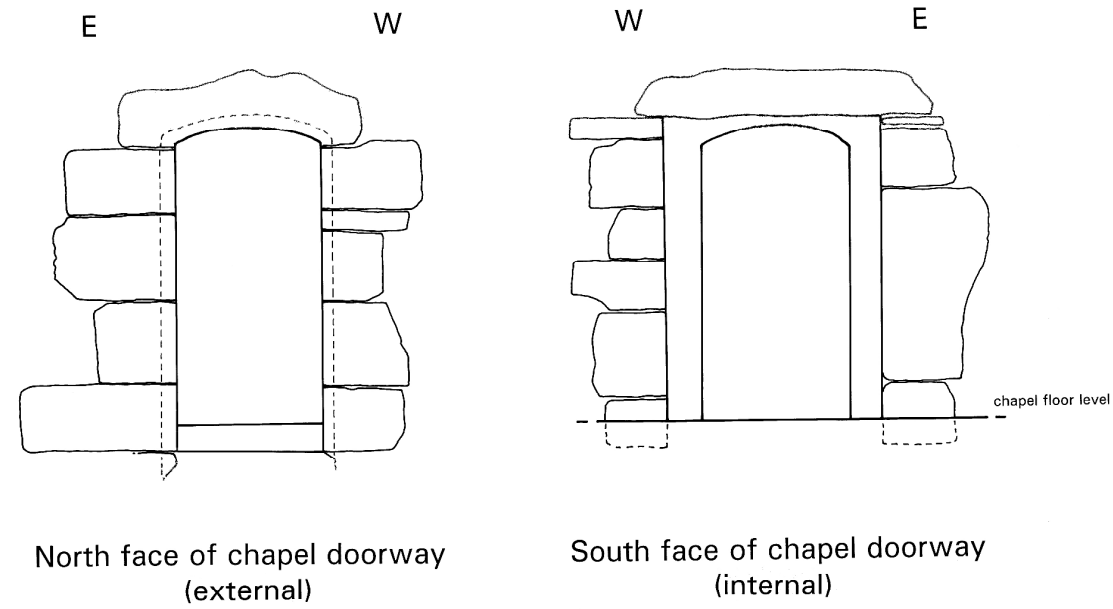
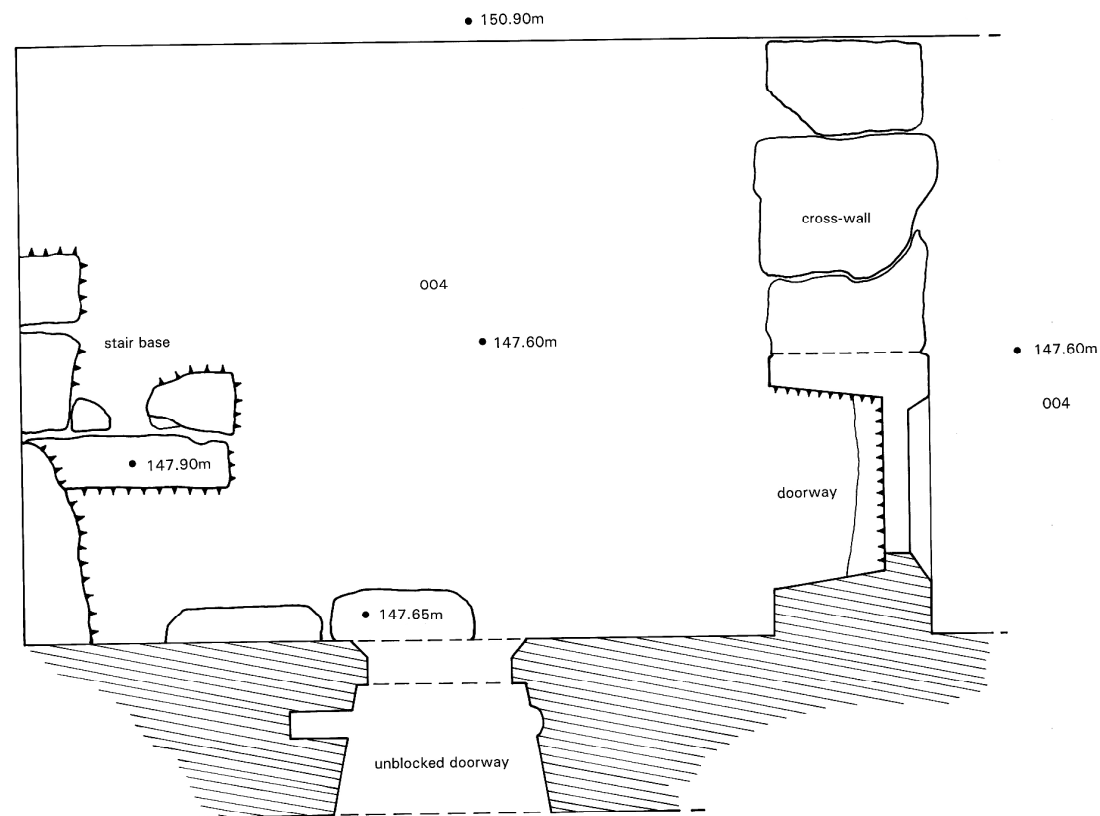
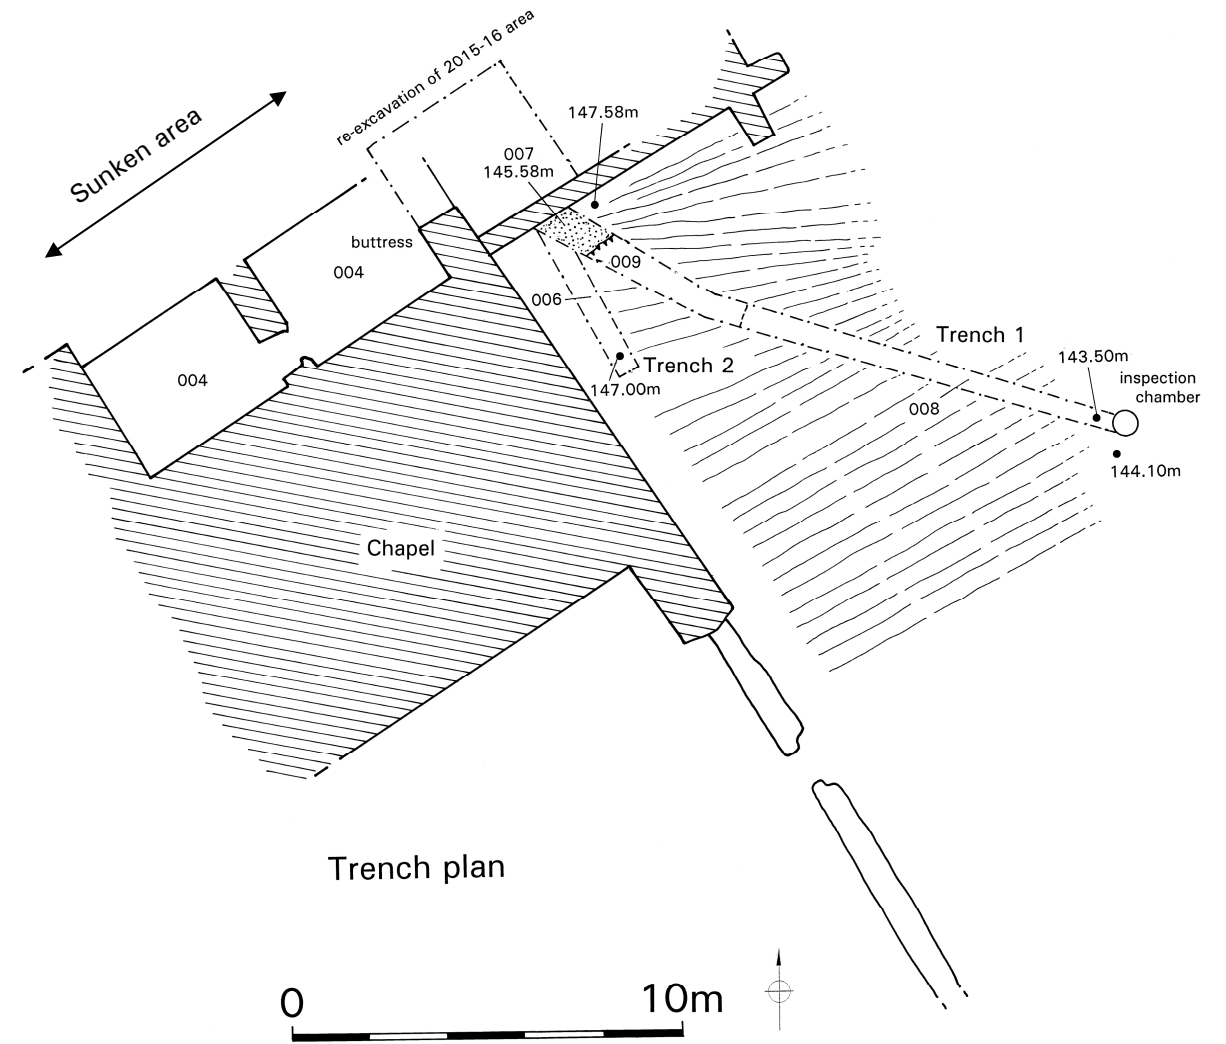
PROJECT BARDEN PRIEST'S HOUSE AND CHAPEL	
TITLE MONITORING RESULTS	
SCALE AS SHOWN	DATE JUN 2019
EDAS	FIGURE 8

- 3.10 As previously noted, much of the retaining wall forming the north side of the sunken area was rebuilt in 2015-16 with a right-angled plan, although features such as the apparent fireplace and the adjacent doorway were reconstructed and/or retained. After rebuilding, the sunken area had maximum internal dimensions of c.9.25m east-west by 3.40m north-south, very similar to before. The ground level to the north and above the retaining wall on the north side of the sunken area was broadly set at 150.90m AOD as before; the ground level in the base of the sunken area varied, sloping upwards from east to west; at the western end, it was set at c.147.80m while at the eastern end it was c.149.00m AOD (see figure 8).

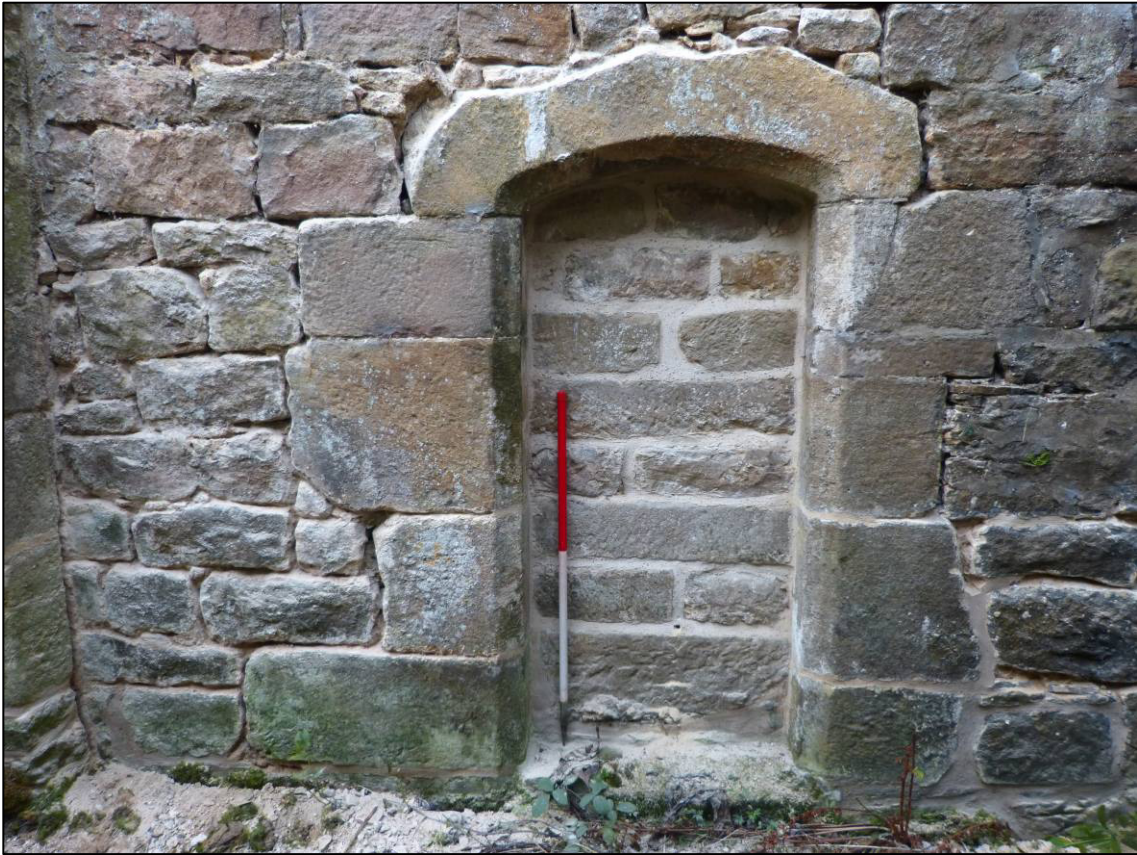
Plate 3: North side of doorway in north chapel wall, prior to unblocking, looking S (photo 1/809).

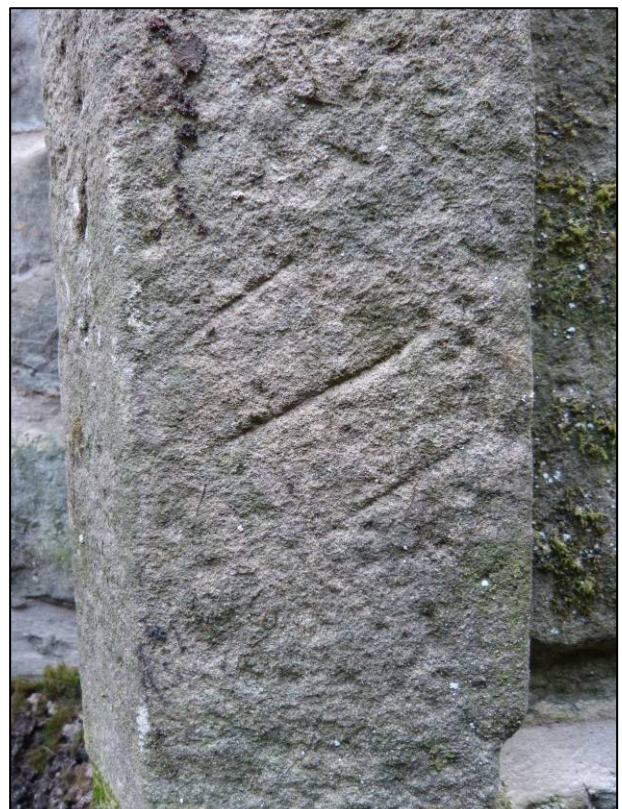
Plate 5: Mason's mark to south jamb of cross-wall doorway, looking SE (photo 1/816).

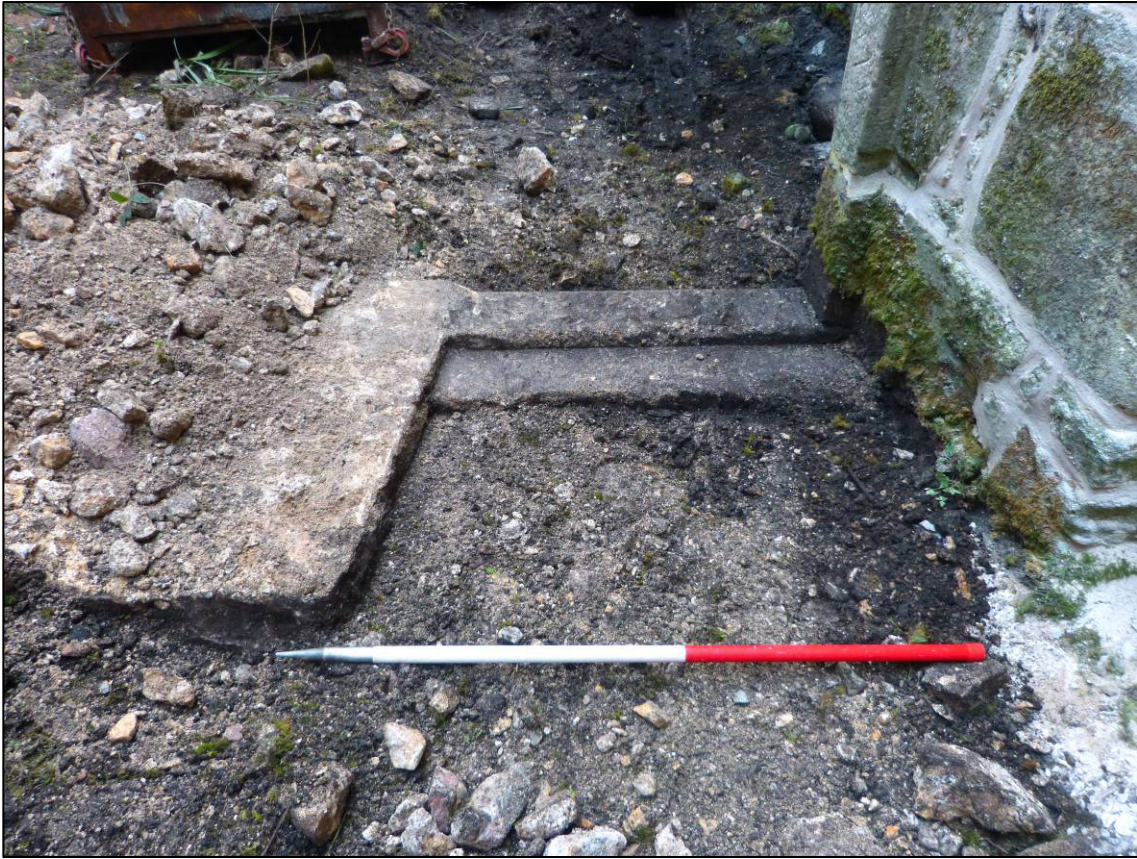
Plate 6: Threshold to cross-wall doorway in sunken area, looking NE (photo 1/812).

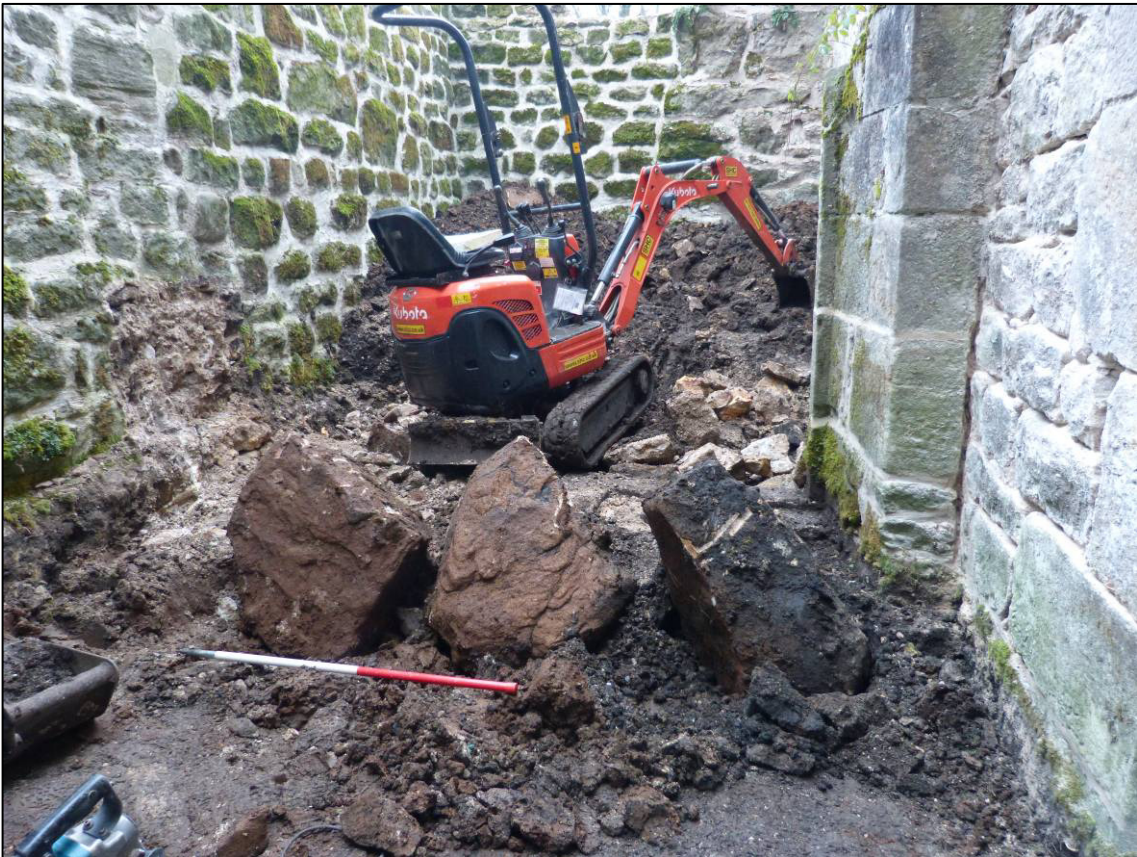
Plate 7: Grubbed up footings of cross-wall in sunken area, looking NE (photo 2/821).

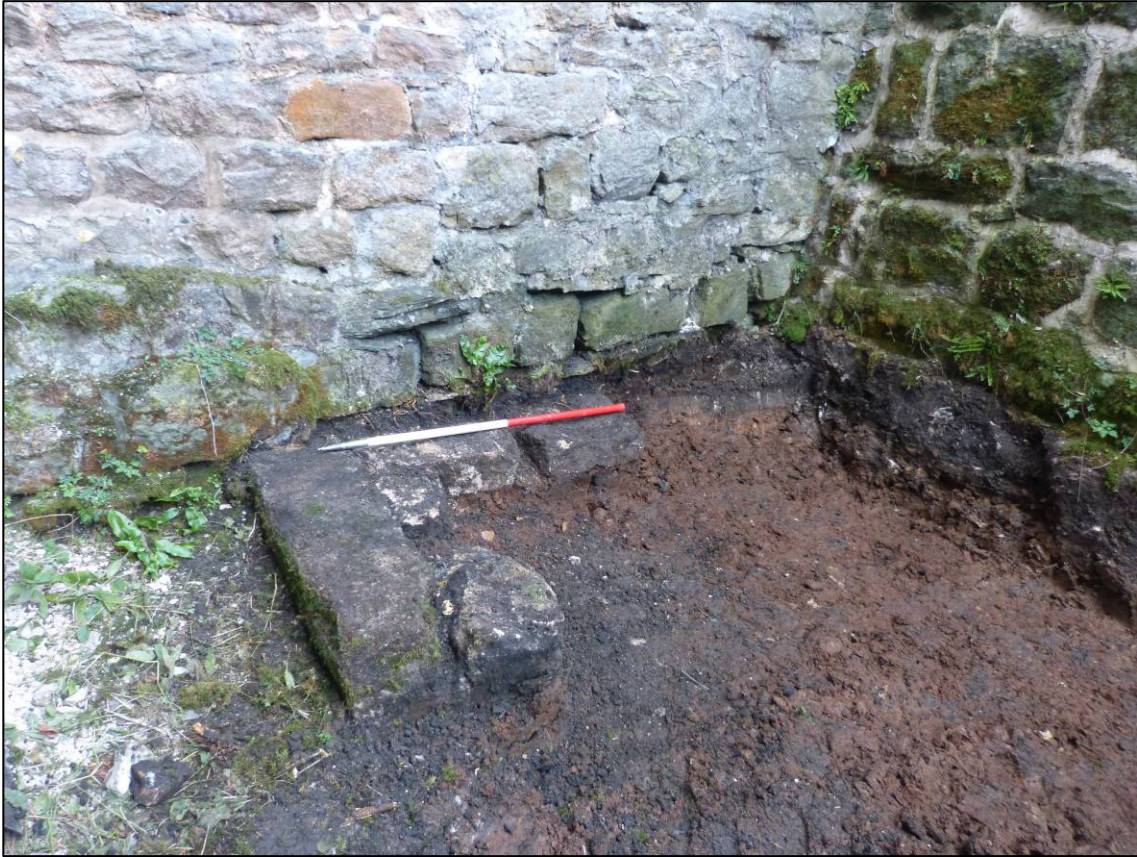
Plate 8: Footings at base of domestic range's east elevation in sunken area, looking NW (photo 1/820).

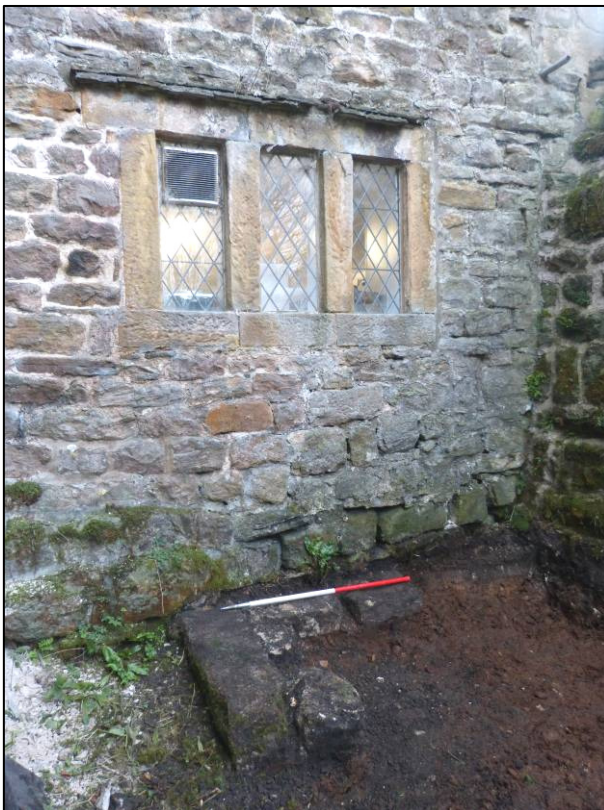
Plate 9: Footings at base of domestic range's east elevation in sunken area, looking NW (photo 1/819).

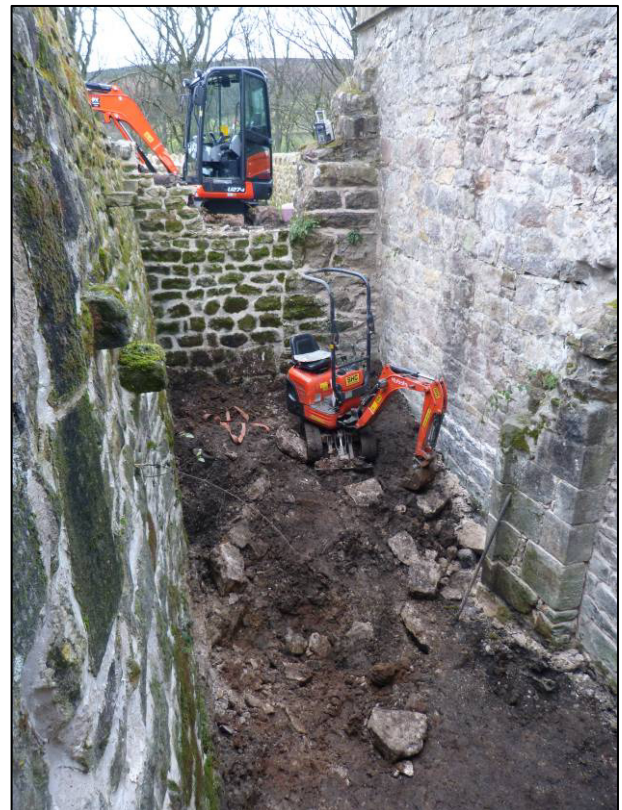
- 3.15 The footings of the cross-wall, when removed, left a hole which was very close to the depth of the base of the foul drain which was to run along the north side of the sunken area. As this area contained the same natural sandy clay (004) observed elsewhere, it was decided not to monitor any further excavation here. Similarly, the clearance of the eastern end of the sunken area had to be undertaken in such a manner (with mini-excavators within a confined area) that it was very unlikely that any features would be observed (see plate 10).

Plate 10: Clearance of sunken area, looking NE (photo 2/826).

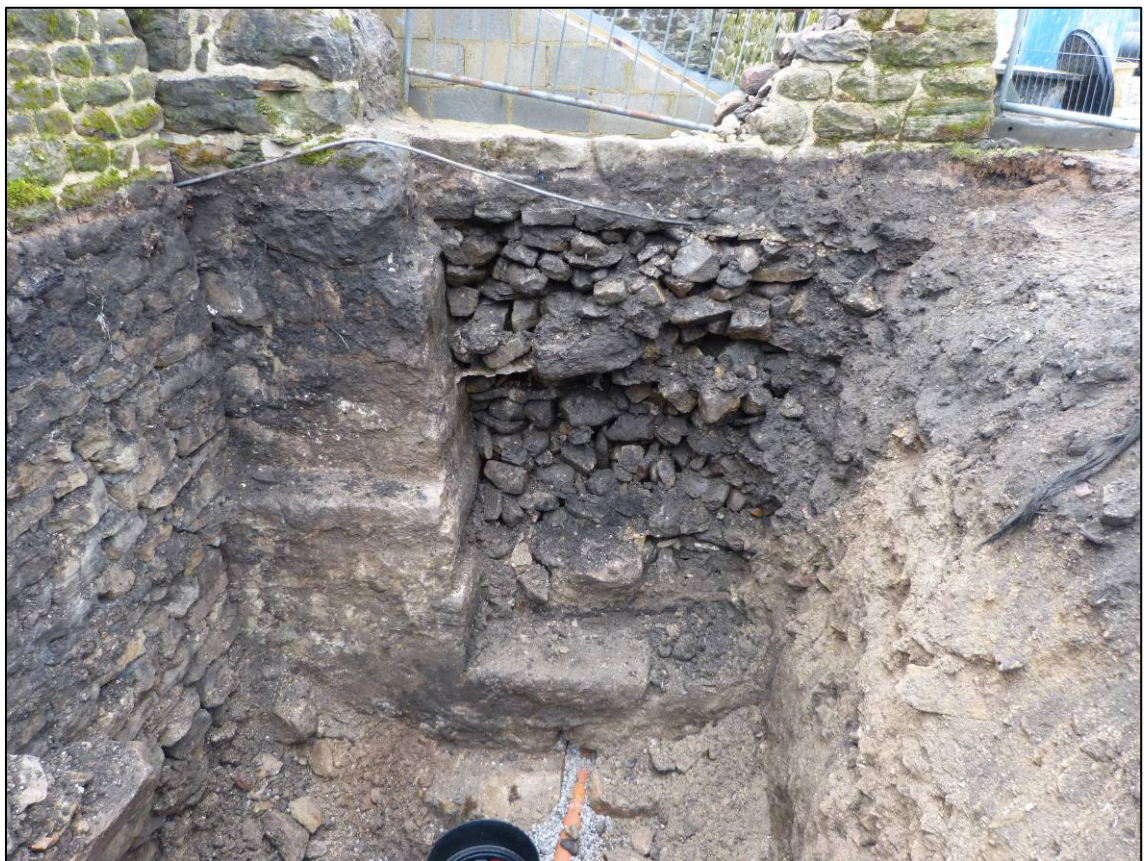
Plate 11: Re-excavation of 2015-16 area, showing buttress to north-east corner of chapel, looking W (photo 5/270).

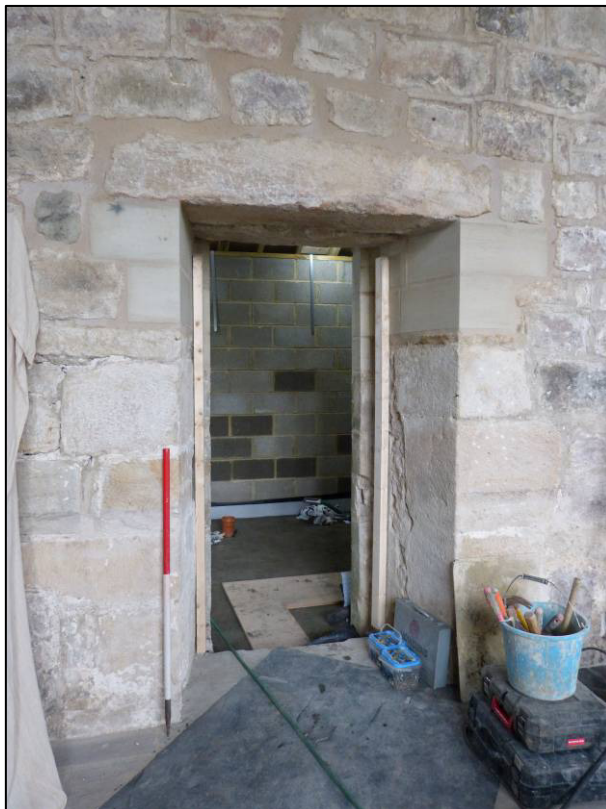
Plate 12: South face of unblocked and raised doorway in north wall of chapel, looking N (photo 5/269).

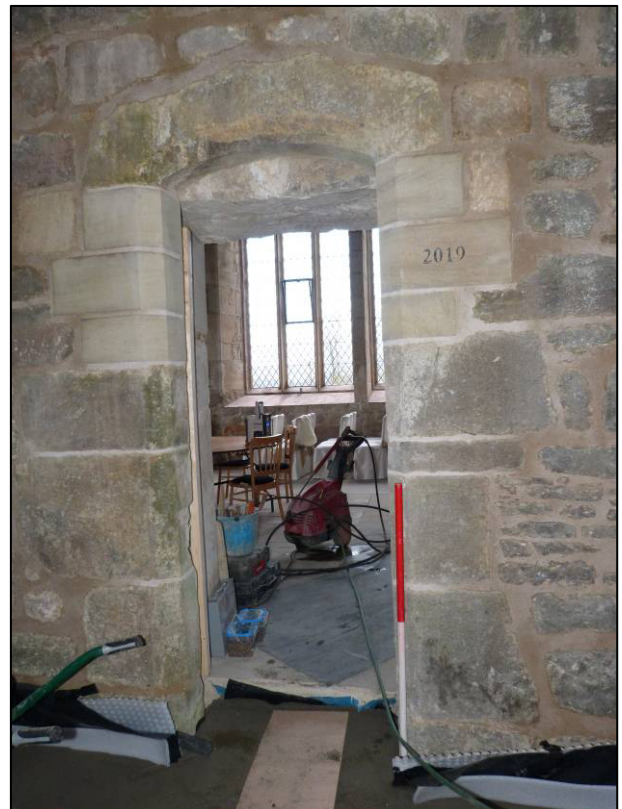
Plate 13: North face of unblocked and raised doorway in north wall of chapel, looking S (photo 5/268).

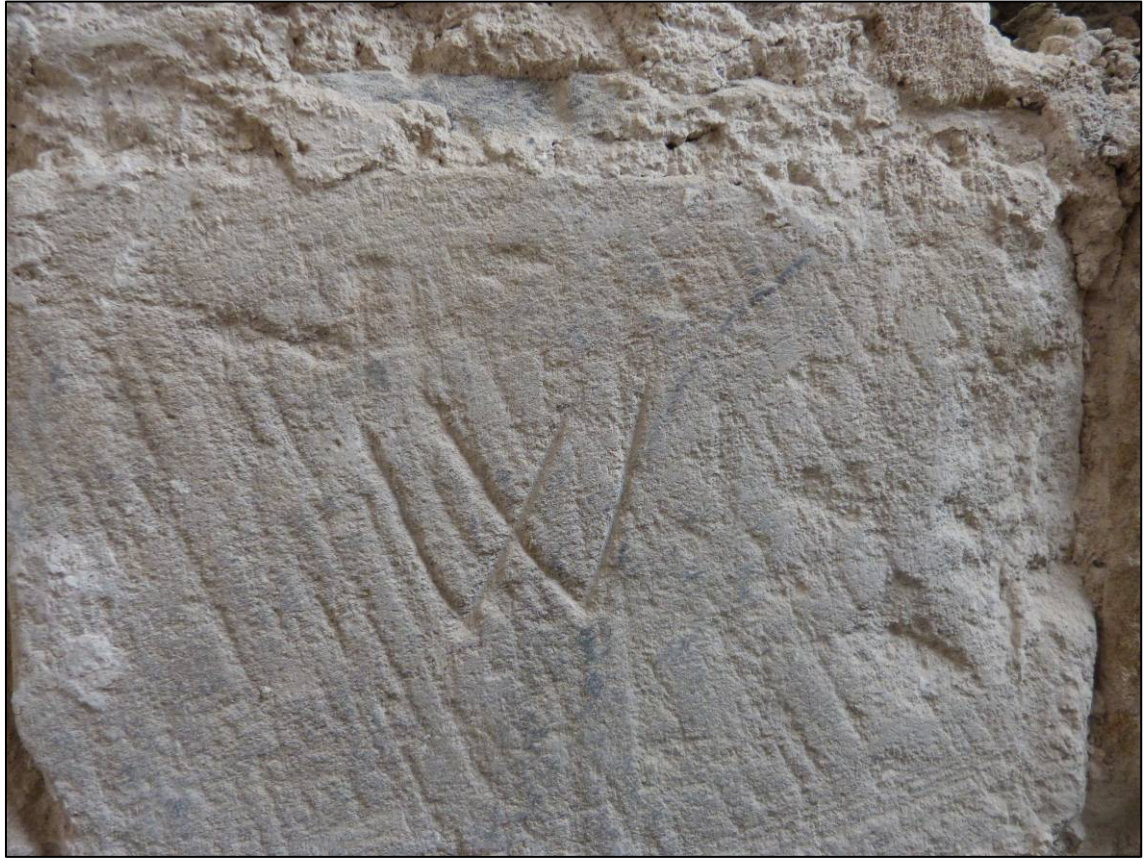
Plate 14: Mason's mark in west jamb of doorway in north wall of chapel, revealed after unblocking, looking W (photo 4/021).

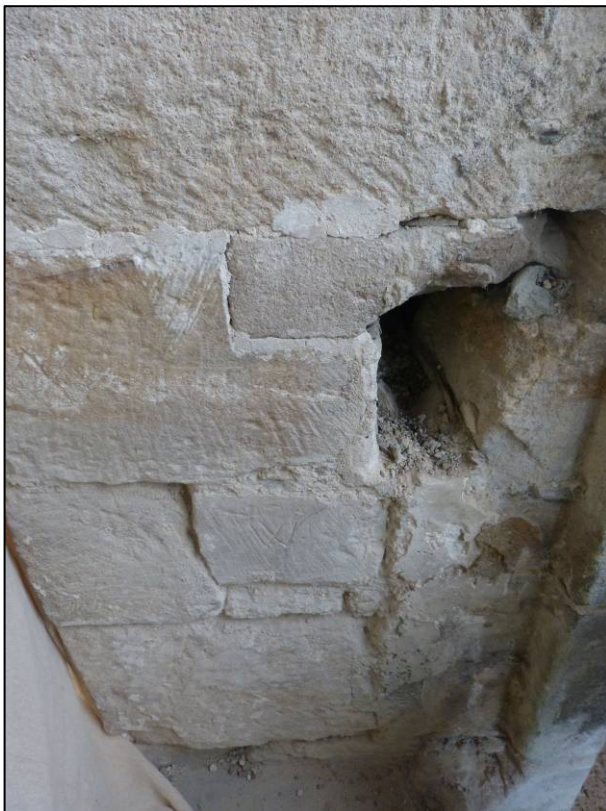
Plate 15: Draw bar recess and adjacent mason's marks in west jamb of doorway in north wall of chapel, revealed after unblocking, looking W (photo 4/019).

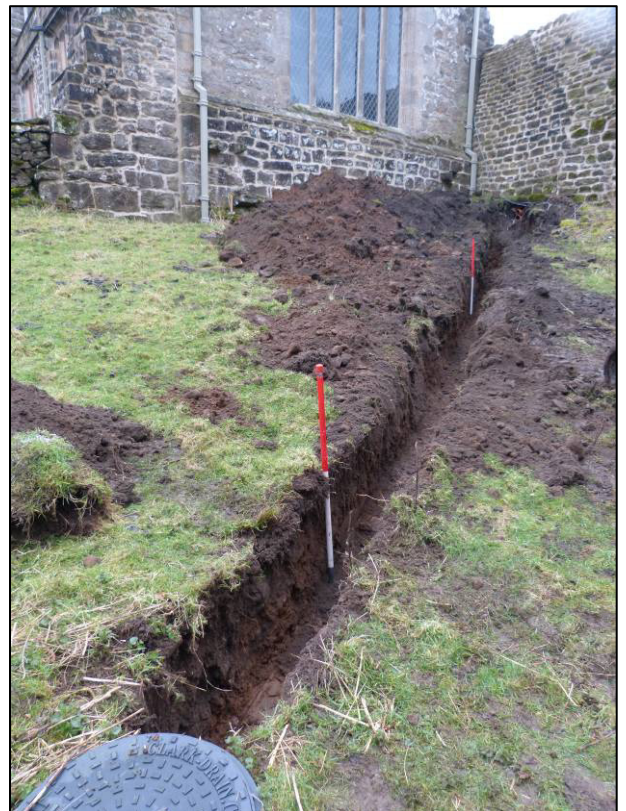
- 3.20 Trench 1 was excavated to carry a foul drain from the base of the rebuilt retaining walls to the north-east of the chapel to a pre-existing septic tank; as already noted above, the section of the drain between the sunken area and this point was not monitored as this area had already been heavily disturbed in 2015-16. Prior to excavation, the grassed ground surface sloped naturally steeply downwards from west to east. The western end of the drainage trench commenced at the junction of the chapel and the rebuilt retaining wall to its east, the ground level here being set at c.147.58m AOD. It then ran for c.15.50m to the south-east towards the inspection chamber of the pre-existing septic tank, set at 144.10m AOD (see plate 16).

Plate 16: Main drainage trench (Trench 1), looking NW (photo 5/266).
