THE AVENUE GATE AND GATEPIERS,
LONDESBOROUGH PARK, LONDESBOROUGH,
EAST YORKSHIRE

ARCHAEOLOGICAL AND
ARCHITECTURAL RECORDING

Report no: 2017/554.R01
Version: Final
Date: February 2019
Author: Shaun Richardson & Ed Dennison

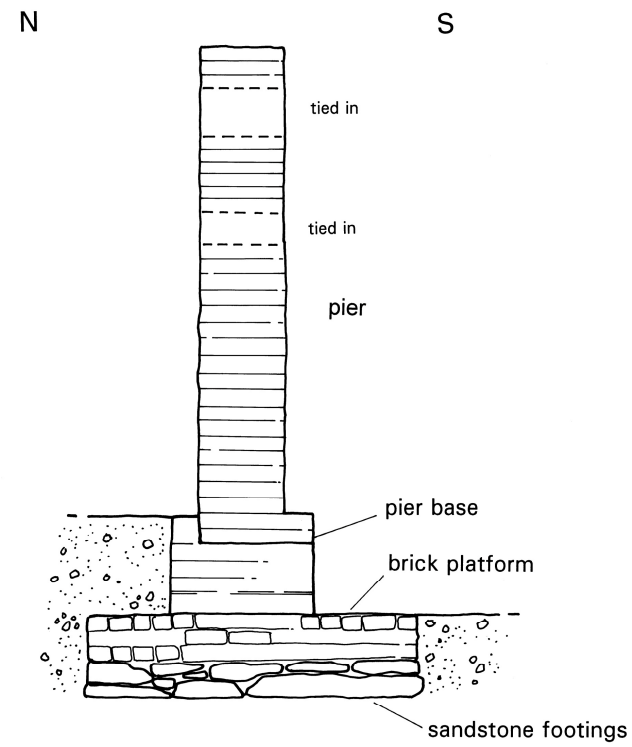
Section through Pier 3

- 3.12 In order to re-erect the south gate pier, the old footings were exposed and the removed. It was noted that the footings were in three parts. The uppermost part was formed by a rectangular block of brickwork, measuring 1.15m east-west by 0.74m north-south. It stood seven courses of brickwork (c.0.50m) high, and had a thick covering of lime mortar to all visible faces. This brickwork block had once been set at the centre of the base of the pier, and formed the core to which the stone mouldings were attached. The core stood on a wider brick platform, measuring 1.60m north-south by at least 1.64m east-west, and stepped to the south-east corner (see plate 12). There was a patchy covering of lime mortar to the upper surface of the platform, together with occasional fragments of blue slate. This slate was re-used, and had been laid flat on the surface of the platform,

presumably to level the base of the stone dressings when they were placed on the platform. The platform was seen to be three courses of brickwork (0.20m) deep; the bricks used were of similar appearance and dimensions to those described above used to build the pier itself. The platform overlay a footing made up of large pieces of angular sandstone, measuring up to 1.00m by 0.50m by 0.15m. These pieces were laid flat, but were un-mortared, and covered the same area as the brick platform above. The stone footing was a total of 0.20m deep. The footings of the adjacent wing wall were noted to extend to at least 1.05m below the top of wall's moulded plinth (see plate 13).

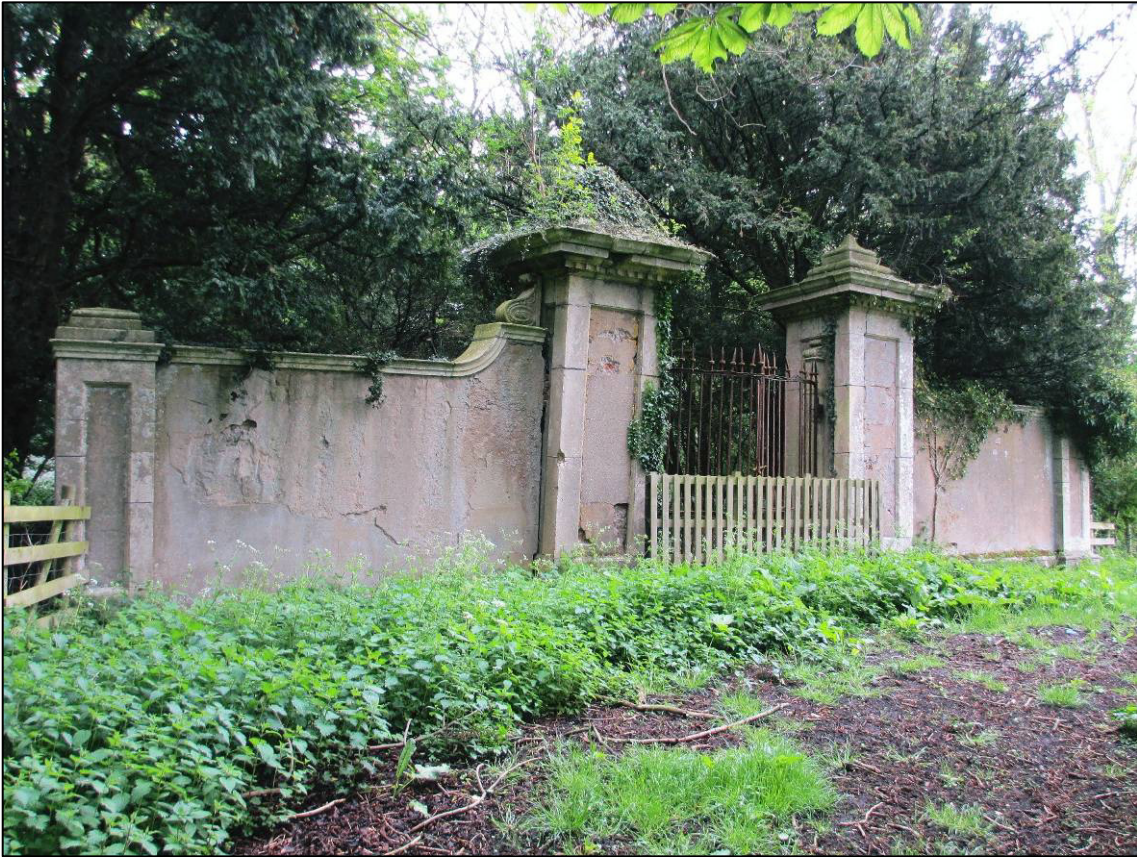
Plate 1: West elevation of gateway, prior to restoration, looking E (May 2013)
(photo courtesy Giles Proctor, Historic England).

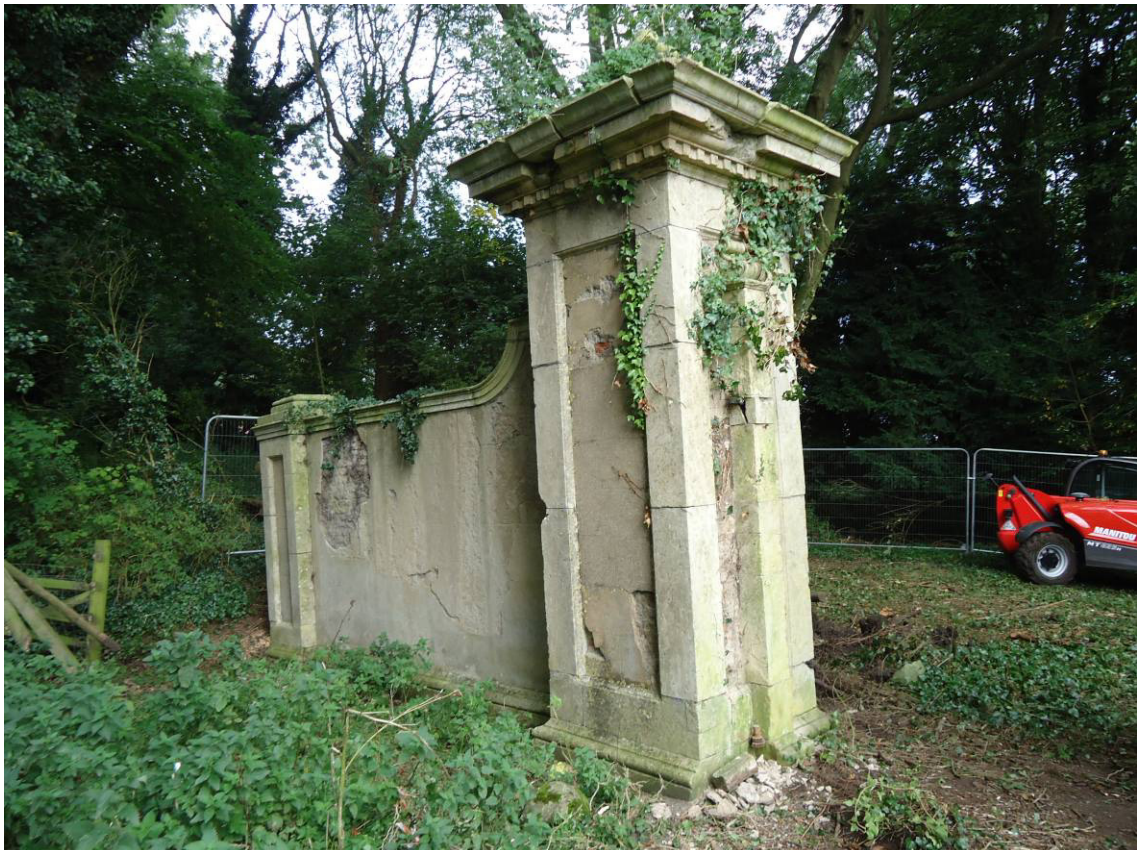
- 1.8 Prior to the start of restoration, the gateway was in a very poor structural condition, with both gate piers and wing walls leaning due to the prevailing ground conditions (see plate 2), and some of the original features such as the ball finials either fallen or missing. Some of the mortar rendering and stone dressings were cracked due to spalling and rusting iron clamps, coping stones and cornices were dislodged and misaligned, and there was significant vegetation growth on and around the gateway which was also causing damage; the gates themselves were also very rusty and corroded, with some rails and spikes missing or bent out of place (Pace 2017; Proctor 2016) (see plates 1 to 3). The decision was therefore taken to virtually rebuild the structure from the original foundations, using appropriate materials. Some arboriculture work was also undertaken to prune the avenue trees so that sightlines to the gateway were improved. The structure was on Historic England's 'Heritage at Risk' register for 2016, where it was described as being in a 'Very Bad' condition and the priority was 'Slow Decay, solution agreed not yet implemented' (Historic England 2016, 1). In the 2017 Register, it was described as being in a 'Fair' condition with a repair scheme in progress (Historic England 2017, 2).

Plate 2: North side of gateway (Piers 1 and 2), west elevation, prior to restoration and after removal of gates, looking N (September 2017) (photo courtesy Peter Pace).

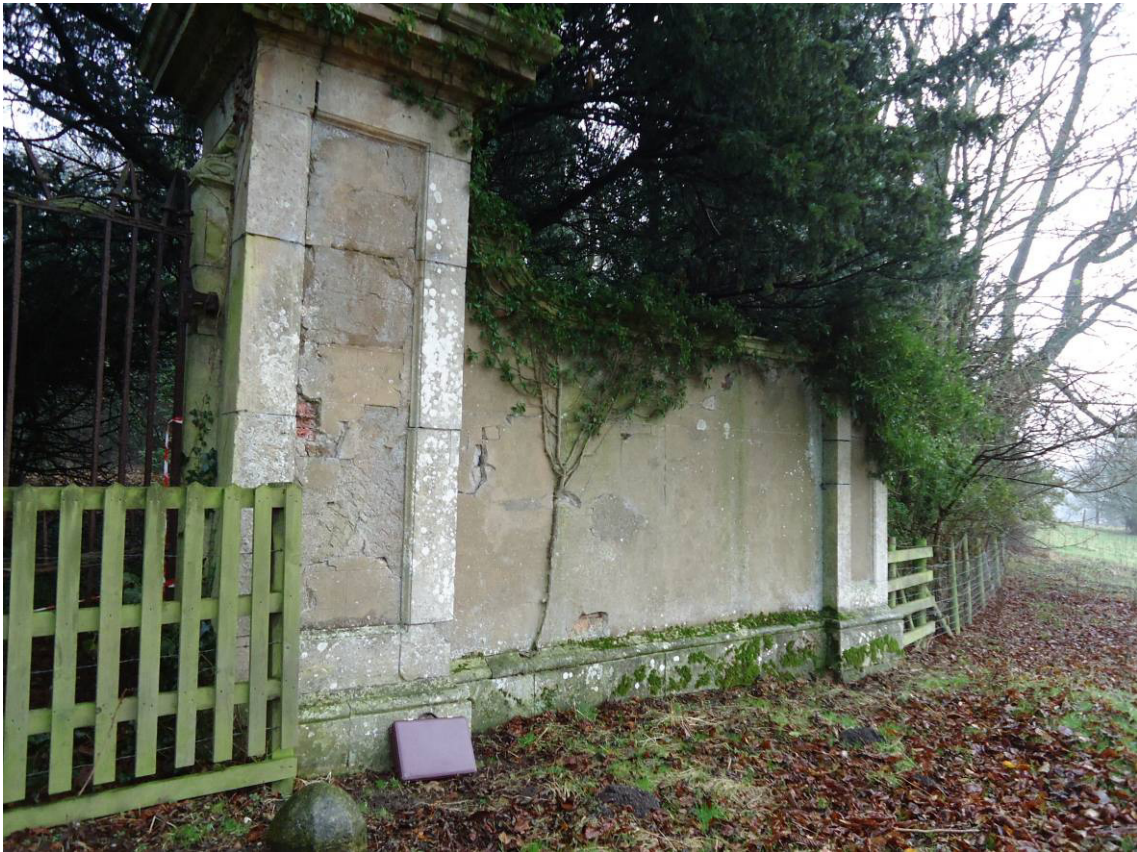
Plate 3: South side of gateway (Piers 3 and 4), west elevation, prior to restoration, looking E (December 2016) (photo courtesy Peter Pace).

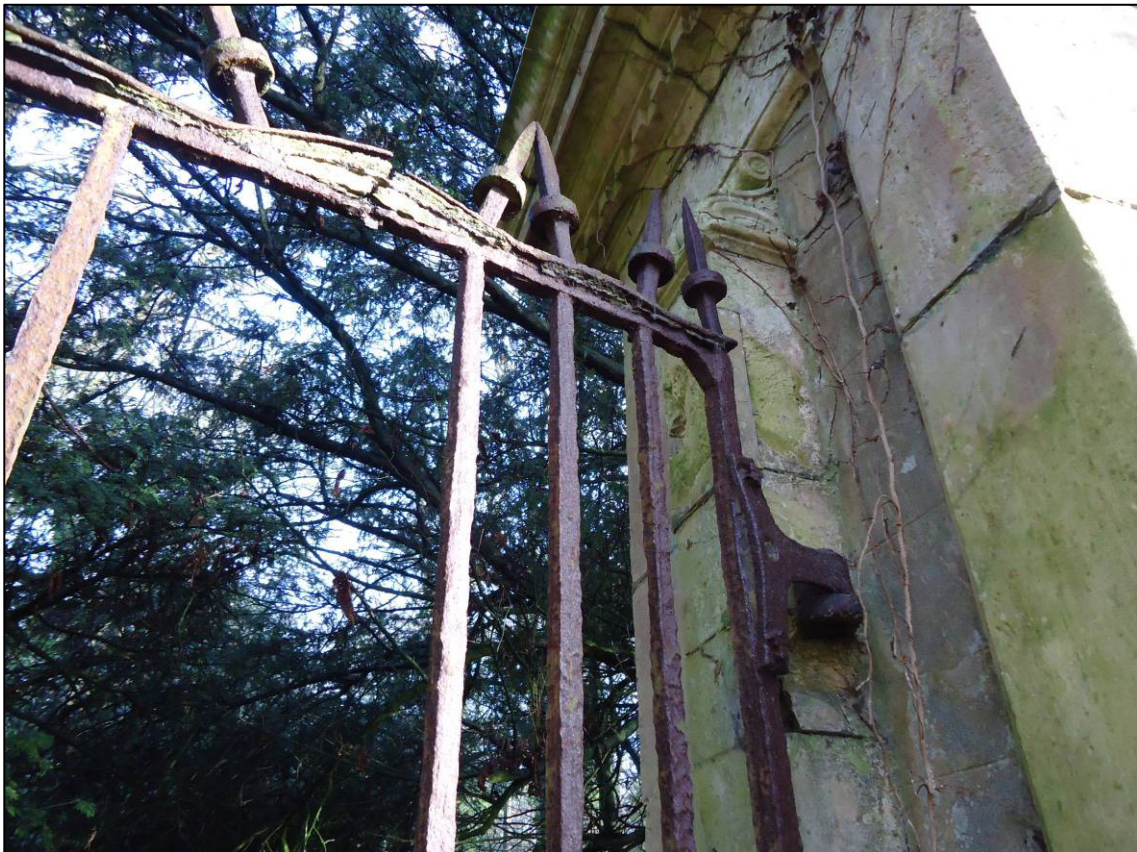
Plate 10: Detail of gate and damaged gate on Pier 3, prior to restoration, looking E (December 2016) (photo courtesy Peter Pace).

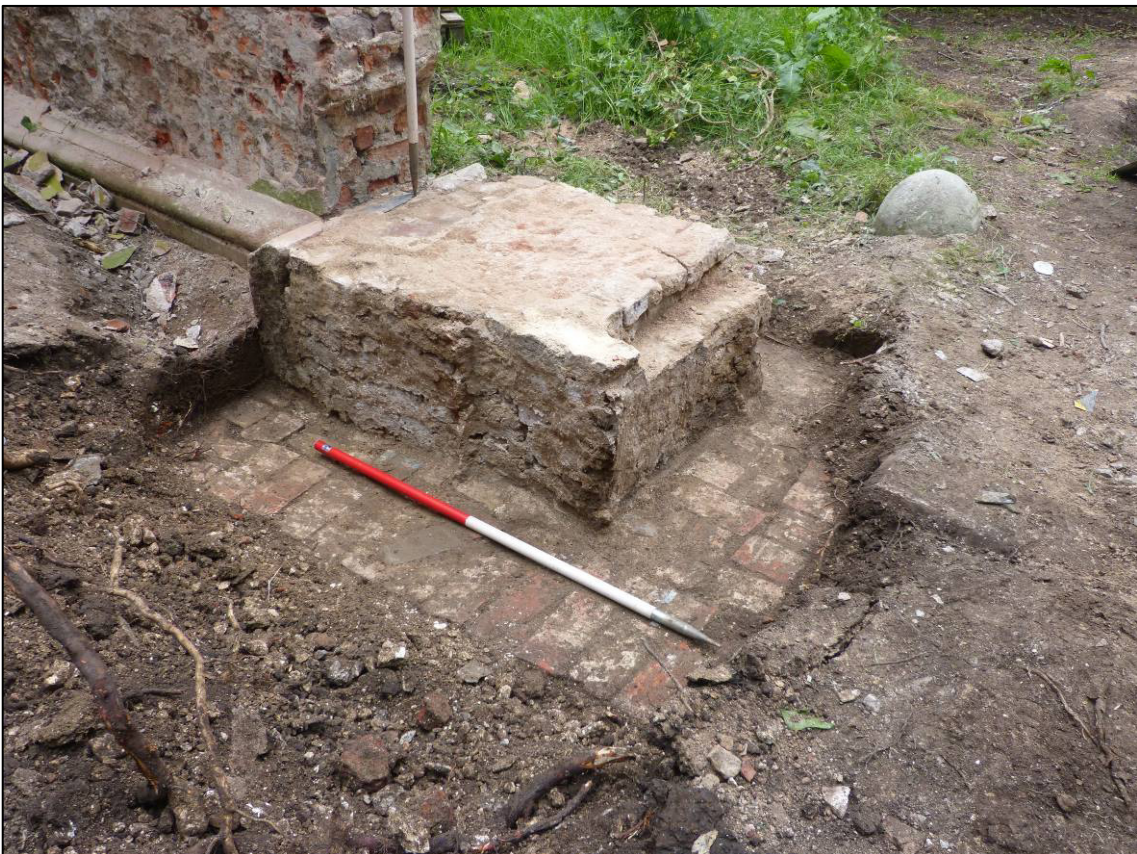
Plate 12: Exposure of pier base and brick platform to Pier 3, looking S (photo 2/042).

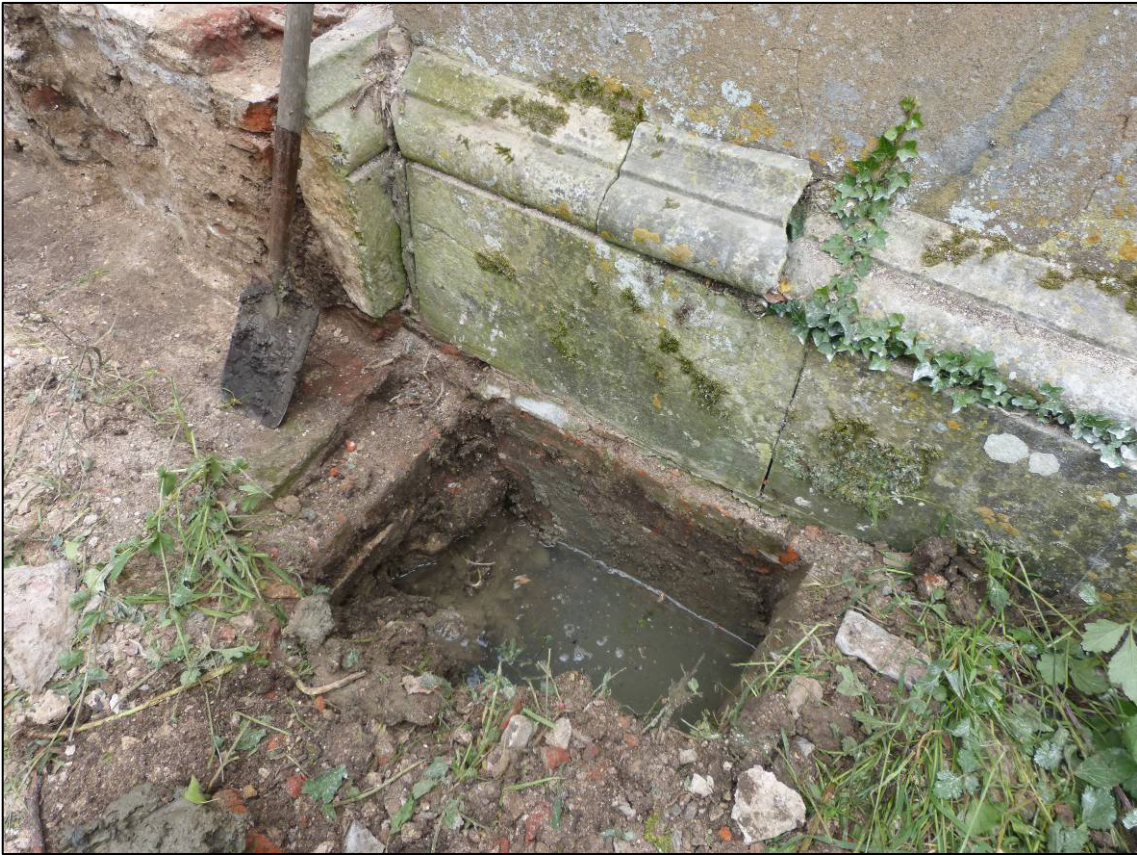
- 3.7 The wing walls clearly butt the gate piers; the plinth and panel mouldings of the gate piers continue behind the wing walls, whilst the plinth mouldings of the wing walls abut those of the piers, rather than the angles being formed by mason's

mitres (see plate 13). When the south gate pier (Pier 3) was dismantled, it was noted that the adjoining brickwork of the wing wall was not tied in to the pier's structure at all for a height of 1.34m above the top of the wall's plinth (see plate 14). Above this level, there had been an attempt to crudely tie the wall into the pier in two places.

Plate 13: Footings of west side of south wing wall, and butting plinths to Pier 3 and wing wall, looking NE (photo 2/069).

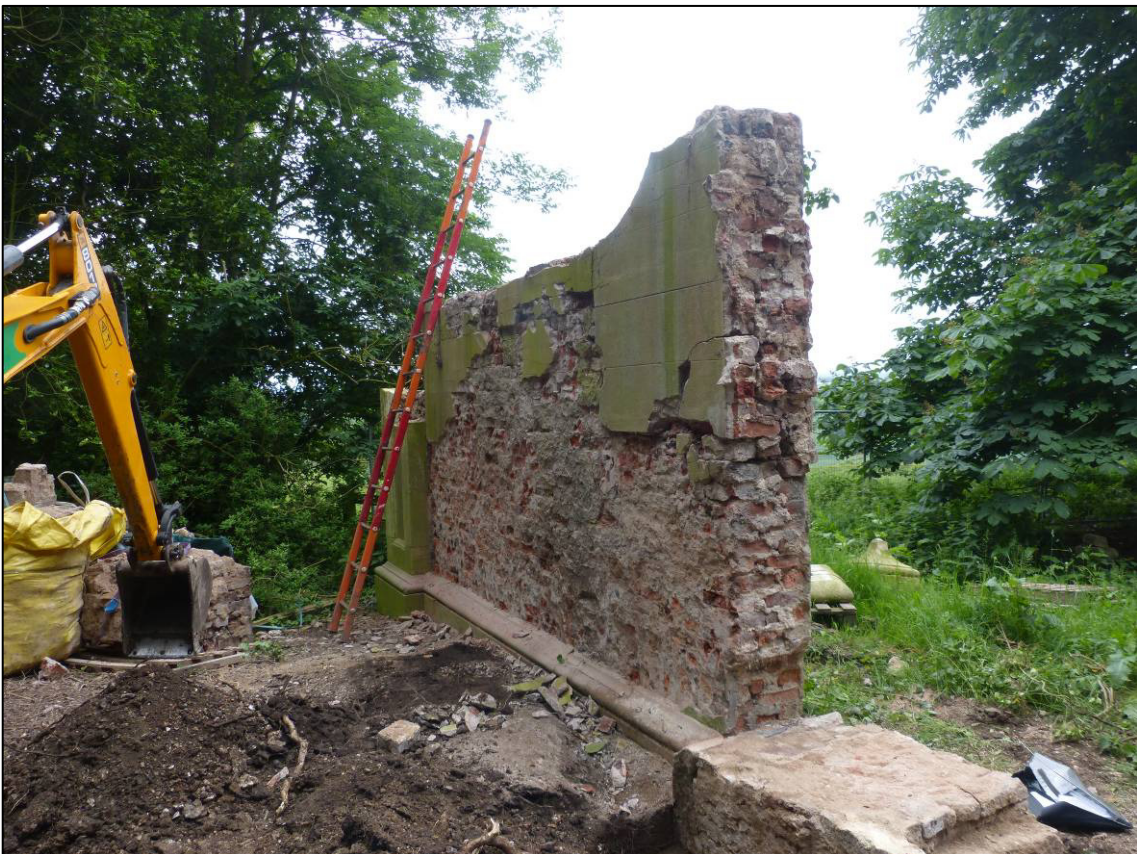
Plate 14: View of south wing wall after demolition of Pier 3, looking S (photo 2/063).

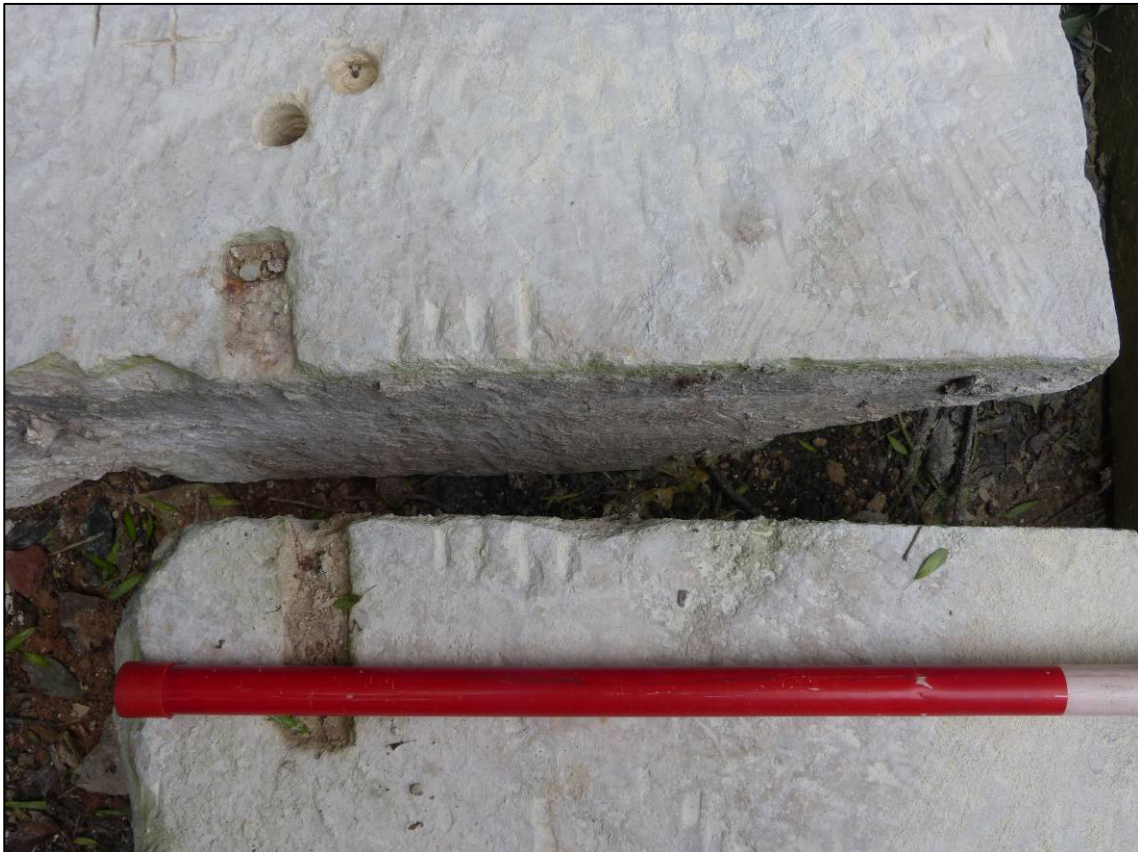
- 3.14 When the cornice of the south gate pier was dismantled and laid on the ground upside down, it was noted that a sequence of marks had been made on the edges of adjacent stones by the masons responsible for originally assembling the structure (as opposed to those who had carved the stones). Described in a clockwise direction, the numbering was 'III', 'V' and then 'VI' (see plate 16). A similar numbering system was noted to the cornice stones of the north pier (Pier 2) when this was dismantled, but in this case the marks did not match up, suggesting that either the stones were re-arranged to make a better fit as the cornice was built or perhaps that it had been dismantled once before and re-erected in the wrong order (Stone Edge contractors, *pers. comm.*). In addition to these assembly marks, a single 'X' mason's mark was noted to the underside of one of the stones. The cornice stones were held together using wrought-iron cramps, averaging 0.20m long and 0.02m deep at the ends. At the time of the EDAS survey, there were a number of *ex situ* cramps on site which were on average 0.50m long and 0.03m deep at the ends. It is assumed that these latter type were used to secure the stones of the pier face panels together.

Plate 16: Dismantled south gate pier cap (Pier 3), showing assembly marks to underside (photo 2/065).
