REPAIRS TO GATEWAY,
FYLING DEER PARK WALL, FYLINGDALE,
NORTH YORKSHIRE

ARCHAEOLOGICAL RECORDING

Report no: 2019/581.R01
Version: Final
Date: May 2019
Author: Ed Dennison

North York Moors National Park Authority
The Old Vicarage
Bondgate
Helmsley
York YO62 5BP

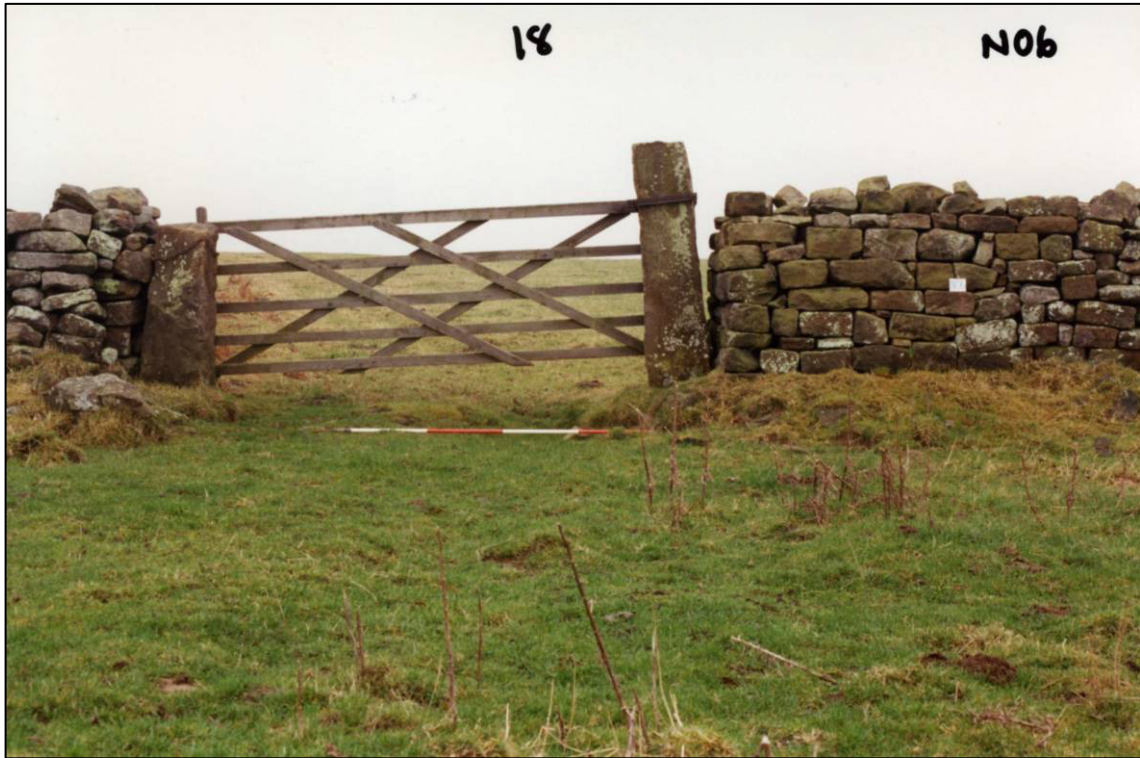
- 4.4 It was the western gate post that had been damaged, and it had a lean of some 10° to the east from the vertical. In actual fact, comparison with photographs of the gateway taken in 1991, as part of a general photographic survey of the deer park wall, shows the gate post with the same lean - it was the fact that the adjacent wall end which had been altered, increasing the gap between wall and post which gave the impression that the post was leaning more than it should be (see plates 1 and 2). This alteration may have been done because the north side of the wall end was leaning towards the post (see plate 3). Comparison with the 1991 photograph also shows that the gate had been replaced.

Plate 1: South side of gateway, looking N, taken 1991 (courtesy NYMNPA).

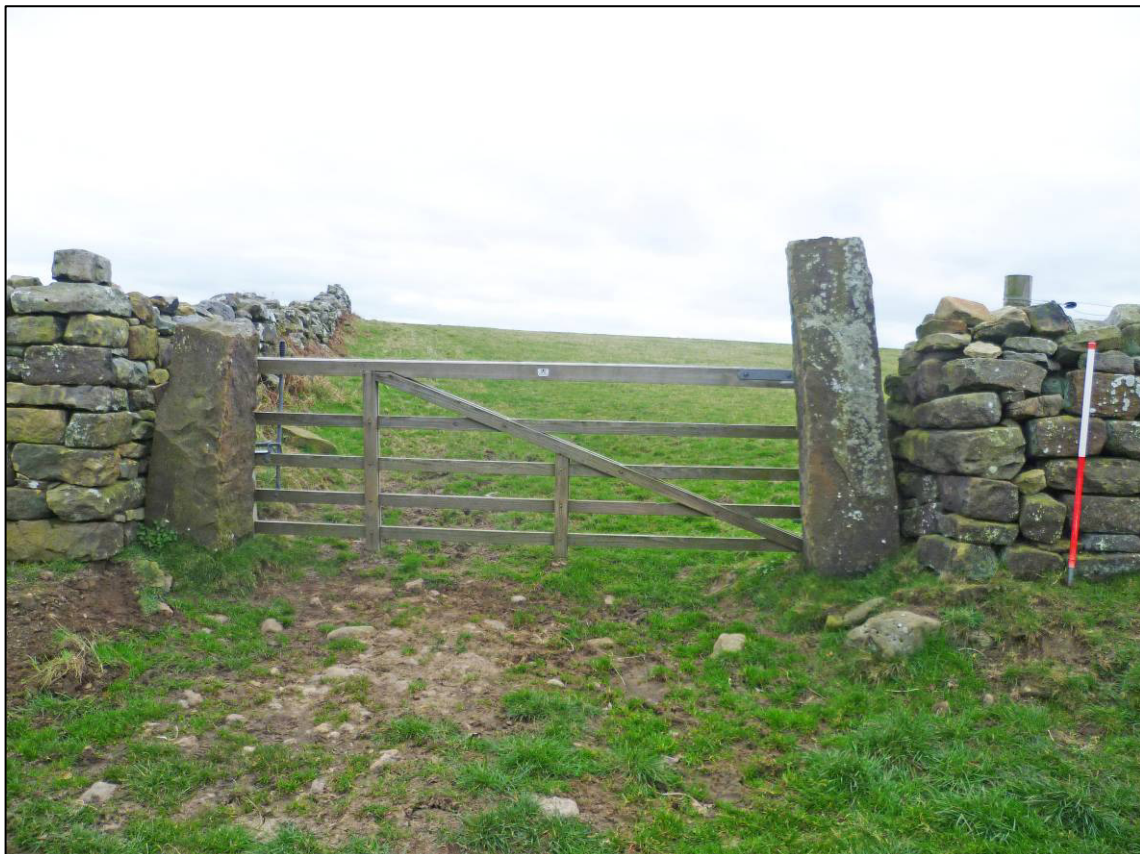
- 4.3 The gateway measures 3.10m wide at ground level. Prior to the work, there was some erosion through the gateway opening, mainly due to the fact that the ground level on the south side of the gate was slightly higher than that on the north; this is a characteristic of the wall in general, with the ground on the north side of the wall (i.e. inside the deer park) being between 0.7m-1.4m lower than that to the south (Dennison 2018, 12). The presence of large stones forming the foundation of the wall could be seen in the eroded ground crossing the gateway opening, showing that the gateway was a relatively recent feature, presumably created once the park had been abandoned and returned to agriculture, at some point after the late 17th century.

Plate 2: South side of gateway, prior to repairs, looking N (photo 1/293).

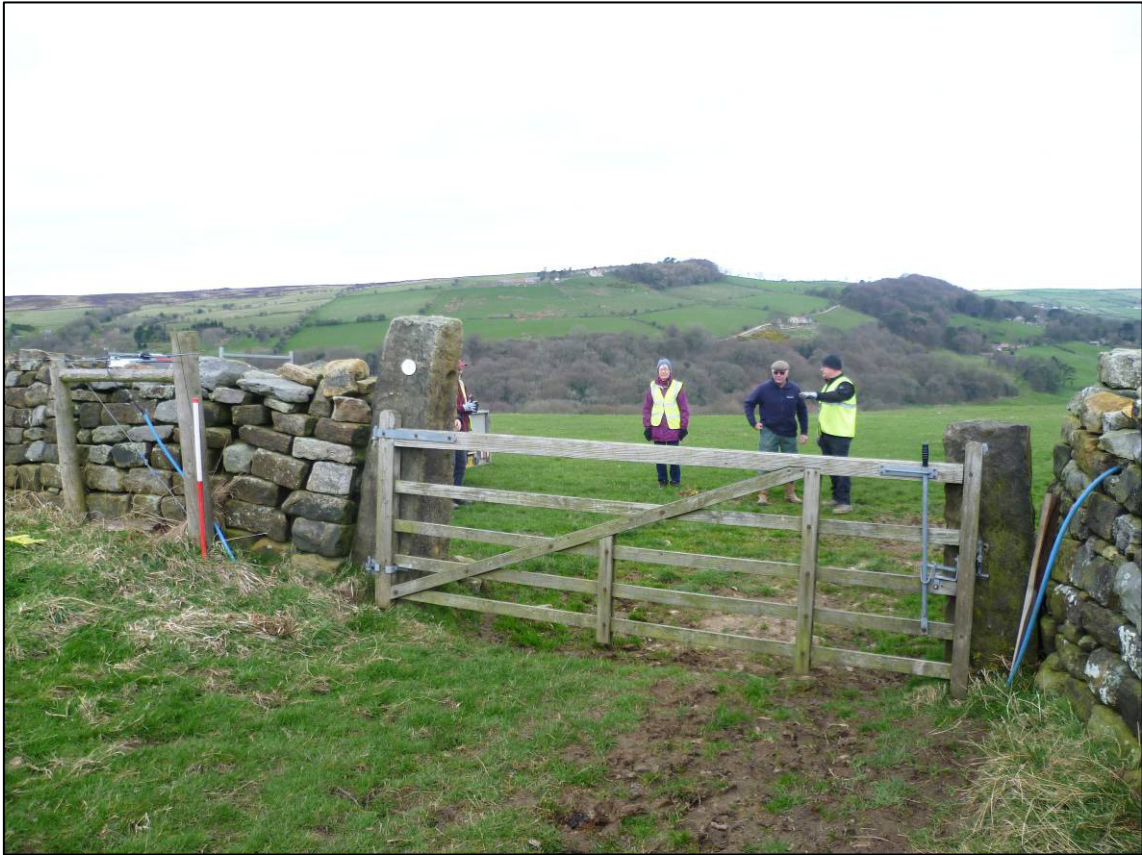
Plate 3: North side of gateway, prior to repairs, looking S (photo 1/295).

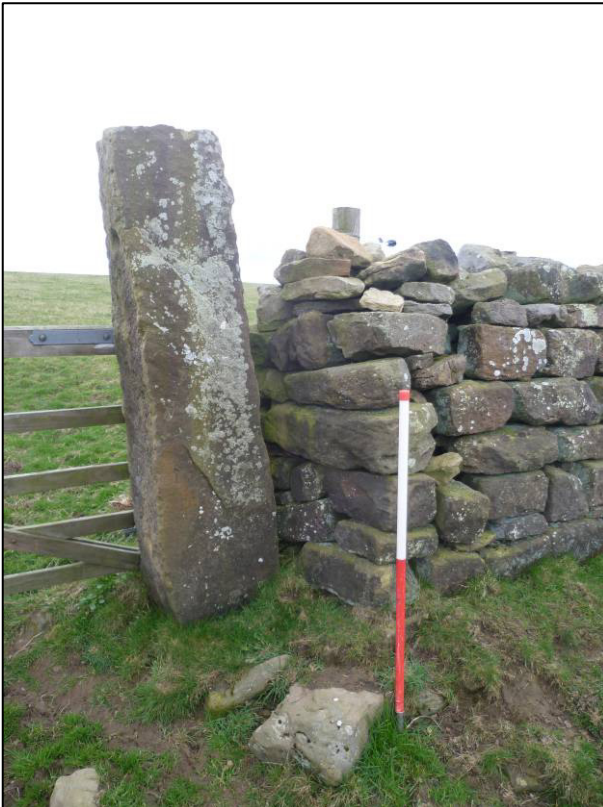
- 4.5 Prior to repair, the western gatepost measured 1.76m high by 0.47m wide and 0.41m deep at ground level. By comparison, the smaller eastern gatepost measured 1.16m high by 0.42m wide and 0.43m deep at ground level. Neither post contained any markings or graffiti, although there were some holes for previous pintels and catches, showing that the gate had been re-hung several times in the past; there was also a central hole towards the top of the inner face of the western post, of uncertain function. The opening was crossed by a wooden post and rail gate, hung with new pintels on the western post (see plate 3). The western wall end measured 1.06m high and was 1.09m wide at the base and 0.82m wide at the top, with several loose courses (0.38m high) on top (see plate 4).

Photo 4: Western wall end and gatepost prior to repair, looking SW (photo 1/298).

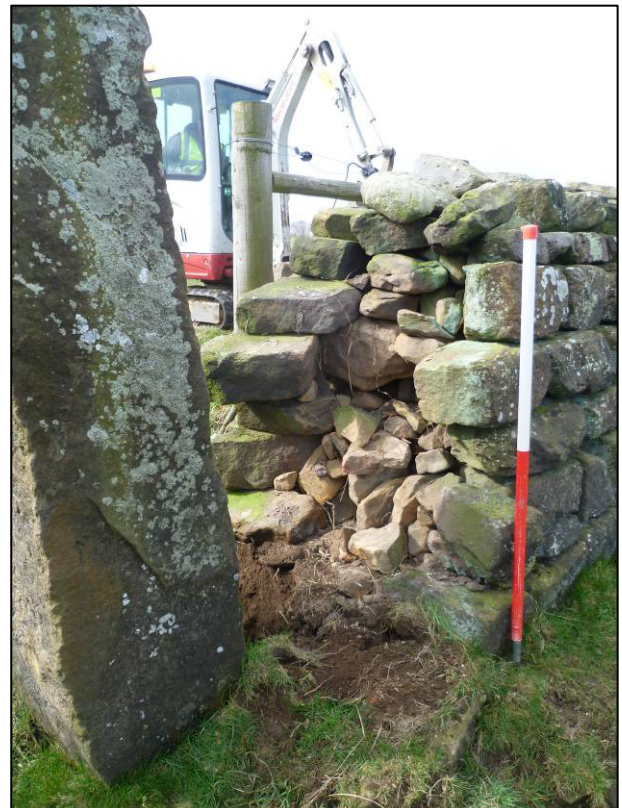
along the alignment, with regularly cut coursed stones forming either face and rubble infill (“hearting”), and there were no throughstones at this point (see plates 5 and 6). A small excavation up to 0.4m deep was then made by hand around the western base of the post to facilitate its restoration to a more upright position, using a small mechanical Kubota excavator to pull the post upright (see plates 7 and 8). The exposed soil comprised a smooth mid-brown clay with no distinguishing features. The removal of this soil showed that 0.40m of the post had been buried, making its full height 2.16m.

Plate 5: Western wall end during dismantling, looking SW (photo 1/303).

- 4.6 In order to re-position the gatepost, the western wall end was taken down, and the stones carefully laid out so they could be replaced in their original positions. The wall construction was the same as that noted during previous repairs elsewhere

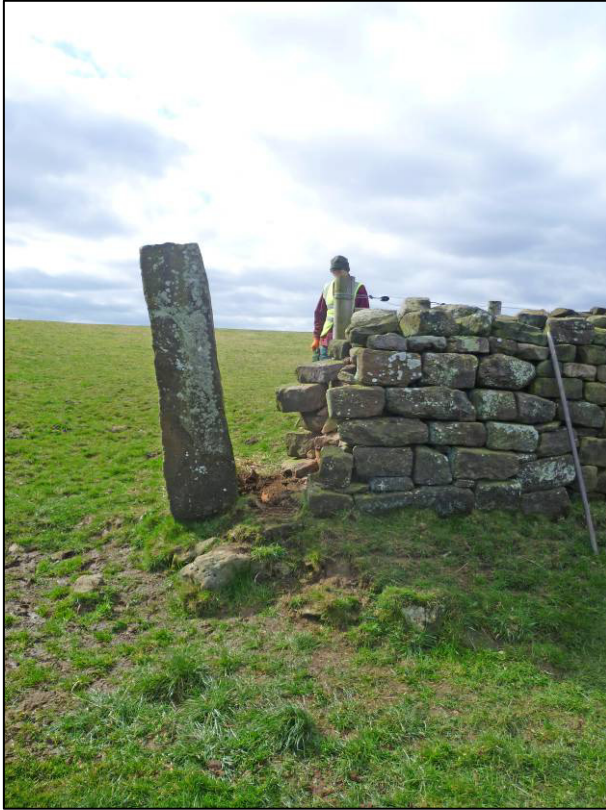
Photo 6: Western wall end after dismantling, looking S (photo 1/302).

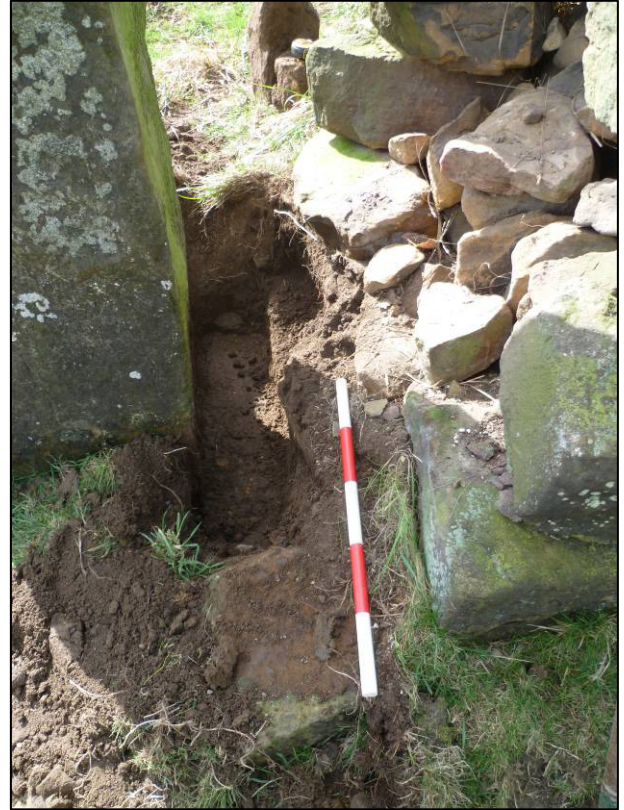
Plate 7: Limited excavations on west side of gatepost, looking S (photo 1/307).

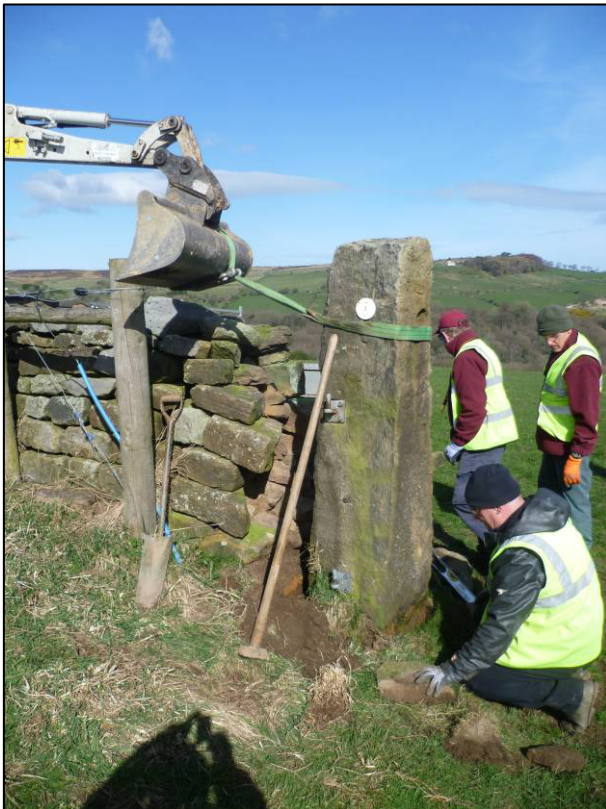
Photo 8: Straightening western gatepost, looking N (plate 1/304).

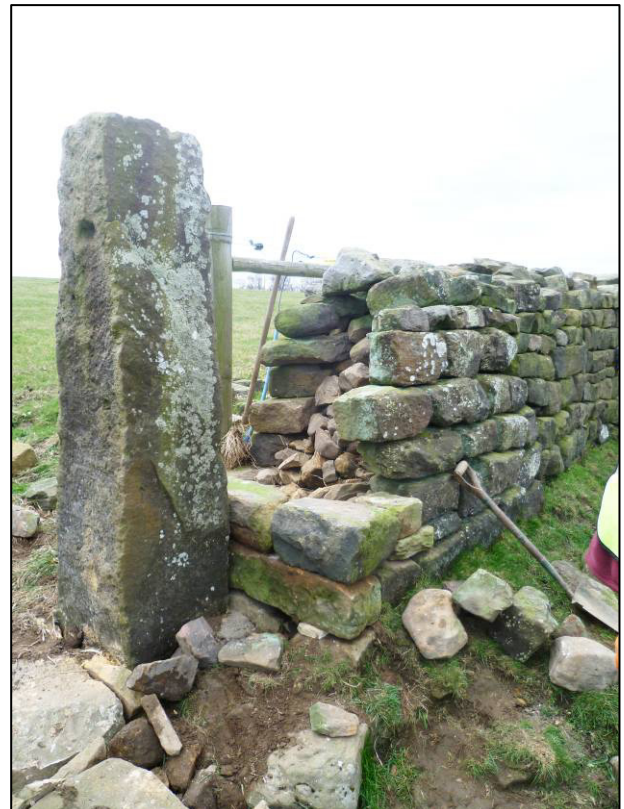
Plate 9: Rebuilding western wall end, looking SW (photo 1/312).

- 4.7 Once the post was re-positioned, larger stones found lying near the adjacent wall end, left over from previous repairs, were placed against the east side of the base to prevent later movement (see plate 10), and the wall end was rebuilt so that its base virtually butted against the base of the post (see plates 9 and 11). The rest of the wall end above was then rebuilt using the dismantled stones replaced in their original positions as far as was possible, respecting the coursing but also incorporating a few throughstones for stability and with a slight batter away from the post so as to reduce pressure on the post (see plate 15); the gap at the top of the wall measured 0.18m (see plates 12 and 13). Once repositioned, the post measured 1.65m high, and the wall end measured 1.15m wide at the base and 0.86m at the top. The wooden gate was re-hung on new pintels on the western post, and the catch on the eastern post was re-positioned to ensure smooth opening (see plates 13 and 14). A new bridleway marker was then placed on the south face of the western post. Finally, the erosion hollow within the gate opening was infilled using soil provided by the landowner, and the resulting surface was reseeded with a grass mix (see plates 16 and 17).

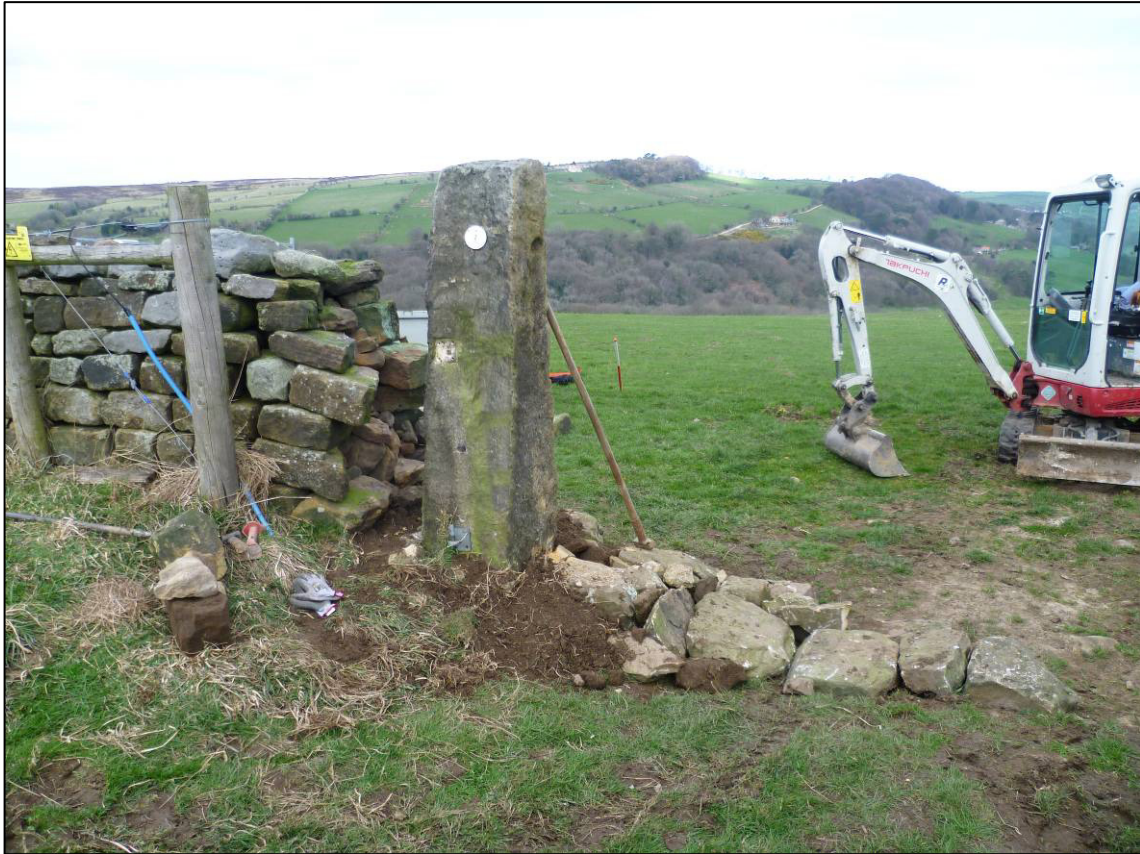
Plate 10: Straightened western gatepost, looking N (photo 1/310).

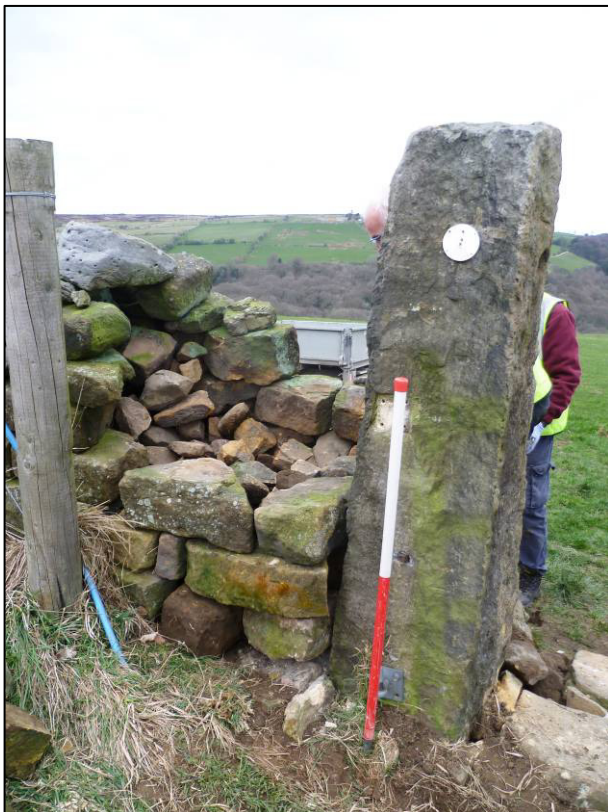
Plate 11: Rebuilding western wall end, looking N (photo 1/314).

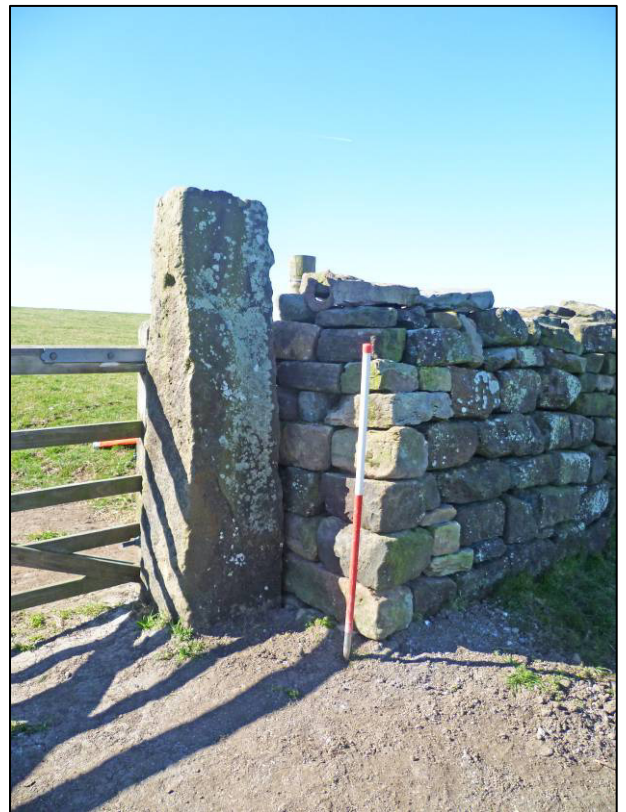
Plate 12: Rebuilt western wall end, looking SW (photo 2/339).

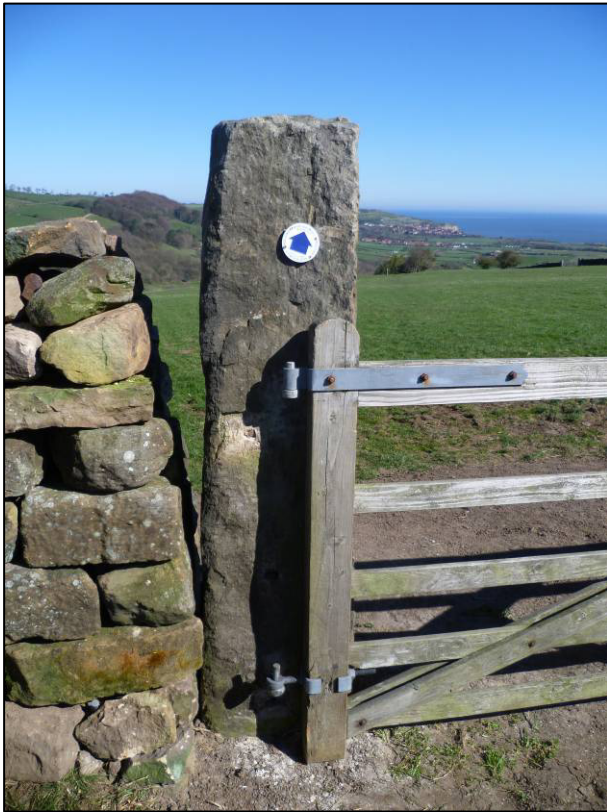
Plate 13: Repositioned western gatepost and rebuilt wall end, looking N (photo 2/351).

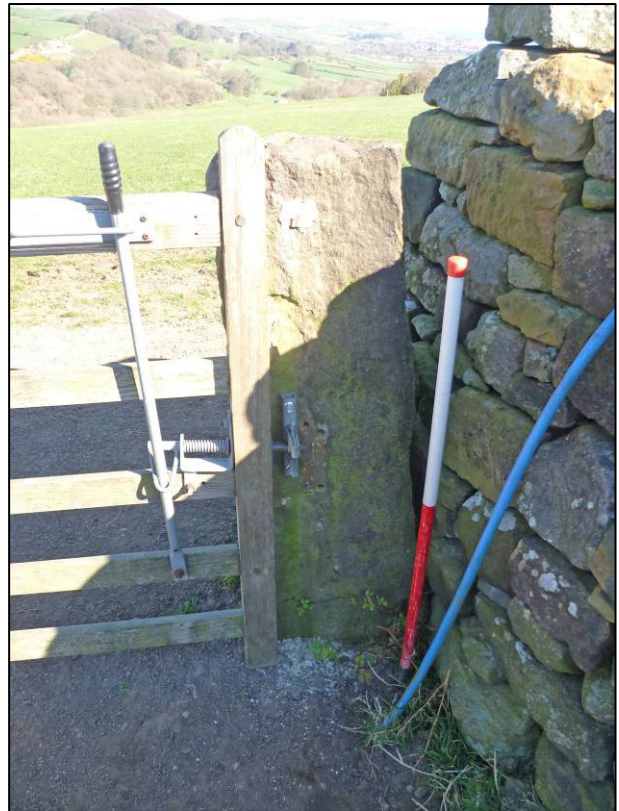
Plate 14: New fittings to eastern gatepost, looking N (photo 2/343).

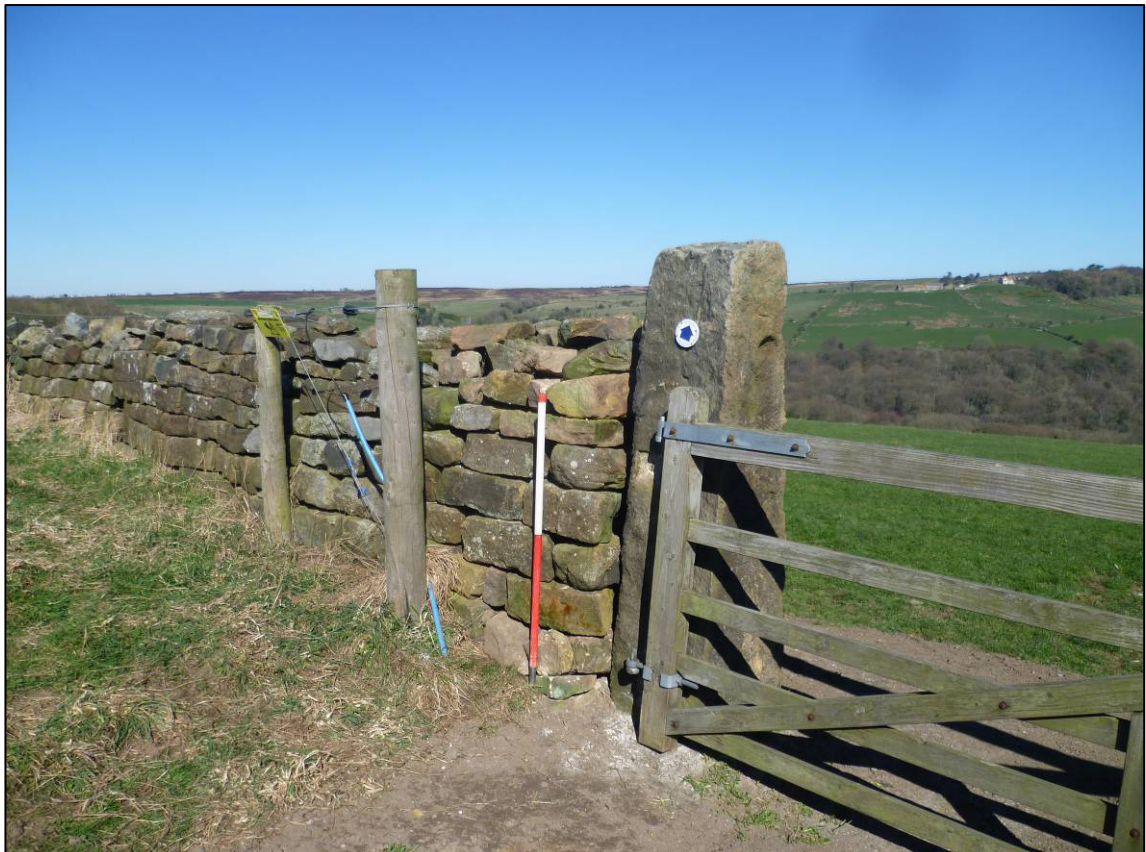
Plate 15: Repositioned western gateway, rebuilt wall end and re-hung gate, looking NW (photo 2/346).

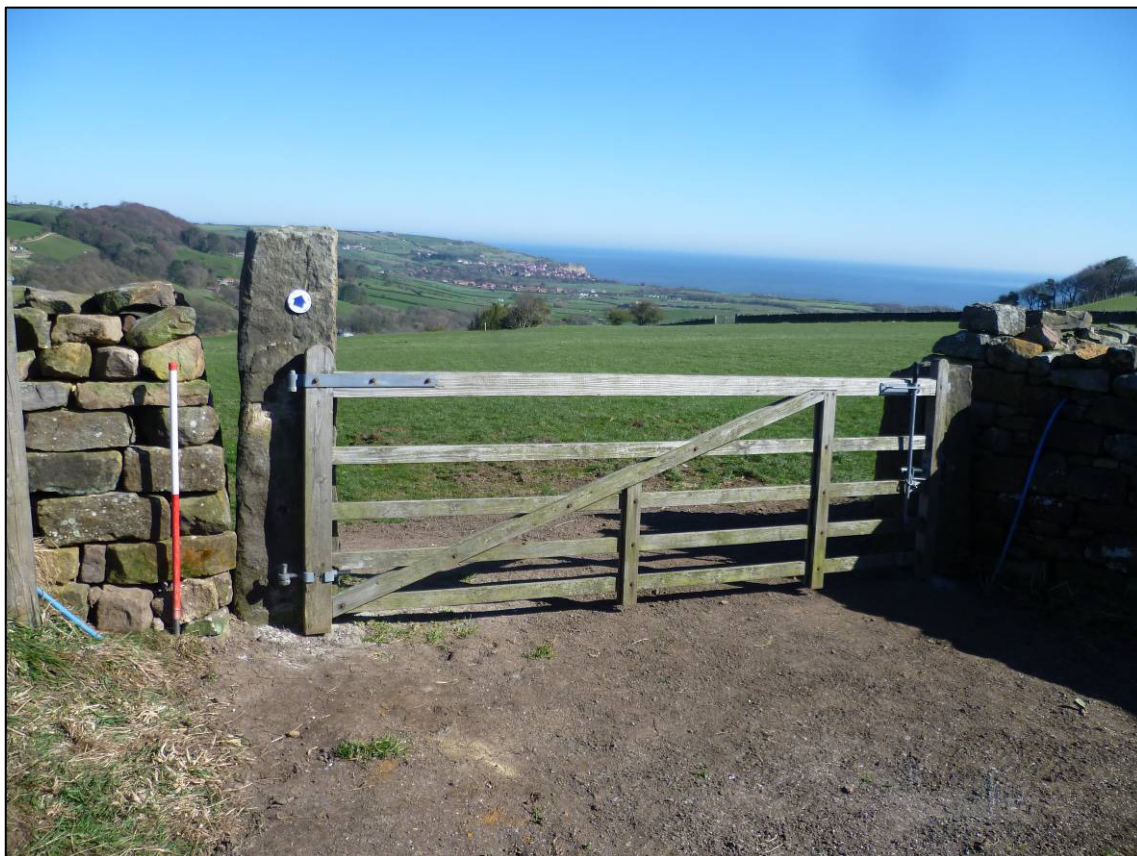
Plate 16: Repaired gateway, looking N (photo 2/344).

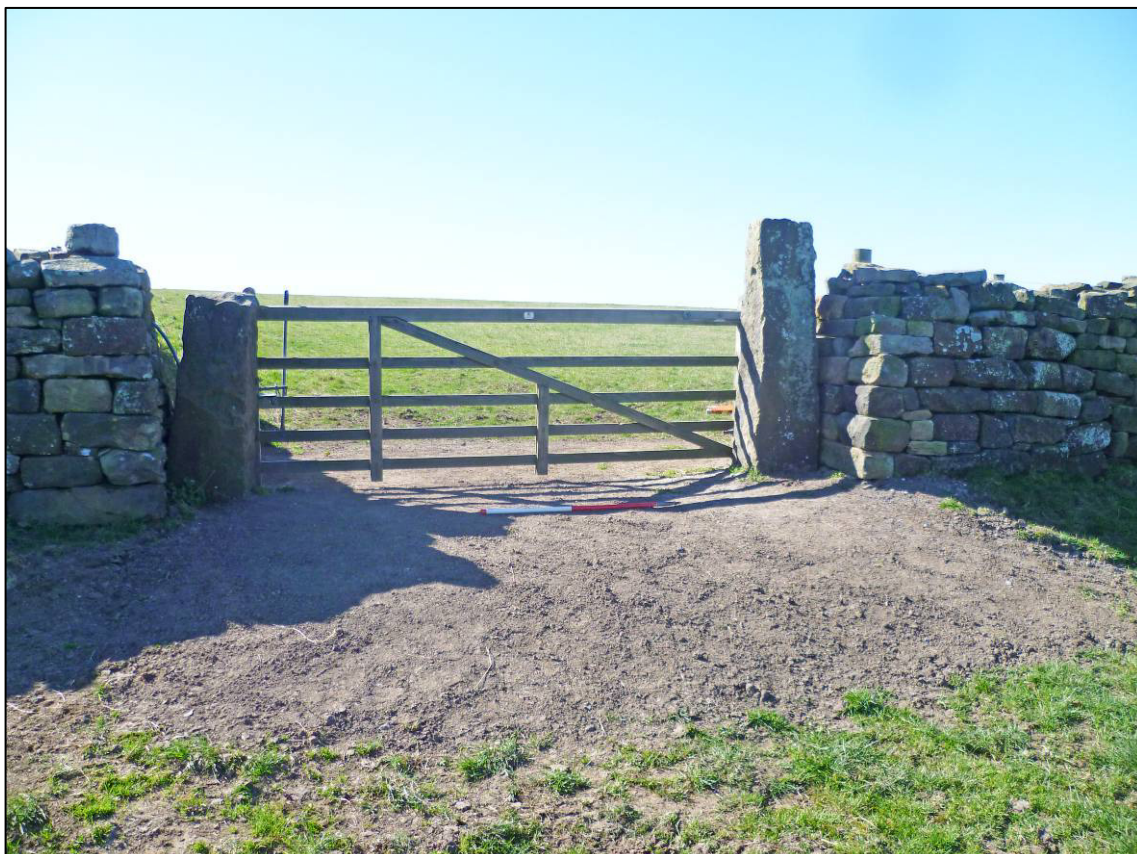
Plate 17: Repaired gateway, looking S (photo 2/349).
