ESTATE SHOOTING TRACK,
NORTH-EAST OF NORTH INGS PLANTATION,
SKELDERSKEW MOOR,
NEAR COMMONDALE, NORTH YORKSHIRE

ARCHAEOLOGICAL MONITORING
OF EROSION REPAIRS

Report no: 2020/621.R01
Version: Final
Date: August 2020
Author: Ed Dennison

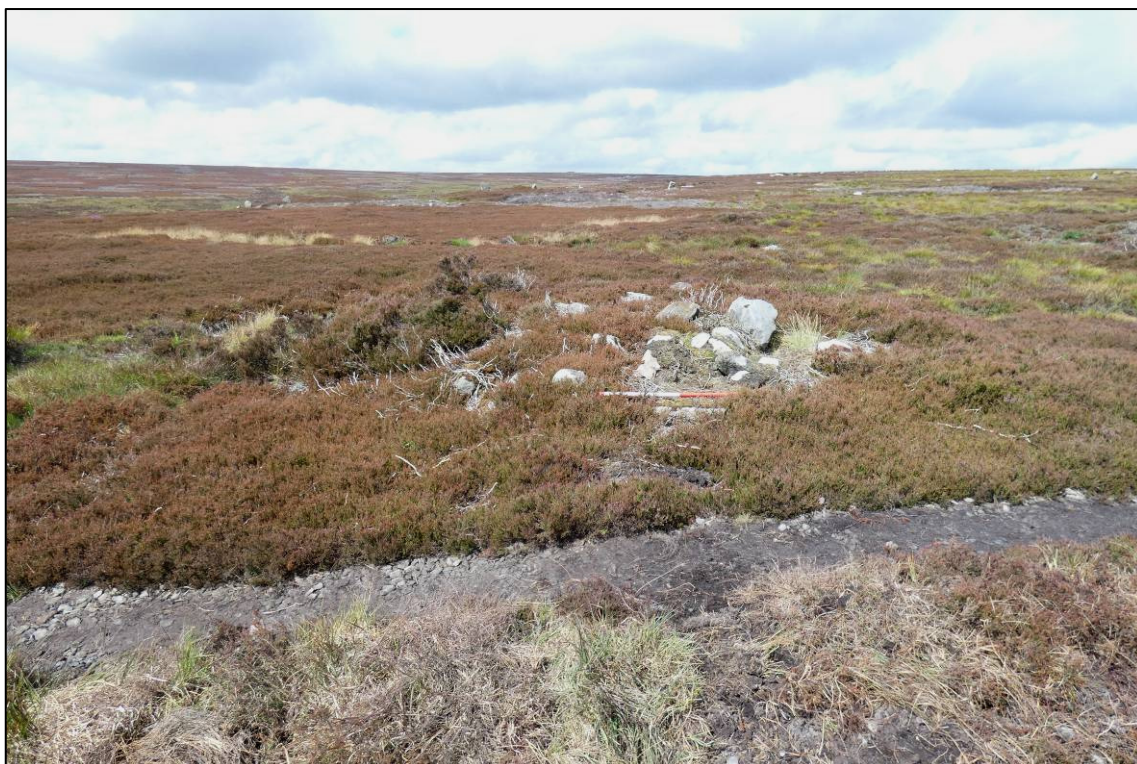
- 2.3 The monument stands up to 0.50m in height, with all sides defined by relatively spread, gently sloping, scarps [2/875-2/877] (see plate 1). The exception is to the north-east quadrant, where it appears that the outer edge has been cut back or otherwise truncated. The flattened top surface of the earthwork is broadly sub-rectangular in plan, measuring a maximum of 3.00m north-south by 2.00m east-west. The break of slope at the edge of the top may once have been edged or defined by larger stones, and a number of stones remain visible in the upper surface, including one set on edge (Dennison & Richardson 2019). The Scheduled Monument description notes that there is a hollow in the top of the cairn where it has been dug into in the past, although this was not clearly visible at the time of the previous EDAS survey. There is nothing in the surviving structure of the cairn or the surrounding topography to suggest that the monument was formed around a natural rock outcrop, and so it assumed that all of the stone used in its construction was gathered specifically for that purpose. There is no evidence for the trackway crossing the top of the earthwork, as suggested by the modern Ordnance Survey map (see figure 2).

Plate 1: Cairn, looking W (photo 2/875).

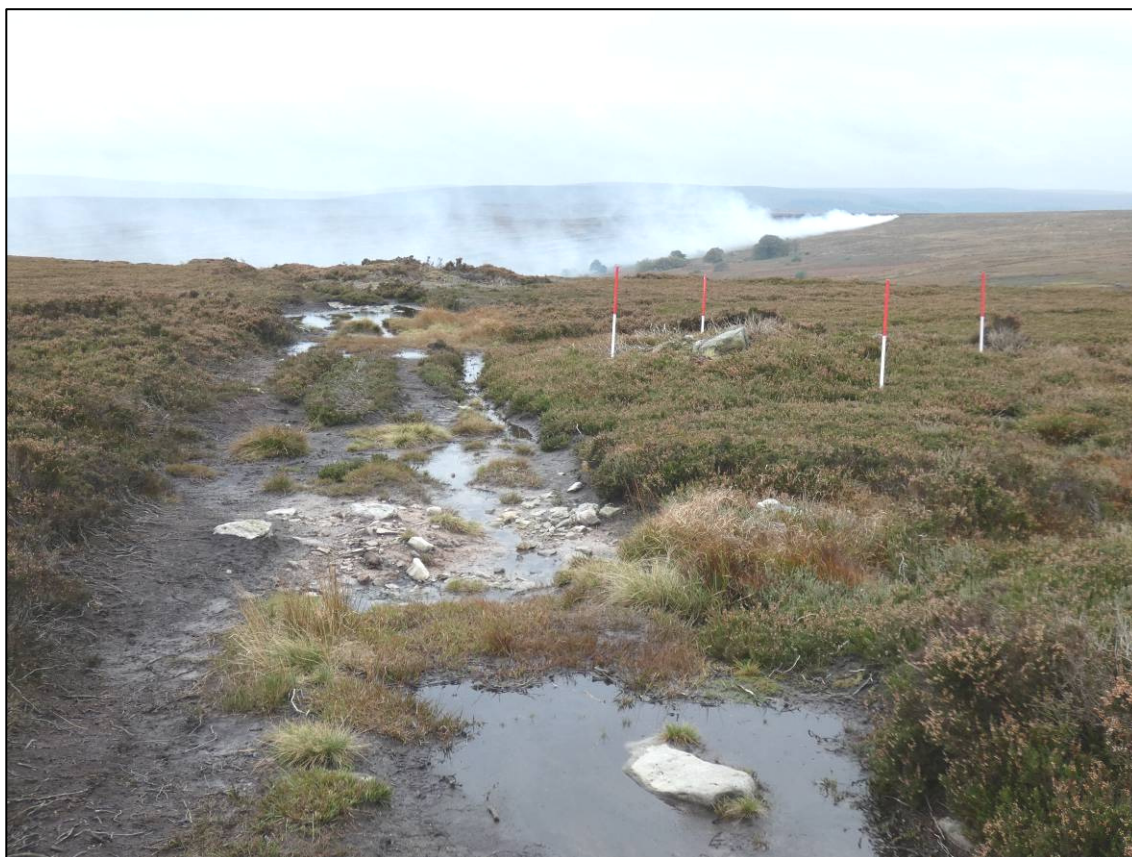
- 2.5 The shooting track runs on a broadly north-south alignment, 1.20m to the east of the cairn and 6.70m to the east of the shooting butt [1/674]. It is between 2.50m and 3.00m wide, and its slightly sinuous course is undulating, formed by occasional sections of stone rubble (representing previous attempts at erosion control), some hollows or depressions in which run-off accumulates, and areas of degraded vegetation with some vehicle ruts (see plate 2).

Plate 2: General view of shooting track showing proximity to cairn, water ponding and previous repairs (10th October 2019).

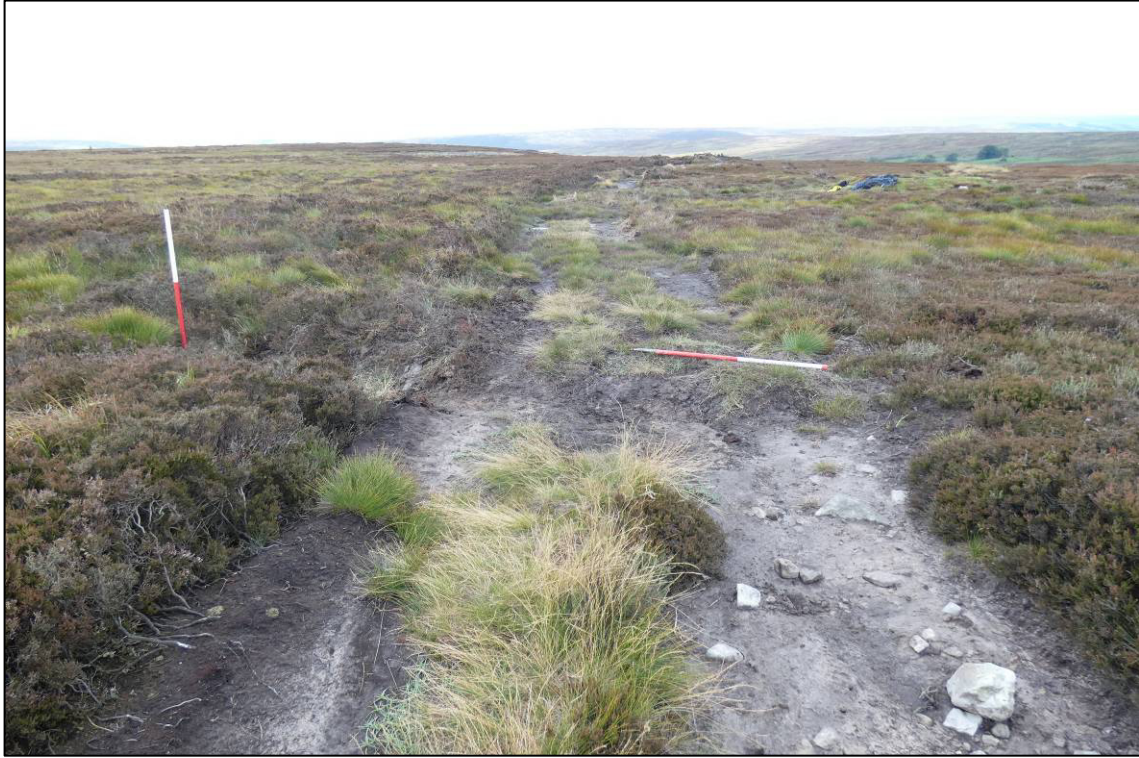
Plate 3: Area 1 - drain and bank across track complete, looking S (photo 2/849).

- 3.2 The northernmost element of work involved the excavation of a short drainage ditch, 2.00m long, 0.45m wide and 0.30m deep, running from the east side of the track in an easterly direction to allow water run-off to flow into an existing apparently natural channel just to the east [1/686]. This excavation was accompanied by a slight reduction of the ground surface in the centre of the track, and spoil was then placed across the track as a narrow 0.3m high bank to force run-off into the channel [1/689, 1/690; 2/847, 2/849, 2/850, 2/880] (see plate 3).

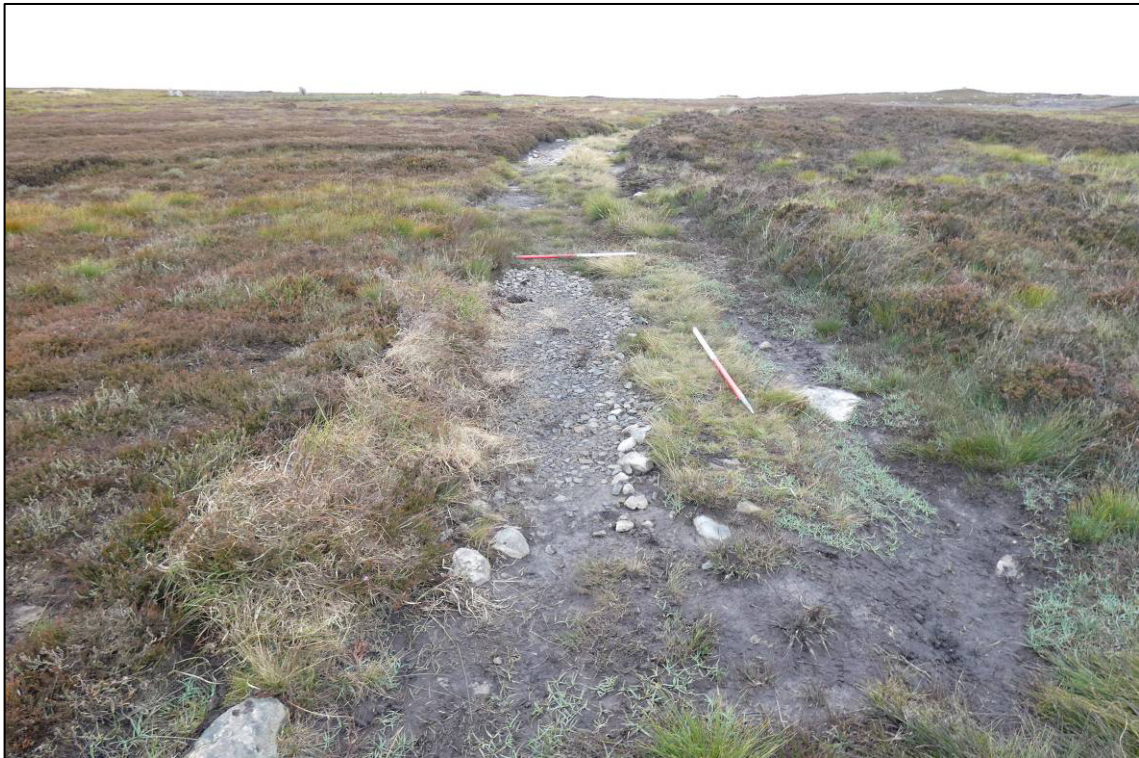
Plate 4: Area 2 - infilling of ruts complete, looking N (photo 2/852).

- 3.3 To the south of Area 1, there was some slight vehicle rutting in the track, including one more pronounced on the west side, extending over an area of 3.50m north-south by 0.75m wide. This was infilled with sandstone rubble aggregate brought in from outside the site and compacted, and some new turves were added to the western edge [2/852, 2/881] (see plate 4).

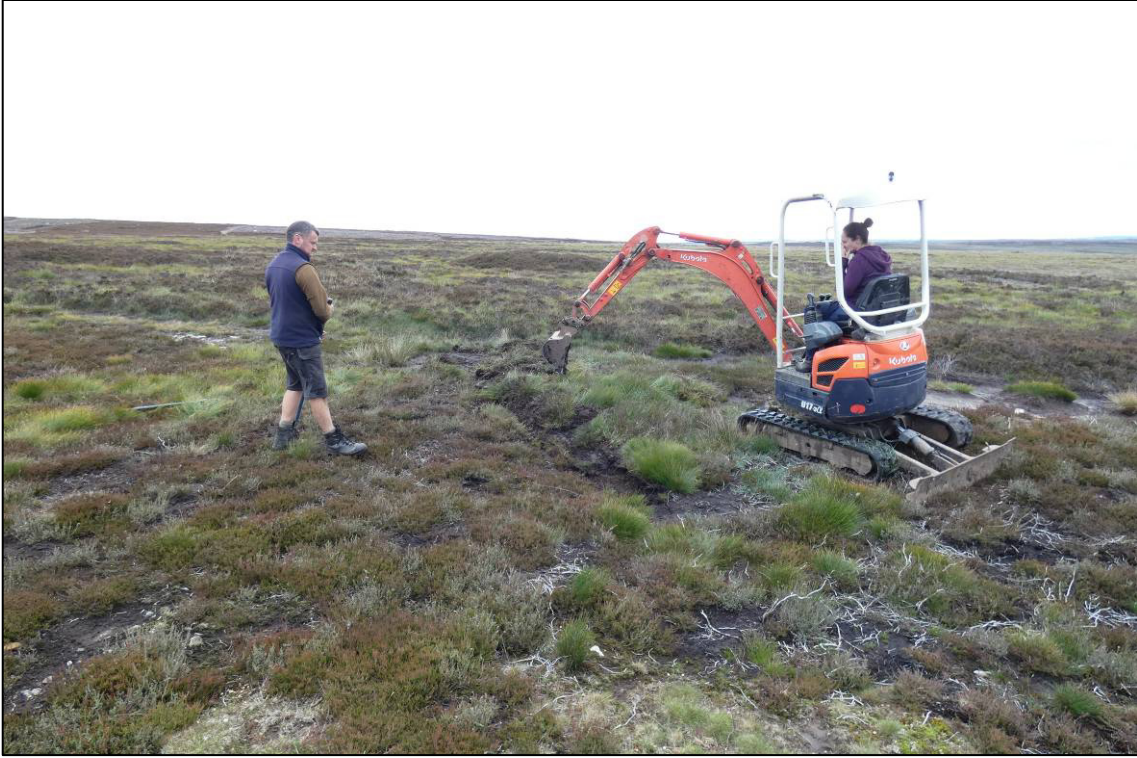
Plate 5: Area 3 - start of drain excavation, looking NE (photo 1/693).

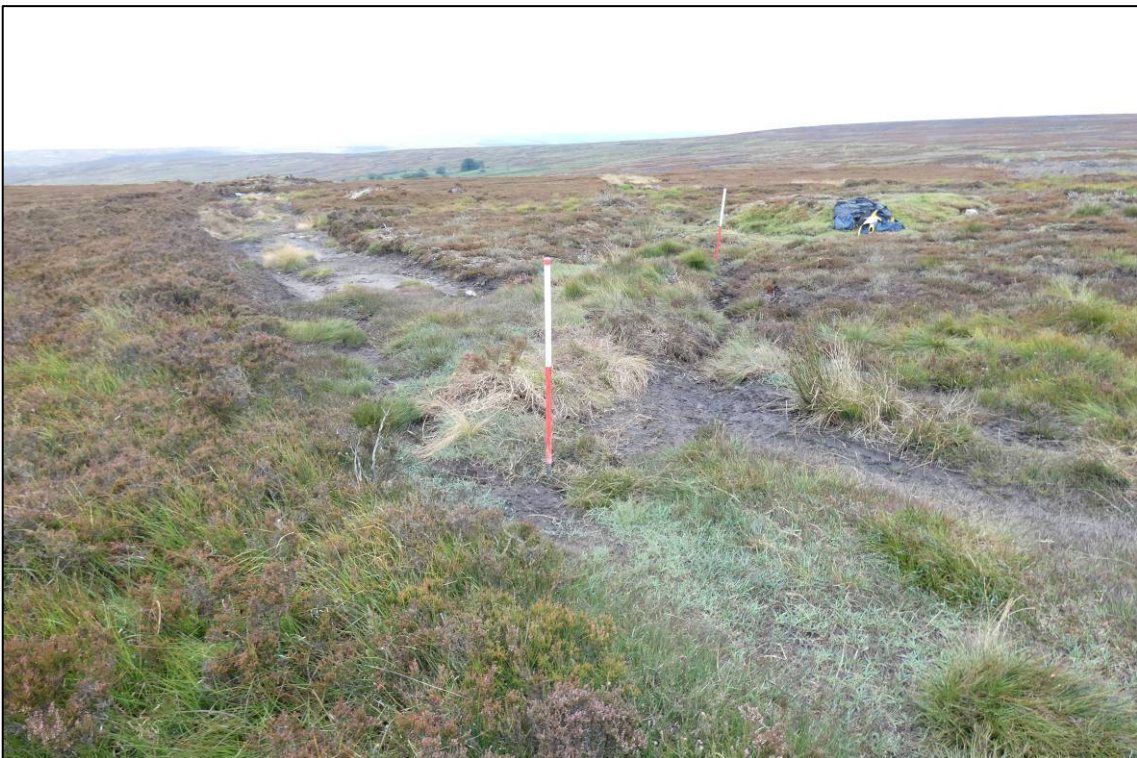
Plate 6: Area 3 - drain and bank across track complete, looking SW (photo 2/854).

- 3.4 Some 7m to the south, another drainage ditch was excavated from the west side of the track, in a south-west direction for a distance of 5.00m towards the south-east corner of the shooting butt [1/691, 1/693] (see plate 5). This ditch was 0.45m wide and 0.40m deep, and again water run-off flowing down the track was channelled into it by constructing a 0.30m high slightly angled bank across the track [1/694, 1/697-1/699; 2/853-2/855, 2/857] (see plate 6).

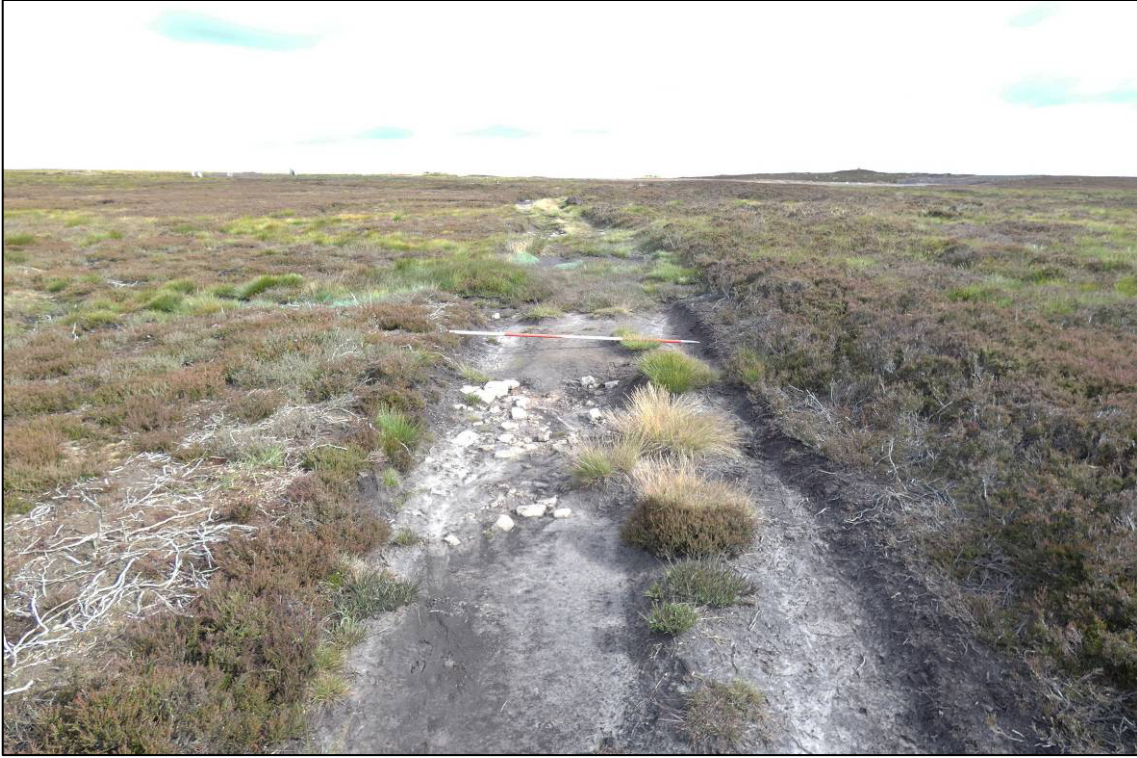
- 3.5 At this point, a small area of stone rubble had been placed on the west side of the track, as part of previous repairs [1/678] (see plate 7). This area was subject to some limited regrading and re-covered with sandstone rubble aggregate brought in from outside the site, and then compacted. The repairs covered an area measuring 2.75m north-south by 2.00m wide [2/858, 2/860] (see plate 8).

Plate 7: Area 4 - stone rubble in track prior to repairs, looking N (photo 1/678).

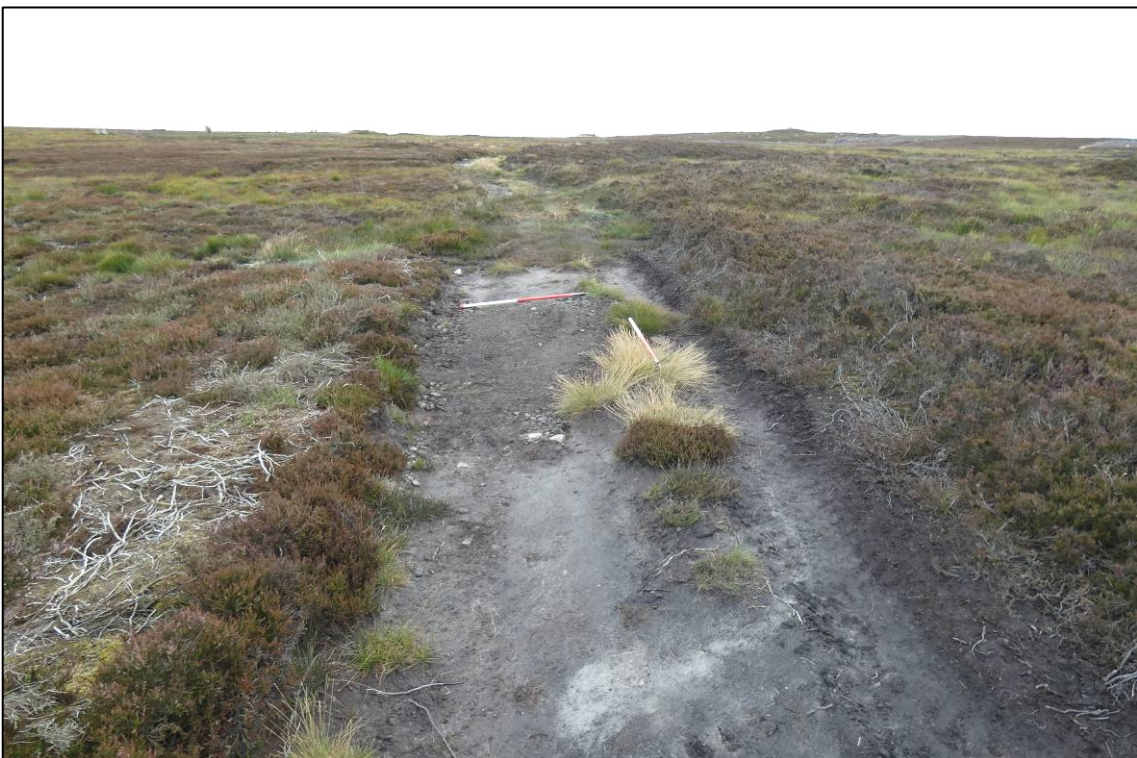
Plate 8: Area 4 - repairs complete, looking N (photo 2/858).

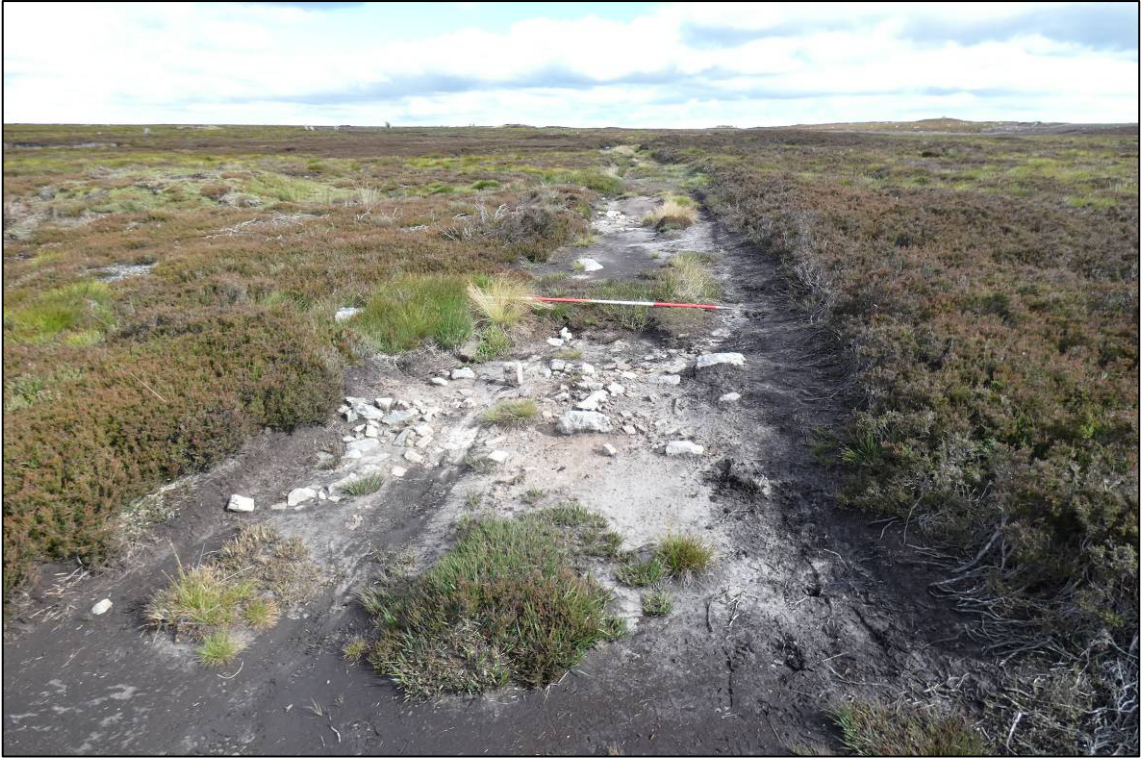
- 3.6 A larger area of stone rubble had been placed in the track as part of previous repairs, and this was becoming eroded and its surface being damaged, especially on the east side [1/677, 1/679, 1/695, 1/696] (see plate 9). The effect of this rubble was to produce a localised higher area and pond water immediately to the south, which was evident at the time of the previous survey. The rubble was reduced in height by no more than 0.20m in depth, the area of 'excavation' covering an area of 3.90m north-south and almost across the full width of the track (2.50m) [1/700-1/703]. Slightly more than the reduced area was then covered with sandstone rubble aggregate brought in from outside the site, and compacted to create a more level surface. New turves were also placed on the east side of the repair [2/862-2/864] (see plate 10).

Plate 9: Area 5 - stone rubble in track prior to repairs, looking N (photo 1/677).

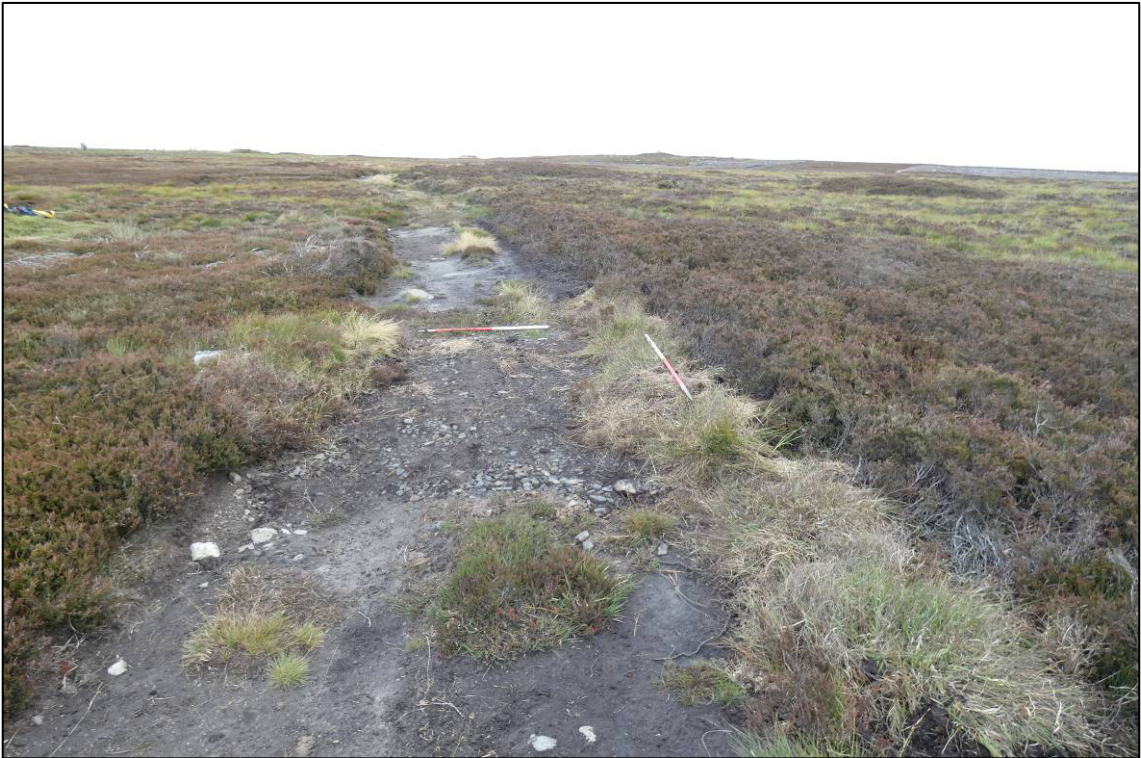
Plate 10: Area 5 - repairs complete, looking N (photo 2/862).

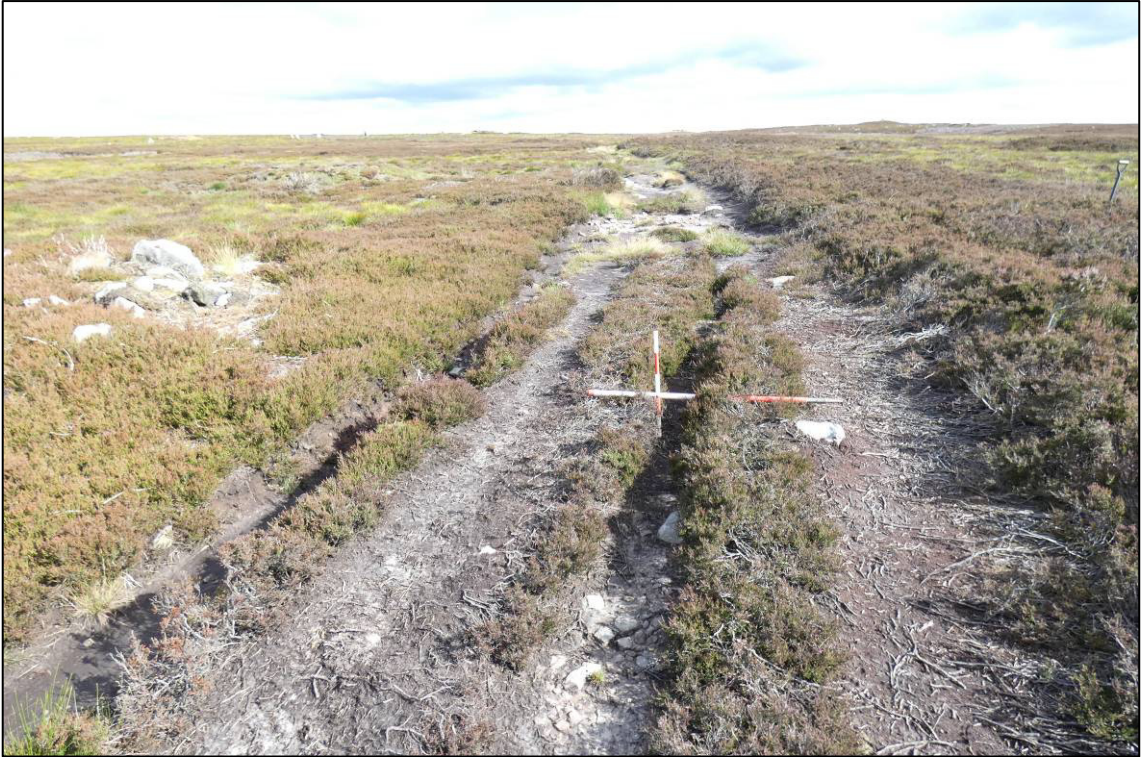
- 3.7 Prior to the repairs, there were two vehicular ruts in the shooting track adjacent to the cairn [1/675, 1/680] (see plate 11). The western rut measured 5.50m long, 0.50m wide and up to 0.35m deep, while the eastern rut was 3.50m long and slightly shallower and narrower, a maximum of 0.20m deep [1/683-1/685]. The ground surface between the ruts was also eroded and devoid of vegetation, as was the eastern part of the track, which would result in future erosion. The repair involved scraping out the loose soil and stones from the two ruts, which slightly extended the ruts to the south [1/704-1/706], and then infilling them with sandstone rubble aggregate brought in from outside the site. Once the ruts had been infilled and compacted, the slightly higher and eroded ground between them was reduced and levelled off slightly, and new heather turves, dug from the moor outside the scheduled area, were placed on the exposed surfaces [2/865, 2/868-2/870, 2/874, 2/879, 2/833, 2/887] (see plate 12). This work was designed to prevent further erosion in the wheel ruts, and to provide a firm surface for estate vehicles so there was no western encroachment onto the cairn.

Plate 11: Area 6 - vehicle ruts prior to repair, looking N (photo 1/684).

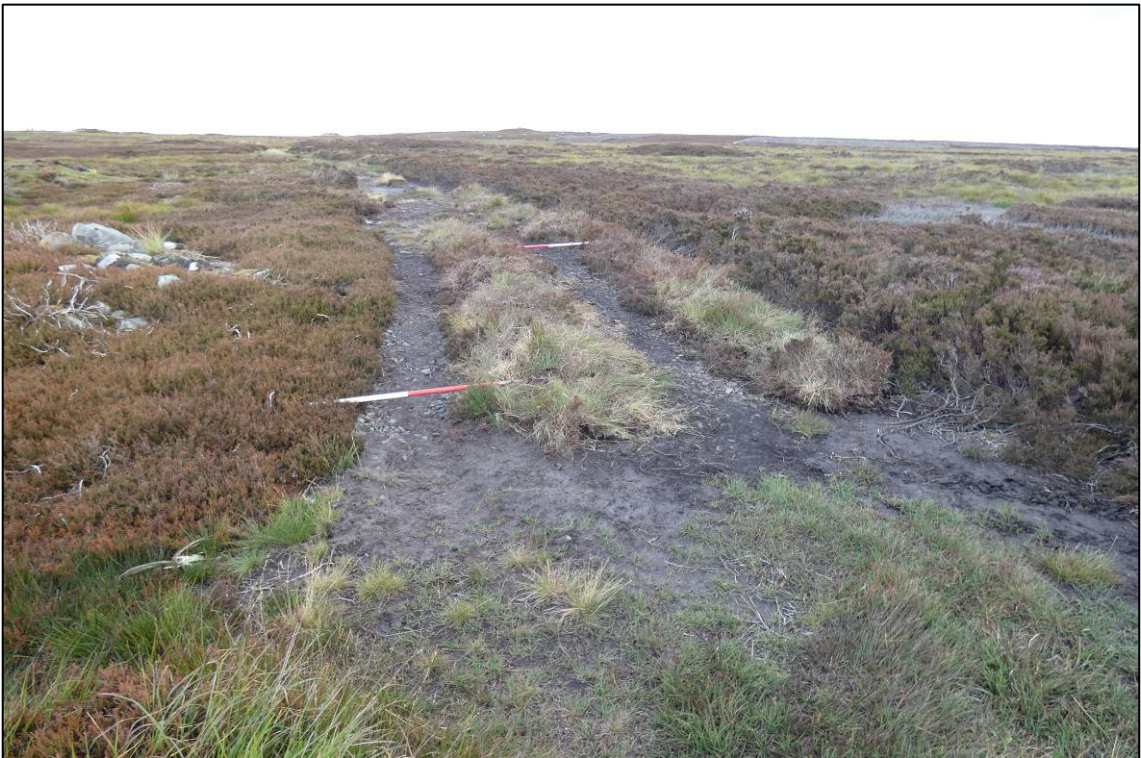
Plate 12: Area 6 - repairs to ruts complete with re-turving, looking N (photo 2/868).

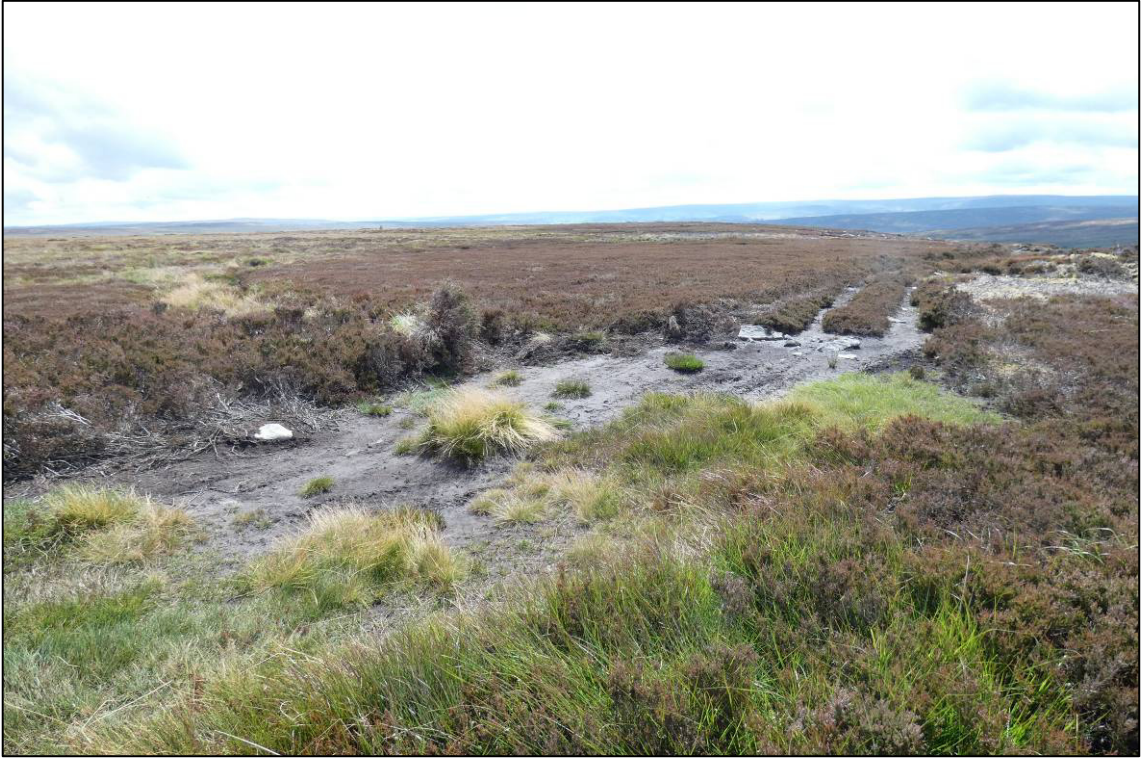
- 3.8 A third drainage channel was excavated at the southern end of this section of the track, from its east side in a south-easterly direction, again to link up with an existing natural drain. There was a depression in the track at this point,

emphasised by the natural slope across the track here adjacent to the cairn, in which run-off naturally ponded [1/682; 2/878, 2/888] (see plate 13). This channel measured 3.00m long, 0.50m wide and 0.40m deep [1/708, 1/709; 2/871, 2/872], and was designed to remove water which had a tendency to pond in this area.

Plate 13: Area 7- area of ponding, looking SE (photo 2/878).

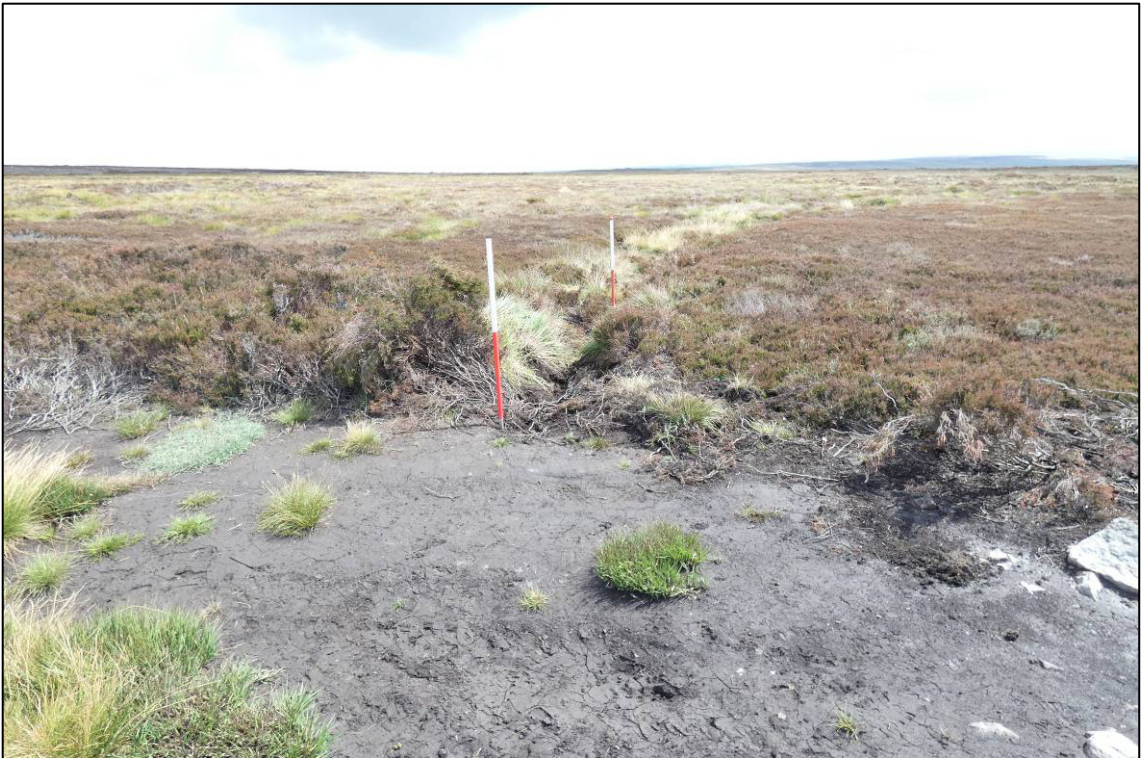
Plate 14: Area 7 - drain complete, looking E (photo 2/871).

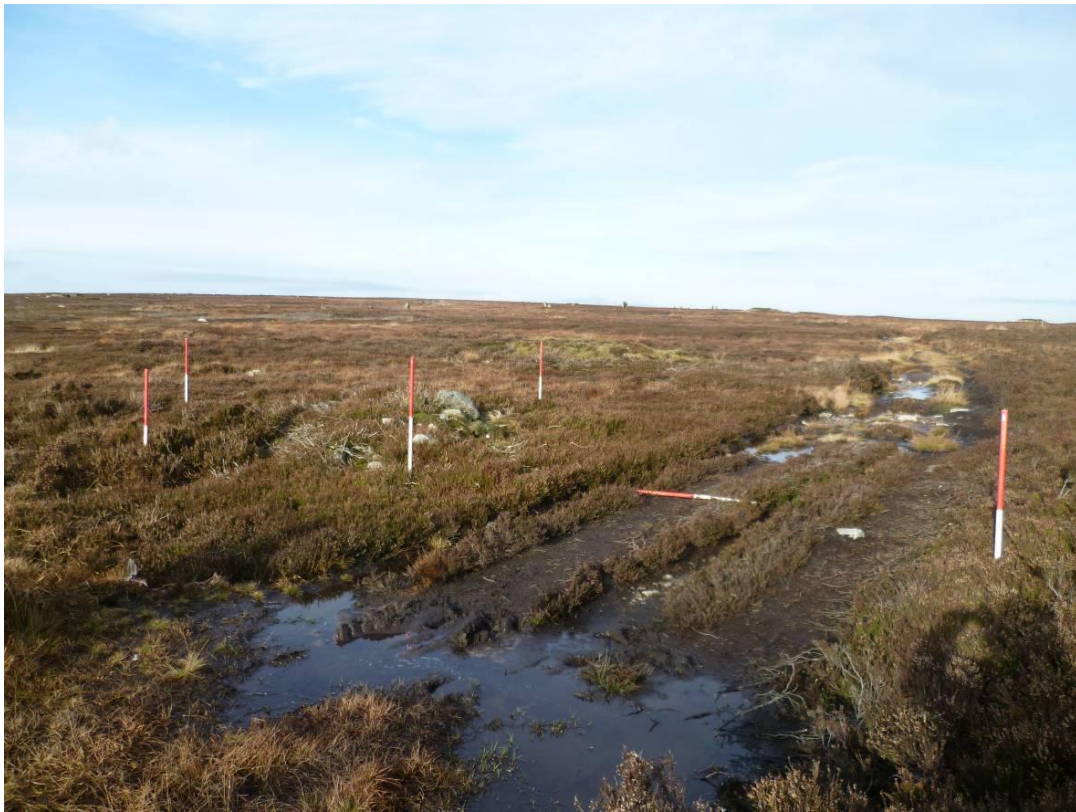
The issue to be resolved by the remedial work is erosion caused by the moorland access track running through the centre of the scheduled area and clipping the eastern edge of the SW cairn (**Plates 1-4**). The track at this point is c.2.50m wide.

Plate 1: SW cairn with track - looking NW (Photo: EDAS)

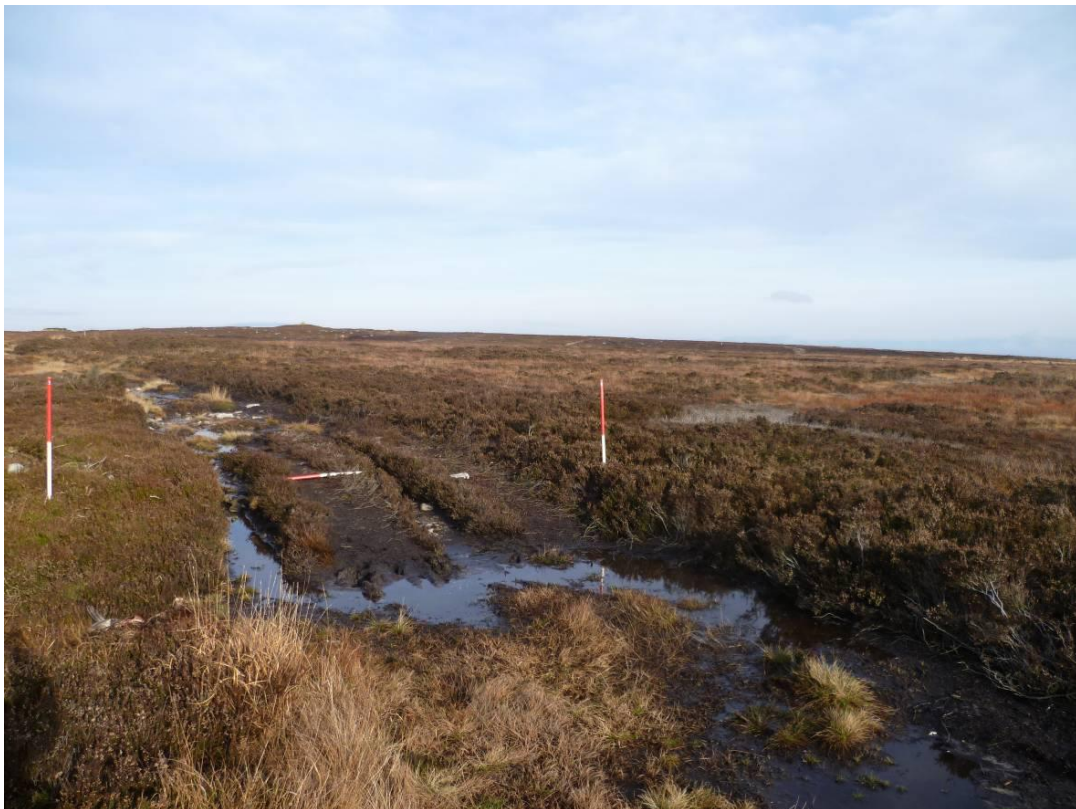
On the eastern side of the SW barrow the wheelings track has cut deep ruts, the deepest one (western most) measures approximately 6m N-S and 0.30m in depth and the eastern one

approximately 4m N-S and shallower than 0.30m in depth. As the track is only used infrequently some of the erosion is exacerbated by water running down the track. The track has moved slightly to the east to avoid the ruts and as such has created bare areas within the vegetation cover.

Plate 2: Track erosion looking NE (Photo: EDAS)

<i>Schedule of Remedial Works</i>	
<i>Item</i>	<i>Tasks</i>
A	Infill the two existing deepest ruts to the east of the SW cairn with sandstone aggregate and consolidate the wheelings tracks. Extend the wheelings to c1m to the south of the cairn, removing, if necessary, a narrow strip of the surface peat and fill with sandstone aggregate (Figure 2).
B	Infill areas of erosion where the track crosses the eastern edge of the SW barrow and the associated platform using heather turves (Figure 2).
C	Within the scheduled area to the north and south of the SW cairn infill deeper areas of erosion with sandstone aggregate (Plates 3 &4).

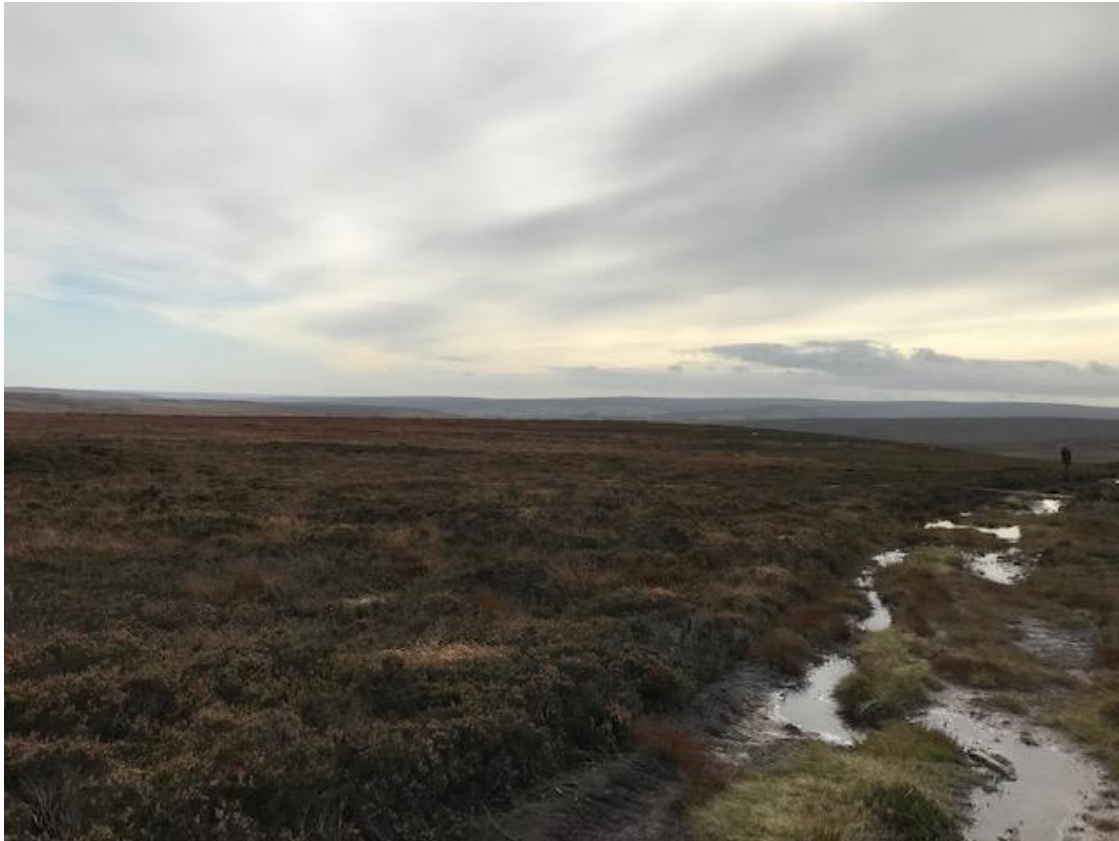
Where the track continues to the north and south of the cairn there are a number of areas of erosion within the scheduled area where water pools during wet periods (Plates 3 & 4).

Plate 3: Area between barrow and cairn with track – looking SE

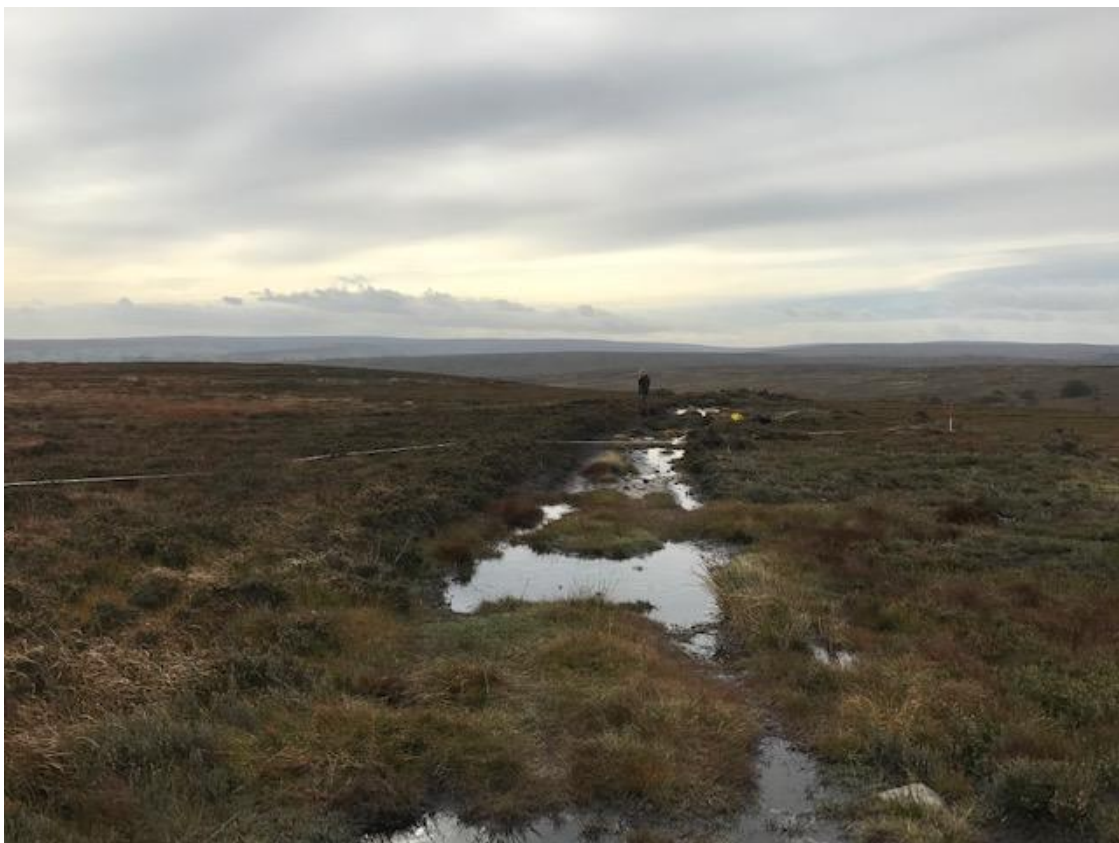
Plate 4: Track running towards SW cairn – looking SE
